City of Rancho Palos Verdes
 Rancho Palos Verdes ADA Assessment
 Facility Report with Photos

Facility ID: # 05 - Eastview Park

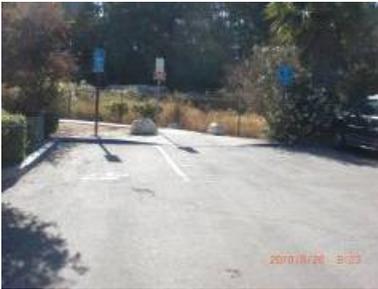
Keynote 1

| Field Condition | |
|--|---|
| 01.09 - Stall Dimensions - Accessible parking spaces, including van spaces, are not at least 9' wide and 18' long with a demarcated access aisle. (Two spaces may share a common aisle; parking space width is measured from the center line of the stripe on one side to the center line of the stripe on the other.) | 1991 ADAAG 4.6.3 |
| Existing Condition: 8'-10" by 18' | 2004 ADAAG 502.2 |

| Corrective Action | |
|--|--|
| 193B - Re-stripe for Compliant Dimensions - Re-stripe to provide parking spaces with compliant dimensions. | |

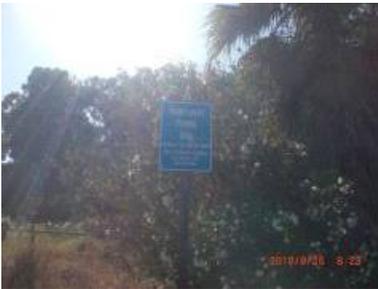
Keynote 2

| Field Condition | |
|--|---|
| 01.15B - Parking Space Sign - Accessible parking space has no reflectorized sign visible from the stall, showing an ISA in white on a blue background. | 1991 ADAAG 4.6.4 |

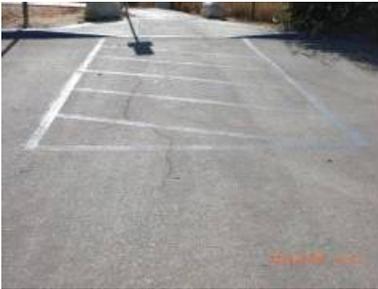
Keynote 5

| Field Condition | |
|---|---|
| 01.19A - Lettering - The words "NO PARKING" is not provided in each access aisle, painted in white, 12" high letters. | 1991 ADAAG - |

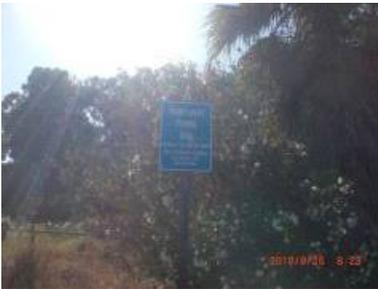
Keynote 6

| Field Condition | |
|---|---|
| 01.19B - Tow-away Sign - A California tow-away sign is not posted in a conspicuous place at each entrance to off-street parking lot, or immediately adjacent to and visible from each accessible stall. | 1991 ADAAG - |
| Existing Condition: Non-compliant tow-away sign, the term "Handicapped" is used. | 2004 ADAAG - |

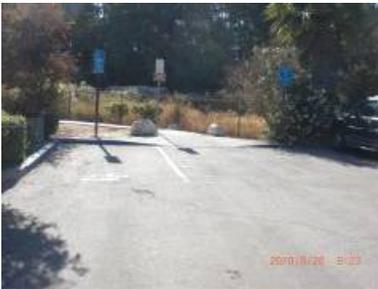
Keynote 8

| Field Condition | |
|---|---|
| Existing Condition: 2.6% to 4.2% RS. | 2004 ADAAG 502.4; advisory 502.4 |

| Corrective Action |
|--|
| 194 - Asphalt Paved Parking Stall and Access Aisle - Remove non-compliant pavement and replace with new asphalt paving. The parking space and access aisle slope shall not exceed 2% in any direction. |

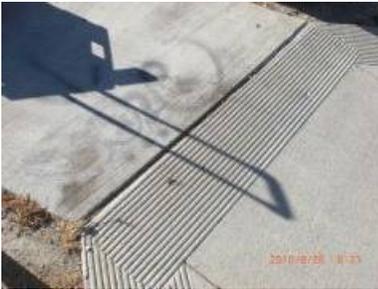
Keynote 9

| Field Condition | |
|--|---|
| 03B.22 - Other - On-Site Accessible Path of Travel - See Additional Comments | 1991 ADAAG - |
| Existing Condition: 1" gap. | 2004 ADAAG - |

| Corrective Action | |
|---|--|
| 005B - Concrete Crack Repair - Clean-out existing concrete crack and inject with epoxy grout. Cracks over 1/4" in width will require a foam backer rod and sealant. | |

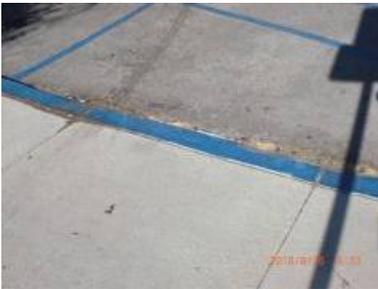
Keynote 10

| Field Condition | |
|--|---|
| 04.03 - Transition - The transition from the curb ramp to the road or gutter is not flush or free of abrupt changes. | 1991 ADAAG 4.7.2 |
| Existing Condition: 1" lip. | 2004 ADAAG 406.2; Fig. 406.2 |

| Corrective Action | |
|--|--|
| 120D - Replace Curb Ramp - Remove existing curb ramp, provide new. | |

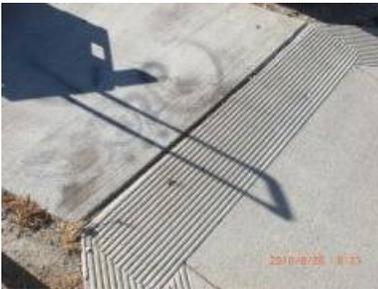
Keynote 11

| Field Condition | |
|---|---|
| 04.09B - Grooved Border - Location - A 12" wide grooved border has not been provided on the level surface of the walkway. | 1991 ADAAG - |
| Existing Condition: On sloped surface. | 2004 ADAAG - |

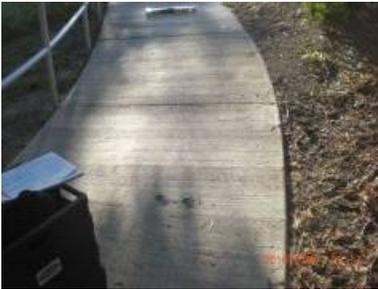
Keynote 13

| Field Condition | |
|--|---|
| 03B.09 - Cross Slope - Cross slope of the accessible route of travel exceeds 1:50. Existing Condition: 2.1% to 4.0% CS. | 1991 ADAAG 4.3.7 2004 ADAAG 403.3 2007 CBC 1133B.7.1.3 Other - |

| Corrective Action | |
|---|--|
| 006 - Concrete Walk - Remove non-compliant pavement and replace with new concrete (area as shown on the drawings). The walkway slope shall not exceed 5% along the POT and cross slope shall not exceed 2%. | |

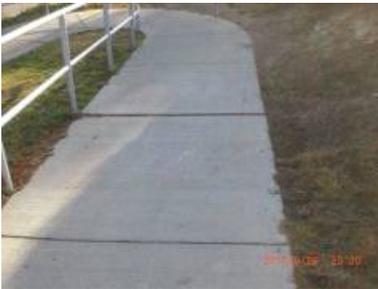
Keynote 14

| Field Condition | |
|--|---|
| 03B.10 - Running Slope - Slope of the accessible route of travel exceeds 1:20. Existing Condition: 5.2% RS. | 1991 ADAAG 4.3.7 2004 ADAAG 403.3 2007 CBC 1133B.7.3 Other - |

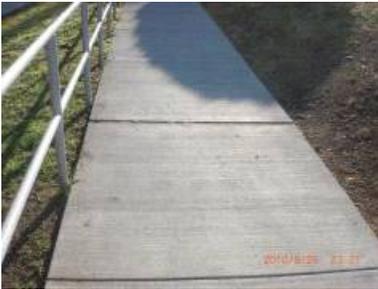
Keynote 15

| Field Condition | |
|--|---|
| 03B.10 - Running Slope - Slope of the accessible route of travel exceeds 1:20. Existing Condition: 5.7% RS. | 1991 ADAAG 4.3.7 2004 ADAAG 403.3 2007 CBC 1133B.7.3 Other - |

| Corrective Action |
|---|
| 006 - Concrete Walk - Remove non-compliant pavement and replace with new concrete (area as shown on the drawings). The walkway slope shall not exceed 5% along the POT and cross slope shall not exceed 2%. Additional Comments: Provide concrete path with less than 5% RS. |

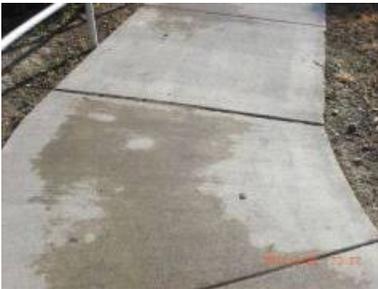
Keynote 16

| Field Condition | |
|--|---|
| 03B.10 - Running Slope - Slope of the accessible route of travel exceeds 1:20. Existing Condition: 5.4% to 5.8% RS. | 1991 ADAAG 4.3.7 2004 ADAAG 403.3 2007 CBC 1133B.7.3 Other - |

| Corrective Action |
|---|
| 006 - Concrete Walk - Remove non-compliant pavement and replace with new concrete (area as shown on the drawings). The walkway slope shall not exceed 5% along the POT and cross slope shall not exceed 2%. Additional Comments: Provide concrete path with less than 5% RS. |

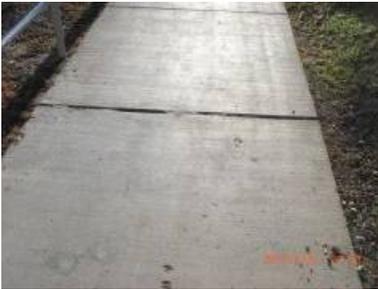
Keynote 21

| Field Condition | |
|--|---|
| 03B.22 - Other - On-Site Accessible Path of Travel - See Additional Comments | 1991 ADAAG - |
| Existing Condition: 21 1" gaps throughout concrete path. | 2004 ADAAG - |

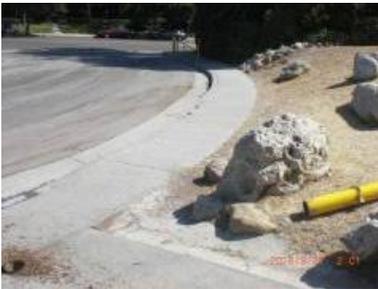
Keynote 22

| Field Condition | |
|--|---|
| 03B.09 - Cross Slope - Cross slope of the accessible route of travel exceeds 1:50. | 1991 ADAAG 4.3.7 |
| Existing Condition: 2.3% to 9.6% CS. | 2004 ADAAG 403.3 |

| Corrective Action | |
|---|--|
| 006 - Concrete Walk - Remove non-compliant pavement and replace with new concrete (area as shown on the drawings). The walkway slope shall not exceed 5% along the POT and cross slope shall not exceed 2%. | |

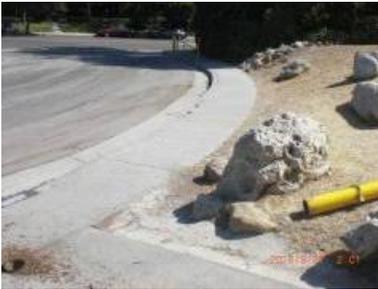
Keynote 23

| Field Condition | |
|--|---|
| 03B.10 - Running Slope - Slope of the accessible route of travel exceeds 1:20. Existing Condition: 5.2% to 7.8% RS. | 1991 ADAAG 4.3.7 2004 ADAAG 403.3 2007 CBC 1133B.7.3 Other - |

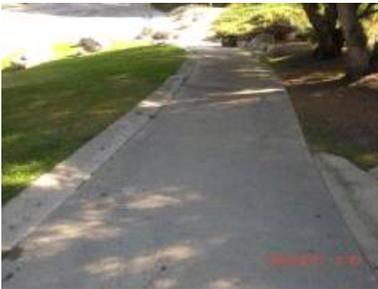
Keynote 24

| Field Condition | |
|--|---|
| 03B.09 - Cross Slope - Cross slope of the accessible route of travel exceeds 1:50. Existing Condition: 2.7% to 5.9% CS. | 1991 ADAAG 4.3.7 2004 ADAAG 403.3 2007 CBC 1133B.7.1.3 Other - |

| Corrective Action |
|---|
| 006 - Concrete Walk - Remove non-compliant pavement and replace with new concrete (area as shown on the drawings). The walkway slope shall not exceed 5% along the POT and cross slope shall not exceed 2%. Additional Comments: |

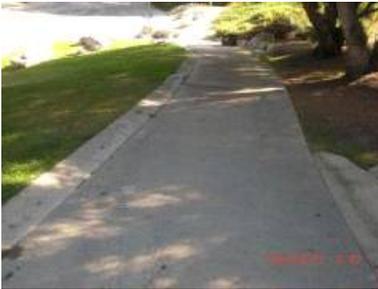
Keynote 25

| Field Condition | |
|---|---|
| 03B.10 - Running Slope - Slope of the accessible route of travel exceeds 1:20. Existing Condition: 6.3% to 19.6% RS. | 1991 ADAAG 4.3.7 2004 ADAAG 403.3 2007 CBC 1133B.7.3 Other - |

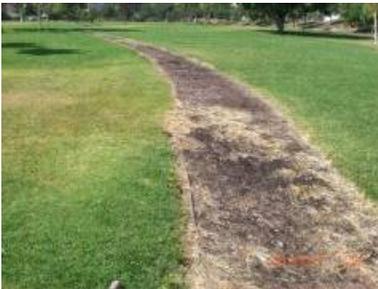
Keynote 26

| Field Condition | |
|---|---|
| 30.06E - Outdoor Recreation Access Route (ORAR) Segment - Cross Slope - Cross slope of the access route segment exceeds 3.33%. Exception: Cross slopes of 5% maximum are permitted to ensure proper drainage. Existing Condition: 5.1% to 6.9% CS. | 1991 ADAAG - 2004 ADAAG - 2007 CBC - Other 1999 ADAAG-16.3.7.1 |

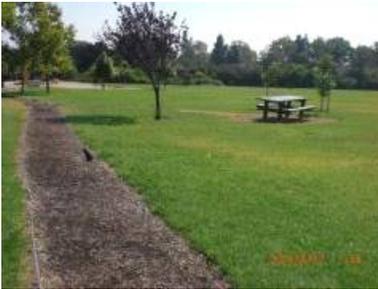
Keynote 27

| Field Condition | |
|---|---|
| Existing Condition: 5.4% to 8.6% RS. | 2004 ADAAG - |

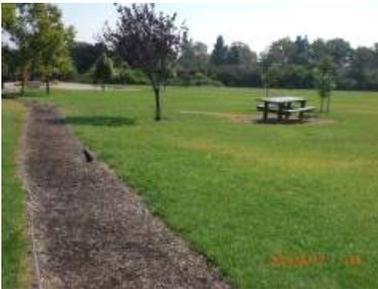
Keynote 28

| Field Condition | |
|---|---|
| Existing Condition: 3.6% CS. | 2004 ADAAG - |

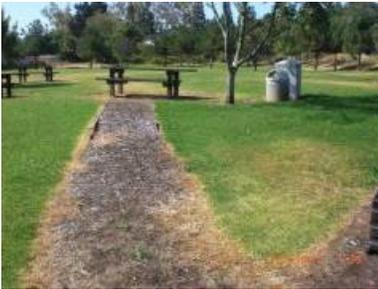
Keynote 29

| Field Condition | |
|---|---|
| Existing Condition: 3.4% CS. & 4.1% at two locations. | 2004 ADAAG - |

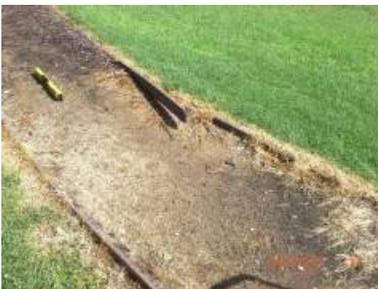
Keynote 30

| Field Condition | |
|--|---|
| Existing Condition: Trip hazards at 7 locations. | 2004 ADAAG - |

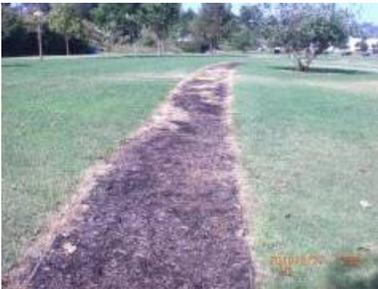
Keynote 31

Existing Condition: 3.9% CS.

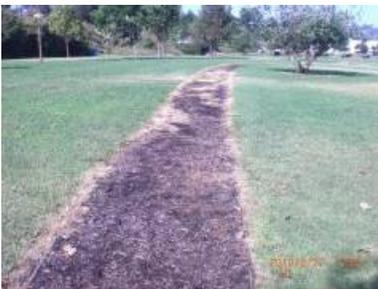
Keynote 32

Existing Condition: 5.1% to 9.7% RS.

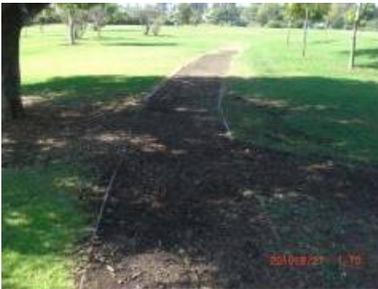
Keynote 33

| Field Condition | |
|--|---|
| 30.06C - Outdoor Recreation Access Route (ORAR) Surface - The surface of the access route is not firm or stable. | 1991 ADAAG - |
| Existing Condition: Mulch surface at trail. | 2004 ADAAG - |

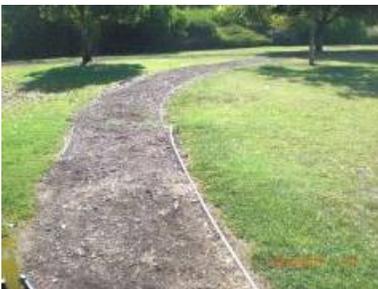
Keynote 34

| Field Condition | |
|---|---|
| 30.06E - Outdoor Recreation Access Route (ORAR) Segment - Cross Slope - Cross slope of the access route segment exceeds 3.33%. Exception: Cross slopes of 5% maximum are permitted to ensure proper drainage. | 1991 ADAAG - |
| Existing Condition: 4.1% CS. | 2004 ADAAG - |

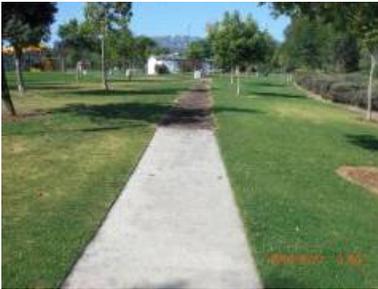
Keynote 35

| Field Condition | |
|---|---|
| Existing Condition: 4.2% to 4.3% CS. | 2004 ADAAG - |

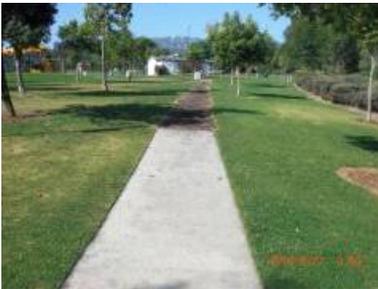
Keynote 36

| Field Condition | |
|---|---|
| Existing Condition: 5.3% to 11.9% RS. | 2004 ADAAG - |

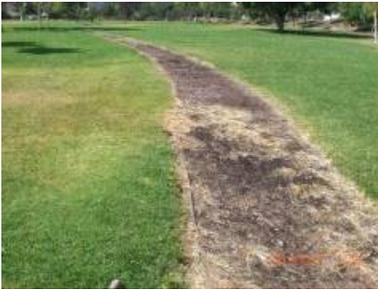
Keynote 37

| 30.06B - Outdoor Recreation Access Route (ORAR) Resting Space - Resting space does not comply with 1999 ADAAG Section 16.3.8 (Resting intervals shall be 60" min. in length, shall have a width at least as wide as the access route and have a slope of 3.33% or less in any direction. The installation of resting spaces is required as follows: Percent slope, maximum length, Rest interval: 0% to 5.0%, No restriction, No restriction; 5.1% to 8.33%, 50', Every 50'; 8.34% to 10%, 30', Every 30'.) | 1991 ADAAG - |

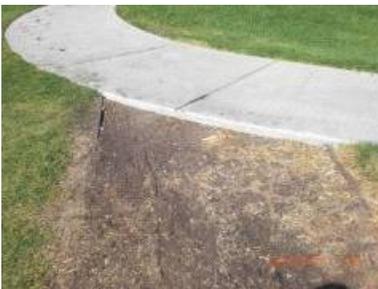
Keynote 38

| 30.68 - Other - Parks - See Additional Comments | 1991 ADAAG - |
| Existing Condition: 2" change in level at walkway/trail merger. | 2004 ADAAG - |

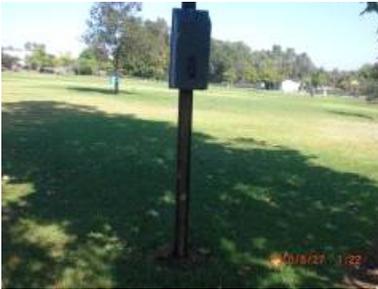
Keynote 39

| Field Condition | |
|---|---|
| Existing Condition: Accessible path of travel to dog waste bags not provided, at three locations. | 2004 ADAAG - |

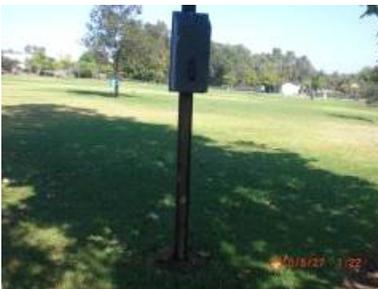
Keynote 40

| Field Condition | |
|---|---|
| Existing Condition: 61" to dog waste bags at two locations. | 2004 ADAAG - |

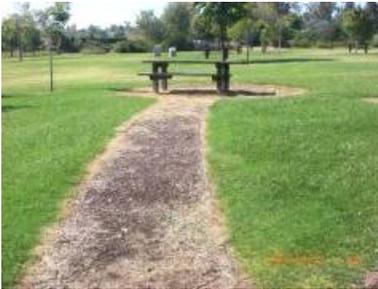
Keynote 41

| Field Condition | |
|--|---|
| 30.33 - Tabletop Height - Distance from the tabletop to the ground is not between 28" and 34". | 1991 ADAAG 4.32.4 |
| Existing Condition: 36" high. | 2004 ADAAG 902.3 |

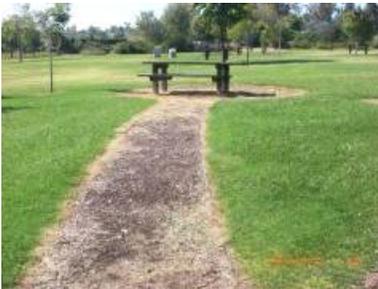
Keynote 42

| Field Condition | |
|--|---|
| 30.32 - 36" Aisle Width Standard - Around the picnic table, there is less than 36" clear space measured from the seat. | 1991 ADAAG - |

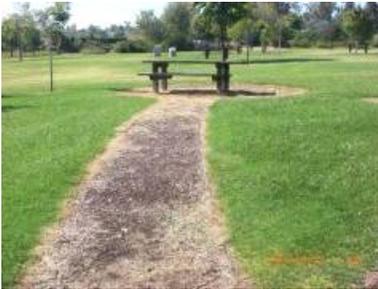
Keynote 43

| Field Condition | |
|---|---|
| 30.28 - Picnic Site - Surface Slope - The accessible picnic site is located on a surface area with slope greater than 2% in some or all directions.(1999 ADAAG: 3% slope is allowed when necessary for drainage). | 1991 ADAAG 4.3.7 |
| Existing Condition: 6.8% slope, uneven landing. | 2004 ADAAG 403.3 |

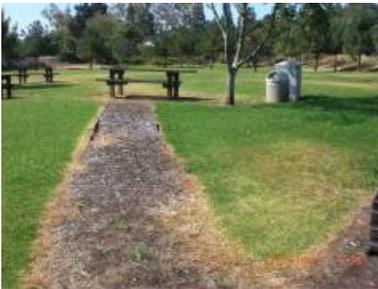
Keynote 44

| Field Condition | |
|--|---|
| 30.33 - Tabletop Height - Distance from the tabletop to the ground is not between 28" and 34". | 1991 ADAAG 4.32.4 |
| Existing Condition: 36" high. | 2004 ADAAG 902.3 |

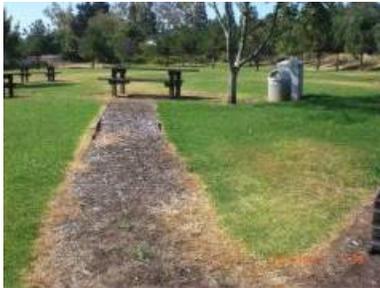
Keynote 47

| Field Condition | |
|---|---|
| Existing Condition: Accessible path of travel to trash and recycling bins not provided. | 2004 ADAAG - |

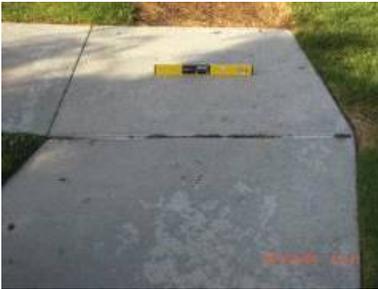
Keynote 49

| Field Condition | |
|--|---|
| 03B.09 - Cross Slope - Cross slope of the accessible route of travel exceeds 1:50. Existing Condition: 2.5% to 2.8% CS. | 1991 ADAAG 4.3.7 2004 ADAAG 403.3 2007 CBC 1133B.7.1.3 Other - |

| Corrective Action | |
|---|--|
| 006 - Concrete Walk - Remove non-compliant pavement and replace with new concrete (area as shown on the drawings). The walkway slope shall not exceed 5% along the POT and cross slope shall not exceed 2%. Additional Comments: At turning point, cross slope shall not exceed 2% in any direction. | |

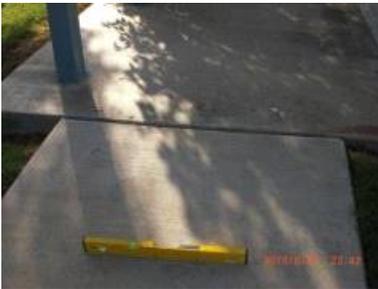
Keynote 50

| Field Condition | |
|---|---|
| 03B.22 - Other - On-Site Accessible Path of Travel - See Additional Comments Existing Condition: 1" gap. | 1991 ADAAG - 2004 ADAAG - 2007 CBC - Other - |

| Corrective Action | |
|--|--|
| 005B - Concrete Crack Repair - Clean-out existing concrete crack and inject with epoxy grout. Cracks over 1/4" in width will require a foam backer rod and sealant. Additional Comments: Fill gap with epoxy grout, backer rod and sealant. | |

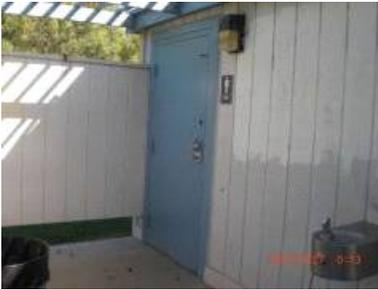
Keynote 51

| Field Condition | |
|---|---|
| Existing Condition: 11 LBF., (fire rated door). | 2004 ADAAG 404.2.9 |

| Corrective Action |
|--|
| 072B - Replace Closer - Replace door closer. |

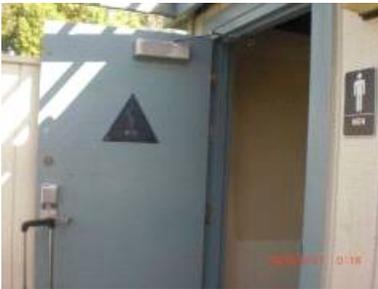
Keynote 52

| Field Condition | |
|--|---|
| Existing Condition: Geometric sign on wrong side of door. Geometric sign has Braille. | 2004 ADAAG - |

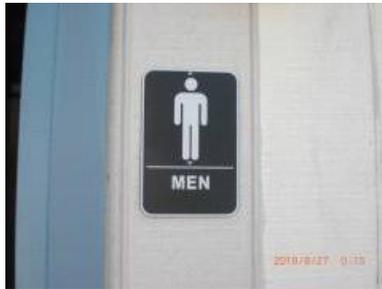
Keynote 55

| Field Condition | |
|--|---|
| Existing Condition: Braille spacing too narrow. | 2004 ADAAG 703.2; 703.3 |

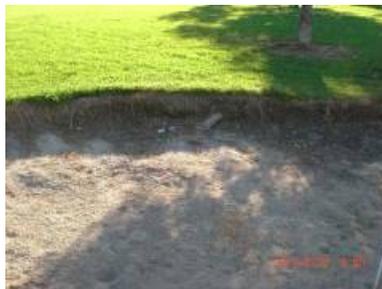
Keynote 56

| Field Condition | |
|--|---|
| Existing Condition: 4" - 12" drop from grass area to playground area. | 2004 ADAAG - |

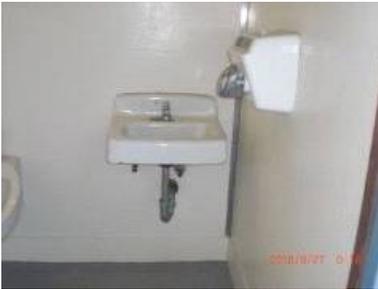
Keynote 59

| Field Condition | |
|---|--|
| 14.30A - Wall-Mounted Protruding Objects - Wall-mounted object(s) with leading edges between 27 and 80" from the floor project more than 4" into the pathway. (Wall mounted objects with leading edges at or below 27" may project any amount as long as the required clear width of an accessible route is not reduced.) | 1991 ADAAG 4.4.1 2004 ADAAG 307.2; Fig. 307.2 |
| Existing Condition: Hand dryer protrudes 6 1/2" at 41" AFF. | 2007 CBC 1133B.8.6.1 Other - |

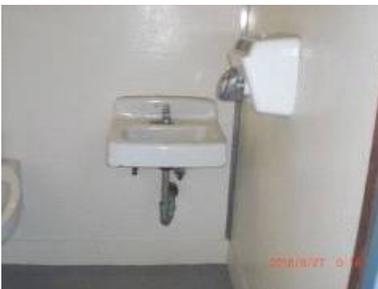
Keynote 60

| Field Condition | |
|--|---|
| 16.78 - Pipe Insulation at Lavatory - Drainpipes and hot water pipes are not insulated to protect against contact. | 1991 ADAAG 4.19.4 2004 ADAAG 606.5 |

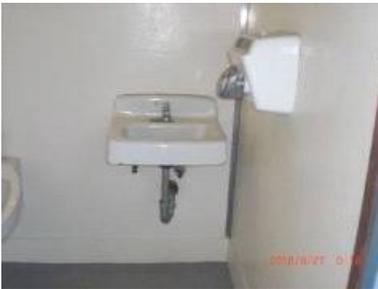
Keynote 62

| Field Condition | |
|---|---|
| Existing Condition: 26" high. | 2004 ADAAG 306.3; Fig. 306.3 |

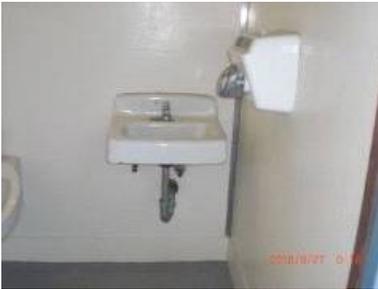
Keynote 63

| Field Condition | |
|--|---|
| 16.76 - Lavatory - Clearance near Sidewall - The centerline of the lavatory is not 18" min.. from the nearest sidewall or partition. | 1991 ADAAG - |
| Existing Condition: 14 1/2" from side wall. | 2004 ADAAG - |

| Corrective Action |
|---|
| 300C - Replace Lavatory - Replace existing lavatory with new compliant model. |

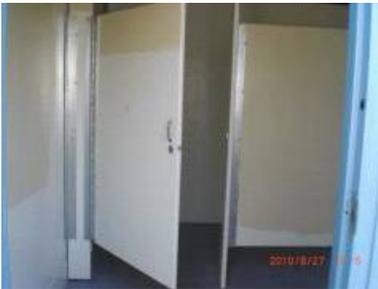
Keynote 64

| Field Condition | |
|---|--|
| 16.36A - Stall Width - The stall is less than 60" wide. | 1991 ADAAG 4.17.3; Fig. 30(a) |
| Existing Condition: 57 1/2" wide. | 2004 ADAAG 604.8.1.1; Advisory 604.8.1.1; Fig. 604.8.1.1 |

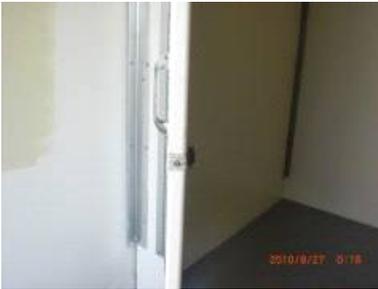
Keynote 65

| Field Condition | |
|--|---|
| 16.32A - U-Pulls at Stall Door - The stall door does not have U-pulls on both sides. | 1991 ADAAG 4.13.9; 4.17.5 |

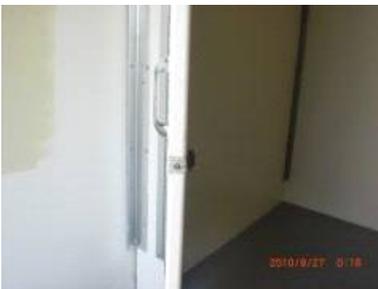
Keynote 66

| Field Condition | |
|--|---|
| 16.32B - Single-Action Stall Door Hardware - The stall door's locking mechanism is not operable with one hand. OR It is not operable without tight grasping, pinching, or twisting of the wrist. | 1991 ADAAG 4.13.9; 4.17.5 |

| Corrective Action | |
|--|--|
| 316C - Single-Action Stall Door Hardware - Replace existing stall door locking mechanism with new single-action door hardware. | |

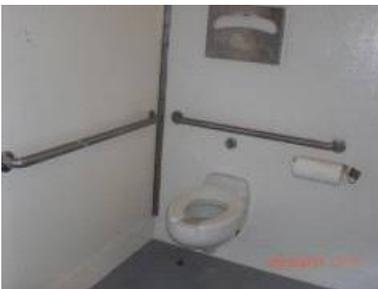
Keynote 68

| Field Condition | |
|---|---|
| Existing Condition: 18 1/2" from side wall. | 2004 ADAAG - |
