# City of Rancho Palos Verdes Rancho Palos Verdes ADA Assessment Facility Report with Photos

Facility ID: # Area 4 Bus Stops

Author: Vaish, B

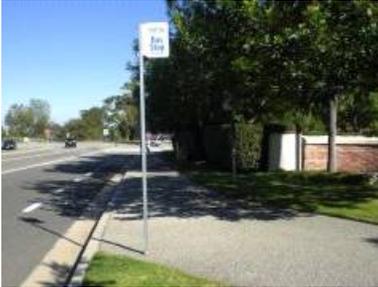
Location: Photo #  
Crest Rd./ Mela Ln. (EB) 1

Field Condition	
02.12B - Bus Stop Pad Slope Perpendicular to Roadway - Bus stop pad slope perpendicular to the roadway exceeds 2%.	1991 ADAAG 10.2.1
Existing Condition:	2004 ADAAG 810.2.4
	2007 CBC 1121B.2.1
	Other

Corrective Action	
004A - Asphalt Paving - Remove non-compliant pavement and replace with new asphalt paving (area as shown on the drawings). The walkway slope shall not exceed 5% along the POT and cross slope shall not exceed 2%.	
Additional Comments:

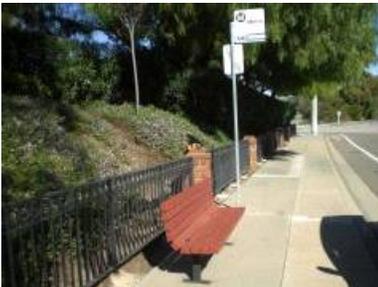
Location: Photo #  
Crest Rd./ Mela Ln. (WB) 2

Field Condition	
02.17 - Other - Passenger Loading Zones - See Additional Comments	1991 ADAAG -
Existing Condition: Bench (16" high seat, 13" deep seat, 15" high back support).	2004 ADAAG -
	2007 CBC -
	Other

Corrective Action	
027 - Site Work - Miscellaneous - See Additional Comments	
Additional Comments: Provide compliant bench.

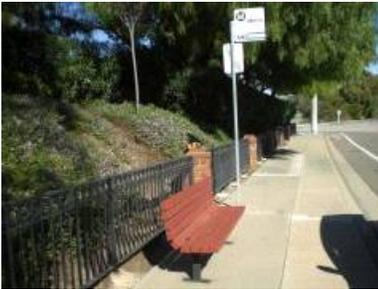
Location: Photo #  
Crest Rd./ Mela Ln. (WB) 2

Field Condition	
02.11A - Bus Stop Pad Size - Bus stop pad does not measure 8' long (measured from the curb or vehicle roadway edge) by 5' wide (measured parallel to the vehicle roadway).	1991 ADAAG 10.2.1
	2004 ADAAG 810.2.2
Existing Condition: Bus pad 7' long x 5' wide.	2007 CBC 1121B.1
	Other

Corrective Action
027 - Site Work - Miscellaneous - See Additional Comments
Additional Comments: See Keynote 5 for corrective action.

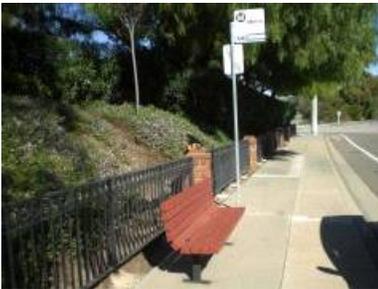
Location: Photo #  
Crest Rd./ Mela Ln. (WB) 2

Field Condition	
02.17 - Other - Passenger Loading Zones - See Additional Comments	1991 ADAAG -
Existing Condition: 2.3% CS.	2004 ADAAG -
	2007 CBC -
	Other

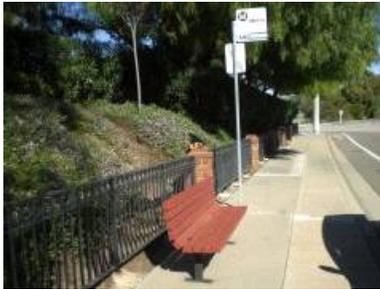
Location: Crest Rd./ Mela Ln. (WB) Photo # 2

Field Condition	
02.12A - Bus Stop Pad Slope Parallel to Roadway - Bus stop pad is not at the same slope as the roadway in the direction parallel to the roadway.	1991 ADAAG 10.2.1
Existing Condition: 3.2% RS at bus pad, 2.7% RS at road.	2004 ADAAG 810.2.4
	2007 CBC 1121B.2.1
	Other

Corrective Action	
006 - Concrete Walk - Remove non-compliant pavement and replace with new concrete (area as shown on the drawings). The walkway slope shall not exceed 5% along the POT and cross slope shall not exceed 2%.	
Additional Comments:

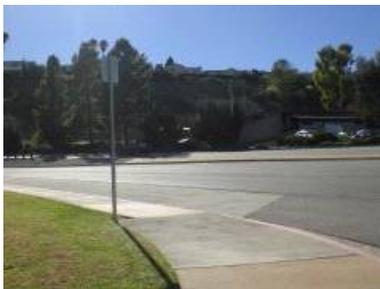
Location: Crenshaw Blvd./ Crestridge Rd. (NB) Photo # 6

Field Condition	
02.11A - Bus Stop Pad Size - Bus stop pad does not measure 8' long (measured from the curb or vehicle roadway edge) by 5' wide (measured parallel to the vehicle roadway).	1991 ADAAG 10.2.1
Existing Condition: Bus pad 7'-2" long x 5' wide.	2004 ADAAG 810.2.2
	2007 CBC 1121B.1
	Other

Corrective Action	
027 - Site Work - Miscellaneous - See Additional Comments	
Additional Comments: See Keynote 7 for corrective action.

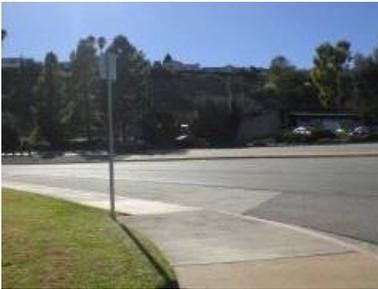
Location: Crenshaw Blvd./ Crestridge Rd. (NB) Photo # 6

Field Condition	
02.12A - Bus Stop Pad Slope Parallel to Roadway - Bus stop pad is not at the same slope as the roadway in the direction parallel to the roadway.	1991 ADAAG 10.2.1
Existing Condition: 8.8% RS at bus pad , 7.2% RS at the road.	2004 ADAAG 810.2.4
	2007 CBC 1121B.2.1
	Other

Corrective Action	
006 - Concrete Walk - Remove non-compliant pavement and replace with new concrete (area as shown on the drawings). The walkway slope shall not exceed 5% along the POT and cross slope shall not exceed 2%.	
Additional Comments:

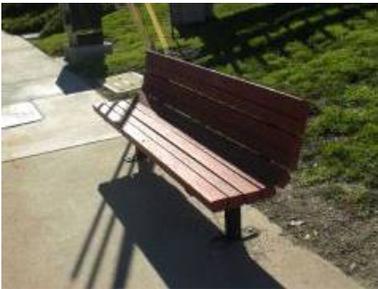
Location: Crenshaw Blvd./ Crestridge Rd. (SB) Photo # 8

Field Condition	
02.17 - Other - Passenger Loading Zones - See Additional Comments	1991 ADAAG -
Existing Condition: Bench (16" high seat, 14" deep seat, 14" high back support).	2004 ADAAG -
	2007 CBC -
	Other

Corrective Action	
027 - Site Work - Miscellaneous - See Additional Comments	
Additional Comments: Provide compliant bench.

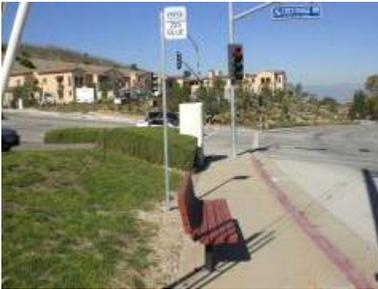
Location: Crenshaw Blvd./ Crestridge Rd. (SB) Photo # 9

Field Condition	
02.11A - Bus Stop Pad Size - Bus stop pad does not measure 8' long (measured from the curb or vehicle roadway edge) by 5' wide (measured parallel to the vehicle roadway).	1991 ADAAG 10.2.1
	2004 ADAAG 810.2.2
	2007 CBC 1121B.1
	Other

Existing Condition: Bus pad 4'-11" long x 5' wide.

Corrective Action
027 - Site Work - Miscellaneous - See Additional Comments
Additional Comments: See Keynote 10 for corrective action.

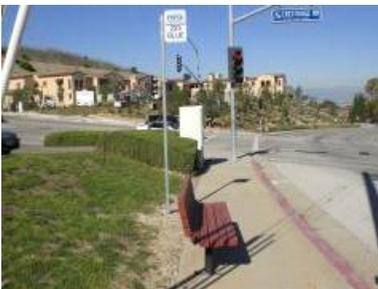
Location: Crenshaw Blvd./ Crestridge Rd. (SB) Photo # 9

Field Condition	
02.12A - Bus Stop Pad Slope Parallel to Roadway - Bus stop pad is not at the same slope as the roadway in the direction parallel to the roadway.	1991 ADAAG 10.2.1
	2004 ADAAG 810.2.4
	2007 CBC 1121B.2.1
	Other

Existing Condition: 6.2% RS at bus pad, 4.1% RS at the road.

Corrective Action
006 - Concrete Walk - Remove non-compliant pavement and replace with new concrete (area as shown on the drawings). The walkway slope shall not exceed 5% along the POT and cross slope shall not exceed 2%.
Additional Comments:

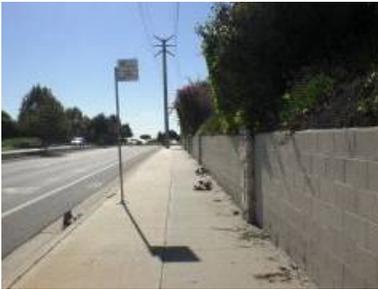
Location: Photo #  
Crest Rd./ Whitley Collins Dr. (WB) 11

Field Condition	
02.12B - Bus Stop Pad Slope Perpendicular to Roadway - Bus stop pad slope perpendicular to the roadway exceeds 2%.	1991 ADAAG 10.2.1
Existing Condition: 2.5% CS.	2004 ADAAG 810.2.4
	2007 CBC 1121B.2.1
	Other

Corrective Action	
006 - Concrete Walk - Remove non-compliant pavement and replace with new concrete (area as shown on the drawings). The walkway slope shall not exceed 5% along the POT and cross slope shall not exceed 2%.	
Additional Comments:

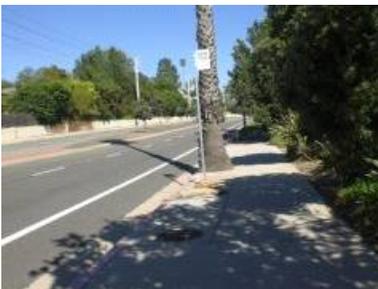
Location: Photo #  
Crest Rd./ Whitley Collins Dr. (EB) 12

Field Condition	
02.12A - Bus Stop Pad Slope Parallel to Roadway - Bus stop pad is not at the same slope as the roadway in the direction parallel to the roadway.	1991 ADAAG 10.2.1
Existing Condition: 2.0% RS at bus pad , 1.7% RS at the road.	2004 ADAAG 810.2.4
	2007 CBC 1121B.2.1
	Other

Corrective Action	
006 - Concrete Walk - Remove non-compliant pavement and replace with new concrete (area as shown on the drawings). The walkway slope shall not exceed 5% along the POT and cross slope shall not exceed 2%.	
Additional Comments:

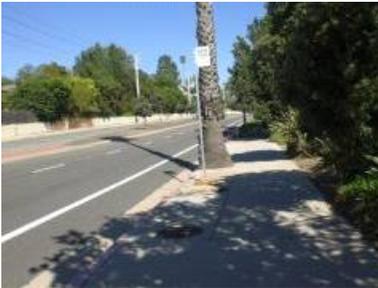
Location: Crest Rd./ Whitley Collins Dr. (EB) Photo # 12

Field Condition	
02.12B - Bus Stop Pad Slope Perpendicular to Roadway - Bus stop pad slope perpendicular to the roadway exceeds 2%.	1991 ADAAG 10.2.1
Existing Condition: 3.0% to 3.3% CS.	2004 ADAAG 810.2.4
	2007 CBC 1121B.2.1
	Other

Corrective Action
027 - Site Work - Miscellaneous - See Additional Comments
Additional Comments: See Keynote 12 for corrective action.

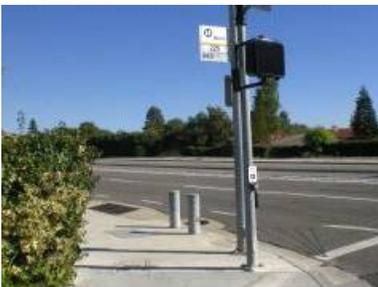
Location: Crest Rd./ Highridge Rd. (WB) Photo # 14

Field Condition	
02.12B - Bus Stop Pad Slope Perpendicular to Roadway - Bus stop pad slope perpendicular to the roadway exceeds 2%.	1991 ADAAG 10.2.1
Existing Condition: 6.9% CS.	2004 ADAAG 810.2.4
	2007 CBC 1121B.2.1
	Other

Corrective Action
006 - Concrete Walk - Remove non-compliant pavement and replace with new concrete (area as shown on the drawings). The walkway slope shall not exceed 5% along the POT and cross slope shall not exceed 2%.
Additional Comments:

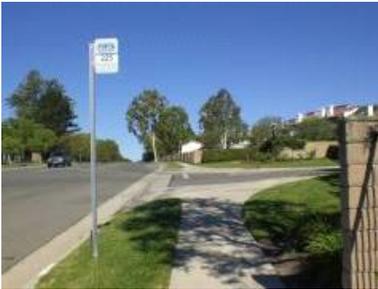
Location: Highridge R./ Scotwood Dr. (NB) Photo # 15

Field Condition	
02.11A - Bus Stop Pad Size - Bus stop pad does not measure 8' long (measured from the curb or vehicle roadway edge) by 5' wide (measured parallel to the vehicle roadway).	1991 ADAAG 10.2.1
	2004 ADAAG 810.2.2
	2007 CBC 1121B.1
	Other
Existing Condition: Bus pad 4'-1" long by 5' wide.

Corrective Action	
006 - Concrete Walk - Remove non-compliant pavement and replace with new concrete (area as shown on the drawings). The walkway slope shall not exceed 5% along the POT and cross slope shall not exceed 2%.	
Additional Comments:

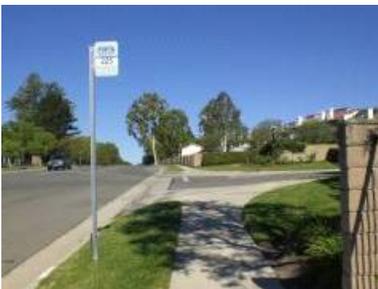
Location: Highridge R./ Scotwood Dr. (NB) Photo # 15

Field Condition	
02.12A - Bus Stop Pad Slope Parallel to Roadway - Bus stop pad is not at the same slope as the roadway in the direction parallel to the roadway.	1991 ADAAG 10.2.1
	2004 ADAAG 810.2.4
	2007 CBC 1121B.2.1
	Other
Existing Condition: 6.3% RS at bus pad, 5.5% RS at the road.

Corrective Action	
027 - Site Work - Miscellaneous - See Additional Comments	
Additional Comments: See Keynote 15 for corrective action.

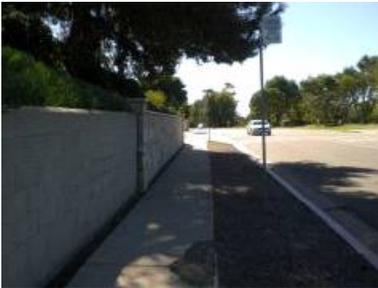
Location: Highridge R./ Whitley Collins Dr. (NB) Photo # 17

Field Condition	
02.11A - Bus Stop Pad Size - Bus stop pad does not measure 8' long (measured from the curb or vehicle roadway edge) by 5' wide (measured parallel to the vehicle roadway).	1991 ADAAG 10.2.1
	2004 ADAAG 810.2.2
	2007 CBC 1121B.1
	Other
Existing Condition: Bus pad 4' long by 5' wide .

Corrective Action
006 - Concrete Walk - Remove non-compliant pavement and replace with new concrete (area as shown on the drawings). The walkway slope shall not exceed 5% along the POT and cross slope shall not exceed 2%.
Additional Comments:

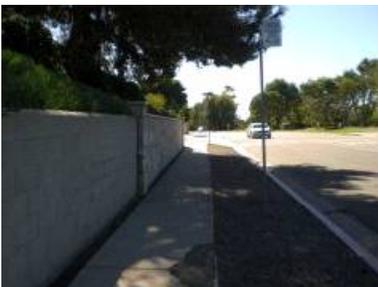
Location: Highridge R./ Whitley Collins Dr. (NB) Photo # 17

Field Condition	
02.12B - Bus Stop Pad Slope Perpendicular to Roadway - Bus stop pad slope perpendicular to the roadway exceeds 2%.	1991 ADAAG 10.2.1
	2004 ADAAG 810.2.4
	2007 CBC 1121B.2.1
	Other
Existing Condition: 3.3% CS.

Corrective Action
027 - Site Work - Miscellaneous - See Additional Comments
Additional Comments: See Keynote 17 for corrective action.
