City of Rancho Palos Verdes
Rancho Palos Verdes ADA Assessment
Facility Report with Photos

Facility ID: # Area 6 Bus Stops

Author: Vaish, B

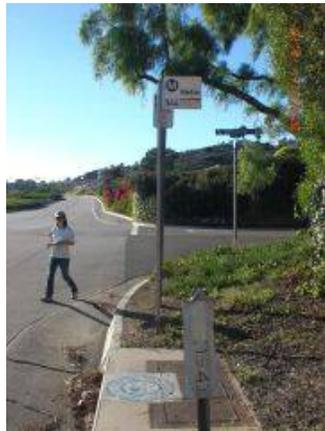
Location: Palos Verdes Dr. S/ Barkentine Rd. (NB) Photo # 1

Field Condition	
02.11B - Bus Stop Pad and Accessible Route - Bus stop pad is not connected to an accessible route.	1991 ADAAG 10.2.1
Existing Condition: No accessible route to bus stop.	2004 ADAAG 810.2.3
	2007 CBC 1121B.1
	Other

Classification	
DOJ Location Type:	1
Use:	PV
Severity:	C
Level of Difficulty	Moderate to High

Corrective Action	
001A - Accessible Route - Provide new accessible route.	
Additional Comments:

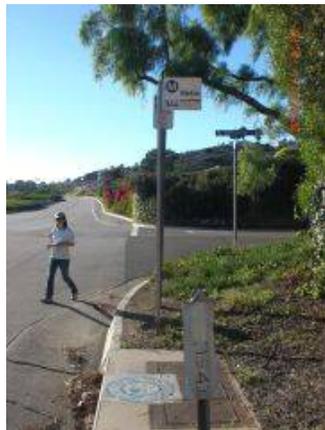
Location: Palos Verdes Dr. S/ Barkentine Rd. (NB) Photo # 1

Field Condition	
02.11A - Bus Stop Pad Size - Bus stop pad does not measure 8' long (measured from the curb or vehicle roadway edge) by 5' wide (measured parallel to the vehicle roadway).	1991 ADAAG 10.2.1
Existing Condition: None provided.	2004 ADAAG 810.2.2
	2007 CBC 1121B.1
	Other

Classification	
DOJ Location Type:	1
Use:	PV
Severity:	C
Level of Difficulty	High

Corrective Action	
006 - Concrete Walk - Remove non-compliant pavement and replace with new concrete (area as shown on the drawings). The walkway slope shall not exceed 5% along the POT and cross slope shall not exceed 2%.	
Additional Comments:

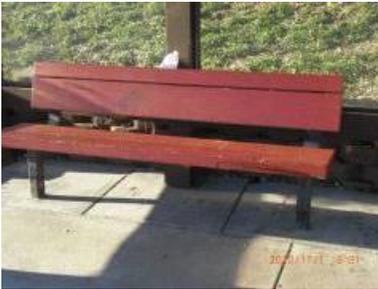
Location: Palos Verdes Dr. S/ Tramonto Rd. (NB) Photo # 3

02.17 - Other - Passenger Loading Zones - See Additional Comments

Existing Condition: Bench (16 3/4" high seat, 14 1/2" deep seat).

027 - Site Work - Miscellaneous - See Additional Comments

Additional Comments: Provide compliant bench with clear WC seating space.

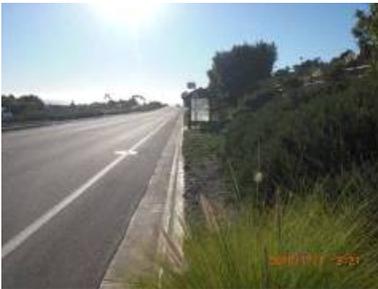
Location: Palos Verdes Dr. S/ Tramonto Rd. (NB) Photo # 4

02.11B - Bus Stop Pad and Accessible Route - Bus stop pad is not connected to an accessible route.

Existing Condition: No accessible route to bus stop.

1991 ADAAG 10.2.1
2004 ADAAG 810.2.3
2007 CBC 1121B.1
Other

001A - Accessible Route - Provide new accessible route.

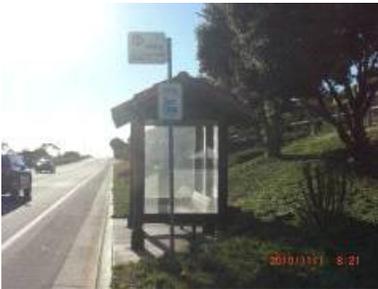
Location: Palos Verdes Dr. S/ Tramonto Rd. (NB) Photo # 5

Field Condition	
02.11A - Bus Stop Pad Size - Bus stop pad does not measure 8' long (measured from the curb or vehicle roadway edge) by 5' wide (measured parallel to the vehicle roadway).	1991 ADAAG 10.2.1
	2004 ADAAG 810.2.2
Existing Condition: None provided.	2007 CBC 1121B.1
	Other

Classification	
DOJ Location Type:	1
Use:	PV
Severity:	C
Level of Difficulty	High

Corrective Action
006 - Concrete Walk - Remove non-compliant pavement and replace with new concrete (area as shown on the drawings). The walkway slope shall not exceed 5% along the POT and cross slope shall not exceed 2%.
Additional Comments:

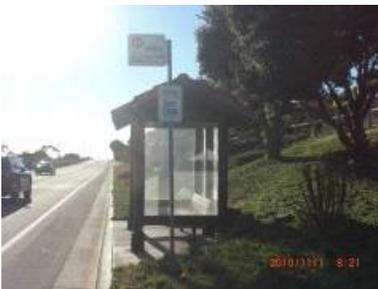
Location: Palos Verdes Dr. S/ Tramonto Rd. (NB) Photo # 5

Field Condition	
02.17 - Other - Passenger Loading Zones - See Additional Comments	1991 ADAAG -
Existing Condition: 2.9% CS.	2004 ADAAG -
	2007 CBC -
	Other

Classification	
DOJ Location Type:	1
Use:	PV
Severity:	C
Level of Difficulty	Moderate

Corrective Action
027 - Site Work - Miscellaneous - See Additional Comments
Additional Comments: See Keynote 5 for corrective action.

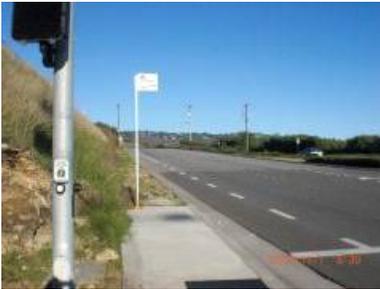
Location: Palos Verdes Dr. S/ Crestmont Ln. (NB)
 Photo # 7

Field Condition	
02.11A - Bus Stop Pad Size - Bus stop pad does not measure 8' long (measured from the curb or vehicle roadway edge) by 5' wide (measured parallel to the vehicle roadway).	1991 ADAAG 10.2.1
	2004 ADAAG 810.2.2
	2007 CBC 1121B.1
	Other
Existing Condition: Bus pad 4'-11" long by 5' wide.

Classification	
DOJ Location Type:	1
Use:	PV
Severity:	C
Level of Difficulty	Moderate

Corrective Action
027 - Site Work - Miscellaneous - See Additional Comments
Additional Comments: See Keynote 8 for corrective action.

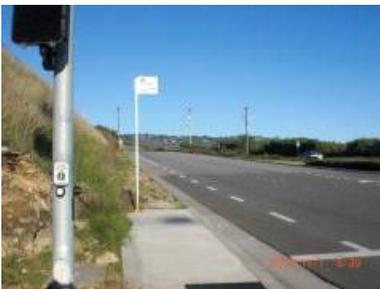
Location: Palos Verdes Dr. S/ Crestmont Ln. (NB)
 Photo # 7

Field Condition	
02.12A - Bus Stop Pad Slope Parallel to Roadway - Bus stop pad is not at the same slope as the roadway in the direction parallel to the roadway.	1991 ADAAG 10.2.1
	2004 ADAAG 810.2.4
	2007 CBC 1121B.2.1
	Other
Existing Condition: 7.6% RS at bus pad , 5.6% RS at the road.

Classification	
DOJ Location Type:	1
Use:	PV
Severity:	C
Level of Difficulty	High

Corrective Action
006 - Concrete Walk - Remove non-compliant pavement and replace with new concrete (area as shown on the drawings). The walkway slope shall not exceed 5% along the POT and cross slope shall not exceed 2%.
Additional Comments:

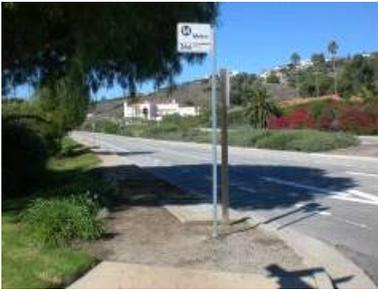
Location: Palos Verdes Dr. S/ Barkentine Rd. (SB)
Photo # 9

Field Condition	
02.11A - Bus Stop Pad Size - Bus stop pad does not measure 8' long (measured from the curb or vehicle roadway edge) by 5' wide (measured parallel to the vehicle roadway).	1991 ADAAG 10.2.1
Existing Condition: Bus pad 3'-7" long by 5' wide.	2004 ADAAG 810.2.2
	2007 CBC 1121B.1
	Other

Classification	
DOJ Location Type:	1
Use:	PV
Severity:	C
Level of Difficulty	High

Corrective Action
006 - Concrete Walk - Remove non-compliant pavement and replace with new concrete (area as shown on the drawings). The walkway slope shall not exceed 5% along the POT and cross slope shall not exceed 2%.
Additional Comments:

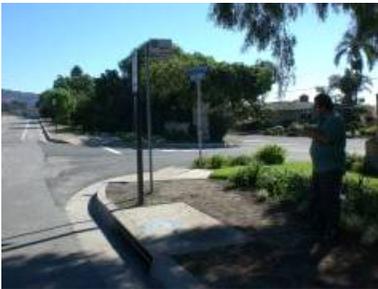
Location: Palos Verdes Dr. S/ Barkentine Rd. (SB)
Photo # 10

Field Condition	
02.11B - Bus Stop Pad and Accessible Route - Bus stop pad is not connected to an accessible route.	1991 ADAAG 10.2.1
Existing Condition: No accessible route to bus stop.	2004 ADAAG 810.2.3
	2007 CBC 1121B.1
	Other

Classification	
DOJ Location Type:	1
Use:	PV
Severity:	C
Level of Difficulty	Moderate

Corrective Action
027 - Site Work - Miscellaneous - See Additional Comments
Additional Comments:

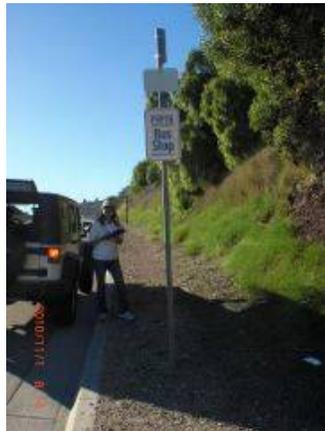
Location: Palos Verdes Dr. S/ Seacove Dr. (NB) Photo # 11

Field Condition	
02.11A - Bus Stop Pad Size - Bus stop pad does not measure 8' long (measured from the curb or vehicle roadway edge) by 5' wide (measured parallel to the vehicle roadway).	1991 ADAAG 10.2.1
Existing Condition: None provided.	2004 ADAAG 810.2.2
	2007 CBC 1121B.1
	Other

Classification	
DOJ Location Type:	1
Use:	PV
Severity:	C
Level of Difficulty	High

Corrective Action	
006 - Concrete Walk - Remove non-compliant pavement and replace with new concrete (area as shown on the drawings). The walkway slope shall not exceed 5% along the POT and cross slope shall not exceed 2%.	
Additional Comments:

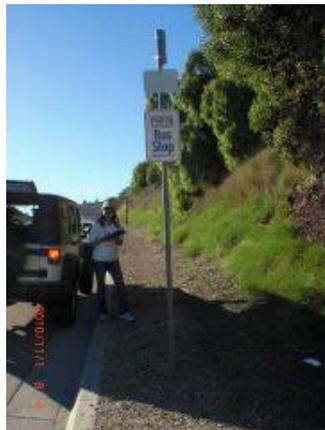
Location: Palos Verdes Dr. S/ Seacove Dr. (NB) Photo # 11

Field Condition	
02.11B - Bus Stop Pad and Accessible Route - Bus stop pad is not connected to an accessible route.	1991 ADAAG 10.2.1
Existing Condition: No accessible route to bus stop.	2004 ADAAG 810.2.3
	2007 CBC 1121B.1
	Other

Classification	
DOJ Location Type:	1
Use:	PV
Severity:	C
Level of Difficulty	Moderate to High

Corrective Action	
001A - Accessible Route - Provide new accessible route.	
Additional Comments:

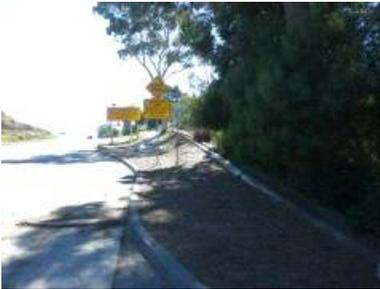
Field Condition	
02.11A - Bus Stop Pad Size - Bus stop pad does not measure 8' long (measured from the curb or vehicle roadway edge) by 5' wide (measured parallel to the vehicle roadway).	1991 ADAAG 10.2.1
	2004 ADAAG 810.2.2
	2007 CBC 1121B.1
	Other
Existing Condition: None provided.

Classification	
DOJ Location Type:	1
Use:	PV
Severity:	C
Level of Difficulty	High

Corrective Action	
006 - Concrete Walk - Remove non-compliant pavement and replace with new concrete (area as shown on the drawings). The walkway slope shall not exceed 5% along the POT and cross slope shall not exceed 2%.	
Additional Comments:

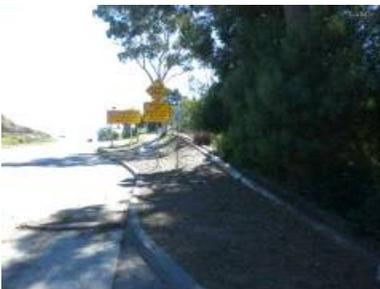
Field Condition	
02.11B - Bus Stop Pad and Accessible Route - Bus stop pad is not connected to an accessible route.	1991 ADAAG 10.2.1
	2004 ADAAG 810.2.3
	2007 CBC 1121B.1
	Other
Existing Condition: No accessible route to bus stop.

Classification	
DOJ Location Type:	1
Use:	PV
Severity:	C
Level of Difficulty	Moderate to High

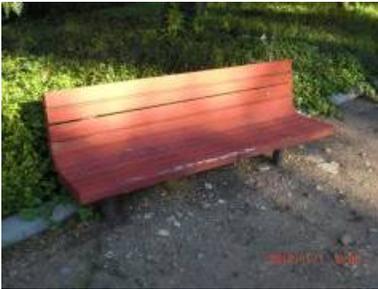
Field Condition	
02.17 - Other - Passenger Loading Zones - See Additional Comments	1991 ADAAG -
Existing Condition: Bench (13" high seat, 16" deep seat, 15 1/2" high back support, 9" shoulder alignment).	2004 ADAAG -
	2007 CBC -
	Other

Classification	
DOJ Location Type:	1
Use:	PV
Severity:	E
Level of Difficulty	Moderate

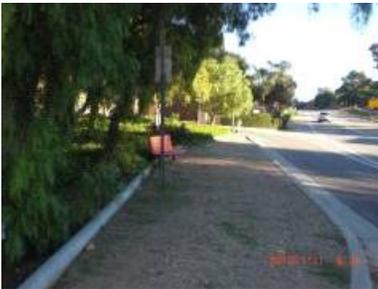
Field Condition	
02.11A - Bus Stop Pad Size - Bus stop pad does not measure 8' long (measured from the curb or vehicle roadway edge) by 5' wide (measured parallel to the vehicle roadway).	1991 ADAAG 10.2.1
Existing Condition: None provided.	2004 ADAAG 810.2.2
	2007 CBC 1121B.1
	Other

Classification	
DOJ Location Type:	1
Use:	PV
Severity:	C
Level of Difficulty	High

Corrective Action
006 - Concrete Walk - Remove non-compliant pavement and replace with new concrete (area as shown on the drawings). The walkway slope shall not exceed 5% along the POT and cross slope shall not exceed 2%.
Additional Comments:

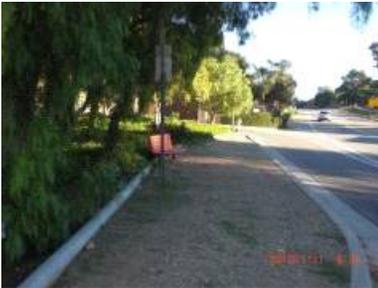
Location: Palos Verdes Dr. S/ Narcissa Dr. (NB) Photo # 16

Field Condition	
02.11B - Bus Stop Pad and Accessible Route - Bus stop pad is not connected to an accessible route.	1991 ADAAG 10.2.1
Existing Condition: No accessible route to bus stop.	2004 ADAAG 810.2.3
	2007 CBC 1121B.1
	Other

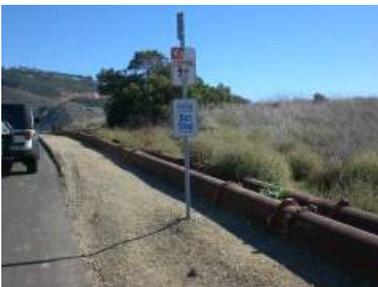
Location: Palos Verdes Dr. S/ Peppertree Dr. (SB) Photo # 18

Field Condition	
02.11A - Bus Stop Pad Size - Bus stop pad does not measure 8' long (measured from the curb or vehicle roadway edge) by 5' wide (measured parallel to the vehicle roadway).	1991 ADAAG 10.2.1
Existing Condition: None provided.	2004 ADAAG 810.2.2
	2007 CBC 1121B.1
	Other

Corrective Action
006 - Concrete Walk - Remove non-compliant pavement and replace with new concrete (area as shown on the drawings). The walkway slope shall not exceed 5% along the POT and cross slope shall not exceed 2%.
Additional Comments:

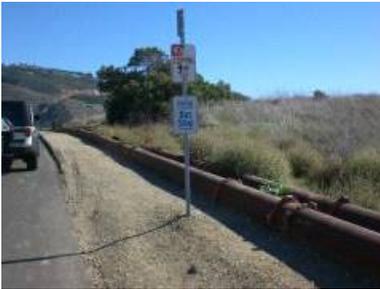
Field Condition	
02.11B - Bus Stop Pad and Accessible Route - Bus stop pad is not connected to an accessible route.	1991 ADAAG 10.2.1
Existing Condition: No accessible route to bus stop.	2004 ADAAG 810.2.3
	2007 CBC 1121B.1
	Other

Classification	
DOJ Location Type:	1
Use:	PV
Severity:	C
Level of Difficulty	Moderate to High

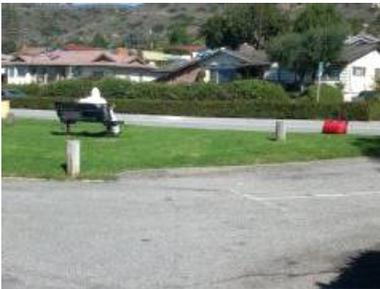
Field Condition	
02.11A - Bus Stop Pad Size - Bus stop pad does not measure 8' long (measured from the curb or vehicle roadway edge) by 5' wide (measured parallel to the vehicle roadway).	1991 ADAAG 10.2.1
Existing Condition: None provided.	2004 ADAAG 810.2.2
	2007 CBC 1121B.1
	Other

Classification	
DOJ Location Type:	1
Use:	PV
Severity:	C
Level of Difficulty	High

Corrective Action	
006 - Concrete Walk - Remove non-compliant pavement and replace with new concrete (area as shown on the drawings). The walkway slope shall not exceed 5% along the POT and cross slope shall not exceed 2%.	
Additional Comments:

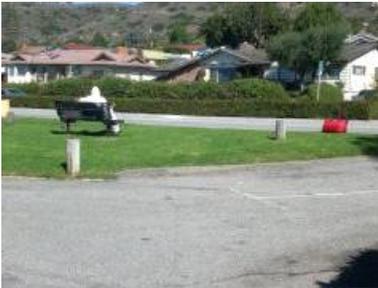
Location: Palos Verdes Dr. S/ P B Bay Club (SB) Photo # 20

Field Condition	
02.11B - Bus Stop Pad and Accessible Route - Bus stop pad is not connected to an accessible route.	1991 ADAAG 10.2.1
Existing Condition: No accessible route to bus stop.	2004 ADAAG 810.2.3
	2007 CBC 1121B.1
	Other

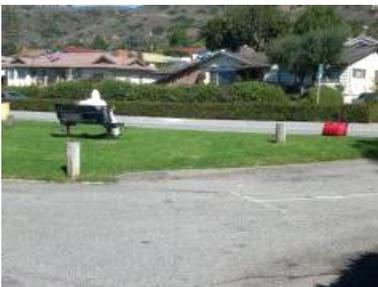
Location: Palos Verdes Dr. S/ P B Bay Club (SB) Photo # 20

Field Condition	
02.17 - Other - Passenger Loading Zones - See Additional Comments	1991 ADAAG -
Existing Condition: Bench (15 1/4" deep seat, 15 1/4" high back support).	2004 ADAAG -
	2007 CBC -
	Other

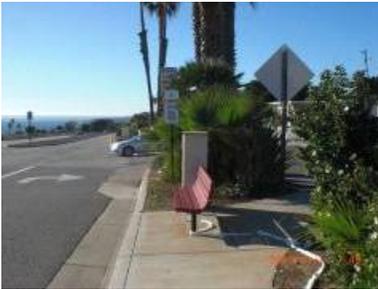
Location: Palos Verdes Dr. S/ Conqueror Dr. (NB)
Photo # 23

Field Condition	
02.17 - Other - Passenger Loading Zones - See Additional Comments	1991 ADAAG -
Existing Condition: Bench (16" high seat, 15 1/2" deep seat, 15 1/2" high back support).	2004 ADAAG -
	2007 CBC -
	Other

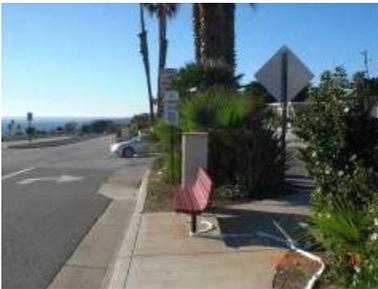
Location: Palos Verdes Dr. S/ Conqueror Dr. (NB)
Photo # 23

Field Condition	
02.11A - Bus Stop Pad Size - Bus stop pad does not measure 8' long (measured from the curb or vehicle roadway edge) by 5' wide (measured parallel to the vehicle roadway).	1991 ADAAG 10.2.1
Existing Condition: Bus pad 4'-9" long by 5' wide.	2004 ADAAG 810.2.2
	2007 CBC 1121B.1
	Other

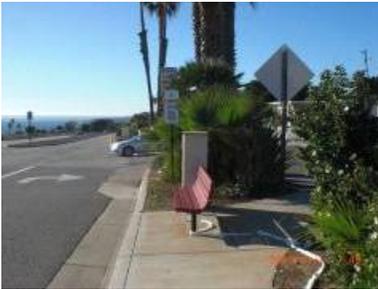
Location: Palos Verdes Dr. S/ Conqueror Dr. (NB)
 Photo # 23

Field Condition	
02.11B - Bus Stop Pad and Accessible Route - Bus stop pad is not connected to an accessible route.	1991 ADAAG 10.2.1
Existing Condition: No accessible route to bus stop.	2004 ADAAG 810.2.3
	2007 CBC 1121B.1
	Other

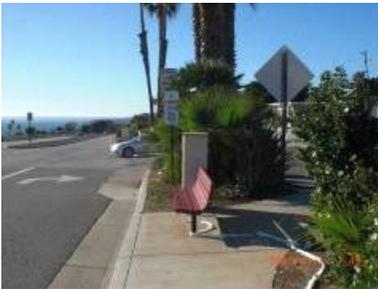
Location: Palos Verdes Dr. S/ Conqueror Dr. (NB)
 Photo # 23

Field Condition	
02.12A - Bus Stop Pad Slope Parallel to Roadway - Bus stop pad is not at the same slope as the roadway in the direction parallel to the roadway.	1991 ADAAG 10.2.1
Existing Condition: 4.1% to 4.4% RS at bus pad, 4.0% RS at the road.	2004 ADAAG 810.2.4
	2007 CBC 1121B.2.1
	Other

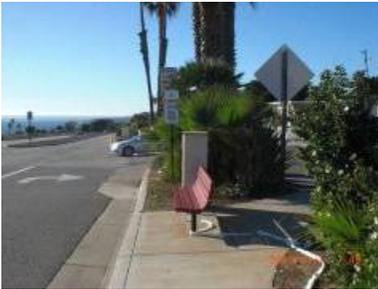
Field Condition	
02.12B - Bus Stop Pad Slope Perpendicular to Roadway - Bus stop pad slope perpendicular to the roadway exceeds 2%.	1991 ADAAG 10.2.1
Existing Condition: 3.5% to 6.0% CS.	2004 ADAAG 810.2.4
	2007 CBC 1121B.2.1
	Other

Classification	
DOJ Location Type:	1
Use:	PV
Severity:	C
Level of Difficulty	High

Corrective Action	
006 - Concrete Walk - Remove non-compliant pavement and replace with new concrete (area as shown on the drawings). The walkway slope shall not exceed 5% along the POT and cross slope shall not exceed 2%.	
Additional Comments:

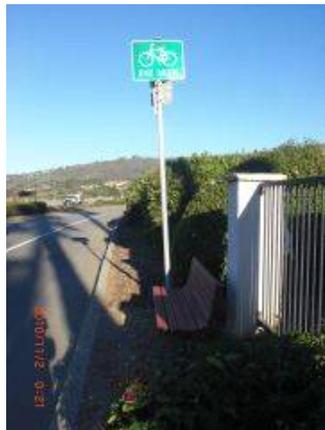
Field Condition	
02.17 - Other - Passenger Loading Zones - See Additional Comments	1991 ADAAG -
Existing Condition: Bench (16" high seat, 14 1/2" deep seat, 14" high back support).	2004 ADAAG -
	2007 CBC -
	Other

Classification	
DOJ Location Type:	1
Use:	PV
Severity:	E
Level of Difficulty	Moderate

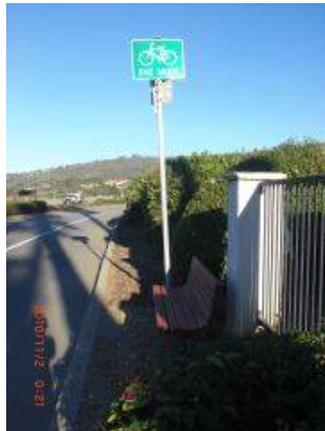
Location: Palos Verdes Dr. S/ Schooner Dr. (NB) Photo # 28

Field Condition	
02.11A - Bus Stop Pad Size - Bus stop pad does not measure 8' long (measured from the curb or vehicle roadway edge) by 5' wide (measured parallel to the vehicle roadway).	1991 ADAAG 10.2.1
Existing Condition: None provided.	2004 ADAAG 810.2.2
	2007 CBC 1121B.1
	Other

Corrective Action	
006 - Concrete Walk - Remove non-compliant pavement and replace with new concrete (area as shown on the drawings). The walkway slope shall not exceed 5% along the POT and cross slope shall not exceed 2%.	
Additional Comments:

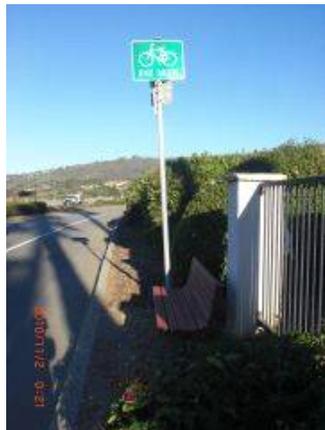
Location: Palos Verdes Dr. S/ Schooner Dr. (NB) Photo # 28

Field Condition	
02.11B - Bus Stop Pad and Accessible Route - Bus stop pad is not connected to an accessible route.	1991 ADAAG 10.2.1
Existing Condition: No accessible route to bus stop.	2004 ADAAG 810.2.3
	2007 CBC 1121B.1
	Other

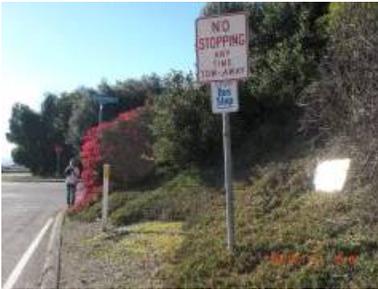
Field Condition	
02.11A - Bus Stop Pad Size - Bus stop pad does not measure 8' long (measured from the curb or vehicle roadway edge) by 5' wide (measured parallel to the vehicle roadway).	1991 ADAAG 10.2.1
	2004 ADAAG 810.2.2
	2007 CBC 1121B.1
Existing Condition: None provided.	Other

Classification	
DOJ Location Type:	1
Use:	PV
Severity:	C
Level of Difficulty	High

Corrective Action	
006 - Concrete Walk - Remove non-compliant pavement and replace with new concrete (area as shown on the drawings). The walkway slope shall not exceed 5% along the POT and cross slope shall not exceed 2%.	
Additional Comments:

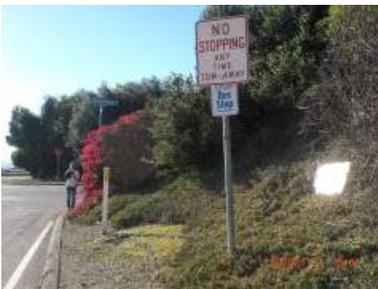
Field Condition	
02.11B - Bus Stop Pad and Accessible Route - Bus stop pad is not connected to an accessible route.	1991 ADAAG 10.2.1
	2004 ADAAG 810.2.3
	2007 CBC 1121B.1
Existing Condition: No accessible route to bus stop.	Other

Classification	
DOJ Location Type:	1
Use:	PV
Severity:	C
Level of Difficulty	Moderate to High

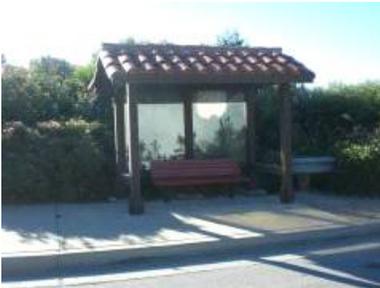
Location: Palos Verdes Dr. S/ Seahill Dr. (SB) Photo # 33

Field Condition	
02.17 - Other - Passenger Loading Zones - See Additional Comments	1991 ADAAG -
Existing Condition: Bench (16" high seat, 15 1/2" deep seat, 15 1/2" high back support).	2004 ADAAG -
	2007 CBC -
	Other

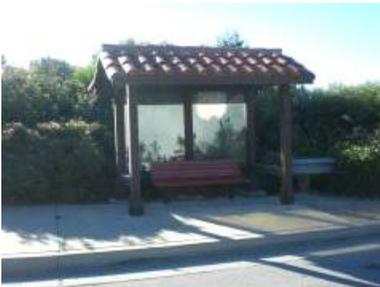
Location: Palos Verdes Dr. S/ Seahill Dr. (SB) Photo # 33

Field Condition	
02.12B - Bus Stop Pad Slope Perpendicular to Roadway - Bus stop pad slope perpendicular to the roadway exceeds 2%.	1991 ADAAG 10.2.1
Existing Condition: 2.1% to 2.3% CS.	2004 ADAAG 810.2.4
	2007 CBC 1121B.2.1
	Other

Corrective Action
006 - Concrete Walk - Remove non-compliant pavement and replace with new concrete (area as shown on the drawings). The walkway slope shall not exceed 5% along the POT and cross slope shall not exceed 2%.
Additional Comments:

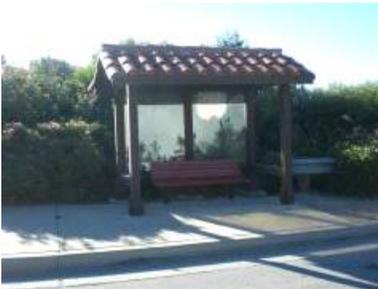
Location: Palos Verdes Dr. S/ Seahill Dr. (SB) Photo # 33

Field Condition	
02.13A - Bus Stop Shelter - Clear Floor Area - Clear floor area of 30" by 48" is not completely within the shelter.	1991 ADAAG 10.2.1(2)
Existing Condition: No WC space provided within the shelter.	2004 ADAAG 810.3
	2007 CBC 1121B.2.1
	Other

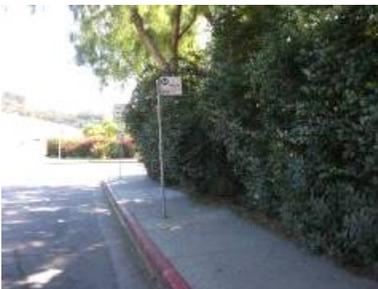
Location: Palos Verdes Dr. S/ Seacove Dr. (SB) Photo # 36

Field Condition	
02.11A - Bus Stop Pad Size - Bus stop pad does not measure 8' long (measured from the curb or vehicle roadway edge) by 5' wide (measured parallel to the vehicle roadway).	1991 ADAAG 10.2.1
Existing Condition: Bus pad 7'-1" long by 5' wide.	2004 ADAAG 810.2.2
	2007 CBC 1121B.1
	Other

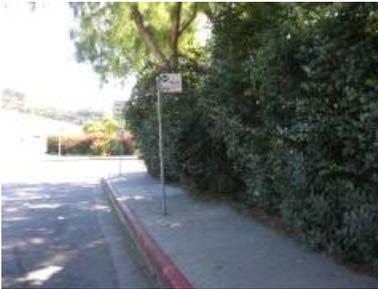
Location: Palos Verdes Dr. S/ Seacove Dr. (SB) Photo # 36

Field Condition	
02.12A - Bus Stop Pad Slope Parallel to Roadway - Bus stop pad is not at the same slope as the roadway in the direction parallel to the roadway.	1991 ADAAG 10.2.1
Existing Condition: 6.9% to 7.9 RS at bus pad, 5.1% to 7.7% RS at the road..	2004 ADAAG 810.2.4
	2007 CBC 1121B.2.1
	Other

Corrective Action
006 - Concrete Walk - Remove non-compliant pavement and replace with new concrete (area as shown on the drawings). The walkway slope shall not exceed 5% along the POT and cross slope shall not exceed 2%.
Additional Comments:

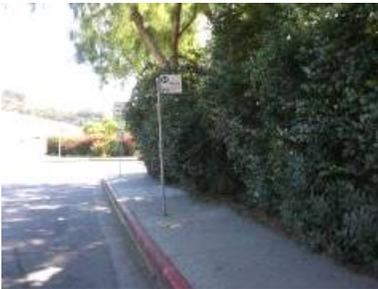
Location: Palos Verdes Dr. S/ Seacove Dr. (SB) Photo # 36

Field Condition	
02.12B - Bus Stop Pad Slope Perpendicular to Roadway - Bus stop pad slope perpendicular to the roadway exceeds 2%.	1991 ADAAG 10.2.1
Existing Condition: 3.7% to 4.4% CS.	2004 ADAAG 810.2.4
	2007 CBC 1121B.2.1
	Other
