*City of Rancho Palos Verdes*  
**Rancho Palos Verdes ADA Assessment**  
**Facility Report with Photos**

**Facility ID: # Area 2 Pedestrian Signals**

**Author: Vaish, B**

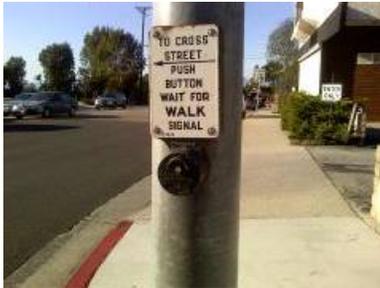
**Keynote 1**

04.24B - Vibrotactile Signal Device - A crosswalk with pedestrian signal indication does not have a vibrotactile signal device integrated into the signal device to indicate the WALK interval.

Severity: C

039 - Operable Parts - Miscellaneous - See Additional Comments

Additional Comments: Replace with vibrotactile signal device.

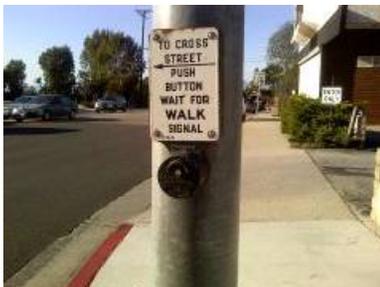
**Keynote 2**

04.24A - Audible Signal Device - A crosswalk with pedestrian signal indication does not have an audible signal device to indicate the WALK interval.

Severity: A

039 - Operable Parts - Miscellaneous - See Additional Comments

Additional Comments: Provide audible signal device.

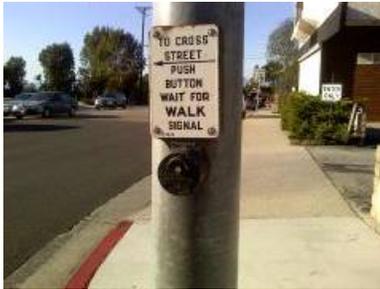
**Keynote 3**

<b>Field Condition</b>	04.32C - Push Button Size - The pedestrian signal push button is not a min.. 2" across in one dimension.	1991 ADAAG -
	Existing Condition: 1/2" diameter.	2004 ADAAG -
		2007 CBC -
		Other 2005 PROWAG-R306.3.3

<b>Classification</b>	
DOJ Location Type:	1
Use:	PV
Severity:	C
Level of Difficulty	Moderate

<b>Corrective Action</b>
039 - Operable Parts - Miscellaneous - See Additional Comments
Additional Comments: See Keynote 1 for corrective action.

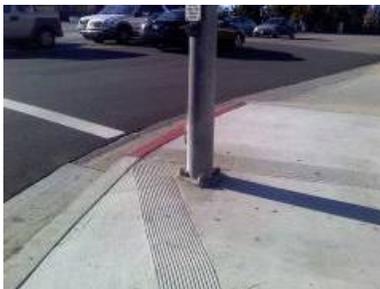
**Keynote 4**

<b>Field Condition</b>	04.25 - Pedestrian Signal Device - Clear Floor Space - Location of pedestrian signal device does not accommodate a level 30" x 48" min.. clear space, centered and parallel to the pedestrian signal push button. (Accessible pedestrian signals shall be located so that the vibrotactile feature can be contacted from the level landing serving a curb ramp, if provided, or from a clear floor or ground space that is in line with the crosswalk line adjacent to the vehicle stop line.)	1991 ADAAG 4.2.4
	Existing Condition: 2.1% RS.	2004 ADAAG 305.3; Fig. 305.3
		2007 CBC 1118B.4 item 1
		Other 2005 PROWAG-R306.2.1

<b>Classification</b>	
DOJ Location Type:	1
Use:	PV
Severity:	C
Level of Difficulty	High

<b>Corrective Action</b>
008 - Concrete Landing - Remove non-compliant pavement and replace with new concrete. The landing slope shall not exceed 2% in any direction.
Additional Comments: Relocate curb ramp.

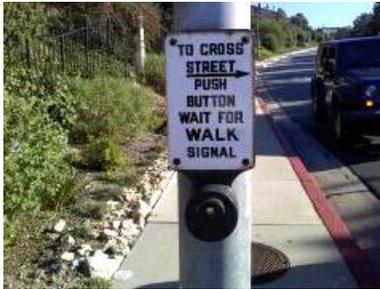
**Keynote 5**

Existing Condition: 1/2" diameter.

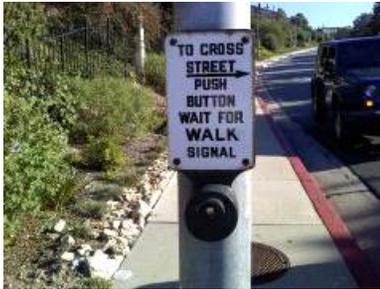
**Keynote 7**

04.24B - Vibrotactile Signal Device - A crosswalk with pedestrian signal indication does not have a vibrotactile signal device integrated into the signal device to indicate the WALK interval.

Additional Comments: Replace with vibrotactile signal device.

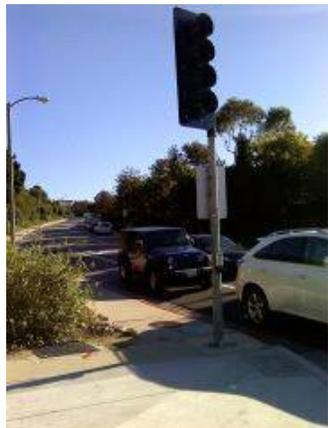
**Keynote 8**

04.25 - Pedestrian Signal Device - Clear Floor Space - Location of pedestrian signal device does not accommodate a level 30" x 48" min.. clear space, centered and parallel to the pedestrian signal push button. (Accessible pedestrian signals shall be located so that the vibrotactile feature can be contacted from the level landing serving a curb ramp, if provided, or from a clear floor or ground space that is in line with the crosswalk line adjacent to the vehicle stop line.)

Existing Condition: 4.6% CS.

008 - Concrete Landing - Remove non-compliant pavement and replace with new concrete. The landing slope shall not exceed 2% in any direction.

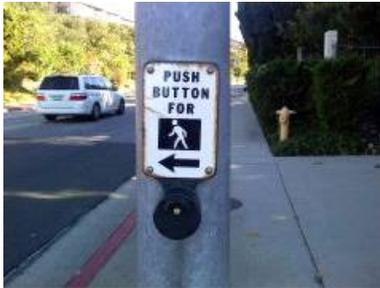
**Keynote 9**

<b>Field Condition</b>	04.24B - Vibrotactile Signal Device - A crosswalk with pedestrian signal indication does not have a vibrotactile signal device integrated into the signal device to indicate the WALK interval.	1991 ADAAG -
	Existing Condition:	2004 ADAAG -
		2007 CBC -
		Other 2005 PROWAG-R306.2

<b>Corrective Action</b>	039 - Operable Parts - Miscellaneous - See Additional Comments
	Additional Comments: Replace with vibrotactile signal device.

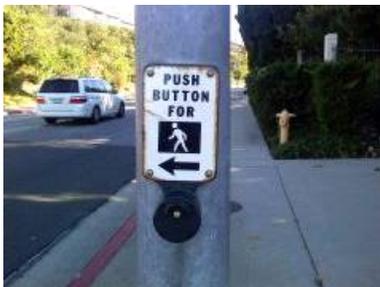
**Keynote 10**

<b>Field Condition</b>	04.24A - Audible Signal Device - A crosswalk with pedestrian signal indication does not have an audible signal device to indicate the WALK interval.	1991 ADAAG -
	Existing Condition:	2004 ADAAG -
		2007 CBC -
		Other 2005 PROWAG-R306.2

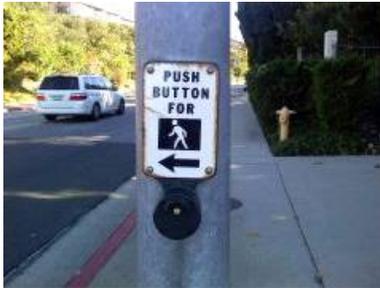
**Keynote 11**

<b>Field Condition</b>	
04.32C - Push Button Size - The pedestrian signal push button is not a min.. 2" across in one dimension.	1991 ADAAG -
Existing Condition: 1/2" diameter.	2004 ADAAG -
	2007 CBC -
	Other 2005 PROWAG-R306.3.3

<b>Classification</b>	
DOJ Location Type:	1
Use:	PV
Severity:	C
Level of Difficulty	Moderate

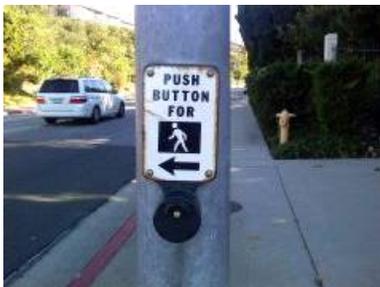
**Keynote 12**

<b>Field Condition</b>	
04.32A - Push Button Operating Effort - The force required to activate operable part(s) of pedestrian signal device exceeds 5 lbs.	1991 ADAAG 4.27.4
Existing Condition: 6 LBF.	2004 ADAAG 309.4
	2007 CBC 1117B.6 item 4
	Other 2005 PROWAG-R306.3.1; R405.4

<b>Classification</b>	
DOJ Location Type:	1
Use:	PV
Severity:	C
Level of Difficulty	Moderate

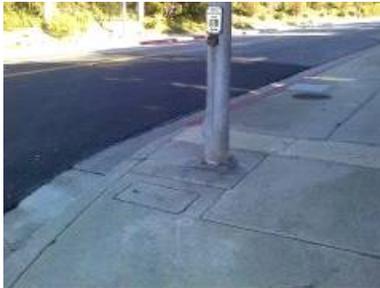
**Keynote 13**

<b>Field Condition</b>									
04.25 - Pedestrian Signal Device - Clear Floor Space - Location of pedestrian signal device does not accommodate a level 30" x 48" min.. clear space, centered and parallel to the pedestrian signal push button. (Accessible pedestrian signals shall be located so that the vibrotactile feature can be contacted from the level landing serving a curb ramp, if provided, or from a clear floor or ground space that is in line with the crosswalk line adjacent to the vehicle stop line.)

1991 ADAAG	4.2.4	2004 ADAAG	305.3; Fig. 305.3	2007 CBC	1118B.4 item 1	Other	2005 PROWAG-R306.2.1
1991 ADAAG	4.2.4								
2004 ADAAG	305.3; Fig. 305.3								
2007 CBC	1118B.4 item 1								
Other	2005 PROWAG-R306.2.1								
Existing Condition: 3.6% RS.

<b>Corrective Action</b>
008 - Concrete Landing - Remove non-compliant pavement and replace with new concrete. The landing slope shall not exceed 2% in any direction.
Additional Comments:

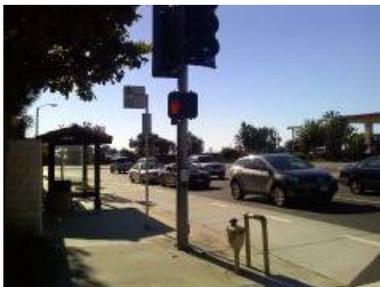
**Keynote 14**

<b>Field Condition</b>									
04.24A - Audible Signal Device - A crosswalk with pedestrian signal indication does not have an audible signal device to indicate the WALK interval.

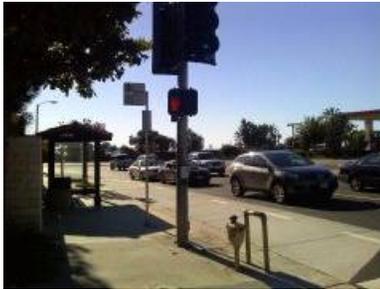
**Keynote 15**

<b>Field Condition</b>	
04.25 - Pedestrian Signal Device - Clear Floor Space - Location of pedestrian signal device does not accommodate a level 30" x 48" min.. clear space, centered and parallel to the pedestrian signal push button. (Accessible pedestrian signals shall be located so that the vibrotactile feature can be contacted from the level landing serving a curb ramp, if provided, or from a clear floor or ground space that is in line with the crosswalk line adjacent to the vehicle stop line.)	<b>1991 ADAAG</b> 4.2.4 <b>2004 ADAAG</b> 305.3; Fig. 305.3 <b>2007 CBC</b> 1118B.4 item 1 <b>Other</b> 2005 PROWAG-R306.2.1
Existing Condition: 3.4% CS & 4.9% RS.

<b>Corrective Action</b>	
008 - Concrete Landing - Remove non-compliant pavement and replace with new concrete. The landing slope shall not exceed 2% in any direction.	
Additional Comments:

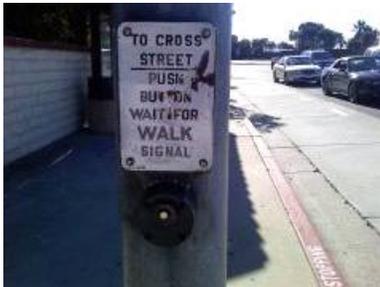
**Keynote 16**

<b>Field Condition</b>	
04.24B - Vibrotactile Signal Device - A crosswalk with pedestrian signal indication does not have a vibrotactile signal device integrated into the signal device to indicate the WALK interval.	<b>1991 ADAAG</b> - <b>2004 ADAAG</b> - <b>2007 CBC</b> - <b>Other</b> 2005 PROWAG-R306.2
Existing Condition:

<b>Corrective Action</b>	
039 - Operable Parts - Miscellaneous - See Additional Comments	
Additional Comments: Replace with vibrotactile signal device.

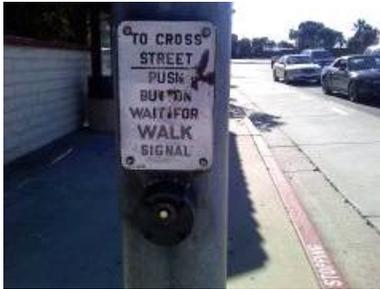
**Keynote 17**

Field Condition	
04.32C - Push Button Size - The pedestrian signal push button is not a min.. 2" across in one dimension.	1991 ADAAG -
Existing Condition: 1/2" diameter.	2004 ADAAG -
	2007 CBC -
	Other 2005 PROWAG-R306.3.3

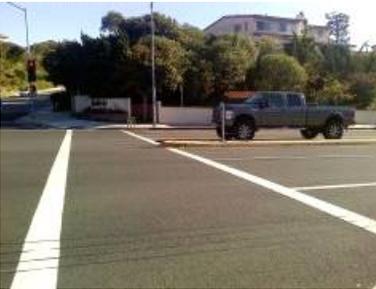
**Keynote 18**

04.34 - Signal Support or Controller - A hindrance to the passage of persons with physical disabilities, a signal support or controller cabinet, obstructs the sidewalk, or access from the sidewalk to the crosswalk. (Per CBC 1133B.7.1 walks & sidewalks shall have a minimum of 48" in width. Exception: When, because of right-of-way restrictions, natural barriers or other existing conditions, the enforcing agency determines that compliance with the 48-inch (1219 mm) clear sidewalk width would create an unreasonable hardship, the clear width may be reduced to 36 inches (914 mm).

Existing Condition: Path of travel to pedestrian signal device is not provided.

Additional Comments: Recommendation: Remove pedestrian signal device.

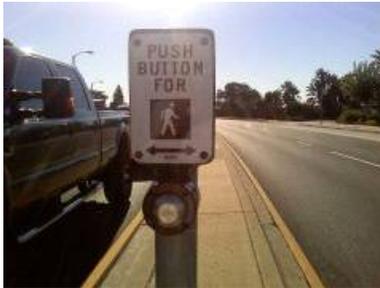
**Keynote 19**

<b>Field Condition</b>	
04.24A - Audible Signal Device - A crosswalk with pedestrian signal indication does not have an audible signal device to indicate the WALK interval.	1991 ADAAG -
Existing Condition:	2004 ADAAG -
	2007 CBC -
	Other 2005 PROWAG-R306.2

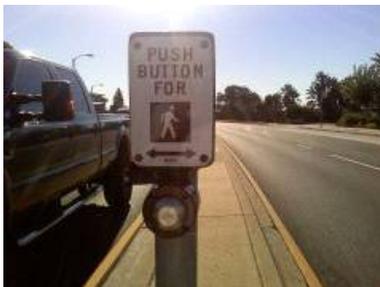
**Keynote 20**

<b>Field Condition</b>	
04.24B - Vibrotactile Signal Device - A crosswalk with pedestrian signal indication does not have a vibrotactile signal device integrated into the signal device to indicate the WALK interval.	1991 ADAAG -
Existing Condition:	2004 ADAAG -
	2007 CBC -
	Other 2005 PROWAG-R306.2

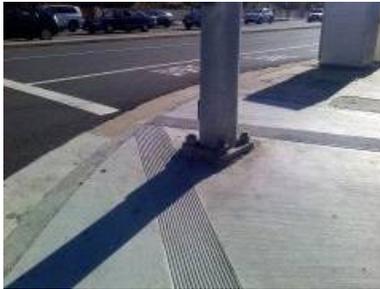
**Keynote 21**

<b>Field Condition</b>	
04.25 - Pedestrian Signal Device - Clear Floor Space - Location of pedestrian signal device does not accommodate a level 30" x 48" min.. clear space, centered and parallel to the pedestrian signal push button. (Accessible pedestrian signals shall be located so that the vibrotactile feature can be contacted from the level landing serving a curb ramp, if provided, or from a clear floor or ground space that is in line with the crosswalk line adjacent to the vehicle stop line.)	
Existing Condition:	2.8% CS & 5% RS.
<b>1991 ADAAG</b>	4.2.4
<b>2004 ADAAG</b>	305.3; Fig. 305.3
<b>2007 CBC</b>	1118B.4 item 1
<b>Other</b>	2005 PROWAG-R306.2.1

<b>Corrective Action</b>
008 - Concrete Landing - Remove non-compliant pavement and replace with new concrete. The landing slope shall not exceed 2% in any direction.
Additional Comments: Relocate curb ramp.

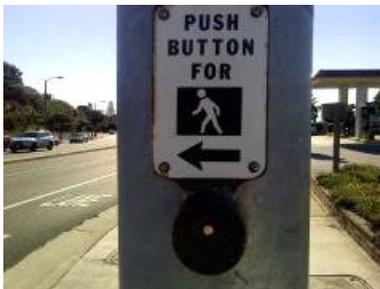
**Keynote 22**

<b>Field Condition</b>	
04.32C - Push Button Size - The pedestrian signal push button is not a min.. 2" across in one dimension.	
Existing Condition:	1/2" diameter.
<b>1991 ADAAG</b>	-
<b>2004 ADAAG</b>	-
<b>2007 CBC</b>	-
<b>Other</b>	2005 PROWAG-R306.3.3

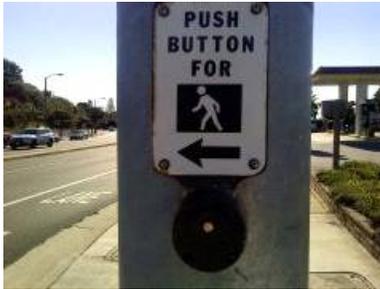
**Keynote 23**

<b>Field Condition</b>	
04.24A - Audible Signal Device - A crosswalk with pedestrian signal indication does not have an audible signal device to indicate the WALK interval.	1991 ADAAG -
Existing Condition:	2004 ADAAG -
	2007 CBC -
	Other 2005 PROWAG-R306.2

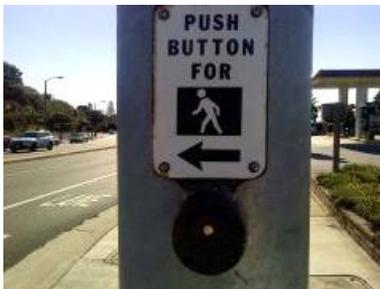
**Keynote 24**

<b>Field Condition</b>	
04.24B - Vibrotactile Signal Device - A crosswalk with pedestrian signal indication does not have a vibrotactile signal device integrated into the signal device to indicate the WALK interval.	1991 ADAAG -
Existing Condition:	2004 ADAAG -
	2007 CBC -
	Other 2005 PROWAG-R306.2

<b>Corrective Action</b>
039 - Operable Parts - Miscellaneous - See Additional Comments
Additional Comments: Replace with vibrotactile signal device.

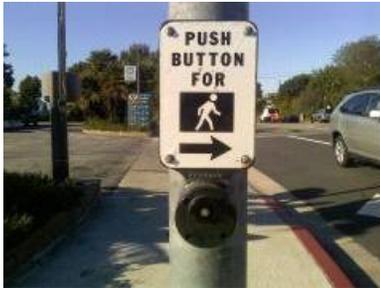
**Keynote 25**

<b>Field Condition</b>	
04.32C - Push Button Size - The pedestrian signal push button is not a min.. 2" across in one dimension.	1991 ADAAG -
Existing Condition: 1/2" diameter.	2004 ADAAG -
	2007 CBC -
	Other 2005 PROWAG-R306.3.3

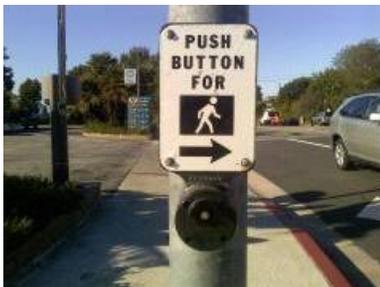
**Keynote 26**

<b>Field Condition</b>	
04.24A - Audible Signal Device - A crosswalk with pedestrian signal indication does not have an audible signal device to indicate the WALK interval.	1991 ADAAG -
Existing Condition:	2004 ADAAG -
	2007 CBC -
	Other 2005 PROWAG-R306.2

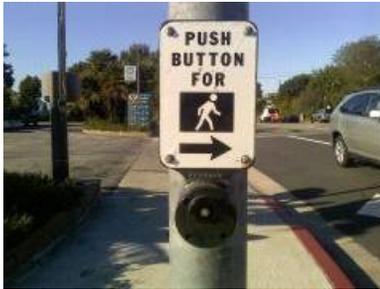
**Keynote 27**

<b>Field Condition</b>	
04.24B - Vibrotactile Signal Device - A crosswalk with pedestrian signal indication does not have a vibrotactile signal device integrated into the signal device to indicate the WALK interval.	1991 ADAAG -
Existing Condition:	2004 ADAAG -
	2007 CBC -
	Other 2005 PROWAG-R306.2

<b>Corrective Action</b>
039 - Operable Parts - Miscellaneous - See Additional Comments
Additional Comments: Replace with vibrotactile signal device.

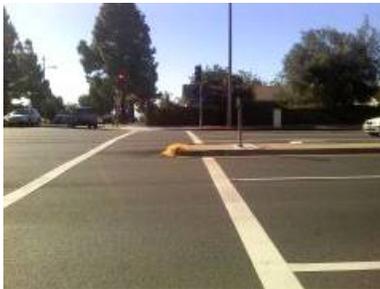
**Keynote 28**

<b>Field Condition</b>	
04.40 - Other - Curb Ramps and Pedestrian Crossings - See Additional Comments	1991 ADAAG -
Existing Condition: Path of travel to pedestrian signal device is not provided.	2004 ADAAG -
	2007 CBC -
	Other -

<b>Corrective Action</b>
039 - Operable Parts - Miscellaneous - See Additional Comments
Additional Comments: Recommendation: Remove pedestrian signal device.

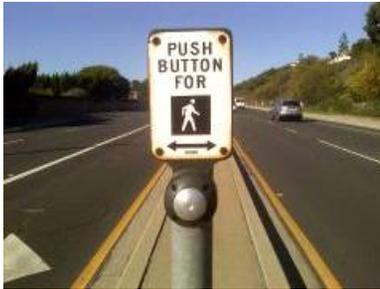
**Keynote 29**

<b>Field Condition</b>	
04.24A - Audible Signal Device - A crosswalk with pedestrian signal indication does not have an audible signal device to indicate the WALK interval.	1991 ADAAG -
Existing Condition:	2004 ADAAG -
	2007 CBC -
	Other 2005 PROWAG-R306.2

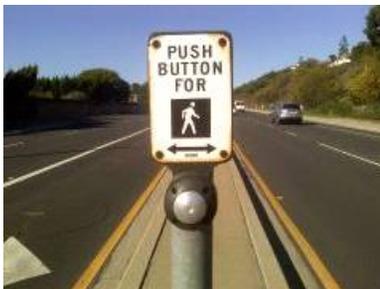
**Keynote 30**

<b>Field Condition</b>	
04.24B - Vibrotactile Signal Device - A crosswalk with pedestrian signal indication does not have a vibrotactile signal device integrated into the signal device to indicate the WALK interval.	1991 ADAAG -
Existing Condition:	2004 ADAAG -
	2007 CBC -
	Other 2005 PROWAG-R306.2

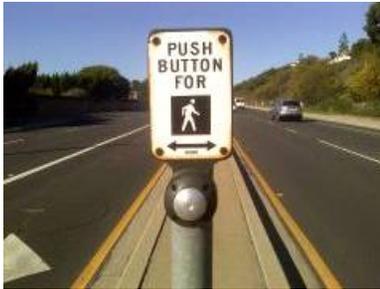
**Keynote 31**

<b>Field Condition</b>	
04.32A - Push Button Operating Effort - The force required to activate operable part(s) of pedestrian signal device exceeds 5 lbs.	<b>1991 ADAAG</b> 4.27.4
Existing Condition:	<b>2004 ADAAG</b> 309.4
	<b>2007 CBC</b> 1117B.6 item 4
	<b>Other</b> 2005 PROWAG-R306.3.1; R405.4

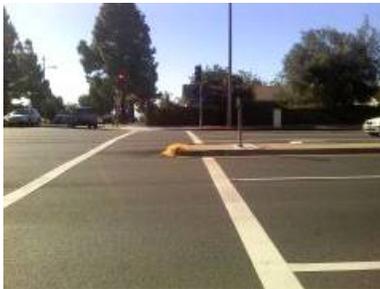
**Keynote 32**

<b>Field Condition</b>	
04.25 - Pedestrian Signal Device - Clear Floor Space - Location of pedestrian signal device does not accommodate a level 30" x 48" min.. clear space, centered and parallel to the pedestrian signal push button. (Accessible pedestrian signals shall be located so that the vibrotactile feature can be contacted from the level landing serving a curb ramp, if provided, or from a clear floor or ground space that is in line with the crosswalk line adjacent to the vehicle stop line.)	<b>1991 ADAAG</b> 4.2.4
Existing Condition: 7.4% CS & 3.3% RS.	<b>2004 ADAAG</b> 305.3; Fig. 305.3
	<b>2007 CBC</b> 1118B.4 item 1
	<b>Other</b> 2005 PROWAG-R306.2.1

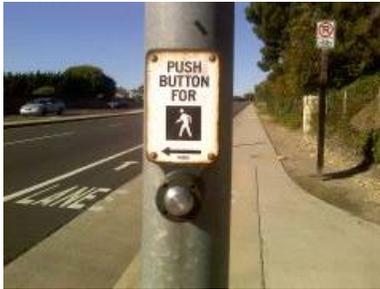
**Keynote 33**

Field Condition	
04.32A - Push Button Operating Effort - The force required to activate operable part(s) of pedestrian signal device exceeds 5 lbs.	1991 ADAAG 4.27.4
Existing Condition: 6 LBF.	2004 ADAAG 309.4
	2007 CBC 1117B.6 item 4
	Other 2005 PROWAG-R306.3.1; R405.4

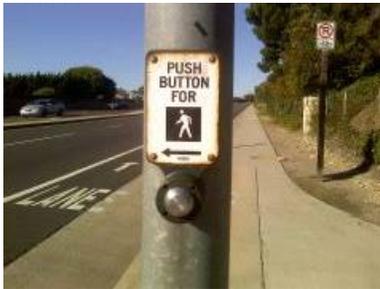
**Keynote 34**

Field Condition	
04.24A - Audible Signal Device - A crosswalk with pedestrian signal indication does not have an audible signal device to indicate the WALK interval.	1991 ADAAG -
Existing Condition:	2004 ADAAG -
	2007 CBC -
	Other 2005 PROWAG-R306.2

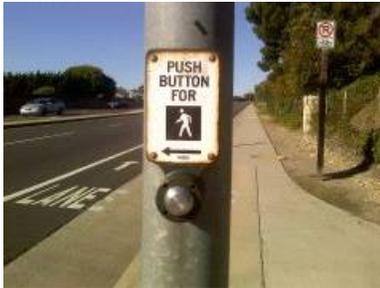
**Keynote 35**

<b>Field Condition</b>	
04.24B - Vibrotactile Signal Device - A crosswalk with pedestrian signal indication does not have a vibrotactile signal device integrated into the signal device to indicate the WALK interval.	1991 ADAAG -
Existing Condition:	2004 ADAAG -
	2007 CBC -
	Other 2005 PROWAG-R306.2

<b>Corrective Action</b>
039 - Operable Parts - Miscellaneous - See Additional Comments
Additional Comments: Replace with vibrotactile signal device.

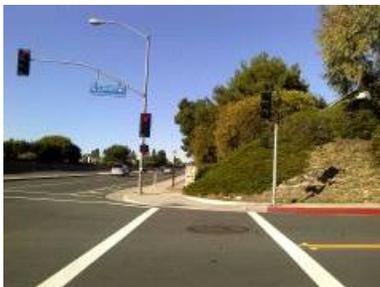
**Keynote 36**

<b>Field Condition</b>	
04.40 - Other - Curb Ramps and Pedestrian Crossings - See Additional Comments	1991 ADAAG -
Existing Condition: Pedestrian and audible signals not provided.	2004 ADAAG -
	2007 CBC -
	Other -

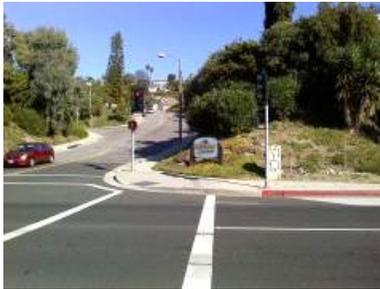
**Keynote 37**

<b>Field Condition</b>	
04.40 - Other - Curb Ramps and Pedestrian Crossings - See Additional Comments	1991 ADAAG -
Existing Condition: Pedestrian and audible signals not provided.	2004 ADAAG -
	2007 CBC -
	Other -

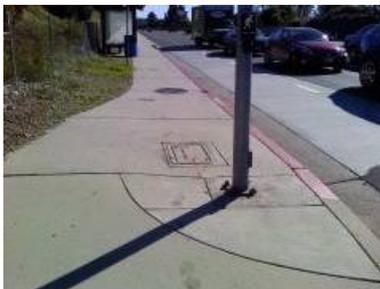
**Keynote 38**

<b>Field Condition</b>	
04.25 - Pedestrian Signal Device - Clear Floor Space - Location of pedestrian signal device does not accommodate a level 30" x 48" min.. clear space, centered and parallel to the pedestrian signal push button. (Accessible pedestrian signals shall be located so that the vibrotactile feature can be contacted from the level landing serving a curb ramp, if provided, or from a clear floor or ground space that is in line with the crosswalk line adjacent to the vehicle stop line.)	1991 ADAAG 4.2.4
Existing Condition: 2.8% CS & 3.8% RS.	2004 ADAAG 305.3; Fig. 305.3
	2007 CBC 1118B.4 item 1
	Other 2005 PROWAG-R306.2.1

<b>Corrective Action</b>	
008 - Concrete Landing - Remove non-compliant pavement and replace with new concrete. The landing slope shall not exceed 2% in any direction.	
Additional Comments:

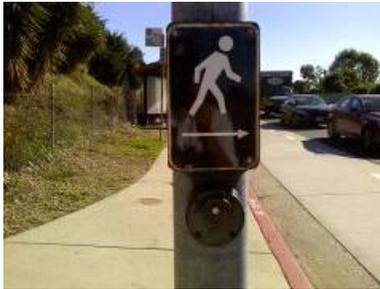
**Keynote 39**

<b>Field Condition</b>	
04.32C - Push Button Size - The pedestrian signal push button is not a min.. 2" across in one dimension.	1991 ADAAG -
Existing Condition: 1/2" diameter.	2004 ADAAG -
	2007 CBC -
	Other 2005 PROWAG-R306.3.3

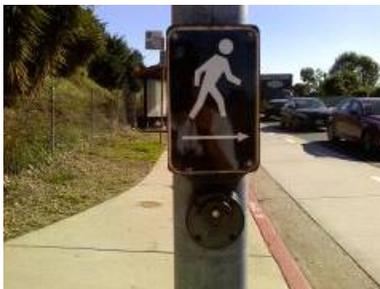
**Keynote 40**

<b>Field Condition</b>	
04.32A - Push Button Operating Effort - The force required to activate operable part(s) of pedestrian signal device exceeds 5 lbs.	1991 ADAAG 4.27.4
Existing Condition: 6 LBF.	2004 ADAAG 309.4
	2007 CBC 1117B.6 item 4
	Other 2005 PROWAG-R306.3.1; R405.4

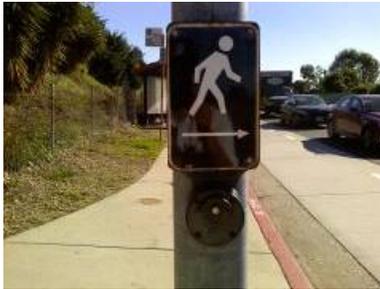
**Keynote 41**

<b>Field Condition</b>	
04.24A - Audible Signal Device - A crosswalk with pedestrian signal indication does not have an audible signal device to indicate the WALK interval.	1991 ADAAG -
Existing Condition:	2004 ADAAG -
	2007 CBC -
	Other 2005 PROWAG-R306.2

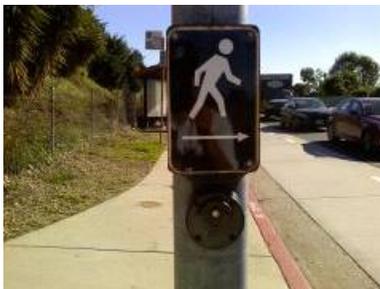
**Keynote 42**

<b>Field Condition</b>	
04.24B - Vibrotactile Signal Device - A crosswalk with pedestrian signal indication does not have a vibrotactile signal device integrated into the signal device to indicate the WALK interval.	1991 ADAAG -
Existing Condition:	2004 ADAAG -
	2007 CBC -
	Other 2005 PROWAG-R306.2

<b>Corrective Action</b>
039 - Operable Parts - Miscellaneous - See Additional Comments
Additional Comments: Replace with vibrotactile signal device.

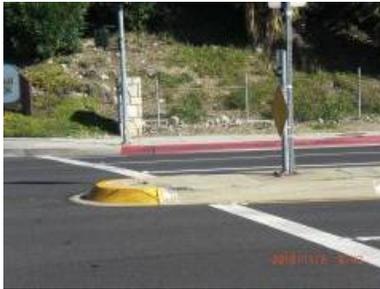
**Keynote 43**

Field Condition	
04.40 - Other - Curb Ramps and Pedestrian Crossings - See Additional Comments	1991 ADAAG -
Existing Condition: 4.6% RS.	2004 ADAAG -
	2007 CBC -
	Other -

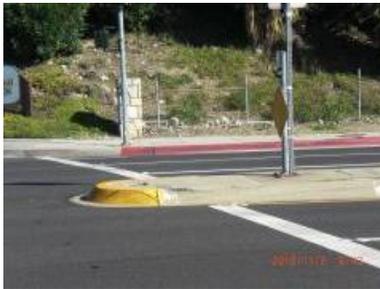
**Keynote 44**

Field Condition	
04.40 - Other - Curb Ramps and Pedestrian Crossings - See Additional Comments	1991 ADAAG -
Existing Condition: Path of travel to pedestrian signal device is not provided.	2004 ADAAG -
	2007 CBC -
	Other -

Corrective Action
039 - Operable Parts - Miscellaneous - See Additional Comments
Additional Comments: Recommendation: Remove pedestrian signal device.

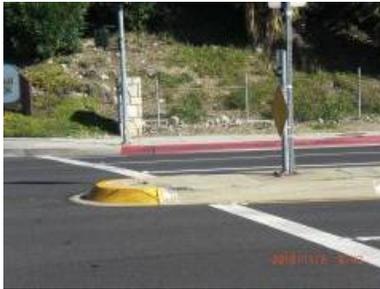
**Keynote 45**

<b>Field Condition</b>	
04.24A - Audible Signal Device - A crosswalk with pedestrian signal indication does not have an audible signal device to indicate the WALK interval.	1991 ADAAG -
Existing Condition:	2004 ADAAG -
	2007 CBC -
	Other 2005 PROWAG-R306.2

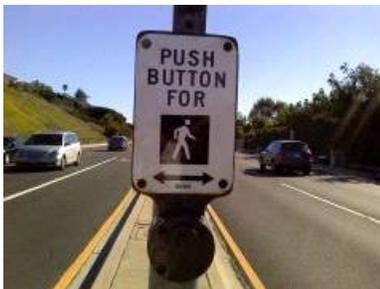
**Keynote 46**

<b>Field Condition</b>	
04.32C - Push Button Size - The pedestrian signal push button is not a min.. 2" across in one dimension.	1991 ADAAG -
Existing Condition: 1/2" diameter.	2004 ADAAG -
	2007 CBC -
	Other 2005 PROWAG-R306.3.3

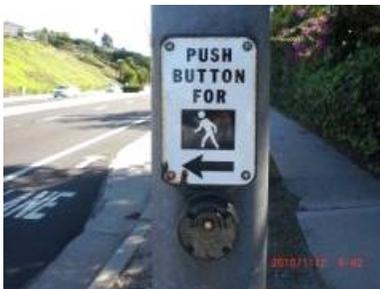
**Keynote 48**

Existing Condition: 1/2" diameter.

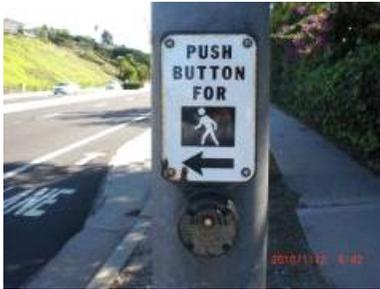
**Keynote 49**

<b>Field Condition</b>	04.24A - Audible Signal Device - A crosswalk with pedestrian signal indication does not have an audible signal device to indicate the WALK interval.	1991 ADAAG -
Existing Condition:		2004 ADAAG -
		2007 CBC -
		Other 2005 PROWAG-R306.2

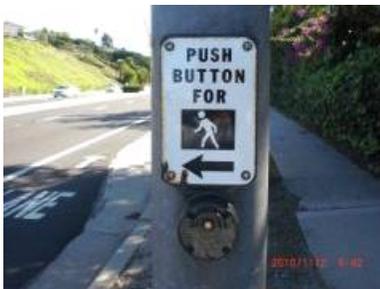
**Keynote 50**

<b>Field Condition</b>	04.24B - Vibrotactile Signal Device - A crosswalk with pedestrian signal indication does not have a vibrotactile signal device integrated into the signal device to indicate the WALK interval.	1991 ADAAG -
Existing Condition:		2004 ADAAG -
		2007 CBC -
		Other 2005 PROWAG-R306.2

<b>Corrective Action</b>	039 - Operable Parts - Miscellaneous - See Additional Comments
Additional Comments:	Replace with vibrotactile signal device.

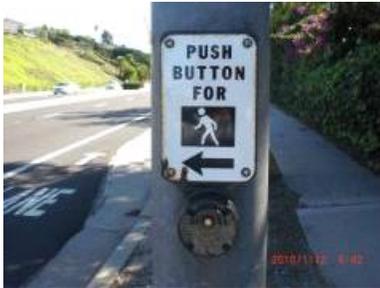
**Keynote 51**

<b>Field Condition</b>	
04.32A - Push Button Operating Effort - The force required to activate operable part(s) of pedestrian signal device exceeds 5 lbs.	<b>1991 ADAAG</b> 4.27.4
Existing Condition: 6 LBF.	<b>2004 ADAAG</b> 309.4
	<b>2007 CBC</b> 1117B.6 item 4
	<b>Other</b> 2005 PROWAG-R306.3.1; R405.4

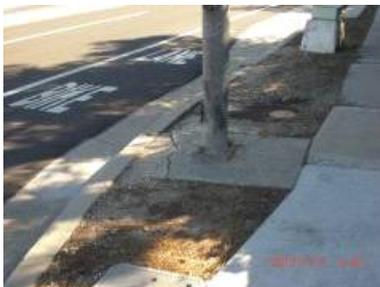
**Keynote 52**

<b>Field Condition</b>	
04.25 - Pedestrian Signal Device - Clear Floor Space - Location of pedestrian signal device does not accommodate a level 30" x 48" min.. clear space, centered and parallel to the pedestrian signal push button. (Accessible pedestrian signals shall be located so that the vibrotactile feature can be contacted from the level landing serving a curb ramp, if provided, or from a clear floor or ground space that is in line with the crosswalk line adjacent to the vehicle stop line.)	<b>1991 ADAAG</b> 4.2.4
Existing Condition: Stable surface not provided.	<b>2004 ADAAG</b> 305.3; Fig. 305.3
	<b>2007 CBC</b> 1118B.4 item 1
	<b>Other</b> 2005 PROWAG-R306.2.1

<b>Corrective Action</b>
008 - Concrete Landing - Remove non-compliant pavement and replace with new concrete. The landing slope shall not exceed 2% in any direction.
Additional Comments:

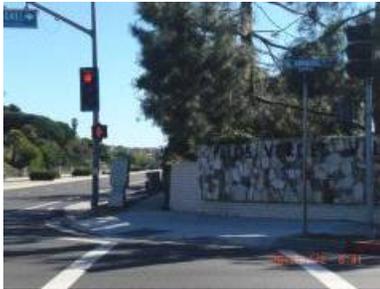
**Keynote 53**

<b>Field Condition</b>	
04.40 - Other - Curb Ramps and Pedestrian Crossings - See Additional Comments	1991 ADAAG -
Existing Condition: Pedestrian and audible signals not provided.	2004 ADAAG -
	2007 CBC -
	Other -

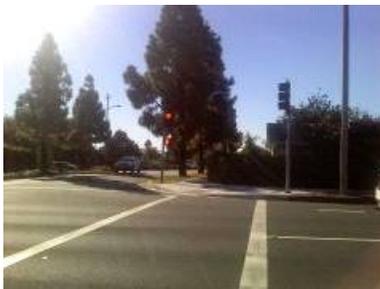
**Keynote 54**

<b>Field Condition</b>	
04.40 - Other - Curb Ramps and Pedestrian Crossings - See Additional Comments	1991 ADAAG -
Existing Condition: Pedestrian and audible signals not provided.	2004 ADAAG -
	2007 CBC -
	Other -

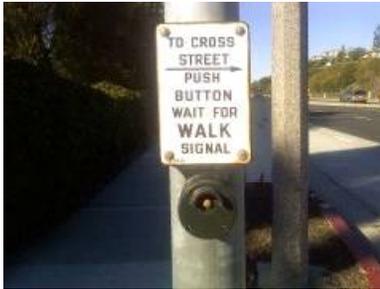
**Keynote 55**

<b>Field Condition</b>	
04.32C - Push Button Size - The pedestrian signal push button is not a min.. 2" across in one dimension.	1991 ADAAG -
Existing Condition: 1/2" diameter.	2004 ADAAG -
	2007 CBC -
	Other 2005 PROWAG-R306.3.3

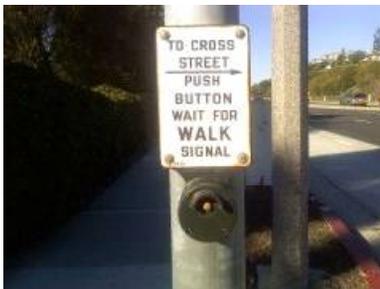
**Keynote 56**

<b>Field Condition</b>	
04.24B - Vibrotactile Signal Device - A crosswalk with pedestrian signal indication does not have a vibrotactile signal device integrated into the signal device to indicate the WALK interval.	1991 ADAAG -
Existing Condition:	2004 ADAAG -
	2007 CBC -
	Other 2005 PROWAG-R306.2

<b>Corrective Action</b>
039 - Operable Parts - Miscellaneous - See Additional Comments
Additional Comments: Replace with vibrotactile signal device.

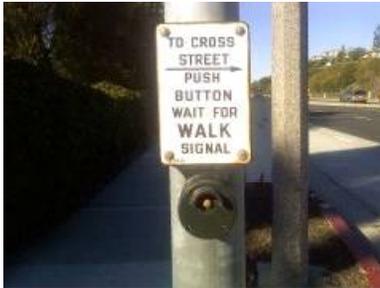
**Keynote 57**

<b>Field Condition</b>	04.24A - Audible Signal Device - A crosswalk with pedestrian signal indication does not have an audible signal device to indicate the WALK interval.	1991 ADAAG -
Existing Condition:		2004 ADAAG -
		2007 CBC -
		Other 2005 PROWAG-R306.2

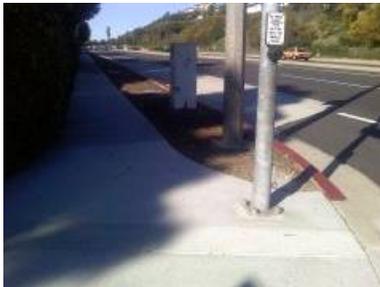
**Keynote 58**

<b>Field Condition</b>	04.25 - Pedestrian Signal Device - Clear Floor Space - Location of pedestrian signal device does not accommodate a level 30" x 48" min.. clear space, centered and parallel to the pedestrian signal push button. (Accessible pedestrian signals shall be located so that the vibrotactile feature can be contacted from the level landing serving a curb ramp, if provided, or from a clear floor or ground space that is in line with the crosswalk line adjacent to the vehicle stop line.)	1991 ADAAG 4.2.4
Existing Condition:	4.6% RS.	2004 ADAAG 305.3; Fig. 305.3
		2007 CBC 1118B.4 item 1
		Other 2005 PROWAG-R306.2.1

<b>Corrective Action</b>	008 - Concrete Landing - Remove non-compliant pavement and replace with new concrete. The landing slope shall not exceed 2% in any direction.
Additional Comments:	Relocate curb ramp.
