PLANNING, BUILDING &
CODE ENFORCEMENT PN 97082-1485

August 1, 2006

Subject: Summary of Site Observations and Cursory Review of Site Conditions, Abalone Cove Landslide Area, Rancho Palos Verdes, California

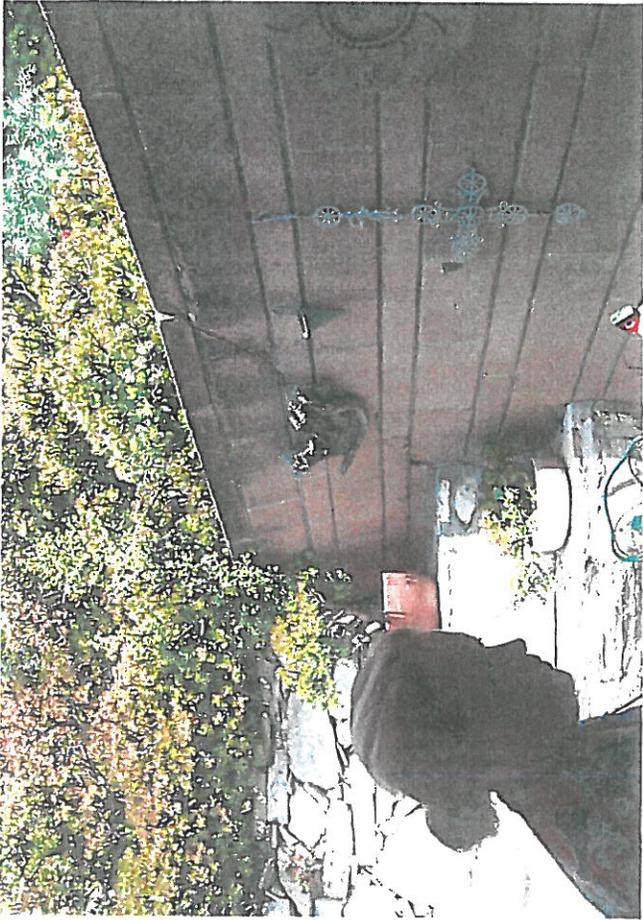
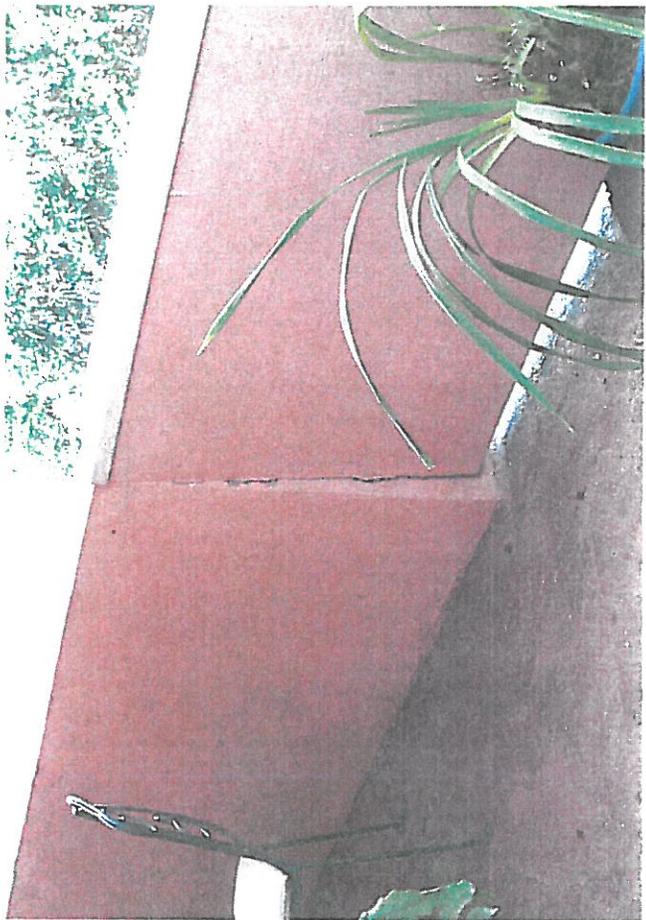
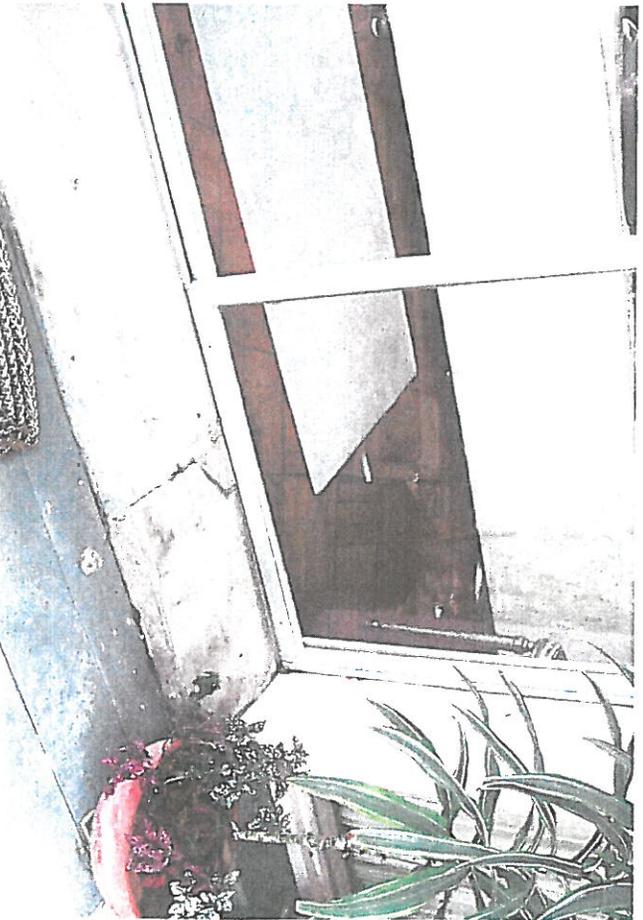
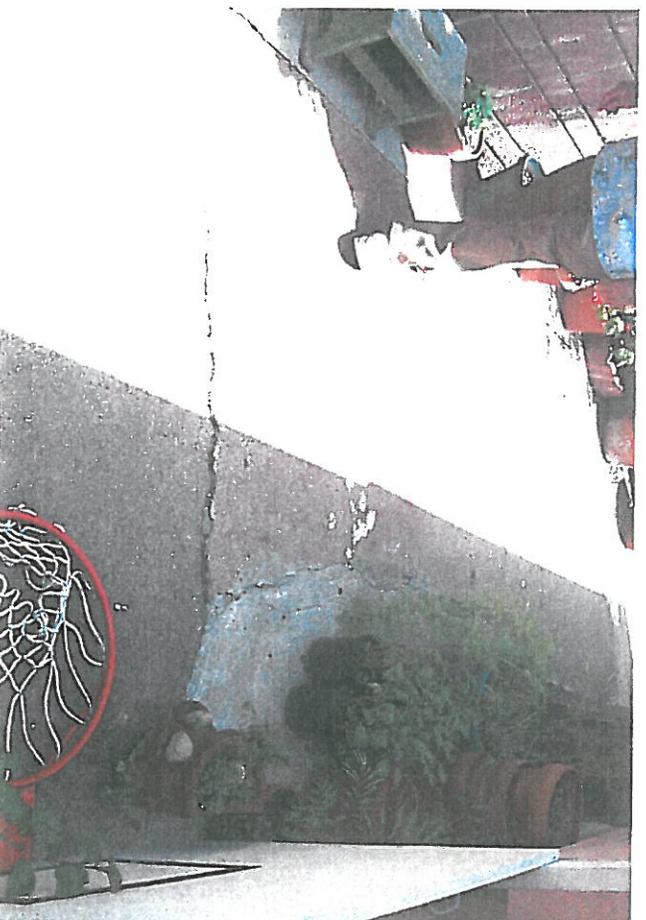
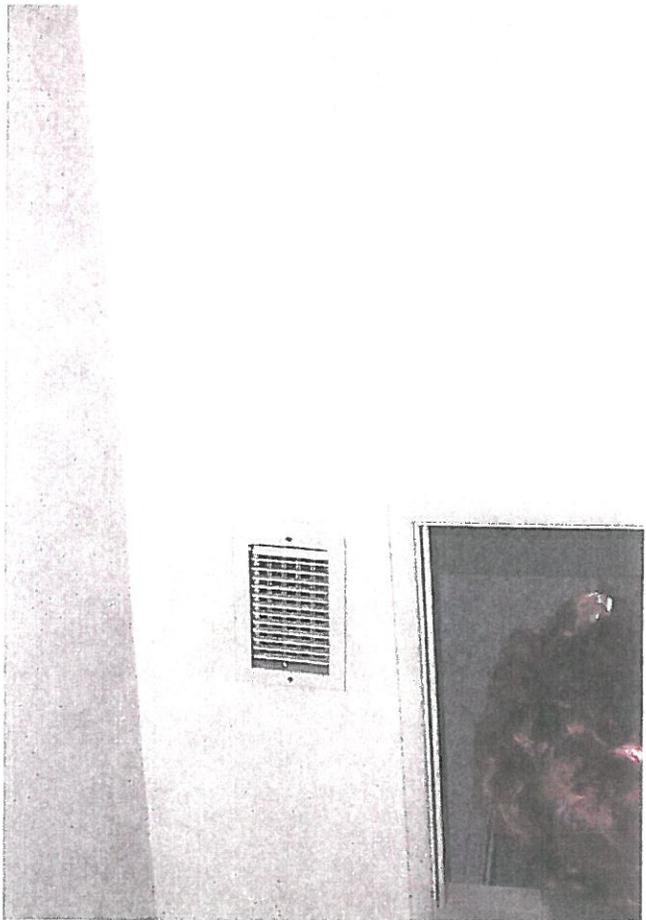
Figure 6

Observations at the Jester residence (28 Narcissa Drive) were confined to the exterior of the residence. Distress in the form of a somewhat continuous crack within the length of the driveway was observed. This crack showed both horizontal and vertical separations on the order of 1/2 to 1 inch (see photos 1 through 4 and ZKCI Figure 4). Additional separations and cracks were observed within the entry stairs and within flatwork and walls of the residence (see photos 5 through 12 and ZKCI photos Figure 5 and 6).

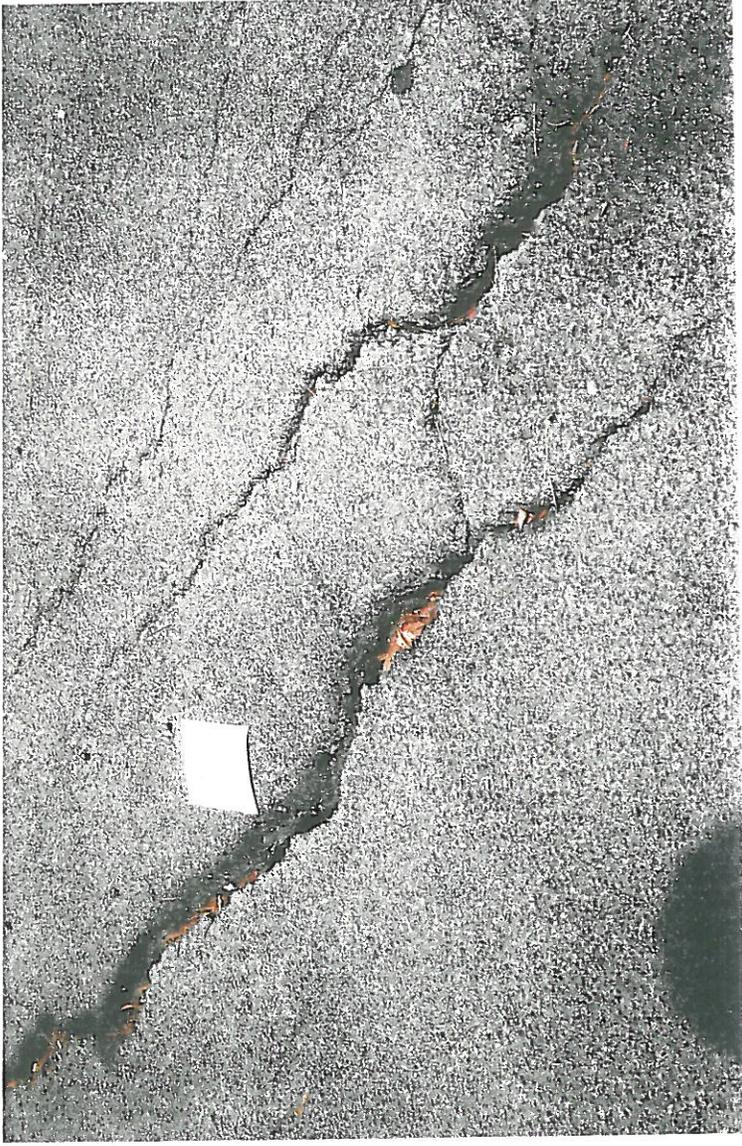
#1

7/24/06

Wester Driveway - 20 Narcissa Dr.
6 in. deep.

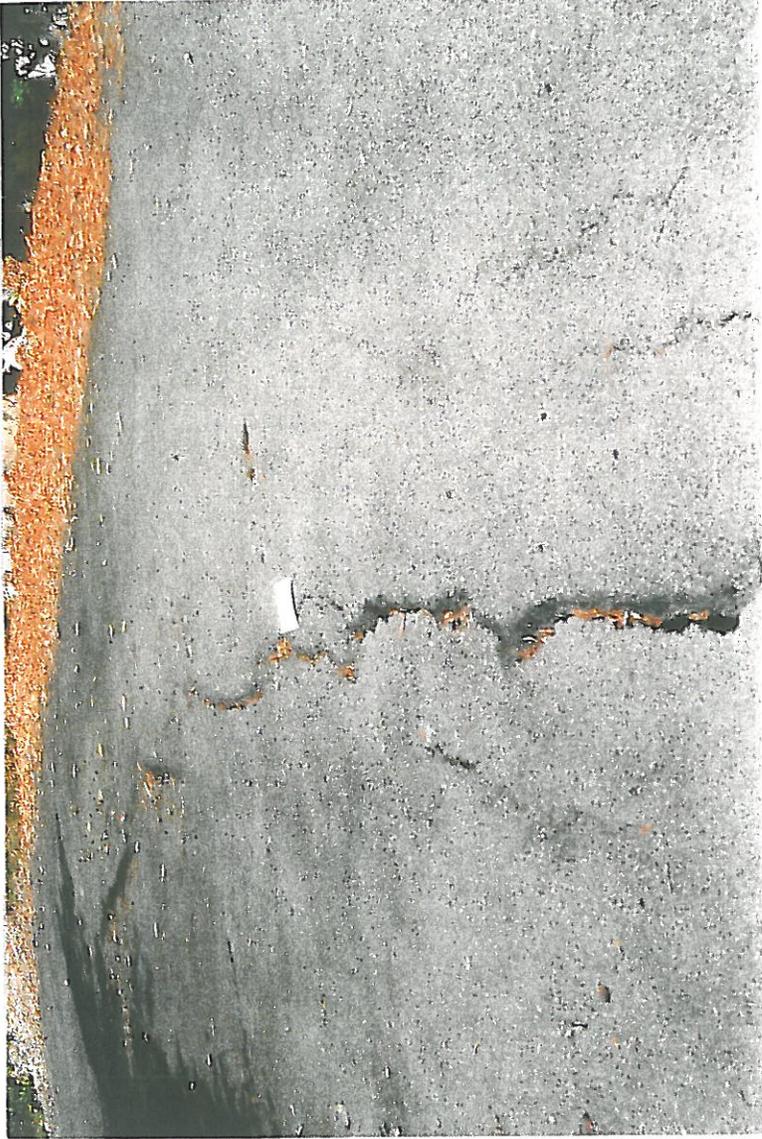
2

JESPER DRIVEWAY - 20
"JACKISS + DR."

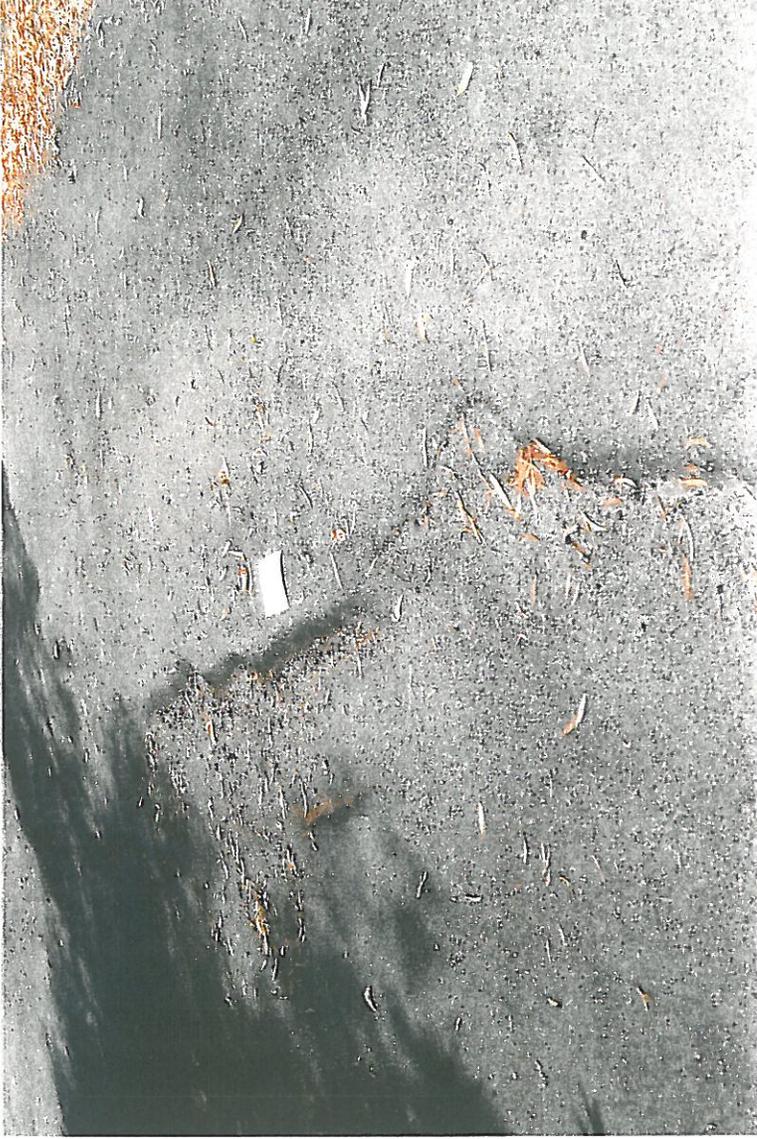
JESTEK DRIVEWAY - 20 NARCISIA DR.

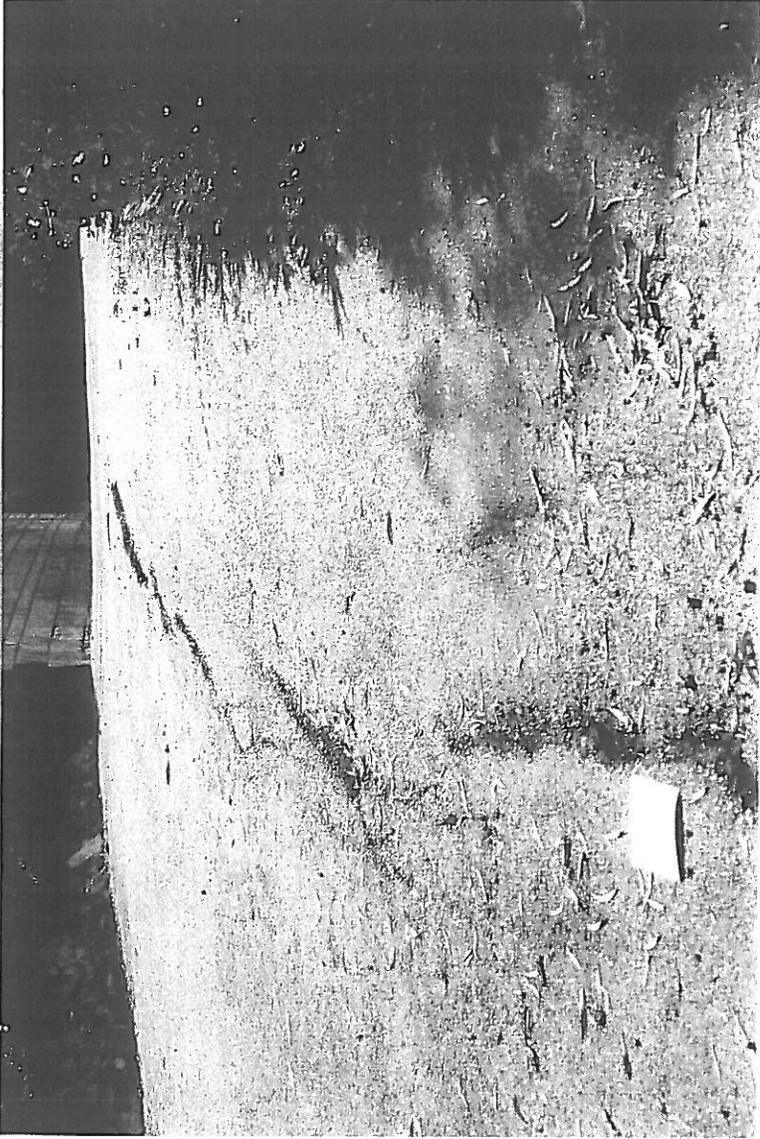
A.

JOSIEK DRIVEWAY, 20 N. ARCISSA DR.

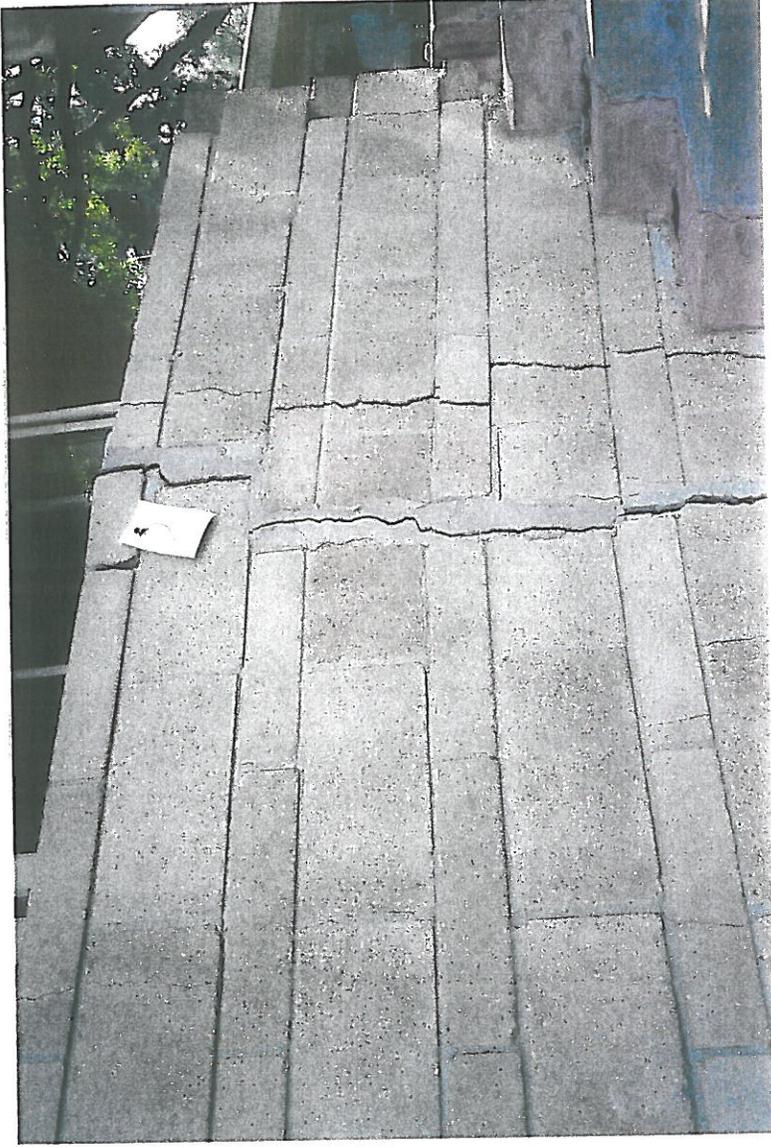
Jester wall in back yard
26 Nutcrissa Dr.

NOTE: previous patching @ #

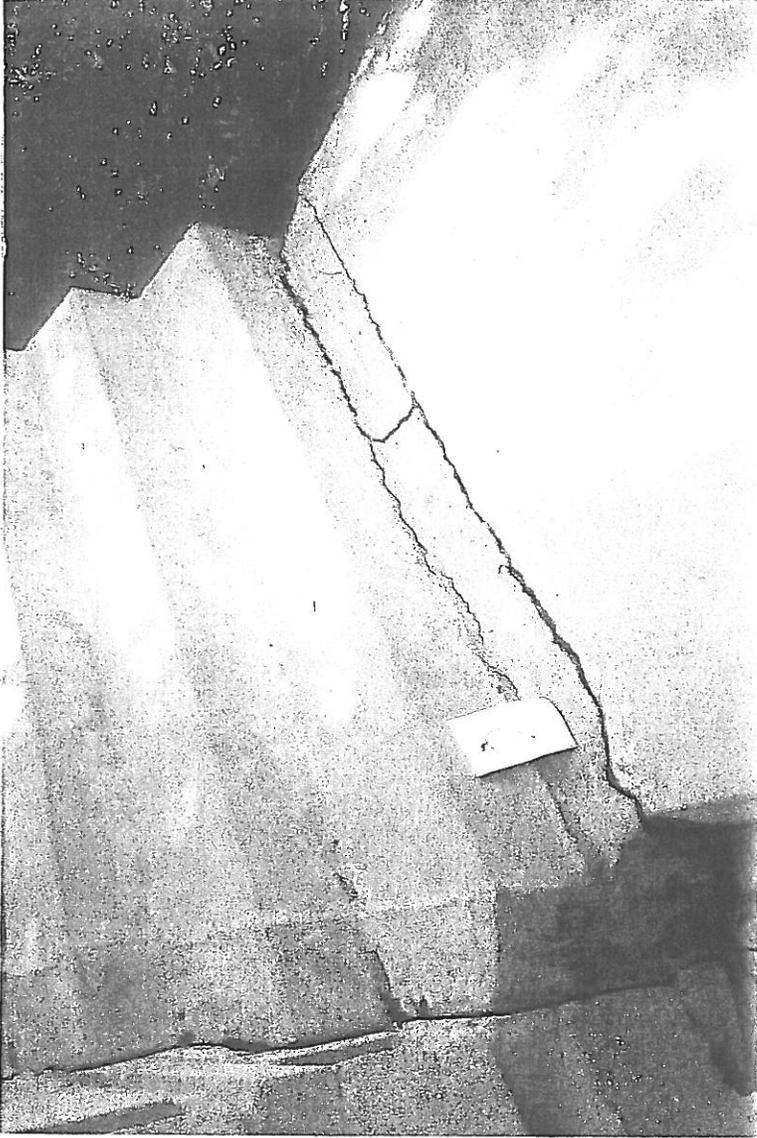
FROST STRAPS AT Jester House
20 ~~500~~ NARCISSE DR.

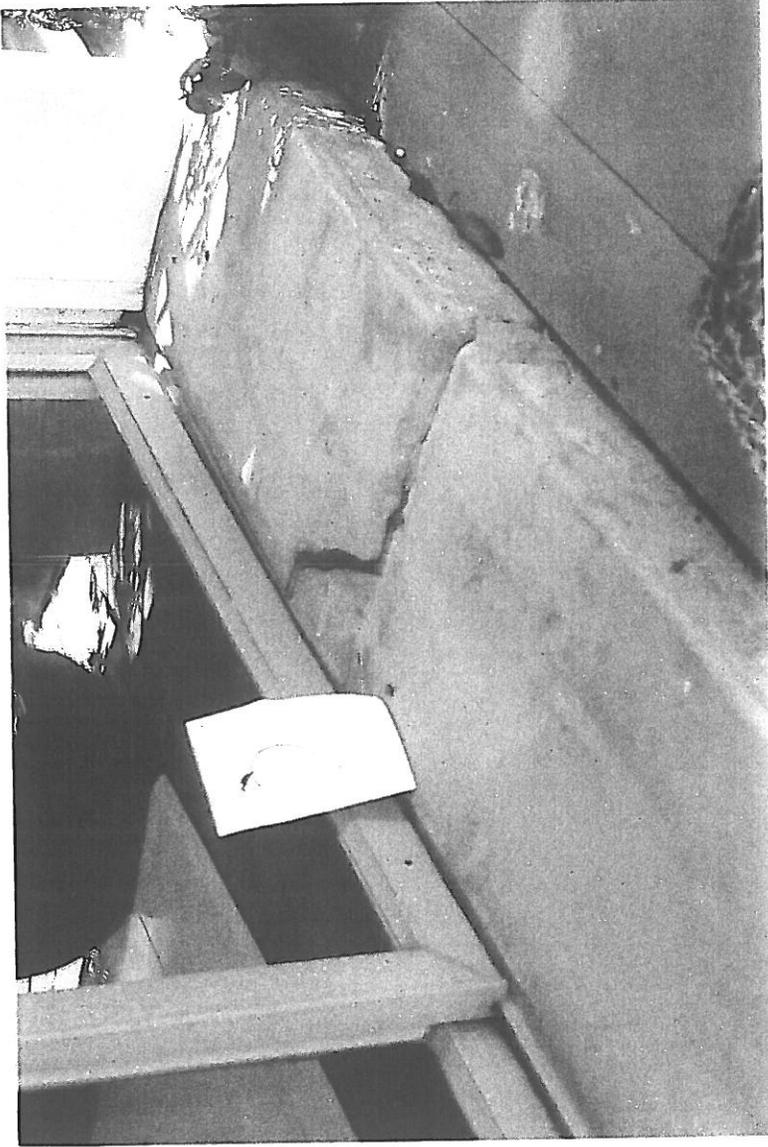
8

FRONT YARD at Jester's
20 NARCISSE DK

POIL APART CRACK ON SLAB

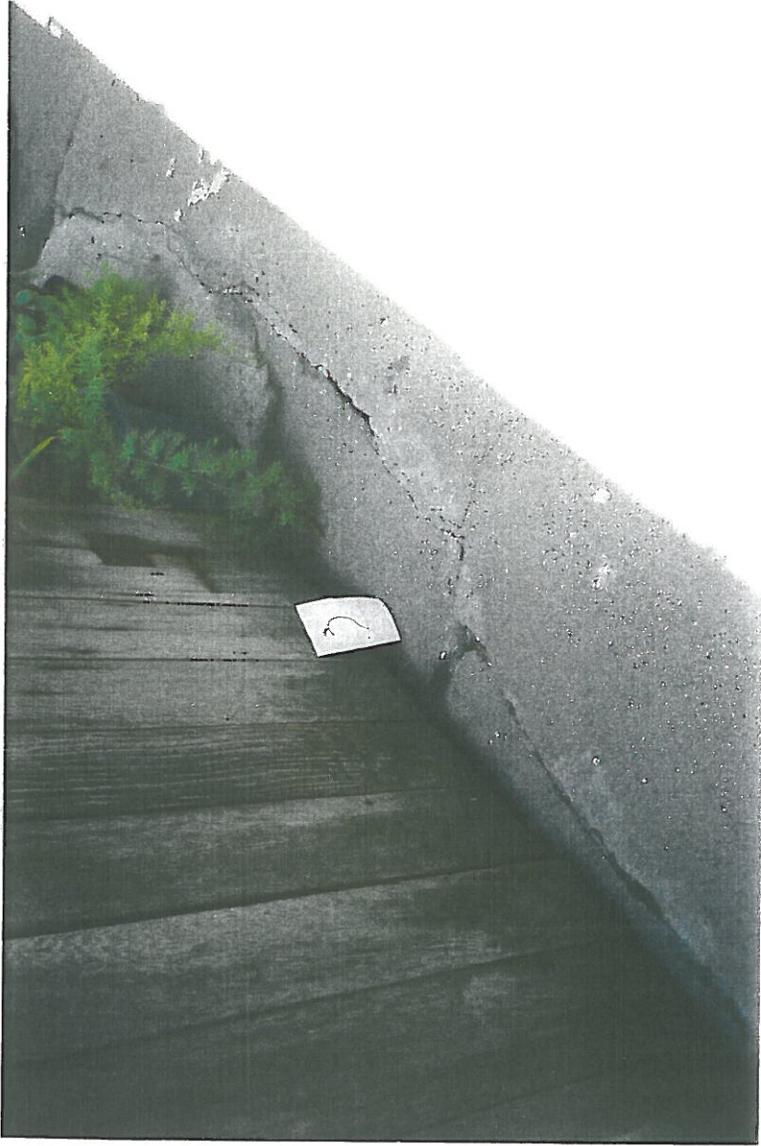
9

BACK YARD AT JESTER'S

200 MARSSA DR.

CRACKS IN SIDEWALK

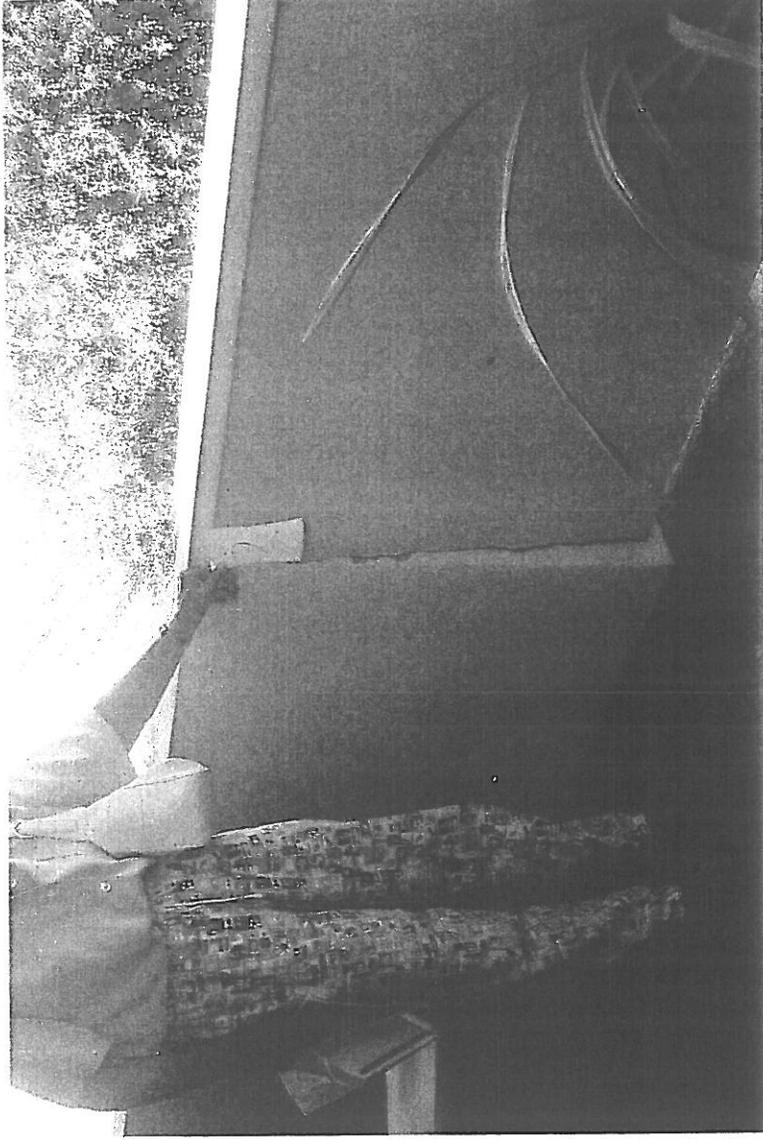
#10

Jester Home - 20 Narcissa Dr.
offset in patio wall.

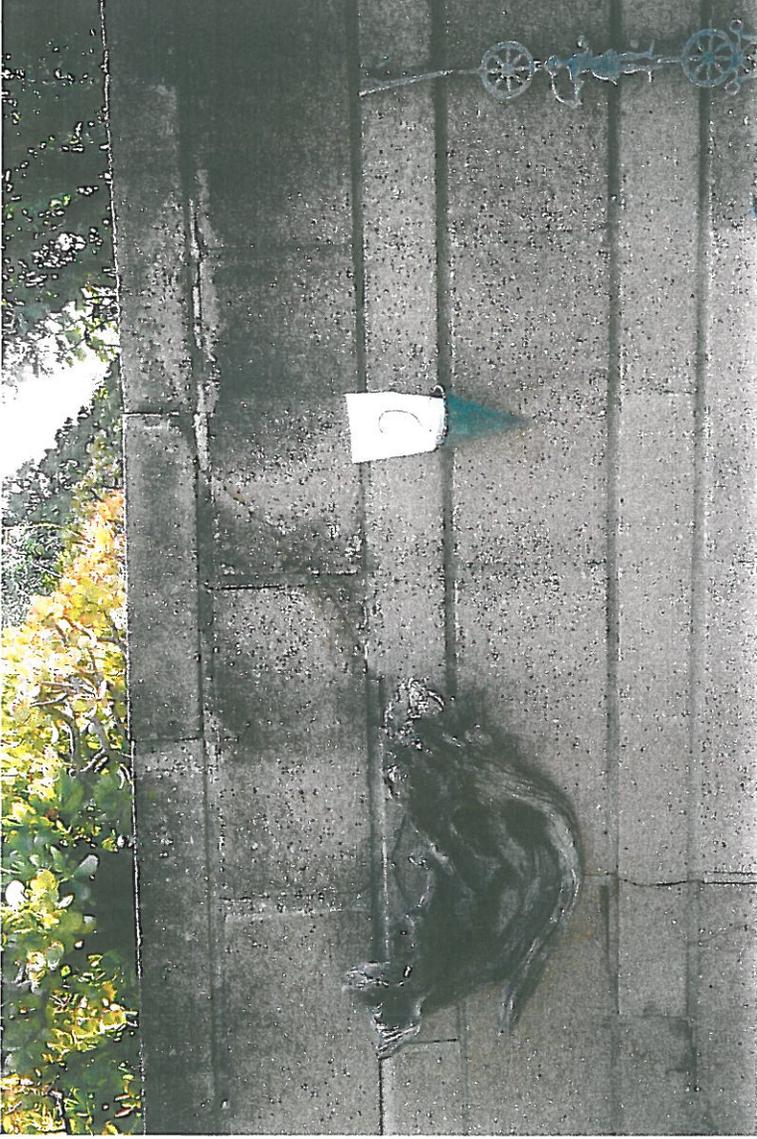
Back yard at Juster's

20 Narcissa DR

New wall cracks

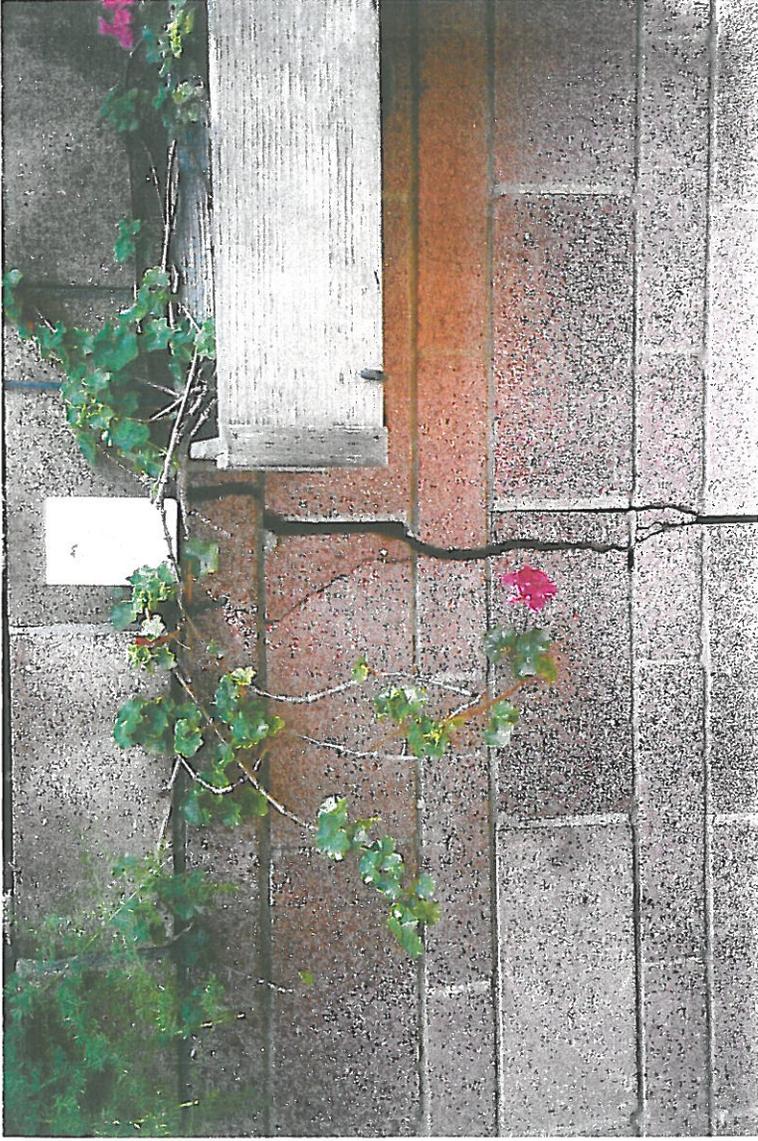
12

JUSTICE BAYC YARD WALL

20 JARCEISSA DR.

Settlement - full apart crack

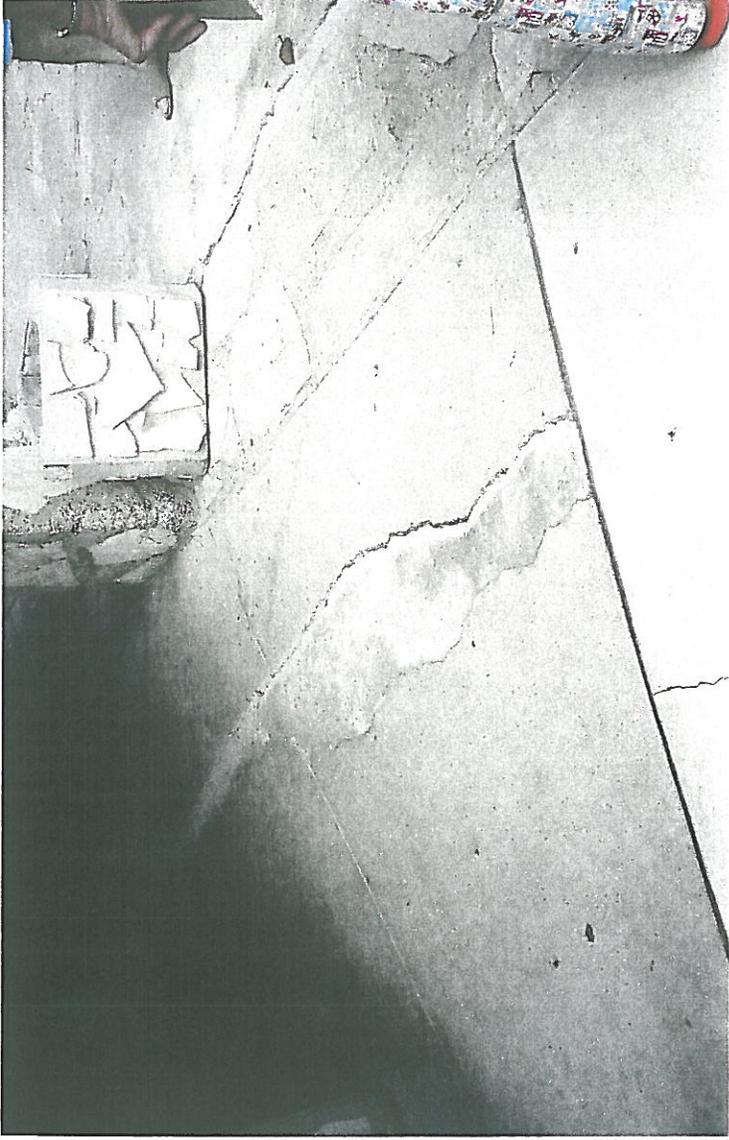
NEW MOVEMENT NEAR GREEN
HOUSE - WAYFARER'S CHAPEL.
UNDER BREEZE WAY

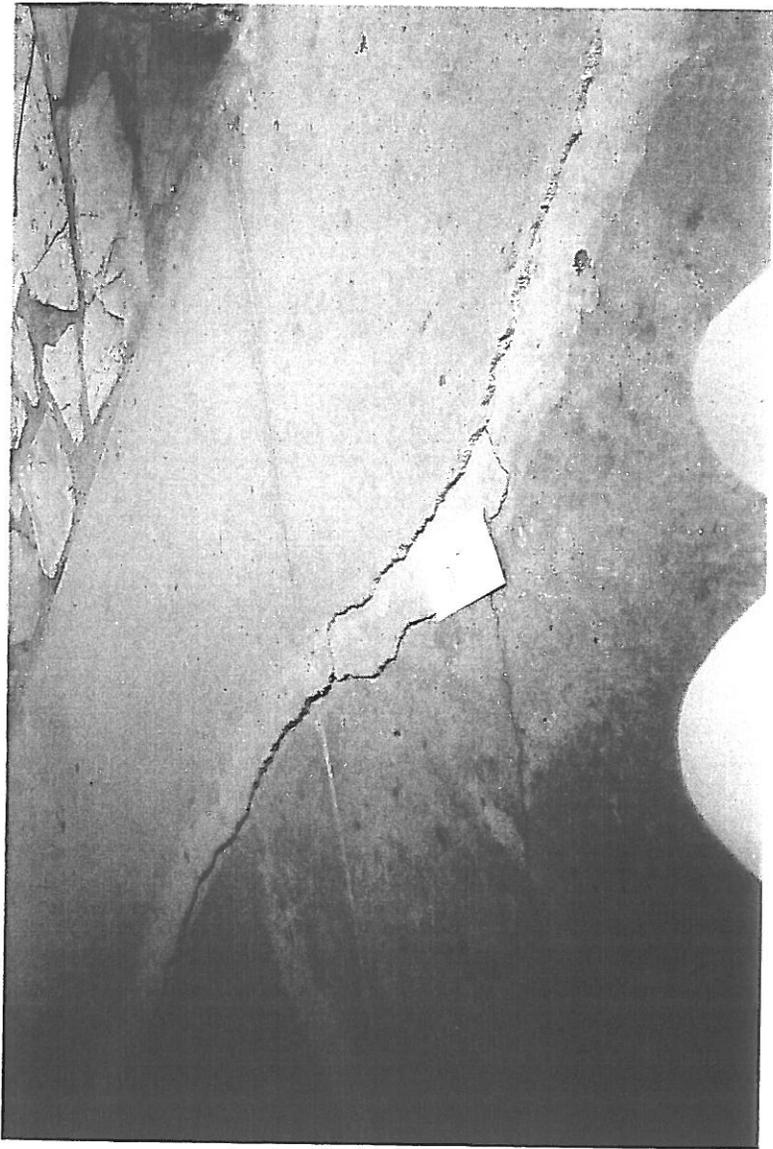
14

Wayfarer's Inn - near garden
House. Sidewalk cracks under
Breezeport

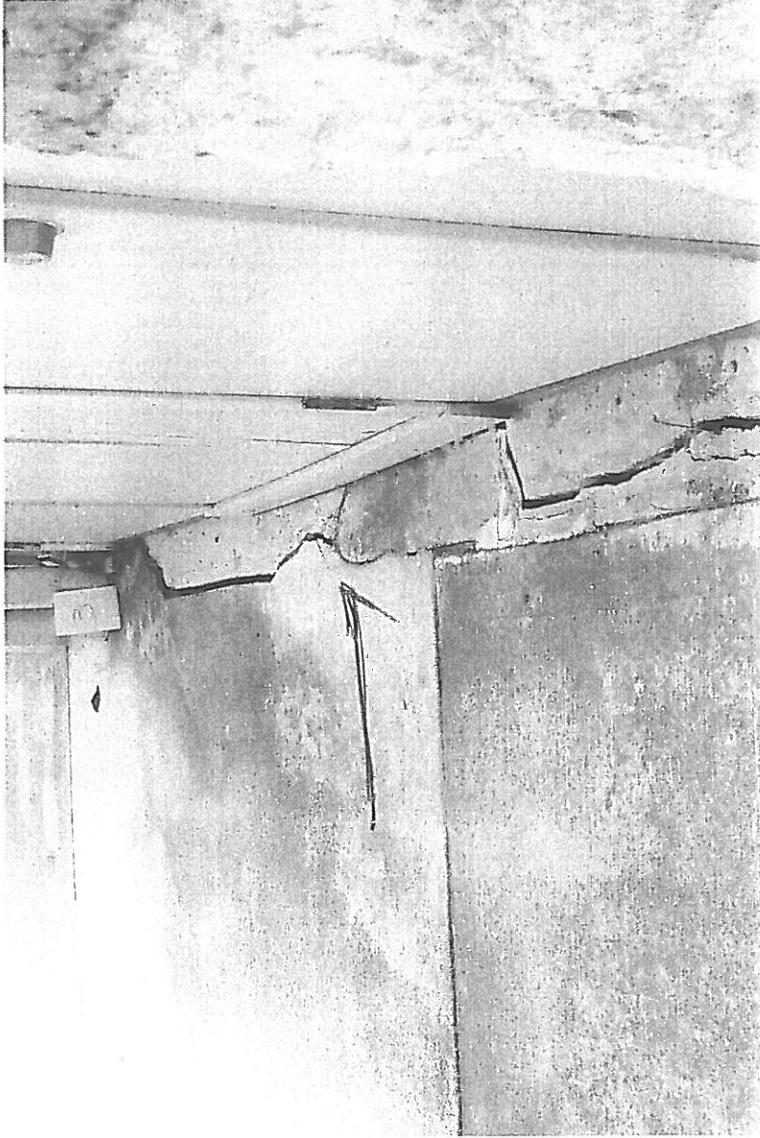
14/15

New movement near garden
house. Wayfarer's Chapel.

Crack in slab under wall.

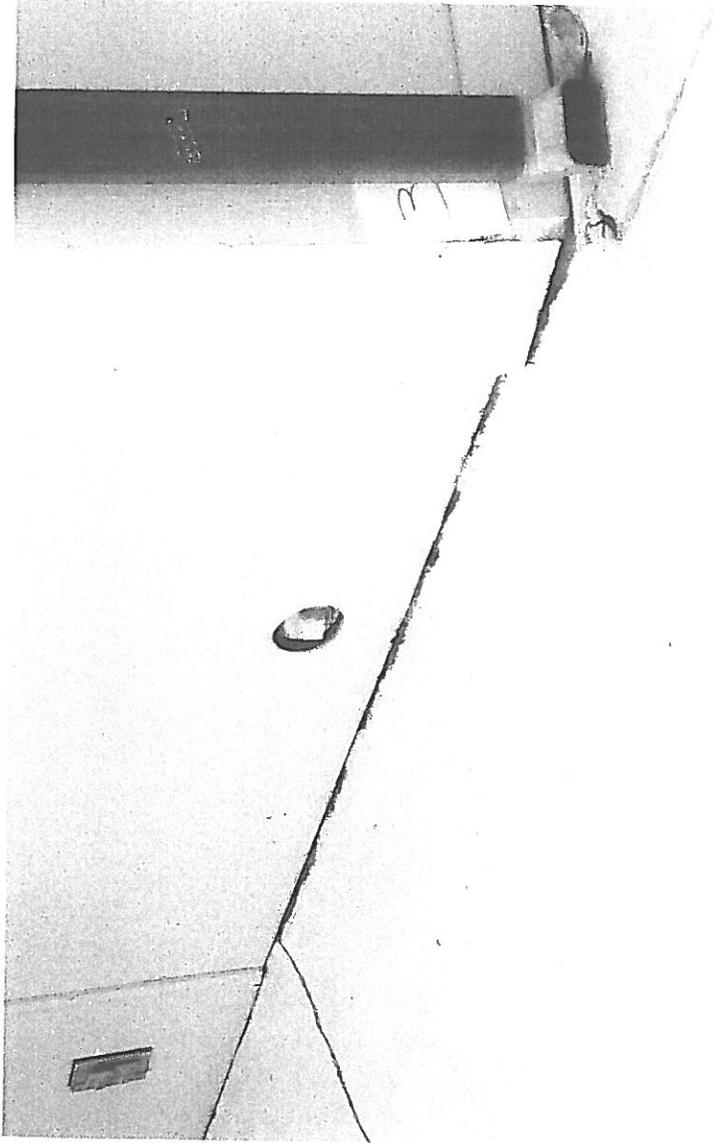
Wayfarer's Chapel - near
garden noise.

sidewalk pulling away from wall

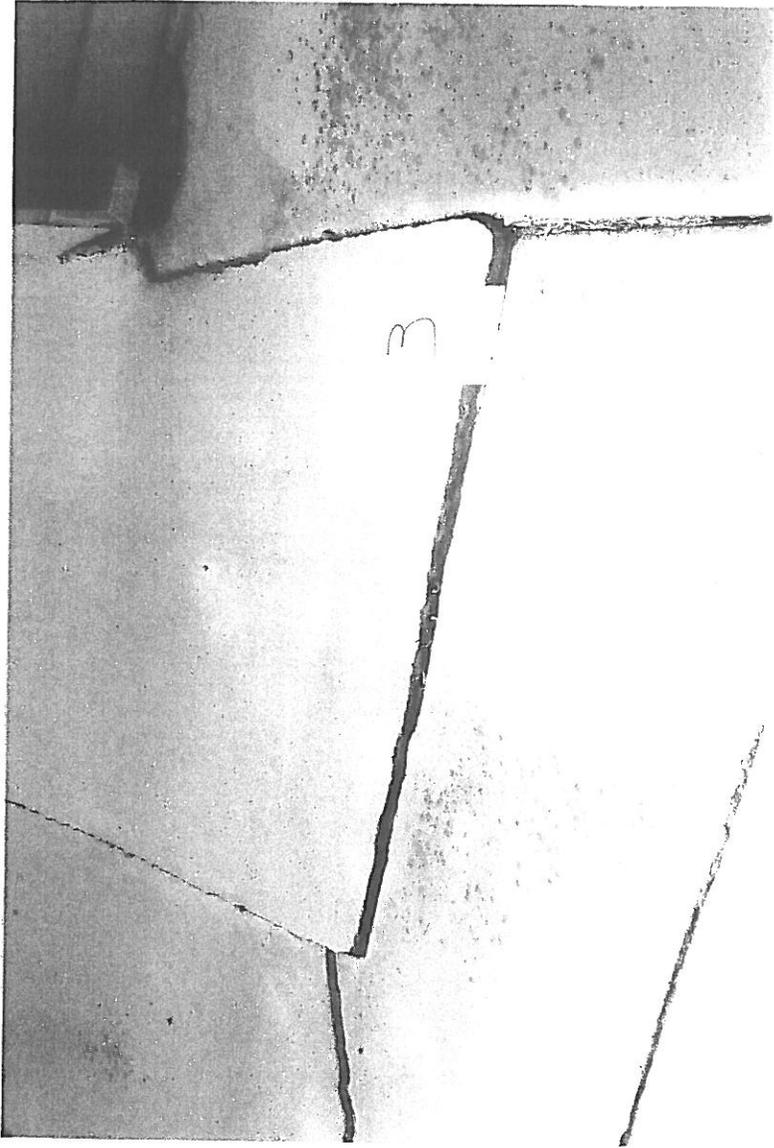
Wayfarer's Chapel

sidewalk outside small Bldg.

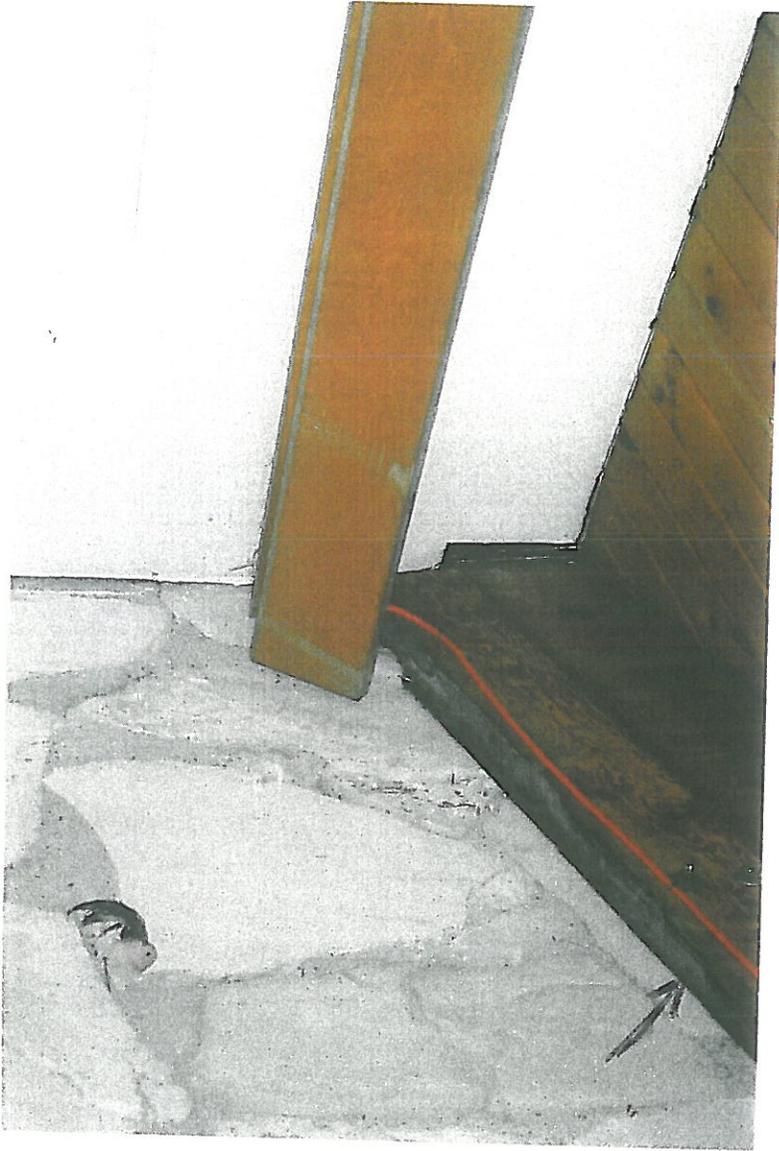
Bldg. at Warfaw's Chapel
Crack in Step

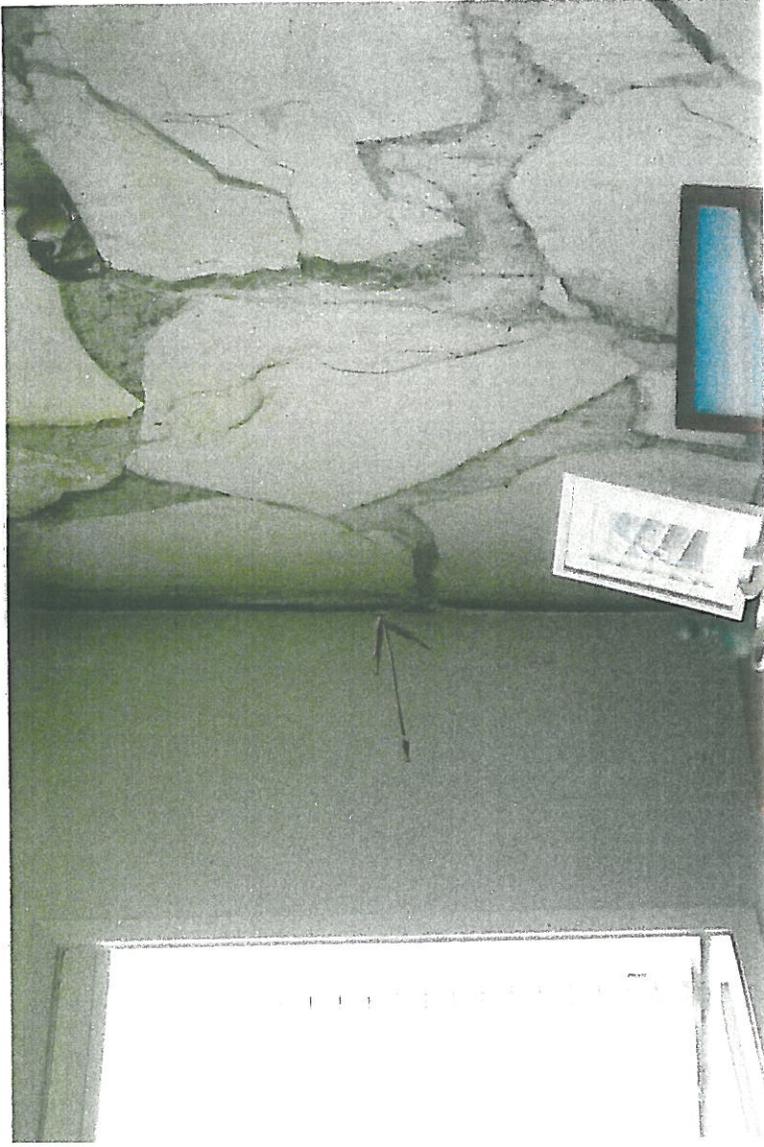
20

Bldg at Wayfarer's Chapel
wall peeling away

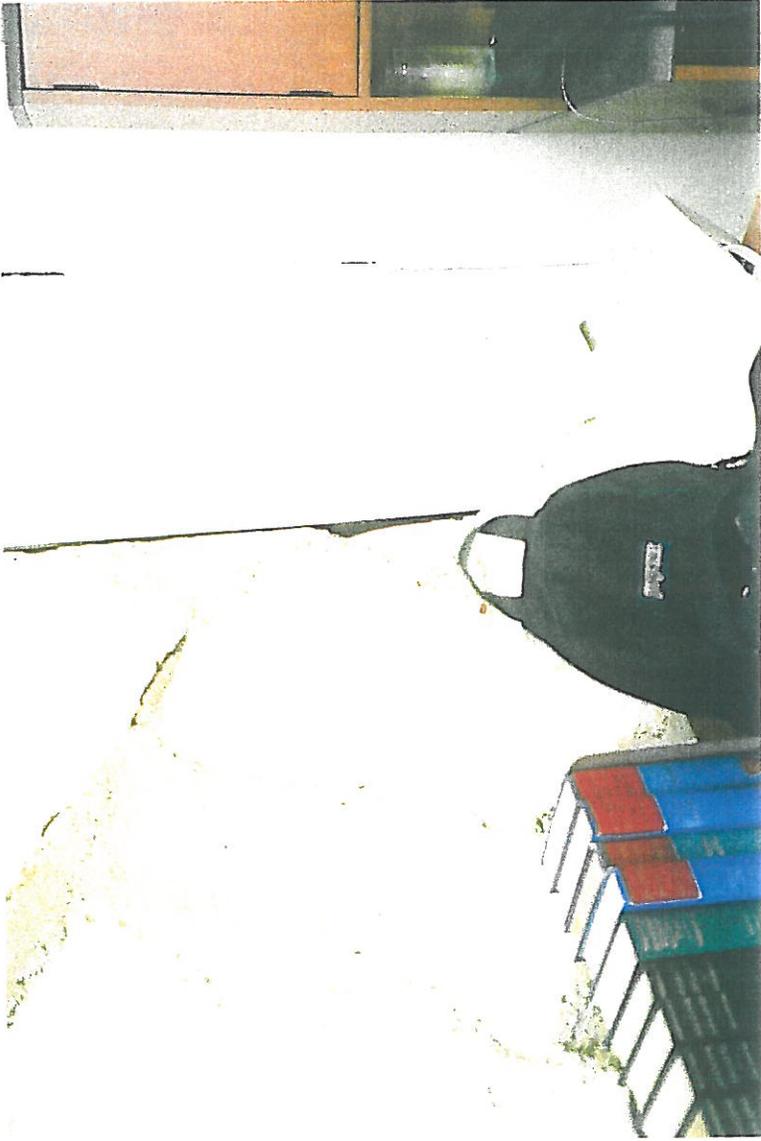
22

Bldg. at Wayfarer's Chapel

walls falling away.

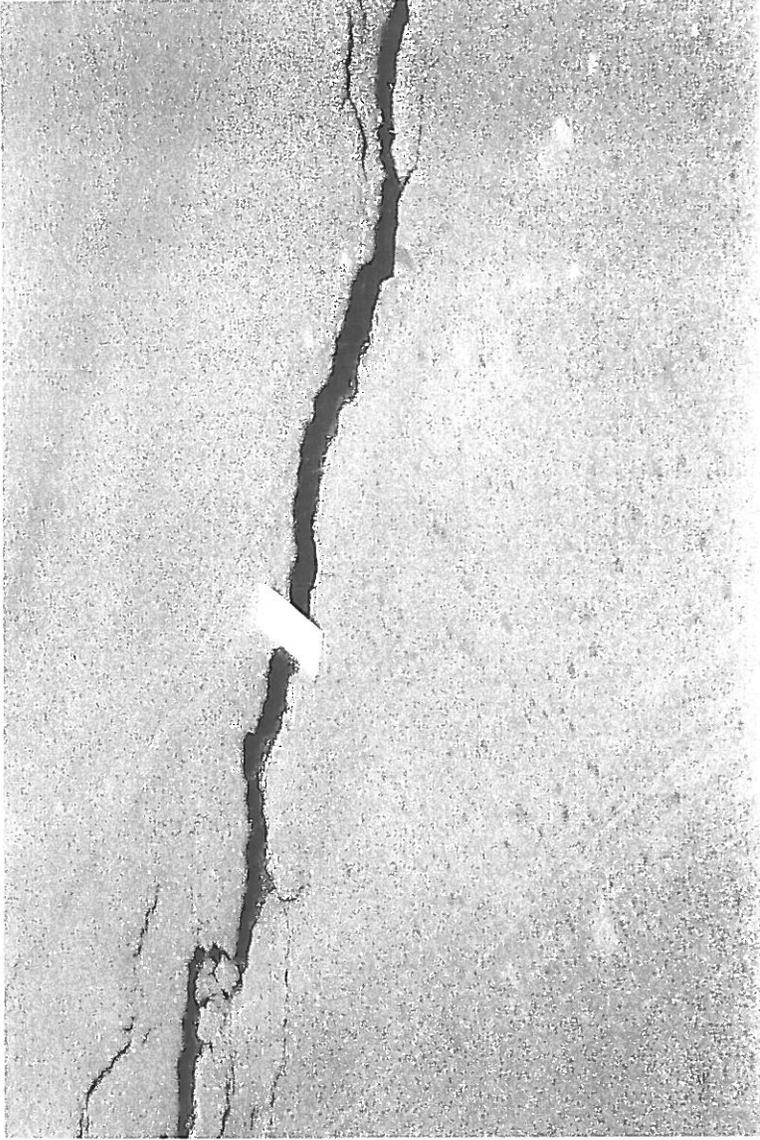
23

ALTAMIRA CANYON - LOWER
NARCISSE DR.

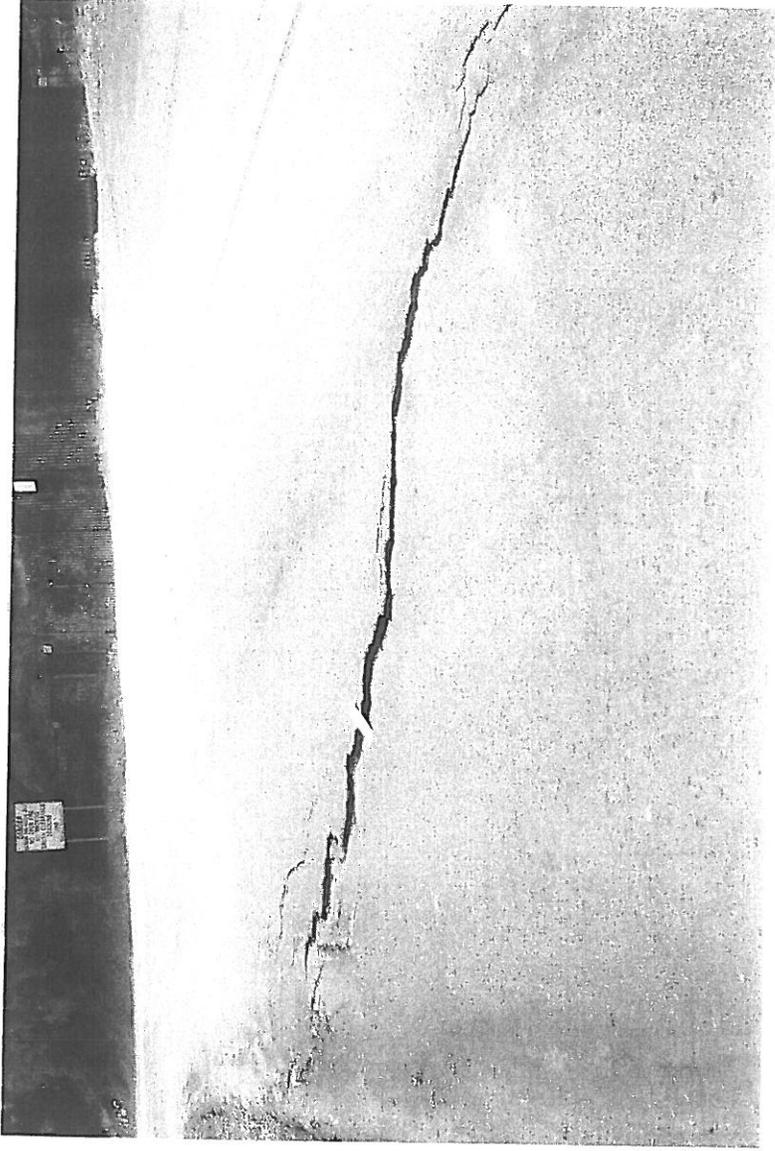
LOWER NARCISSA DR. NEAR ALTAMIR'S CHURCH
ON JULY 24, 06

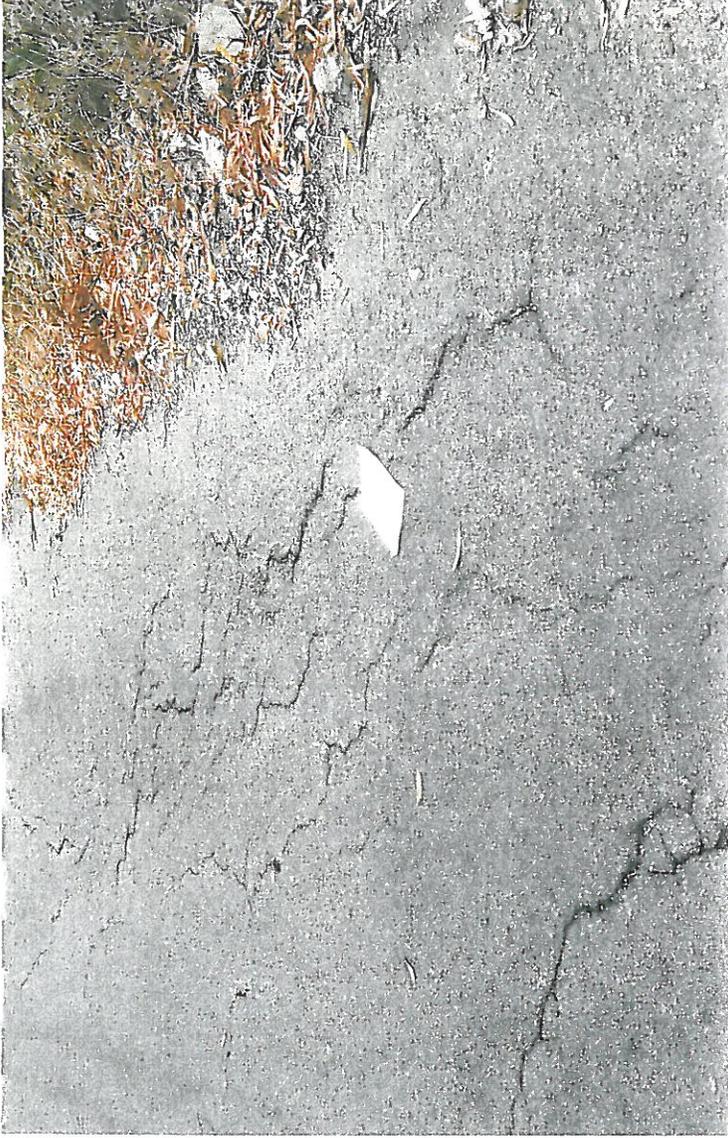
ROAD BREAKING ON RIGHT SIDE OF
NARCISSA DR. NEAR ATAMING CANYON
