PLANNING, BUILDING &
CODE ENFORCEMENT PN 97082-1485

August 1, 2006

Subject: Summary of Site Observations and Cursory Review of Site Conditions, Abalone Cove Landslide Area, Rancho Palos Verdes, California

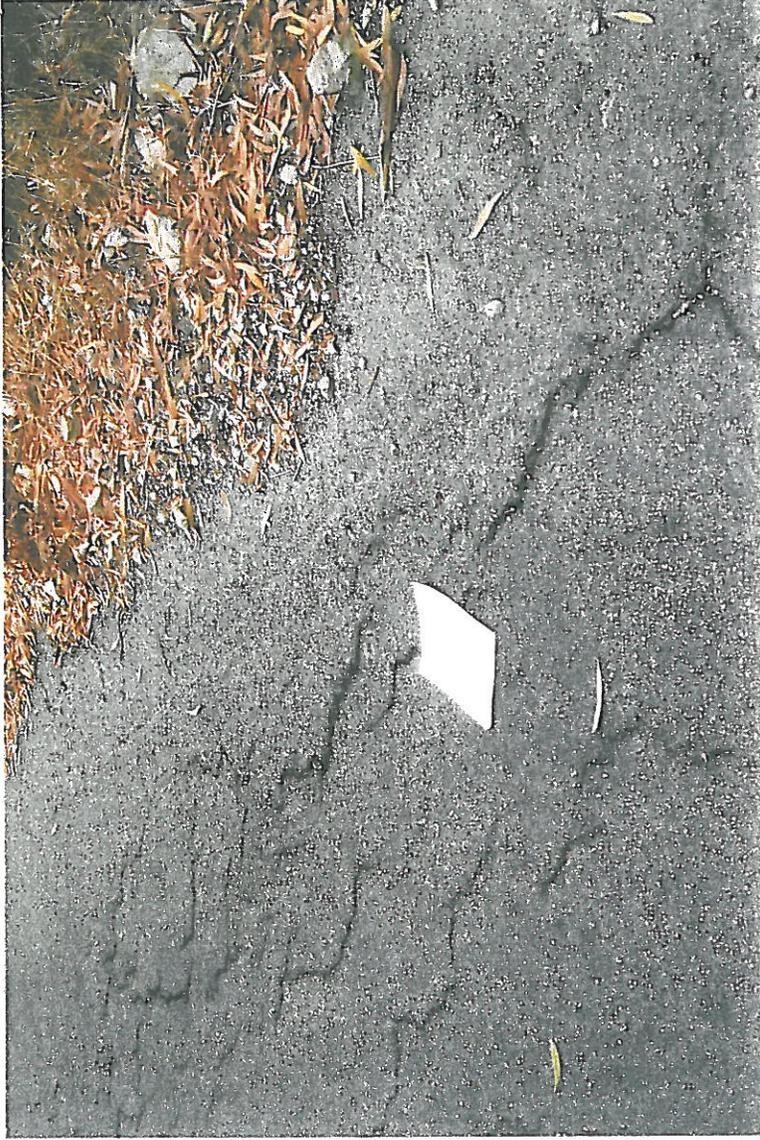
ROAD CRACKING ON NARCISSA DR.
NEAR DUNYON

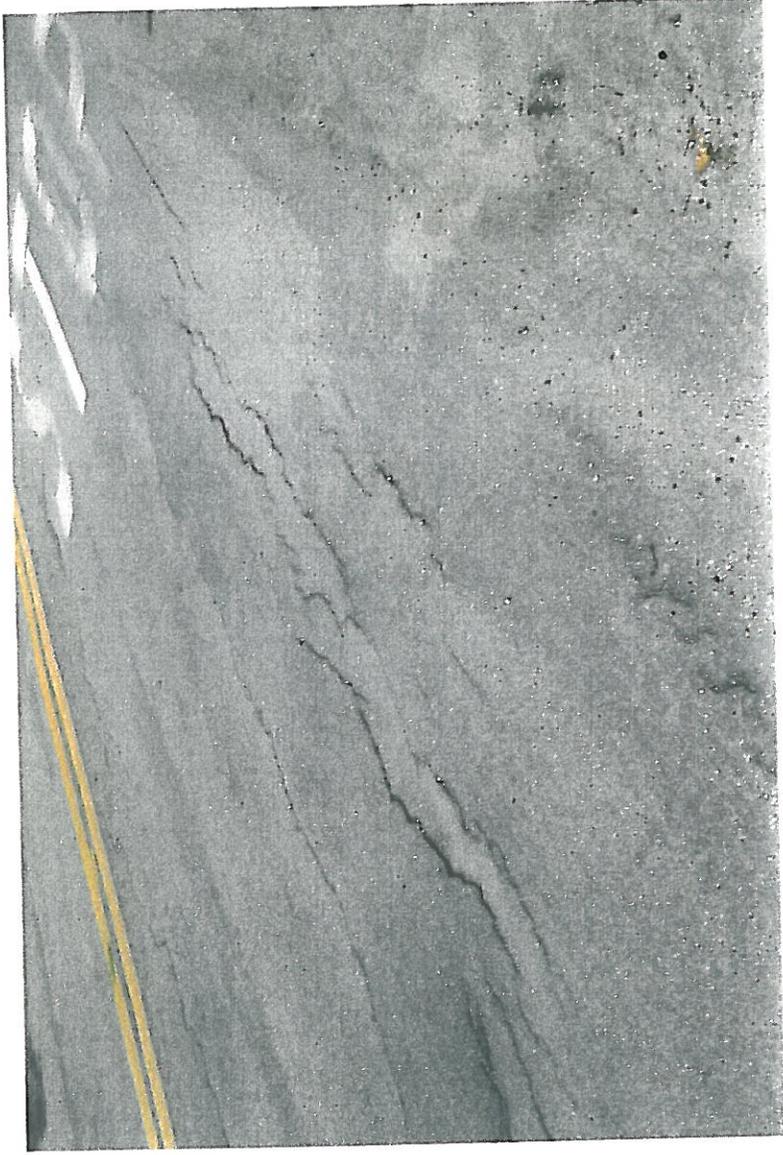
Cindermon in front of #1
Looking toward Narcissa

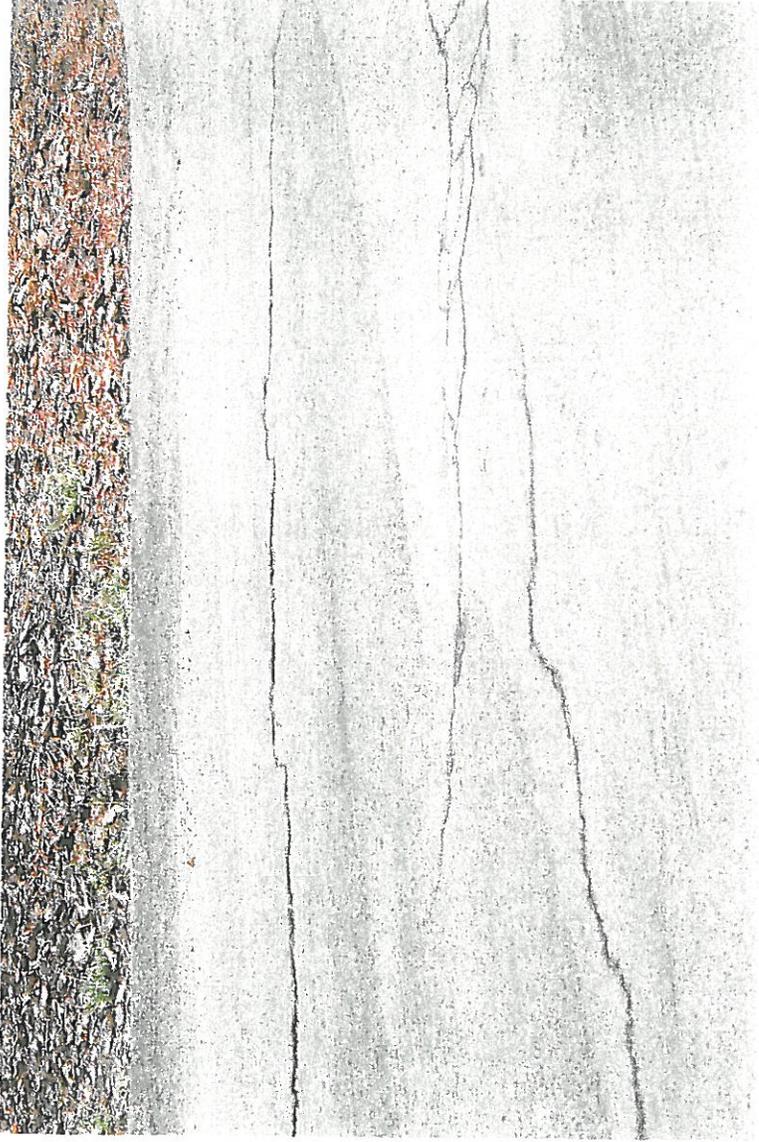
at Jester 20 Narcissa

near in echelon cracks

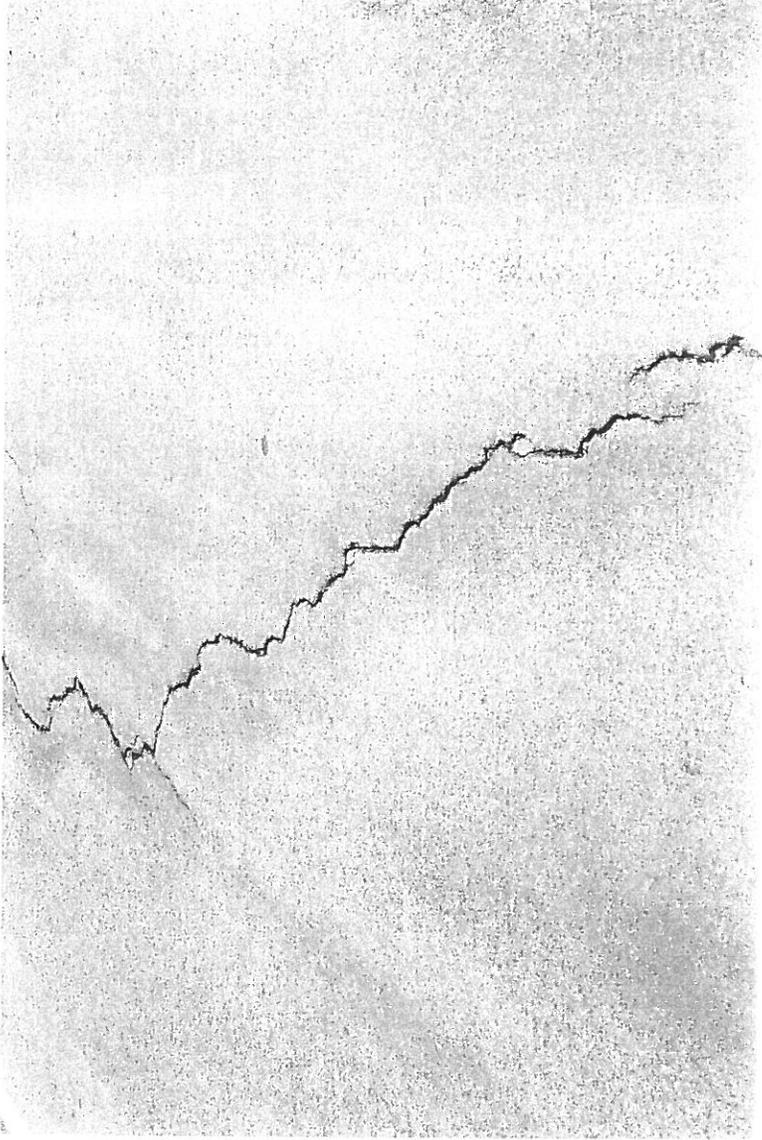
New open crack at 20 North
from Movement

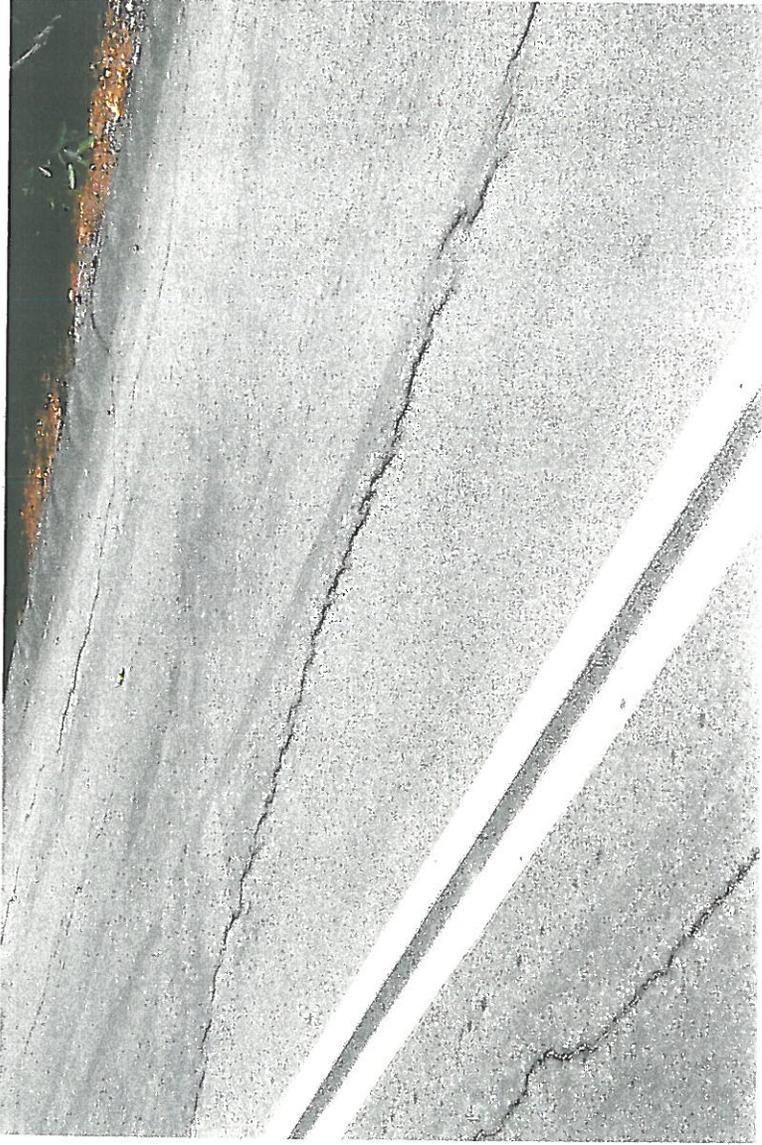
AT 16 Narvissin (Pav. 10)

nice new crack

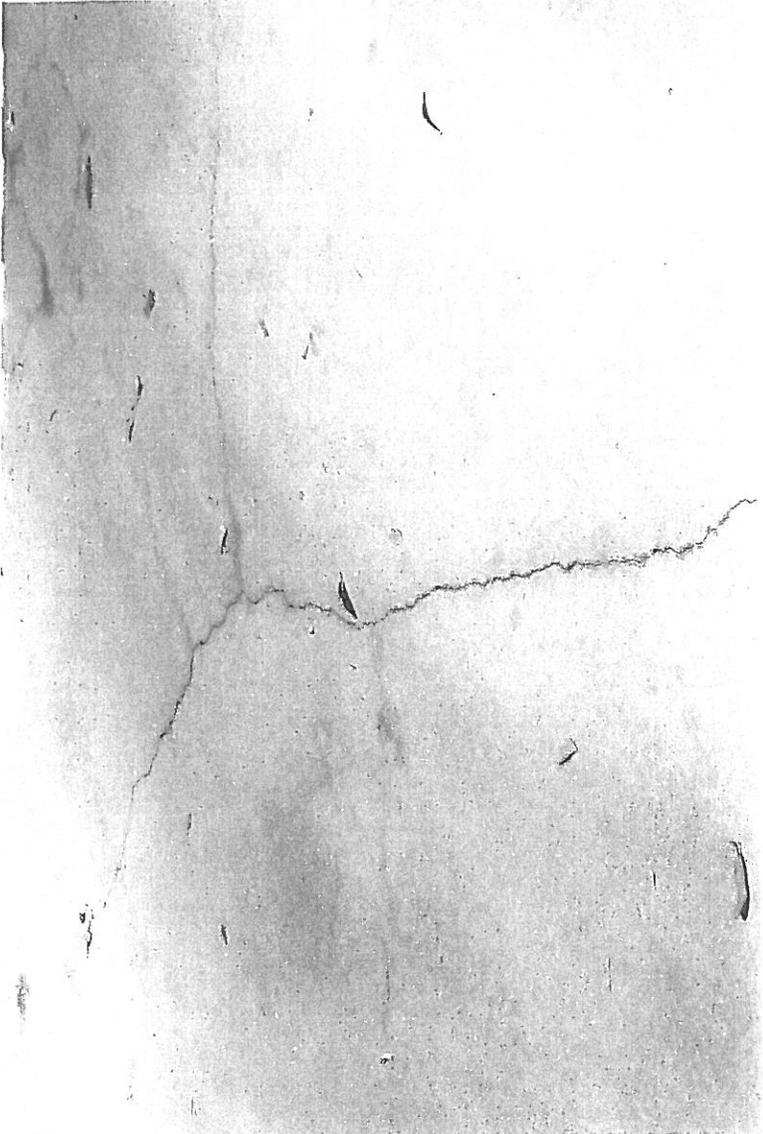
Reinforced Concrete Driveway
at 16 Narcissa (Parks)

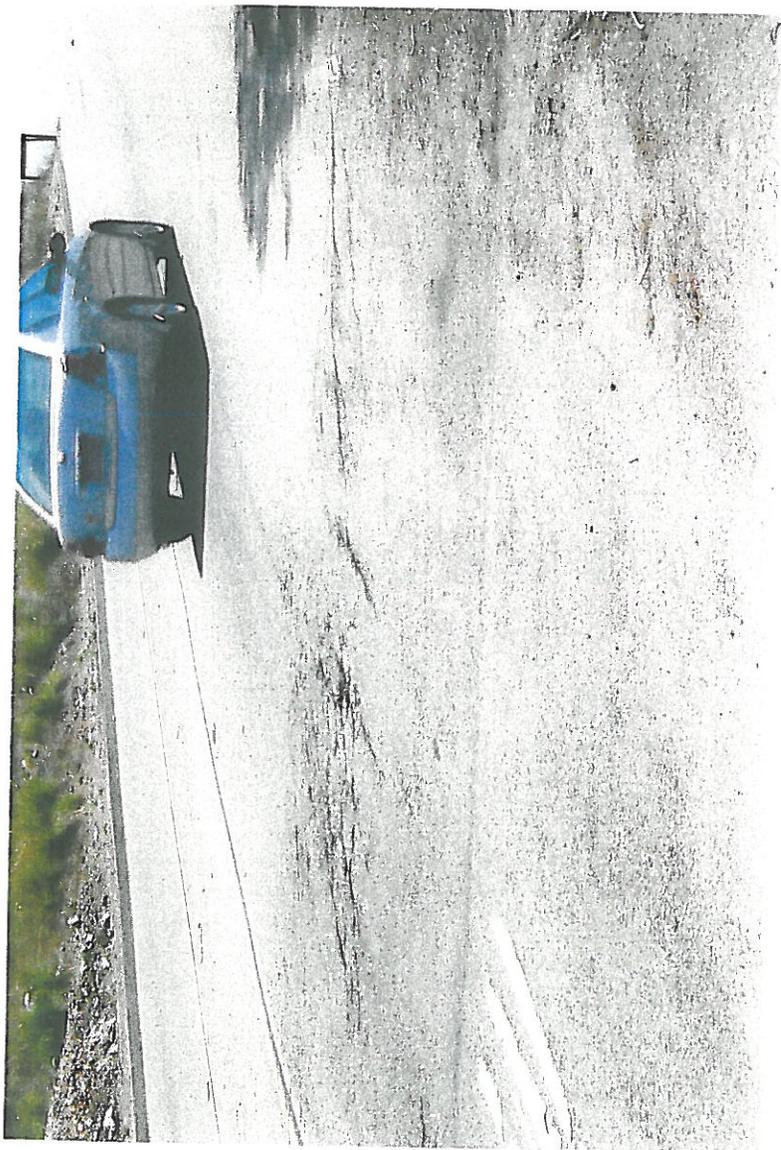
07/24/06 Palos Verdes Drive South
Fresh cracks 200 feet east of
Nauvissa at the main sweep of
Abelou. Cove landslide and the stable
Porteguer Point

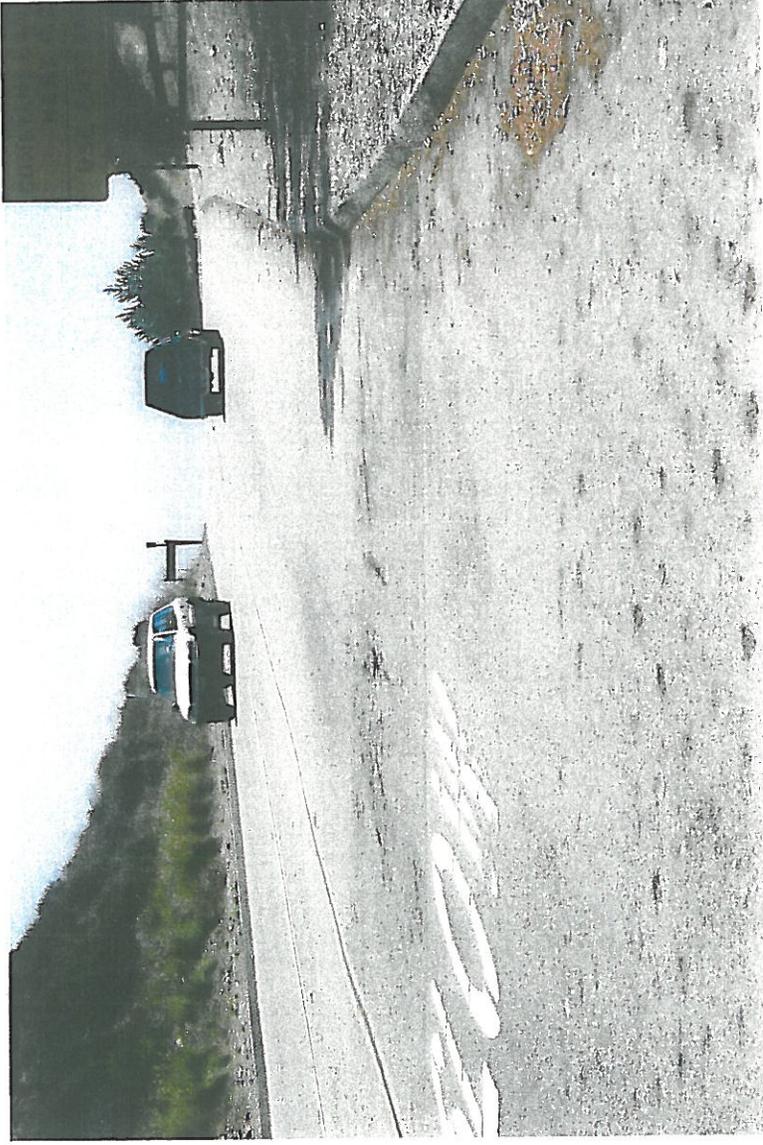
07/24/06 Palos Verdes Drive Santa
Contact between the Abalone Cove
Landslide and the Stack Portuguese
Point.

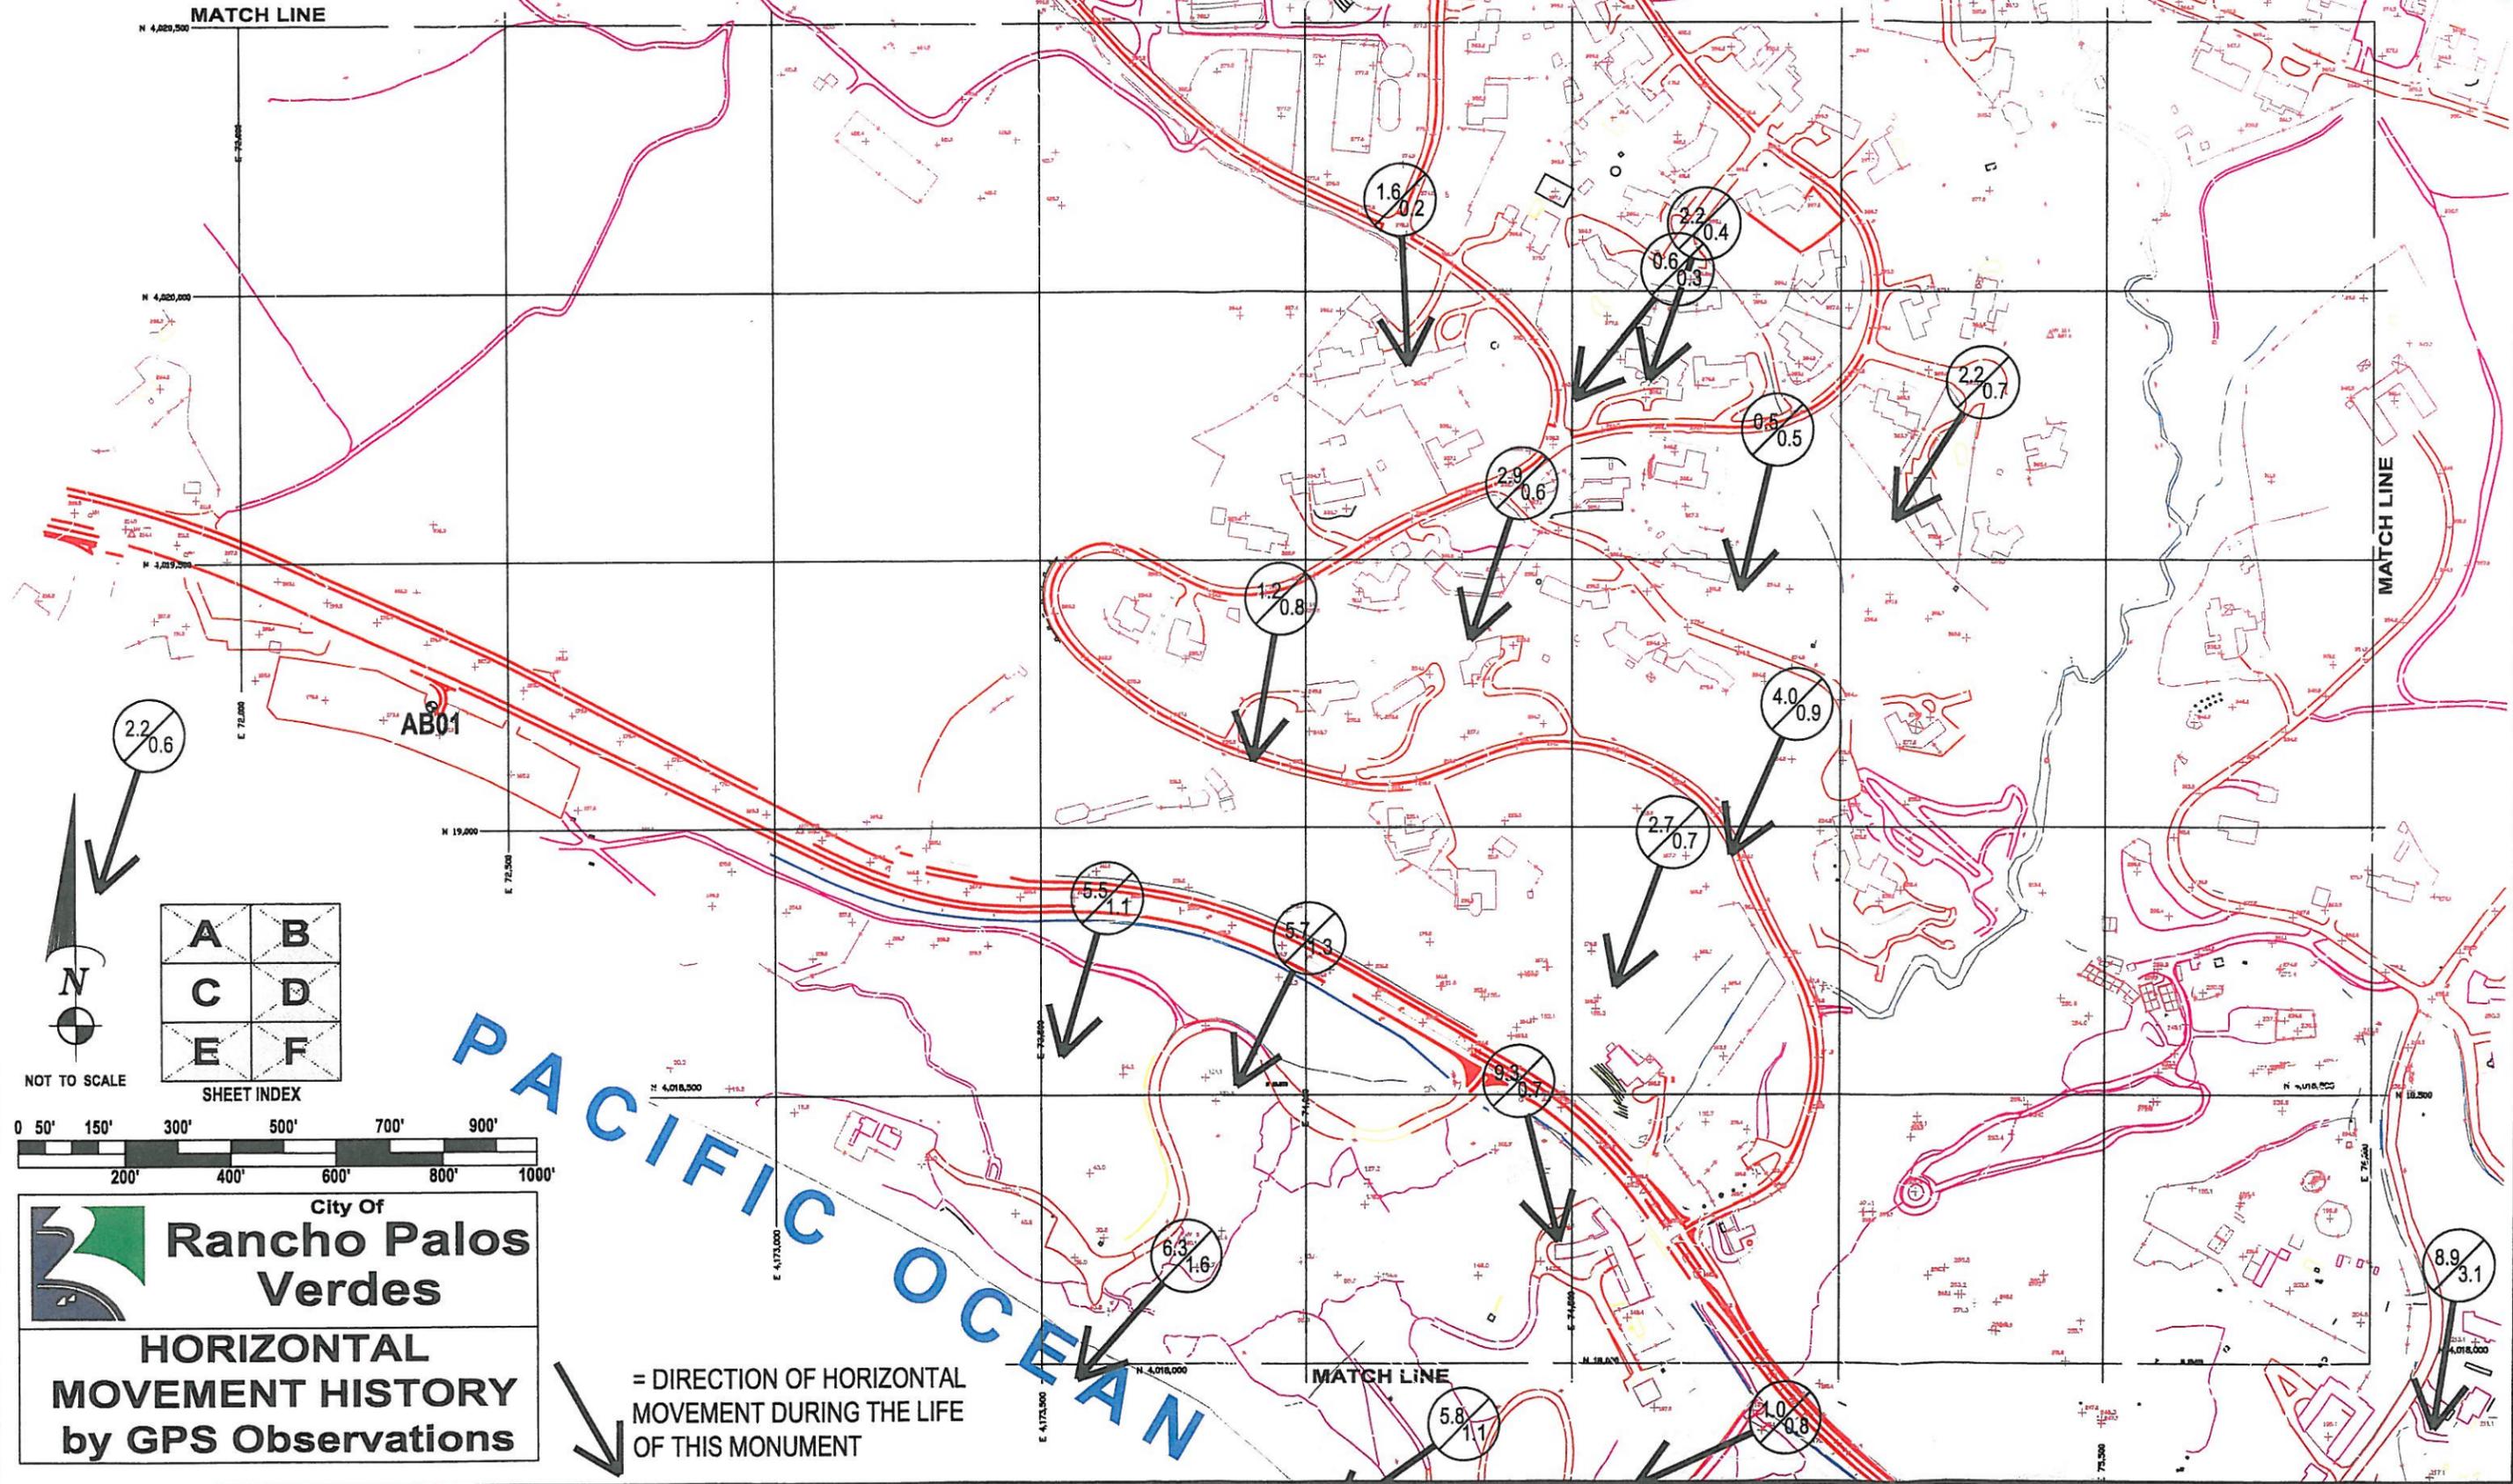
HORIZONTAL MOVEMENT HISTORY by GPS Observations

The horizontal movement recorded by GPS survey observations during 2005 within the area in question by Charles Abbott Associates, Inc. is consistent with the movement observed during our recent site visit. It is recommended that GPS survey observations be continued at a frequency of four quarterly readings per year. In addition, it is recommended that site observations of the general distress also be completed on a quarterly basis. It should be stressed to all involved that if a change in the current distress regime occurs, the city should be notified so that additional steps can be taken if warranted.
