5.0 Existing Collection System Evaluation

5.3 CCTV Inspection

5.4 County CCTV Inspection (2005-2006/2007)

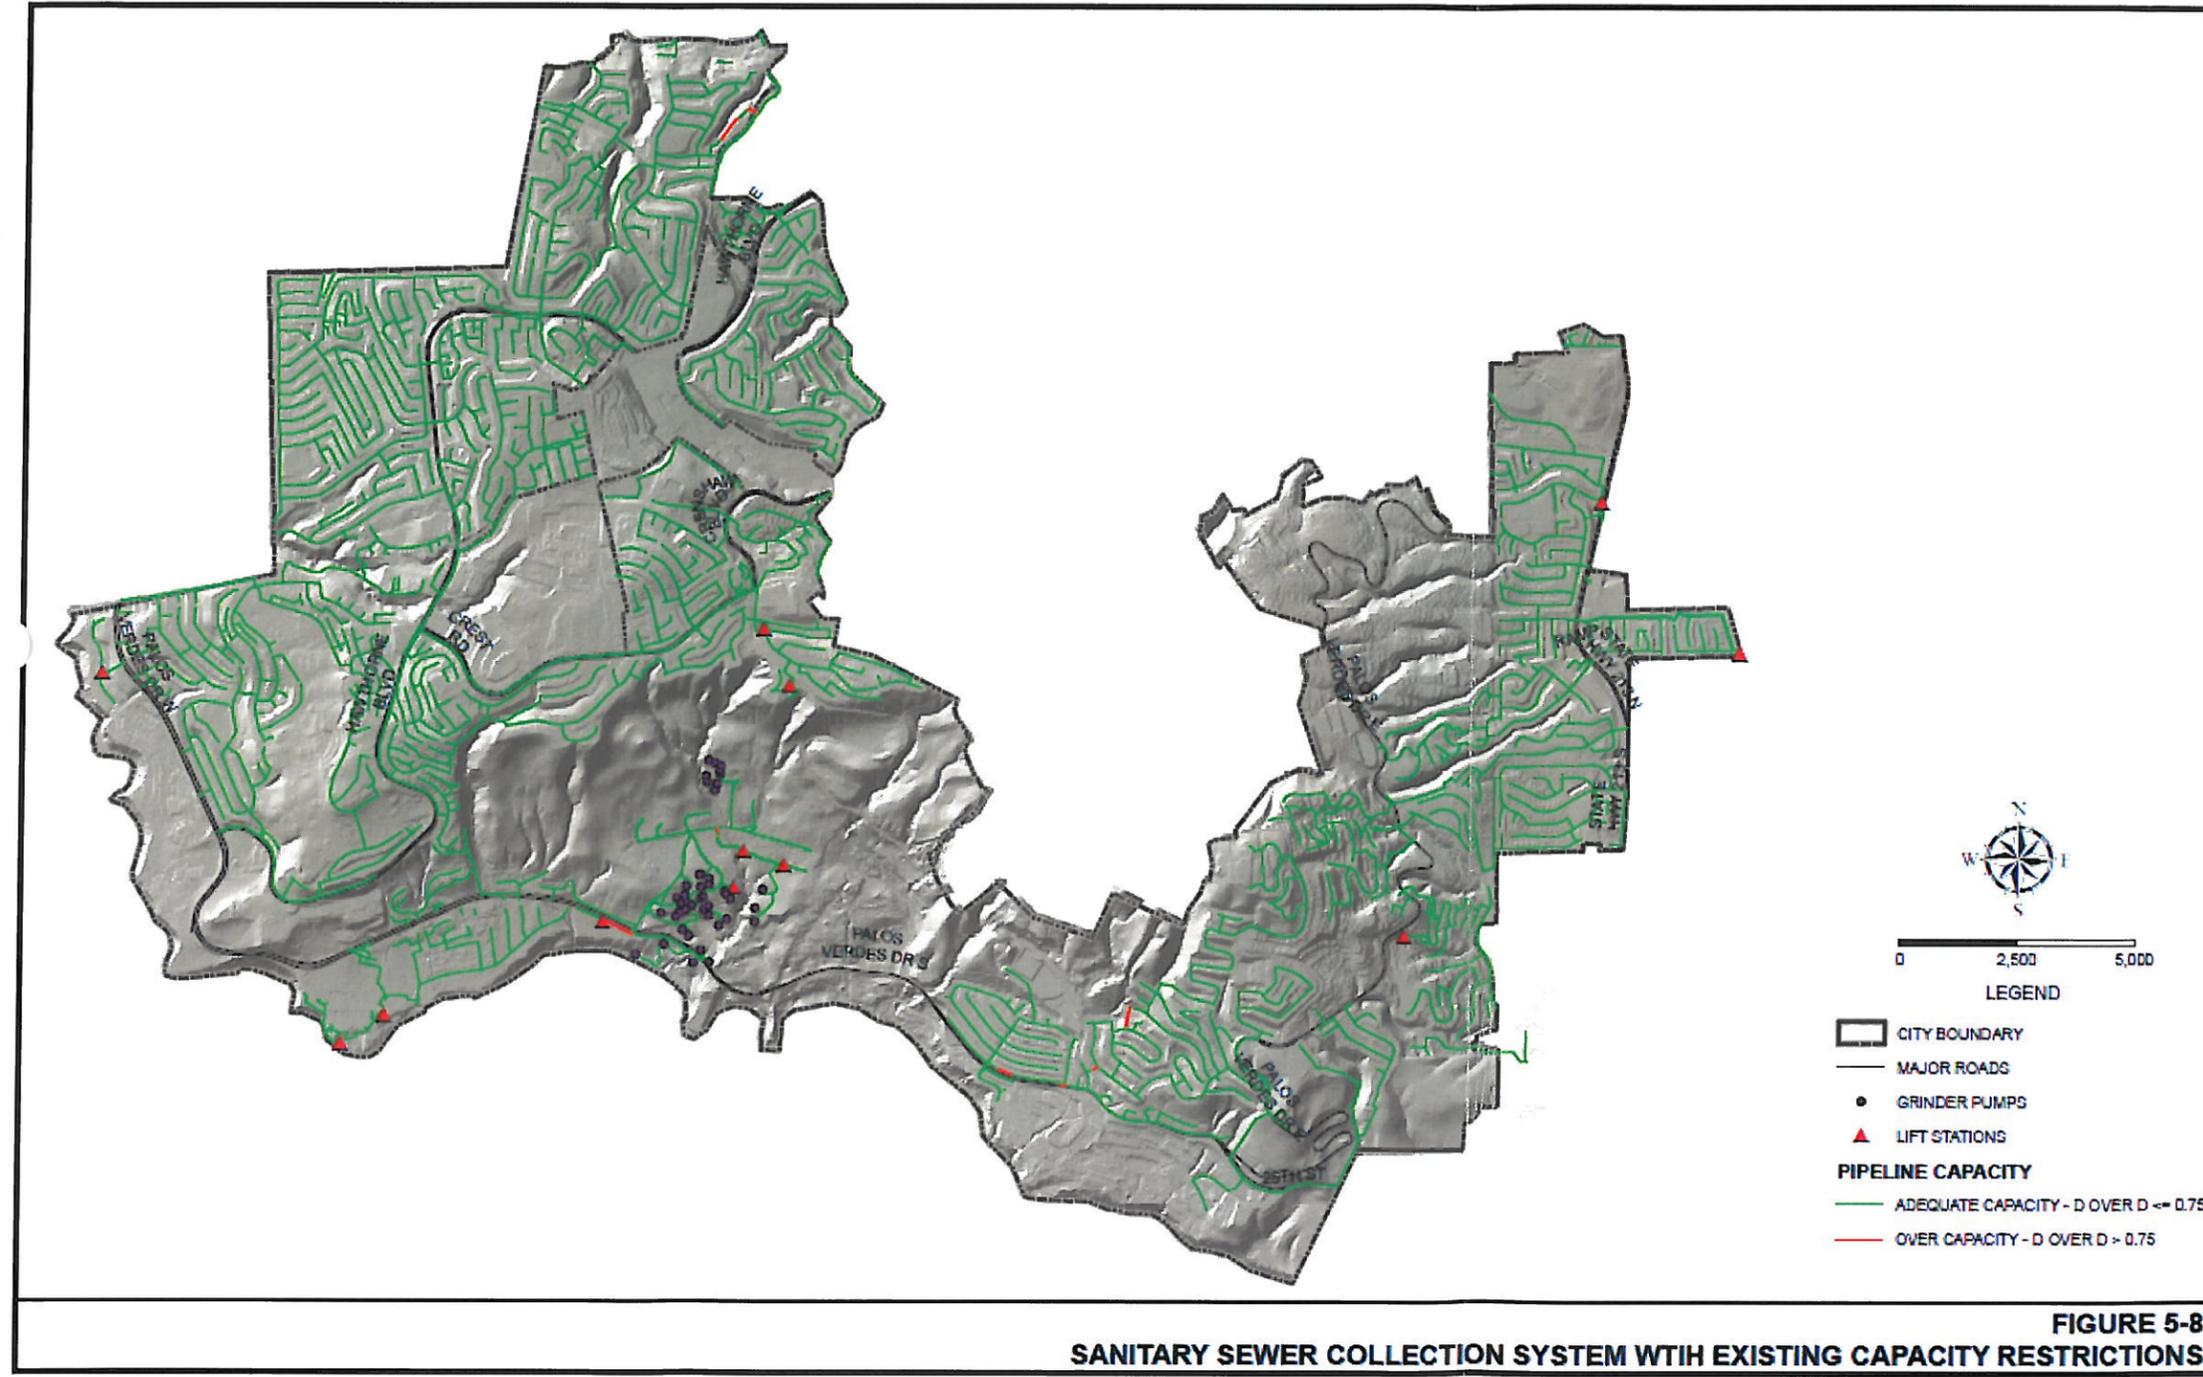
Figure 5-8 Existing Capacity Restrictions

The predicted (modeled) and measured flows are within good calibration limits. This indicates that our modeled assumptions are valid for these basins. Given the calibration results and the number of pipes that are expected to flow more than half full, the overall capacity analysis shows that the collection system has adequate capacity for dry weather conditions. None of the lines identified as flowing more than half full are causing a critical surcharge condition.

Flow Load	Deficient Segments	% Deficient
Average Dry Weather	14	0.37%
2.5 x ADW	71	1.9%

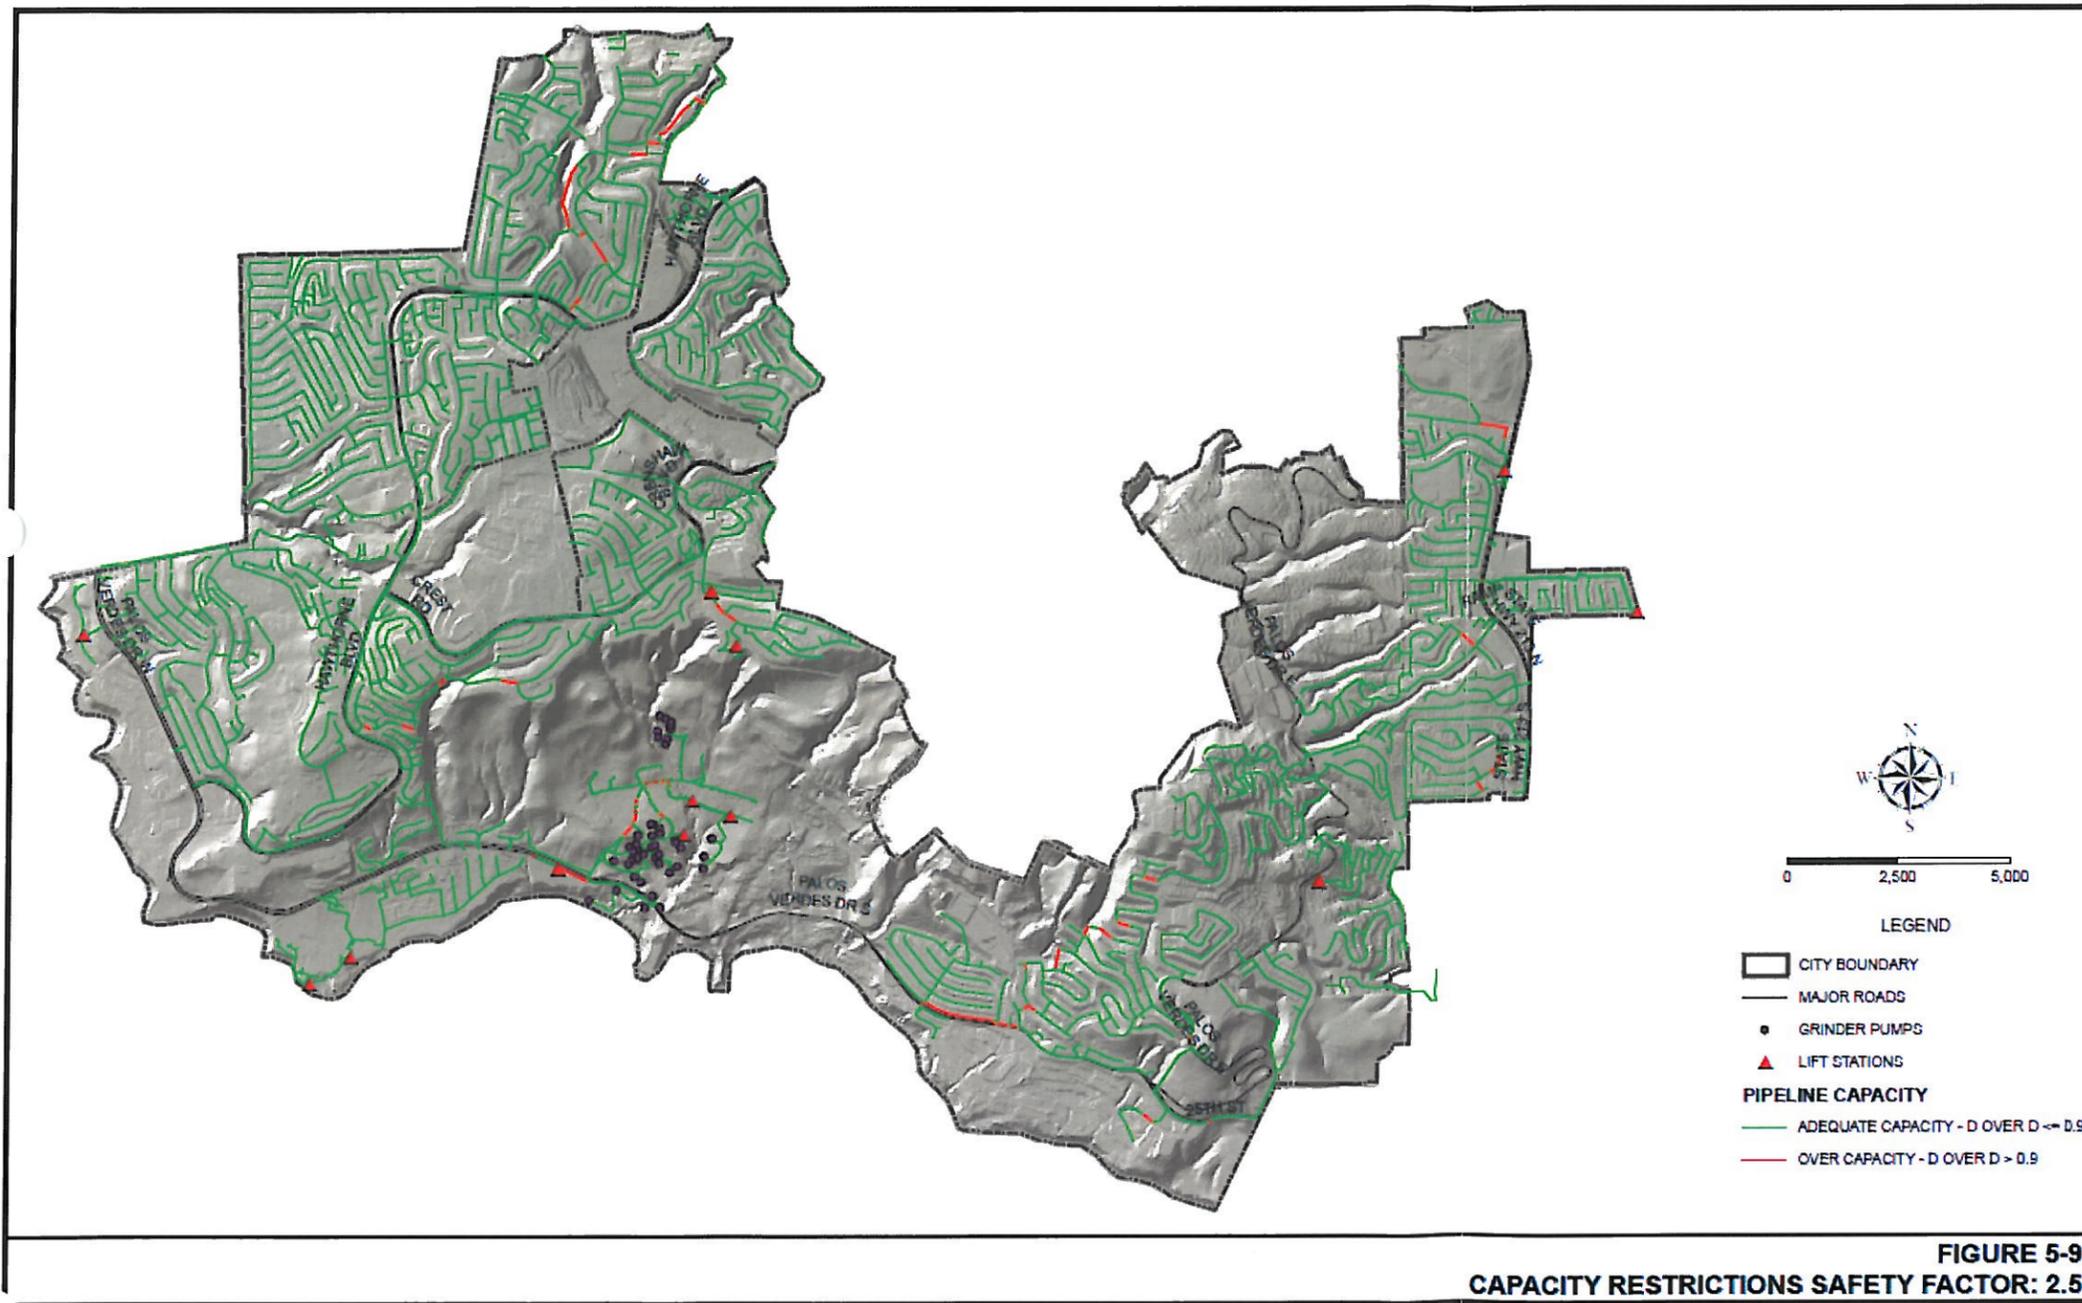
Figure 5-9 Capacity Restrictions Safety Factor = 2.5

To determine the hydraulic capacity of the system to increased flows like that which they may have experienced in wet weather, all flows were multiplied by a safety factor of 2.5. The capacity criteria were also increased to allow flow to attain a depth/diameter ratio of 0.9 or 90% of full pipe diameter. This allowance is a widely accepted value for wet weather flows. The results of this showed that of the 3,812 gravity pipes in the system, 71 now exceeded the desired depth/diameter ratio. This represents around 1.9% of the entire system. Again this is

outstanding hydraulic performance. Many systems see more than 25% of their collection system exceeding this performance criterion.

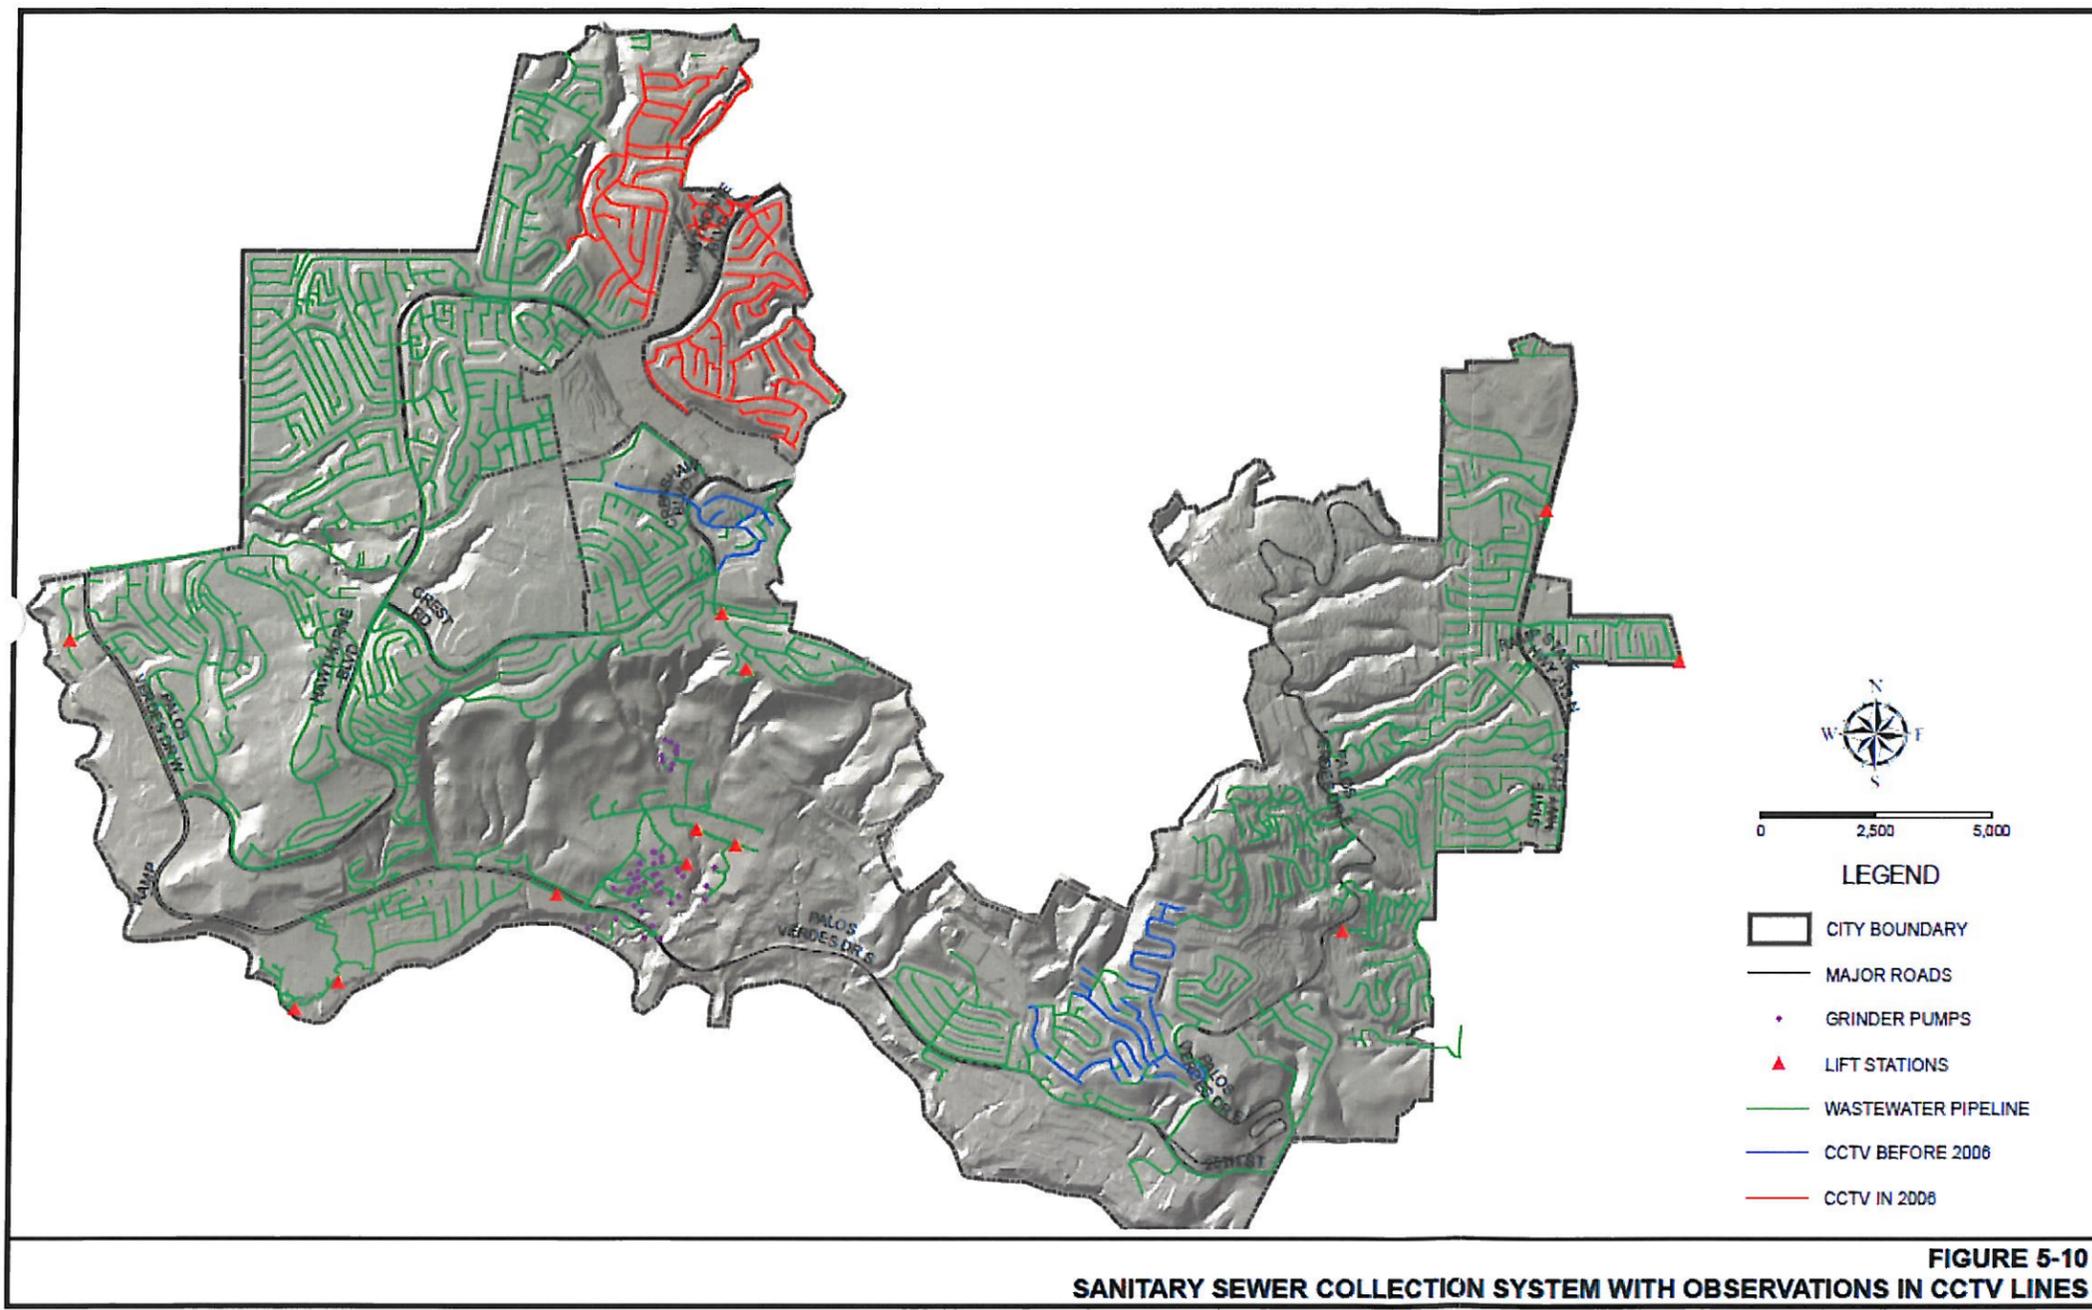
Figure 5-10 Area of CCTV Inspection by Year

In the fiscal years 2005-2006/2007 the county CCTV inspection program Y0TV0506F inspected an additional 76,591 linear feet of sewer pipeline or 10.6% of the entire system. A primary advantage of this inspection was that the county has adopted the relatively new national standard for establishing the condition of the sewer pipes. These codes are assigned to each segment based on a certified operator using the Pipeline Assessment and Certification Program (PACP) coding scheme. The condition codes are provided for cleanliness are called Maintenance codes and those related to cracked pipes are called Structural codes. Each has a similar scale that varies from 1-5 from better to worse condition. The codes and the observed conditions are:

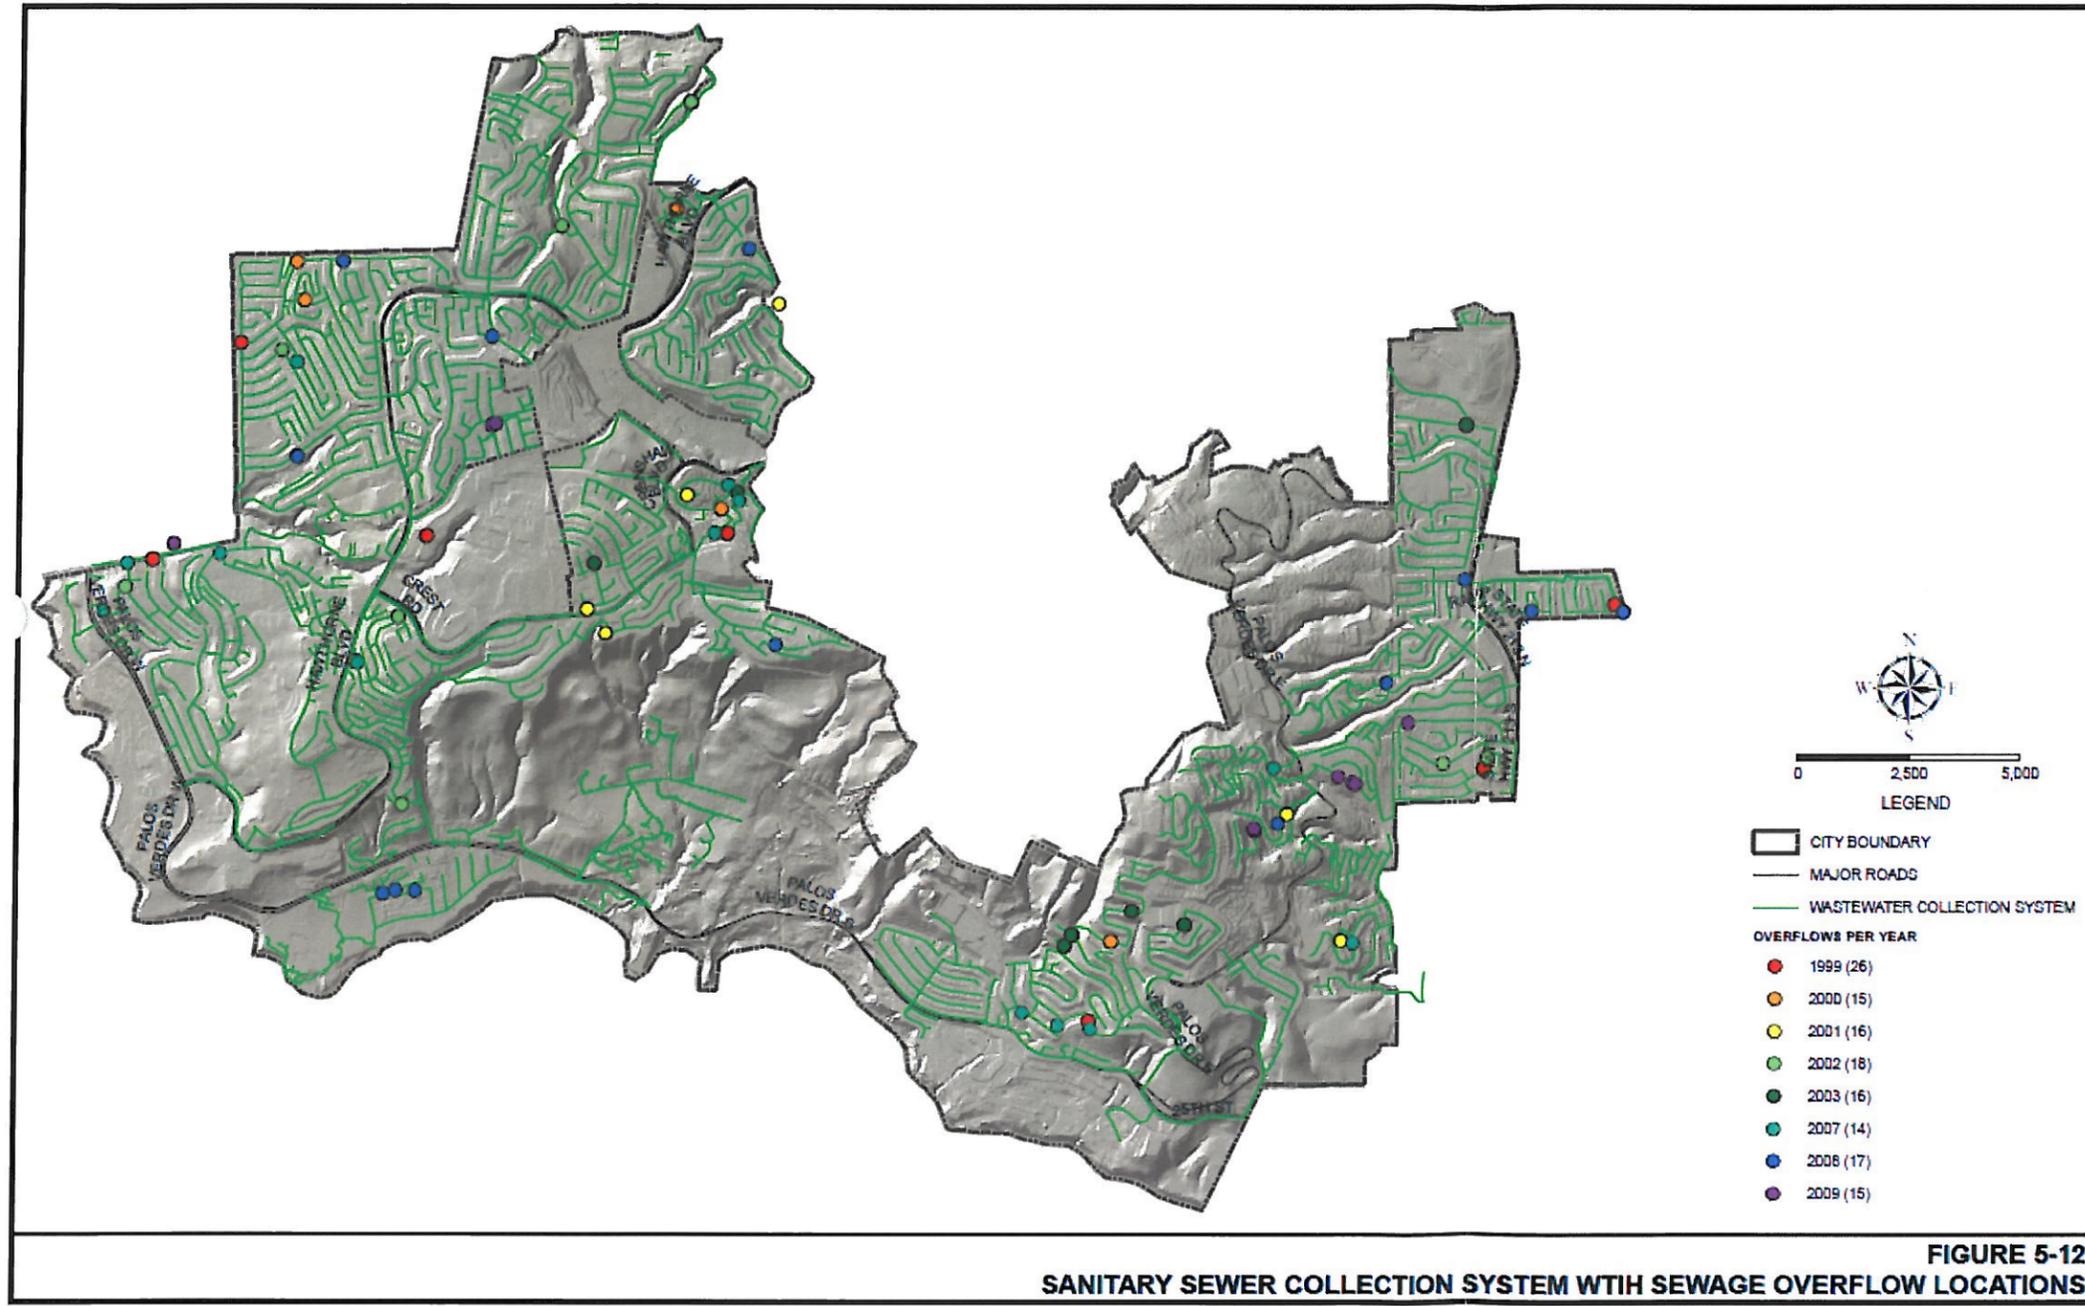
Figure 5-12 Known Overflow Locations

Known overflow locations, provided by the County were also mapped to determine the overall nature of these occurrences. It is apparent from a review of these that the County is well aware of the frequency of occurrence of overflows. Given the funding limitations described by the County, it is unlikely that a clear program for reducing the number and frequency of overflows in Rancho Palos Verdes exists. Updated known overflow locations are shown in Figure 5-12.

This table indicates that the City has more SSOs than any other agency maintained by the LACSMMD. When normalized to consider the length of the system, the City ranks third of the highest five ranked systems. The SSO frequency is a further indicator of the physical condition of the system.

Note that in Table 5-9 three of the top five communities are located on “the hill.” This seems to indicate that a shared physical characteristic contributes to the frequency and amount of overflows. Factors that are likely to create this situation are the dominant construction material and techniques and the steep slopes. The steep slopes would result in a downward stress on the pipe joints which could enlarge the gap at the joint. This pulling apart could result in more root intrusion and structural cracking. The following table shows the PACP rating (1=Excellent – 5 = Worst), slope and length of pipe.

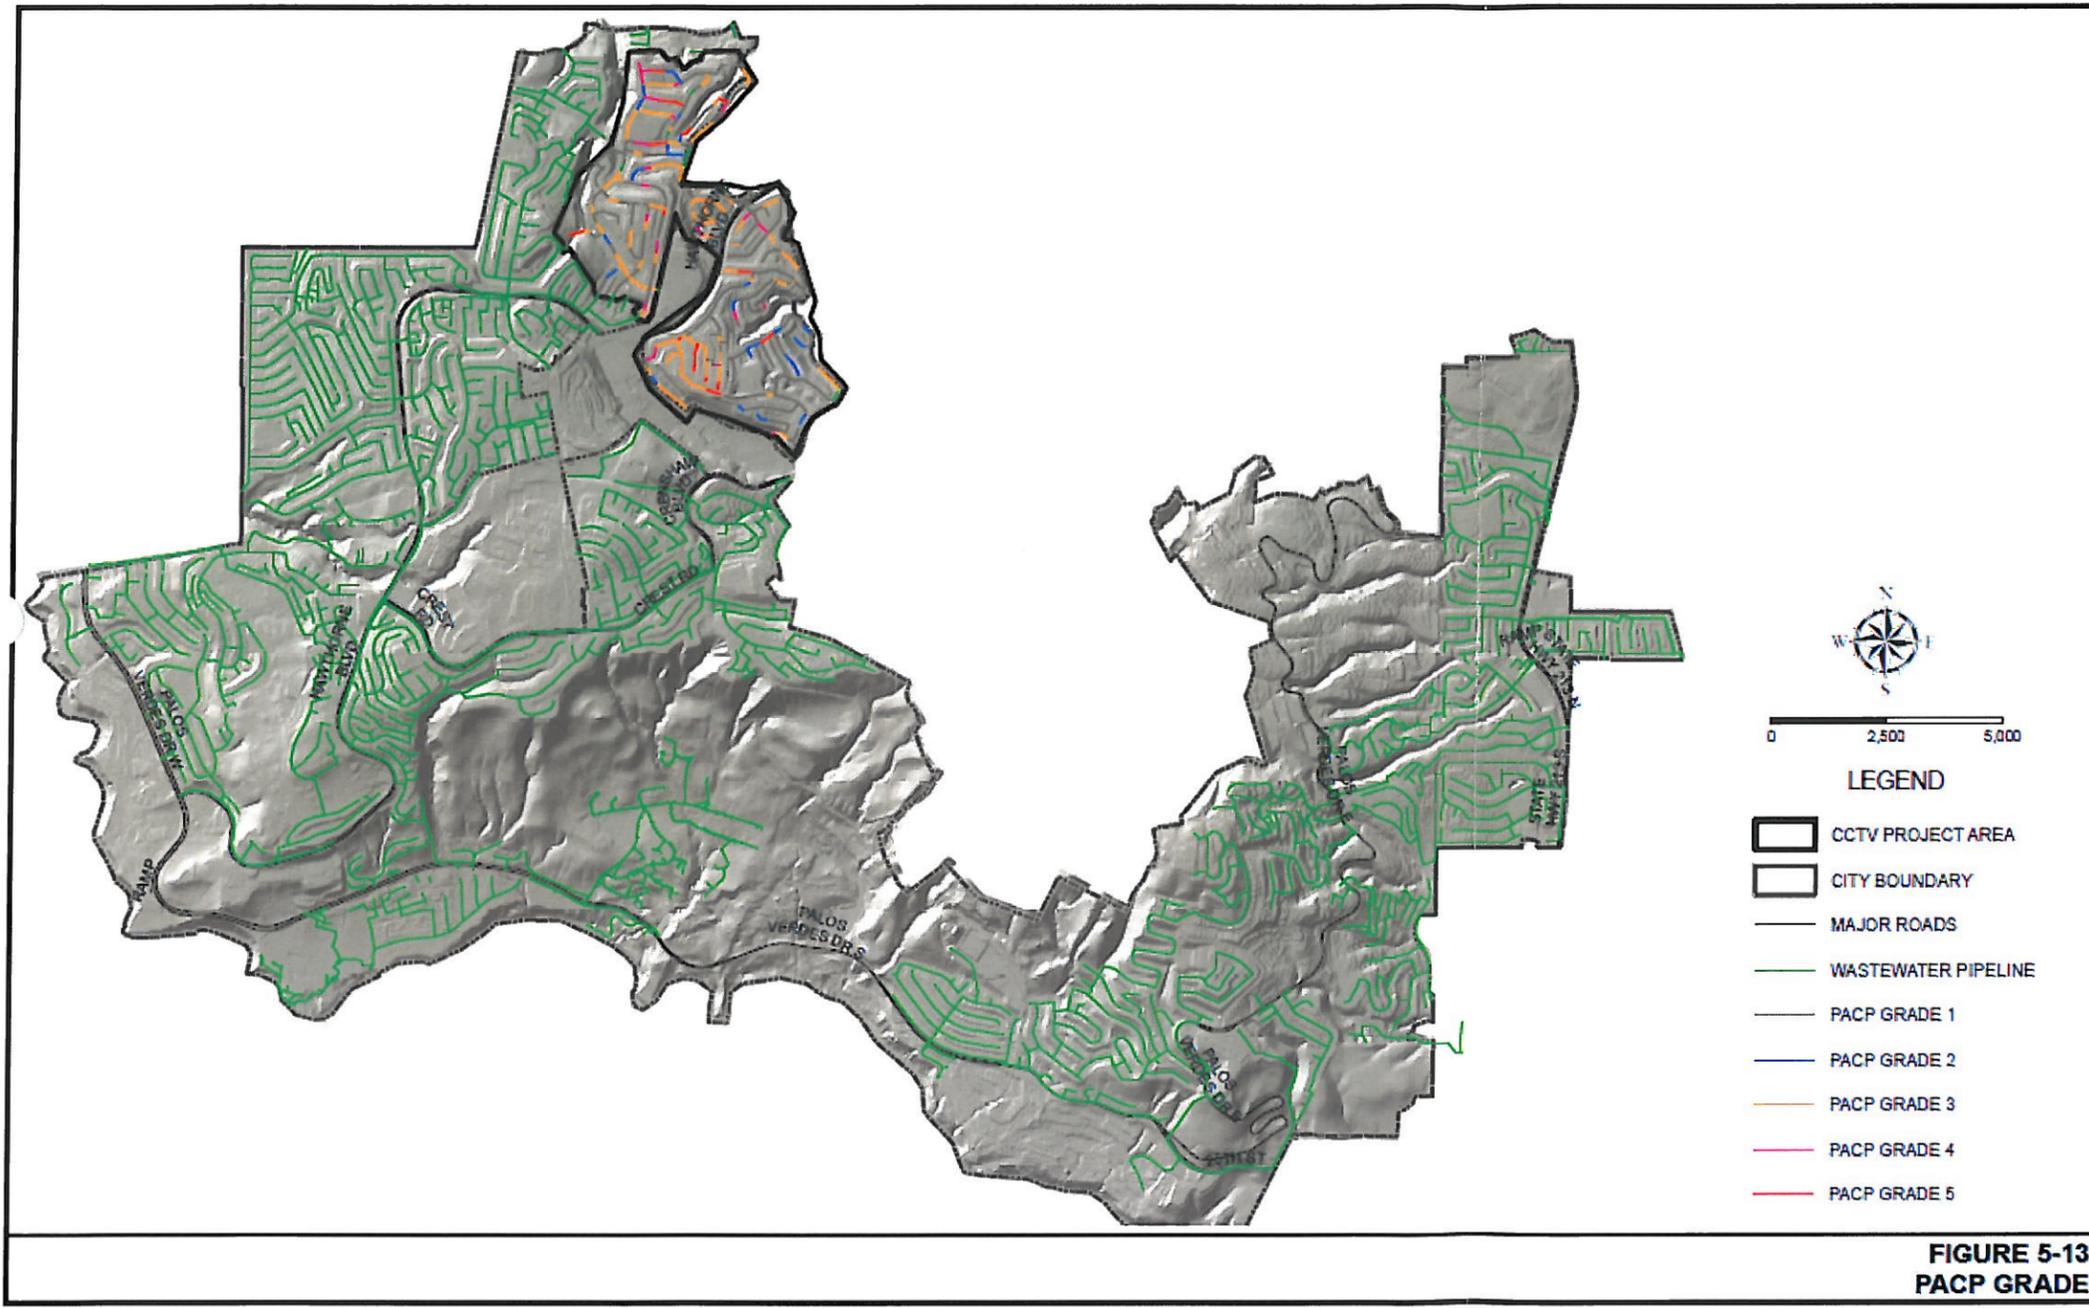
Figure 5-13 PACP Grade

Of the 388 pipe segments that were CCTV inspected, 42 were given a Structural Quick Rating of 4 or 5, meaning they were either in poor structural condition or had structural defects that required immediate attention.

Of the approximately 388 pipeline segments that were CCTV inspected, 79 were given a Pipeline Assessment and Certification Program (PACP) Maintenance Quick Rating of 4 or 5, indicating blockages, either due to roots, fats, or grease. This represents approximately 20.4% of the pipelines observed.

In conclusion, the CCTV inspections performed in 2004 and in 2006 shows that the actual physical condition of the collection system is deteriorated with maintenance defects in over 20% of the system and structural defects in over 10%. Some pipes have both maintenance and structural defects. The frequency and widely dispersed nature of the overflows indicates a system that needs continuing, consistent maintenance and a watchful eye on the cracked pipes and root intrusion areas. Based on the results of the hydraulic model, no overflows were predicted in the properly cleaned system in the existing or future dry conditions.
