REPORT OF EARTH MOVEMENT

PORTUGUESE BEND, CALIFORNIA

April 26, 1957

MACKINTOSH & MACKINTOSH  
Consulting Engineers  
Los Angeles 4, California

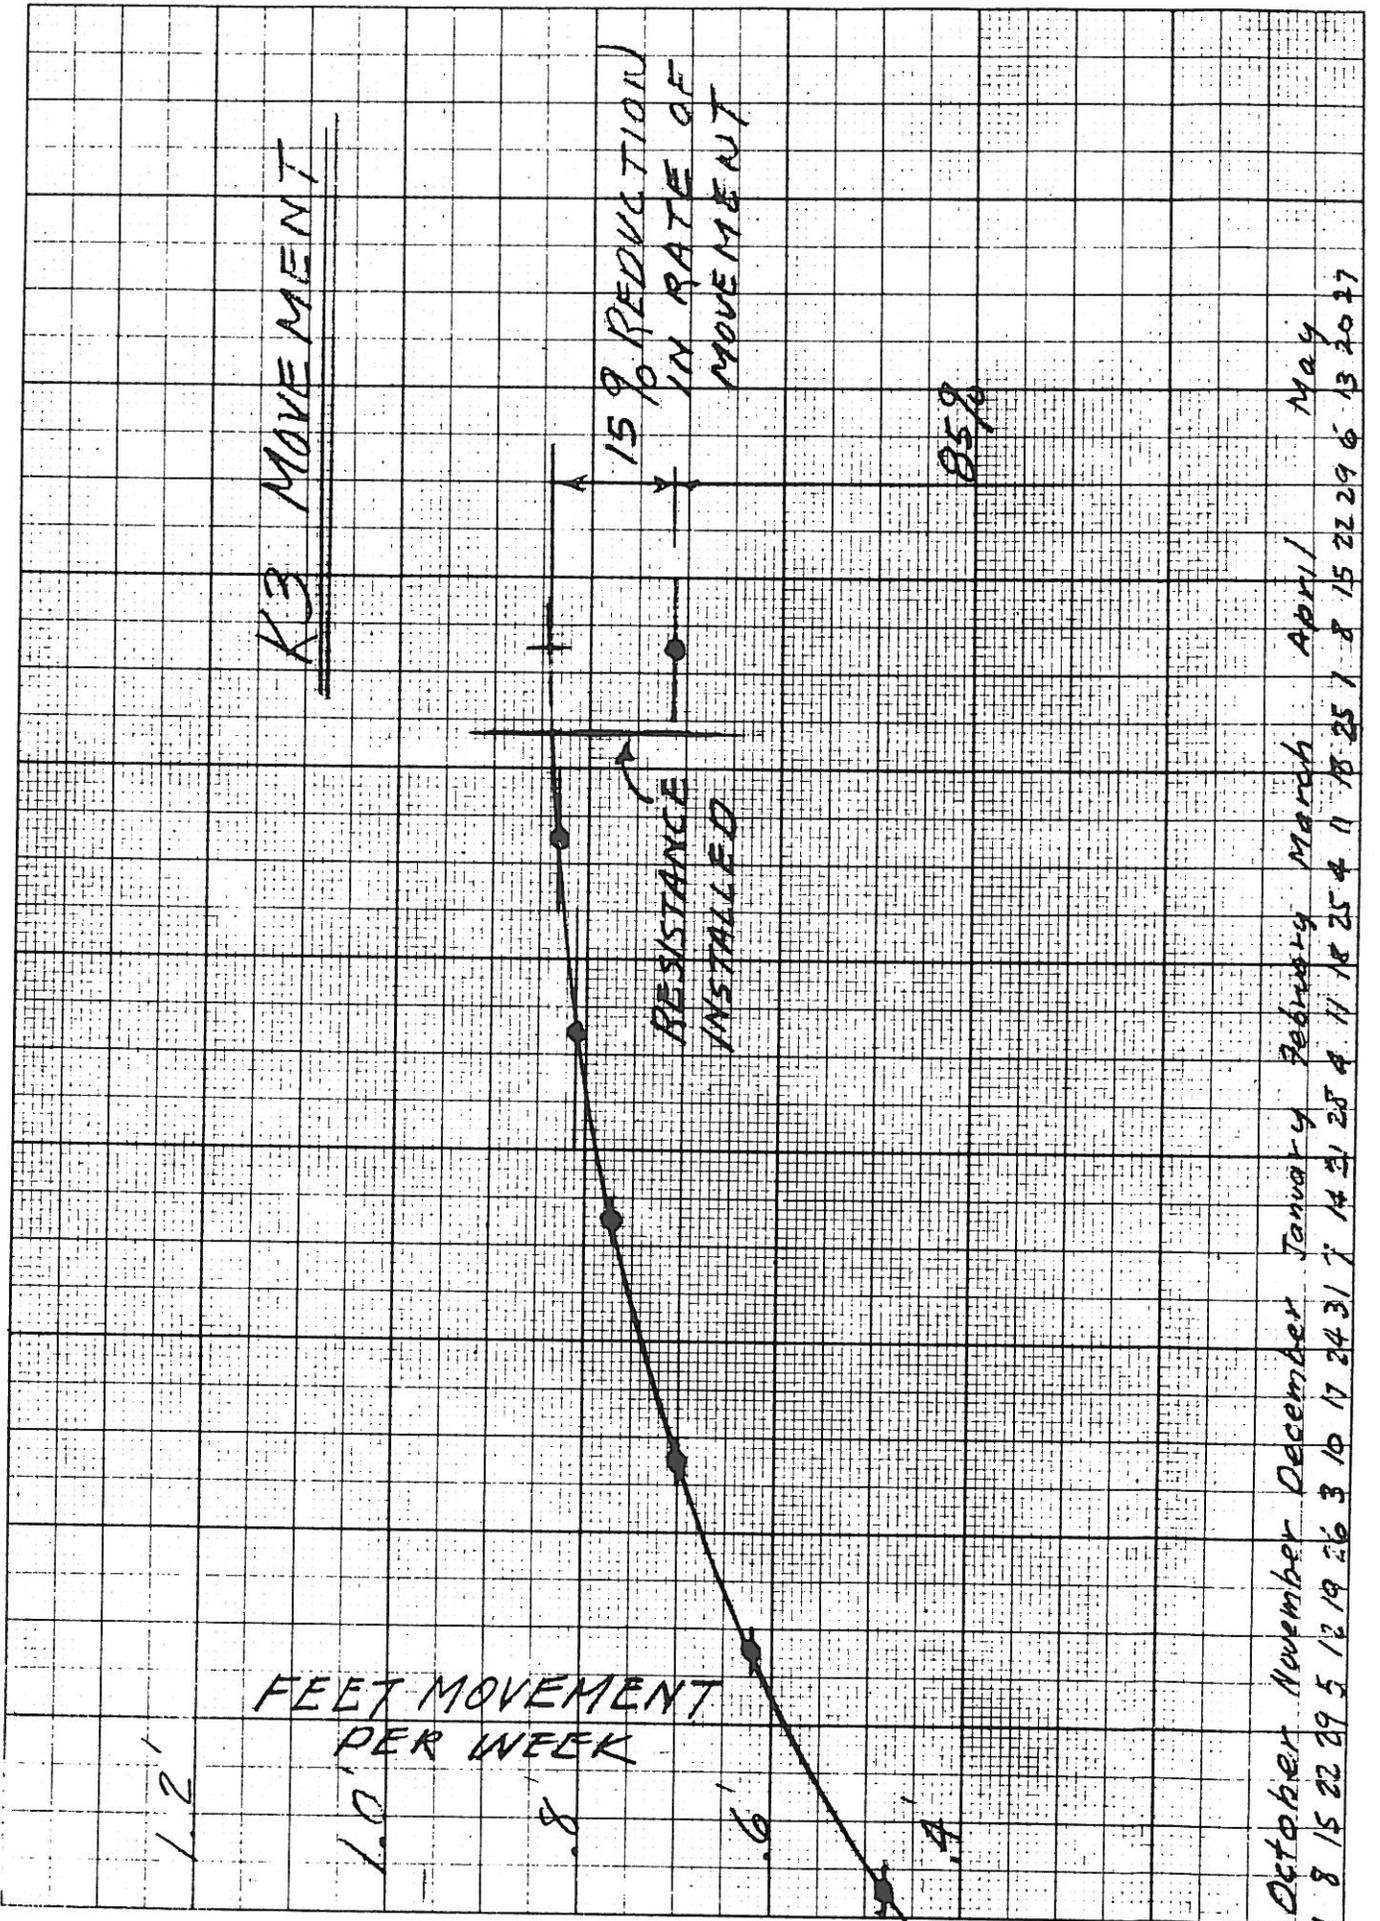
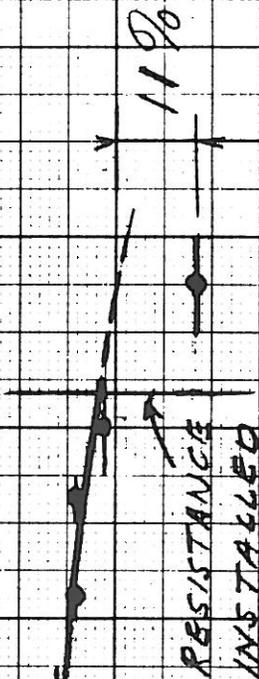
# A3 MOVEMENT

The horizontal movements of many points scattered over the surface of the slide area have been recorded by public and private survey parties. From data of the County Surveyor, seven months movement of K3, a central point near the bottom or south end of the movement, and of A3, a point on the easterly side, 2,300 feet to the northeast, has been plotted on the attached large graph at the back of this report. Graphs I and II have been plotted from this to show the rate of change of movement at K3 and A3 throughout the same period. The maximum movement has increased from about one foot in 15 days the first of October, 1956, to one foot in  $8\frac{1}{2}$  days about March 10, 1957.

the steel was stressed well beyond its elastic limit, so that a total resistance of over 2 million pounds was secured by the test. This force reduced the velocity of the earth movement generally throughout the slide by approximately 15 per cent as shown on graphs I, II, and III, the first 2 graphs being plotted from survey points and the latter graph being prepared from the clock-recorded data. The difference in the percentages shown is not surprising since the surface measurements were made at different points at different times and with different accuracy and there is some distortion in the mass as it moves, caused by the variations in shape and slope of the slip-plane. However, the fact that the slowing movement was immediately evident at widely separated points indicates that the resistances had, as was expected, caused a general slowing down rather than any purely local effect.

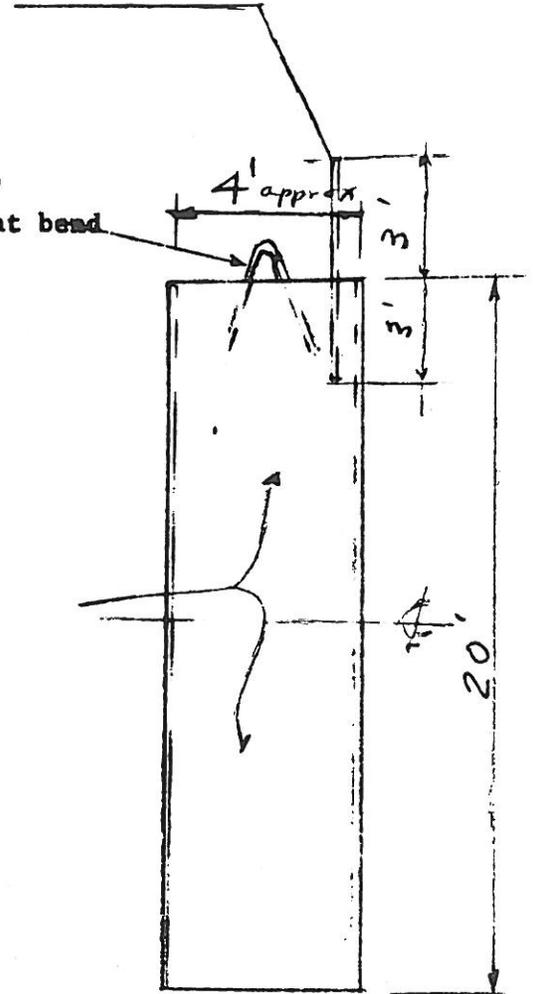
k. Measurement of unbalanced forces. Two twenty-foot-long reinforced concrete pins, 4 foot in diameter, and designed to produce 1,000,000 pounds of resistance as shown on page 10, were inserted and grouted in holes which were drilled vertically across the slip-plane at a convenient location near the bottom end of the slide in a region of maximum movement. (See Photos IV & V.) The stress in the steel shell was measured with strain gages.

Pipe of approx. 4' dia. and of 1/4" thickness shall be clean and free from grease, to provide concrete bond. Avoid circumferential welds in the middle half of the length.

Fill with about 1,000# of <sup>new</sup> ~~used~~ reinforcing steel, (no pipe) and with high early strength vibrated 2,000#/sq. in. - 7 day concrete of not over 4 in. slump. Do not splice rein. near slip plane.

Drill hole to depth which will place c.l. of pipe length approx. at the slip plane

Approx. 6 SR4 or other strain gages to be installed on steel pipe by testing laboratory which shall take readings twice daily for at least one week.

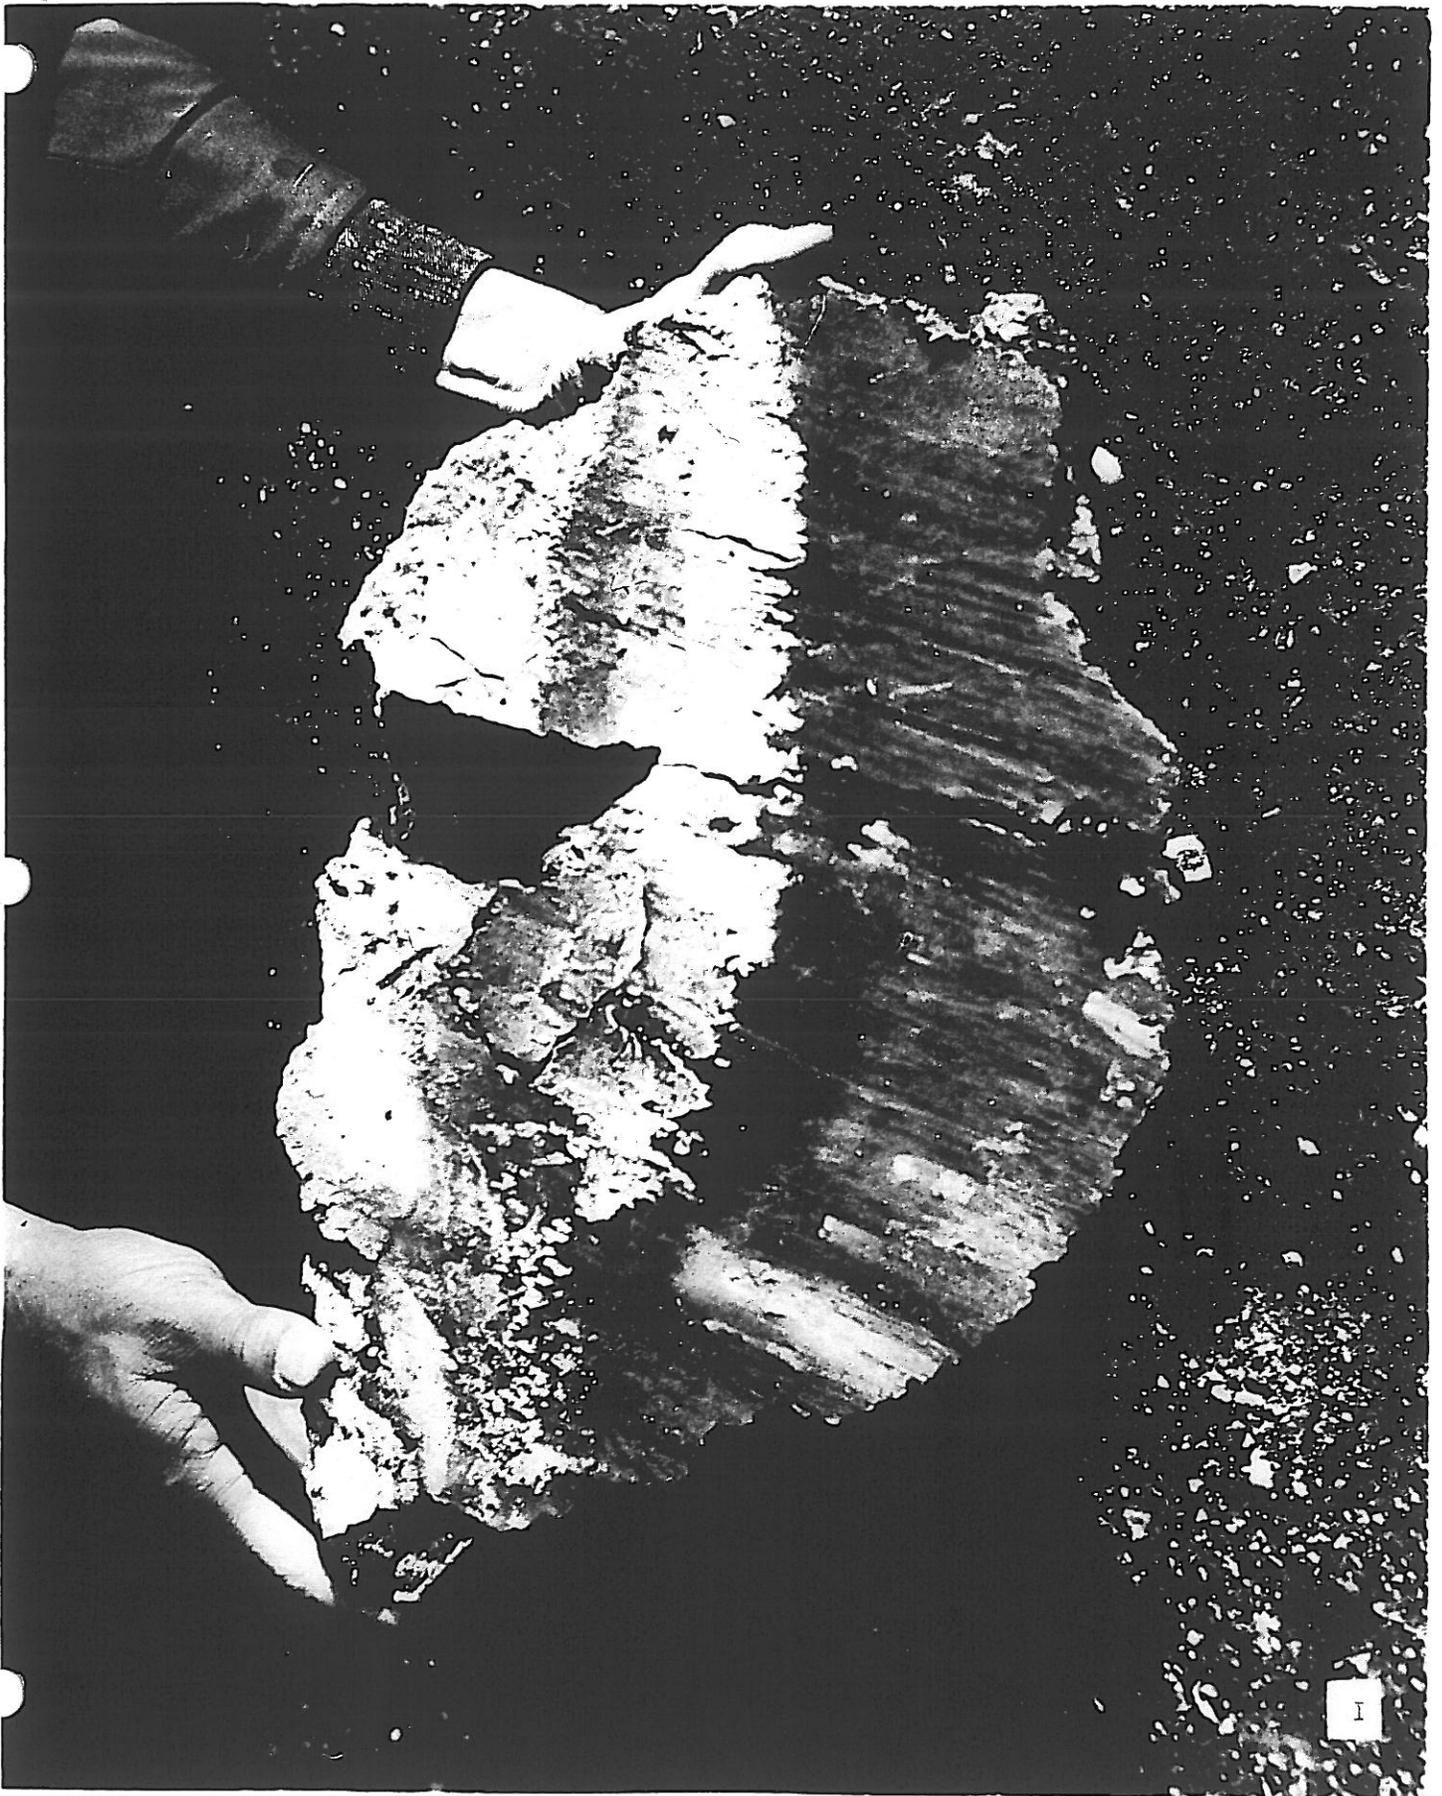
A moist, fine, clay slickensided plane of movement is exposed in portions of the southerly edge of the slide. (See Photos I, II, and III.)

The movement is on a slickenside either in the clay or at the juncture of the clay and an underlying reddish-brown softened shale. Photo I shows a piece of the upper surface of the slickenside. Photo II shows the projecting upper surface of the slide

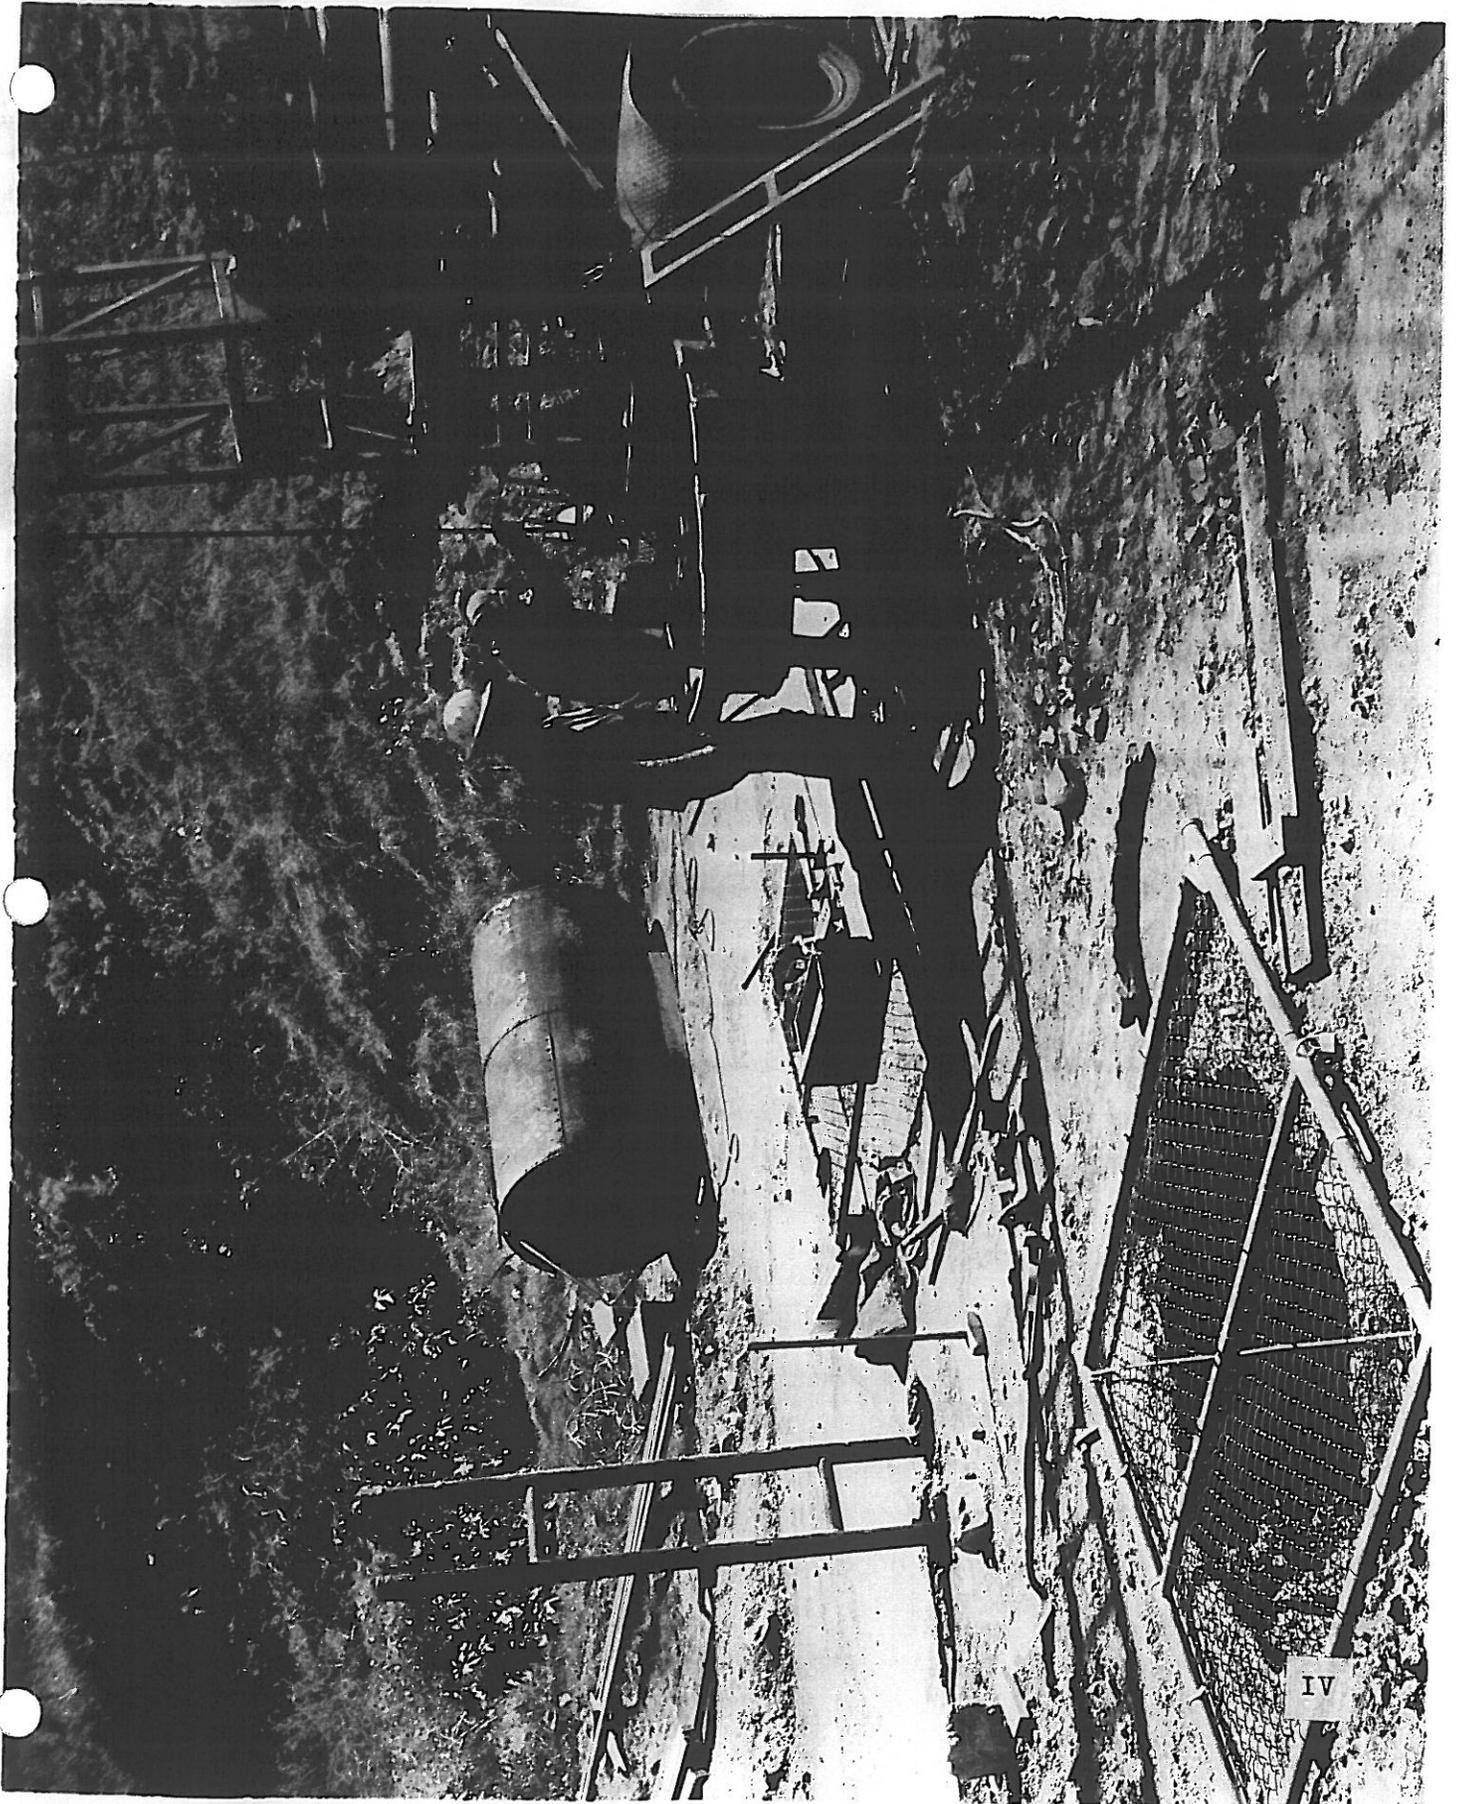
Photo IV shows the holes being prepared for the pins. The hole in the foreground is covered by a hinged protective gate. A segment of the hard earth encountered below the slip-plane is in the foreground by the gate. Standards on which to mount the recording gage box appear as ladder in the left rear and the 4-foot diameter 8-foot section of pipe at the rear was used to trim the hole.

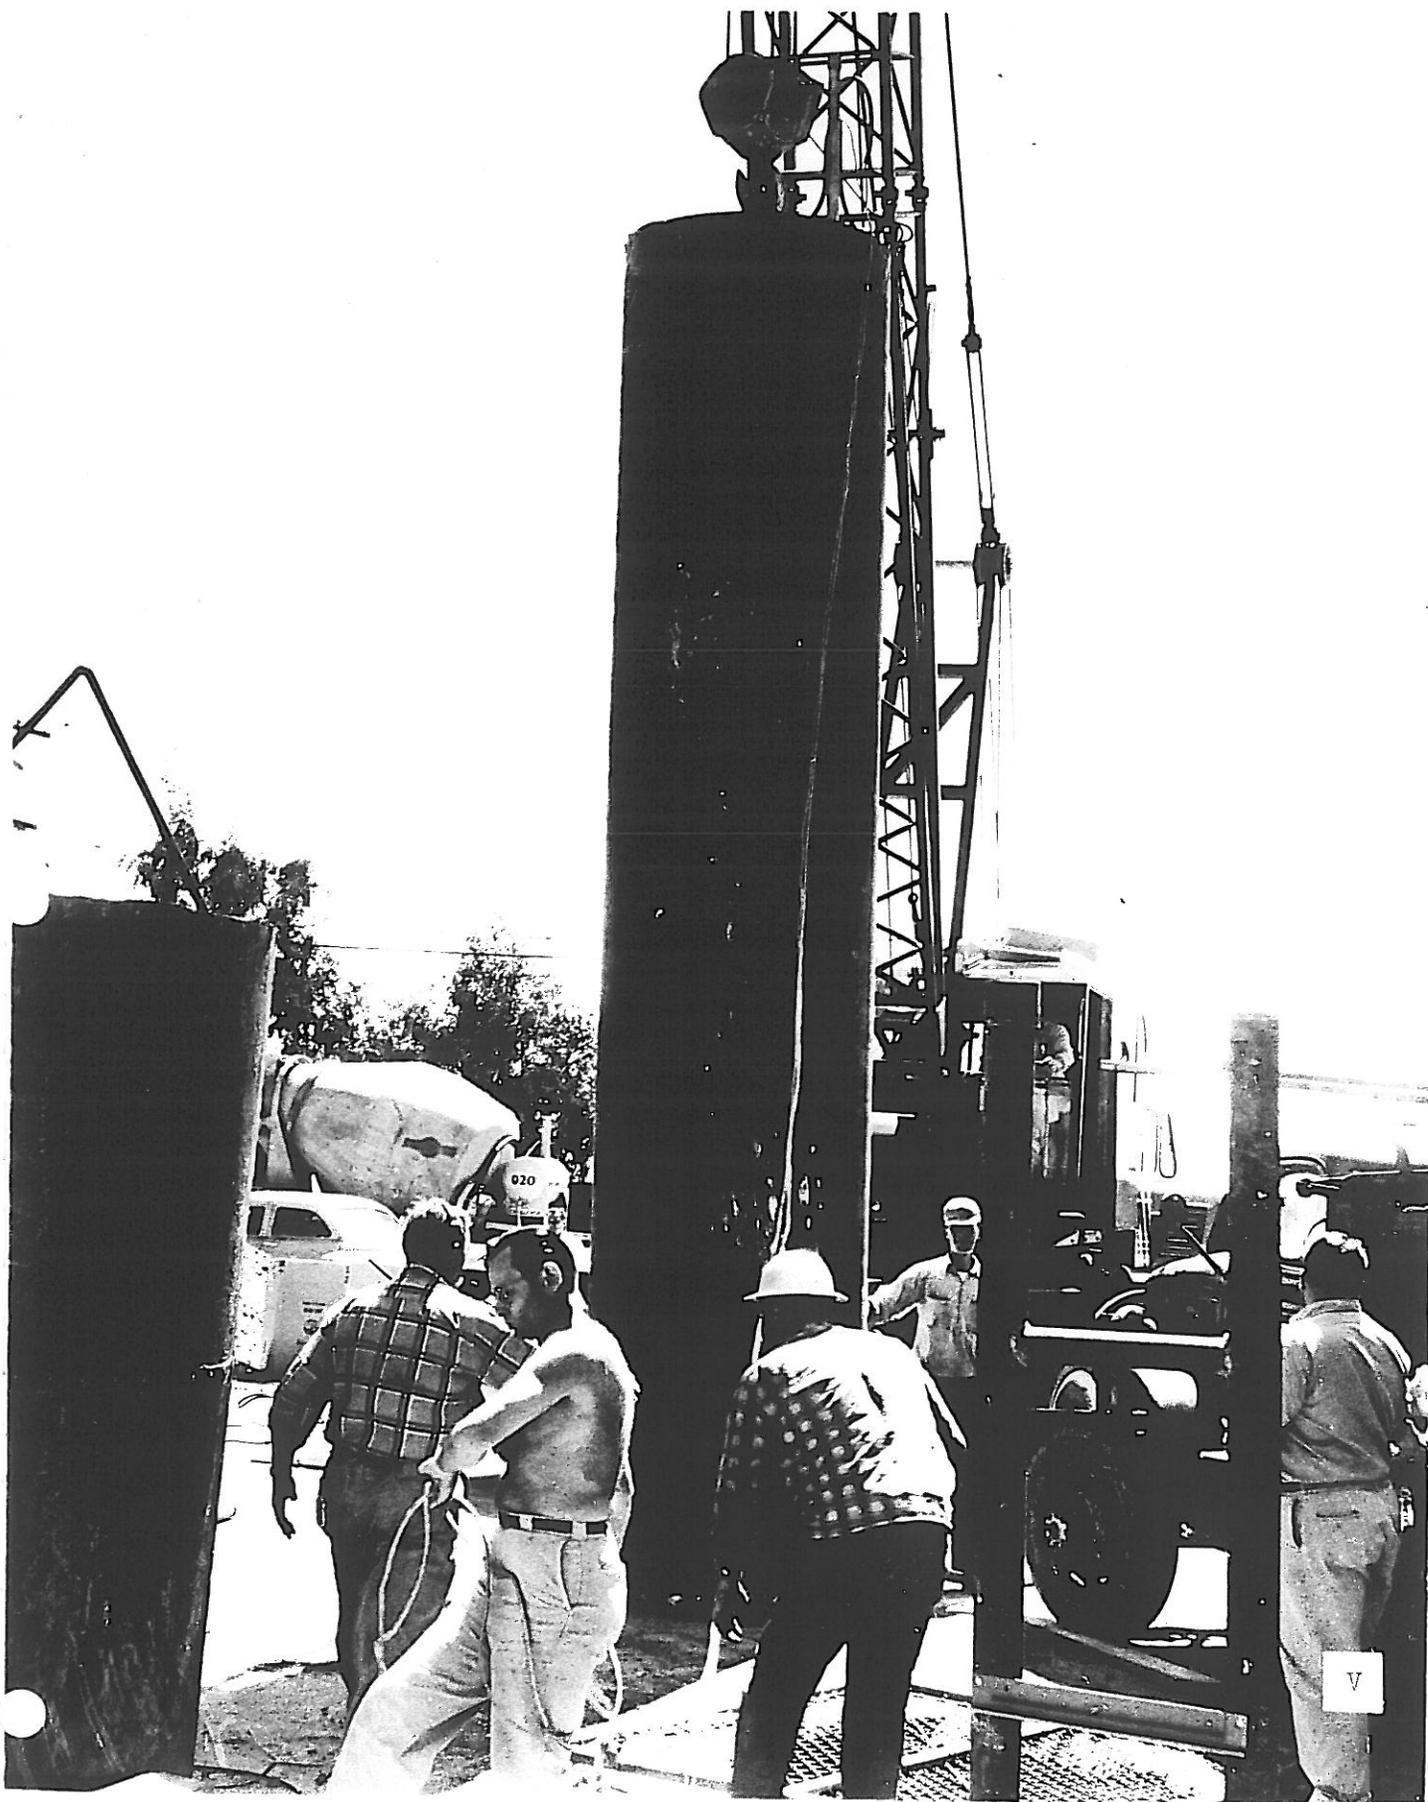
Photo V shows one of the precast reinforced pins being lowered into one of the drilled holes.
