August 1, 2006

PN 97082-1485

Subject: Summary of Site Observations and Cursory Review of Site Conditions, Abalone Cove Landslide Area, Rancho Palos Verdes, California

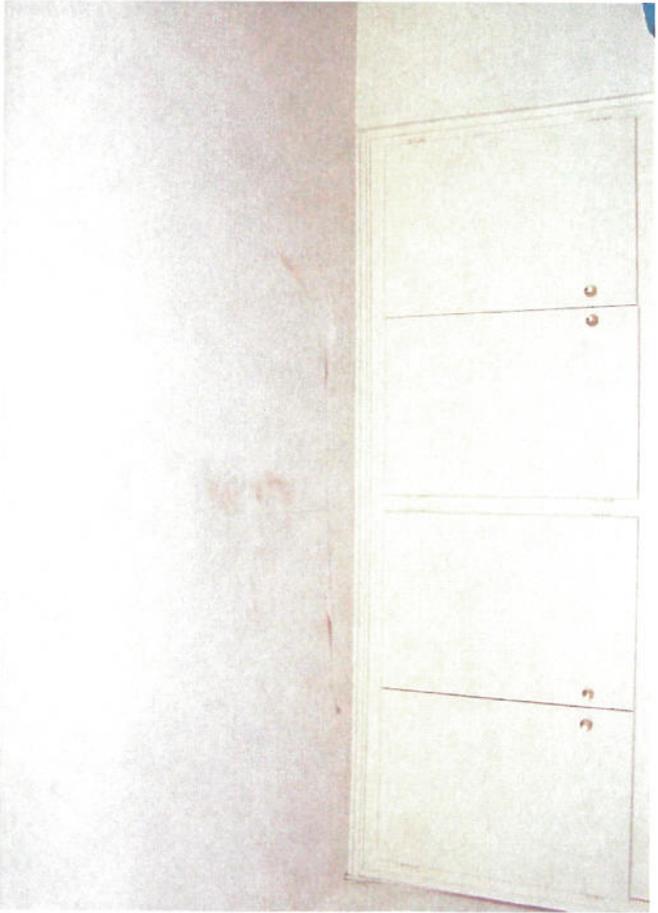
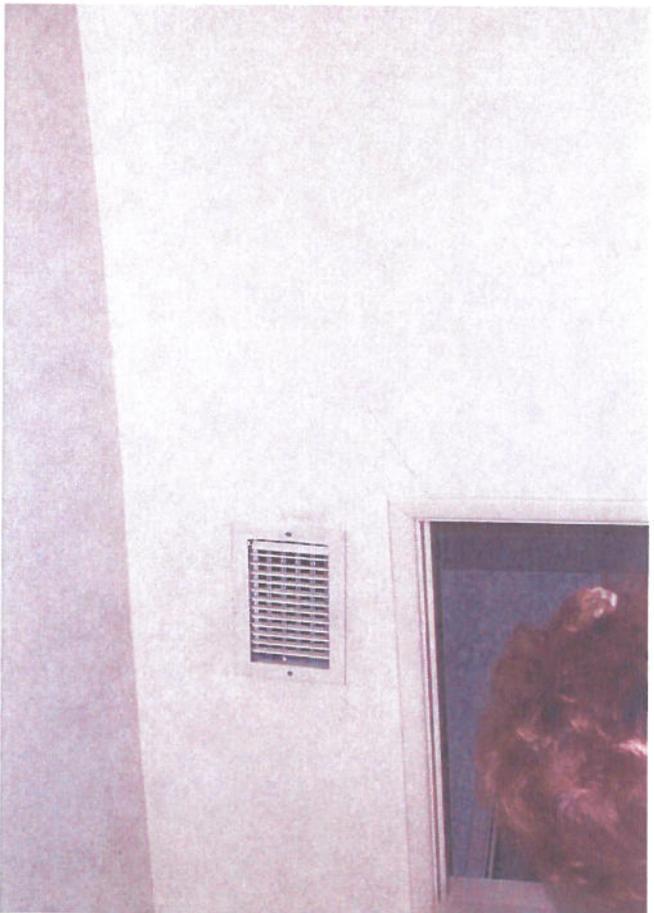
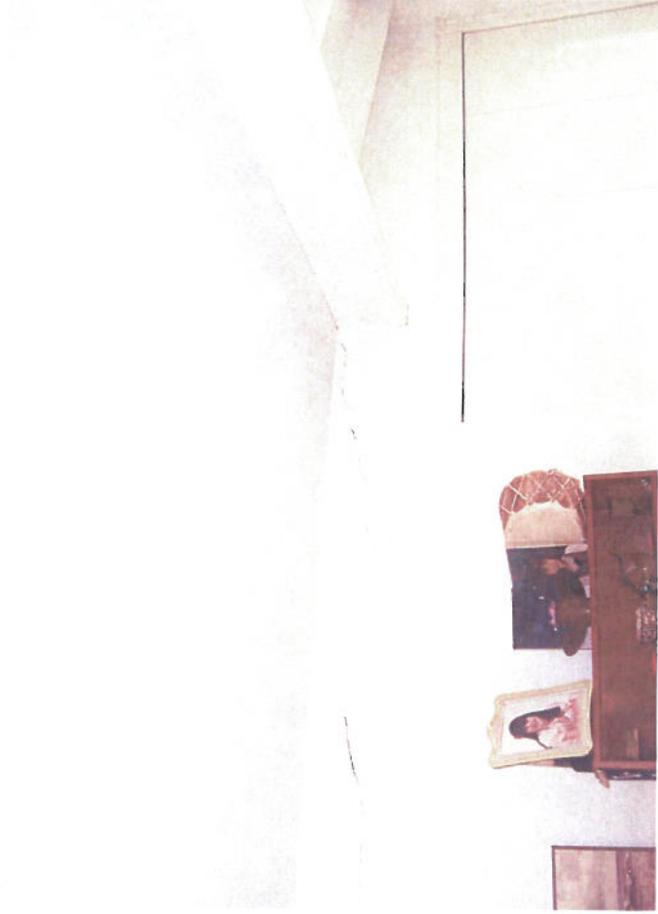
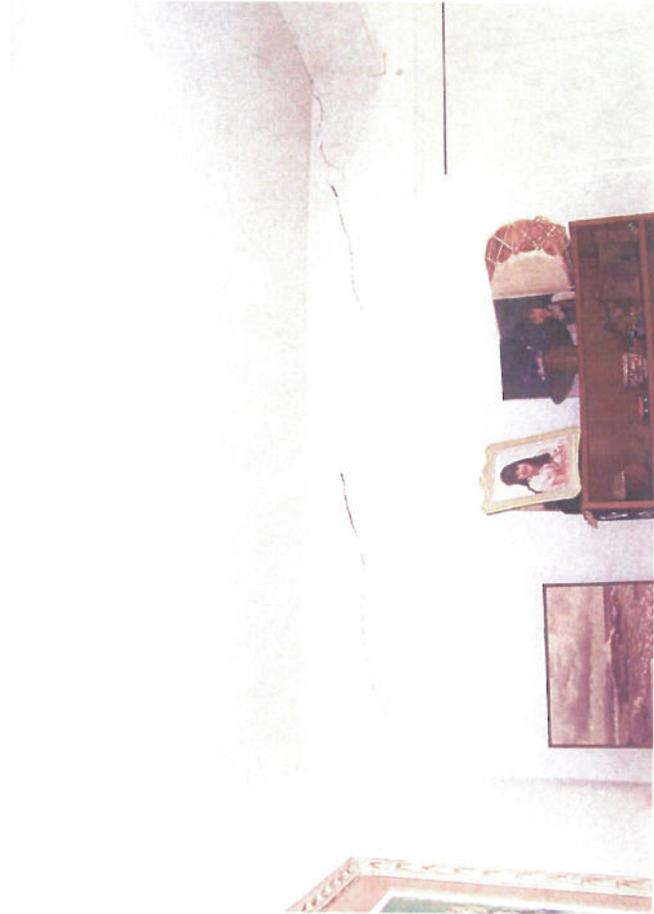
Figure 7

The Horan residence (28 Narcissa Drive) included both interior and exterior observations. Observations included movement and separation in the brick driveway and cracking and tearing of interior drywall (see figure 7). Additional observations included uneven flooring within much of the residence.

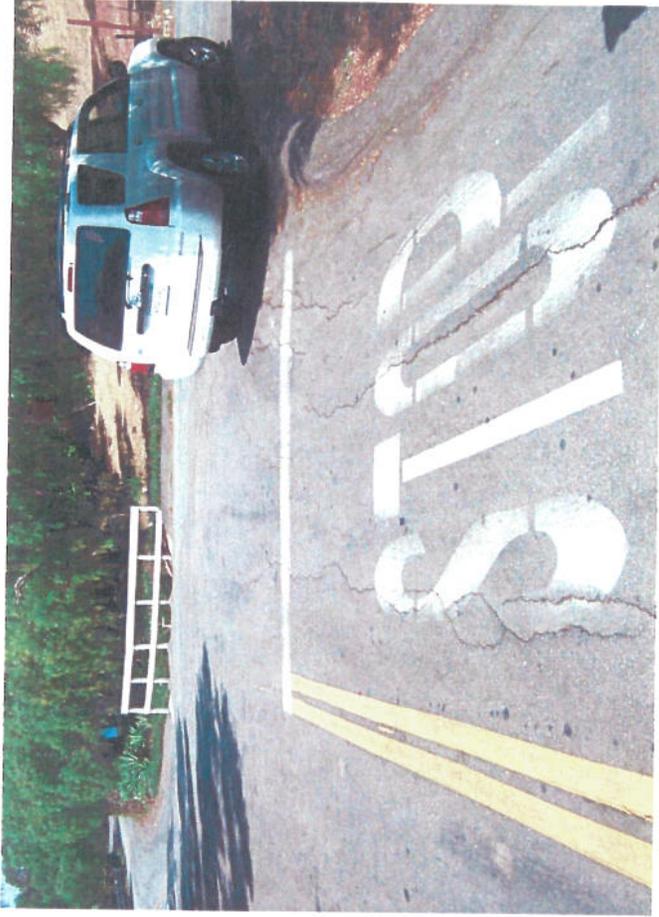
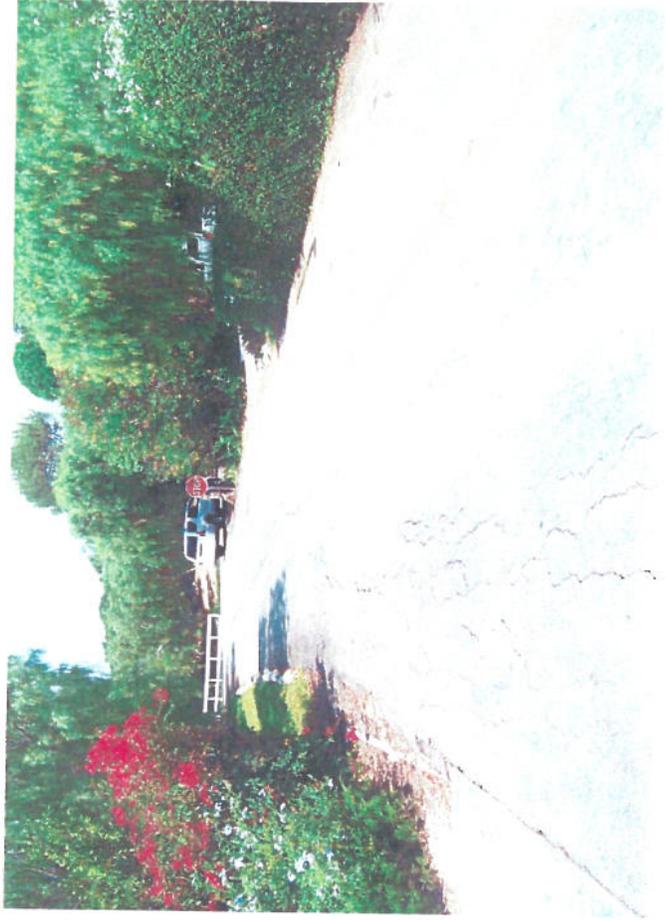
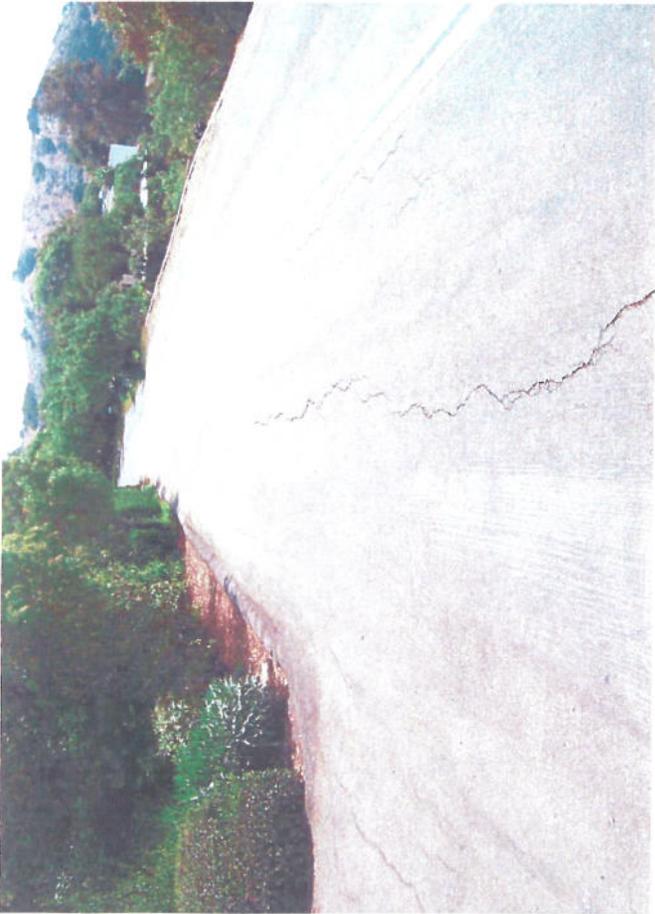
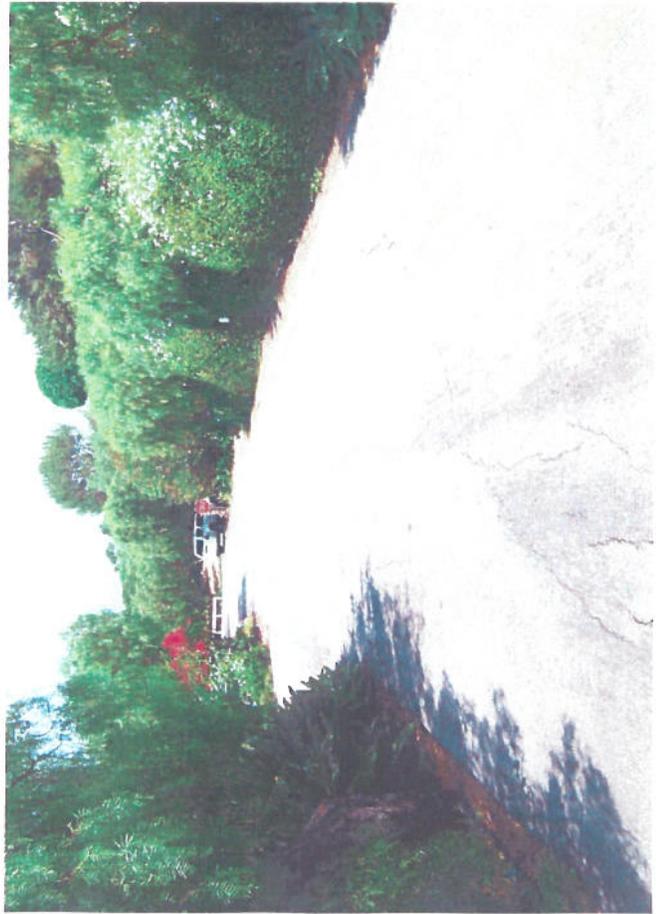
Figure 8

Street distress observed included general cracking of asphalt pavements that appeared to be typical of aged pavements, other cracks that may be related to minor movement (lower Narcissa Drive, Photos 23 and 24 and in front of 1 and 2 Cinnamon Lane, Photos 27 through 29 and ZKCI Figure 8), and some areas that show heaving or settlement within pavement areas (Palos Verdes Drive South photos 35 and 36). The cracks observed are generally between 1/8 to 1 inch (see photos 23 through 36 and ZKCI Figure 8).

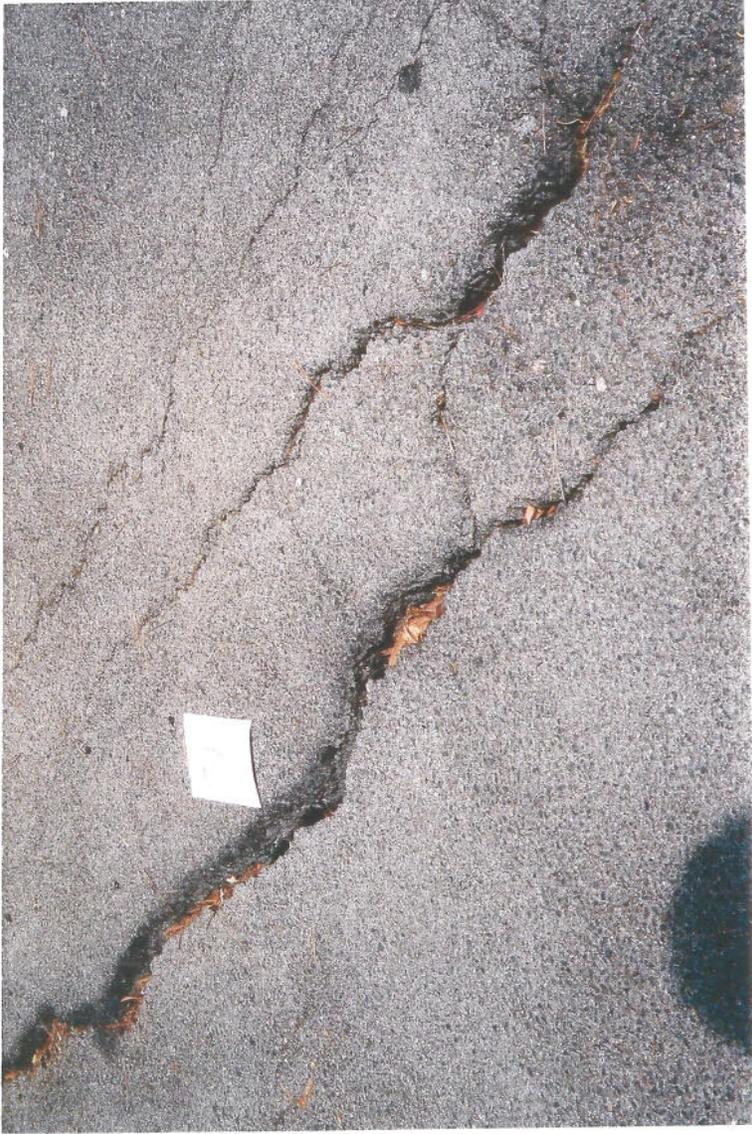
#1

7/24/06
Jester Driveway - 20 Narcissus Dr
6 in. deep.

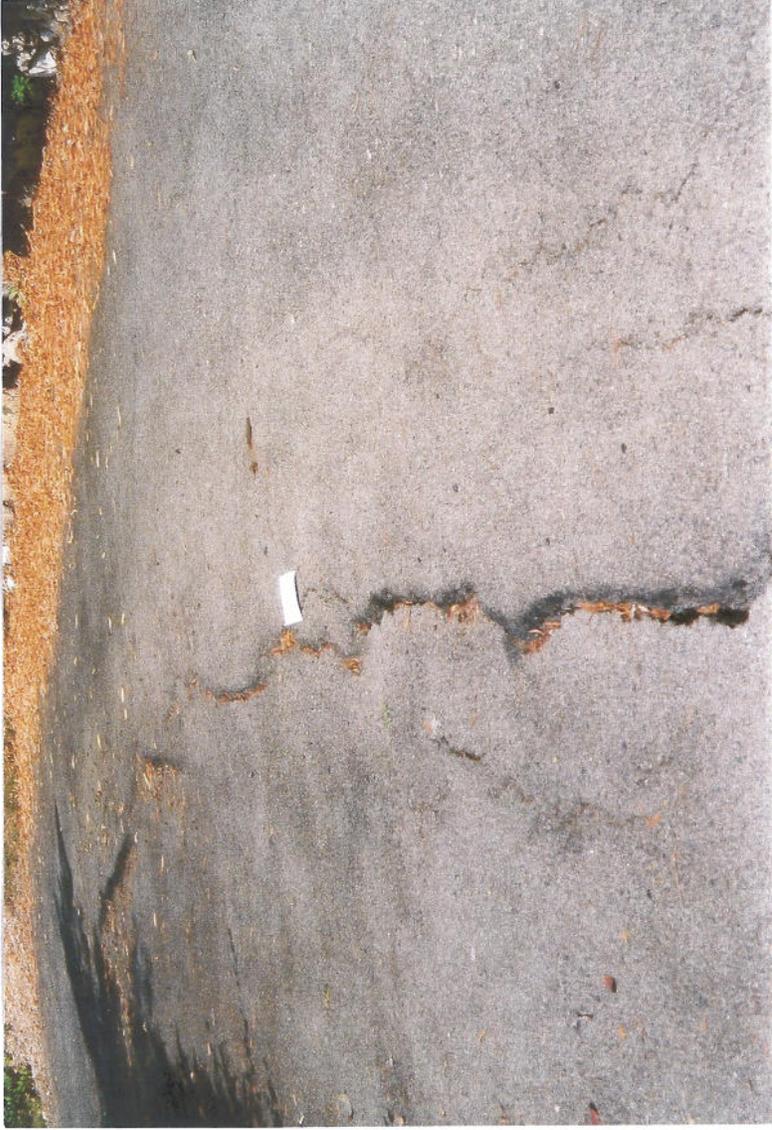
2

Jester Driveway - 20
Narciss + PR.

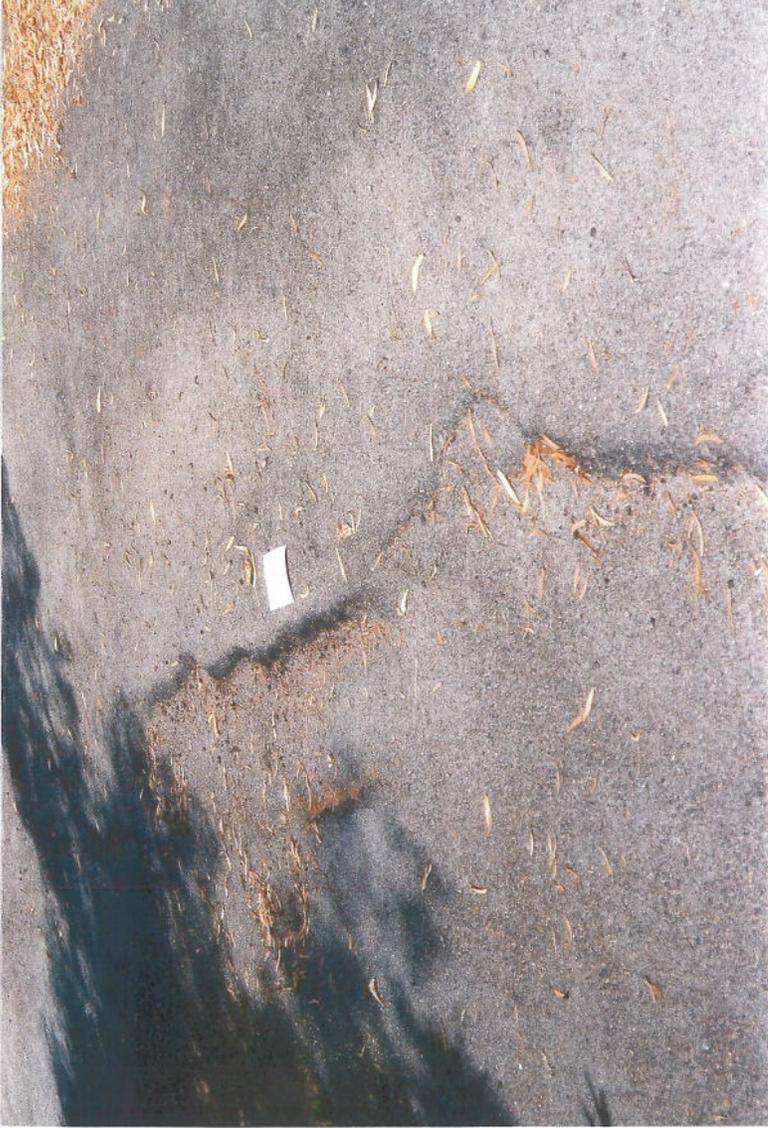
JESTEK DRIVEWAY - 20 NARCISSE DR.

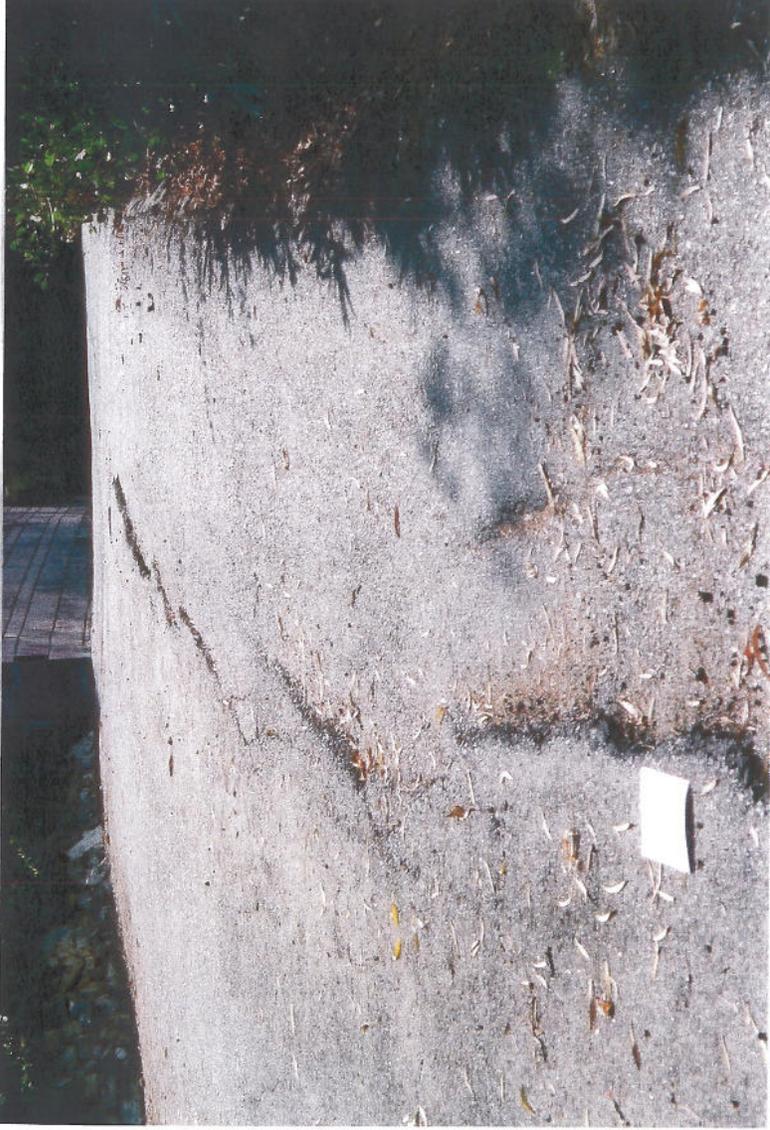
4

Jester Driveway - 20 NARCISSE DR.

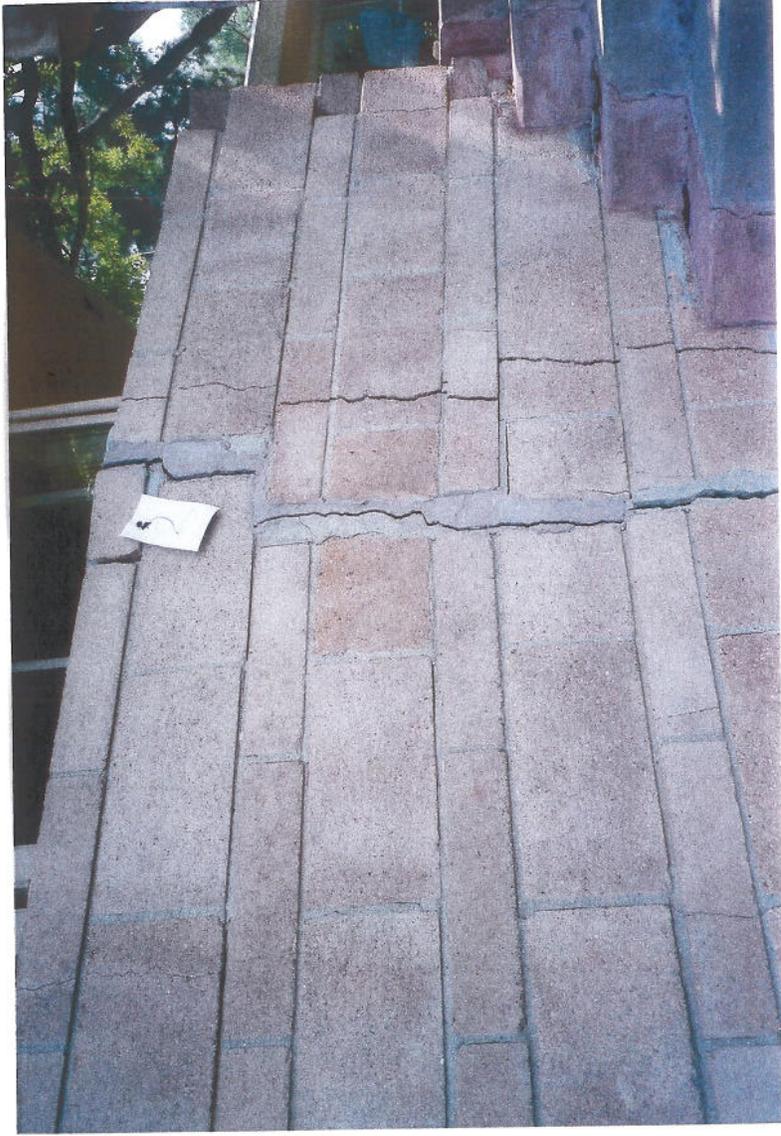
Jester wall in BACK YARD
26 NARCISSE DR.

NOTE: previous patching is #

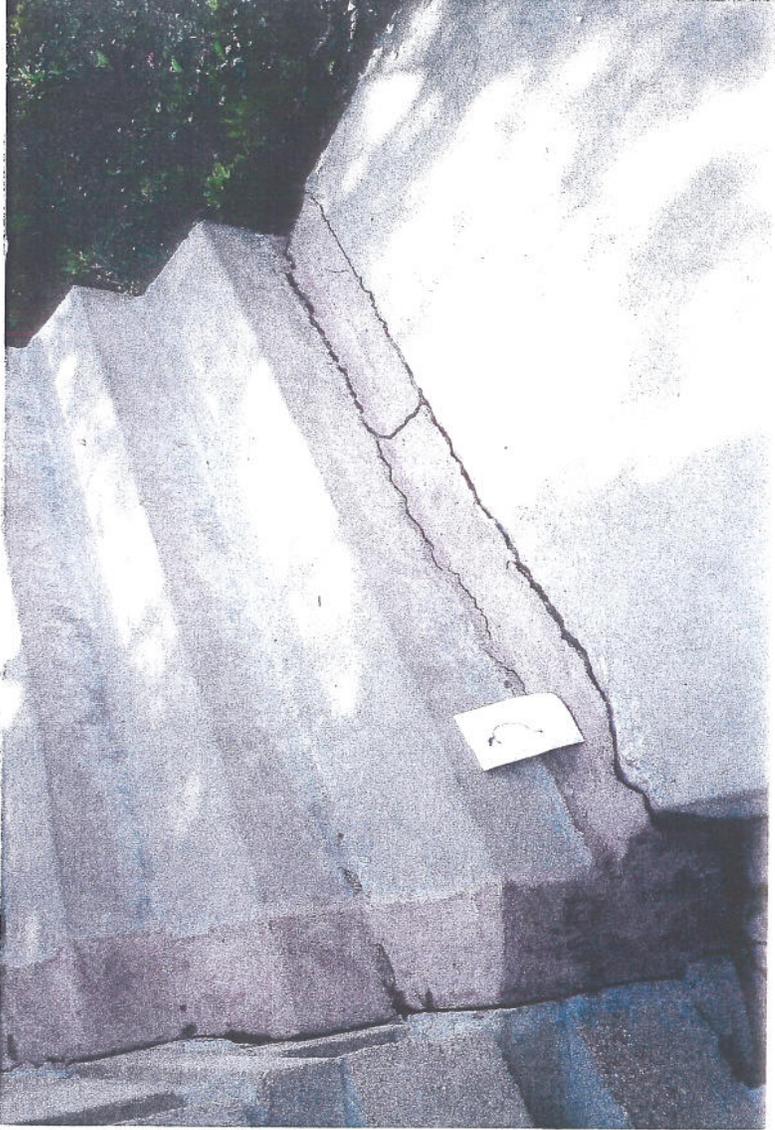
FRONT STEPS AT JESTER HOUSE
20 ~~STREETS~~ NARCISSE DR.

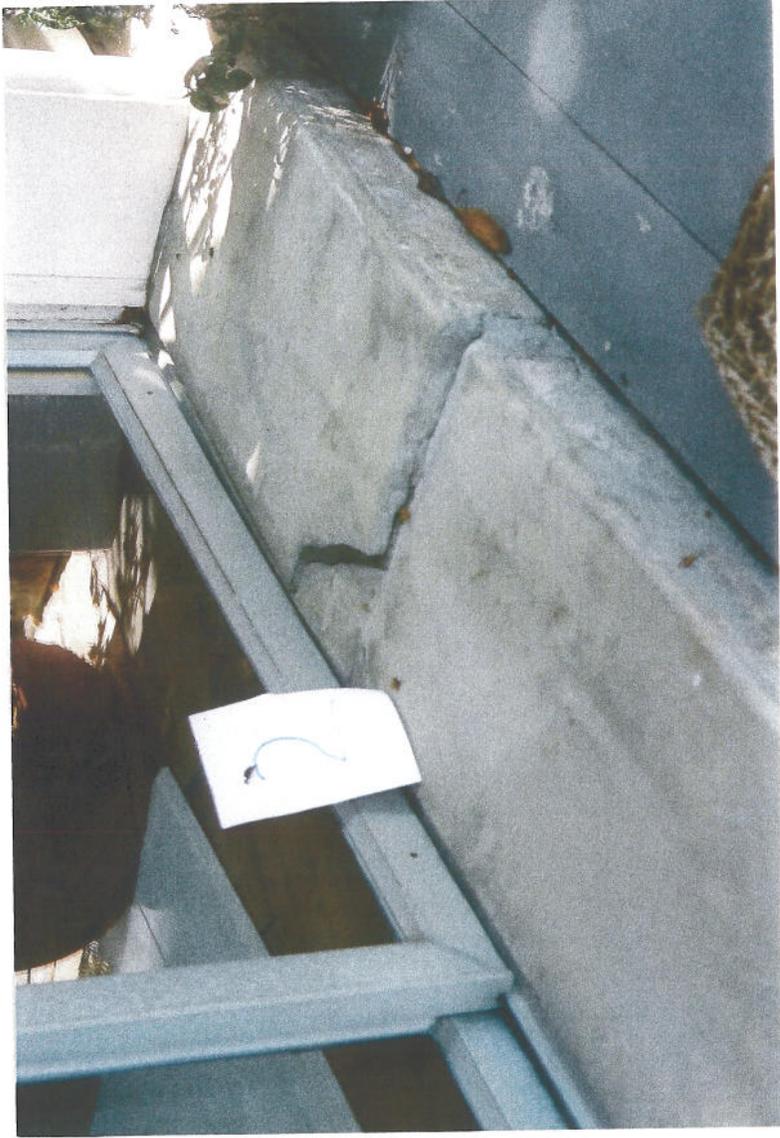
8

FRONT YARD at Jester's
20 NARCISSE # DK

PULL APART CRACK ON SLAB

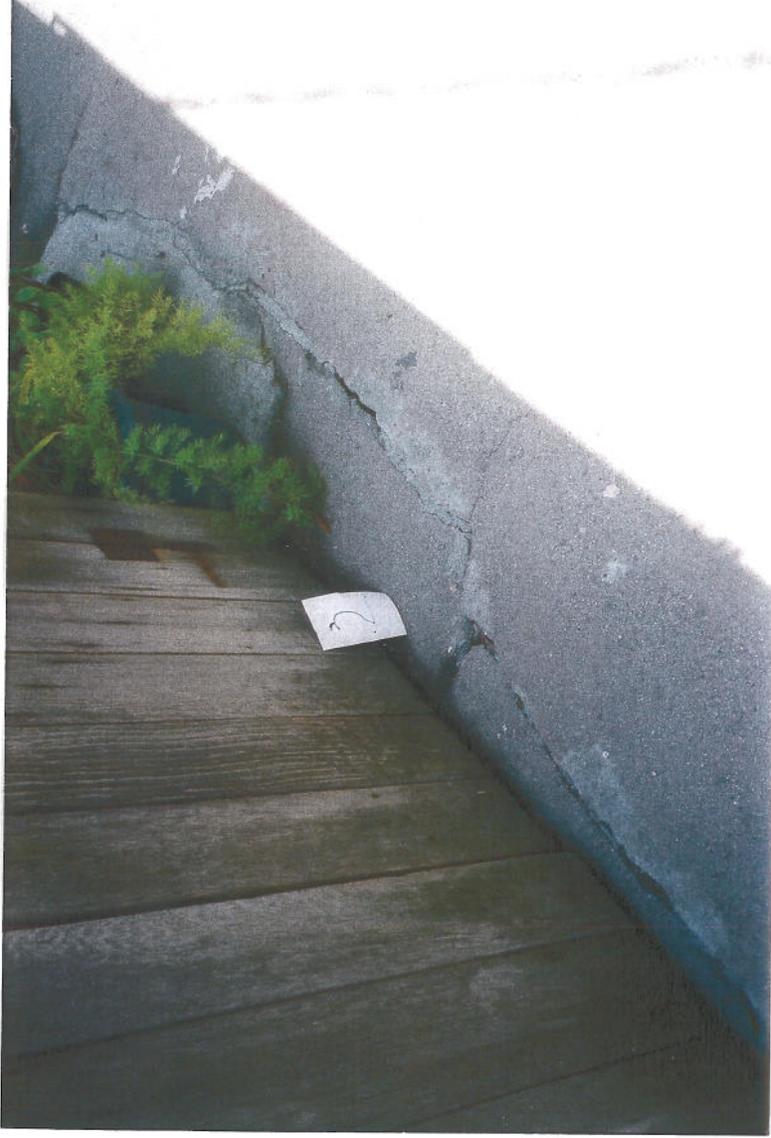
9

BACK YARD AT JESTER'S
200 W. ALBERTA DR.
CRACKS IN SIDEWALK

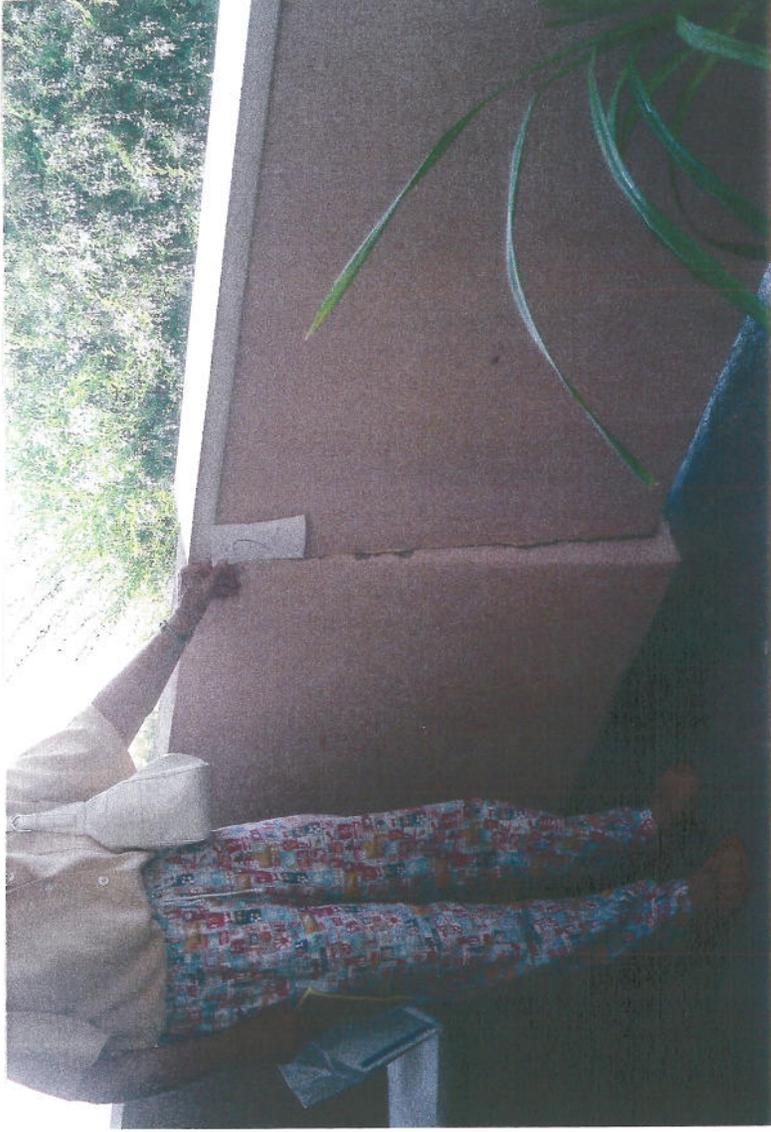
#10

Jester Home - 20 NARCISSE DR.
offset in patio wall.

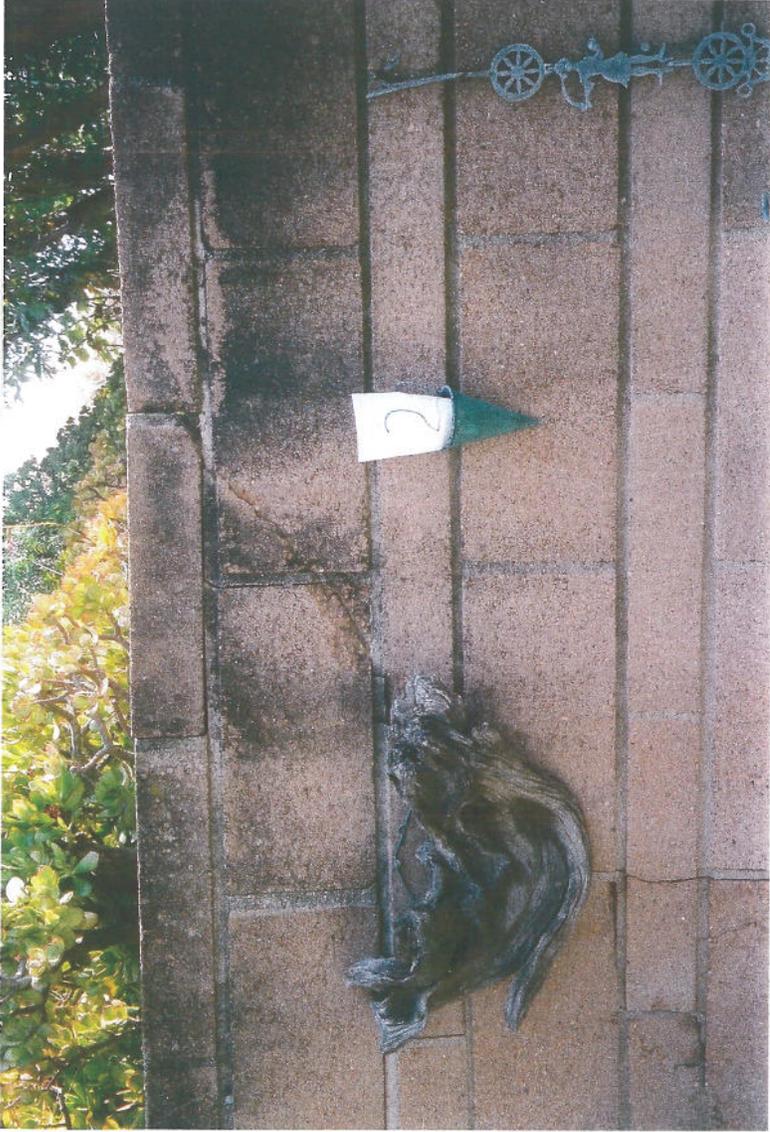
11

Back yard at Jester's
20 Narcissa Dr
New wall cracks

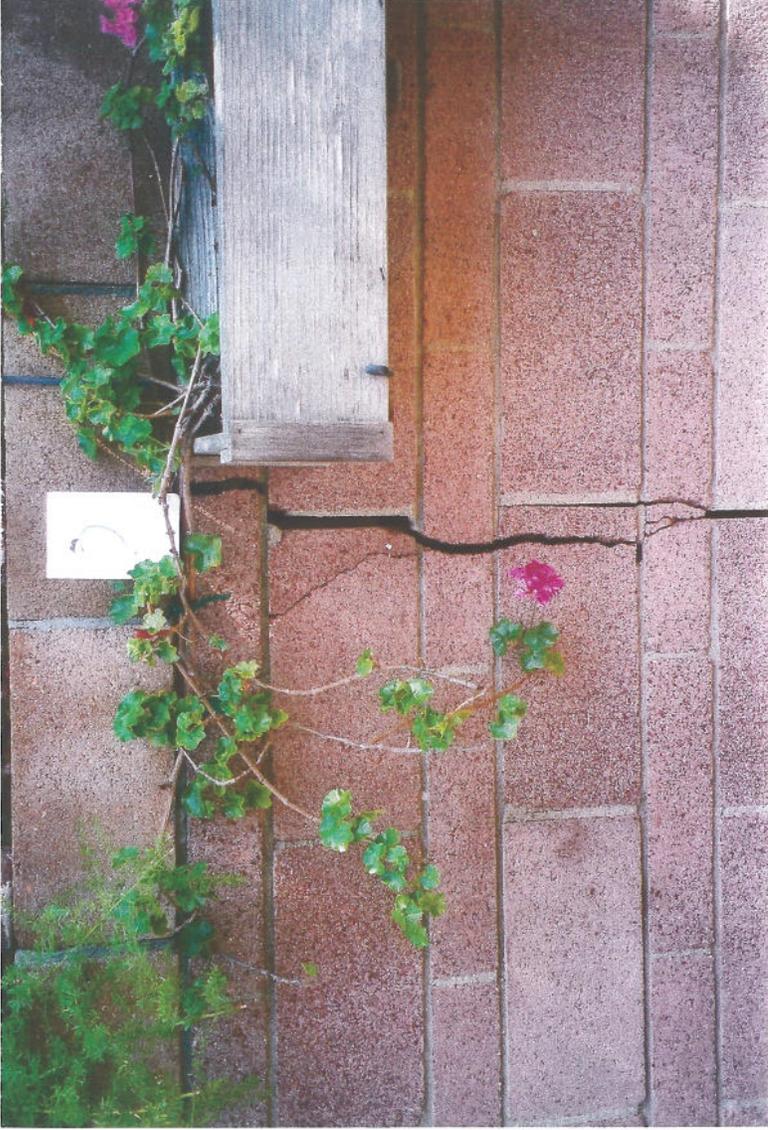
12

JUSTICE BACIE YARD WALL

Settlement a full apart crack

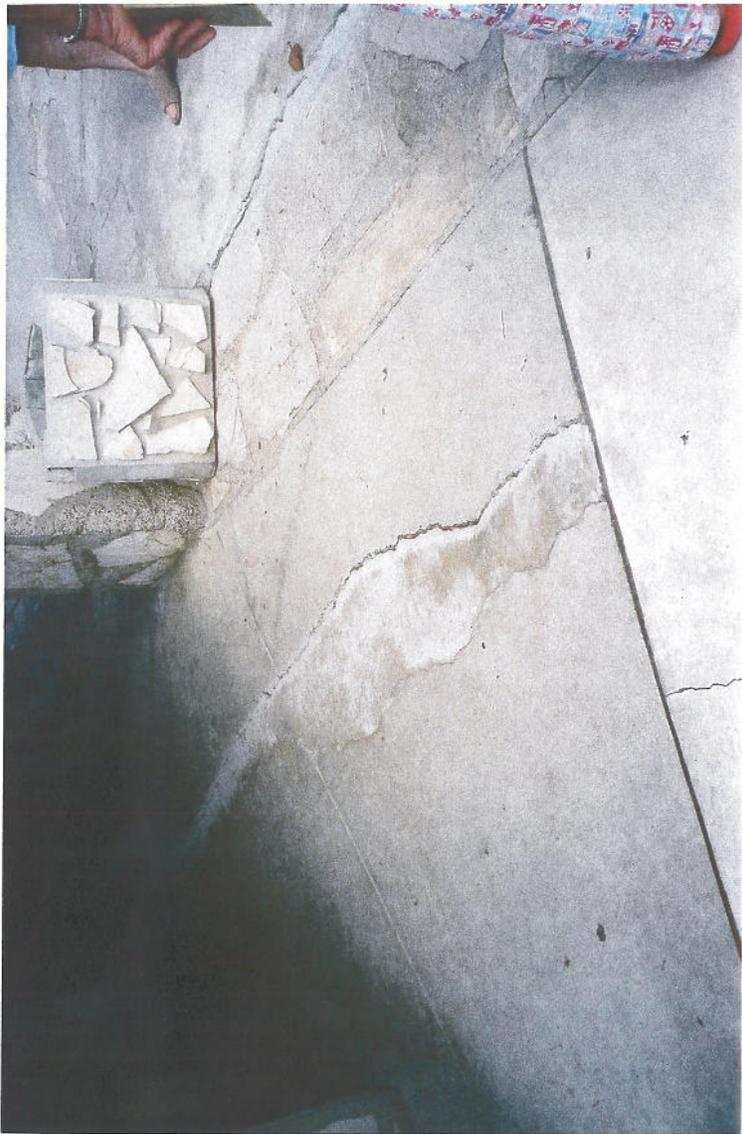
NEW MOVEMENT NEAR GREEN
HOUSE - wayfarer's Chapel.
UNDER Breeze way

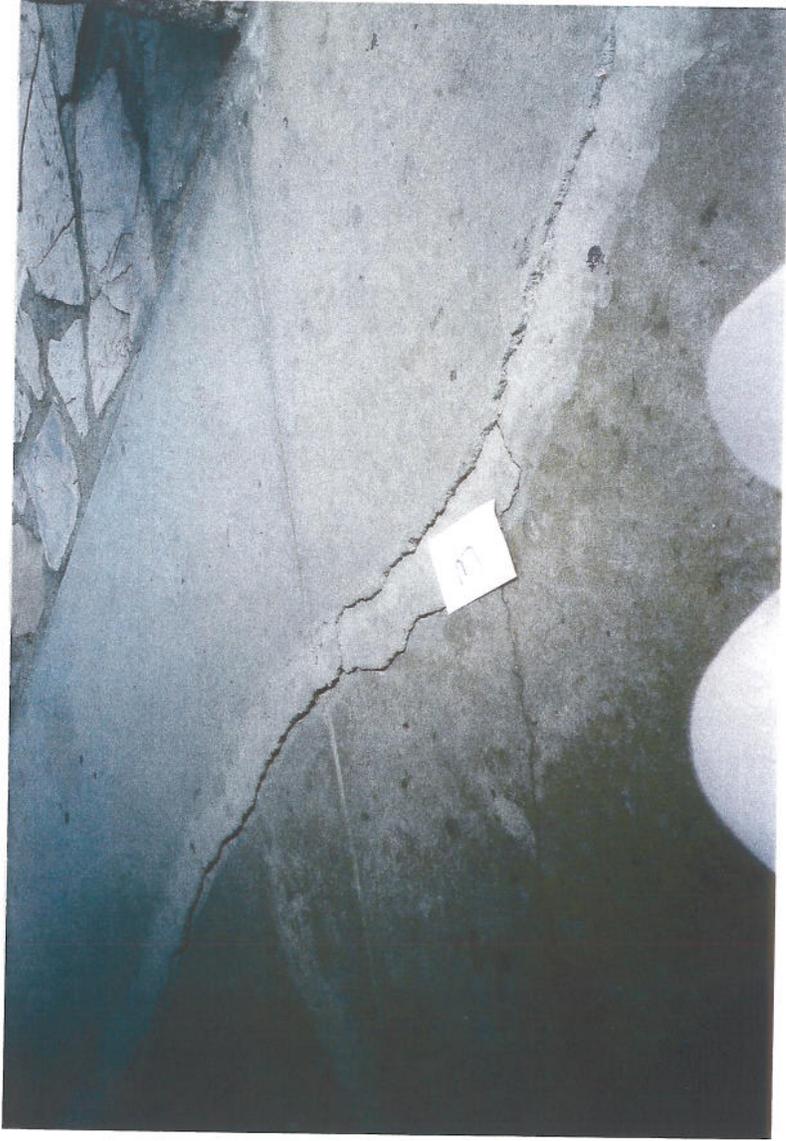
14

Wayfare's Chapel - near garden
House. Sidewalk cracks UNDER
Breeze way.

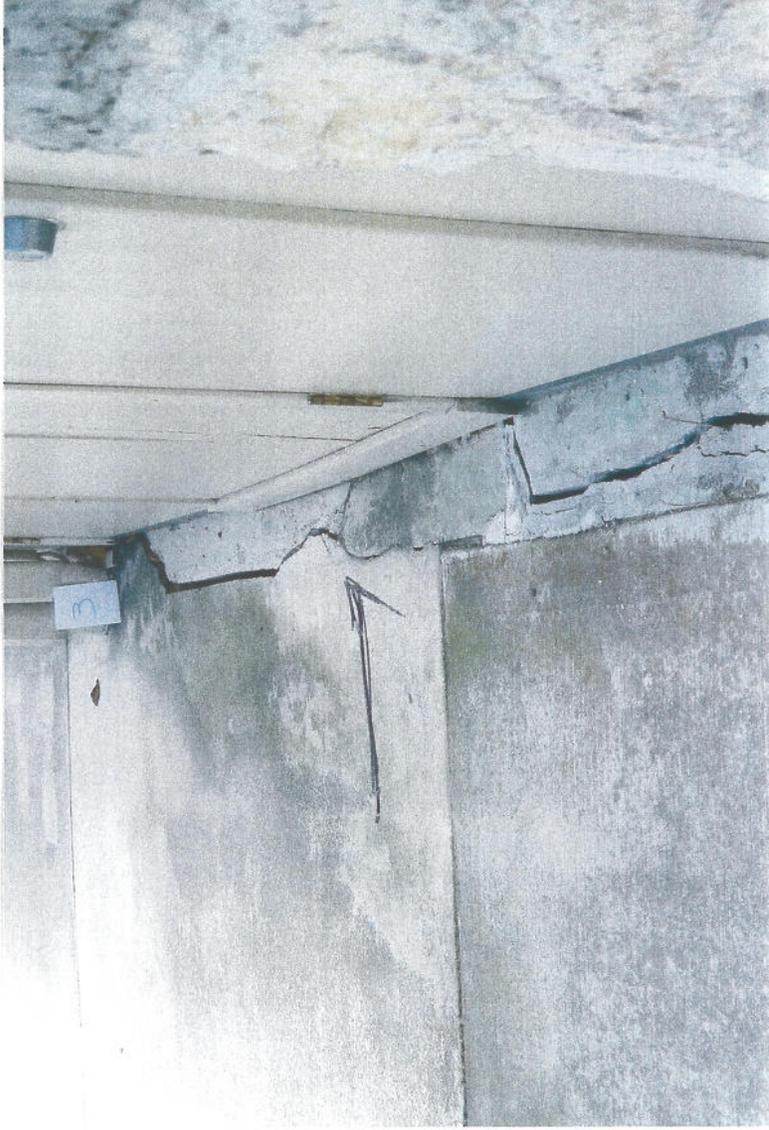
NEW MOVEMENT NEAR GARDEN
HOUSE. WAYFARER'S CHAPEL.

CRACK IN SLAB UNDER WALL.

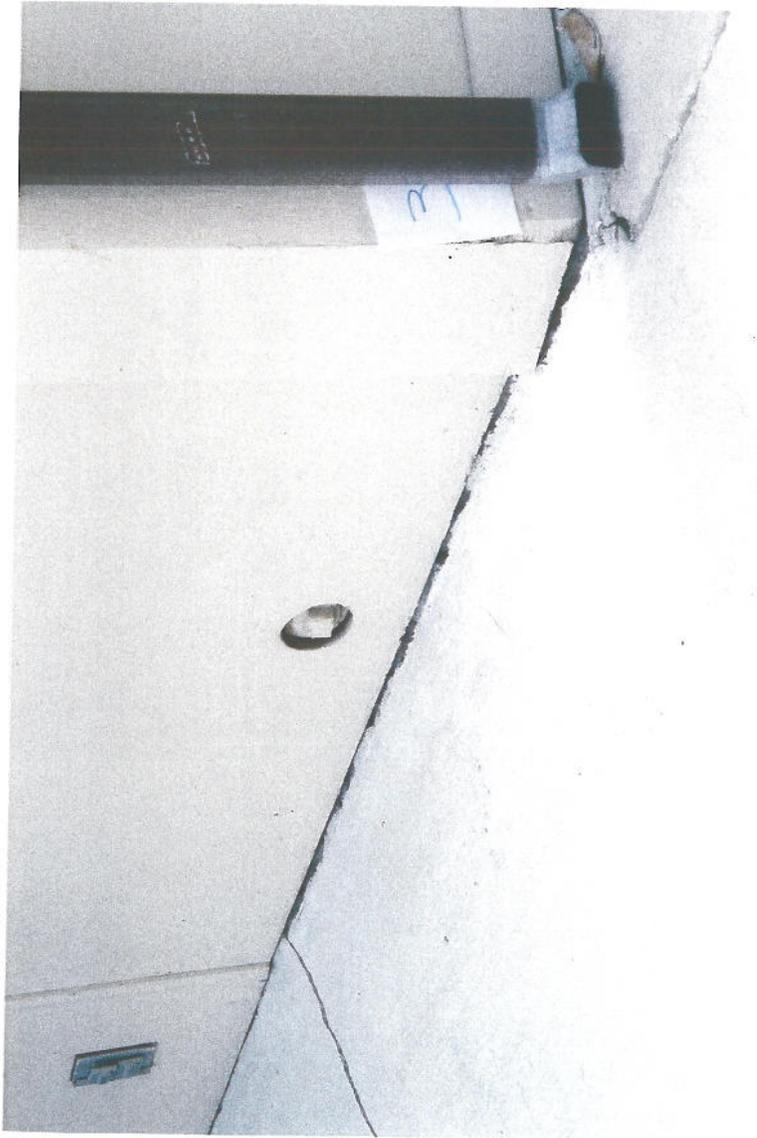
Wayfarer's Chapel - near
Garden House.

sidewalk pulling away from wall

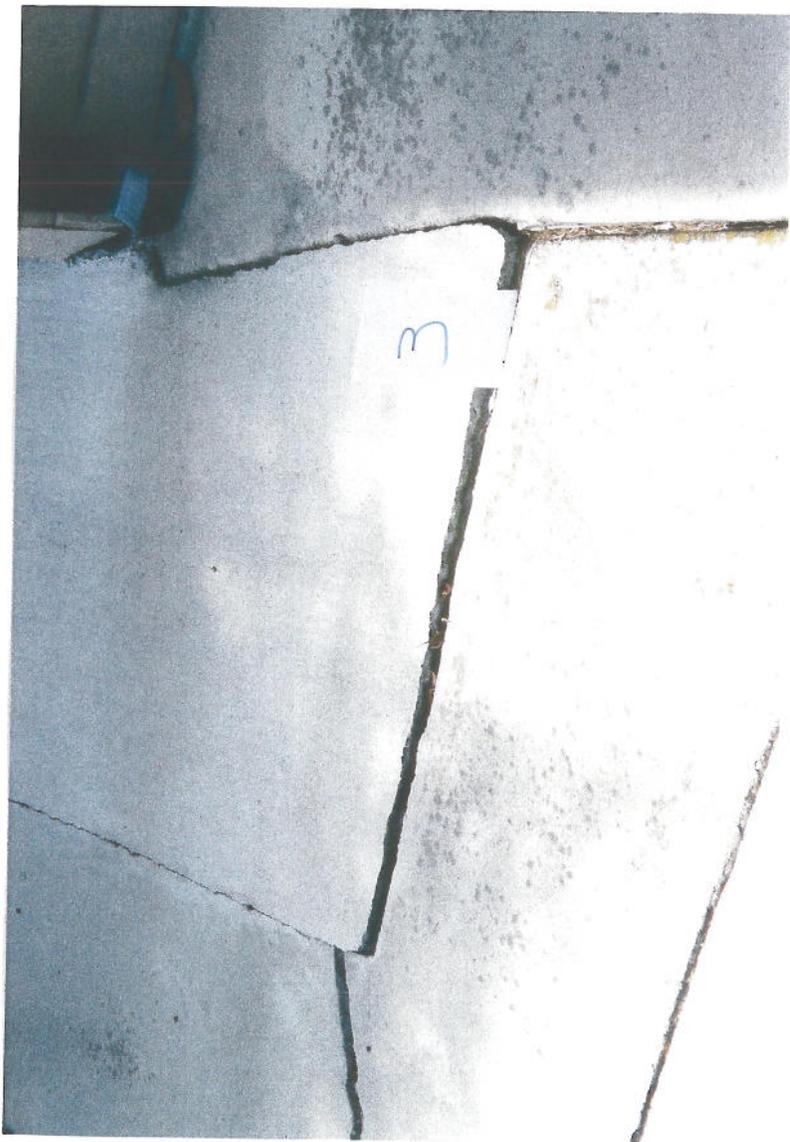
Wayfarer's Chapel
sidewalk outside small Bldg.

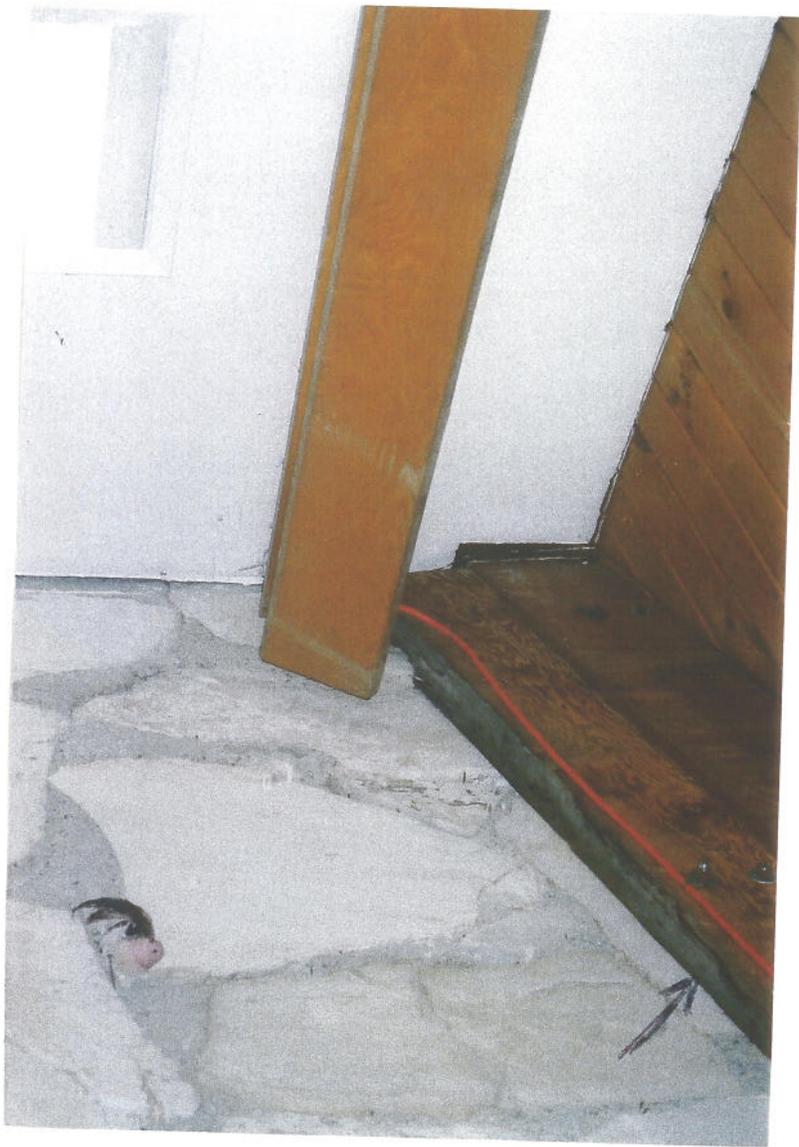
Bldg. at Wayfarer's Chapel
Crack in step.

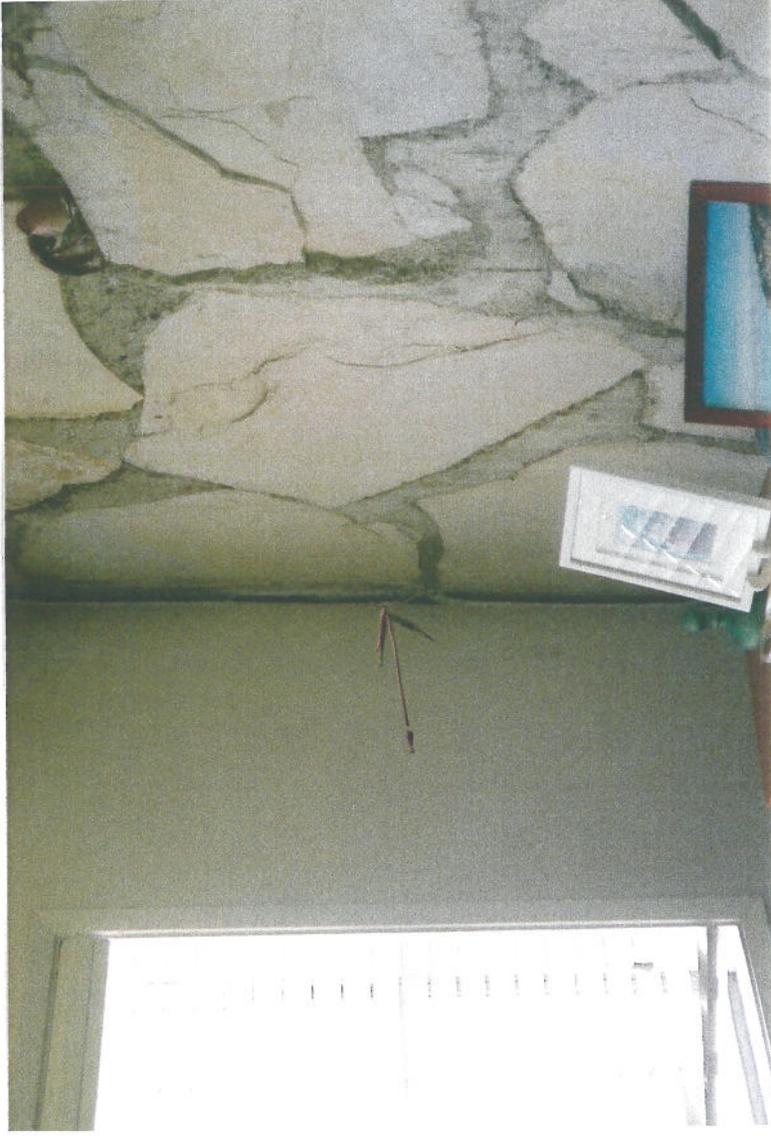
Bldg. at Wayfarer's Chapel
wall peeling away

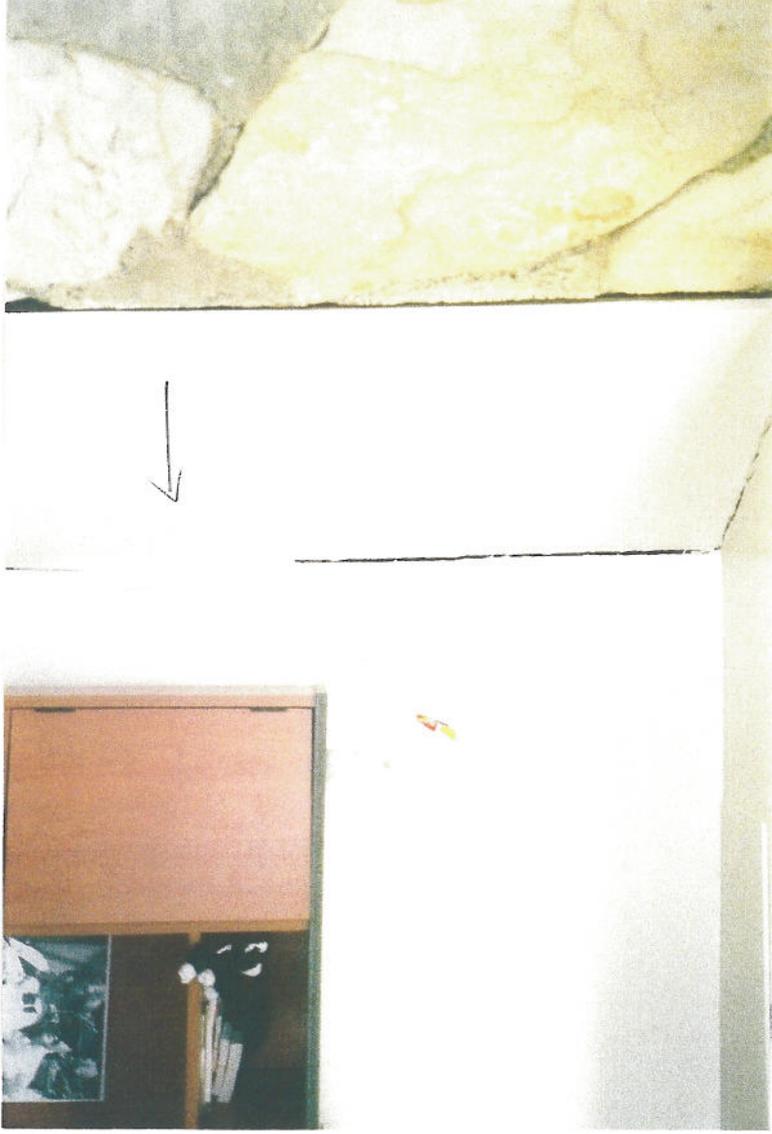
Bldg. at wayfare's Chapel
walls pulling away.

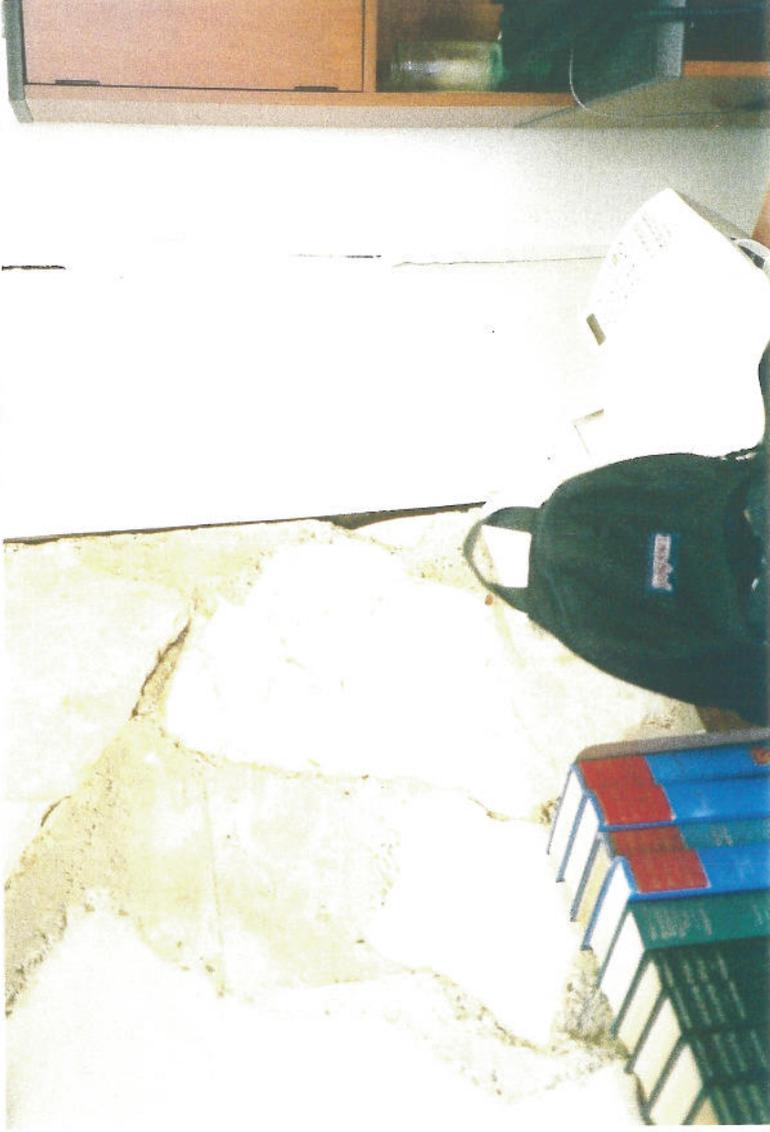
22

Blkg. at Wayfarer's Chapel
walls falling away.
