August 1, 2006

PN 97082-1485

Subject: Summary of Site Observations and Cursory Review of Site Conditions, Abalone Cove Landslide Area, Rancho Palos Verdes, California

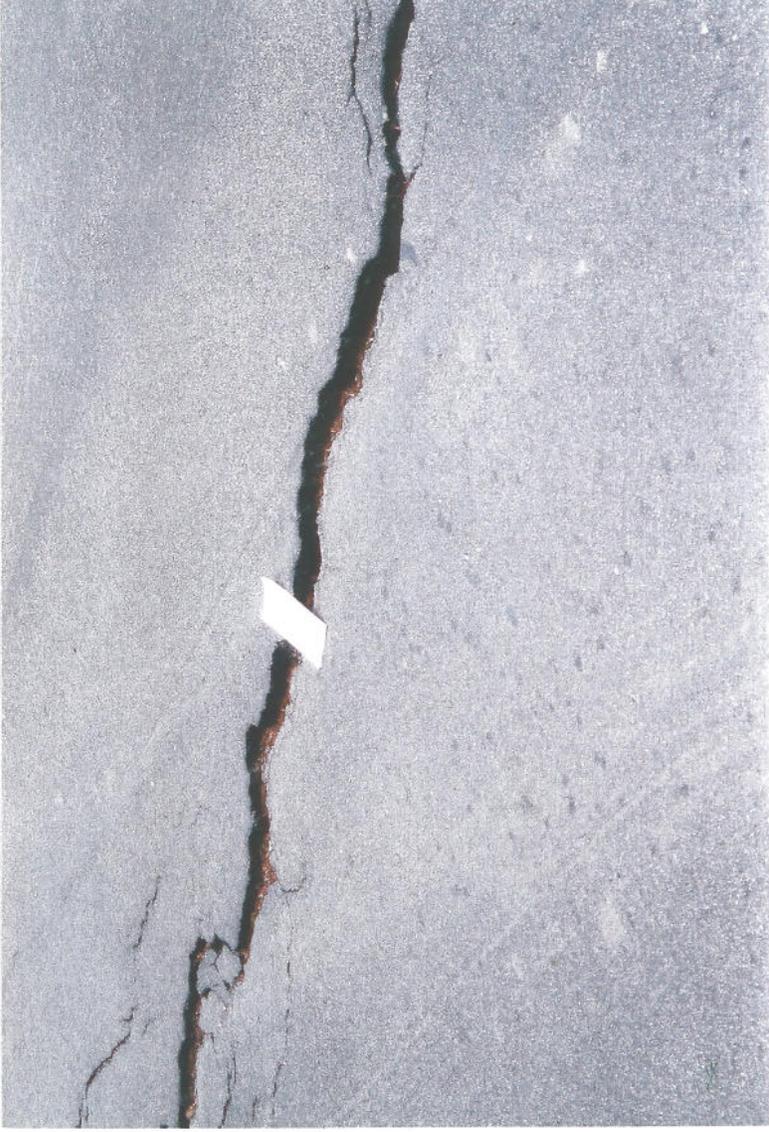
23

ALTAMIRA CANYON - LOWER
NARCISSE DR.

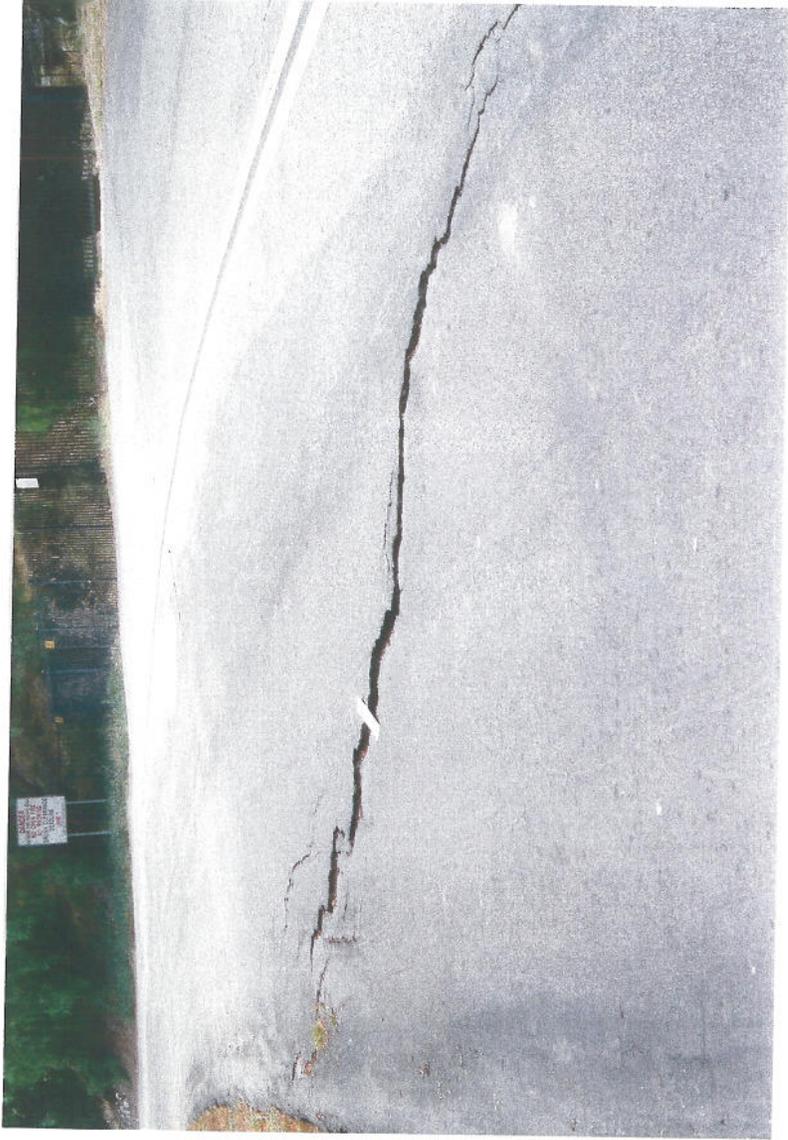
24

HOWER NARCISSA DR. NEAR ALTAMIRAS CANYON
ON JULY 24, '06

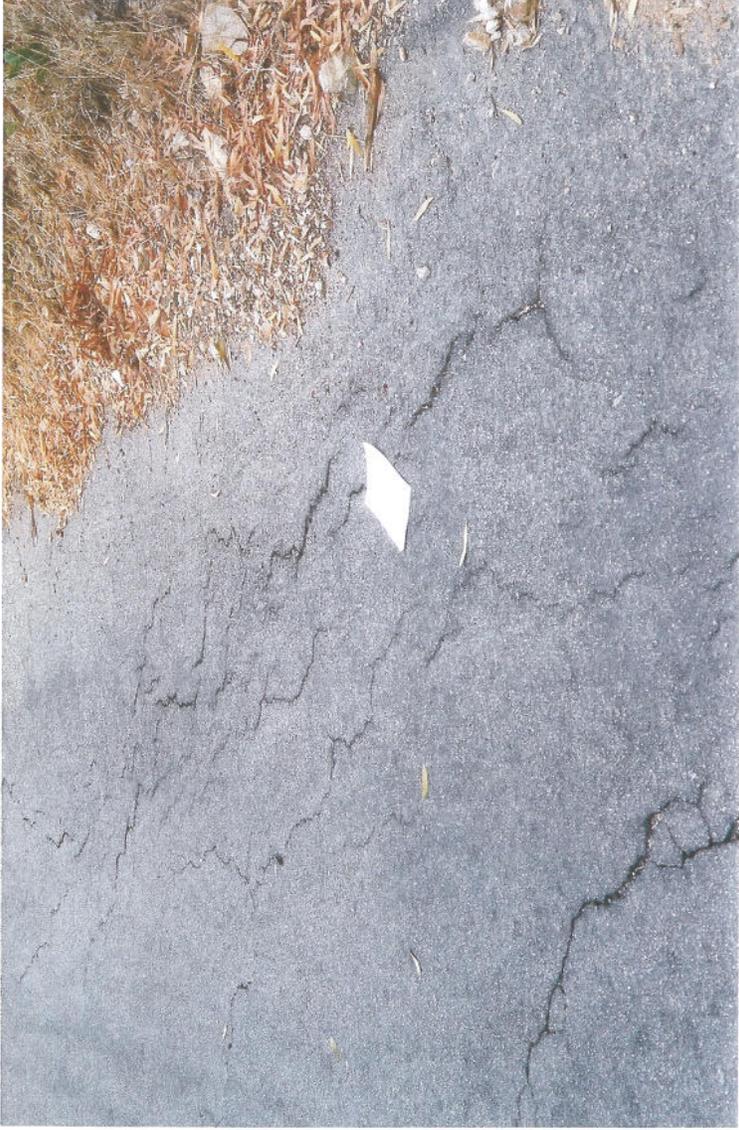
ROAD BREAKING ON RIGHT SIDE OF
NARCISSA DR. NEAR ATAMING CANYON

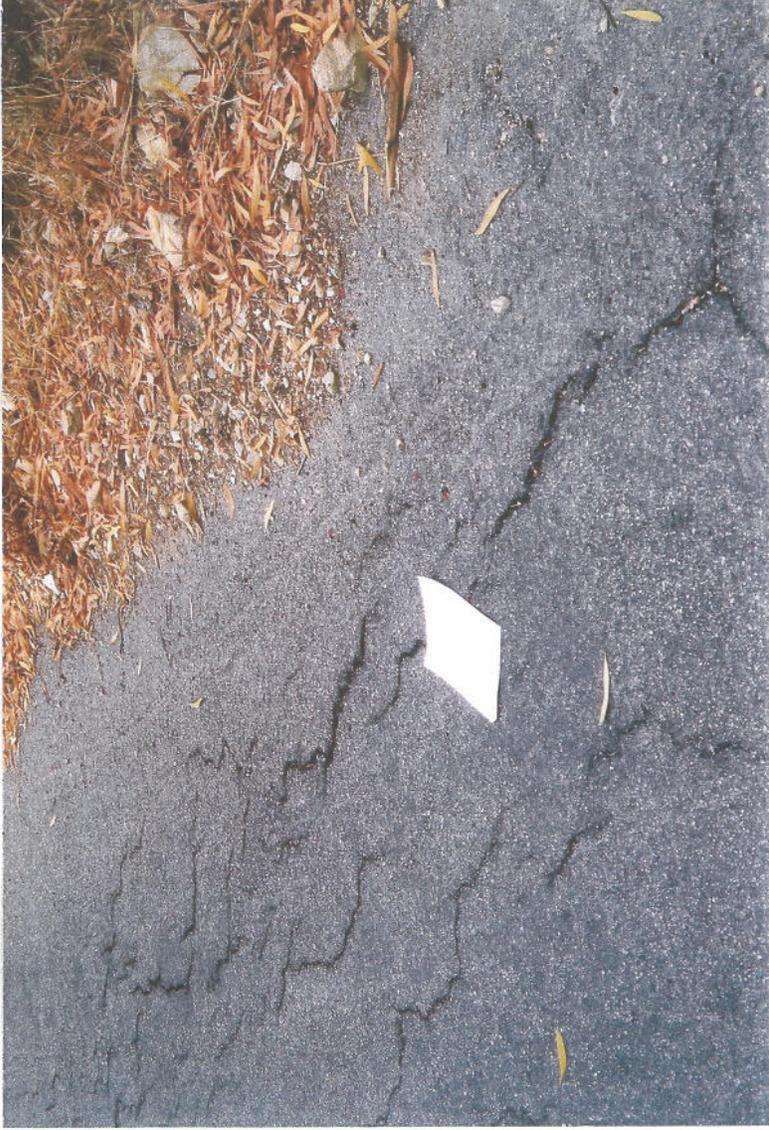
26

ROAD CRACKING ON NARCISSE DR.
ALTA MOUNTAIN
NEAR CANYON

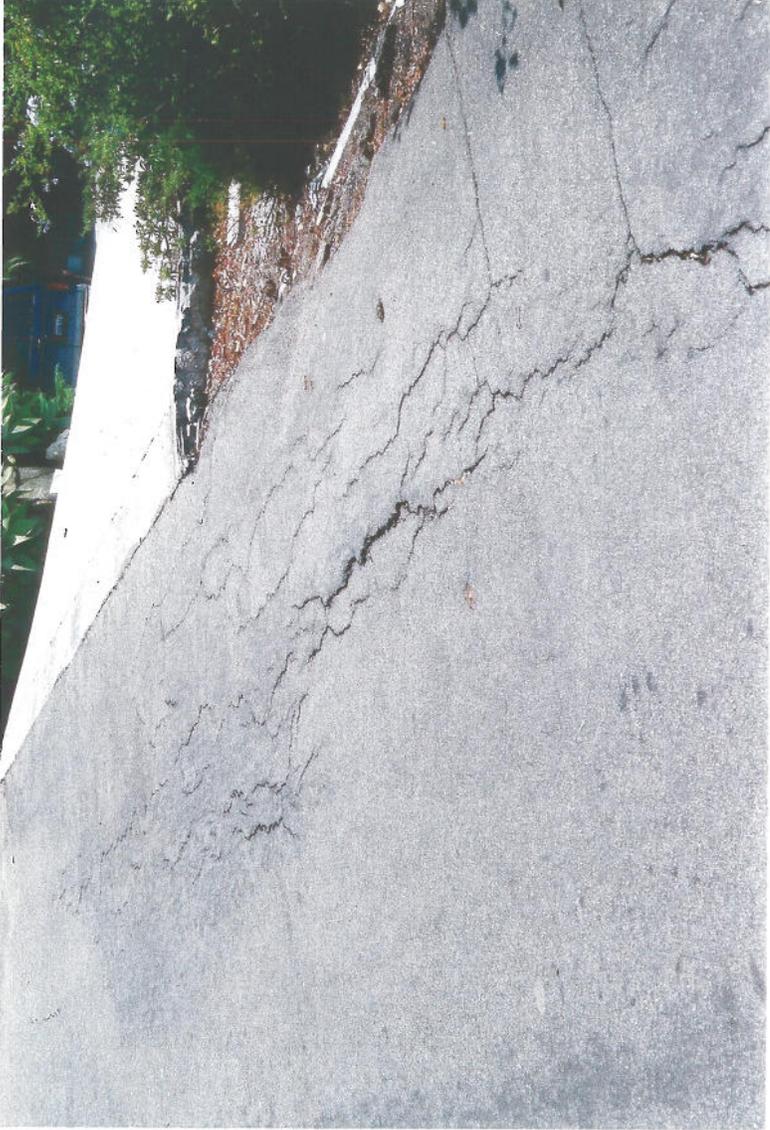
27

In echelon cracks

2 cinnamon - Weber Dürenberg

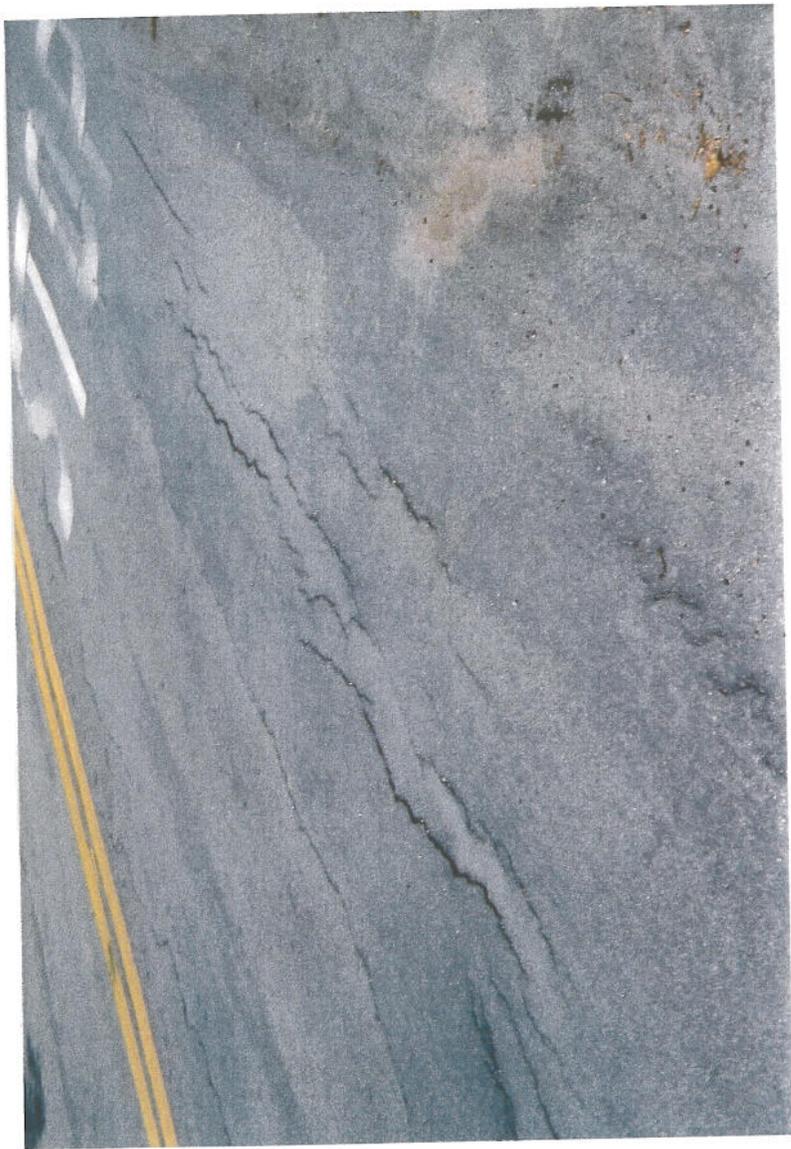
28

Cinnamon in front of #1
Looking toward Narcissa

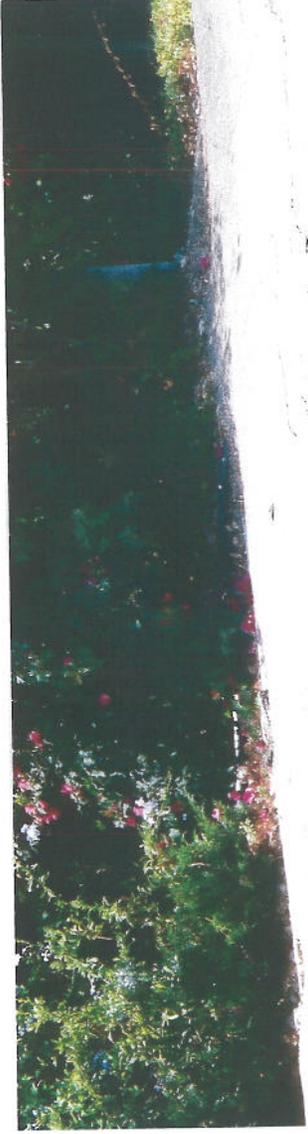
29

Narcissus - ~~near~~ near #28 Haven

Cracks on original scarp

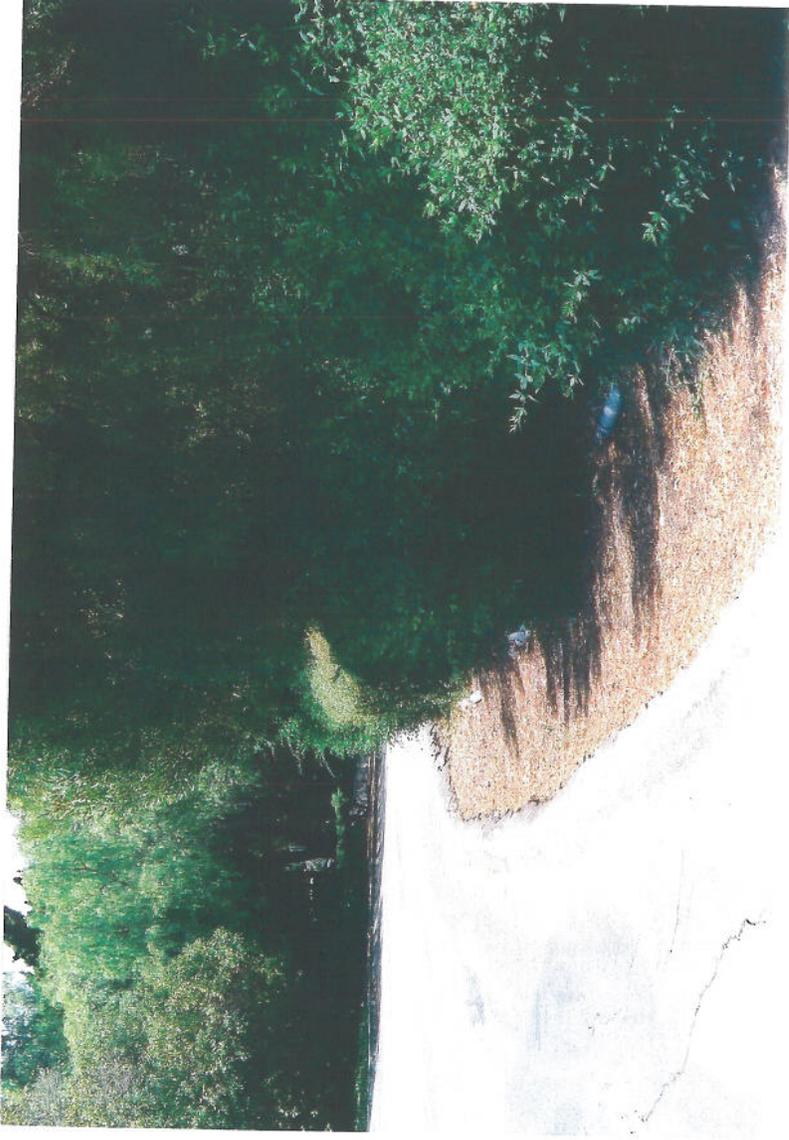
30

In front of 27 Navisca
The old scarp/offset

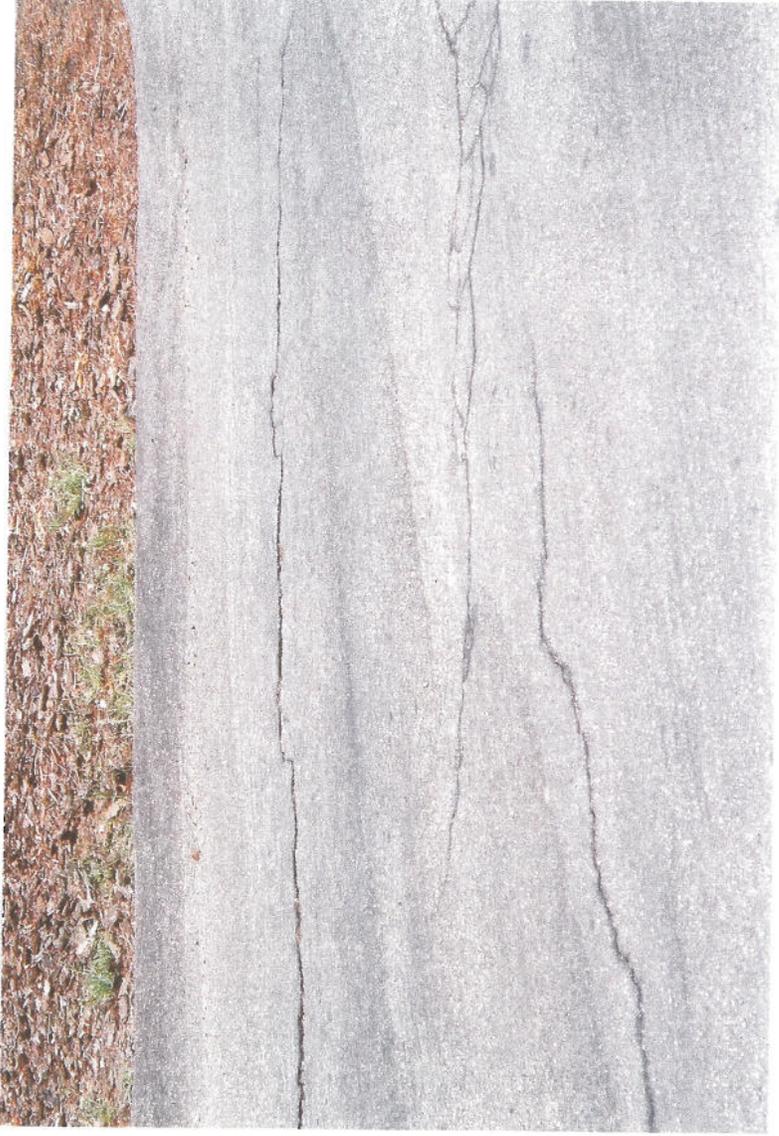
at Jester 20 Narcissia
near in echelon cracks

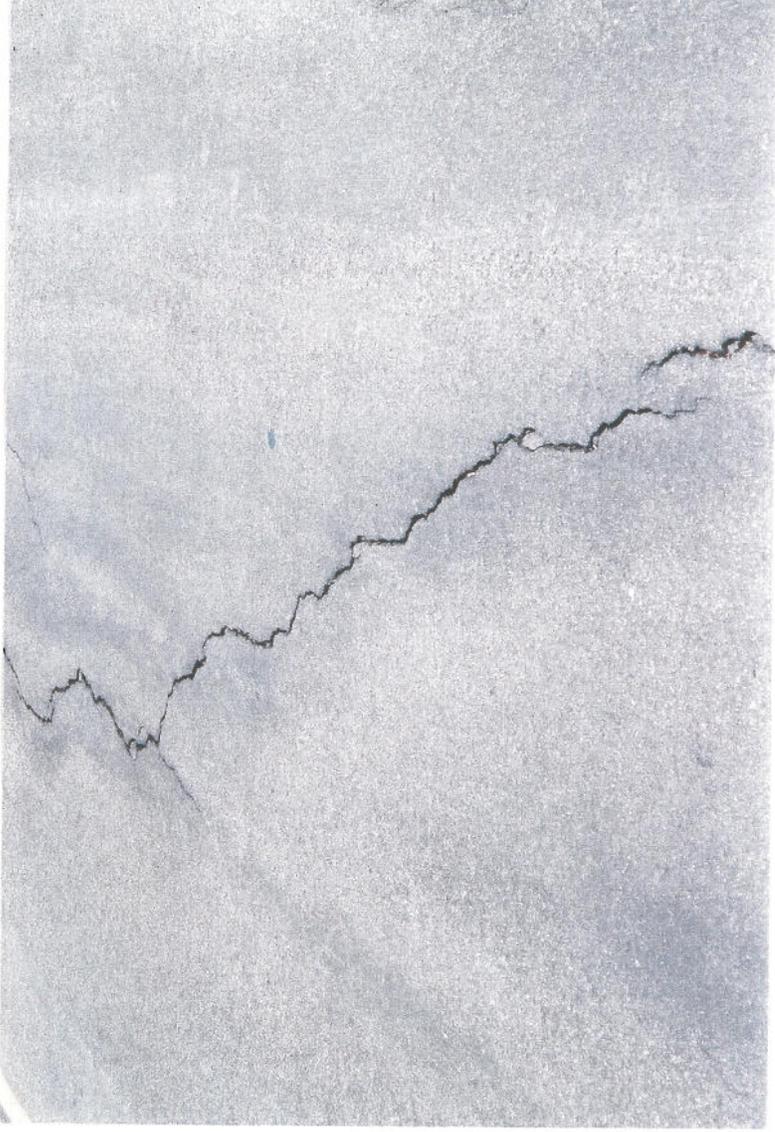
32

New open crack at 20 Navassa
fresh Movement

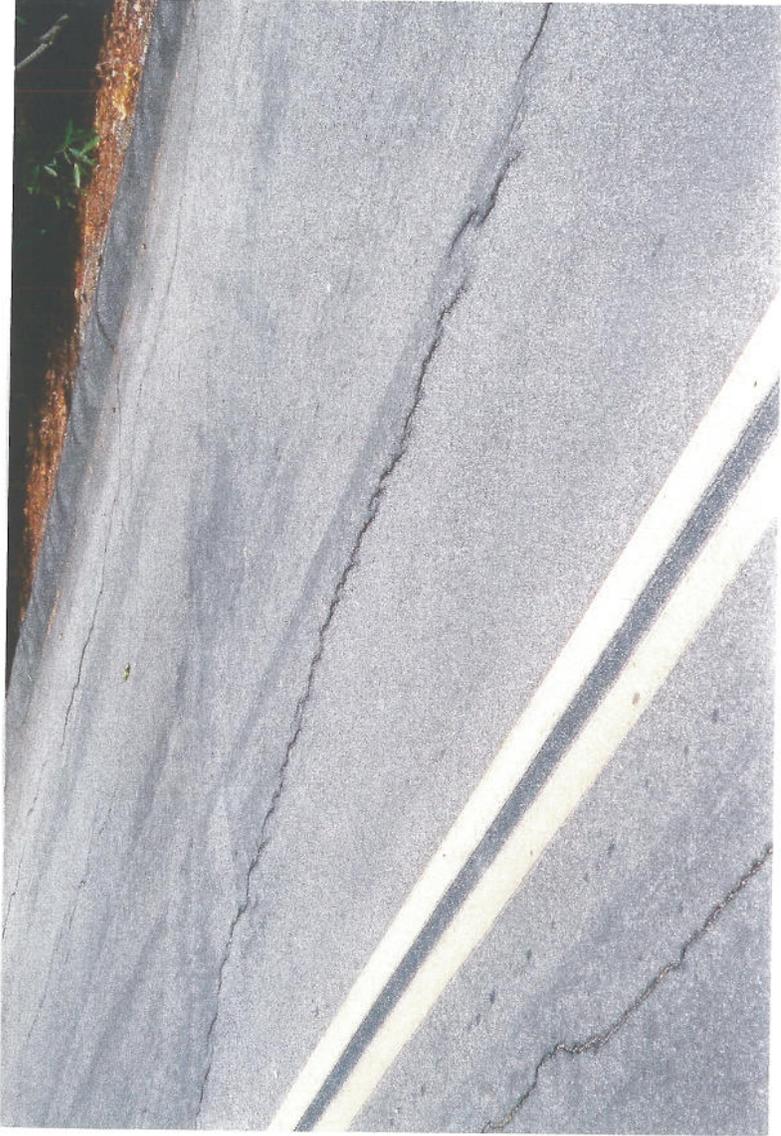
AT 16 Narcissa (Park)

wide new crack

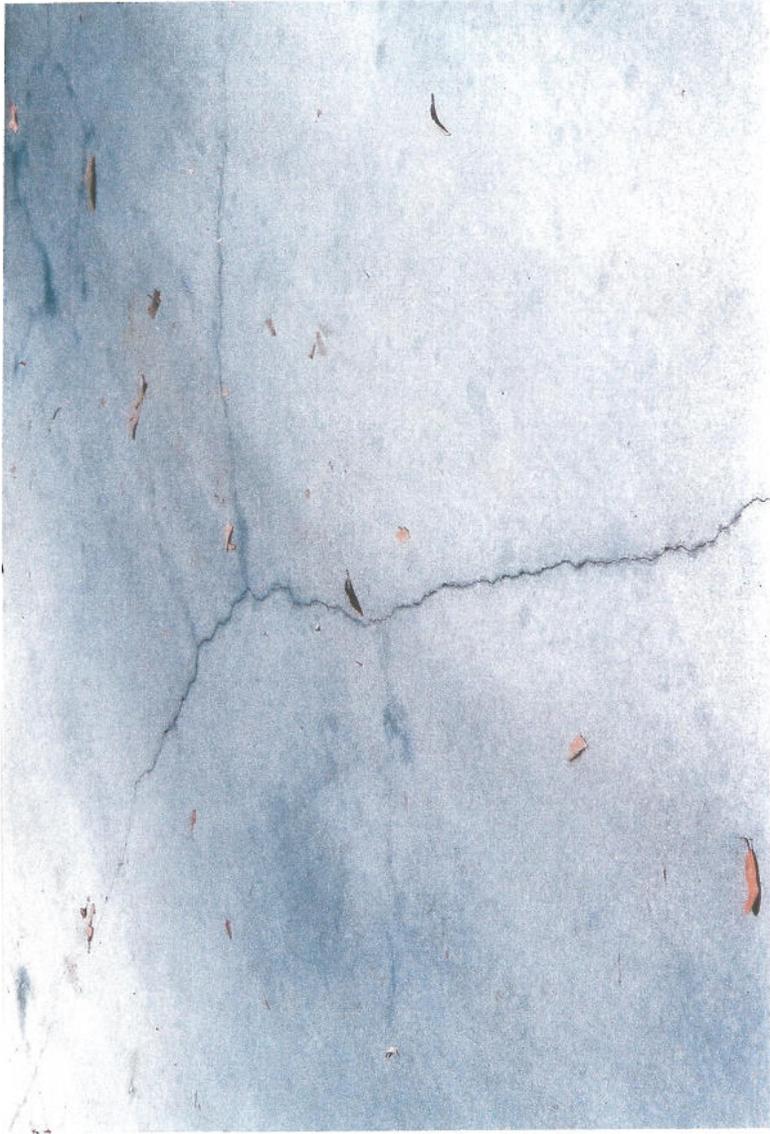
Reinforced Conc Driveway
at 16 Narissa (P&Ps)

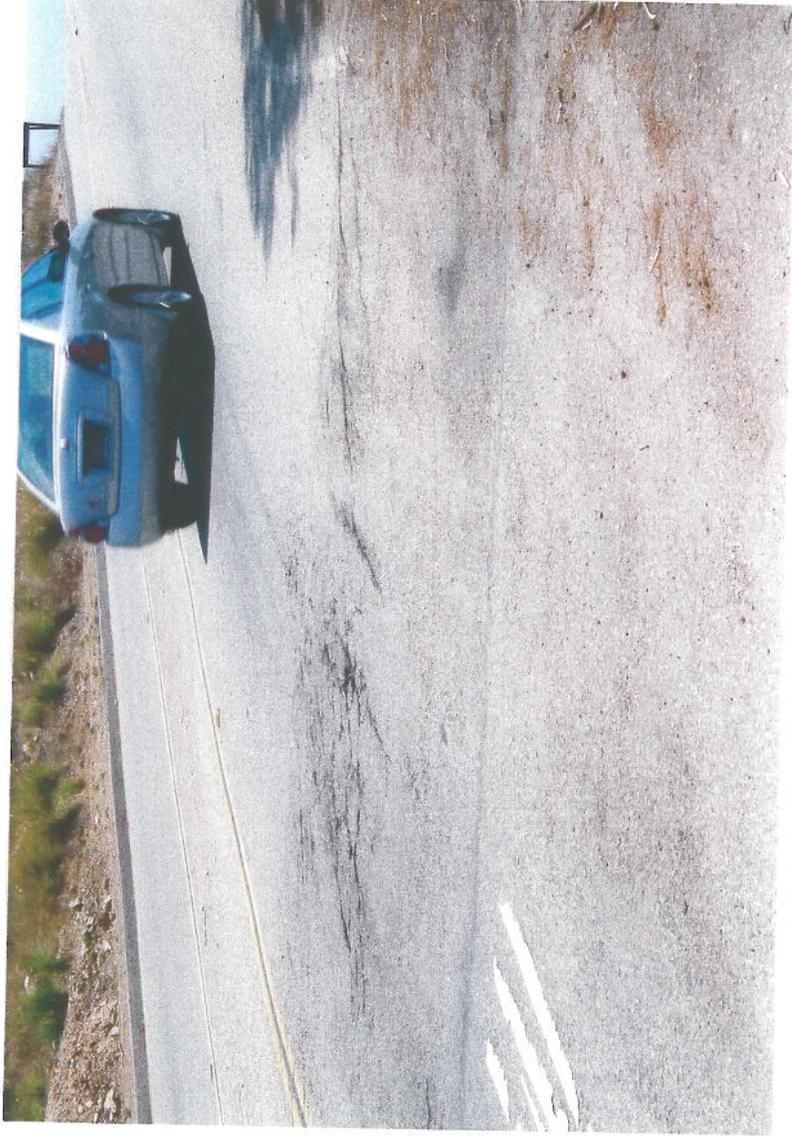
07/27/06 Potos Verde Drive South
Fresh cracks 200 feet east of
Nawassa at the main scarp of
Abelon Cove landslide and the stage
Portuguese Point

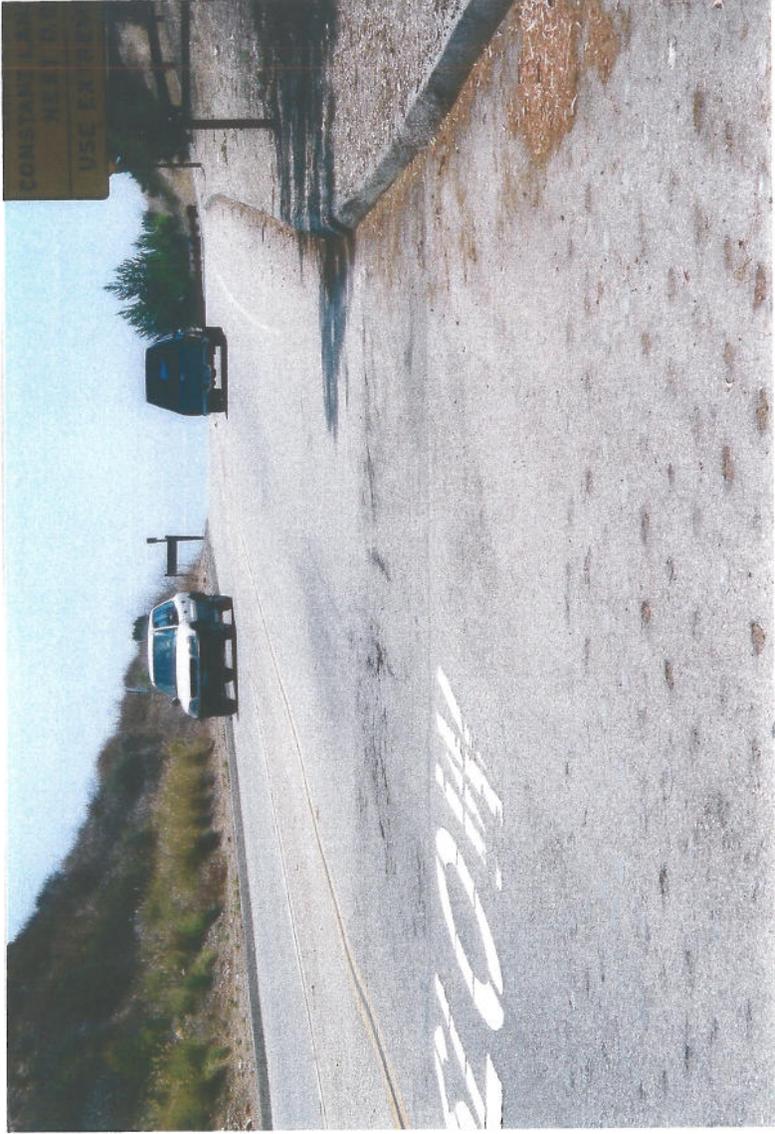
36

07/24/06 Polos Unidos Drive Santa
Contact between the Alcala Cove
Landslide and the Stark Portuguese
Point,

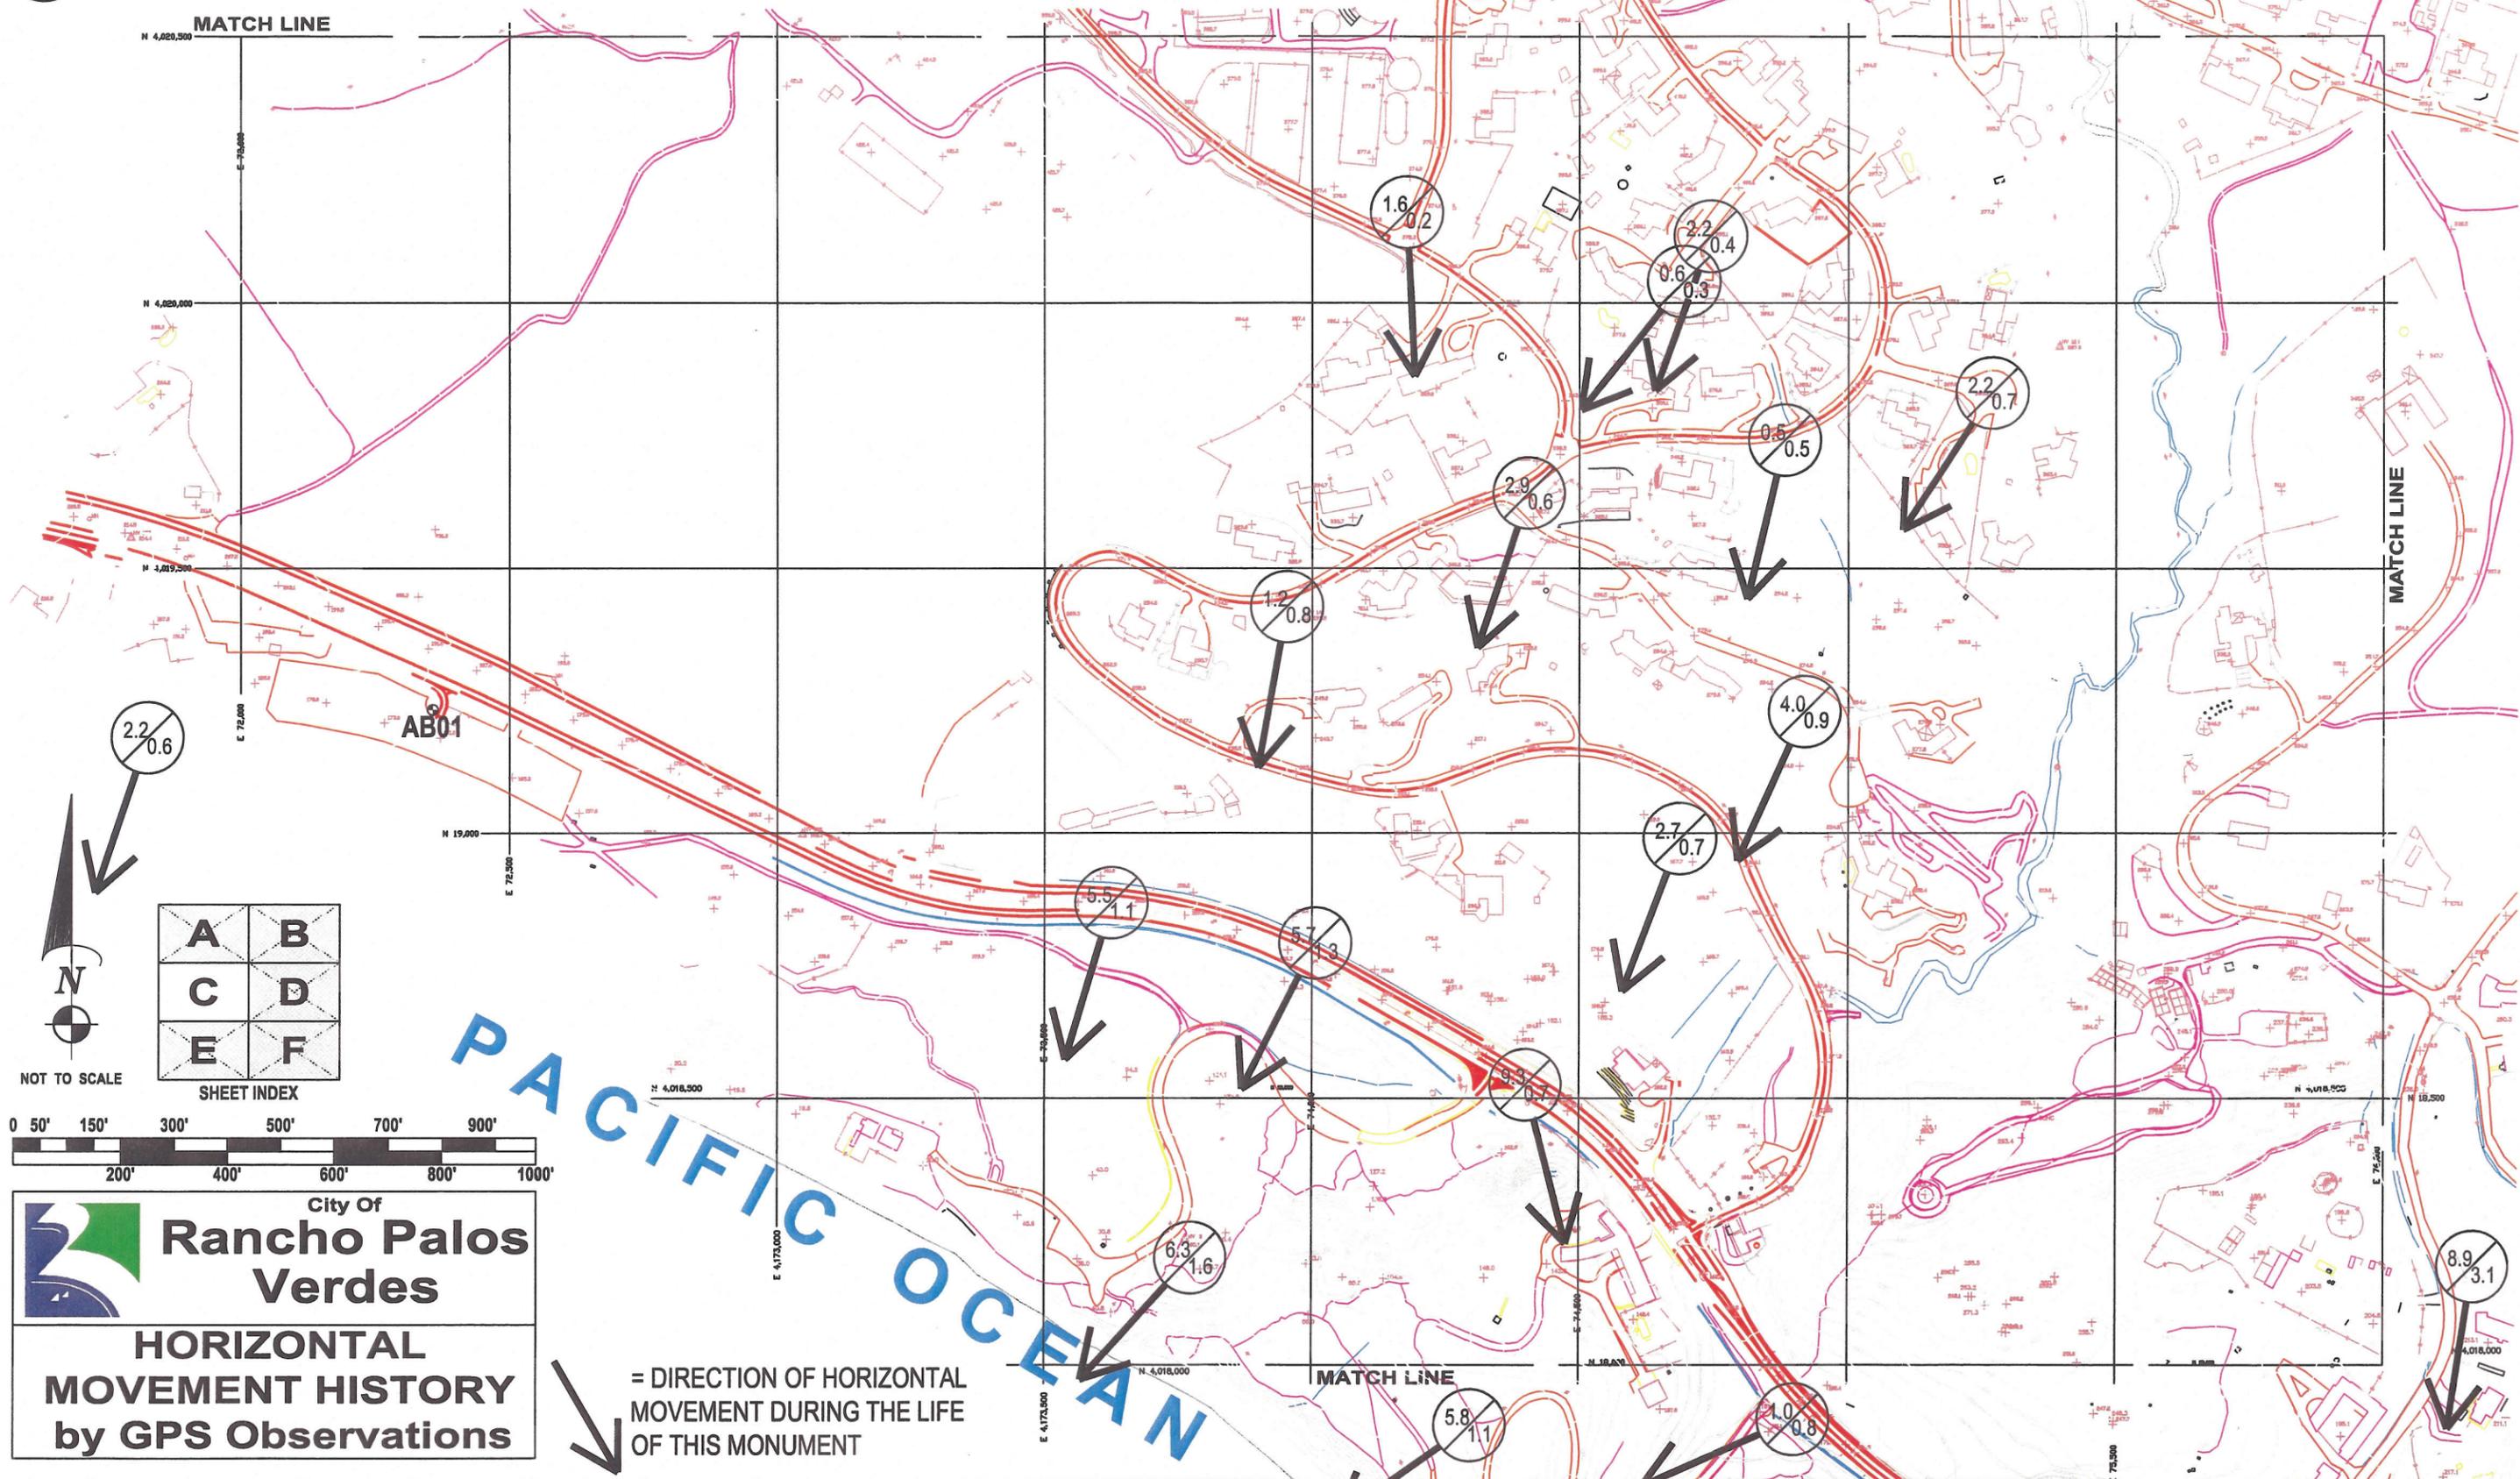
HORIZONTAL MOVEMENT HISTORY by GPS Observations

The horizontal movement recorded by GPS survey observations during 2005 within the area in question by Charles Abbott Associates, Inc. is consistent with the movement observed during our recent site visit. It is recommended that GPS survey observations be continued at a frequency of four quarterly readings per year. In addition, it is recommended that site observations of the general distress also be completed on a quarterly basis. It should be stressed to all involved that if a change in the current distress regime occurs, the city should be notified so that additional steps can be taken if warranted.
