March 14, 2006

PN 97082-1364

Subject: Evaluation of Recent Movement related to the Klondike Canyon Landslide, Rancho Palos Verdes, California.

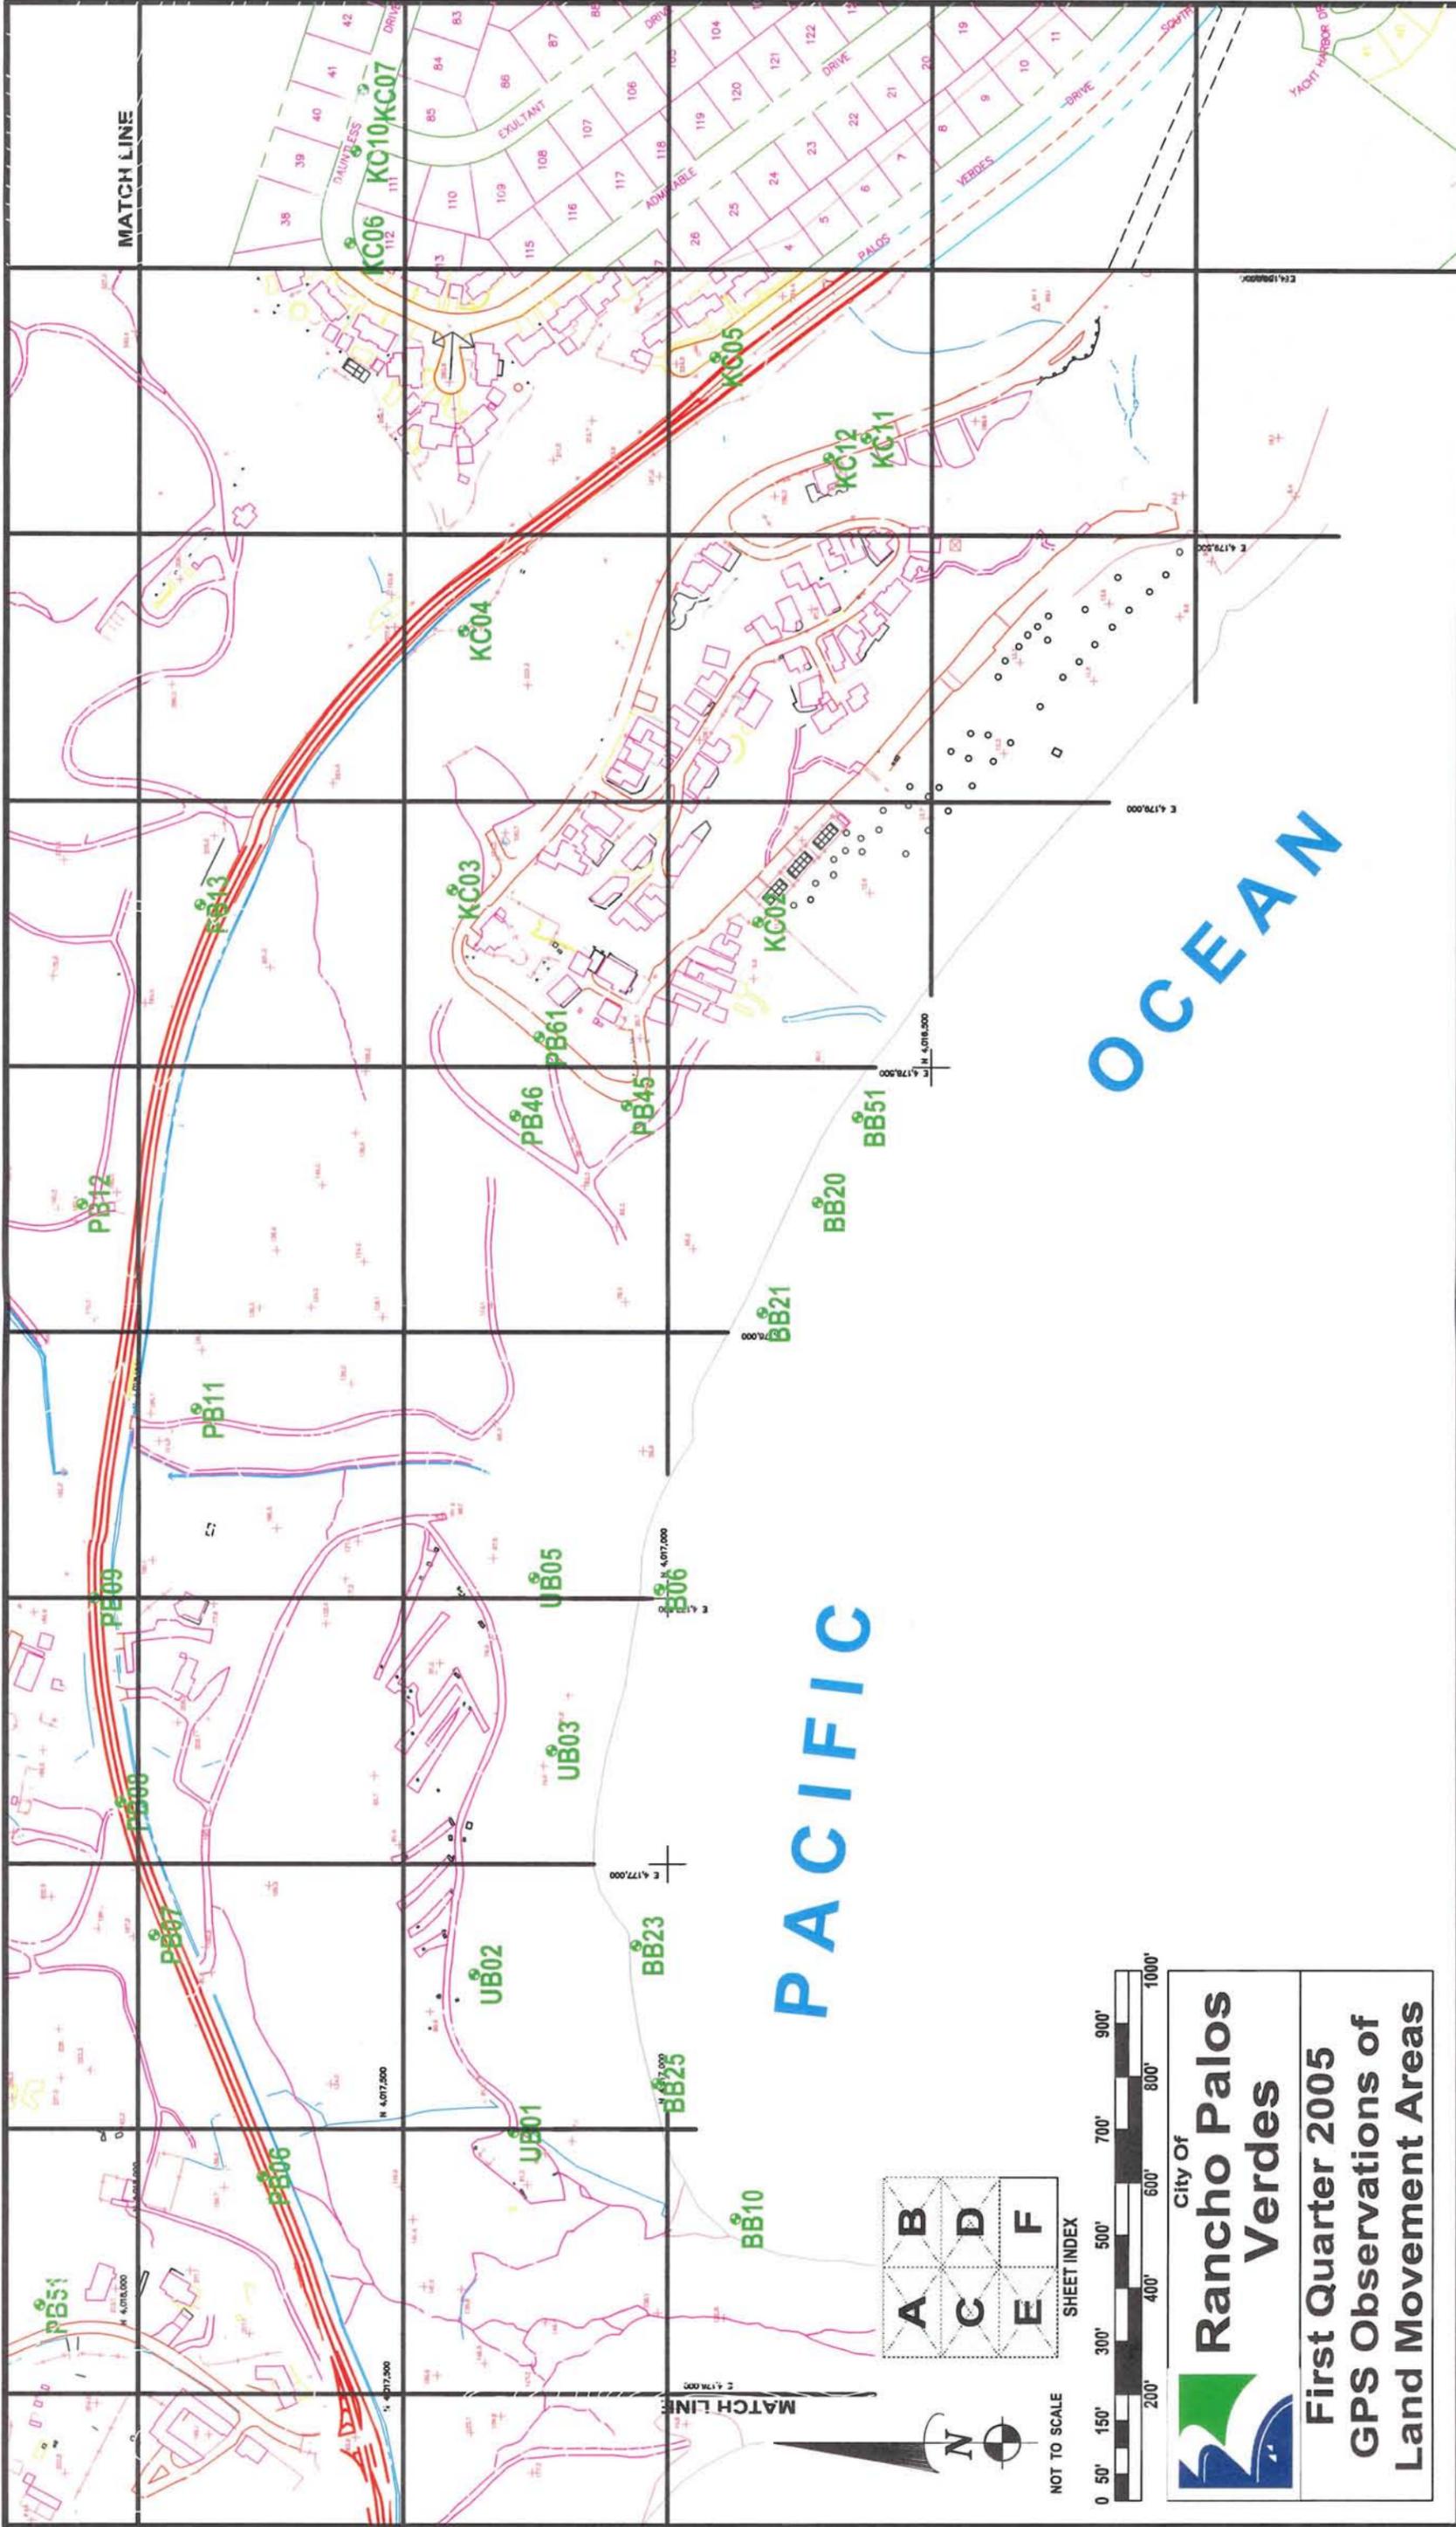
SHEET F

**First Quarter 2005
GPS Observations of
Land Movement Areas**

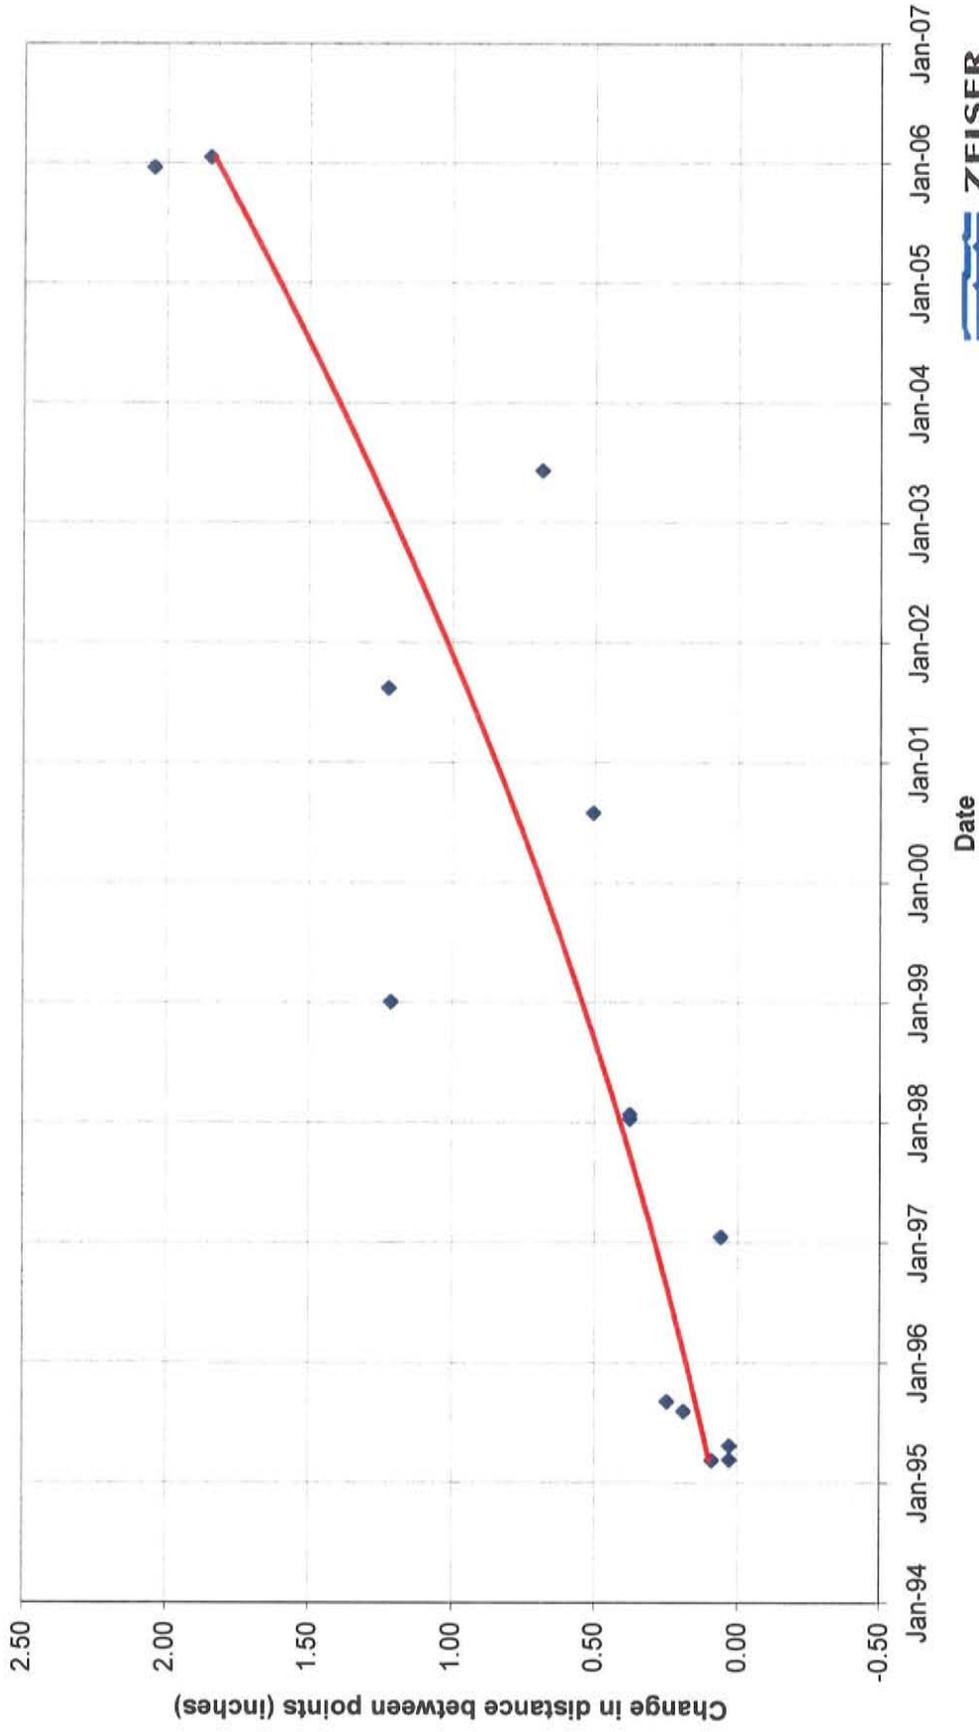
Figure 1

A set of monitoring points for the Klondike Canyon Landslide were established in late 1994 and early 1995 and have been monitored using global position satellites (GPS) since installation. The monitoring data was provided by Charles Abbott and Associates at the direction of the City of Rancho Palos Verdes Public Works Department. A review of the monitoring points indicate that the readings show abundant scatter, and appear to be within a range of potential survey error (due to thermal expansion, traffic disturbance, etc.). In order to more accurately evaluate the movement of the landslide, we have evaluated the distance between the individual monitoring points. Point KC07 is northeast of the recognized landslide headscarp and is therefore considered to be out of the zone subject to movement. Using KC07 as a base point, we have compared the distance over time between KC07 and other monitoring points. In order to further reduce the error from one reading to another, we have evaluated the cumulative change in distance between points over time (see Figures 1 through 4). The distance between points has

increased over time for all the points evaluated which indicates continued movement of the landslide. In addition, the graph of distance versus time over the past 11 years plots generally as a straight line indicating relatively continuous movement throughout the monitoring period. Vertical differences were not observed in the data beyond the precision of the survey.

Klondike Canyon Landslide Area Cumulative Change in Distance KC6 vs. KC7

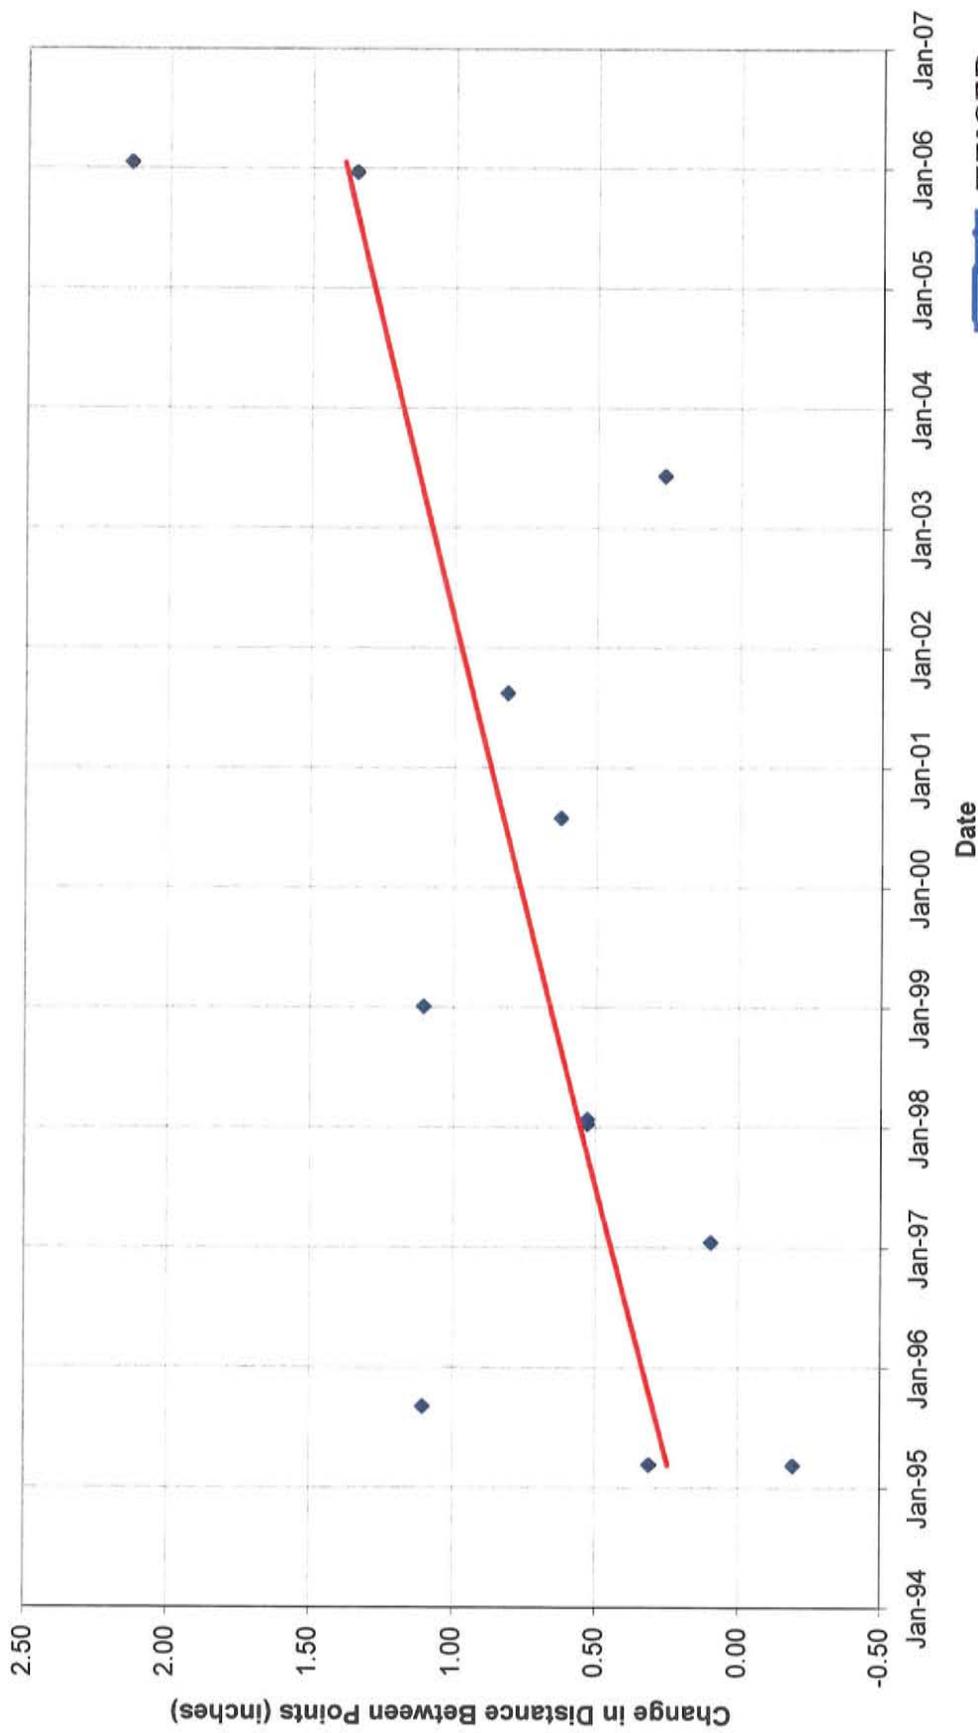
Figure 2

**Klondike Canyon Landslide Area
Cumulative Change in Distance
KC5 vs. KC7**

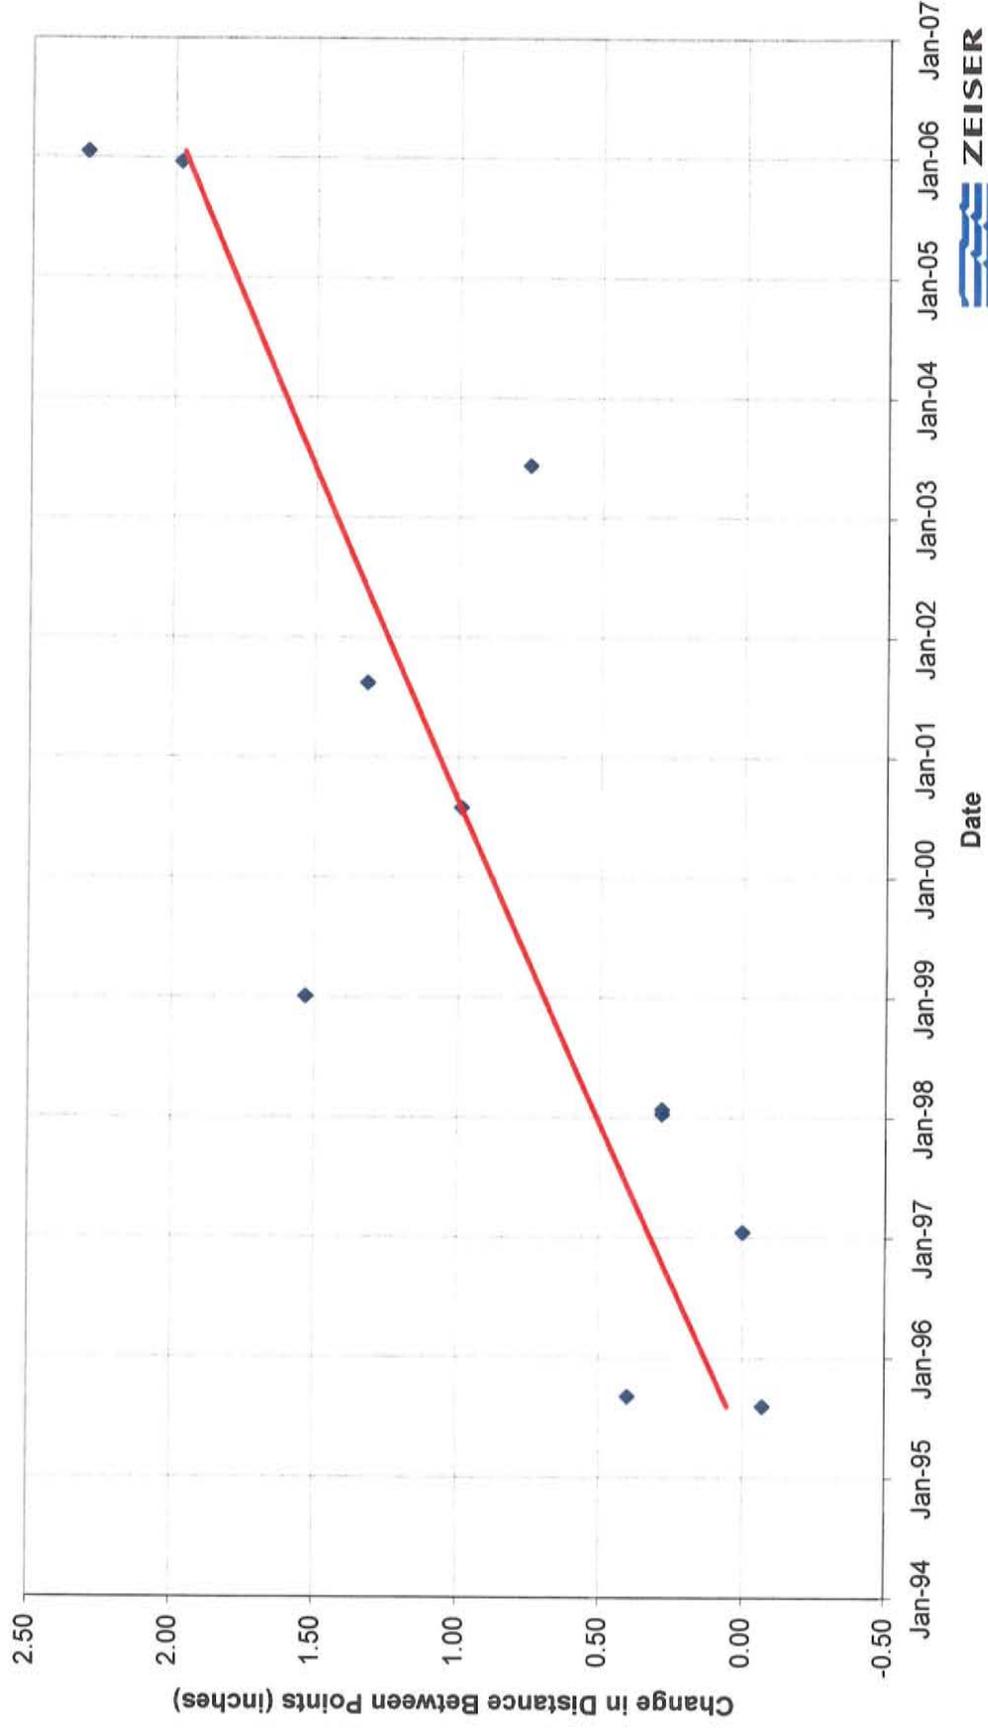
Figure 3

**Klondike Canyon Landslide Area
Cumulative Change in Distance
KC4 vs. KC7**

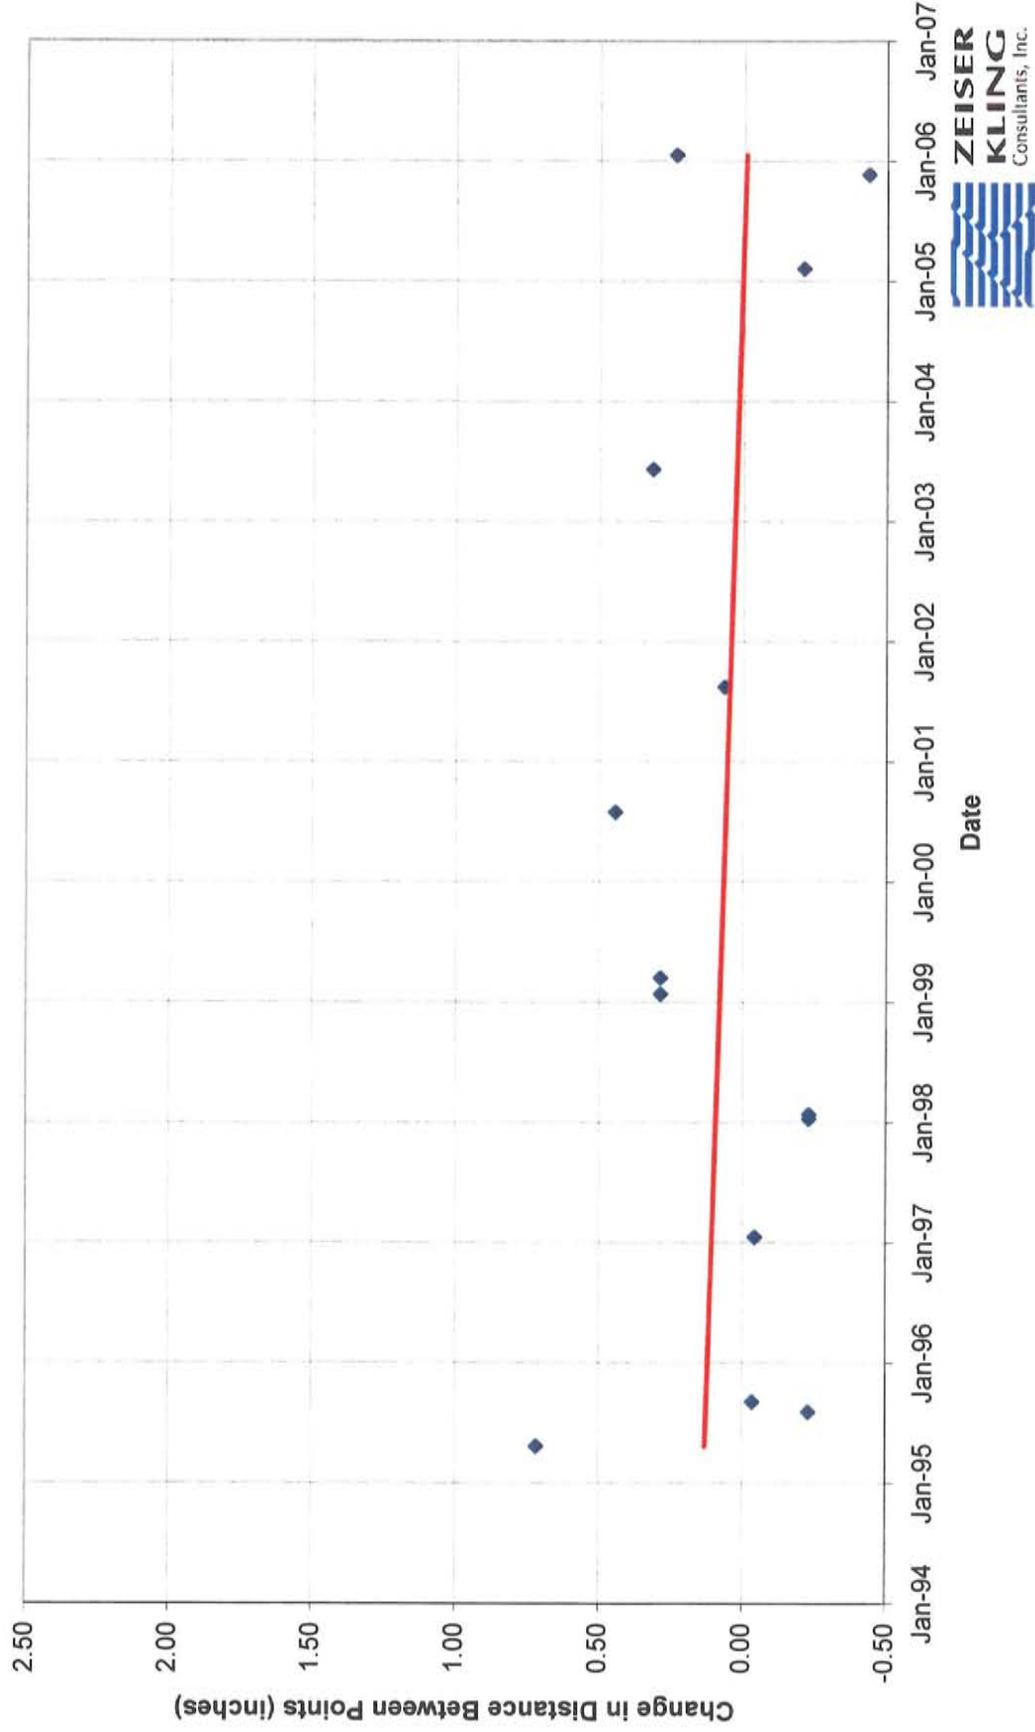
Figure 4

**Klondike Canyon Landslide Area
Cumulative Change in Distance
KC4 vs. KC6**
