City of Rancho Palos Verdes
 Rancho Palos Verdes ADA Assessment
 Facility Report with Photos

Facility ID: # 02A - City Hall Grounds

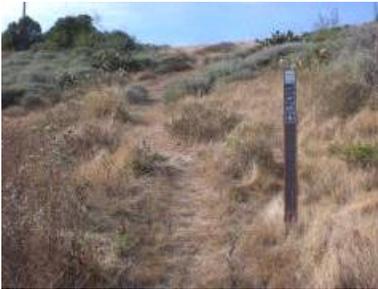
Location: South Spur Trail
 Photo # 1

Field Condition	
30.08 - Maintenance of Accessible Trail - Title II Entity - Accessible trail is not in operable working condition. (28 CFR 35.133)	1991 ADAAG -
Existing Condition: Landscape on trail.	2004 ADAAG -
	2007 CBC 1101B.3
	Other 28 CFR 35.133

Corrective Action
027 - Site Work - Miscellaneous - See Additional Comments
Additional Comments: See keynote 2 for corrective action.

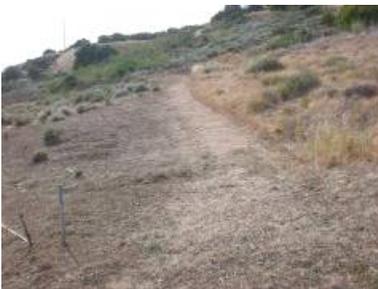
Location: South Spur Trail
 Photo # 2

Field Condition	
30.10C - Trail Segment - Cross Slope - Cross slope of the trail segment exceeds 1:20.	1991 ADAAG -
Existing Condition: 22.5%, 13.5%, 14.2%, & 24.4%	2004 ADAAG -
	2007 CBC -
	Other 1999 ADAAG-16.2.7.1

Corrective Action
015C - Decomposed Granite Trail - New decomposed granite outdoor recreation access route (area as shown on the drawings). Slope along the POT shall conform to the following: PercentSlope//MaximumLength//RestInterval ; 0% - 5.0% // No Restriction // No Restriction ; 5.1% - 8.33% //
Additional Comments:

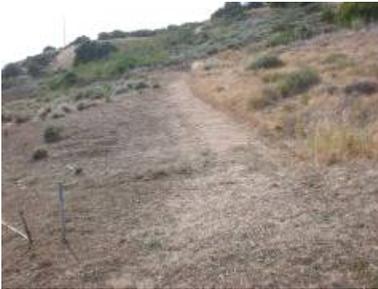
Location: South Spur Trail
 Photo # 2

Field Condition	
30.10E - Trail Surface - The surface of the trail is not firm or stable.	1991 ADAAG -
Existing Condition: Loose dirt & landscape.	2004 ADAAG -
	2007 CBC -
	Other 1999 ADAAG-16.2.1

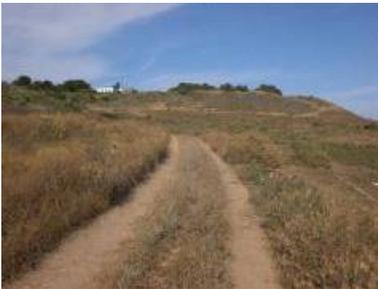
Location: Alta Vicente Trail
 Photo # 4

Field Condition	
30.08 - Maintenance of Accessible Trail - Title II Entity - Accessible trail is not in operable working condition. (28 CFR 35.133)	1991 ADAAG -
Existing Condition: Landscape on trail.	2004 ADAAG -
	2007 CBC 1101B.3
	Other 28 CFR 35.133

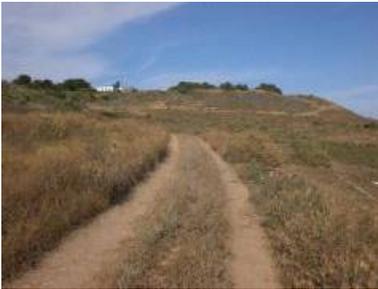
Location: Alta Vicente Trail
Photo # 4

Field Condition	
30.10B - Trail Resting Space - Resting space does not comply with 1999 ADAAG Section 16.2.8 (Resting intervals shall be 60" min. in length, shall have a width at least as wide as the trail and have a slope of 5% or less in any direction. The installation of resting spaces is required as follows: Percent slope, maximum length, Rest interval: 0% to 5.0%, No restriction, No restriction; 5.1% to 8.33%, 200', Every 200'; 8.34% to 10%, 30', Every 30'; 10.1% to 12%, 10', Every 10'.)	1991 ADAAG - 2004 ADAAG - 2007 CBC - Other 1999 ADAAG-16.2.7.2; 16.2.8
Existing Condition:

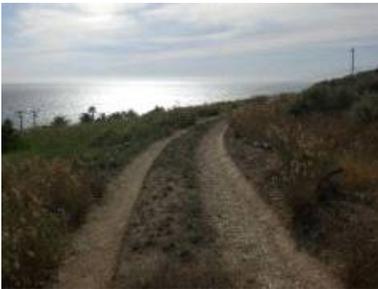
Location: Alta Vicente Trail
Photo # 7

Field Condition	
30.10C - Trail Segment - Cross Slope - Cross slope of the trail segment exceeds 1:20.	1991 ADAAG - 2004 ADAAG - 2007 CBC - Other 1999 ADAAG-16.2.7.1
Existing Condition: 12.4%, 5.3%, 20.9%, 11.5%, 16.8%...

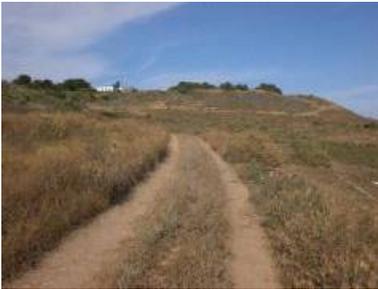
Location: Alta Vicente Trail
 Photo # 4

Field Condition	
30.10D - Clear Tread Width of Trail - The clear tread width of the trail is not 36" min., except the width may be reduced to 32" where existing conditions cannot be mitigated.	1991 ADAAG -
Existing Condition: 30" clear varies.	2004 ADAAG -
	2007 CBC -
	Other 1999 ADAAG-16.2.2

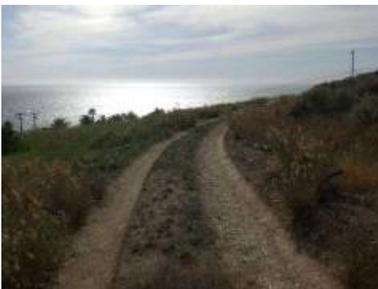
Location: Alta Vicente Trail
 Photo # 7

Field Condition	
30.10E - Trail Surface - The surface of the trail is not firm or stable.	1991 ADAAG -
Existing Condition: Loose dirt & landscape.	2004 ADAAG -
	2007 CBC -
	Other 1999 ADAAG-16.2.1

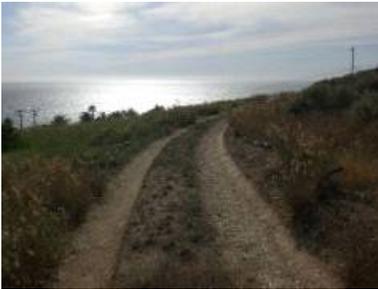
Location: Alta Vicente Trail
 Photo # 7

Field Condition	
30.11F - Trails - Passing Space - Where the width of the trail is less than 60", passing spaces measuring 60" x 60" are not provided at intervals of 1000' maximum.	1991 ADAAG -
Existing Condition:	2004 ADAAG -
	2007 CBC -
	Other 1999 ADAAG-16.2.6

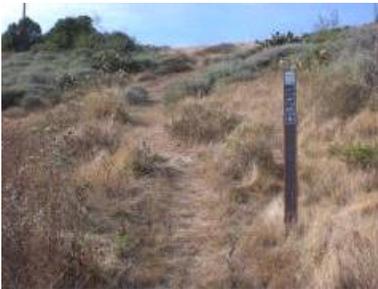
Location: Alta Vicente Trail
 Photo # 1

Field Condition	
30.11H - Trails - Signs - Trail complying with 1999 ADAAG Section 16.2 is not designated with a symbol at the trailhead and at designated access points. OR Signage has been provided but does not indicate the total distance of the accessible segment and the location of the first point of departure from the Section 16.2 requirements.	1991 ADAAG -
Existing Condition:	2004 ADAAG -
	2007 CBC -
	Other 1999 ADAAG-16.2.10

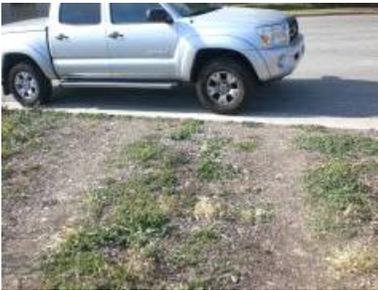
Location: Alta Vicente Trail
Photo # 12

Field Condition	
03A.15 - Other - Pedestrian Accessible Route (Public Right of Way) - See Additional Comments	1991 ADAAG -
Existing Condition: No compliant access to Trail Park.	2004 ADAAG -
	2007 CBC -
	Other -

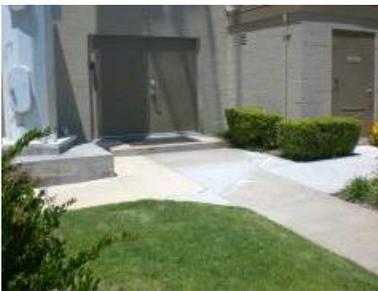
Location: SE. of Admin. Bldg.
Photo # 13

Field Condition	
03B.09 - Cross Slope - Cross slope of the accessible route of travel exceeds 1:50.	1991 ADAAG 4.3.7
Existing Condition: 3.4% & 4.7%	2004 ADAAG 403.3
	2007 CBC 1133B.7.1.3
	Other -

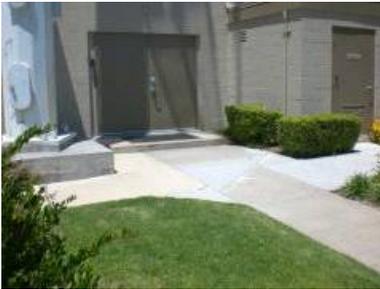
Field Condition	
03B.13 - > 1/2" Changes in Level - Curb ramps, ramps, or elevators are not used for changes in level greater than 1/2 inch. (Lifts may only be used in certain limited situations.)	1991 ADAAG 4.5.2
	2004 ADAAG 303.4
Existing Condition: 5" high step	2007 CBC 1124B.2
	Other -

Classification	
DOJ Location Type:	1
Use:	CP
Severity:	B
Level of Difficulty	Low to Moderate

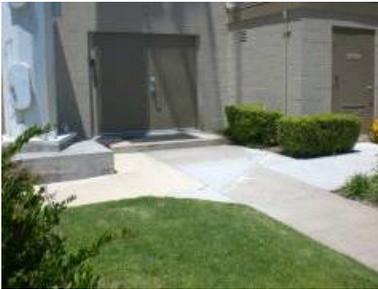
10.06A - Door Maneuvering Space - Door that is not automatic or power-assisted does not have compliant maneuvering space relative to the direction of approach as shown in CBC Fig. 11B-26. (Approach // Side // Width // Depth) (Front // Pull // D + 24" * // 60") (Front // Push // D + 0" ** // 48") (Latch // Pull // D + 24" // 60") (Latch // Push // D + 24" // 44" ***) (Hinge // Pull // D + 36" // 60") (Hinge // Push // 54" **** // 44" *****) (* D + 18" at interior doors.) (** D + 12" if door has both a latch and a closer.) (***) 48" if door has closer.) (**** Measured from latch toward hinge.) (***** 48" if door has both a latch and a closer.)

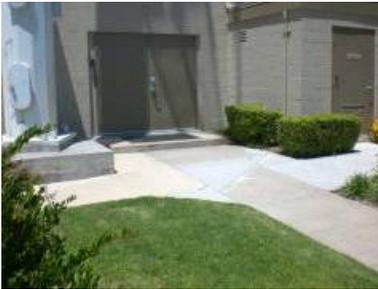
Location: SE. of Admin. Bldg. Photo # 16

Field Condition	
03B.09 - Cross Slope - Cross slope of the accessible route of travel exceeds 1:50. Existing Condition: 6.0%, 5.5% & 3.4% at turning point.	1991 ADAAG 4.3.7 2004 ADAAG 403.3 2007 CBC 1133B.7.1.3 Other -

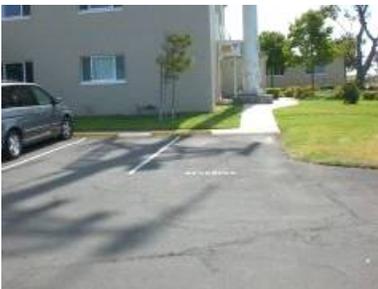
Location: SE. of Admin. Bldg. Photo # 17

Field Condition	
03B.11 - Ramps - This portion of an accessible route with a slope greater than 5% does not comply with the requirements for compliant ramps. Existing Condition:	1991 ADAAG 4.8.1 2004 ADAAG 405 2007 CBC 1133B.5 Other -

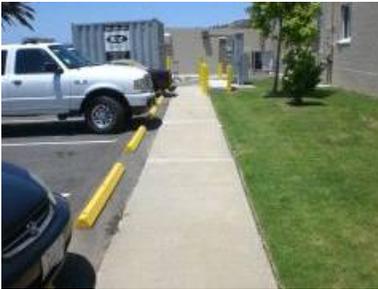
Location: Photo #
 W. of Admin. Bldg. 18

Field Condition	
03B.04 - Width - Accessible route of travel is less than 48" wide (note: 48" wide requirement does not apply to doorways or gates).	1991 ADAAG 4.3.3
Existing Condition: 47" wide	2004 ADAAG 403.5.1
	2007 CBC 1133B.7.1
	Other -

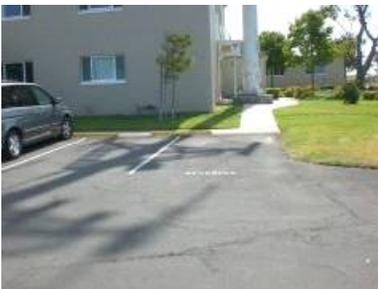
Location: Photo #
 W. of Admin. Bldg. 17

Field Condition	
03B.09 - Cross Slope - Cross slope of the accessible route of travel exceeds 1:50.	1991 ADAAG 4.3.7
Existing Condition: 3.2%	2004 ADAAG 403.3
	2007 CBC 1133B.7.1.3
	Other -

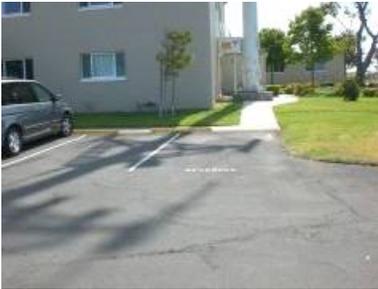
03B.21 - Hazardous Vehicular Areas - Detectable Warnings - Where a walk crosses or adjoins the vehicular way and the walking surface is not separated by curbs, railings, or other elements between the pedestrian areas and vehicular areas, the boundary between the areas is not defined by a continuous detectable warning at least 36" wide complying with CBC 1121B.3.1 item 8(a). (i.e., the warning surface shall contrast visually with adjoining surfaces, either light on dark or dark on light, and shall differ from adjoining walking surfaces in resiliency or sound on cane contact. Color: yellow conforming to Federal Color No. 33538, Table IV/ Standard No. 595B. Where the color value contrast between the yellow warning and the main walking surface is less than 70 percent, a 1" wide black strip shall separate the yellow warning from the main walking surface.)

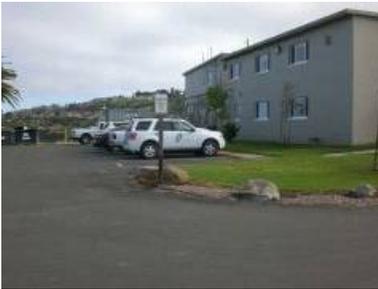
Field Condition	
01.02 - Number - Accessible Parking Spaces - Where parking spaces are provided for self-parking by employees or visitors or both, the required number of accessible parking spaces is not provided. (Note: All or some of the accessible parking spaces may be in a different location if equivalent or greater accessibility is ensured.) (Spaces required: (1 to 25 // 1) (26 to 50 // 2) (51 to 75 // 3) (76 to 100 // 4) (101 to 150 // 5) (151 to 200 // 6) (201 to 300 // 7) (301 to 400 // 8) (401 to 500 // 9) (501 to 1,000 // *) (1,000 and over // **) (*Two percent of total.) (**Twenty plus one for each 100, or fraction over 1,001.)	1991 ADAAG 4.1.2(5) 2004 ADAAG 208.3.1(2) 2007 CBC 1129B.1; 1129B.2; Table 11B-6 Other
Existing Condition: Authorized vehicles only parking lot.

Corrective Action
194 - Asphalt Paved Parking Stall and Access Aisle - Remove non-compliant pavement and replace with new asphalt paving. The parking space and access aisle slope shall not exceed 2% in any direction.
Additional Comments: Provide one van accessible space with required signs.

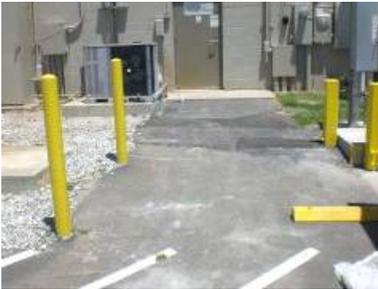
Field Condition	
03B.11 - Ramps - This portion of an accessible route with a slope greater than 5% does not comply with the requirements for compliant ramps.	1991 ADAAG 4.8.1
Existing Condition: 9.5%	2004 ADAAG 405
	2007 CBC 1133B.5
	Other -

Corrective Action	
429 - Signs - Miscellaneous - See Additional Comments	
Additional Comments: Provide warning sign stating existing condition.

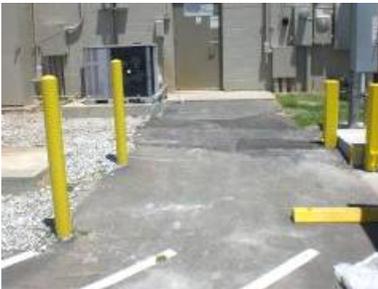
Field Condition	
03B.13 - > 1/2" Changes in Level - Curb ramps, ramps, or elevators are not used for changes in level greater than 1/2 inch. (Lifts may only be used in certain limited situations.)	1991 ADAAG 4.5.2
Existing Condition:	2004 ADAAG 303.4
	2007 CBC 1124B.2
	Other -

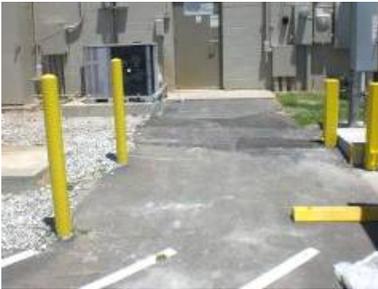
03B.21 - Hazardous Vehicular Areas - Detectable Warnings - Where a walk crosses or adjoins the vehicular way and the walking surface is not separated by curbs, railings, or other elements between the pedestrian areas and vehicular areas, the boundary between the areas is not defined by a continuous detectable warning at least 36" wide complying with CBC 1121B.3.1 item 8(a). (i.e., the warning surface shall contrast visually with adjoining surfaces, either light on dark or dark on light, and shall differ from adjoining walking surfaces in resiliency or sound on cane contact. Color: yellow conforming to Federal Color No. 33538, Table IV/ Standard No. 595B. Where the color value contrast between the yellow warning and the main walking surface is less than 70 percent, a 1" wide black strip shall separate the yellow warning from the main walking surface.)

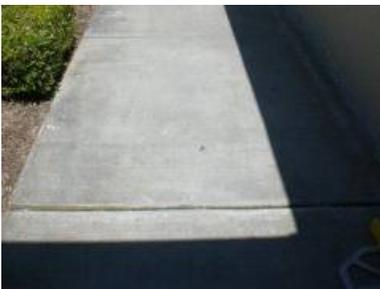
Location: N. of Comm. Dev. Bldg. Photo # 26

Existing Condition: 3/4" gap

005B - Concrete Crack Repair - Clean-out existing concrete crack and inject with epoxy grout. Cracks over 1/4" in width will require a foam backer rod and sealant.

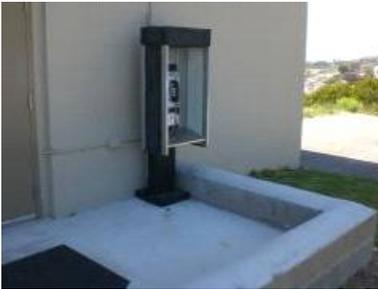
Location: E. of Admin. Bldg. Photo # 27

Field Condition	
06.02B - ISA Sign - The wheelchair accessible telephone is not identified by the ISA.	1991 ADAAG 4.1.3(17)(b); 4.30.7(1)
Existing Condition:	2004 ADAAG 703.2.1; Fig. 703.2.1
	2007 CBC 1117B.5.8.1
Other	-

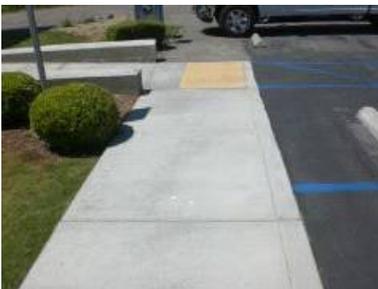
Location: E. of Admin. Bldg. Photo # 28

Field Condition	
03B.09 - Cross Slope - Cross slope of the accessible route of travel exceeds 1:50.	1991 ADAAG 4.3.7
Existing Condition: 4.6% & 4.4 at mail box	2004 ADAAG 403.3
	2007 CBC 1133B.7.1.3
Other	-

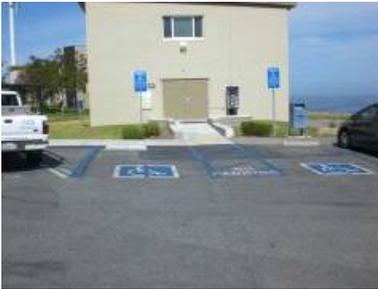
Location: E. of Admin. Bldg. Photo # 29

Field Condition	
01.09 - Stall Dimensions - Accessible parking spaces, including van spaces, are not at least 9' wide and 18' long with a demarcated access aisle. (Two spaces may share a common aisle; parking space width is measured from the center line of the stripe on one side to the center line of the stripe on the other.)	1991 ADAAG 4.6.3
Existing Condition: 16'-5" long stall.	2004 ADAAG 502.2
	2007 CBC 1129B.3 items 1 & 2
	Other

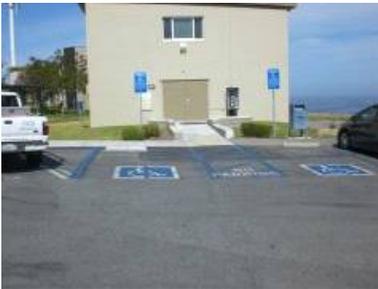
Location: E. of Admin. Bldg. Photo # 29

Field Condition	
01.11 - Car Access Aisle - Dimensions - Car access aisle is not at least 5' wide and 18' long. (Aisle width is measured from the center line of the stripe on one side to the center line of the stripe on the other.)	1991 ADAAG 4.1.2(5)(a)
Existing Condition: 4'-8" wide x 16'-8" long	2004 ADAAG 502.3.1
	2007 CBC 1129B.3 item 1
	Other

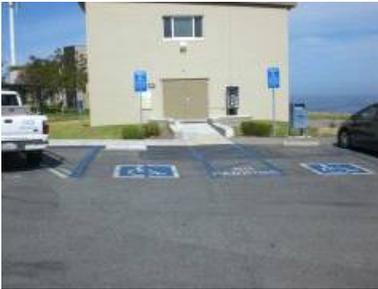
Location: E. of Admin. Bldg. Photo # 29

Field Condition	
01.13 - Level Surface - The accessible parking spaces and access aisles are not level (slope is greater than 2%).	1991 ADAAG 4.6.3
Existing Condition: 3.3%, 1.9%, & 3.8%	2004 ADAAG 502.4; advisory 502.4
	2007 CBC 1129B.3 items 3 & 4
	Other

Corrective Action
194 - Asphalt Paved Parking Stall and Access Aisle - Remove non-compliant pavement and replace with new asphalt paving. The parking space and access aisle slope shall not exceed 2% in any direction.
Additional Comments:

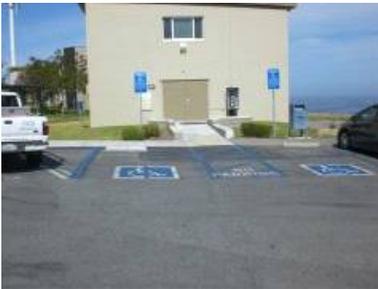
Location: E. of Admin. Bldg. Photo # 29

Field Condition	
01.15C - Minimum Fine Sign - Accessible parking space has no sign stating "Minimum Fine \$250" below the ISA.	1991 ADAAG -
Existing Condition:	2004 ADAAG -
	2007 CBC 1129B.4
	Other

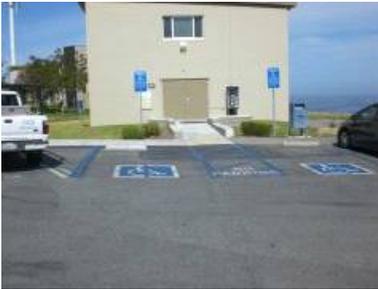
Location: Photo #
E. of Admin. Bldg. 29

Field Condition	
01.18 - Pavement Sign - A 36" square ISA is not painted on the pavement at the rear of the stall.	1991 ADAAG -
Existing Condition:	2004 ADAAG 502.6
	2007 CBC 1129B.4
	Other

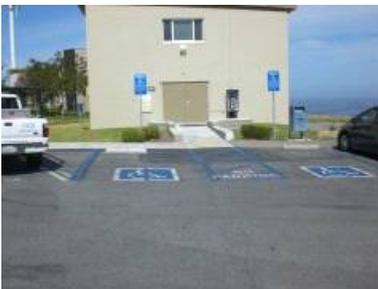
Location: Photo #
E. of Admin. Bldg. 29

Field Condition	
01.19C - Tow-away Sign - Contact Information - California tow-away sign does not include contact information.	1991 ADAAG -
Existing Condition:	2004 ADAAG -
	2007 CBC 1129B.4
	Other

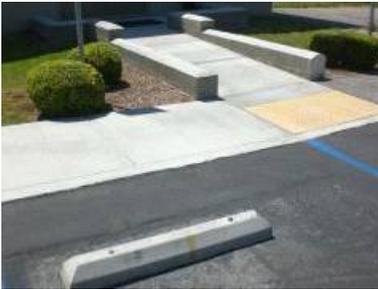
03B.21 - Hazardous Vehicular Areas - Detectable Warnings - Where a walk crosses or adjoins the vehicular way and the walking surface is not separated by curbs, railings, or other elements between the pedestrian areas and vehicular areas, the boundary between the areas is not defined by a continuous detectable warning at least 36" wide complying with CBC 1121B.3.1 item 8(a). (i.e., the warning surface shall contrast visually with adjoining surfaces, either light on dark or dark on light, and shall differ from adjoining walking surfaces in resiliency or sound on cane contact. Color: yellow conforming to Federal Color No. 33538, Table IV/ Standard No. 595B. Where the color value contrast between the yellow warning and the main walking surface is less than 70 percent, a 1" wide black strip shall separate the yellow warning from the main walking surface.)

Existing Condition: No detectable warning between parking & walkway

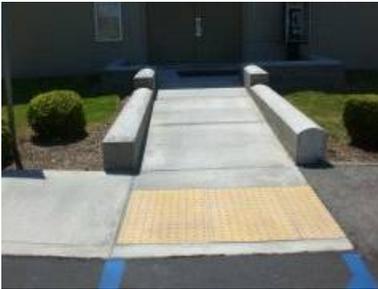
Location: E. of Admin. Bldg. Photo # 36

Field Condition	
03B.22 - Other - On-Site Accessible Path of Travel - See Additional Comments	1991 ADAAG -
Existing Condition: 35" wide detectable warnings	2004 ADAAG -
	2007 CBC -
	Other -

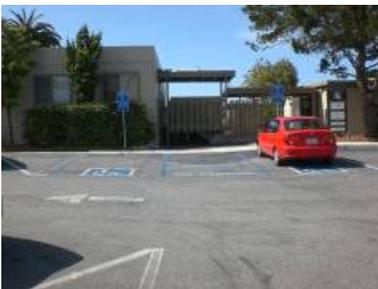
Location: N. PV Net Bldg. Photo # 37

Field Condition	
01.13 - Level Surface - The accessible parking spaces and access aisles are not level (slope is greater than 2%).	1991 ADAAG 4.6.3
Existing Condition: 2.6% to 7.2%	2004 ADAAG 502.4; advisory 502.4
	2007 CBC 1129B.3 items 3 & 4
	Other

Corrective Action
194 - Asphalt Paved Parking Stall and Access Aisle - Remove non-compliant pavement and replace with new asphalt paving. The parking space and access aisle slope shall not exceed 2% in any direction.
Additional Comments:

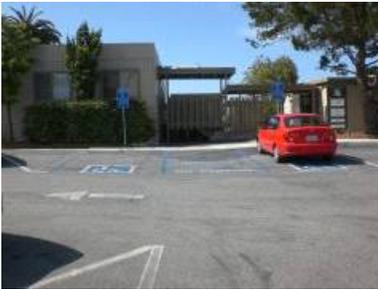
Location: N. PV Net Bldg. Photo # 37

Field Condition	
01.15C - Minimum Fine Sign - Accessible parking space has no sign stating "Minimum Fine \$250" below the ISA.	1991 ADAAG -
Existing Condition:	2004 ADAAG -
	2007 CBC 1129B.4
	Other

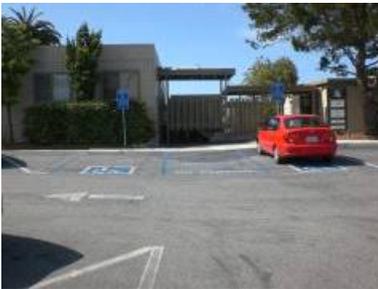
Location: N. PV Net Bldg. Photo # 37

Field Condition	
01.17 - Van Accessible Sign - Van accessible space has no sign stating "Van Accessible" below the ISA.	1991 ADAAG 4.6.4
Existing Condition:	2004 ADAAG 502.6
	2007 CBC 1129B.4
	Other

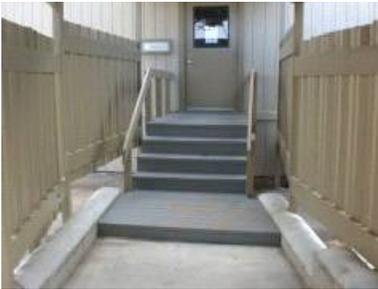
Location: W. PV Net Bldg. Photo # 43

Field Condition	
08.02B - Riser Height - The risers are not uniform. OR The risers are not between 4" and 7" in height.	1991 ADAAG 4.9.2
Existing Condition: 8" high.	2004 ADAAG 504.2
	2007 CBC 1009.3; 1133B.4.5.3
	Other -

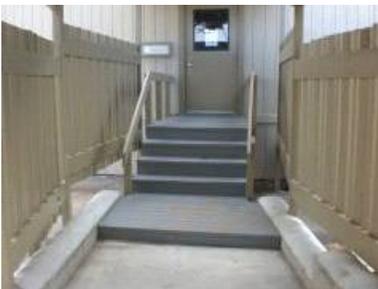
Location: W. PV Net Bldg. Photo # 43

Field Condition	
08.03D - Level Landing - Landing is not level (slope is greater than 2% in some or all directions).	1991 ADAAG -
Existing Condition: 3.5%	2004 ADAAG -
	2007 CBC 1009.5.1
	Other -

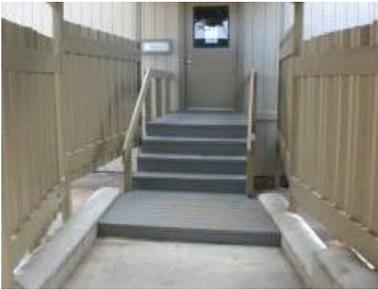
Field Condition	
08.05A - Exterior Stairs - Color Strip - Contrasting color strips have not been provided.	1991 ADAAG -
Existing Condition:	2004 ADAAG -
	2007 CBC 1133B.4.4
	Other -

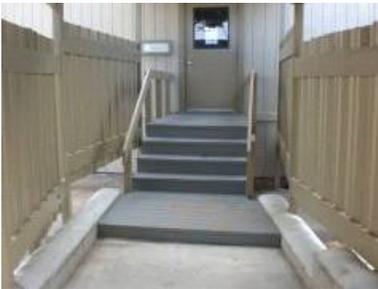
Field Condition	
08.07A - Continuous Handrails - Continuous handrails are not provided along both sides.	1991 ADAAG 4.9.4
Existing Condition: 2x Guard w/ no handrails	2004 ADAAG 504.6; 505.2
	2007 CBC 1133B.4.1.1
	Other -

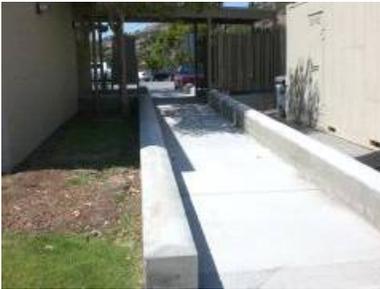
Field Condition	
03B.09 - Cross Slope - Cross slope of the accessible route of travel exceeds 1:50.	1991 ADAAG 4.3.7
Existing Condition: 2.8% to 3.1%	2004 ADAAG 403.3
	2007 CBC 1133B.7.1.3
	Other -

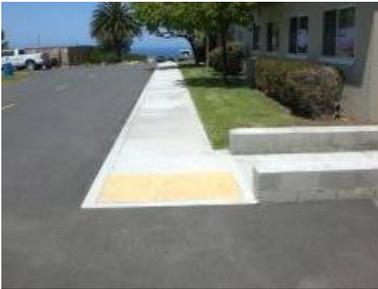
03B.21 - Hazardous Vehicular Areas - Detectable Warnings - Where a walk crosses or adjoins the vehicular way and the walking surface is not separated by curbs, railings, or other elements between the pedestrian areas and vehicular areas, the boundary between the areas is not defined by a continuous detectable warning at least 36" wide complying with CBC 1121B.3.1 item 8(a). (i.e., the warning surface shall contrast visually with adjoining surfaces, either light on dark or dark on light, and shall differ from adjoining walking surfaces in resiliency or sound on cane contact. Color: yellow conforming to Federal Color No. 33538, Table IV/ Standard No. 595B. Where the color value contrast between the yellow warning and the main walking surface is less than 70 percent, a 1" wide black strip shall separate the yellow warning from the main walking surface.)

Existing Condition: No detectable warning between walkway & vehicular area at flush transition.

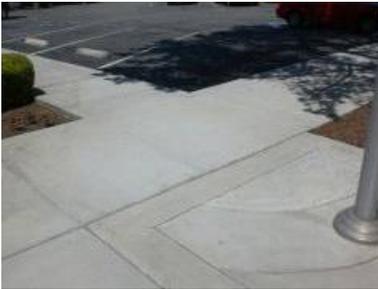
Field Condition	
03B.09 - Cross Slope - Cross slope of the accessible route of travel exceeds 1:50. Existing Condition: 2.5%	1991 ADAAG 4.3.7 2004 ADAAG 403.3 2007 CBC 1133B.7.1.3 Other -

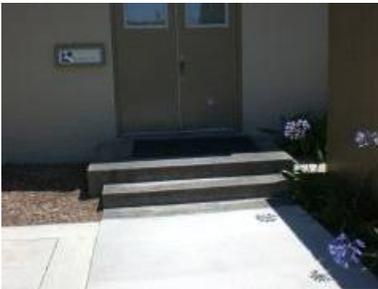
Field Condition	
03B.13 - > 1/2" Changes in Level - Curb ramps, ramps, or elevators are not used for changes in level greater than 1/2 inch. (Lifts may only be used in certain limited situations.) Existing Condition: 1 3/8" high between door & landing.	1991 ADAAG 4.5.2 2004 ADAAG 303.4 2007 CBC 1124B.2 Other -

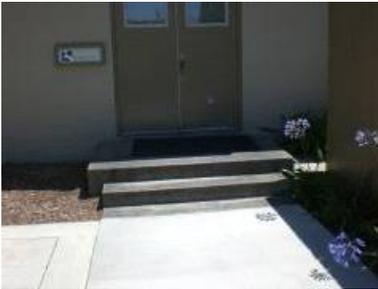
Location: Photo #
 N. of Comm. Dev. Bldg. 51

Field Condition	
08.05A - Exterior Stairs - Color Strip - Contrasting color strips have not been provided.	1991 ADAAG -
Existing Condition:	2004 ADAAG -
	2007 CBC 1133B.4.4
	Other -

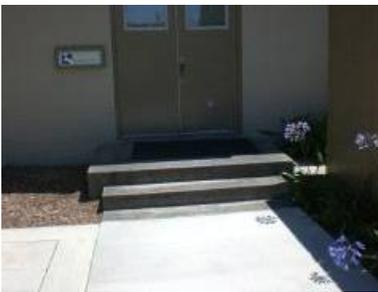
Location: Photo #
 N. of Comm. Dev. Bldg. 51

Field Condition	
08.07A - Continuous Handrails - Continuous handrails are not provided along both sides.	1991 ADAAG 4.9.4
Existing Condition:	2004 ADAAG 504.6; 505.2
	2007 CBC 1133B.4.1.1
	Other -

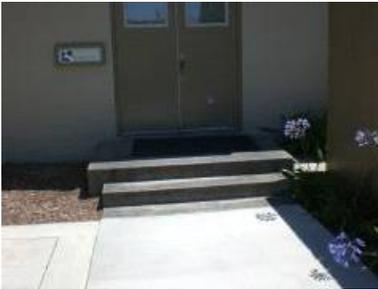
Existing Condition: 48" deep landing on pull side

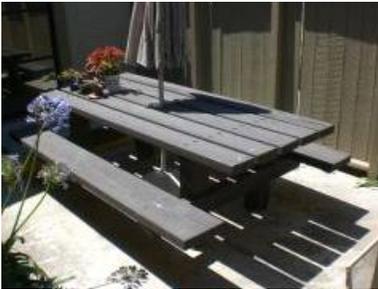
Location: Photo #
N. of Comm. Dev. Bldg. 55

Field Condition	
03B.22 - Other - On-Site Accessible Path of Travel - See Additional Comments	1991 ADAAG -
Existing Condition: No compliant access to bench. Bench not accessible	2004 ADAAG -
	2007 CBC -
	Other -

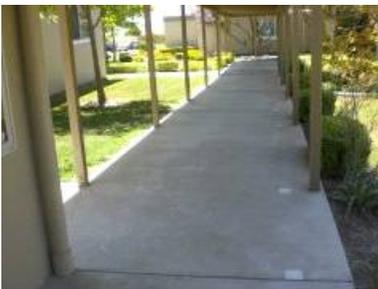
Location: Photo #
N. of Comm. Dev. Bldg. 56

Field Condition	
03B.09 - Cross Slope - Cross slope of the accessible route of travel exceeds 1:50.	1991 ADAAG 4.3.7
Existing Condition: 2.1%, 3.3%, 3.5% at transition points.	2004 ADAAG 403.3
	2007 CBC 1133B.7.1.3
	Other -

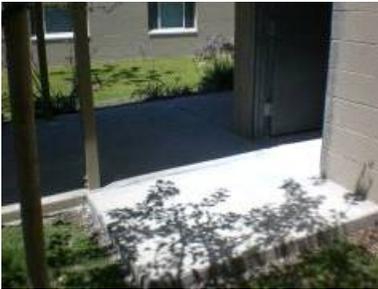
Field Condition	
10.07A - Landing - Level and Clear - Floor is not level (slope is greater than 2% in some or all directions). OR Floor is not clear within the required maneuvering space.	1991 ADAAG 4.13.6; Fig. 25
Existing Condition: 3.3%	2004 ADAAG 305; 404.2.4.4
	2007 CBC 1133B.2.4
	Other -

Corrective Action	
008 - Concrete Landing - Remove non-compliant pavement and replace with new concrete. The landing slope shall not exceed 2% in any direction.	
Additional Comments:

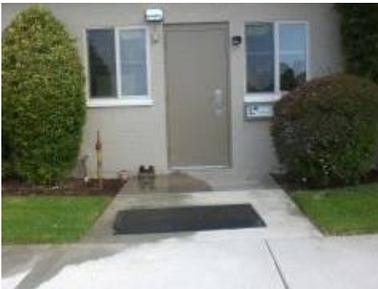
Field Condition	
03B.13 - > 1/2" Changes in Level - Curb ramps, ramps, or elevators are not used for changes in level greater than 1/2 inch. (Lifts may only be used in certain limited situations.)	1991 ADAAG 4.5.2
Existing Condition: 1 3/4" high.	2004 ADAAG 303.4
	2007 CBC 1124B.2
	Other -

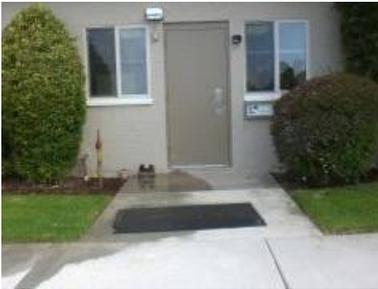
Existing Condition: 23" clear at strike side.

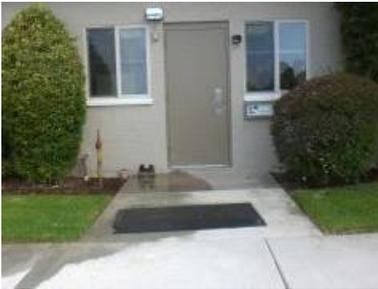
Location: Photo #
 S. of Comm. Dev. Bldg. 60

Field Condition	
10.07A - Landing - Level and Clear - Floor is not level (slope is greater than 2% in some or all directions). OR Floor is not clear within the required maneuvering space.	1991 ADAAG 4.13.6; Fig. 25
Existing Condition: 3.2%	2004 ADAAG 305; 404.2.4.4
	2007 CBC 1133B.2.4
	Other -

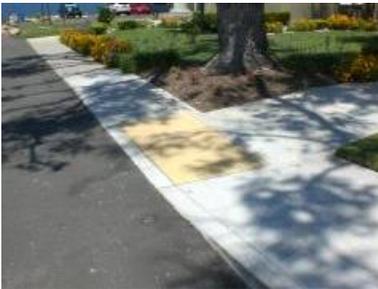
Location: Photo #
 SE. of Comm. Dev. Bldg. 61

Field Condition	
03B.09 - Cross Slope - Cross slope of the accessible route of travel exceeds 1:50.	1991 ADAAG 4.3.7
Existing Condition: 3.9%	2004 ADAAG 403.3
	2007 CBC 1133B.7.1.3
	Other -

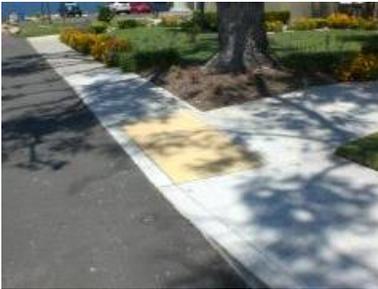
Field Condition	
03B.22 - Other - On-Site Accessible Path of Travel - See Additional Comments	1991 ADAAG -
Existing Condition: 35" wide domes in lieu of 36" wide.	2004 ADAAG -
	2007 CBC -
	Other -

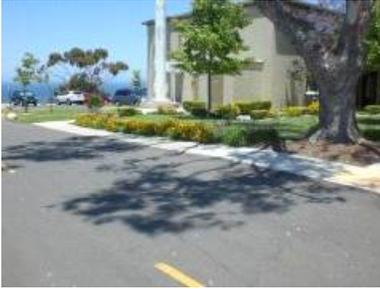
Field Condition	
03B.10 - Running Slope - Slope of the accessible route of travel exceeds 1:20.	1991 ADAAG 4.3.7
Existing Condition: 6.5% RS & no handrails provided.	2004 ADAAG 403.3
	2007 CBC 1133B.7.3
	Other -

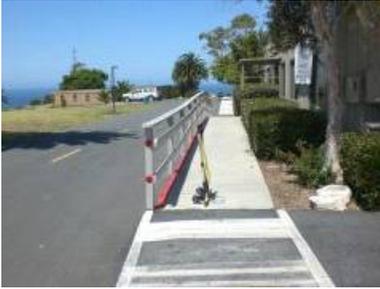
Field Condition	
03B.09 - Cross Slope - Cross slope of the accessible route of travel exceeds 1:50.	1991 ADAAG 4.3.7
Existing Condition: 2.7%	
	2004 ADAAG 403.3
	2007 CBC 1133B.7.1.3
	Other -

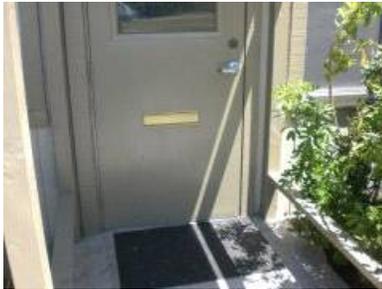
Existing Condition: 6" strike clearance

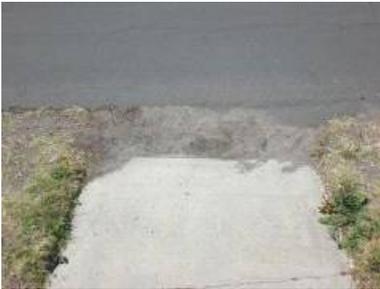
Field Condition	
03B.15 - Surface - Accessible route surfaces are not stable, firm and slip-resistant.	1991 ADAAG 4.5.1
Existing Condition: Cracks & loose surface	2004 ADAAG 302.1; Advisory 302.1
	2007 CBC 1124B.1
	Other -

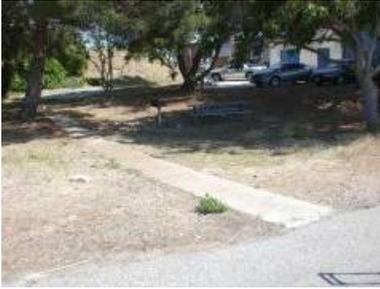
Field Condition	
30.34C - Picnic Table - Knee Space Depth - Picnic table does not provide at least 19" depth for accessible knee clearance.	1991 ADAAG 4.32.3
Existing Condition:	2004 ADAAG 305; 306
	2007 CBC 1122B.3
	Other 1999 ADAAG-16.5.4
