City of Rancho Palos Verdes
Rancho Palos Verdes ADA Assessment
Facility Report with Photos

Facility ID: # Area 3 Bus Stops

Author: Vaish, B

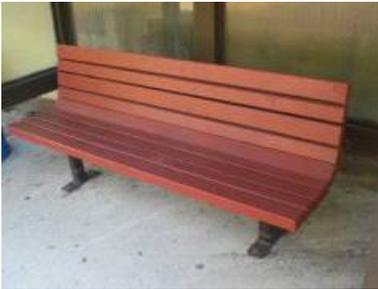
Keynote 1

Field Condition	
02.17 - Other - Passenger Loading Zones - See Additional Comments	1991 ADAAG -
Existing Condition: Bench (16" high seat, 14" deep seat, 15" high back support).	2004 ADAAG -
	2007 CBC -
	Other

Corrective Action
027 - Site Work - Miscellaneous - See Additional Comments
Additional Comments: Provide compliant bench & relocate for clear WC seating space.

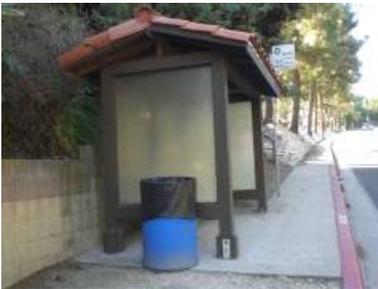
Keynote 2

Field Condition	
02.11A - Bus Stop Pad Size - Bus stop pad does not measure 8' long (measured from the curb or vehicle roadway edge) by 5' wide (measured parallel to the vehicle roadway).	1991 ADAAG 10.2.1
Existing Condition: Bus pad 4'-1" long x 5' wide.	2004 ADAAG 810.2.2
	2007 CBC 1121B.1
	Other

Corrective Action
006 - Concrete Walk - Remove non-compliant pavement and replace with new concrete (area as shown on the drawings). The walkway slope shall not exceed 5% along the POT and cross slope shall not exceed 2%.
Additional Comments:

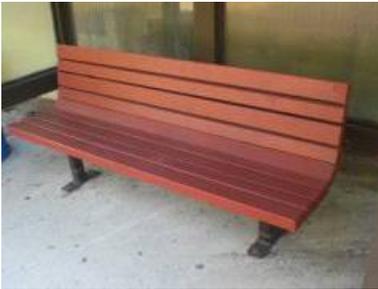
Keynote 3

Field Condition		1991 ADAAG	10.2.1(2)
02.13A - Bus Stop Shelter - Clear Floor Area - Clear floor area of 30" by 48" is not completely within the shelter.			
Existing Condition: No WC space provided within the shelter.		2004 ADAAG	810.3
		2007 CBC	1121B.2.1
		Other

Corrective Action
027 - Site Work - Miscellaneous - See Additional Comments
Additional Comments: See Keynote 1 for corrective action.

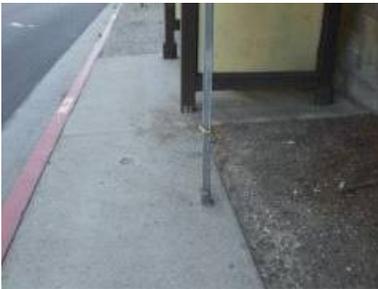
Keynote 4

Field Condition		1991 ADAAG	-
02.17 - Other - Passenger Loading Zones - See Additional Comments			
Existing Condition: 2.1% to 5.4% CS.		2004 ADAAG	-
		2007 CBC	-
		Other

Corrective Action
006 - Concrete Walk - Remove non-compliant pavement and replace with new concrete (area as shown on the drawings). The walkway slope shall not exceed 5% along the POT and cross slope shall not exceed 2%.
Additional Comments:

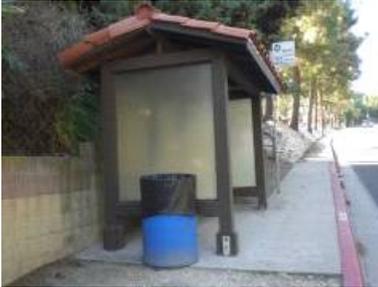
Keynote 5

Field Condition	
02.17 - Other - Passenger Loading Zones - See Additional Comments	1991 ADAAG -
Existing Condition: 74" headroom clearance to bus shelter.	2004 ADAAG -
	2007 CBC -
	Other

Corrective Action
027 - Site Work - Miscellaneous - See Additional Comments
Additional Comments: Raise bus shelter to allow for compliant headroom clearance.

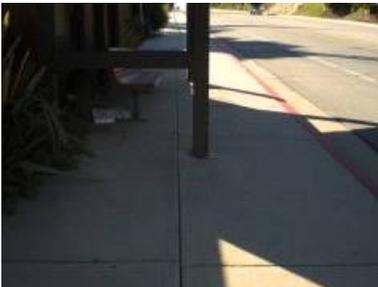
Keynote 6

Field Condition	
02.12A - Bus Stop Pad Slope Parallel to Roadway - Bus stop pad is not at the same slope as the roadway in the direction parallel to the roadway.	1991 ADAAG 10.2.1
Existing Condition: 12.2% RS at bus pad , 10.6% RS at the road.	2004 ADAAG 810.2.4
	2007 CBC 1121B.2.1
	Other

Corrective Action
027 - Site Work - Miscellaneous - See Additional Comments
Additional Comments: See Keynote 7 for corrective action.

Corrective Action
006 - Concrete Walk - Remove non-compliant pavement and replace with new concrete (area as shown on the drawings). The walkway slope shall not exceed 5% along the POT and cross slope shall not exceed 2%.
Additional Comments:

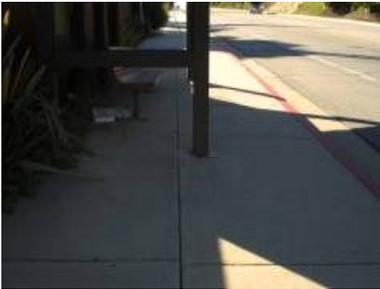
Keynote 7

Field Condition	
02.12B - Bus Stop Pad Slope Perpendicular to Roadway - Bus stop pad slope perpendicular to the roadway exceeds 2%.	1991 ADAAG 10.2.1
Existing Condition: 2.9% to 3.4% CS.	2004 ADAAG 810.2.4
	2007 CBC 1121B.2.1
	Other

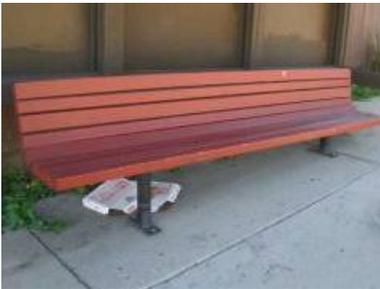
Keynote 8

Field Condition	
02.17 - Other - Passenger Loading Zones - See Additional Comments	1991 ADAAG -
Existing Condition: Bench (10" - 21" high seat, 15" deep seat, 14 1/2" high back support).	2004 ADAAG -
	2007 CBC -
	Other

Corrective Action
027 - Site Work - Miscellaneous - See Additional Comments
Additional Comments: Provide compliant bench & relocate for clear WC seating space.

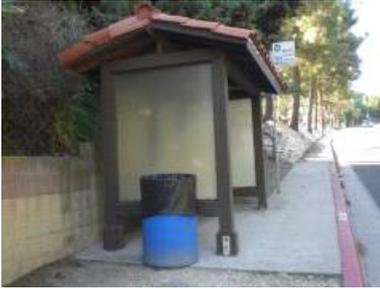
Keynote 9

Field Condition	
02.13A - Bus Stop Shelter - Clear Floor Area - Clear floor area of 30" by 48" is not completely within the shelter.	1991 ADAAG 10.2.1(2)
Existing Condition: No WC space provided within the shelter.	2004 ADAAG 810.3
	2007 CBC 1121B.2.1
	Other

Corrective Action	
027 - Site Work - Miscellaneous - See Additional Comments	
Additional Comments: See Keynote 8 for corrective action.
