City of Rancho Palos Verdes
 Rancho Palos Verdes ADA Assessment
 Facility Report with Photos

Facility ID: # Area 5 Bus Stops

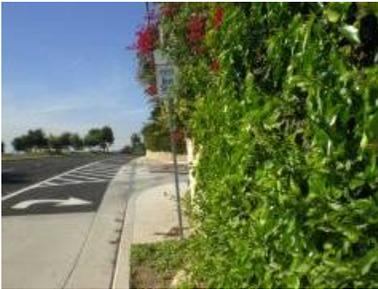
Keynote 1

Field Condition	
02.11A - Bus Stop Pad Size - Bus stop pad does not measure 8' long (measured from the curb or vehicle roadway edge) by 5' wide (measured parallel to the vehicle roadway).	1991 ADAAG 10.2.1
	2004 ADAAG 810.2.2
	2007 CBC 1121B.1
	Other
Existing Condition: Bus pad 3'-7" long x 5' wide.

Corrective Action
006 - Concrete Walk - Remove non-compliant pavement and replace with new concrete (area as shown on the drawings). The walkway slope shall not exceed 5% along the POT and cross slope shall not exceed 2%.
Additional Comments:

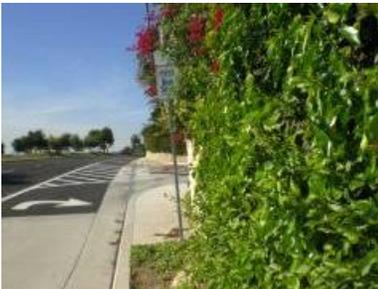
Keynote 2

Field Condition	
02.12A - Bus Stop Pad Slope Parallel to Roadway - Bus stop pad is not at the same slope as the roadway in the direction parallel to the roadway.	1991 ADAAG 10.2.1
	2004 ADAAG 810.2.4
	2007 CBC 1121B.2.1
	Other
Existing Condition: 2.2% RS at bus pad , 2.0% RS at the road.

Corrective Action
027 - Site Work - Miscellaneous - See Additional Comments
Additional Comments: See Keynote 1 for corrective action.

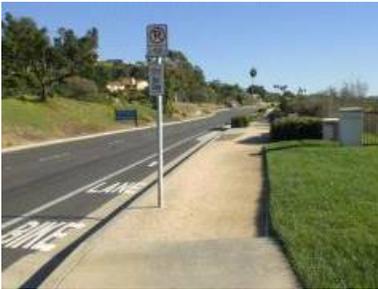
Keynote 3

Field Condition		1991 ADAAG	10.2.1
02.12B - Bus Stop Pad Slope Perpendicular to Roadway - Bus stop pad slope perpendicular to the roadway exceeds 2%.			
Existing Condition: 2.3% CS at concrete & 4.9% CS at DG.		2004 ADAAG	810.2.4
		2007 CBC	1121B.2.1
		Other

Corrective Action	
006 - Concrete Walk - Remove non-compliant pavement and replace with new concrete (area as shown on the drawings). The walkway slope shall not exceed 5% along the POT and cross slope shall not exceed 2%.	
Additional Comments:

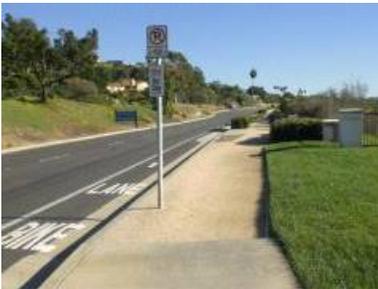
Keynote 4

Field Condition		1991 ADAAG	10.2.1
02.11A - Bus Stop Pad Size - Bus stop pad does not measure 8' long (measured from the curb or vehicle roadway edge) by 5' wide (measured parallel to the vehicle roadway).			
Existing Condition: Bus pad 6'-5" long x 5' wide.		2004 ADAAG	810.2.2
		2007 CBC	1121B.1
		Other

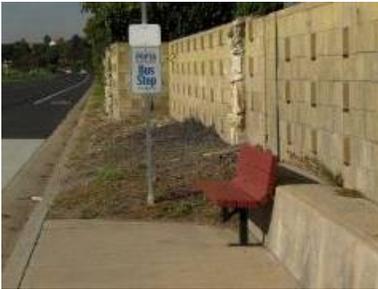
Keynote 5

Field Condition	
02.17 - Other - Passenger Loading Zones - See Additional Comments	1991 ADAAG -
Existing Condition: Bench (16" high seat, 14" deep seat, 14" high back support, 0" WC shoulder alignment).	2004 ADAAG -
	2007 CBC -
	Other

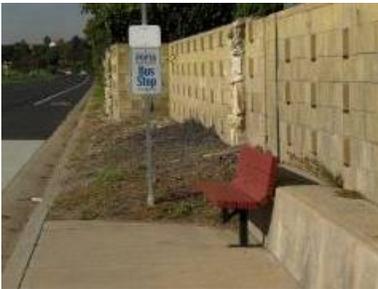
Keynote 6

Field Condition	
02.11A - Bus Stop Pad Size - Bus stop pad does not measure 8' long (measured from the curb or vehicle roadway edge) by 5' wide (measured parallel to the vehicle roadway).	1991 ADAAG 10.2.1
Existing Condition: Bus pad 6'-1" long by 5' wide.	2004 ADAAG 810.2.2
	2007 CBC 1121B.1
	Other

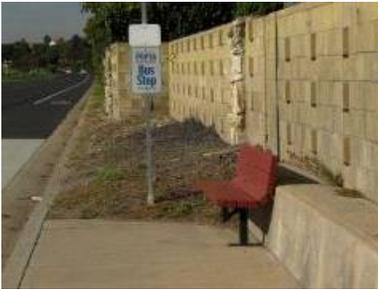
Keynote 7

Field Condition	
02.12B - Bus Stop Pad Slope Perpendicular to Roadway - Bus stop pad slope perpendicular to the roadway exceeds 2%.	1991 ADAAG 10.2.1
Existing Condition: 3.1% CS.	2004 ADAAG 810.2.4
	2007 CBC 1121B.2.1
	Other

Corrective Action	
006 - Concrete Walk - Remove non-compliant pavement and replace with new concrete (area as shown on the drawings). The walkway slope shall not exceed 5% along the POT and cross slope shall not exceed 2%.	
Additional Comments:

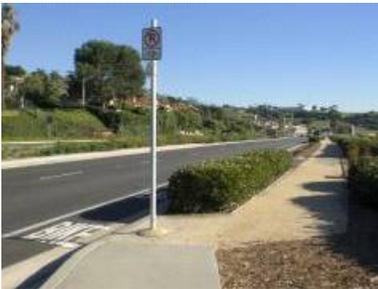
Keynote 8

Field Condition	
02.11A - Bus Stop Pad Size - Bus stop pad does not measure 8' long (measured from the curb or vehicle roadway edge) by 5' wide (measured parallel to the vehicle roadway).	1991 ADAAG 10.2.1
Existing Condition: Bus pad 5' long by 5' wide.	2004 ADAAG 810.2.2
	2007 CBC 1121B.1
	Other

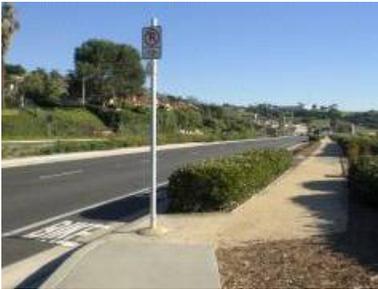
Keynote 9

Field Condition	
02.12B - Bus Stop Pad Slope Perpendicular to Roadway - Bus stop pad slope perpendicular to the roadway exceeds 2%.	1991 ADAAG 10.2.1
Existing Condition: 4.7% CS.	2004 ADAAG 810.2.4
	2007 CBC 1121B.2.1
	Other

Corrective Action	
006 - Concrete Walk - Remove non-compliant pavement and replace with new concrete (area as shown on the drawings). The walkway slope shall not exceed 5% along the POT and cross slope shall not exceed 2%.	
Additional Comments:

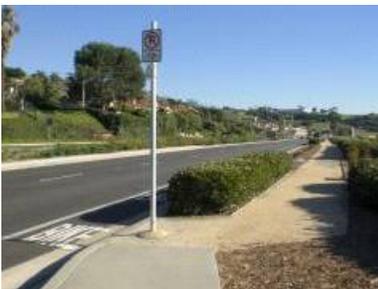
Keynote 10

Field Condition	
02.12A - Bus Stop Pad Slope Parallel to Roadway - Bus stop pad is not at the same slope as the roadway in the direction parallel to the roadway.	1991 ADAAG 10.2.1
Existing Condition: 3.0% RS at bus pad , 1.5% RS at the road.	2004 ADAAG 810.2.4
	2007 CBC 1121B.2.1
	Other

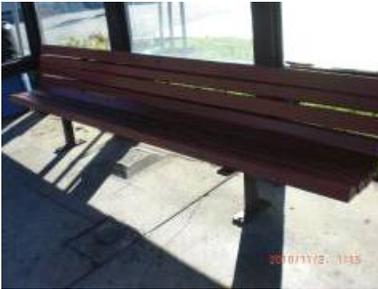
Keynote 11

Field Condition	
02.17 - Other - Passenger Loading Zones - See Additional Comments	1991 ADAAG -
Existing Condition: Bench (16" high seat, 11" deep seat, 14 1/2" high back support, hazard condition, no 12" shoulder alignment).	2004 ADAAG -
	2007 CBC -
	Other

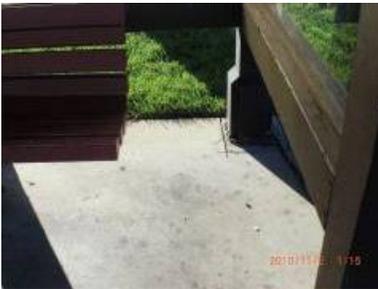
Keynote 12

Field Condition	
02.13A - Bus Stop Shelter - Clear Floor Area - Clear floor area of 30" by 48" is not completely within the shelter.	1991 ADAAG 10.2.1(2)
Existing Condition: No WC space provided within the shelter.	2004 ADAAG 810.3
	2007 CBC 1121B.2.1
	Other

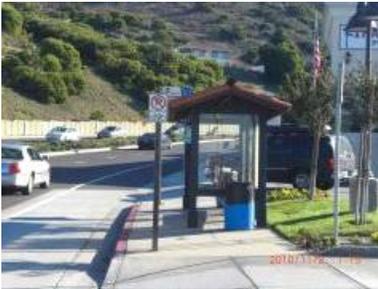
Keynote 13

Field Condition	
02.12B - Bus Stop Pad Slope Perpendicular to Roadway - Bus stop pad slope perpendicular to the roadway exceeds 2%.	1991 ADAAG 10.2.1
Existing Condition: 2.7% to 3.5% CS.	2004 ADAAG 810.2.4
	2007 CBC 1121B.2.1
	Other

Corrective Action	
006 - Concrete Walk - Remove non-compliant pavement and replace with new concrete (area as shown on the drawings). The walkway slope shall not exceed 5% along the POT and cross slope shall not exceed 2%.	
Additional Comments:

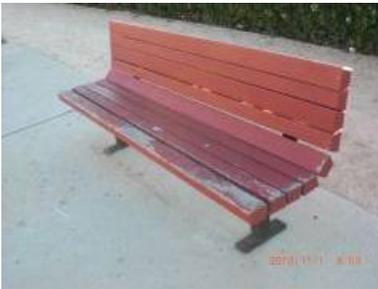
Keynote 14

Field Condition	
02.17 - Other - Passenger Loading Zones - See Additional Comments	1991 ADAAG -
Existing Condition: Bench (16" high seat, 15 3/4" deep seat, 15" high back support).	2004 ADAAG -
	2007 CBC -
	Other

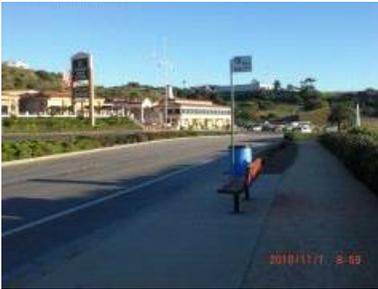
Keynote 15

Field Condition		1991 ADAAG	10.2.1
02.12B - Bus Stop Pad Slope Perpendicular to Roadway - Bus stop pad slope perpendicular to the roadway exceeds 2%.			
Existing Condition: 4.2% CS.		2004 ADAAG	810.2.4
		2007 CBC	1121B.2.1
		Other

Corrective Action	
006 - Concrete Walk - Remove non-compliant pavement and replace with new concrete (area as shown on the drawings). The walkway slope shall not exceed 5% along the POT and cross slope shall not exceed 2%.	
Additional Comments:

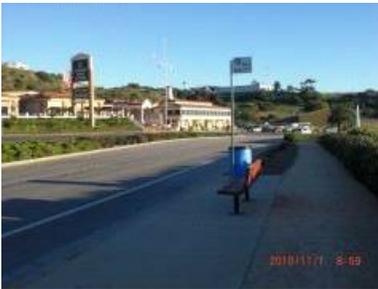
Keynote 16

Field Condition		1991 ADAAG	10.2.1
02.11A - Bus Stop Pad Size - Bus stop pad does not measure 8' long (measured from the curb or vehicle roadway edge) by 5' wide (measured parallel to the vehicle roadway).			
Existing Condition: Bus pad 6' long by 5' wide.		2004 ADAAG	810.2.2
		2007 CBC	1121B.1
		Other

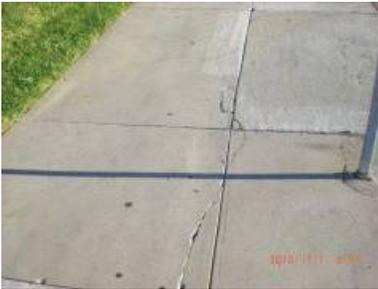
Keynote 17

Field Condition	
02.17 - Other - Passenger Loading Zones - See Additional Comments	1991 ADAAG -
Existing Condition: Uneven surface.	2004 ADAAG -
	2007 CBC -
	Other

Corrective Action
006 - Concrete Walk - Remove non-compliant pavement and replace with new concrete (area as shown on the drawings). The walkway slope shall not exceed 5% along the POT and cross slope shall not exceed 2%.
Additional Comments:

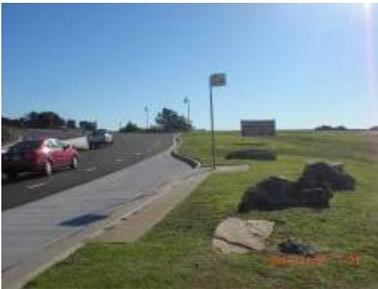
Keynote 18

Field Condition	
02.11B - Bus Stop Pad and Accessible Route - Bus stop pad is not connected to an accessible route.	1991 ADAAG 10.2.1
Existing Condition: No accessible route to bus stop.	2004 ADAAG 810.2.3
	2007 CBC 1121B.1
	Other

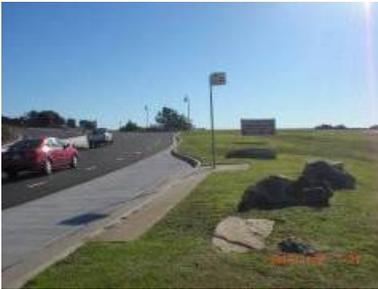
Keynote 19

Field Condition	
02.11A - Bus Stop Pad Size - Bus stop pad does not measure 8' long (measured from the curb or vehicle roadway edge) by 5' wide (measured parallel to the vehicle roadway).	1991 ADAAG 10.2.1
	2004 ADAAG 810.2.2
Existing Condition: bus pad 5'-6" long by 5' wide.	2007 CBC 1121B.1
	Other

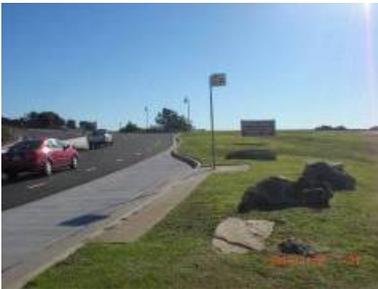
Keynote 20

Field Condition	
02.12A - Bus Stop Pad Slope Parallel to Roadway - Bus stop pad is not at the same slope as the roadway in the direction parallel to the roadway.	1991 ADAAG 10.2.1
	2004 ADAAG 810.2.4
Existing Condition: 2.3% to 6.7% RS at bus pad, 2.4% to 4.9% RS at the road.	2007 CBC 1121B.2.1
	Other

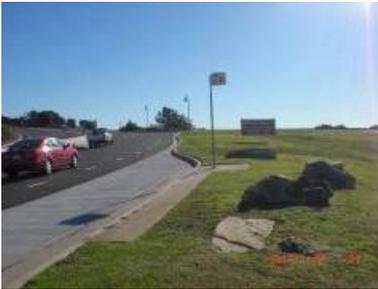
Keynote 21

Field Condition			
02.12B - Bus Stop Pad Slope Perpendicular to Roadway - Bus stop pad slope perpendicular to the roadway exceeds 2%.	1991 ADAAG	10.2.1	
Existing Condition: 4.1% to 5.5% CS.	2004 ADAAG	810.2.4	
	2007 CBC	1121B.2.1	
	Other

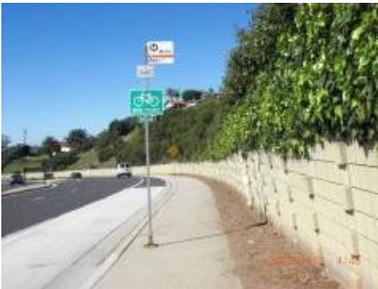
Keynote 22

Field Condition			
02.11A - Bus Stop Pad Size - Bus stop pad does not measure 8' long (measured from the curb or vehicle roadway edge) by 5' wide (measured parallel to the vehicle roadway).	1991 ADAAG	10.2.1	
Existing Condition: Bus pad 6' long by 5' wide.	2004 ADAAG	810.2.2	
	2007 CBC	1121B.1	
	Other

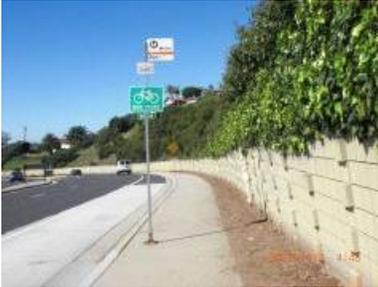
Keynote 23

Field Condition	
02.12B - Bus Stop Pad Slope Perpendicular to Roadway - Bus stop pad slope perpendicular to the roadway exceeds 2%.	1991 ADAAG 10.2.1
Existing Condition: 3.9% CS.	2004 ADAAG 810.2.4
	2007 CBC 1121B.2.1
	Other

Corrective Action	
006 - Concrete Walk - Remove non-compliant pavement and replace with new concrete (area as shown on the drawings). The walkway slope shall not exceed 5% along the POT and cross slope shall not exceed 2%.	
Additional Comments:

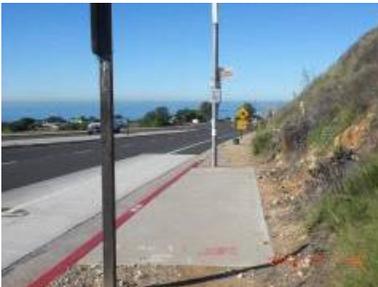
Keynote 24

Field Condition	
02.11B - Bus Stop Pad and Accessible Route - Bus stop pad is not connected to an accessible route.	1991 ADAAG 10.2.1
Existing Condition: No accessible route to bus stop.	2004 ADAAG 810.2.3
	2007 CBC 1121B.1
	Other

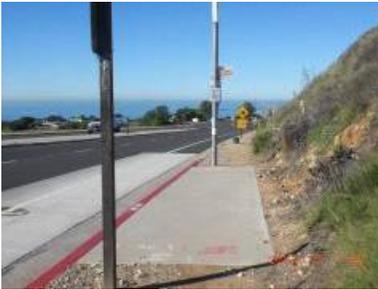
Keynote 25

Field Condition	
02.12A - Bus Stop Pad Slope Parallel to Roadway - Bus stop pad is not at the same slope as the roadway in the direction parallel to the roadway.	1991 ADAAG 10.2.1
Existing Condition: 3.9% to 5.2% RS at bus pad, 7.0% RS at the road.	2004 ADAAG 810.2.4
	2007 CBC 1121B.2.1
	Other

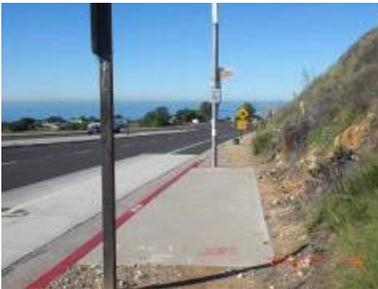
Keynote 26

Field Condition	
02.12B - Bus Stop Pad Slope Perpendicular to Roadway - Bus stop pad slope perpendicular to the roadway exceeds 2%.	1991 ADAAG 10.2.1
Existing Condition: 3.9% to 4.5% CS.	2004 ADAAG 810.2.4
	2007 CBC 1121B.2.1
	Other

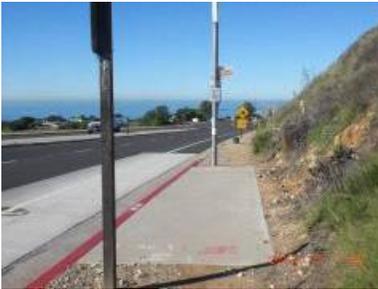
Keynote 27

Field Condition	
02.11A - Bus Stop Pad Size - Bus stop pad does not measure 8' long (measured from the curb or vehicle roadway edge) by 5' wide (measured parallel to the vehicle roadway).	1991 ADAAG 10.2.1
	2004 ADAAG 810.2.2
	2007 CBC 1121B.1
	Other
Existing Condition: Bus pad 6'-6" long by 5' wide.

Corrective Action	
006 - Concrete Walk - Remove non-compliant pavement and replace with new concrete (area as shown on the drawings). The walkway slope shall not exceed 5% along the POT and cross slope shall not exceed 2%.	
Additional Comments:

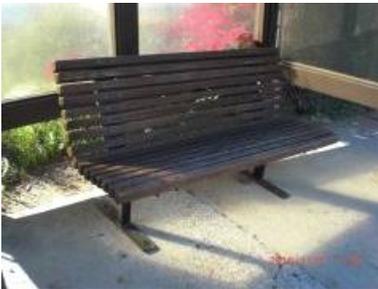
Keynote 28

Field Condition	
02.17 - Other - Passenger Loading Zones - See Additional Comments	1991 ADAAG -
	2004 ADAAG -
	2007 CBC -
	Other
Existing Condition: Bench (16 1/2" high seat, 15 1/2" deep seat, 17 1/2" high back support).

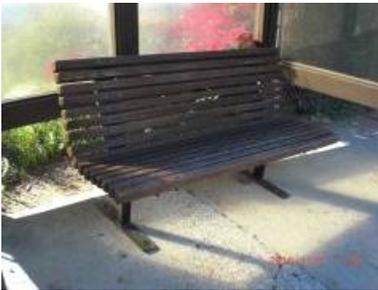
Keynote 29

Field Condition		1991 ADAAG	10.2.1(2)
02.13A - Bus Stop Shelter - Clear Floor Area - Clear floor area of 30" by 48" is not completely within the shelter.			
Existing Condition: No WC space provided within the shelter.		2004 ADAAG	810.3
		2007 CBC	1121B.2.1
		Other

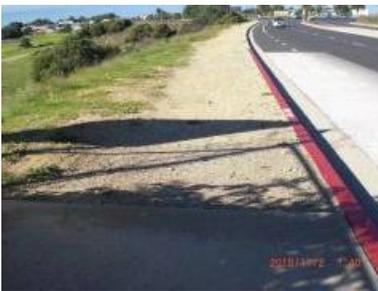
Keynote 30

Field Condition		1991 ADAAG	10.2.1
02.11B - Bus Stop Pad and Accessible Route - Bus stop pad is not connected to an accessible route.			
Existing Condition: No accessible route to bus pad.		2004 ADAAG	810.2.3
		2007 CBC	1121B.1
		Other

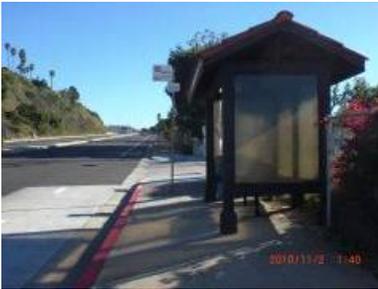
Keynote 31

Field Condition	
02.12B - Bus Stop Pad Slope Perpendicular to Roadway - Bus stop pad slope perpendicular to the roadway exceeds 2%.	1991 ADAAG 10.2.1
Existing Condition: 7.1% to 8.3% CS.	2004 ADAAG 810.2.4
	2007 CBC 1121B.2.1
	Other

Corrective Action	
006 - Concrete Walk - Remove non-compliant pavement and replace with new concrete (area as shown on the drawings). The walkway slope shall not exceed 5% along the POT and cross slope shall not exceed 2%.	
Additional Comments:

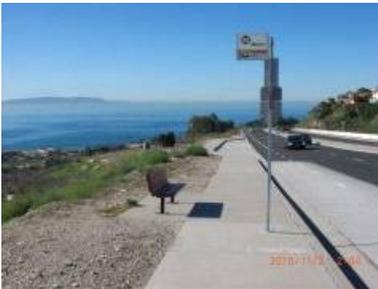
Keynote 32

Field Condition	
02.17 - Other - Passenger Loading Zones - See Additional Comments	1991 ADAAG -
Existing Condition: Bench (16" high seat, 14" deep seat, 15" high back support).	2004 ADAAG -
	2007 CBC -
	Other

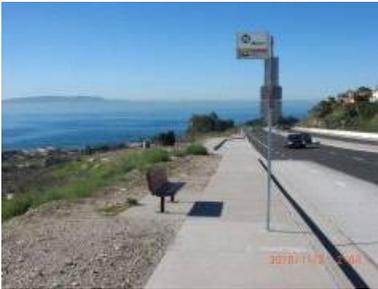
Keynote 33

Field Condition	
02.12A - Bus Stop Pad Slope Parallel to Roadway - Bus stop pad is not at the same slope as the roadway in the direction parallel to the roadway.	1991 ADAAG 10.2.1
Existing Condition: 7.3% to 10.6 RS at bus pad, 5.6% to 7.0% RS at the road.	2004 ADAAG 810.2.4
	2007 CBC 1121B.2.1
	Other

Corrective Action
006 - Concrete Walk - Remove non-compliant pavement and replace with new concrete (area as shown on the drawings). The walkway slope shall not exceed 5% along the POT and cross slope shall not exceed 2%.
Additional Comments:

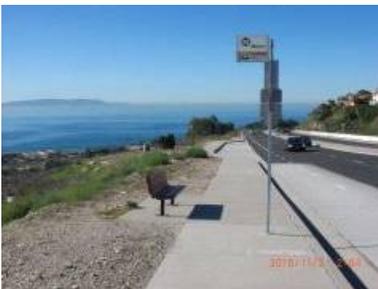
Keynote 34

Field Condition	
02.12B - Bus Stop Pad Slope Perpendicular to Roadway - Bus stop pad slope perpendicular to the roadway exceeds 2%.	1991 ADAAG 10.2.1
Existing Condition: 3.0% to 5.0% CS.	2004 ADAAG 810.2.4
	2007 CBC 1121B.2.1
	Other

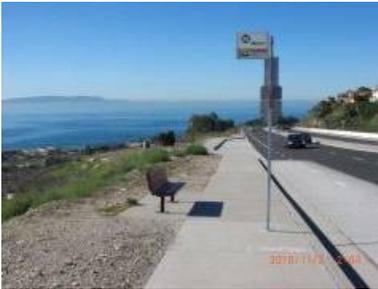
Keynote 35

Field Condition	
02.11A - Bus Stop Pad Size - Bus stop pad does not measure 8' long (measured from the curb or vehicle roadway edge) by 5' wide (measured parallel to the vehicle roadway).	1991 ADAAG 10.2.1
	2004 ADAAG 810.2.2
	2007 CBC 1121B.1
	Other
Existing Condition: Bus pad 6' long by 5' wide.

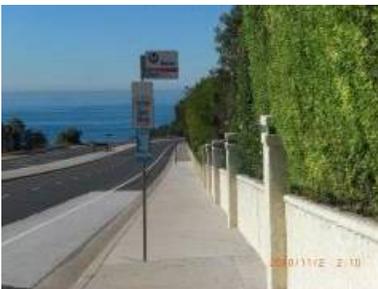
Keynote 36

Field Condition	
02.11A - Bus Stop Pad Size - Bus stop pad does not measure 8' long (measured from the curb or vehicle roadway edge) by 5' wide (measured parallel to the vehicle roadway).	1991 ADAAG 10.2.1
	2004 ADAAG 810.2.2
	2007 CBC 1121B.1
	Other
Existing Condition: Bus pad 7'-5" long by 5' wide.

Corrective Action
006 - Concrete Walk - Remove non-compliant pavement and replace with new concrete (area as shown on the drawings). The walkway slope shall not exceed 5% along the POT and cross slope shall not exceed 2%.
Additional Comments:

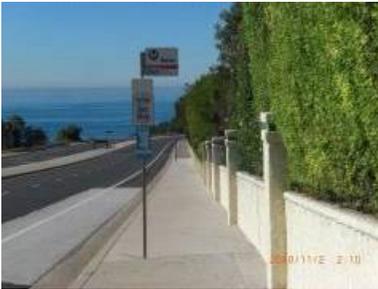
Keynote 37

Field Condition	
02.12A - Bus Stop Pad Slope Parallel to Roadway - Bus stop pad is not at the same slope as the roadway in the direction parallel to the roadway.	1991 ADAAG 10.2.1
Existing Condition: 9.1% RS at bus pad , 10.4% RS at the road.	2004 ADAAG 810.2.4
	2007 CBC 1121B.2.1
	Other

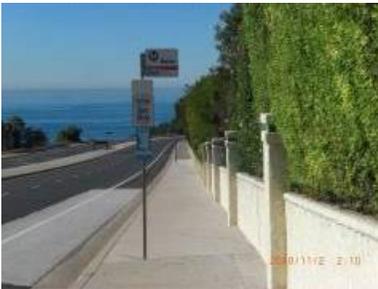
Keynote 38

Field Condition	
02.12B - Bus Stop Pad Slope Perpendicular to Roadway - Bus stop pad slope perpendicular to the roadway exceeds 2%.	1991 ADAAG 10.2.1
Existing Condition: 4.4% CS.	2004 ADAAG 810.2.4
	2007 CBC 1121B.2.1
	Other

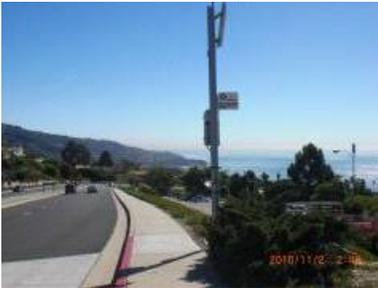
Keynote 39

Field Condition	
02.11A - Bus Stop Pad Size - Bus stop pad does not measure 8' long (measured from the curb or vehicle roadway edge) by 5' wide (measured parallel to the vehicle roadway).	1991 ADAAG 10.2.1
	2004 ADAAG 810.2.2
	2007 CBC 1121B.1
	Other
Existing Condition: Bus pad 5' long by 5' wide.

Corrective Action	
006 - Concrete Walk - Remove non-compliant pavement and replace with new concrete (area as shown on the drawings). The walkway slope shall not exceed 5% along the POT and cross slope shall not exceed 2%.	
Additional Comments:

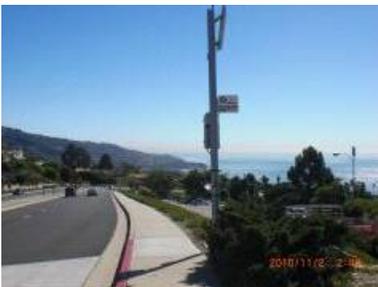
Keynote 40

Field Condition	
02.12A - Bus Stop Pad Slope Parallel to Roadway - Bus stop pad is not at the same slope as the roadway in the direction parallel to the roadway.	1991 ADAAG 10.2.1
	2004 ADAAG 810.2.4
	2007 CBC 1121B.2.1
	Other
Existing Condition: 8% RS at bus pad , 10.8% RS at the road.

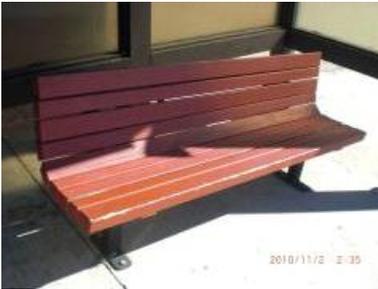
Keynote 41

Field Condition	
02.17 - Other - Passenger Loading Zones - See Additional Comments	1991 ADAAG -
Existing Condition: Bench (16" high seat, 14" deep seat, 14 1/2" high back support).	2004 ADAAG -
	2007 CBC -
	Other

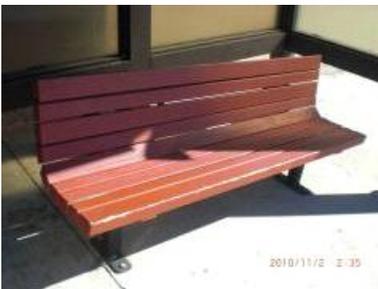
Keynote 42

Field Condition	
02.13A - Bus Stop Shelter - Clear Floor Area - Clear floor area of 30" by 48" is not completely within the shelter.	1991 ADAAG 10.2.1(2)
Existing Condition: No WC space provided within the shelter.	2004 ADAAG 810.3
	2007 CBC 1121B.2.1
	Other

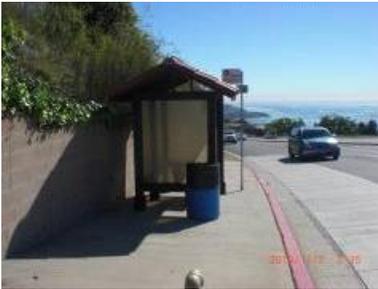
Keynote 43

Field Condition	
02.12A - Bus Stop Pad Slope Parallel to Roadway - Bus stop pad is not at the same slope as the roadway in the direction parallel to the roadway.	1991 ADAAG 10.2.1
Existing Condition: 7.7% to 9.4 RS at bus pad, 6.5% to 7.4% RS at the road.	2004 ADAAG 810.2.4
	2007 CBC 1121B.2.1
	Other

Corrective Action
006 - Concrete Walk - Remove non-compliant pavement and replace with new concrete (area as shown on the drawings). The walkway slope shall not exceed 5% along the POT and cross slope shall not exceed 2%.
Additional Comments:

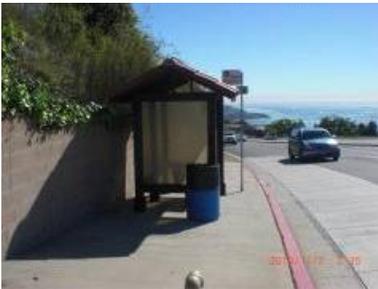
Keynote 44

Field Condition	
02.12B - Bus Stop Pad Slope Perpendicular to Roadway - Bus stop pad slope perpendicular to the roadway exceeds 2%.	1991 ADAAG 10.2.1
Existing Condition: 3.4% to 3.6% CS.	2004 ADAAG 810.2.4
	2007 CBC 1121B.2.1
	Other

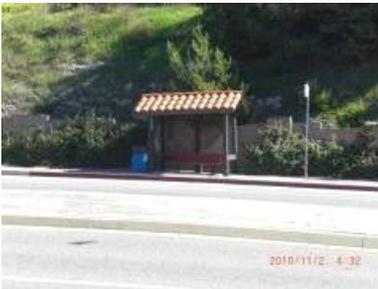
Keynote 45

Existing Condition: Bench (16" high seat, 13 1/2" deep seat, 14 1/2" high back support).

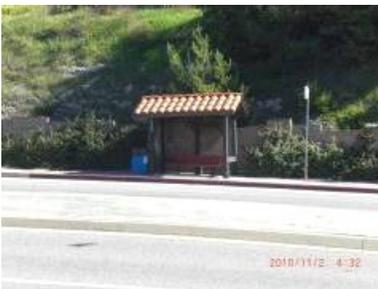
Keynote 46

Existing Condition: No WC space provided within the shelter.

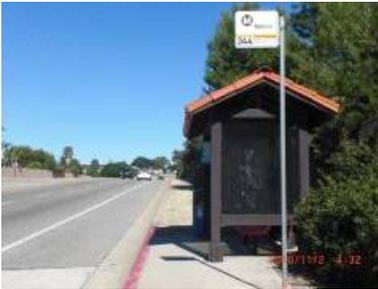
Keynote 47

Field Condition		
02.11B - Bus Stop Pad and Accessible Route - Bus stop pad is not connected to an accessible route.	1991 ADAAG	10.2.1
Existing Condition: No accessible route to bus stop.	2004 ADAAG	810.2.3
	2007 CBC	1121B.1
	Other

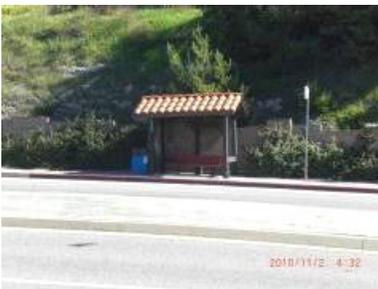
Keynote 48

Field Condition		
02.11A - Bus Stop Pad Size - Bus stop pad does not measure 8' long (measured from the curb or vehicle roadway edge) by 5' wide (measured parallel to the vehicle roadway).	1991 ADAAG	10.2.1
Existing Condition: Bus pad 6' long by 5' wide.	2004 ADAAG	810.2.2
	2007 CBC	1121B.1
	Other

Corrective Action
006 - Concrete Walk - Remove non-compliant pavement and replace with new concrete (area as shown on the drawings). The walkway slope shall not exceed 5% along the POT and cross slope shall not exceed 2%.
Additional Comments:

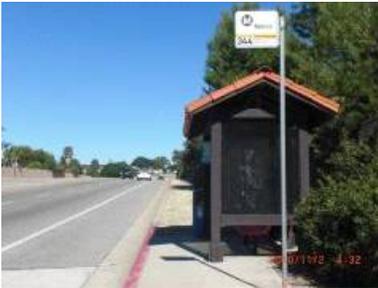
Keynote 49

Field Condition	
02.12A - Bus Stop Pad Slope Parallel to Roadway - Bus stop pad is not at the same slope as the roadway in the direction parallel to the roadway.	1991 ADAAG 10.2.1
Existing Condition: 4.7% to 5.7% RS at bus pad, 5.1% to 5.7% RS at the road.	2004 ADAAG 810.2.4
	2007 CBC 1121B.2.1
	Other

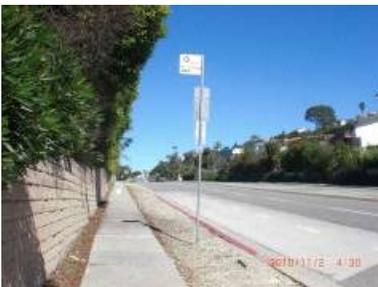
Keynote 50

Field Condition	
02.11A - Bus Stop Pad Size - Bus stop pad does not measure 8' long (measured from the curb or vehicle roadway edge) by 5' wide (measured parallel to the vehicle roadway).	1991 ADAAG 10.2.1
Existing Condition: Bus pad 3'-11" long by 5' wide.	2004 ADAAG 810.2.2
	2007 CBC 1121B.1
	Other

Corrective Action
006 - Concrete Walk - Remove non-compliant pavement and replace with new concrete (area as shown on the drawings). The walkway slope shall not exceed 5% along the POT and cross slope shall not exceed 2%.
Additional Comments:

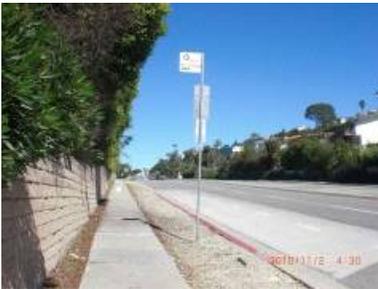
Keynote 51

Field Condition	
02.12B - Bus Stop Pad Slope Perpendicular to Roadway - Bus stop pad slope perpendicular to the roadway exceeds 2%.	1991 ADAAG 10.2.1
Existing Condition: 4.5% CS.	2004 ADAAG 810.2.4
	2007 CBC 1121B.2.1
	Other

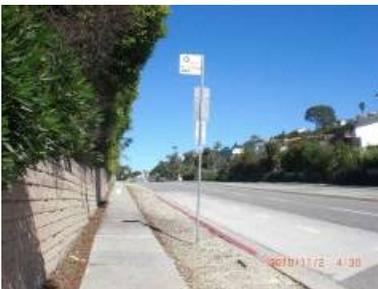
Keynote 52

Field Condition	
02.11B - Bus Stop Pad and Accessible Route - Bus stop pad is not connected to an accessible route.	1991 ADAAG 10.2.1
Existing Condition: No accessible route to bus stop.	2004 ADAAG 810.2.3
	2007 CBC 1121B.1
	Other

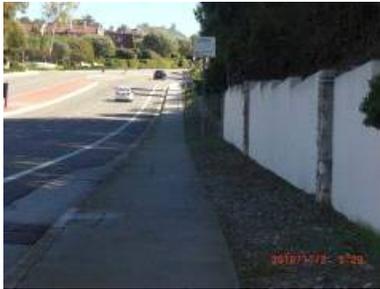
Keynote 57

Field Condition	
02.12B - Bus Stop Pad Slope Perpendicular to Roadway - Bus stop pad slope perpendicular to the roadway exceeds 2%.	1991 ADAAG 10.2.1
Existing Condition: 5.0% CS.	2004 ADAAG 810.2.4
	2007 CBC 1121B.2.1
	Other

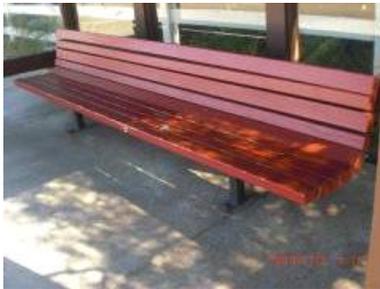
Keynote 58

Field Condition	
02.17 - Other - Passenger Loading Zones - See Additional Comments	1991 ADAAG -
Existing Condition: Bench (16" high seat, 14" deep seat, 15" high back support).	2004 ADAAG -
	2007 CBC -
	Other

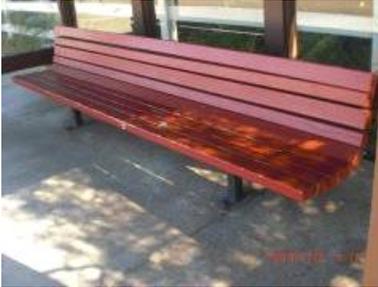
Keynote 59

Field Condition	
02.13A - Bus Stop Shelter - Clear Floor Area - Clear floor area of 30" by 48" is not completely within the shelter.	1991 ADAAG 10.2.1(2)
Existing Condition: No WC space provided within the shelter.	2004 ADAAG 810.3
	2007 CBC 1121B.2.1
	Other

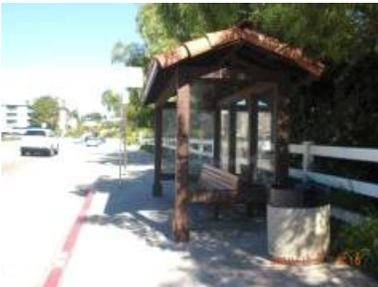
Keynote 60

Field Condition	
02.17 - Other - Passenger Loading Zones - See Additional Comments	1991 ADAAG -
Existing Condition: 2.2% to 2.3% CS.	2004 ADAAG -
	2007 CBC -
	Other
