THE CITY OF
RANCHO PALOS VERDES

Infrastructure Report Card

Revised May 14, 2014

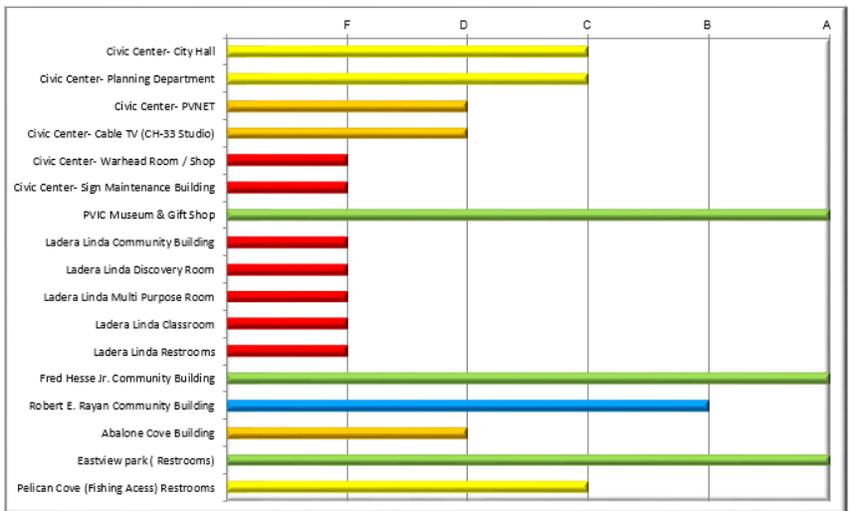
Figure 5.1: Grades of City-owned Buildings

The Overall Grade for the public buildings is D. The overall grade was calculated as the average of the individual grades of the 17 buildings. **Figure 5.2** below provides the grades of the individual buildings:

To upgrade the public buildings one grade up (from D to C), the city needs to perform retrofitting for some buildings and system replacement for others. This includes the replacement of the mechanical and electrical systems for the City Hall Buildings and Ladera Linda Community Center Buildings, and the retrofitting of Ryan Community Building and Abalone Cove Park Building. The upgrade also includes the necessary ADA Compliance improvements for items identified as the “Potential Safety Hazard” and “Severe” barriers (the most severe) in the City’s ADA Assessment Compliance Report.

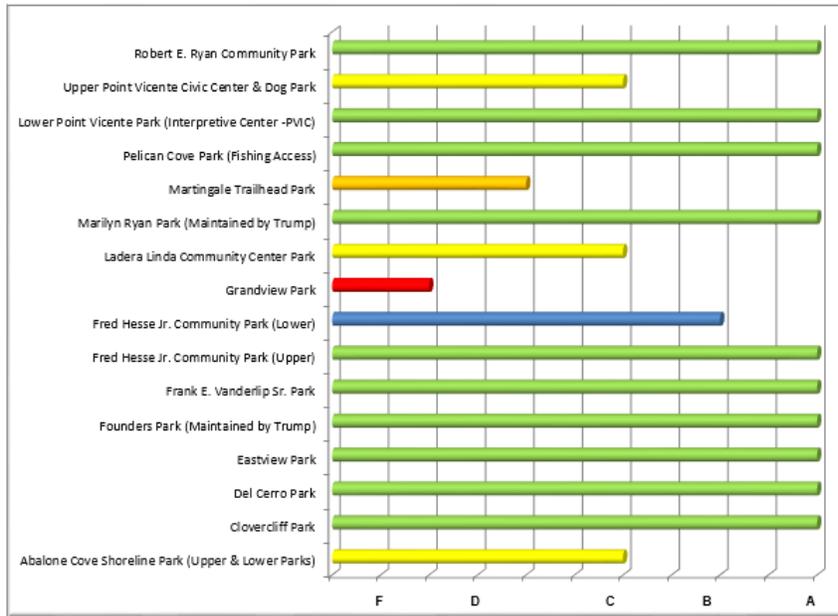
Figure 6.2: Park Grades

The Overall Grade for the parks is B. The overall grade was calculated as the average of the individual grades of the 15 Parks. **Figure 6.2** below provides the grades of the individual parks:

It is important to mention that the current very good condition of the City parks is the result of the recent improvement/renovation projects. Maintaining this grade requires the continuity of these projects.

Investments will be needed to upgrade the parks system from B to A. This includes Abalone Cove Shoreline Park Parking Improvement; Abalone Cove Shoreline Parking Lot Improvements; Lower Hesse Park Improvement; Hesse Park parking lot resurfacing; Minor improvements to Civic Center park; Ryan Park Parking Lot Improvements; Ladera Linda Park site Improvement; Lower Point Vicente Park Improvements; Grandview Park Improvements; Gateway Park improvements; and all ADA compliance improvements for all parks. ADA Compliance improvements for the “Potential Safety Hazard” and “Severe” barriers (the most severe)

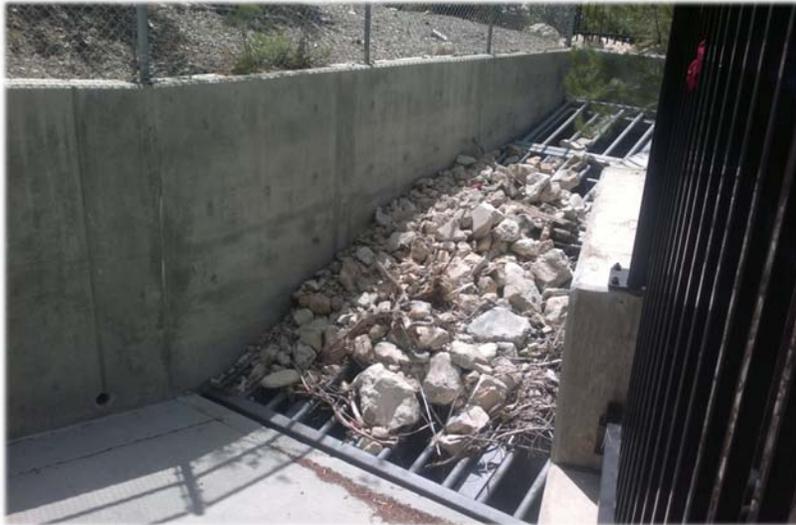
Figure 8.1: McCarrell Canyon Storm Drain Inlet North of PVD South

The City's landscape consists of a diverse topography that consists of undeveloped hilly terrain and canyons. As a result, the City is more vulnerable to flooding from nearby canyons that carry runoff during rainstorms. To protect property and loss of life, the City's storm drain system has been carefully designed to capture the maximum amount of storm water through numerous inlets, including the newly constructed McCarrell Canyon Storm Drain inlet shown below in **Figure 8.1**:

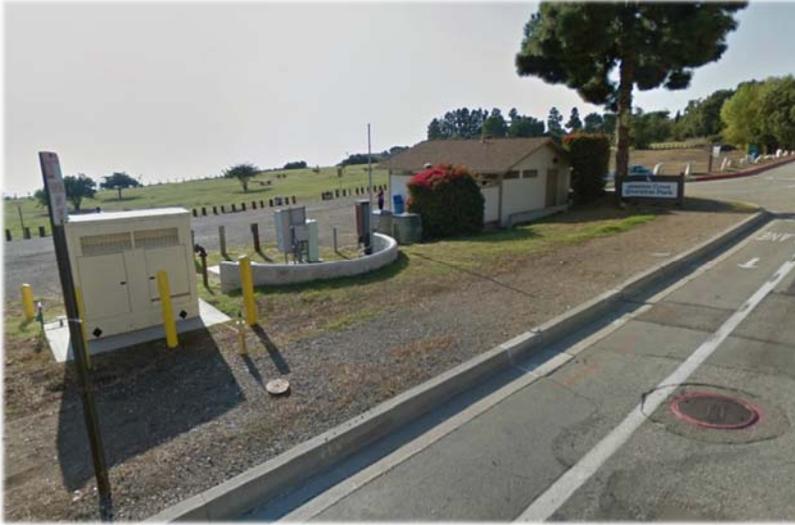
Figure 10.2: Abalone Cove Shoreline Park Sewer Lift Station

As mentioned previously, the District, as well as the City overall, has a diverse, hilly terrain. The terrain varies from elevations at sea level to over 1,400 feet above sea level. As a result, the District has to utilize a combination of gravity pipes, grinder pumps, low-pressure sewer mains, lift stations, and high pressurized force mains. According to the 2009 Master Plan, the District's system was installed in 2001 to replace septic systems in landslide areas. There are 130 manholes, 1 diversion structure, approximately 19,000 linear feet of gravity pipeline, 19,615 linear feet of low pressure pipe, and 2,505 linear feet of force main. Overall, there are 44 grinder pumps in the District, with 41 of them serving single family homes and 3 duplex grinder pumps serving two or more residences. There are 4 lift stations serving the District, one of which is the Abalone Cove Shoreline Park Lift Station shown in **Figure 10.2** below:

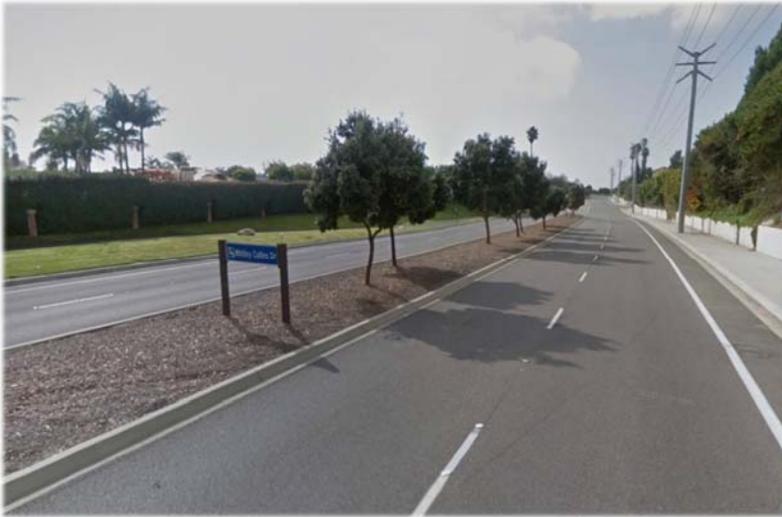
Figure 11.1: Crest Rd west of Crenshaw Blvd looking southwest

The City maintains a right of way network that consists of over 142 miles of local streets and major arterials. Due to the demographics of the City, local streets comprise the majority of the City's roadways at approximately 75% of the overall length or 106 miles. All of the City's roadways consist of asphalt-concrete (AC), with over 23 million square feet of AC pavement. In addition to the road network, the City also maintains traffic signals, safety lights, and flashers. The City's right of way network serves both motorists as well as bicyclists and pedestrians with nearly all major arterials consisting of a sidewalk and bike lanes. **Figure 11.1** below provides a sample of the condition of the City's streets.

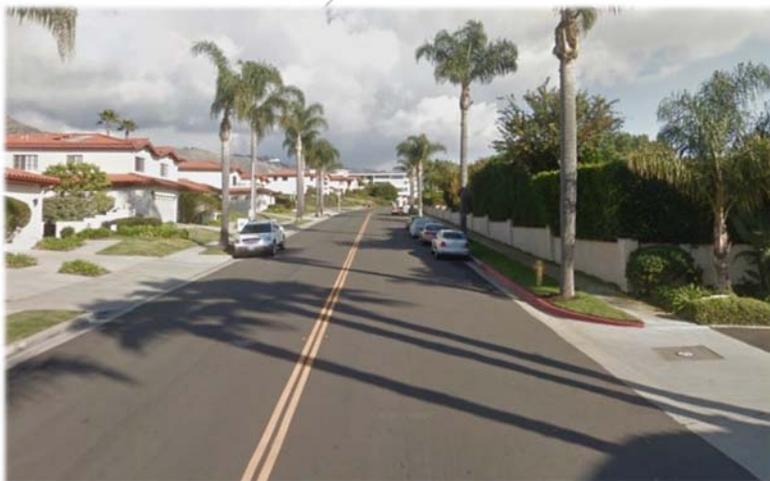
Figure 11.3: Beach View Drive Looking East

One major factor that makes the City's streets so appealing to both motorists and cyclists is the condition of the pavement, not only on major arterials but throughout the City's streets as whole. The 2009 Pavement Management System (PMS) revealed that the City's streets received an overall score of 84.5 on the Pavement Condition Index (PCI) and 95.3 on the Structural Index (SI), while arterials received a score of 76.8 on the PCI index and 90.8 on the SI index. The PCI and SI indexes focus on different aspects of pavement conditions. Residential streets received a score of 87.6 on the PCI Index and a score of 97.1 on the SI index. The 2013 PMS update revealed that the City's streets received an overall score of 82 on the PCI index. PCIs greater than 86 are considered to be "very good" and SIs greater than 90 are considered to be "good". Figure 11.2 below shows a sample condition of residential streets:

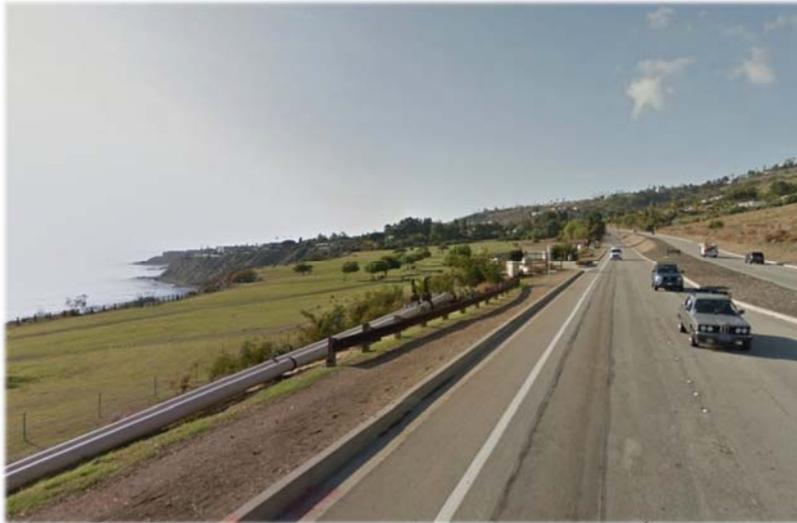
Figure 12.1: Palos Verdes Drive South along Landslide Area

A significant portion of the City lies within a natural landslide area that is composed of several component landslides. Overall, these landslides move southerly towards the ocean into the Abalone Cove, Sacred Cove, and Portuguese Bend shorelines. Approximately 1,000 acres, or 12% of the City's 13.6 square mile limits, are affected by landslide. The landslide affects not only surface streets and buildings, but also other infrastructure as well, including below grade utilities. **Figure 12.1** below shows part of the City's landscape that is located within the landslide region:

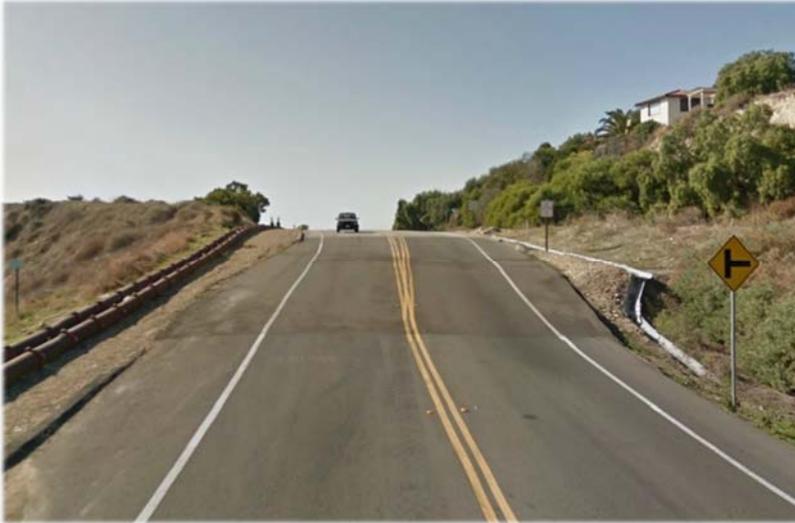
Figure 12.2: Landslide Damage to Palos Verdes Drive South

There are over a dozen landslides that make up what is known as the City's landslide area along Palos Verdes Drive South. The three main landslides in the City are the Abalone Cove, Portuguese Bend, and Klondike Canyon Landslides. The landslides are caused primarily by groundwater which decreases the strength of clays and adds additional weight to subsurface soils. Rainfall is the primary contributor to groundwater. The City has three main drainage basins within the landslide regions that collect rainwater and allow it to percolate to the soils below. These drainage basins include the Altamira Canyon Drainage Basin, the Portuguese Canyon/Paintbrush Canyon Drainage Basin, and the Klondike Canyon Drainage Basin. It is estimated that 50-75% of storm water infiltrates the canyons to become groundwater, primarily through fractures and expansive soils. Although the City has established drainage facilities within these canyons, the landslide movement causes damage to drainage facilities which enables more storm water to enter the surface below. **Figure 12.1** shows a damaged half corrugated pipe system along Palos Verdes Drive South resulting from continuous landslide movement:
