Hazardous Material Survey

City Hall Administration & Planning Building
39040 Hawthorne Boulevard
Rancho Palos Verdes, California

PSI Project # 0588313-1

Date: September 10, 2010

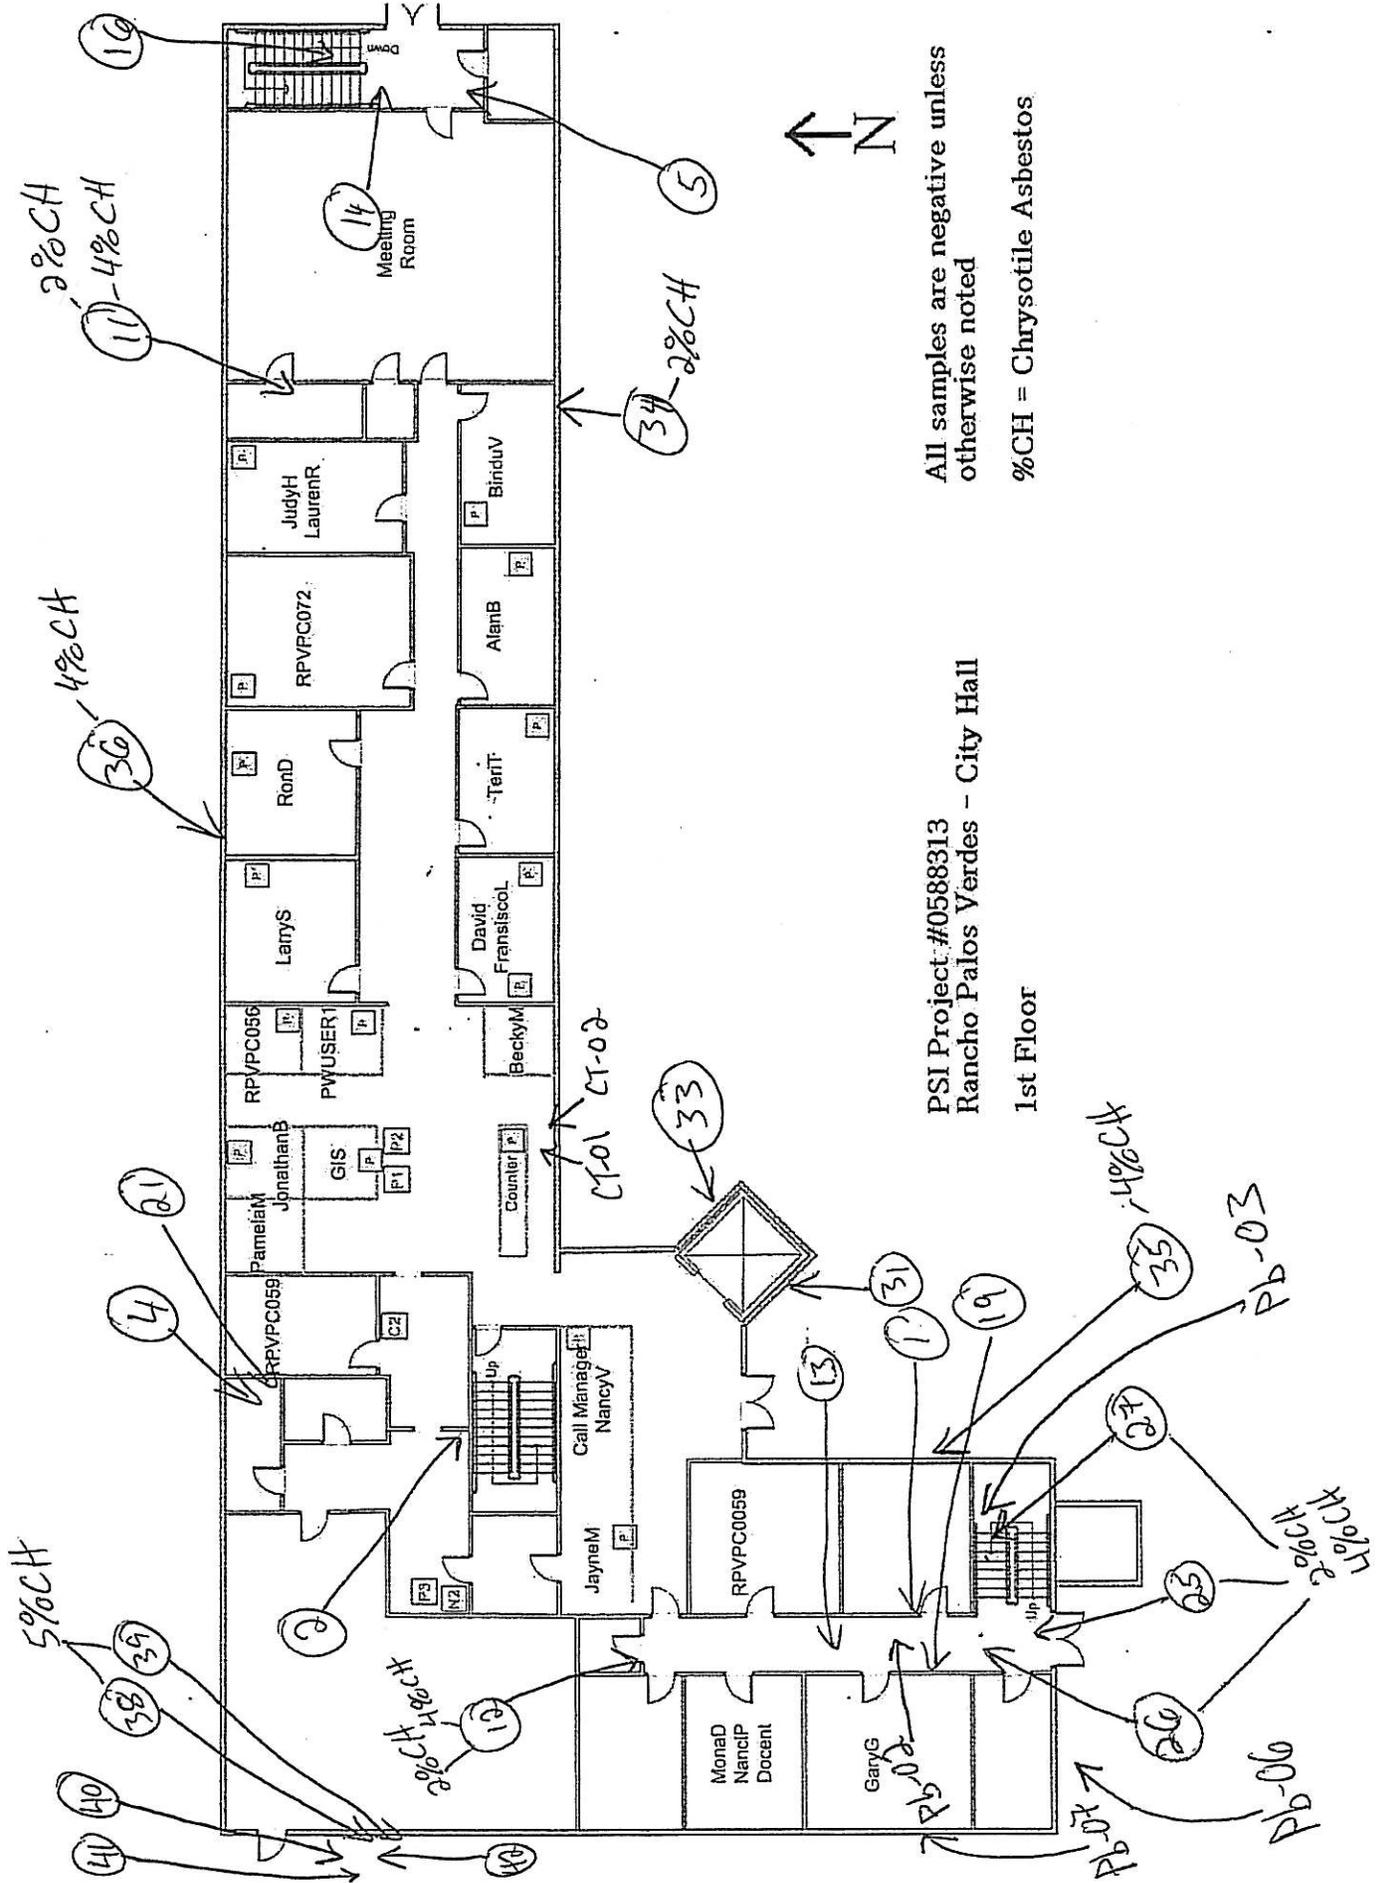
All samples are negative unless otherwise noted

%CH = Chrysotile Asbestos

4%CH

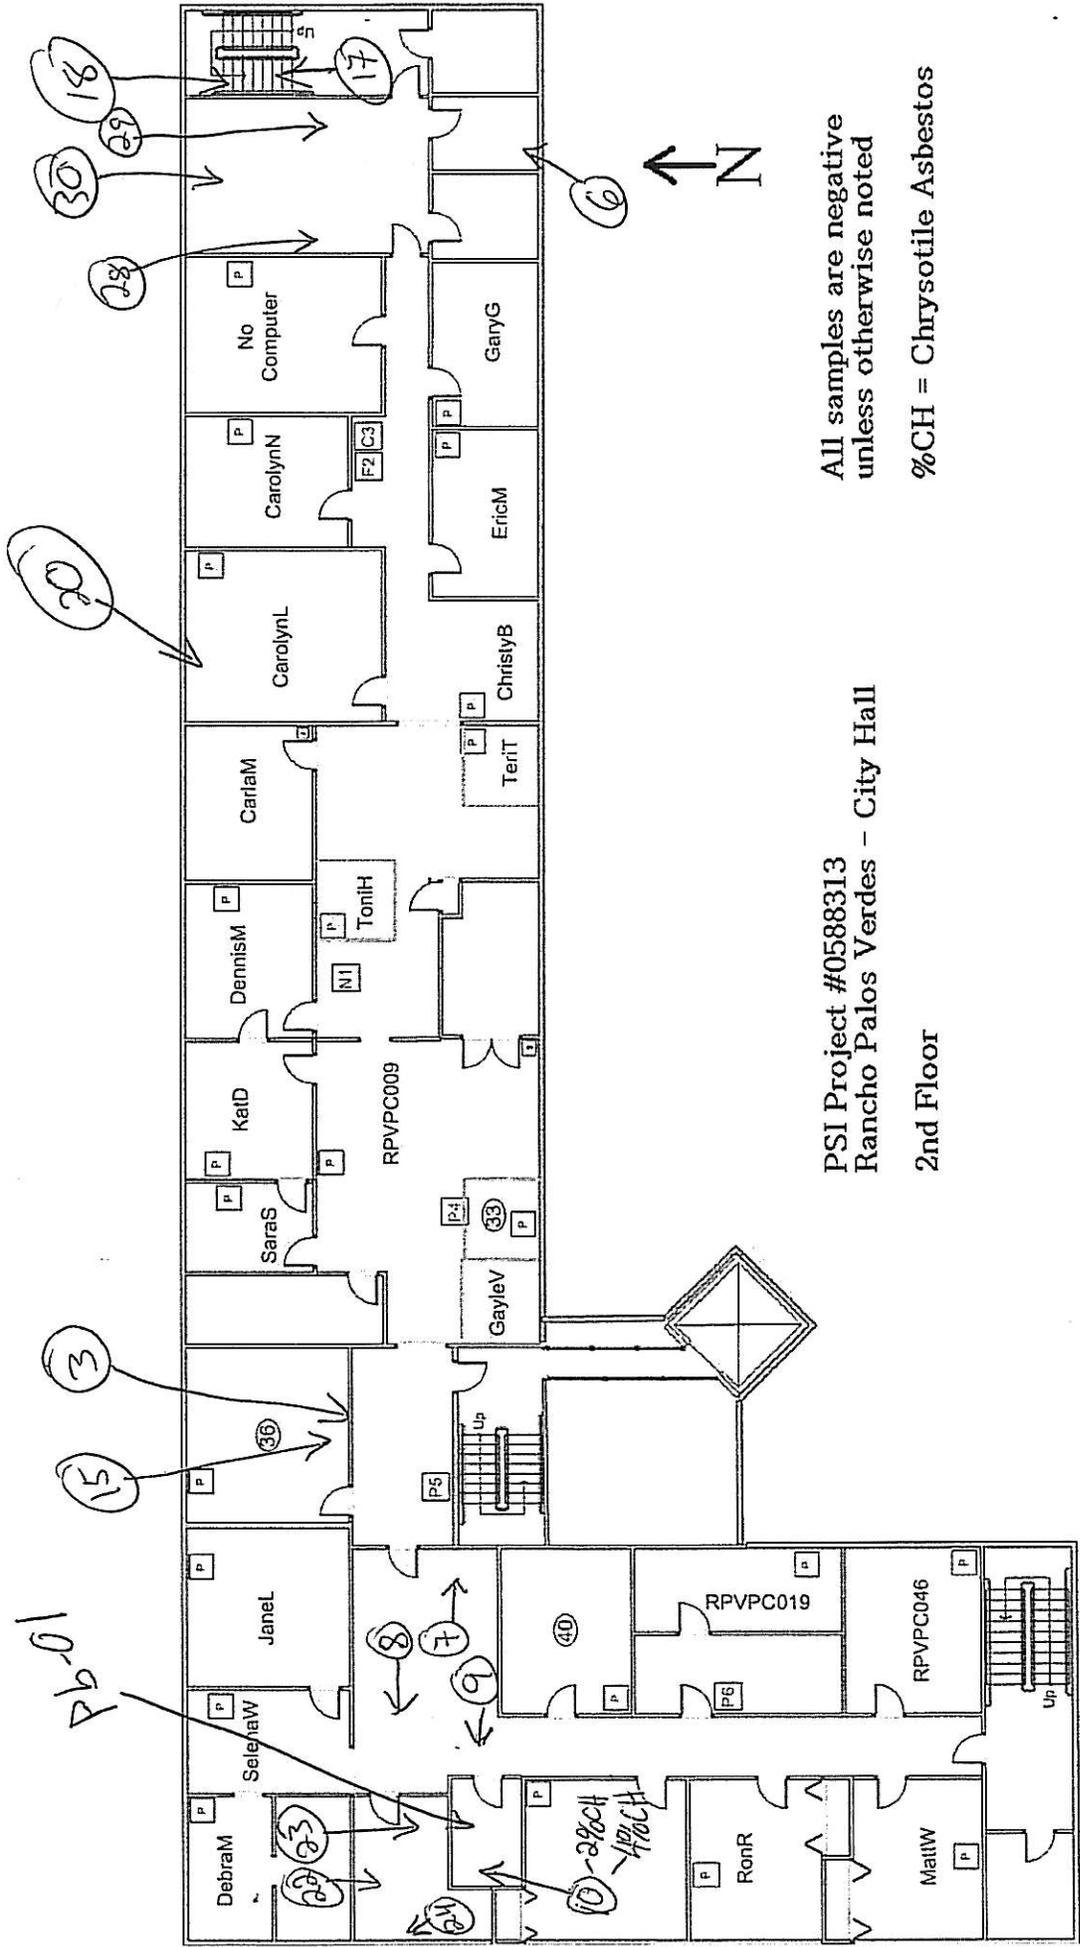
2nd Floor

All samples are negative unless otherwise noted

%CH = Chrysotile Asbestos

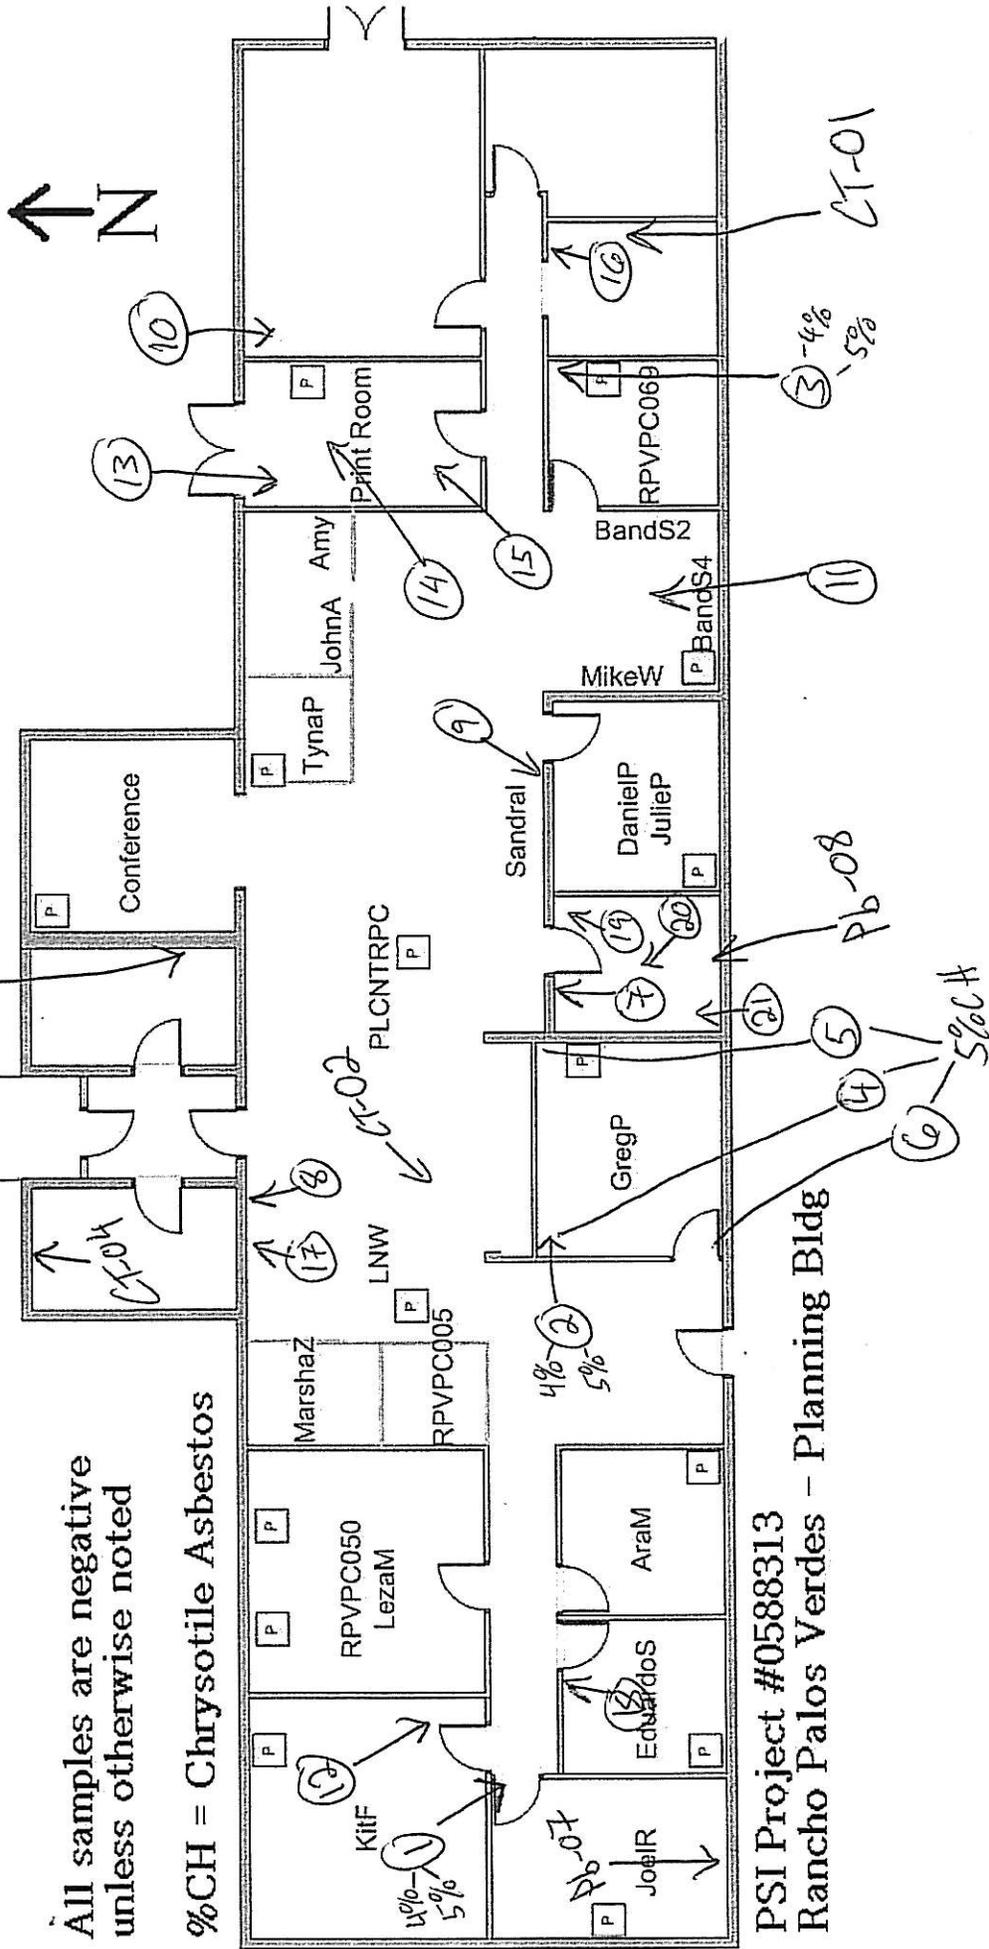
Rancho Palos Verdes - Planning Bldg

All samples are negative unless otherwise noted

%CH = Chrysotile Asbestos

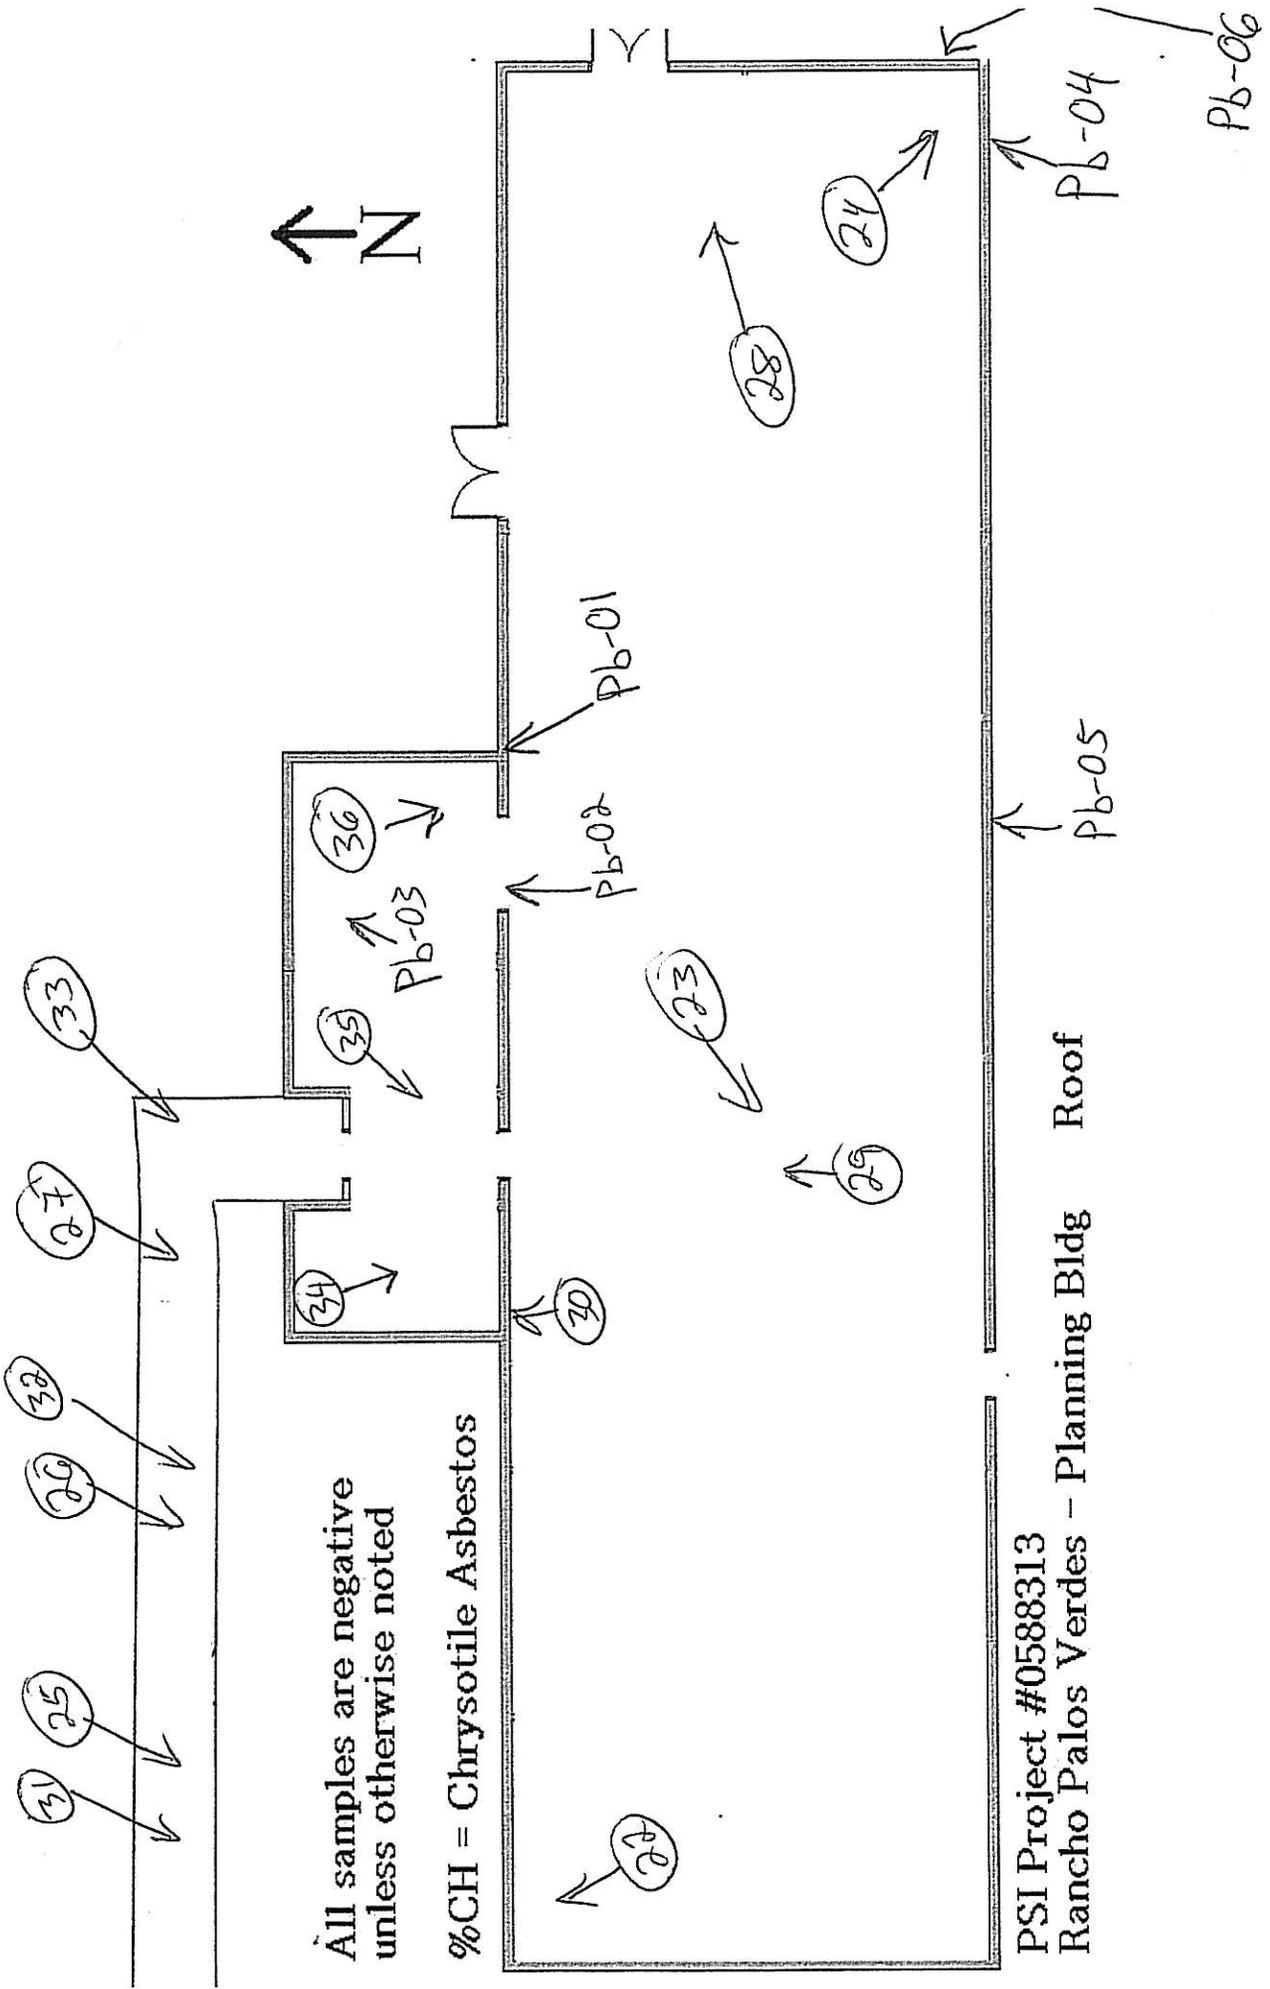
All samples are negative unless otherwise noted

%CH = Chrysotile Asbestos
