**Re: Infrared Inspections for Planning Department and  
Ladera Linda Community Center Buildings J&K**

Certified Thermography Report  
for

**Planning Department Building**  
30940 Hawthorne Blvd.

**Ladera Linda Community Center**  
Recreation Room Building J & K  
32201 Forrestal Drive

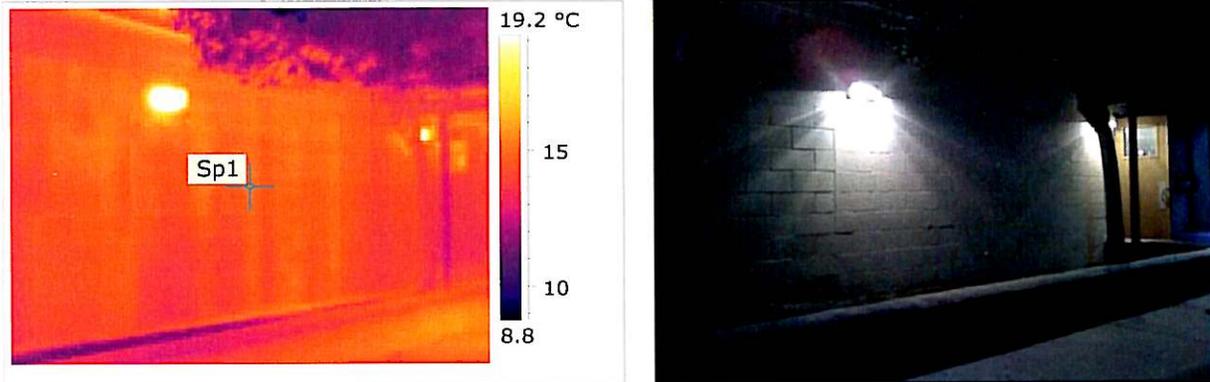
**Picture 1. Captured at: (Planning Department  
 Date & Time: 3/12/2010 7:13:32 PM**

<b>Comment:</b> Thermal differential inadequate for IR imaging.
<b>Recommendation:</b> Re-image later

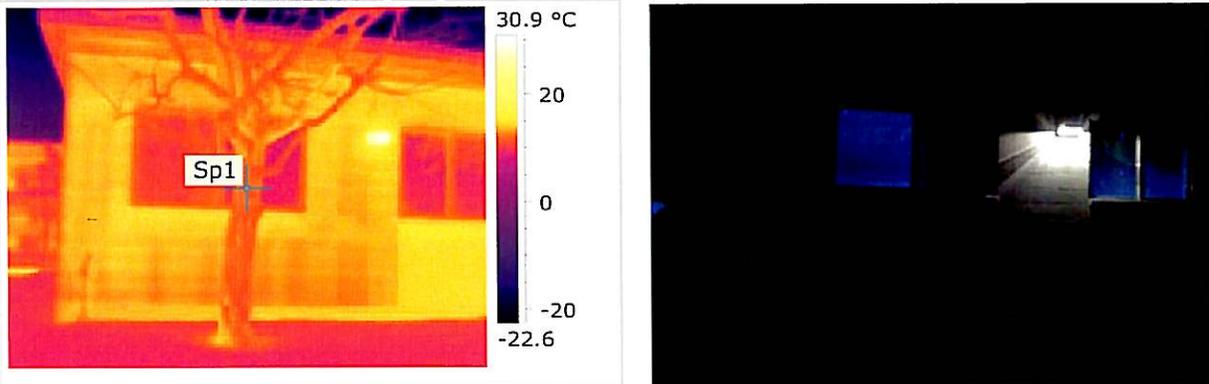
**Picture 2. Captured at: (South Elevation SW Quadrant)  
 Date & Time: 3/13/2010 7:03:45 PM**

<b>Comment:</b> Note solid bright section below window on right. Graphic and block joint alignment indicate door opening existed when originally constructed.
<b>Recommendation:</b> None

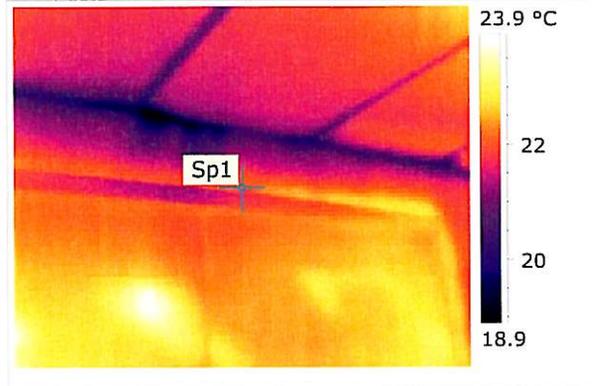
**Picture 3. Captured at: (South Elevation SE Quadrant)**

**Comment:** Bright spot under window could be a combination of metal flashing and energy loss. Difficult to know without further investigation and testing

**Recommendation:** Make small penetration to establish substrate material or presence of metal flashing.

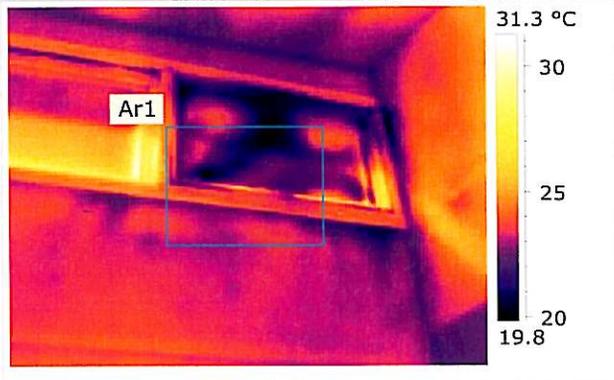
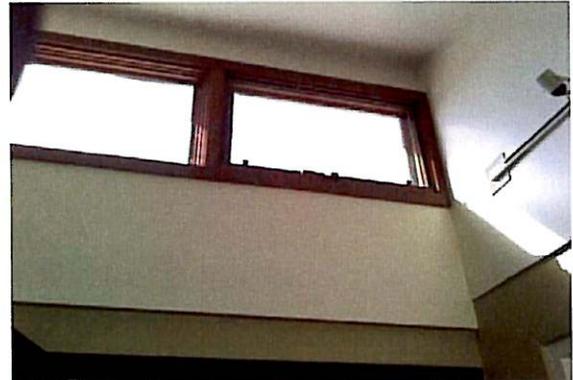
**Picture 4. Captured at: (Bathroom window above roof line)**

**Comment:** Significant air-infiltration in and around bathroom window above roof line

**Recommendation:** Caulk and seal from interior and exterior window may need to be removed, replaced or reinstalled. Further investigation required

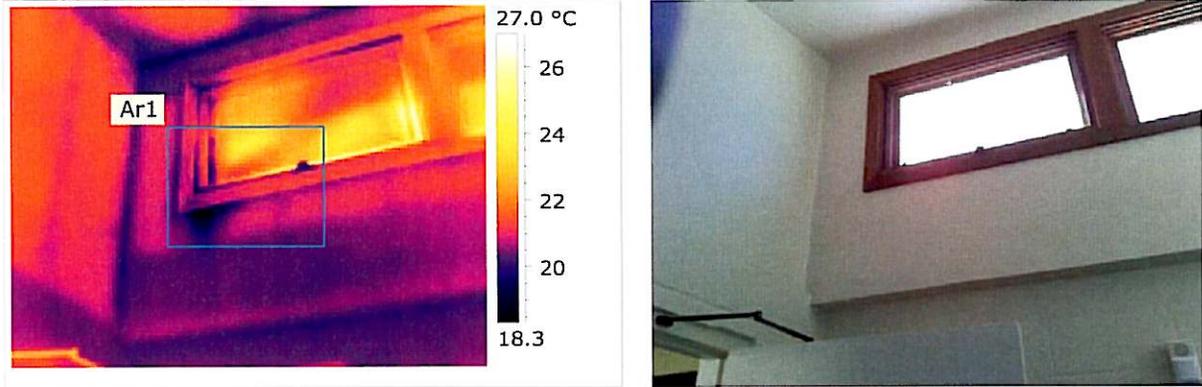
**Picture 5. Captured at: (Bathroom window above roof line)**

**Comment:** Lid-line and window air-infiltration

**Recommendation:** Caulk and seal from interior and exterior, Note: window may need to be replaced and/or removed and re-installed further investigation required

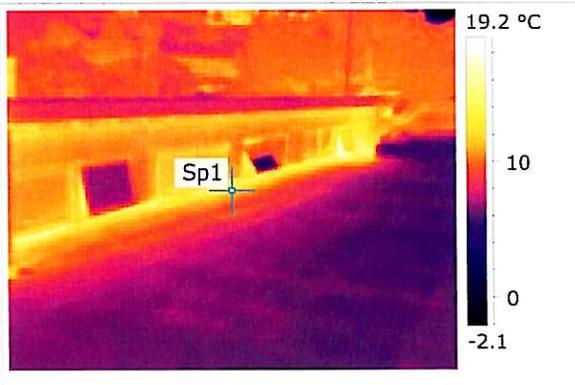
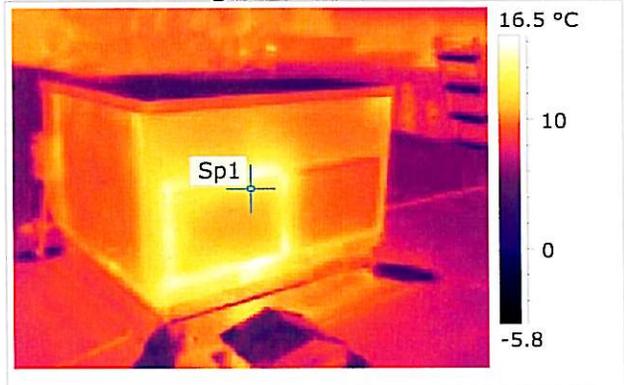
**Picture 6. Captured at: (Planning Roof 3/13 7:45:21 PM)**

**Comment:** Hot spot below windows is more than likely flashing. However the hot spots around the windows are points of interest regarding energy loss.

**Recommendation:** See interior images above for reasonable confirmation.

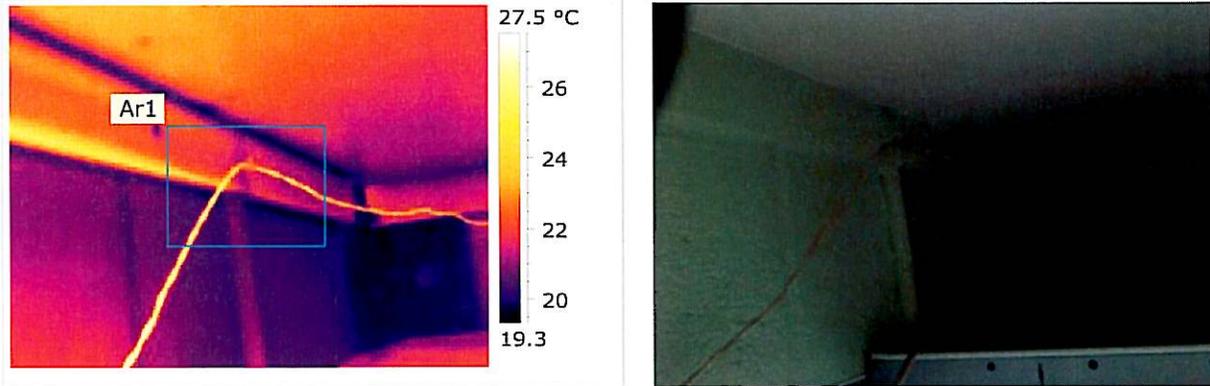
**Picture 7. Captured at: (Inside Ceiling SW Corner office)**

**Comment:** Black line above and below wood baton indicates colder air-infiltration. Note: This infiltration is present without the use of blower door.  
**Recommendation:** See same image below using blower door. Cable indicates potential phantom electrical issue.

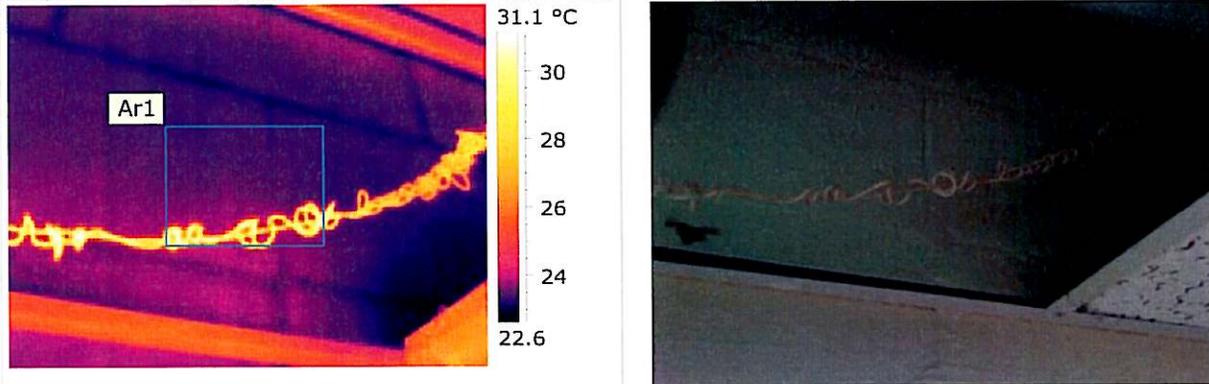
**Picture 8. (Inside Ceiling adjacent (west) to SW Corner office)**

**Comment:** Black line above and below wood baton indicates colder air-infiltration. Note: This infiltration is present without the use of blower door.

**Recommendation:** See same image below using blower door. Cable indicates potential phantom electrical issue.

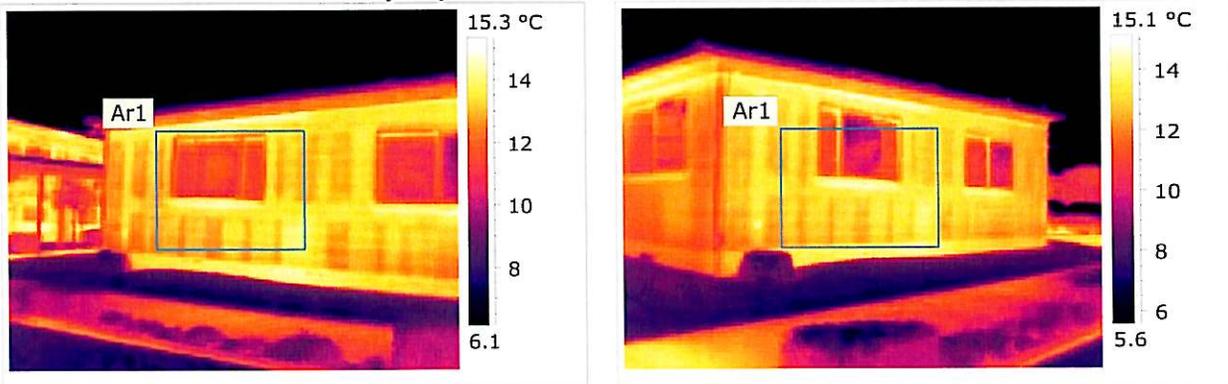
**Picture 9. Captured at: (West Elevation)**

**Comment:** Thermal signature almost achieved

**Recommendation:** Further investigation and testing recommended

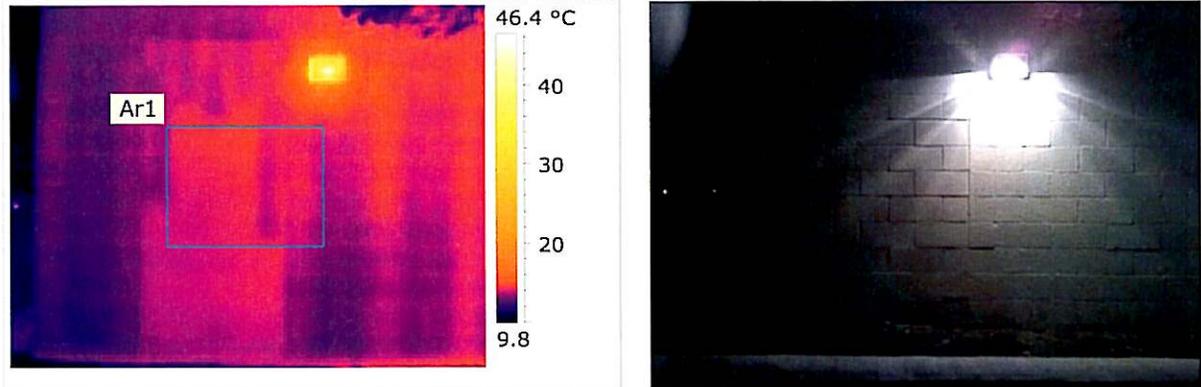
**Picture 10. Captured at: (East Elevation)**

**Comment:** Wall still acclimating to addressable thermal signature

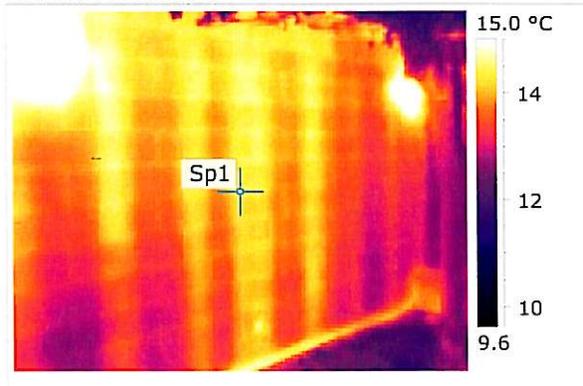
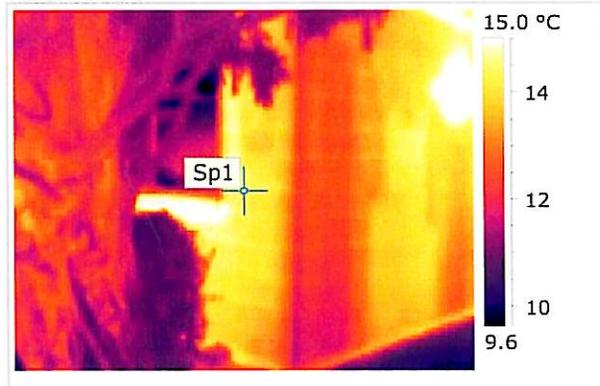
**Picture 11. Captured at: (East and SE Corner Elevation)**  
**South Elevation**

**Comment:** Note picture on left with double grouted cells in center. Picture on right indicates prior doorway during original construction.

**Recommendation:** Further investigation and testing recommended

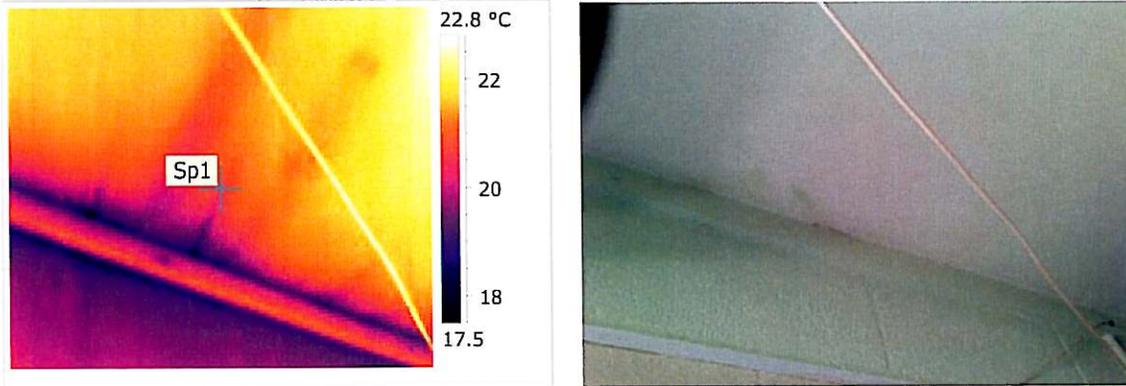
**Picture 12. Captured at: (SW Office)**

**Comment:** Lid line air-infiltration using blower door

**Recommendation:** Perimeter tile removed. Baton exposed along with underside of finished roof joints. Caulk and seal wood baton all sides. Further investigation required

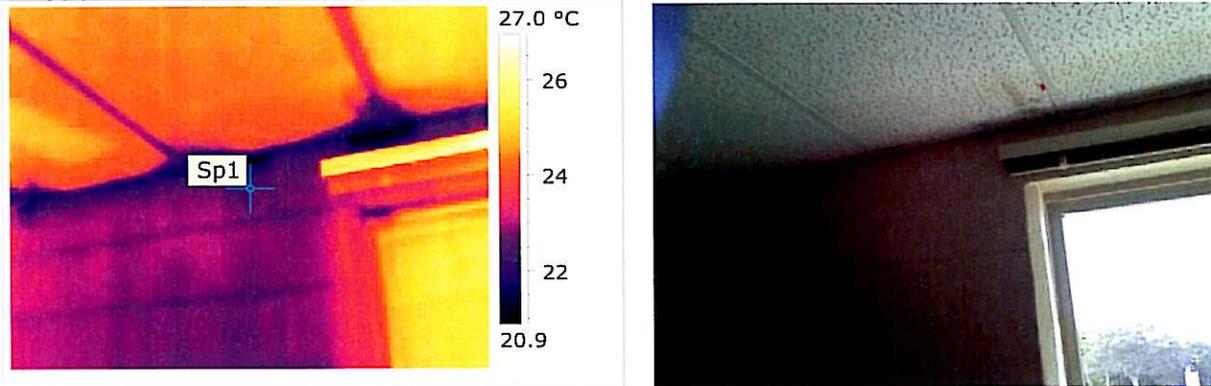
**Picture 13. Captured at: (Office adjacent to SW Office)**

**Comment:** View of lid line air leaks with tile in place

**Recommendation:** Remove perimeter tile caulk and seal wood baton all sides. Further investigation required

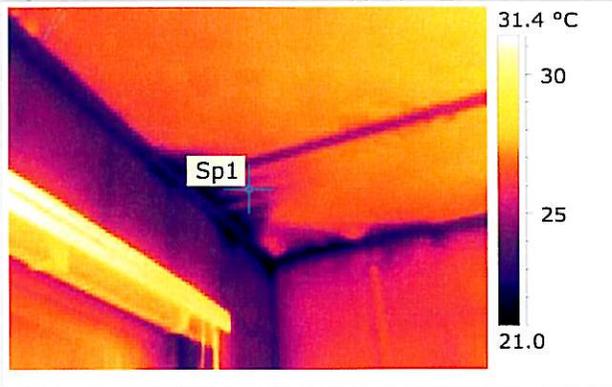
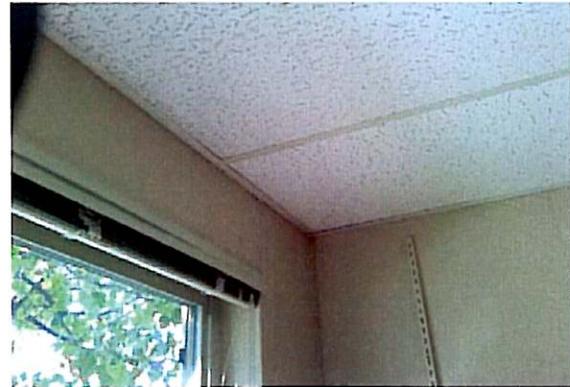
Picture 15. Captured at: (South Elevation Office)

**Comment:** Lid line air-infiltration

**Recommendation:** Remove perimeter tile caulk and seal wood baton all sides. Further investigation required.

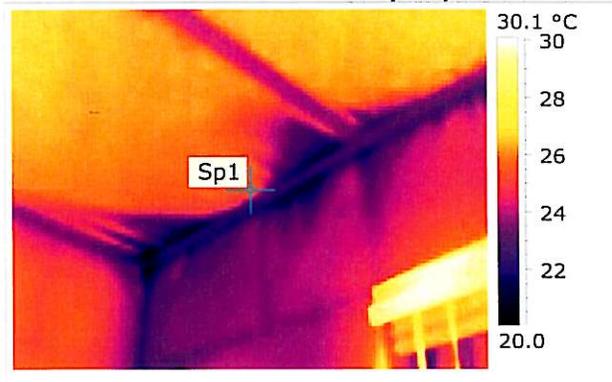
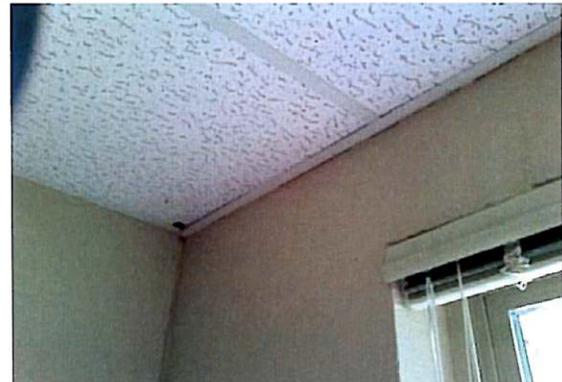
**Picture 16. Captured at: (South Elevation Office)**

**Comment:** Lid line air-infiltration

**Recommendation:** Remove perimeter tile caulk and seal wood baton all sides. Further investigation required

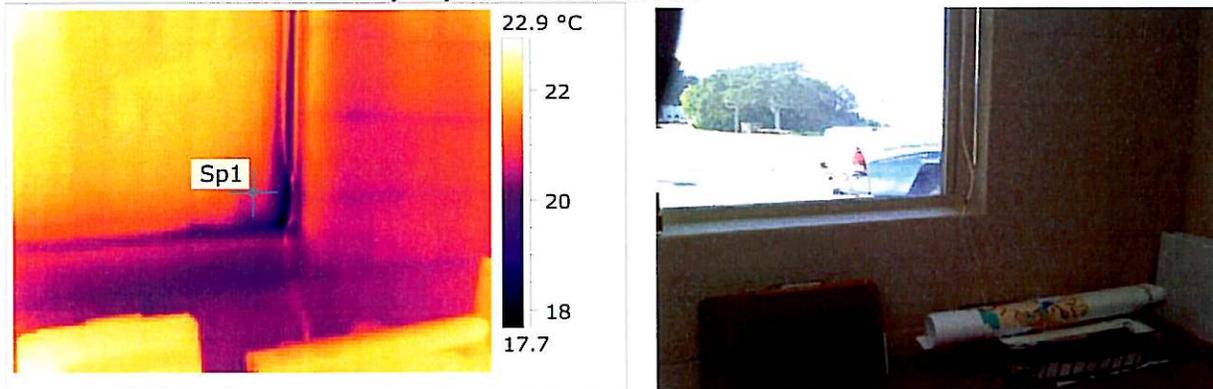
**Picture 17. Captured at: (South Elevation Office)**

**Comment:** Lower right corner air-infiltration

**Recommendation:** Caulk and seal as needed from interior and exterior Further investigation needed.

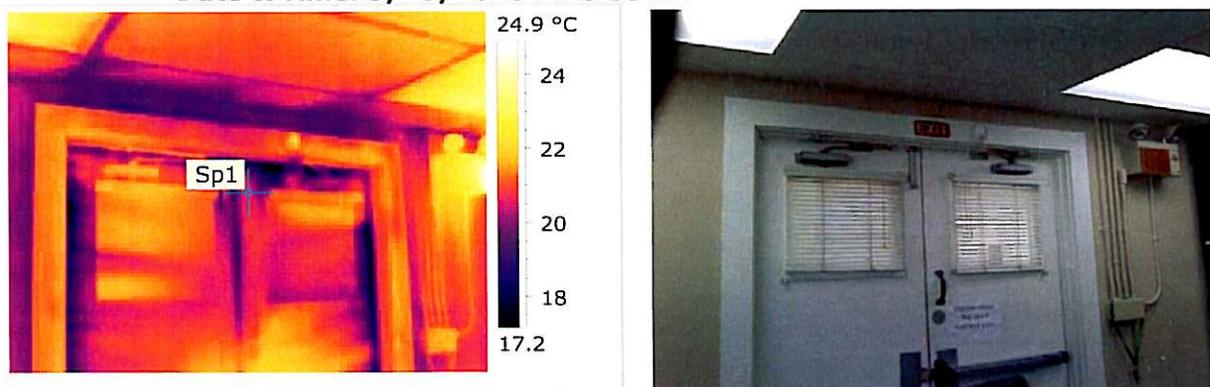
**Picture 18. Captured at: (Exit doors Conference room)**

**Comment:** Ceiling tile and door air-infiltration

**Recommendation:** Caulk and seal as needed. Removal of door moldings may be required. Further investigation needed.

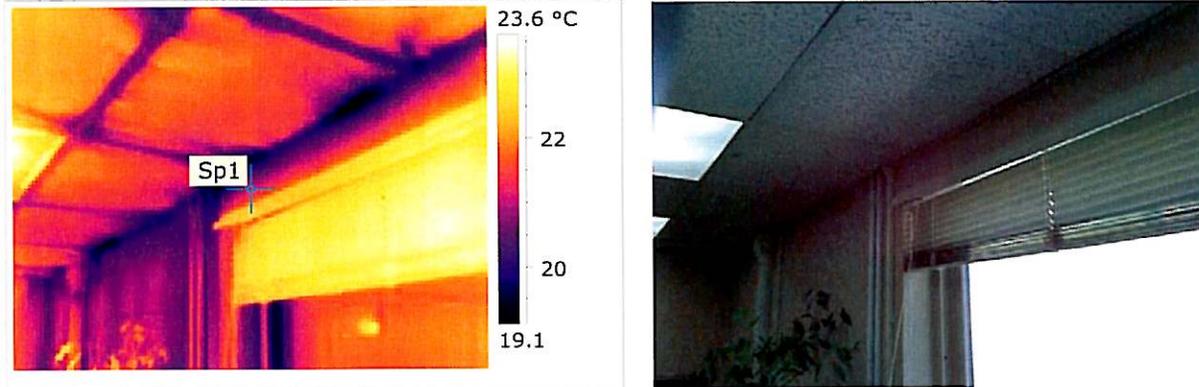
**Comment:** Severe lid line and ceiling tile air-infiltration

**Recommendation:** Caulk and seal as needed. Removal of ceiling tile will be required for further investigation of infiltration source.

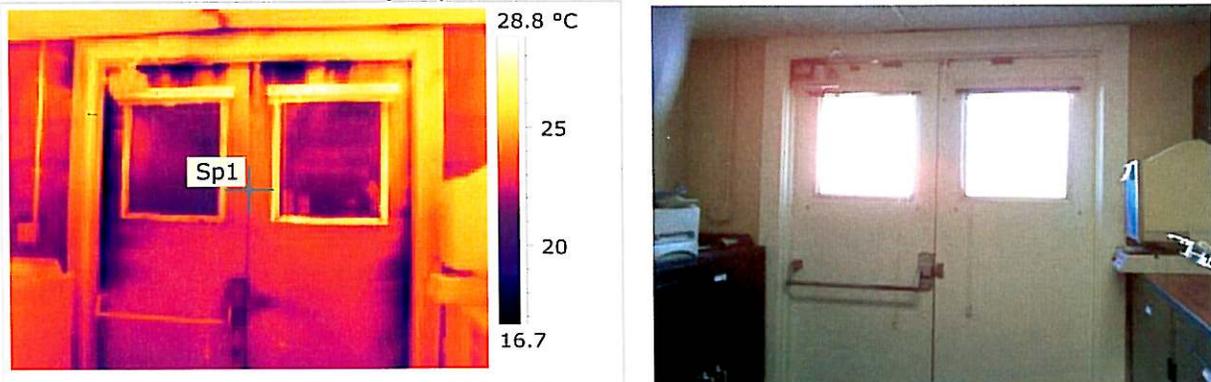
**Comment:** Air-infiltration around door, jamb and ceiling tile

**Recommendation:** Caulk and seal as needed. Removal of door moldings may be required. Further investigation needed.

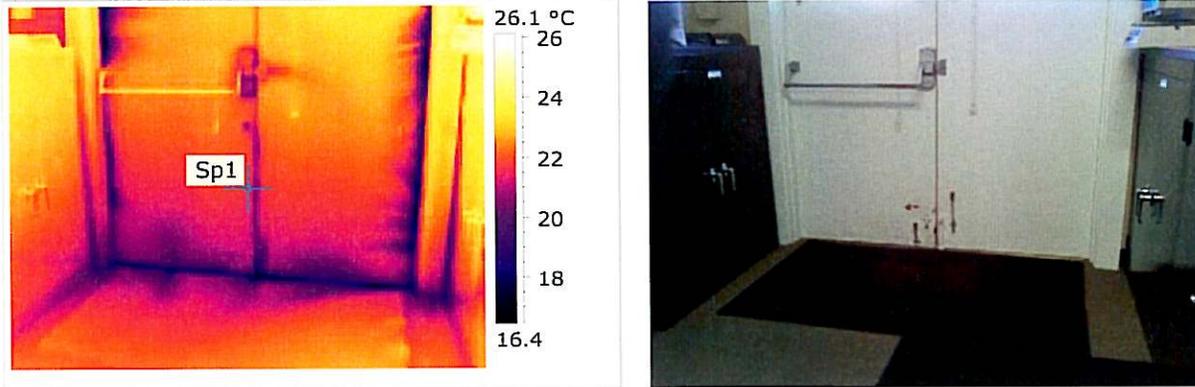
**Comment:** Air-infiltration door and jamb

**Recommendation:** Caulk and seal as needed. Removal of door moldings may be required. Further investigation needed

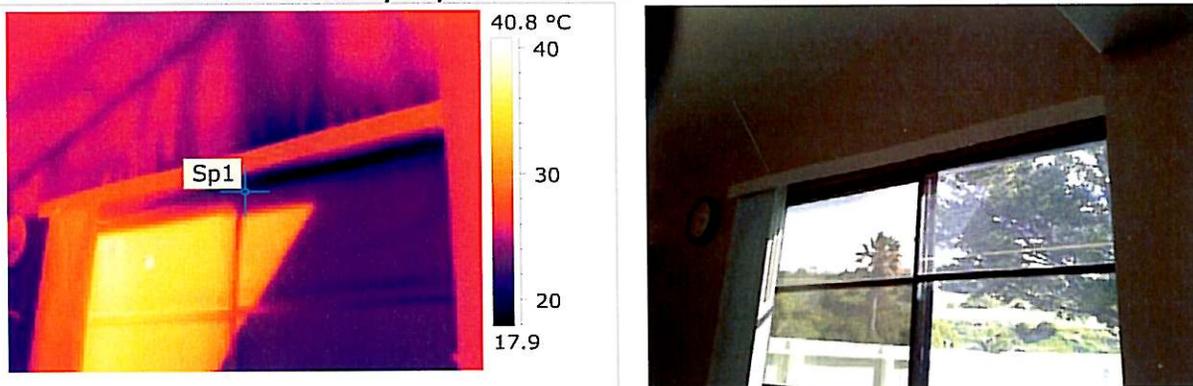
**Comment:** Air-infiltration from window frame at courtyard location

**Recommendation:** Caulk and seal as needed from interior and exterior. Remove, replace and or reinstall properly as needed

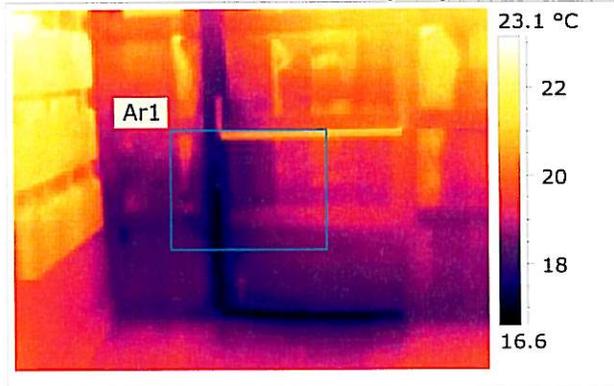
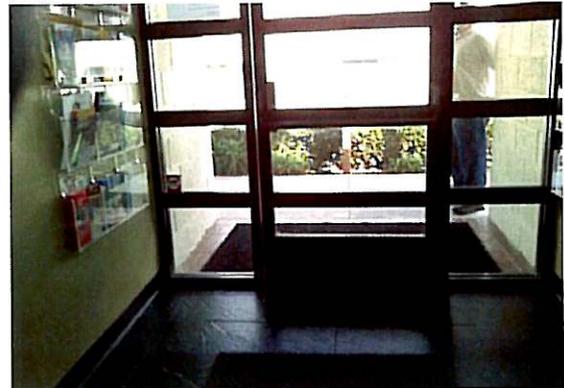
**Comment:** Lower entrance door air-infiltration

**Recommendation:** Add weather stripping where applicable

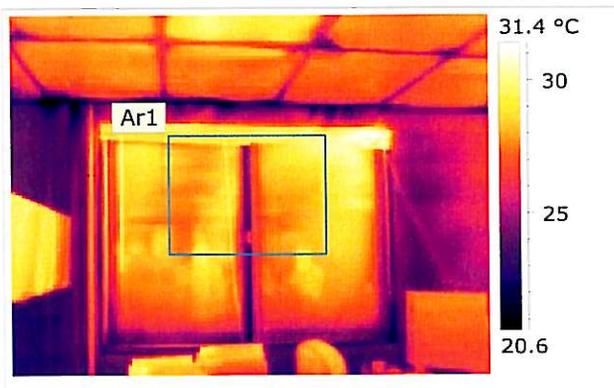
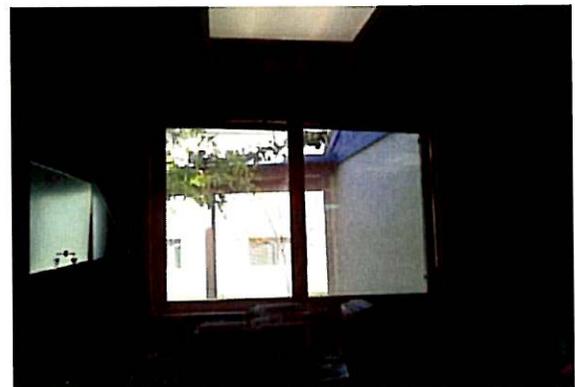
**Picture 24. Captured at: (North West office adjacent to NW corner office)**

**Comment:** Dark spots along ceiling tile line, center and bottom corners of window indicate air-infiltration. Note additional air-infiltration at corners of ceiling tile.

**Recommendation:** Air-infiltration at the center of the room and light warrants further investigation and testing. Removal of field tile required to be able to properly examine infiltration

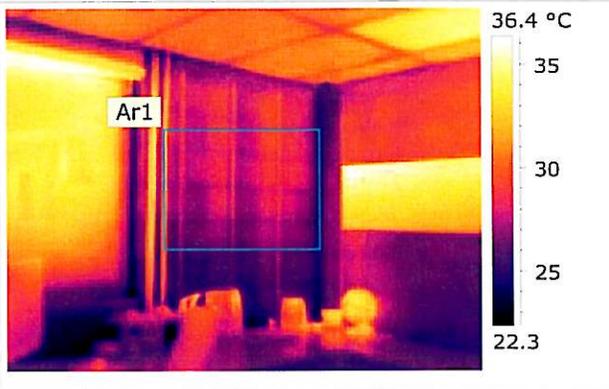
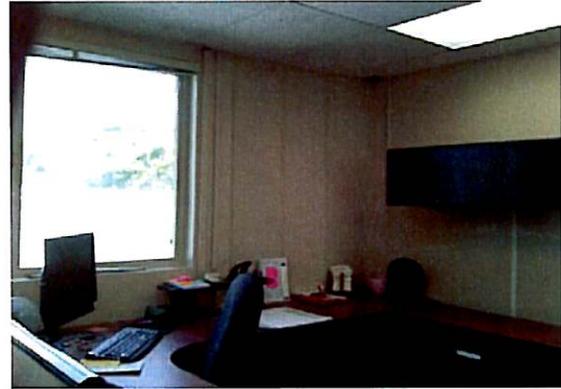
**South Elevation Office**

**Comment:** Dark spots around pipes, corners of walls, around window and along ceiling tile line indicate air-infiltration

**Recommendation:** Walls need to be fixed and insulated properly to meet energy standards

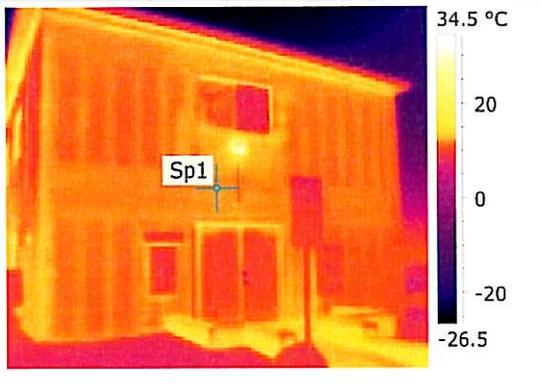
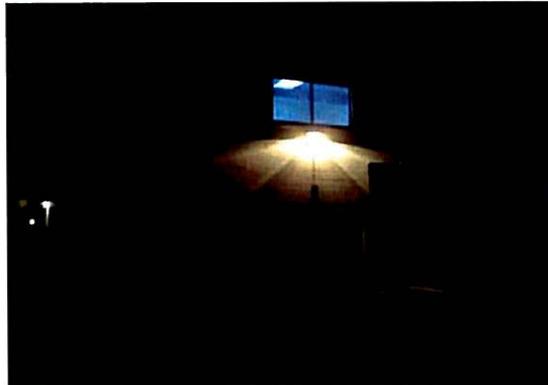
**East Elevation**

**Comment:** Thermal signature still acclimating across East Elevation surface. Note potential energy loss around window and door.

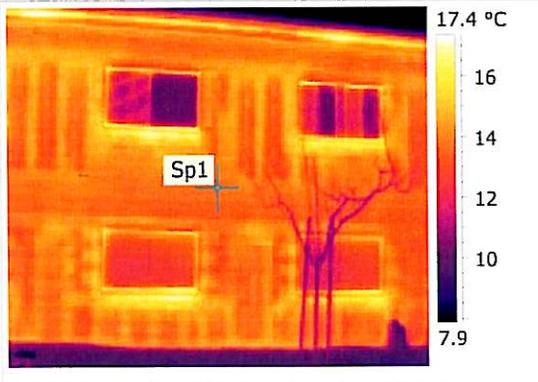
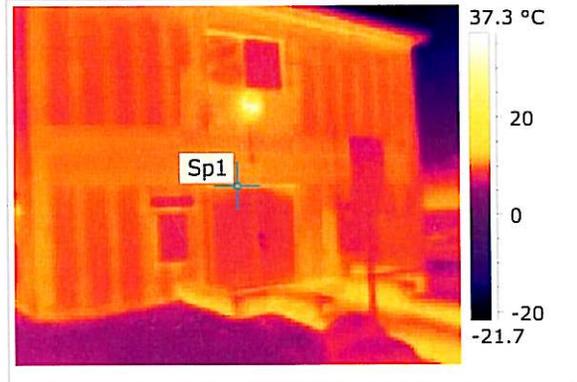
**Comment:** Thermal signature still settling across South Elevation surface, window frames appear to be emitting energy at tops and sides. Thermal signature of East elevation ideal for imaging.

**Recommendation:** Aluminum windows should be replaced with energy efficient windows and installed properly. Engineer should review and evaluate structure for integrity based on current codes.

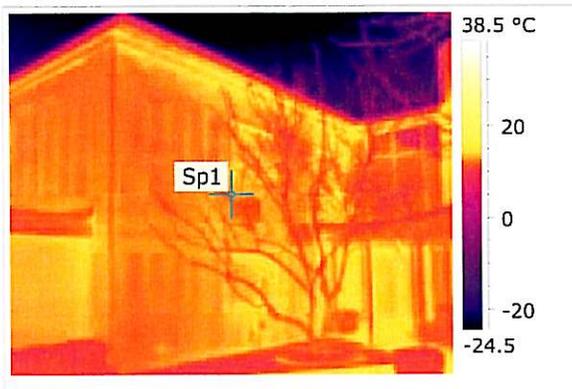
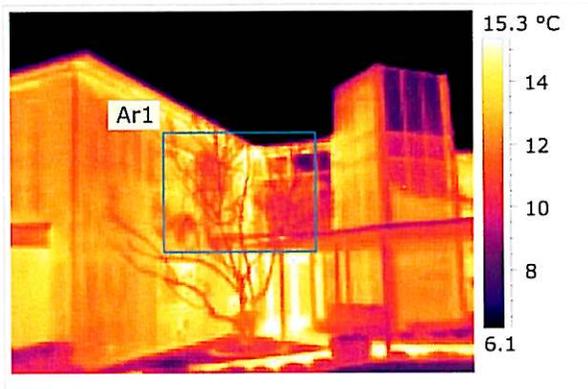
### City Hall Entrance

**Comment:** Glass entrance indicates possible source of energy loss

**Recommendation:** Check glass panels for proper sealing and/or replace with properly sealed double pane insulated glass panels. Further investigation recommended.

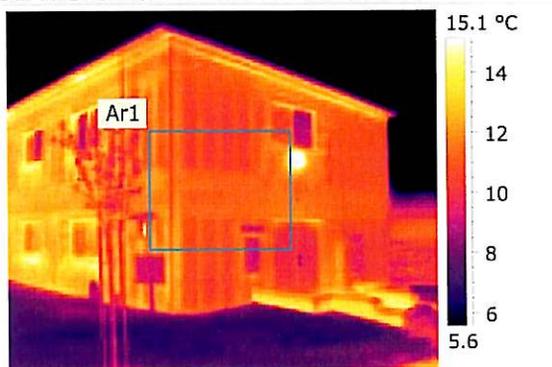
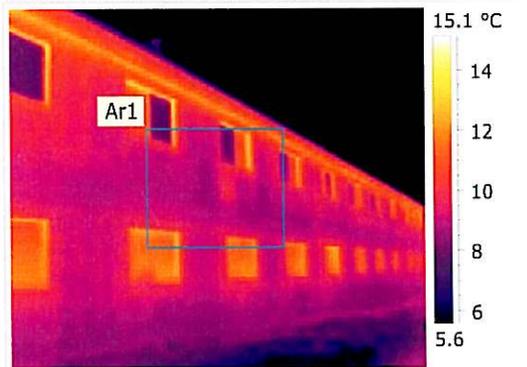
**Comment:** Dark spaces are empty cells, light color indicates grouted cells 2' O.C. Picture on right light color around windows indicates heat emitting through window frames

**Recommendation:** Engineer should review and evaluate structural concerns, replace aluminum frame windows. Proper Sealing when Installed Required.

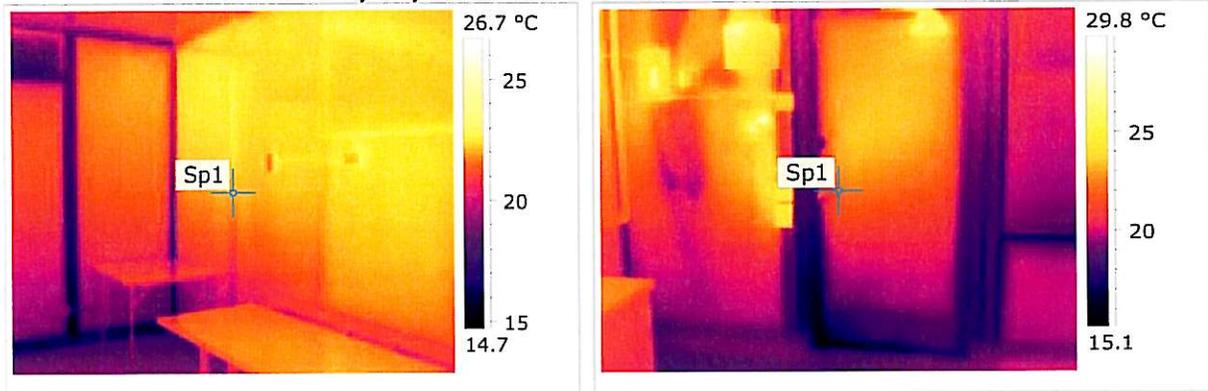
**Comment:** Dark wall mullions absorbing cooler air from outside and window and door air-infiltration

**Recommendation:** Further testing of materials required to determine best practice remediation for mullions, windows and door requiring weather stripping

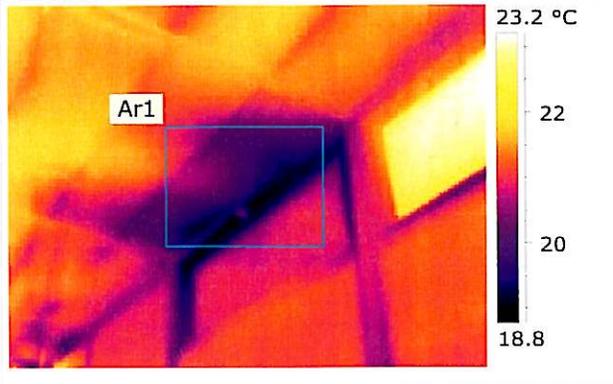
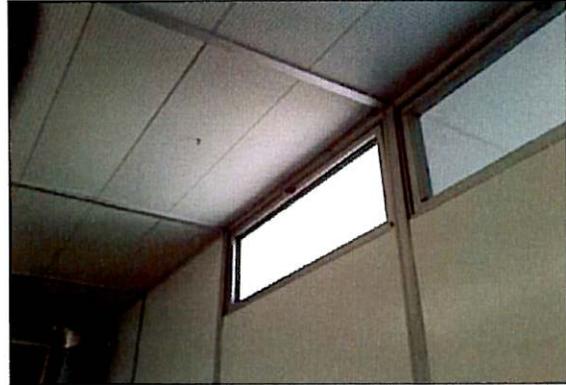
**Comment:** Severe window air-infiltration

**Recommendation:** Caulk and seal properly, may need replacement

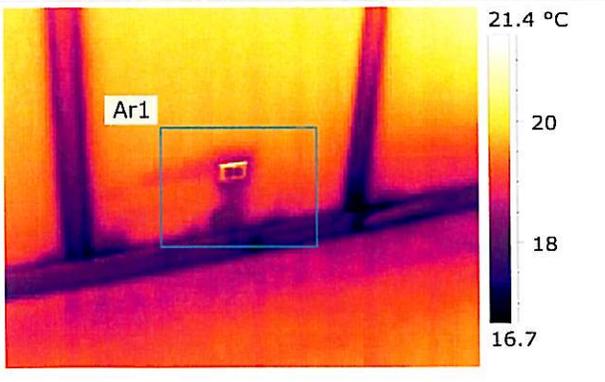
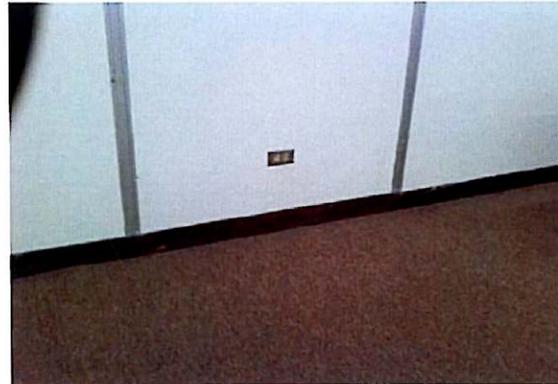
**Comment:** Outlet air-infiltration, Panel and sill joint air-infiltration

**Recommendation:** Caulk and seal behind outlet plate, Panel joints and sill molding may need to be removed to seal properly. May require additional costs once unforeseen conditions are exposed.

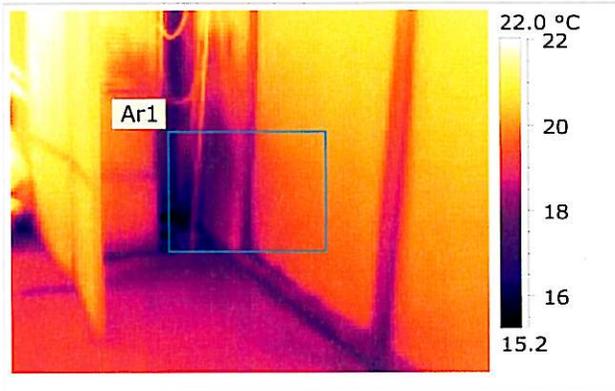
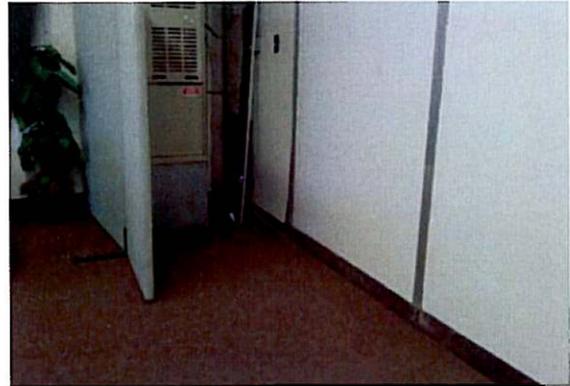
**Picture 29. (Center Room)**

**Comment:** Typical 14" x 14" hole behind furnace in wall all rooms

**Recommendation:** Patch as needed and re-plumb as needed
