Facility No.: B1
Facility Name: [City Hall \(Administration Building & Catalina Wing\) - Civic Center](#)
Location: [Point Vicente Park and Civic Center](#)

Facility No.: B2
Facility Name: [Planning Dept Building - Civic Center](#)
Location: Point Vicente Park and Civic Center

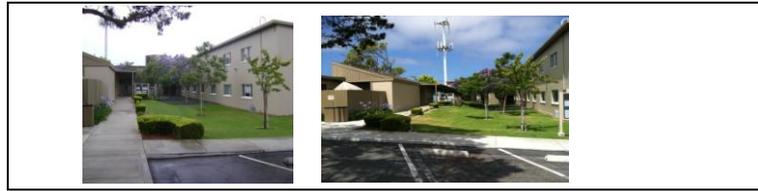
1	Maintenance Program	Operation: (1) Lack of Mechanical Ventilation (only local cooling equipment for the computer rooms): violating code of buildings for occupancy type. (2) Shortage of sanitary facilities. (3) Supply water pipe is too small to meet code with increased sanitary facilities. (4) The building is an energy hog: does not meet the current Title 24 requirements. Maintenance Cost: Approx. \$500K/year for all buildings. FY13-14 Budget around \$600K
2	\$/year Current

1	Safety Incidents/Accidents	(1) Fire Alarm system minimal. (2) No Automatic Sprinkler System. (3) Internal is not compliant with ADA requirements. (4) Building does not meet current building codes and ASCE and FEMA criteria (minimally reinforced concrete masonry unit (CMU) walls and weak connections from the floor and roof diaphragms do not meet current design standards for earthquake resistance. The existing suspended ceilings and cabinet/equipment anchorage do not meet current standards.)
2	Any Injuries/Law Suits

A	90-100%	(1) A cost benefit analysis to be performed to decide between replacement or retrofitting (if replacement is an option). (2) Estimated cost for reconstruction approx. \$4 M (inherent constraints of the
B	Fred Hesse Community Building Plans, The Reynolds Environmental Group, Jan. 5, 1982.	
2	Fred Hesse Community Building Floor Plan and Plumbing and Mechanical Plan, Black & O'Dowd & Associates Inc., Oct. 8, 1985	
D	41-69%

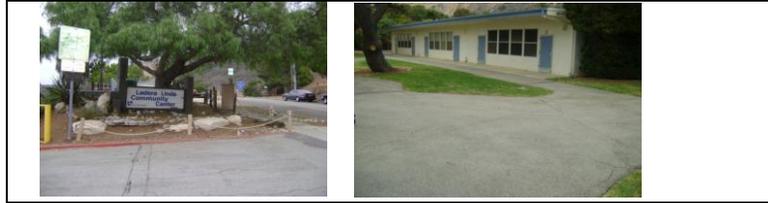
Facility No.: B8
Facility Name: Community Building
Location: Ladera Linda Community Center

4	Identified Problems / Issues	Old buildings. Maintenance no longer effective. No ventilation. No operating heating/cooling system.

1	Maintenance Program	(1) Building declared an energy hog by California IR. (2) Parking lot in fair condition and will need resurfacing in the near future. (3) Forced air heating equipment are inefficient and are not worth replacing. (4) Temporary electric heaters are too small and do not provide comfort and should be removed as a safety measure.
2	\$/year Future

1	Safety Incidents/Accidents	(1) Structures seems seismically questionable (2) Temporary electric heaters should be removed as a safety measure. (3) No Sprinkler System (4) Not ADA compliant. Accessibility needs to be upgraded (5) In terms of liability the defects should be abated from the electrical and plumbing systems.
2	Any Injuries/Law Suits

Grading Criteria
A	90-100%	(1) Prefabricated buildings since 1960's (2) Structures seems seismically questionable. (3) Building systems are too old and are not operating properly. (4) No ventilation (5) Liability due to defects in the electrical and plumbing systems.
B	80-89%	(6) Peeling paint lead based. (7) Floor and ceiling tiles and other building materials contain asbestos. Note: Title IV of the Toxic Substances Control Act considers buildings built prior 1978 contain lead.
C	70-79%	<p>Recommendation: (1) Given the potential costs associates with renovation, the cost of maintenance, and the fact that the building is an energy hog, a new facility might be a better investment. (2) The remediation of the building is unreasonable for the overall Return On Investment (2) For the time being, at a minimum, seismic retrofitting should be considered.</p>
D	41-69%	
F	40% or Lower

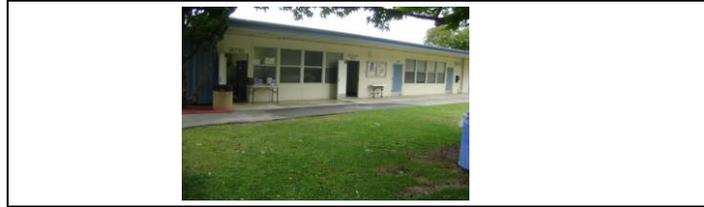
Facility No.: B9
Facility Name: Discovery Room
Location: Ladera Linda Community Center

1	Maintenance Program	(1) Building declared an energy hog by California IR. (2) Parking lot in fair condition and will need resurfacing in the near future. (3) Forced air heating equipment are inefficient and are not worth replacing. (4)
	\$/year Current	Temporary electric heaters are too small and do not provide comfort and should be removed as a safety measure.

1	Safety Incidents/Accidents	(1) Structures seems seismically questionable (2) Temporary electric heaters should be removed as a safety measure. (3) No Sprinkler System (4) Not ADA compliant. Accessibility needs to be upgraded (5)
2	Any Injuries/Law Suits	In terms of liability the defects should be abated from the electrical and plumbing systems.

Grading		Grading Criteria
A	90-100%	(1) Prefabricated buildings since 1960's (2) Structures seems seismically questionable. (3) Building systems are too old and are not operating properly. (4) No ventilation (5) Liability due to defects in the electrical and plumbing systems. (6) Peeling paint lead based. (7) Floor and ceiling tiles and other building materials contain asbestos . Note: Title IV of the Toxic Substances Control Act considers buildings built prior 1978 contain lead. Recommendation: (1) Given the potential costs associates with renovation, the cost of maintenance, and the fact that the building is an energy hog, a new facility might be a better investment. (2) The remediation of the building is unreasonable for the overall Return On Investment (2) For the time being, at a minimum, seismic retrofitting should be considered.
B	80-89%	
C	70-79%	
D	41-69%	
F	40% or Lower

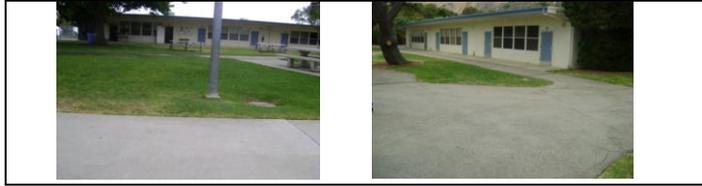
Facility No.: B10
Facility Name: Multi Purpose Room
Location: Ladera Linda Community Center

1	Maintenance Program	(1) Building declared an energy hog by California IR. (2) Parking lot in fair condition and will need resurfacing in the near future. (3) Forced air heating equipment are inefficient and are not worth replacing. (4) Temporary electric heaters are too small and do not provide comfort and should be removed as a safety measure.
2	\$/year Current

1	Safety Incidents/Accidents	(1) Structures seems seismically questionable (2) Temporary electric heaters should be removed as a safety measure. (3) No Sprinkler System (4) Not ADA compliant. Accessibility needs to be upgraded (5)
2	Any Injuries/Law Suits	In terms of liability the defects should be abated from the electrical and plumbing systems.

Grading		Grading Criteria
A	90-100%	(1) Prefabricated buildings since 1960's (2) Structures seems seismically questionable. (3) Building systems are too old and are not operating properly. (4) No ventilation (5) Liability due to defects in the electrical and plumbing systems. (6) Peeling paint lead based. (7) Floor and ceiling tiles and other building materials contain asbestos. Note: Title IV of the Toxic Substances Control Act considers buildings built prior 1978 contain lead. Recommendation: (1) Given the potential costs associates with renovation, the cost of maintenance, and the fact that the building is an energy hog, a new facility might be a better investment. (2) The remediation of the building is unreasonable for the overall Return On Investment (2) For the time being, at a minimum, seismic retrofitting should be considered.
B	80-89%	
C	70-79%	
D	41-69%	
F	40% or Lower

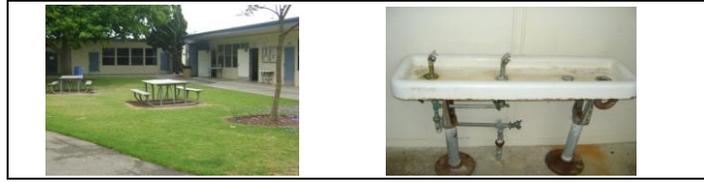
Facility No.: B11
Facility Name: Classroom
Location: Ladera Linda Community Center

1	Maintenance Program	(1) Building declared an energy hog by California IR. (2) Parking lot in fair condition and will need resurfacing in the near future. (3) Forced air heating equipment are inefficient and are not worth replacing. (4) Temporary electric heaters are too small and do not provide comfort and should be removed as a safety measure.
6	\$/year Current Future

1	Safety Incidents/Accidents	(1) Structures seems seismically questionable (2) Temporary electric heaters should be removed as a safety measure. (3) No Sprinkler System (4) Not ADA compliant. Accessibility needs to be upgraded (5) In terms of liability the defects should be abated from the electrical and plumbing systems.
2	Any Injuries/Law Suits

A	90-100%	<p>(1) Prefabricated buildings since 1960's (2) Structures seems seismically questionable. (3) Building systems are too old and are not operating properly. (4) No ventilation (5) Liability due to defects in the electrical and plumbing systems. (6) Peeling paint lead based. (7) Floor and ceiling tiles and other building materials contain asbestos. Note: Title IV of the Toxic Substances Control Act considers buildings built prior 1978 contain lead.</p> <p>Recommendation: (1) Given the potential costs associates with renovation, the cost of maintenance, and the fact that the building is an energy hog, a new facility might be a better investment. (2) The remediation of the building is unreasonable for the overall Return On Investment (2) For the time being, at a minimum, seismic retrofitting should be considered.</p>
B	80-89%	
C	70-79%	
D	41-69%	
F	40% or Lower

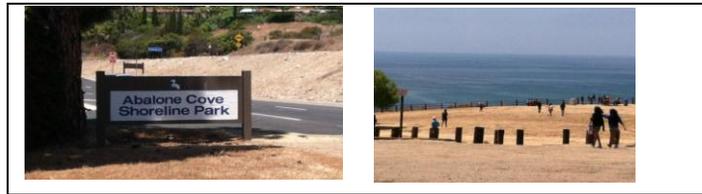
Facility No.: B15
Facility Name: Abalone Cove Building
Location: Abalone Cove Shoreline

A	90-100%	(1) Building was built in 1989 and has not undergone major renovation since. (2) The site visit shows the building in a poor condition. (3) Renovation for the park site is scheduled for 2014. (4) FY13/14 budget includes Abalone Cove Shoreline Park Staff Building, Restroom, and Driveway Improvements: These additional improvements will enhance the overall condition of this facility and also improve the City's ADA compliance.
B	80-89%	
C	70-79%	
D	41-69%	
F	40% or Lower
