## **2.0 Executive Summary**

### **2.2 Condition Assessment**

#### **2.2.1 CCTV Results**

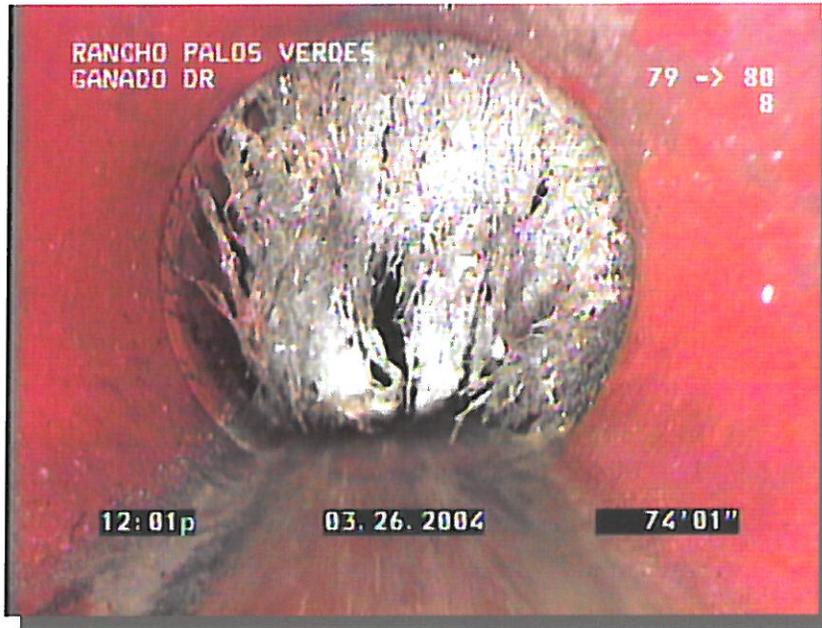
Figure 2-1 Typical TV Observation of Normal of Roots at Ungasketed Joint (2004)

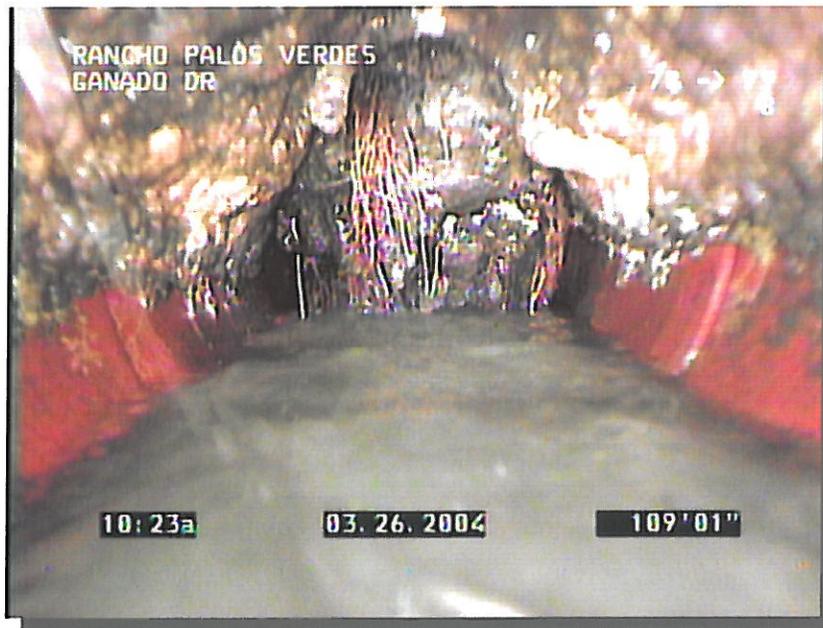
Figure 2-2 Fats, Oils and Grease (2004)

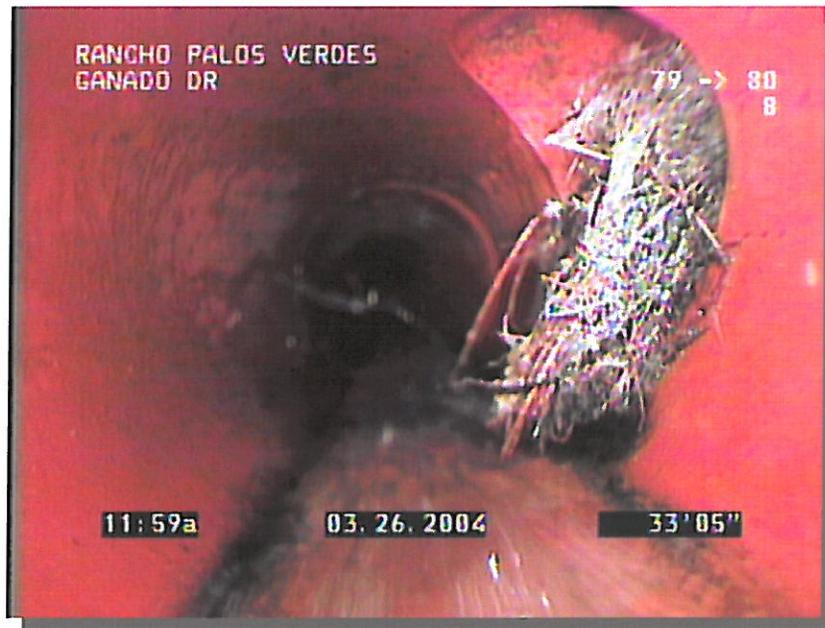
Figure 2-3 Roots from Service Connection (2004)
