Peninsula CIMP Appendix I
Peninsula Outfall Screening Report

Peninsula Outfall Screening Report

May 2015

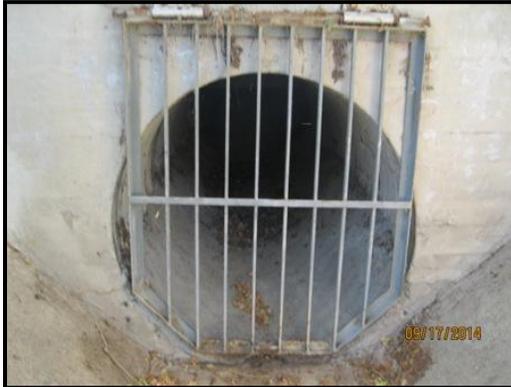
Figure 3: Outfall ID 44 with no flow.

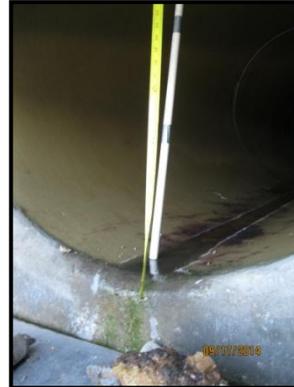
Figure 4: Outfall ID 41 with trickle flow.

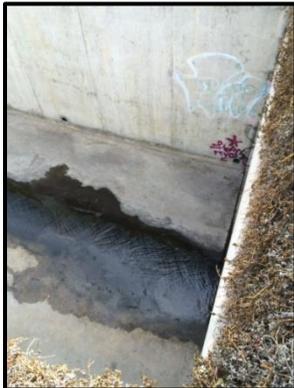
Figure 5: Outfall ID 57 with moderate flow.

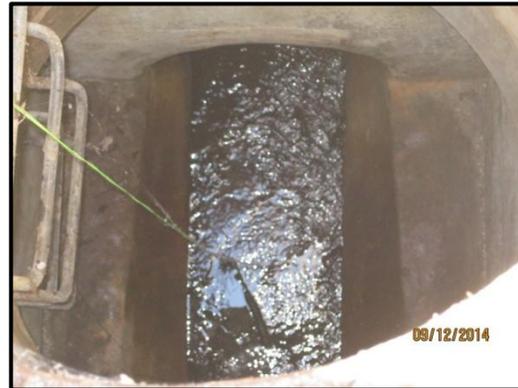
Figure 6: Outfall ID 100 with Substantial Flow.

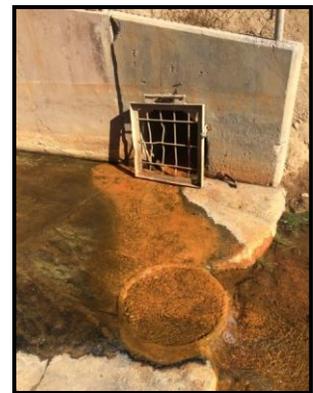
Out of the remaining outfalls that required follow-up screenings, the NSW discharges comprised of either unknown or conditionally exempt non-essential discharges or potential illicit discharges. Potential sources considered exempt non-essential discharges include natural groundwater. According to local residents, business owners, and city officials, this area is known to have high groundwater which commonly seeps into streams, channels, and canyons. One particular outfall, ID 100, was found to have heavy flow, thick vegetation, no odor and no signs of trash. This outfall is suspected to have natural groundwater. Other unknown sources, such as an outfall, ID 57, showed significant indicators such as odor and visual stains that will trigger further investigation.

Figure 8: Outfall ID 57 with moderate flow requiring additional investigation.

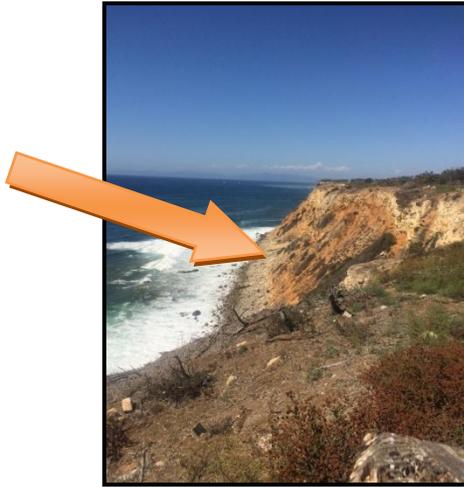
There were 5 outfall locations which were too hazardous to screen or take accurate measurements. Hazards and obstacles that deterred the outfall screening included conditions such as steep cliffs, tidal changes, bio-hazardous conditions, and slippery surfaces. Alternate upstream monitoring locations were selected for four of the five outfalls that were too hazardous to screen (see Figure 9 and Figure 10 below).

Figure 9: Outfall location.

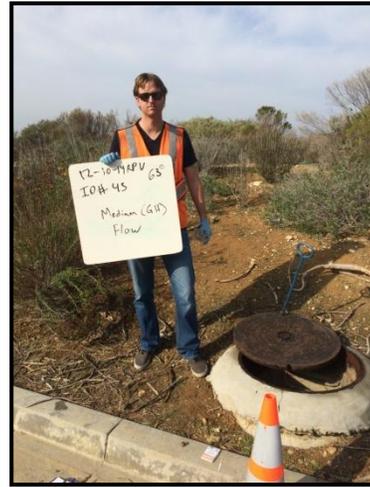
Figure 10: Alternate monitoring location.
