City of Rancho Palos Verdes
Rancho Palos Verdes ADA Assessment
Facility Report with Photos

Facility ID: # 03 - Clovercliff Park

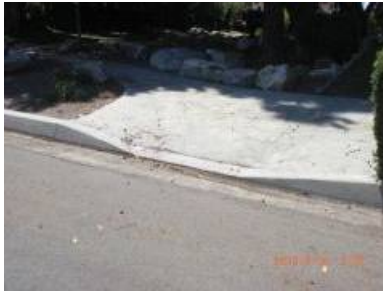
Keynote 1

Field Condition	
04.03 - Transition - The transition from the curb ramp to the road or gutter is not flush or free of abrupt changes.	1991 ADAAG 4.7.2
Existing Condition:	2004 ADAAG 406.2; Fig. 406.2
	2007 CBC 1127B.5 item 3
	Other 2005 PROWAG-R301.5.1

Classification	
DOJ Location Type:	1
Use:	PV
Severity:	C
Level of Difficulty	High

Corrective Action	
120D - Replace Curb Ramp - Remove existing curb ramp, provide new.	
Additional Comments:

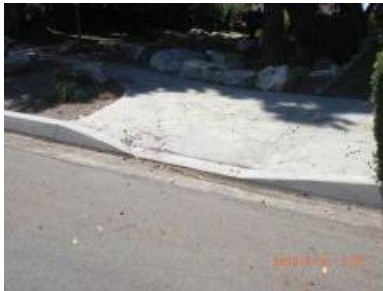
Keynote 2

Field Condition	
04.04 - Counter Slope - The running slopes of the road, gutter or accessible route adjoining the ramp exceed 5%.	1991 ADAAG 4.7.2
Existing Condition: 13.3% counter slope at gutter.	2004 ADAAG 406.2
	2007 CBC 1127B.5 item 3
	Other 2005 PROWAG-R303.3.5

Classification	
DOJ Location Type:	1
Use:	PV
Severity:	C
Level of Difficulty	High

Corrective Action	
123 - Curb Ramps - Miscellaneous - See Additional Comments	
Additional Comments: Provide compliant counter slope at gutter with a slope less than 5%.

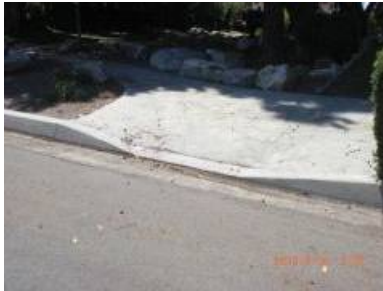
Keynote 3

Field Condition	
04.02 - Slope - Slope of the curb ramp exceeds 8.33% (or the least possible compliant slope).	1991 ADAAG 4.7.2; 4.8.2
Existing Condition: 10.2% RS.	2004 ADAAG 405.2; Advisory 405.2
	2007 CBC 1127B.5 item 3
	Other 2005 PROWAG-R303.2.1.1; R303.2.2.1

Classification	
DOJ Location Type:	1
Use:	PV
Severity:	C
Level of Difficulty	High

Corrective Action
123 - Curb Ramps - Miscellaneous - See Additional Comments
Additional Comments: See Keynote 1 for corrective action.

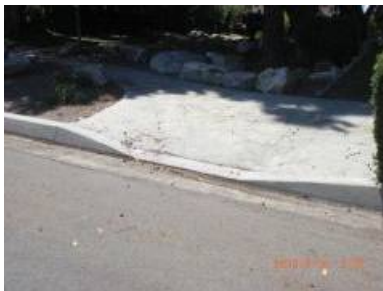
Keynote 4

Field Condition	
04.07B - Side Flare Slope (8.33% Max. Requirement) - Where the landing at the top of the ramp is less than 48" deep and wheelchair users must use the side flares for access, the flared sides have a slope greater than 8.33% (measured along the curb).	1991 ADAAG Fig. 12(a)
Existing Condition: Flare slopes vary from 12.9% - 16%, curb ramp top landing 46" wide.	2004 ADAAG 406.3; Fig. 406.3
	2007 CBC 1127B.5 item 4
	Other -

Classification	
DOJ Location Type:	1
Use:	PV
Severity:	B
Level of Difficulty	High

Corrective Action
123 - Curb Ramps - Miscellaneous - See Additional Comments
Additional Comments: See Keynote 1 for corrective action.

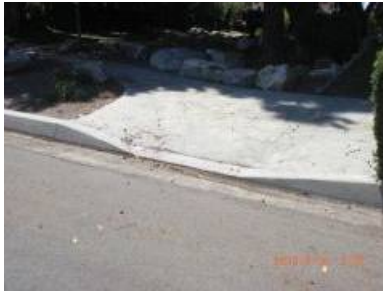
Keynote 5

Field Condition	
04.05 - Width - The width of the curb ramp, not including the flared sides, is less than 48".	1991 ADAAG 4.7.3
Existing Condition: 46" wide curb ramp.	2004 ADAAG 406.1; 405.5
	2007 CBC 1127B.5 item 2
	Other 2005 PROWAG-R303.3.1

Classification	
DOJ Location Type:	1
Use:	PV
Severity:	C
Level of Difficulty	High

Corrective Action	
123 - Curb Ramps - Miscellaneous - See Additional Comments	
Additional Comments: See Keynote 1 for corrective action.

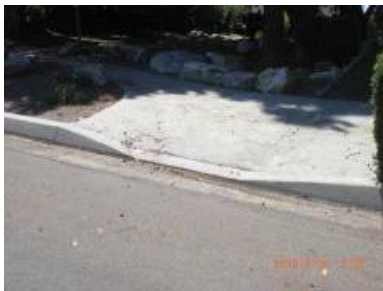
Keynote 6

Field Condition	
04.10 - Detectable Warning Requirement - Regardless of slope, the curb ramp does not have a detectable warning.	1991 ADAAG 4.7.7; 4.29.2
Existing Condition: None provided.	2004 ADAAG 705.1; Fig. 705.1
	2007 CBC 1127B.5 item 7
	Other 2005 PROWAG-R303.3.2

Classification	
DOJ Location Type:	1
Use:	PV
Severity:	A
Level of Difficulty	Moderate to High

Corrective Action	
122B - Detectable Warnings - Provide a 3-ft. long detectable warning surface (i.e. in-line truncated domes) extending the full width of the curb ramp, excluding the flares.	
Additional Comments:

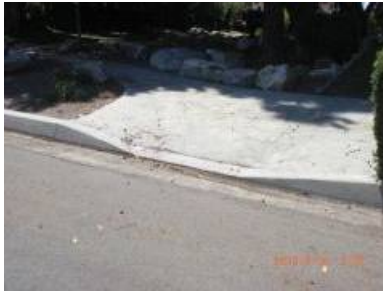
Keynote 7

Field Condition	
04.09A - Grooved Border Requirement - Curb ramp does not have a 12" wide grooved border around upper edges of curb ramp and flares to indicate transition from sidewalk to curb ramp.	1991 ADAAG -
Existing Condition: No grooved border provided.	2004 ADAAG -
	2007 CBC 1127B.5 item 6
	Other -

Classification	
DOJ Location Type:	1
Use:	PV
Severity:	C
Level of Difficulty	High

Corrective Action
123 - Curb Ramps - Miscellaneous - See Additional Comments
Additional Comments: See Keynote 1 for corrective action.

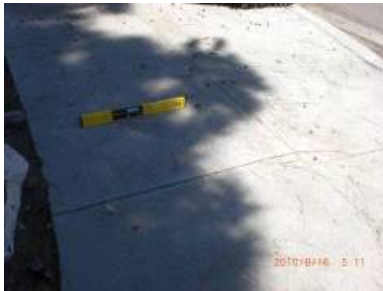
Keynote 8

Field Condition	
03A.07A - Cross Slope (PAR) - Cross slope of the pedestrian access route exceeds 1:50.	1991 ADAAG 4.3.7
Existing Condition: 3.3% CS.	2004 ADAAG 403.3
	2007 CBC 1133B.7.1.3
	Other 2005 PROWAG-R301.4.1

Classification	
DOJ Location Type:	1
Use:	PV
Severity:	C
Level of Difficulty	Moderate

Corrective Action
027 - Site Work - Miscellaneous - See Additional Comments
Additional Comments: See Keynote 12 for corrective action.

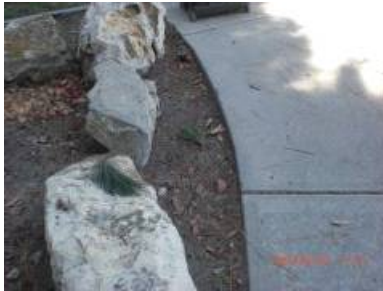
Keynote 9

Field Condition	03A.09 - > 1/4" Changes in Level - Where walkway levels change abruptly, the vertical difference between them exceed 1/4 inch. OR Changes in level between 1/4 inch and 1/2 inch are beveled with a slope greater than 1:2.	1991 ADAAG 4.5.2
	Existing Condition: 2 1/2" level change at edge of concrete walk.	2004 ADAAG 303.2; 303.3
		2007 CBC 1124B.2
		Other 2005 PROWAG-R301.5.2

Classification	
DOJ Location Type:	1
Use:	PV
Severity:	A
Level of Difficulty	Moderate

Corrective Action	027 - Site Work - Miscellaneous - See Additional Comments
Additional Comments:	See Keynote 12 for corrective action.

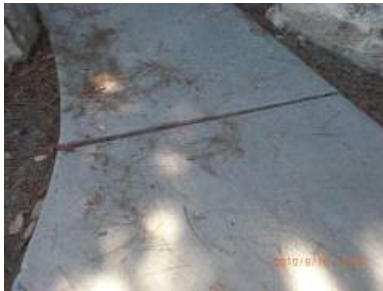
Keynote 10

Field Condition	03A.15 - Other - Pedestrian Accessible Route (Public Right of Way) - See Additional Comments	1991 ADAAG -
	Existing Condition: Level change and 3/4" gap.	2004 ADAAG -
		2007 CBC -
		Other -

Classification	
DOJ Location Type:	1
Use:	PV
Severity:	A
Level of Difficulty	Moderate

Corrective Action	027 - Site Work - Miscellaneous - See Additional Comments
Additional Comments:	See Keynote 12 for corrective action.

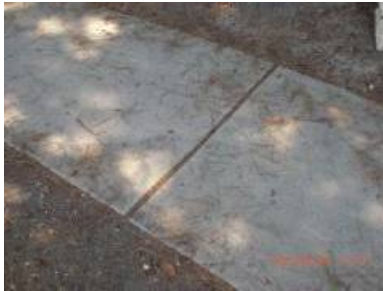
Keynote 11

Field Condition	
03A.15 - Other - Pedestrian Accessible Route (Public Right of Way) - See Additional Comments	1991 ADAAG -
Existing Condition: 1 1/4" gap.	2004 ADAAG -
	2007 CBC -
	Other -

Classification	
DOJ Location Type:	1
Use:	PV
Severity:	A
Level of Difficulty	Moderate

Corrective Action	
027 - Site Work - Miscellaneous - See Additional Comments	
Additional Comments: See Keynote 12 for corrective action.

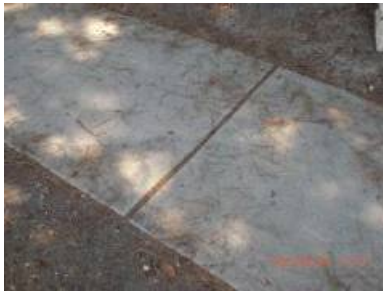
Keynote 12

Field Condition	
03A.02A - Width - Accessible route of travel is less than 48" wide (note: 48" wide requirement does not apply to doorways or gates).	1991 ADAAG 4.3.3
Existing Condition: Concrete walk is 3'-9" wide.	2004 ADAAG 403.5.1
	2007 CBC 1133B.7.1
	Other 2005 PROWAG-R301.3.1

Classification	
DOJ Location Type:	1
Use:	PV
Severity:	C
Level of Difficulty	Moderate to High

Corrective Action	
007 - Widen Concrete Walk - Widen existing concrete pathway. The walkway slope shall not exceed 5% along the POT and cross slope shall not exceed 2%.	
Additional Comments:

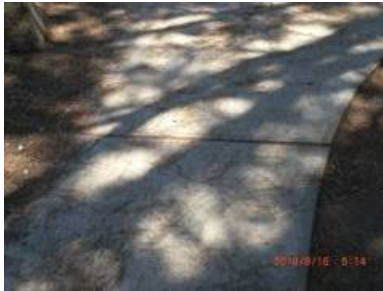
Keynote 13

Field Condition	
03A.15 - Other - Pedestrian Accessible Route (Public Right of Way) - See Additional Comments	1991 ADAAG -
Existing Condition: 1" gap.	2004 ADAAG -
	2007 CBC -
	Other -

Classification	
DOJ Location Type:	1
Use:	PV
Severity:	C
Level of Difficulty	Moderate

Corrective Action	
027 - Site Work - Miscellaneous - See Additional Comments	
Additional Comments: See Keynote 12 for corrective action.

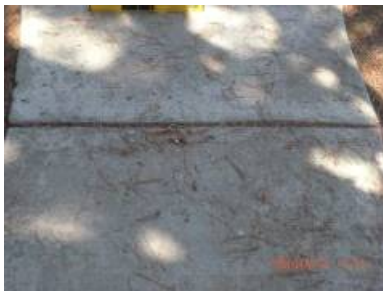
Keynote 14

Field Condition	
03A.15 - Other - Pedestrian Accessible Route (Public Right of Way) - See Additional Comments	1991 ADAAG -
Existing Condition: 1" gap.	2004 ADAAG -
	2007 CBC -
	Other -

Classification	
DOJ Location Type:	1
Use:	PV
Severity:	A
Level of Difficulty	Moderate

Corrective Action	
027 - Site Work - Miscellaneous - See Additional Comments	
Additional Comments: See Keynote 12 for corrective action.

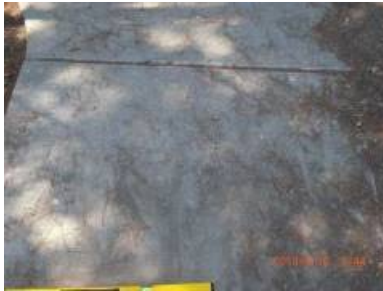
Keynote 15

Field Condition	
03A.15 - Other - Pedestrian Accessible Route (Public Right of Way) - See Additional Comments	1991 ADAAG -
Existing Condition: 1" gap.	2004 ADAAG -
	2007 CBC -
	Other -

Classification	
DOJ Location Type:	1
Use:	PV
Severity:	A
Level of Difficulty	Moderate

Corrective Action	
027 - Site Work - Miscellaneous - See Additional Comments	
Additional Comments: See Keynote 12 for corrective action.

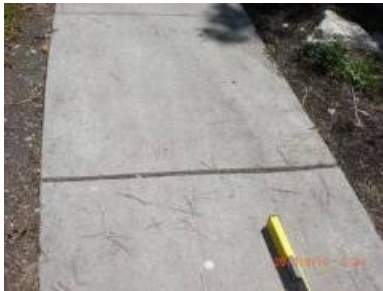
Keynote 16

Field Condition	
03A.15 - Other - Pedestrian Accessible Route (Public Right of Way) - See Additional Comments	1991 ADAAG -
Existing Condition: 1" gap.	2004 ADAAG -
	2007 CBC -
	Other -

Classification	
DOJ Location Type:	1
Use:	PV
Severity:	A
Level of Difficulty	Moderate

Corrective Action	
027 - Site Work - Miscellaneous - See Additional Comments	
Additional Comments: See Keynote 12 for corrective action.

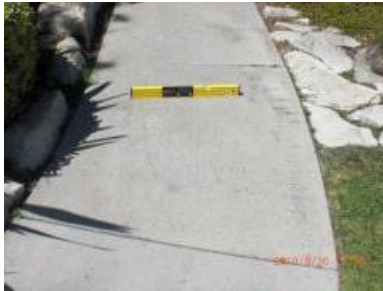
Keynote 17

Field Condition	
03A.07A - Cross Slope (PAR) - Cross slope of the pedestrian access route exceeds 1:50.	1991 ADAAG 4.3.7
Existing Condition: 3.4%	2004 ADAAG 403.3
	2007 CBC 1133B.7.1.3
	Other 2005 PROWAG-R301.4.1

Classification	
DOJ Location Type:	1
Use:	PV
Severity:	C
Level of Difficulty	High

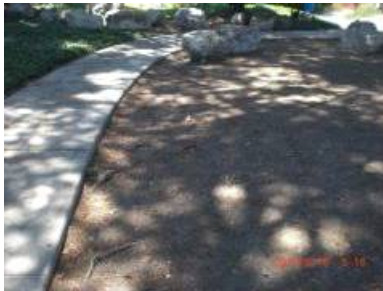
Keynote 18

Field Condition	
03B.09 - Cross Slope - Cross slope of the accessible route of travel exceeds 1:50.	1991 ADAAG 4.3.7
Existing Condition: 2.2% to 5.8% CS.	2004 ADAAG 403.3
	2007 CBC 1133B.7.1.3
	Other -

Classification	
DOJ Location Type:	1
Use:	PV
Severity:	C
Level of Difficulty	High

Corrective Action
006 - Concrete Walk - Remove non-compliant pavement and replace with new concrete (area as shown on the drawings). The walkway slope shall not exceed 5% along the POT and cross slope shall not exceed 2%.
Additional Comments:

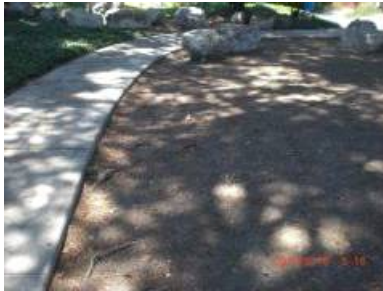
Keynote 19

Field Condition									
03B.10 - Running Slope - Slope of the accessible route of travel exceeds 1:20. Existing Condition: 5.7% and 8.9% RS.

<table><tr> <td>1991 ADAAG</td> <td>4.3.7</td> </tr></table>

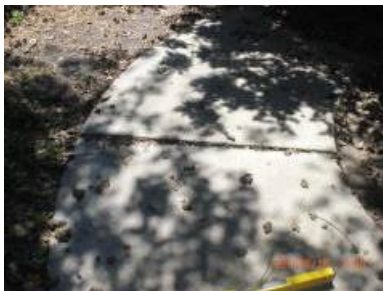
Keynote 20

Field Condition									
03B.13 - > 1/2" Changes in Level - Curb ramps, ramps, or elevators are not used for changes in level greater than 1/2 inch. (Lifts may only be used in certain limited situations.) Existing Condition: 1" level change.

<table><tr> <td>1991 ADAAG</td> <td>4.5.2</td> </tr></table>

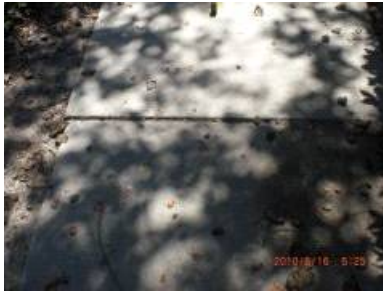
Keynote 21

Field Condition	
03B.13 - > 1/2" Changes in Level - Curb ramps, ramps, or elevators are not used for changes in level greater than 1/2 inch. (Lifts may only be used in certain limited situations.)	1991 ADAAG 4.5.2
Existing Condition: 1/2" level change.	2004 ADAAG 303.4
	2007 CBC 1124B.2
	Other -

Classification	
DOJ Location Type:	1
Use:	PV
Severity:	C
Level of Difficulty	Moderate to High

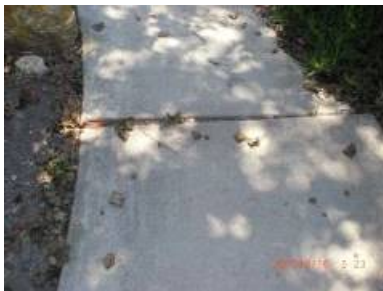
Keynote 22

Field Condition	
03B.13 - > 1/2" Changes in Level - Curb ramps, ramps, or elevators are not used for changes in level greater than 1/2 inch. (Lifts may only be used in certain limited situations.)	1991 ADAAG 4.5.2
Existing Condition: 1/2" level change.	2004 ADAAG 303.4
	2007 CBC 1124B.2
	Other -

Classification	
DOJ Location Type:	1
Use:	PV
Severity:	C
Level of Difficulty	Moderate to High

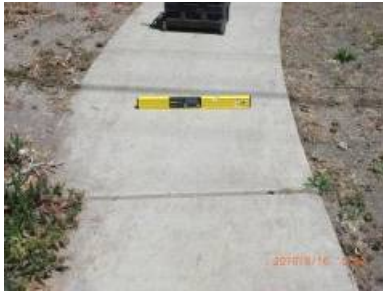
Keynote 23

Field Condition	
03B.22 - Other - On-Site Accessible Path of Travel - See Additional Comments	1991 ADAAG -
Existing Condition: 1" gap.	2004 ADAAG -
	2007 CBC -
	Other -

Classification	
DOJ Location Type:	1
Use:	PV
Severity:	C
Level of Difficulty	Moderate to High

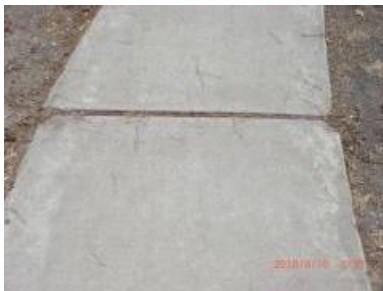
Keynote 24

Field Condition	
03B.22 - Other - On-Site Accessible Path of Travel - See Additional Comments	1991 ADAAG -
Existing Condition: 1" gap.	2004 ADAAG -
	2007 CBC -
	Other -

Classification	
DOJ Location Type:	1
Use:	PV
Severity:	C
Level of Difficulty	Moderate to High

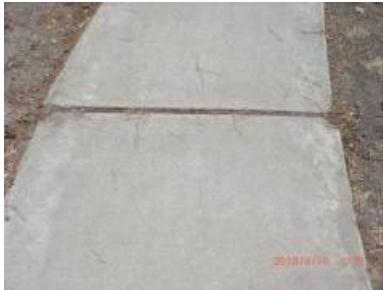
Keynote 25

Field Condition	
03B.12 -> 1/4" Changes in Level - Where walkway levels change abruptly, the vertical difference between them exceeds 1/4 inch. Or changes in level between 1/4 inch and 1/2 inch are beveled with a slope greater than 1:2.	1991 ADAAG 4.5.2
Existing Condition: Level change.	2004 ADAAG 303.2; 303.3
	2007 CBC 1124B.2
	Other -

Classification	
DOJ Location Type:	1
Use:	PV
Severity:	C
Level of Difficulty	Moderate to High

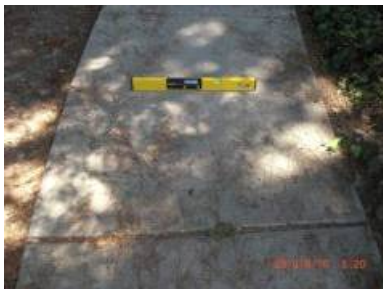
Keynote 26

Field Condition	
03B.22 - Other - On-Site Accessible Path of Travel - See Additional Comments	1991 ADAAG -
Existing Condition: 1" gap.	2004 ADAAG -
	2007 CBC -
	Other -

Classification	
DOJ Location Type:	1
Use:	PV
Severity:	C
Level of Difficulty	Moderate to High

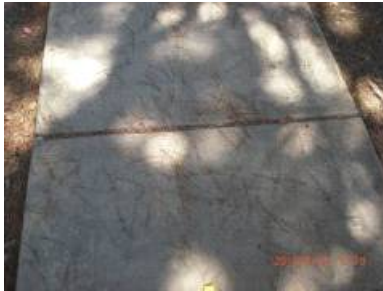
Keynote 27

Field Condition	
03B.22 - Other - On-Site Accessible Path of Travel - See Additional Comments	1991 ADAAG -
Existing Condition: 1" gap.	2004 ADAAG -
	2007 CBC -
	Other -

Classification	
DOJ Location Type:	1
Use:	PV
Severity:	C
Level of Difficulty	Moderate to High

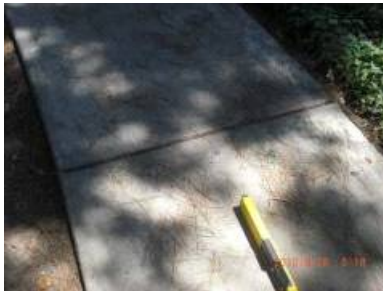
Keynote 28

Field Condition	
03B.22 - Other - On-Site Accessible Path of Travel - See Additional Comments	1991 ADAAG -
Existing Condition: 1" gap.	2004 ADAAG -
	2007 CBC -
	Other -

Classification	
DOJ Location Type:	1
Use:	PV
Severity:	C
Level of Difficulty	Moderate to High

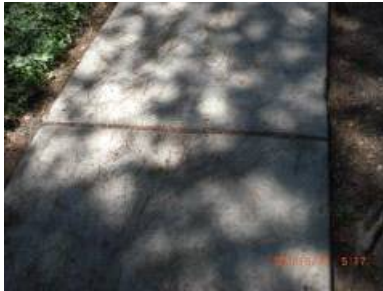
Keynote 29

Field Condition	
03B.22 - Other - On-Site Accessible Path of Travel - See Additional Comments	1991 ADAAG -
Existing Condition: 1" gap.	2004 ADAAG -
	2007 CBC -
	Other -

Classification	
DOJ Location Type:	1
Use:	PV
Severity:	C
Level of Difficulty	Moderate to High

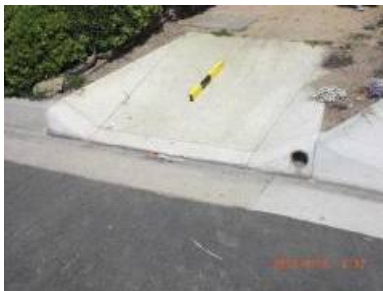
Keynote 30

Field Condition	
04.05 - Width - The width of the curb ramp, not including the flared sides, is less than 48".	1991 ADAAG 4.7.3
Existing Condition: 49" wide curb ramp.	2004 ADAAG 406.1; 405.5
	2007 CBC 1127B.5 item 2
	Other 2005 PROWAG-R303.3.1

Classification	
DOJ Location Type:	1
Use:	PV
Severity:	C
Level of Difficulty	High

Corrective Action	
120D - Replace Curb Ramp - Remove existing curb ramp, provide new.	
Additional Comments:

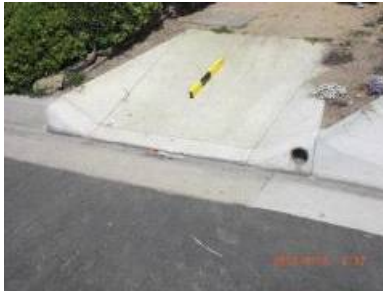
Keynote 31

Field Condition	
04.02 - Slope - Slope of the curb ramp exceeds 8.33% (or the least possible compliant slope).	1991 ADAAG 4.7.2; 4.8.2
Existing Condition: 15.6% RS and 2.1% CS at Curb Ramp	2004 ADAAG 405.2; Advisory 405.2
	2007 CBC 1127B.5 item 3
	Other 2005 PROWAG-R303.2.1.1; R303.2.2.1

Classification	
DOJ Location Type:	1
Use:	PV
Severity:	C
Level of Difficulty	High

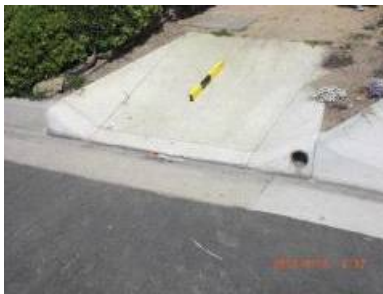
Keynote 32

Field Condition	
04.07B - Side Flare Slope (8.33% Max. Requirement) - Where the landing at the top of the ramp is less than 48" deep and wheelchair users must use the side flares for access, the flared sides have a slope greater than 8.33% (measured along the curb).	1991 ADAAG Fig. 12(a)
Existing Condition: Side flare slopes at 48% and 35%.	2004 ADAAG 406.3; Fig. 406.3
	2007 CBC 1127B.5 item 4
	Other -

Classification	
DOJ Location Type:	1
Use:	PV
Severity:	C
Level of Difficulty	High

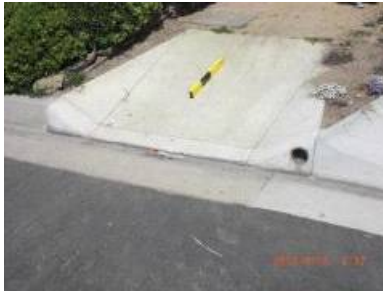
Keynote 33

Field Condition	
04.03 - Transition - The transition from the curb ramp to the road or gutter is not flush or free of abrupt changes.	1991 ADAAG 4.7.2
Existing Condition: 1" transition lip.	2004 ADAAG 406.2; Fig. 406.2
	2007 CBC 1127B.5 item 3
	Other 2005 PROWAG-R301.5.1

Classification	
DOJ Location Type:	1
Use:	PV
Severity:	C
Level of Difficulty	High

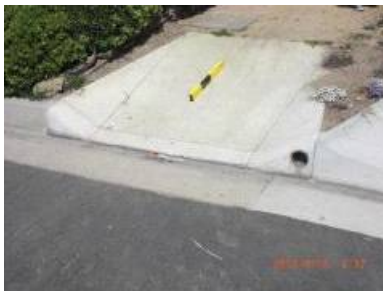
Keynote 34

Field Condition	
04.04 - Counter Slope - The running slopes of the road, gutter or accessible route adjoining the ramp exceed 5%.	1991 ADAAG 4.7.2
Existing Condition: 13.4% counter slope at gutter.	2004 ADAAG 406.2
	2007 CBC 1127B.5 item 3
	Other 2005 PROWAG-R303.3.5

Classification	
DOJ Location Type:	1
Use:	PV
Severity:	C
Level of Difficulty	High

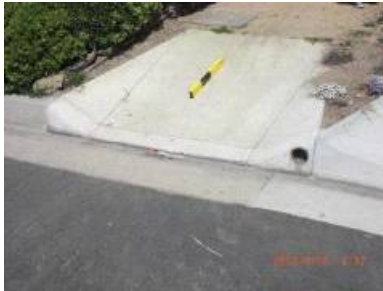
Keynote 35

Field Condition	
04.10 - Detectable Warning Requirement - Regardless of slope, the curb ramp does not have a detectable warning.	1991 ADAAG 4.7.7; 4.29.2
Existing Condition: None provided.	2004 ADAAG 705.1; Fig. 705.1
	2007 CBC 1127B.5 item 7
	Other 2005 PROWAG-R303.3.2

Classification	
DOJ Location Type:	1
Use:	PV
Severity:	A
Level of Difficulty	Moderate to High

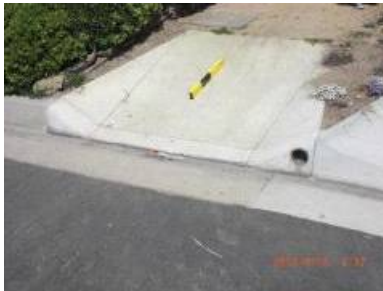
Keynote 36

Field Condition	
04.09A - Grooved Border Requirement - Curb ramp does not have a 12" wide grooved border around upper edges of curb ramp and flares to indicate transition from sidewalk to curb ramp.	1991 ADAAG -
Existing Condition: None provided.	2004 ADAAG -
	2007 CBC 1127B.5 item 6
	Other -

Classification	
DOJ Location Type:	1
Use:	PV
Severity:	C
Level of Difficulty	High

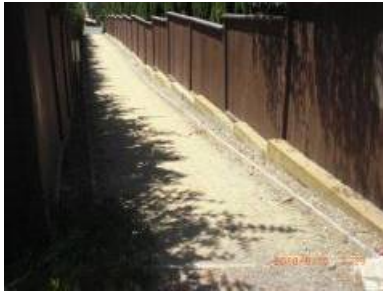
Keynote 37

Field Condition	
30.06A - Outdoor Recreation Access Route (ORAR) Segment - Running Slope - Running slope of access route segment in the direction of travel does not comply with the following: a. 5% or less for any distance. b. From 5.1% to 8.33% for 50' maximum. c. From 8.34% to 10% for 30' maximum.	1991 ADAAG -
Existing Condition: 6.2% and 14.0% RS.	2004 ADAAG -
	2007 CBC -
	Other 1999 ADAAG-16.3.7.2.1; 16.3.7.2.2; 16.3.7.2.3

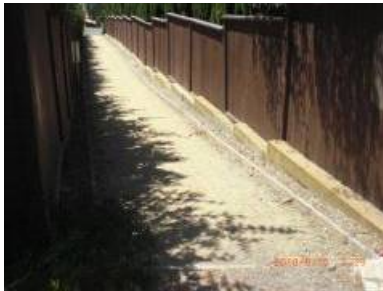
Keynote 38

Field Condition	
30.06E - Outdoor Recreation Access Route (ORAR) Segment - Cross Slope - Cross slope of the access route segment exceeds 3.33%. Exception: Cross slopes of 5% maximum are permitted to ensure proper drainage.	1991 ADAAG -
Existing Condition: 4.1% to 12.6% CS.	2004 ADAAG -
	2007 CBC -
	Other 1999 ADAAG-16.3.7.1

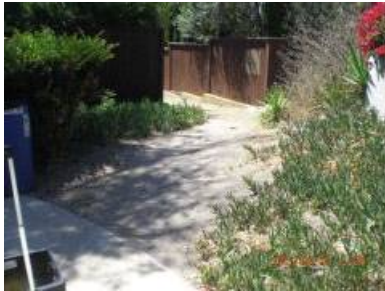
Keynote 39

Field Condition	
30.06C - Outdoor Recreation Access Route (ORAR) Surface - The surface of the access route is not firm or stable.	1991 ADAAG -
Existing Condition: Uneven surface.	2004 ADAAG -
	2007 CBC -
	Other 1999 ADAAG-16.3.1

Classification	
DOJ Location Type:	1
Use:	PV
Severity:	C
Level of Difficulty	Moderate to High
