*City of Rancho Palos Verdes*  
**Rancho Palos Verdes ADA Assessment**  
**Facility Report with Photos**

**Reporting: 266 of 4367 Rcds**

**Facility ID: # 07 - Fred Hesse Jr. Community Park (Upper Part)**

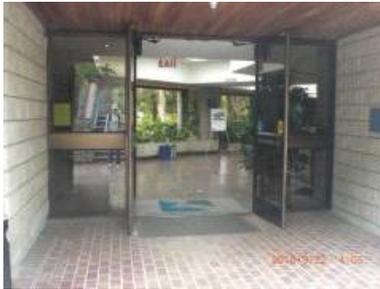
**Location:** Main Entrance  
**Photo #** 3

11.17A - Recommendation: Providing Room/Space ID Sign - A sign designating the permanent room or space has not been provided.

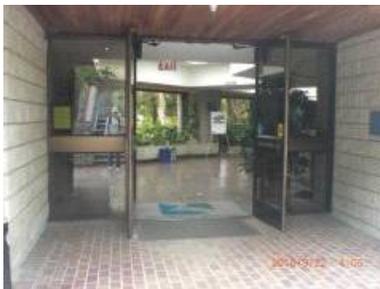
**Location:** Main Entrance  
**Photo #** 3

Existing Condition: 20 LBF. required to stop door from closing.

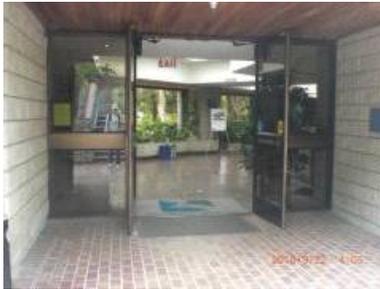
Field Condition	
11.07D - Floor Mat - Attachment to Floor - Floor mat used on a ground or floor surface is not securely attached.	1991 ADAAG 4.5.3
Existing Condition: Loose floor mats.	2004 ADAAG 303.2; Advisory 302.2
	2007 CBC 1124B.3
	Other -

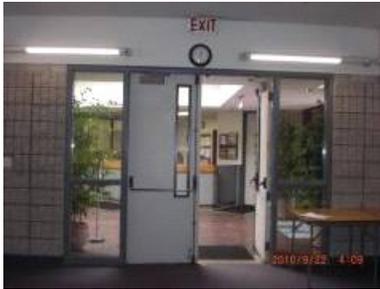
**Location:** Meeting Room  
**Photo #** 6

11.15A - Kick Plate - Bottom 10" of door does not have a smooth, uninterrupted surface on the push side to allow the door to be opened by a wheelchair footrest without creating a trap or hazardous condition. (This requirement does not apply to automatic and sliding doors.)

Existing Condition: Door stop and panic rod on kick plate.

072D - Replace Hardware with Panic Device - Replace door hardware with panic device.

Additional Comments: Replace panic hardware and remove door stops.

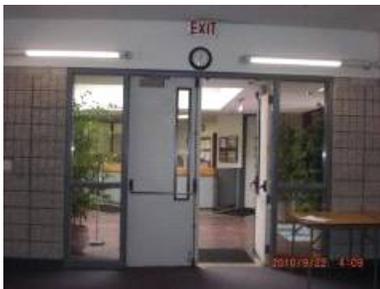
**Location:** Meeting Room  
**Photo #** 6

Existing Condition: 8 LBF.

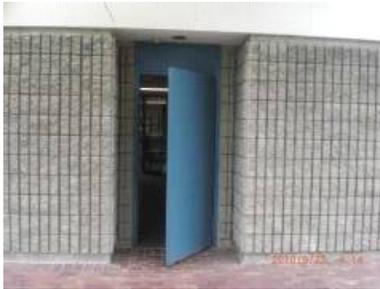
10.06A - Door Maneuvering Space - Door that is not automatic or power-assisted does not have compliant maneuvering space relative to the direction of approach as shown in CBC Fig. 11B-26. (Approach // Side // Width // Depth) (Front // Pull // D + 24" \* // 60") (Front // Push // D + 0" \*\* // 48") (Latch // Pull // D + 24" // 60") (Latch // Push // D + 24" // 44" \*\*\* ) (Hinge // Pull // D + 36" // 60") (Hinge // Push // 54" \*\*\*\* // 44" \*\*\*\*\* ) (\* D + 18" at interior doors.) (\*\* D + 12" if door has both a latch and a closer.) (\*\*\*) 48" if door has closer.) (\*\*\*\* Measured from latch toward hinge.) (\*\*\*\*\* 48" if door has both a latch and a closer.)

Existing Condition: 9" on pull side.

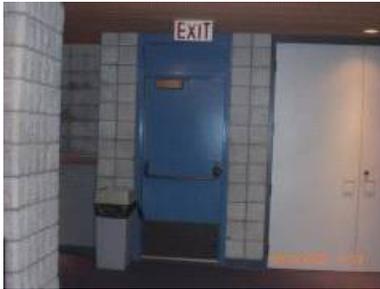
**Location:** Meeting Room  
**Photo #** 14

<b>Field Condition</b>	
10.13A - Required Exit Door Sign - At grade level exterior exit door, there is no tactile and CA Braille exit sign with the word "EXIT" mounted on the wall adjacent to the latch side of the door.	<b>1991 ADAAG</b> 4.1.3(16); 4.30.1
Existing Condition:	<b>2004 ADAAG</b> 216.4; 703.2; 703.3; 703.4
	<b>2007 CBC</b> 1011.3 item 1
	<b>Other</b> -

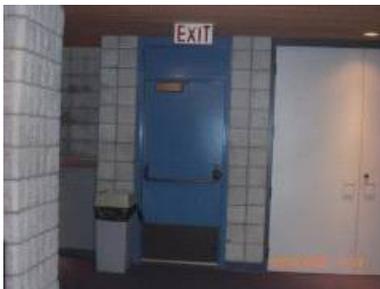
**Location:** Meeting Room  
**Photo #** 14

<b>Field Condition</b>	
10.08 - Kick Plate - Bottom 10" of door does not have a smooth, uninterrupted surface on the push side to allow the door to be opened by a wheelchair footrest without creating a trap or hazardous condition. (This requirement does not apply to automatic and sliding doors.)	<b>1991 ADAAG</b> -
Existing Condition: Door stop on kick plate.	<b>2004 ADAAG</b> 404.2.10
	<b>2007 CBC</b> 1133B.2.6
	<b>Other</b> -

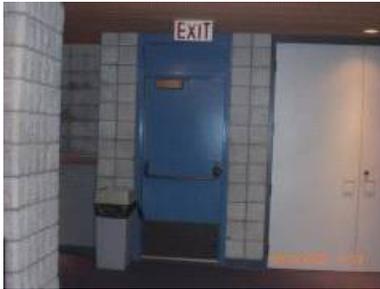
**Location:** Meeting Room  
**Photo #** 14

Field Condition	
10.11A - Door Operating Effort - The force required to operate door exceeds 5 lbs. (Fire doors may have up to 15 lbs to achieve positive latching).	1991 ADAAG 4.13.11
Existing Condition: 10 LBF.	2004 ADAAG 404.2.9
	2007 CBC 1133B.2.5
	Other -

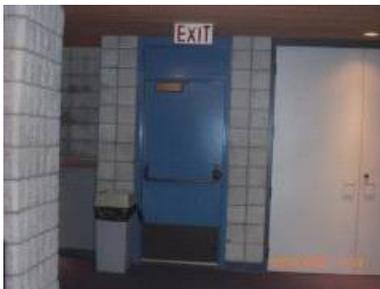
**Location:** Meeting Room  
**Photo #** 14

Field Condition	
10.11B - Hardware Operating Effort - The force required to activate handles, pulls, latches, locks, and other operable parts of door exceeds 5 lbs.	1991 ADAAG 4.27.4
Existing Condition: 10 LBF.	2004 ADAAG 309.4
	2007 CBC 1117B.6 item 4
	Other -

Corrective Action
072D - Replace Hardware with Panic Device - Replace door hardware with panic device.
Additional Comments:

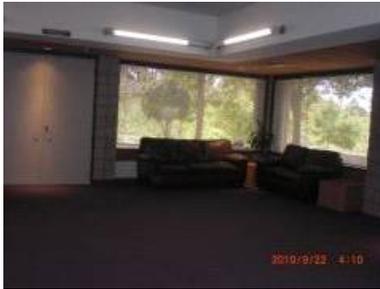
**Location:** Meeting Room  
**Photo #** 20

<b>Field Condition</b>	20.04 - Common Use Areas - Visual Alarms - Visual alarms are not provided in common use area(s) of the building such as meeting and conference rooms, open office space, classrooms, cafeterias, filing and photocopy rooms, employee break rooms, dressing, examination, and treatment rooms, and similar spaces that are not used solely as employee work areas.	<b>1991 ADAAG</b> 4.28.1
Existing Condition:		<b>2004 ADAAG</b> 215.2; 702.1
		<b>2007 CBC</b> 907.9.1.1
		<b>Other</b> -

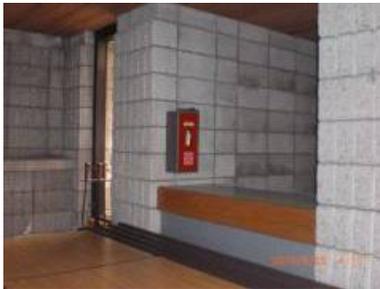
**Location:** Meeting Room  
**Photo #** 21

<b>Field Condition</b>	20.16B - Surface-Mounted Fire Extinguisher - Mounting Height - Where fire extinguishers are surface-mounted, mounting height of the extinguisher is not compliant. (Compliant surface-mounted extinguisher is 48" AFF maximum, as measured to the highest operable part, or in existing buildings, when the extinguisher is 54" AFF and parallel approach is provided)	<b>1991 ADAAG</b> 4.27.3
Existing Condition: Fire Extinguisher mounted at 64" high.		<b>2004 ADAAG</b> 308.2.1; Fig. 308.2.1; 308.3.1; Fig. 308.3.1
		<b>2007 CBC</b> 1118B.4(1); 1118B.5; 1118B.6
		<b>Other</b> -

<b>Corrective Action</b>	388C - Replace and Relocate Fire Extinguisher Cabinet - Replace existing fire extinguisher cabinet with compliant model in new location.
Additional Comments:

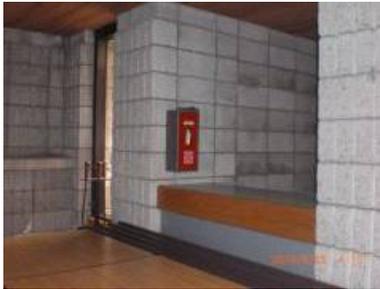
<b>Field Condition</b>									
20.17B - Surface-Mounted Fire Extinguisher - Operation - Operating hardware of the fire extinguisher is not accessible (i.e.: it require tight grasping, pinching, or twisting of the wrist, or requires a force exceeding 5 lbs.)

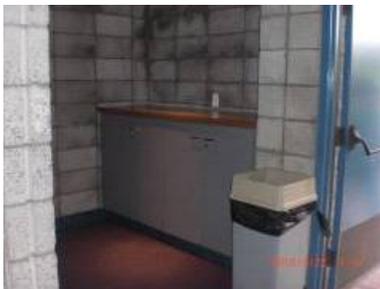
<b>Field Condition</b>									
14.28 - Fixed/Built-in Seating, Tables or Counters - At fixed or built-in seating, tables, or counters in public or common employee areas, less than 5% of the provided seating spaces are wheelchair accessible and have a 30" by 48" clear space which overlaps an accessible route of travel. (Wheelchair accessible seating spaces are between 28" - 34" high and with knee space measuring at least 27" high, 30" wide, and 19" deep.) (These elements include study carrels and student laboratory stations.)

1991 ADAAG	4.1.3(18); 4.32.1; 4.32.4	2004 ADAAG	226.1; Advisory 226.1; 305; 306; 902.2	2007 CBC	1122B.1	Other	-
1991 ADAAG	4.1.3(18); 4.32.1; 4.32.4								
2004 ADAAG	226.1; Advisory 226.1; 305; 306; 902.2								
2007 CBC	1122B.1								
Other	-								
Existing Condition: 42" high Counter.

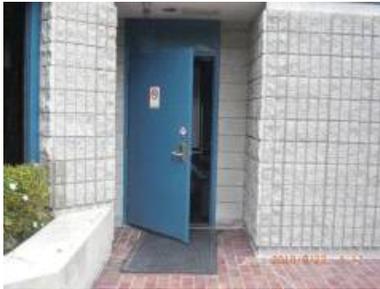
**Location:** Meeting Room  
**Photo #** 24

Field Condition	
11.07D - Floor Mat - Attachment to Floor - Floor mat used on a ground or floor surface is not securely attached.	1991 ADAAG 4.5.3
Existing Condition: Loose floor mat.	2004 ADAAG 303.2; Advisory 302.2
	2007 CBC 1124B.3
	Other -

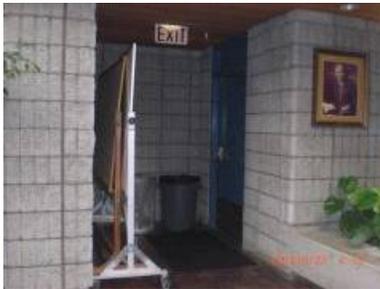
**Location:** Meeting Room  
**Photo #** 25

Field Condition	
10.08 - Kick Plate - Bottom 10" of door does not have a smooth, uninterrupted surface on the push side to allow the door to be opened by a wheelchair footrest without creating a trap or hazardous condition. (This requirement does not apply to automatic and sliding doors.)	1991 ADAAG -
Existing Condition: Door stop on kick plate.	2004 ADAAG 404.2.10
	2007 CBC 1133B.2.6
	Other -

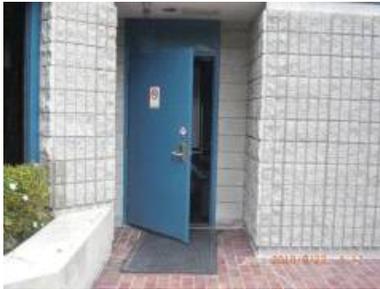
Existing Condition: 14" on pull side.

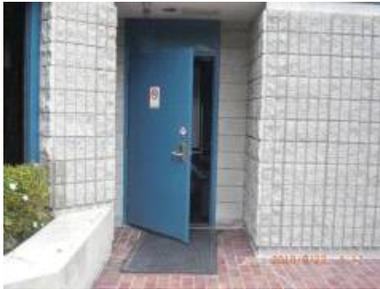
**Location:** Meeting Room  
**Photo #** 24

Field Condition	
10.11B - Hardware Operating Effort - The force required to activate handles, pulls, latches, locks, and other operable parts of door exceeds 5 lbs.	1991 ADAAG 4.27.4
Existing Condition: 12 LBF.	2004 ADAAG 309.4
	2007 CBC 1117B.6 item 4
	Other -

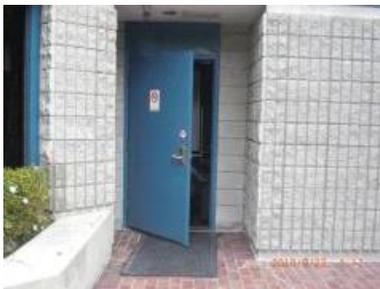
**Location:** Meeting Room  
**Photo #** 24

Field Condition	
10.11A - Door Operating Effort - The force required to operate door exceeds 5 lbs. (Fire doors may have up to 15 lbs to achieve positive latching).	1991 ADAAG 4.13.11
Existing Condition: 14 LBF.	2004 ADAAG 404.2.9
	2007 CBC 1133B.2.5
	Other -

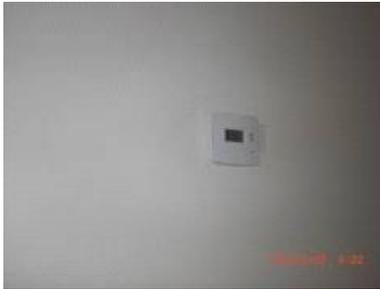
Existing Condition: 65" high thermostat.

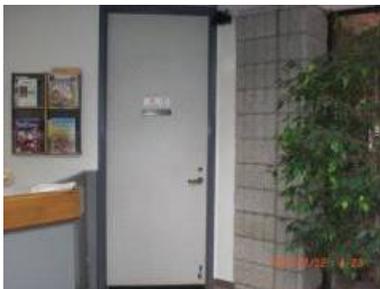
Existing Condition: 10 LBF.

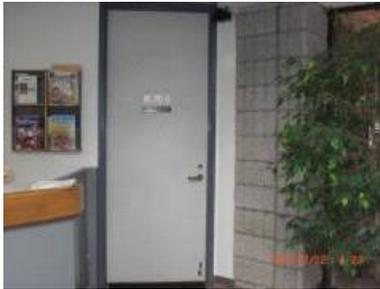
<b>Field Condition</b>	
11.15A - Kick Plate - Bottom 10" of door does not have a smooth, uninterrupted surface on the push side to allow the door to be opened by a wheelchair footrest without creating a trap or hazardous condition. (This requirement does not apply to automatic and sliding doors.)	<b>1991 ADAAG</b> -
Existing Condition: Door stop on kick plate.	<b>2004 ADAAG</b> 404.2.10
	<b>2007 CBC</b> 1133B.2.6
	<b>Other</b> -

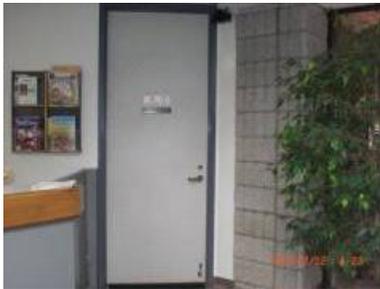
<b>Field Condition</b>	
11.17A - Recommendation: Providing Room/Space ID Sign - A sign designating the permanent room or space has not been provided.	<b>1991 ADAAG</b> 4.1.2(7)
Existing Condition:	<b>2004 ADAAG</b> 216.2; 703.1; 703.2; 703.5
	<b>2007 CBC</b> 1117B.5.1 item 1
	<b>Other</b> -

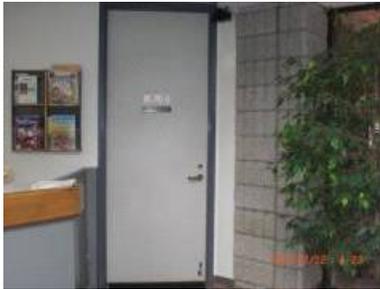
Existing Condition: 3 1/2".

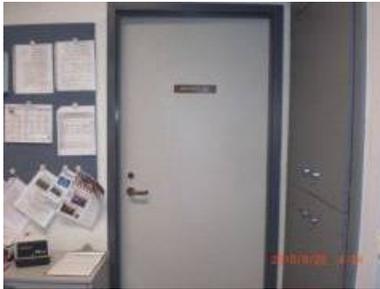
Field Condition	
11.17A - Recommendation: Providing Room/Space ID Sign - A sign designating the permanent room or space has not been provided.	1991 ADAAG 4.1.2(7)
Existing Condition:	2004 ADAAG 216.2; 703.1; 703.2; 703.5
	2007 CBC 1117B.5.1 item 1
Other	-

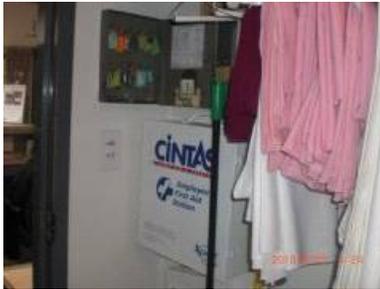
Existing Condition: 17 1/4" on pull side.

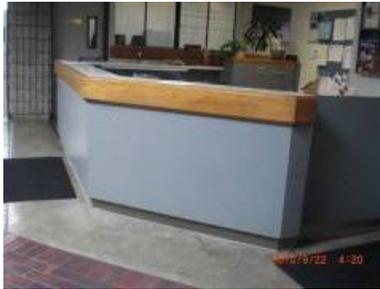
**Location:** Lobby  
**Photo #** 40

Existing Condition: 42" high Counter.

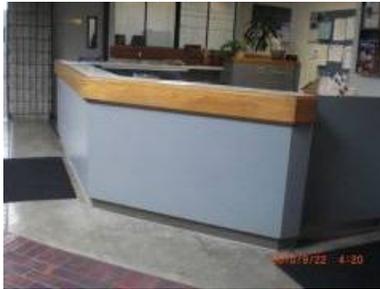
Field Condition	
14.23B - Floor Surface - Accessible route surfaces are not stable, firm and slip-resistant.	1991 ADAAG 4.5.1
Existing Condition: Loose floor mats.	2004 ADAAG 302.1; Advisory 302.1
	2007 CBC 1124B.1
	Other -

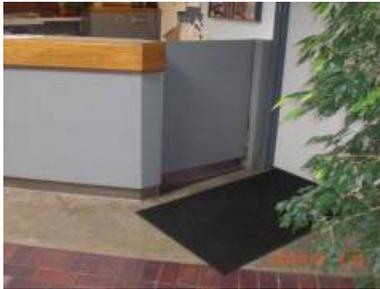
Existing Condition: 1 3/4" .

054A - Replace Door - Remove existing door and replace with new door and door frame. Provide new accessible door hardware.

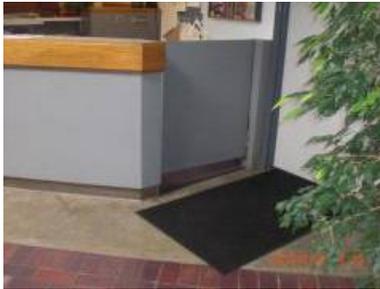
<b>Field Condition</b>	
11.15A - Kick Plate - Bottom 10" of door does not have a smooth, uninterrupted surface on the push side to allow the door to be opened by a wheelchair footrest without creating a trap or hazardous condition. (This requirement does not apply to automatic and sliding doors.)	<b>1991 ADAAG</b> -
Existing Condition: 4" gap.	<b>2004 ADAAG</b> 404.2.10
	<b>2007 CBC</b> 1133B.2.6
	<b>Other</b> -

<b>Corrective Action</b>
079 - Doors - Miscellaneous - See Additional Comments
Additional Comments: Replace door.

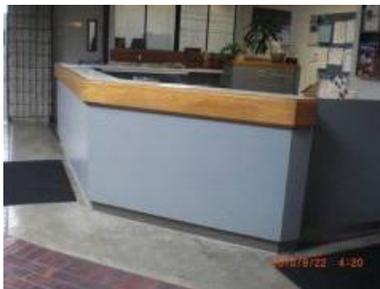
<b>Field Condition</b>	
14.29A - Counter - Knee Space Height - Where seating for persons in wheelchairs is provided at table or counter, knee space is less than 27" high.	<b>1991 ADAAG</b> 4.32.3
Existing Condition: 23 5/8" high on employee side.	<b>2004 ADAAG</b> 306.3.1; Fig. 306.3
	<b>2007 CBC</b> 1122B.3; Fig. 11B-13
	<b>Other</b> -

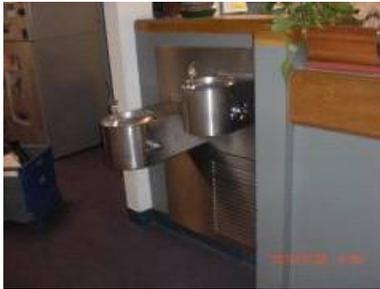
Existing Condition: 24 1/2" high.

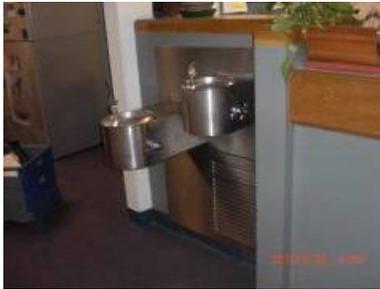
Field Condition	
05.13 - Operation - The controls are not compliant.(Accessible controls shall be operable with one hand, and without tight grasping, pinching, or twisting of the wrist, and the force to operate the controls shall be no greater than 5 lbs.)	1991 ADAAG 4.27.4
Existing Condition: Twist type control.	2004 ADAAG 602.3; 309.4
	2007 CBC 1115B.4.6 item 4
	Other -

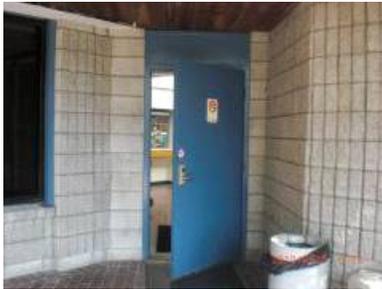
Existing Condition: 16" pull side.

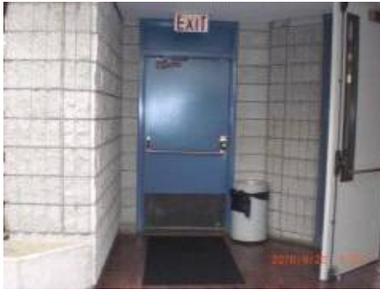
**Location:** Hallway  
**Photo #** 50

Field Condition	
10.11A - Door Operating Effort - The force required to operate door exceeds 5 lbs. (Fire doors may have up to 15 lbs to achieve positive latching).	1991 ADAAG 4.13.11
Existing Condition: 10 LBF.	2004 ADAAG 404.2.9
	2007 CBC 1133B.2.5
	Other -

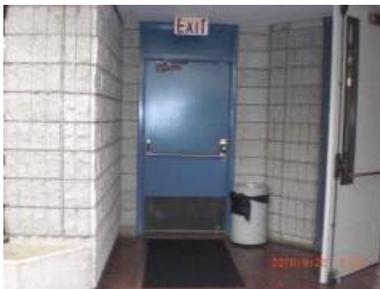
**Location:** Hallway  
**Photo #** 50

Field Condition	
10.11B - Hardware Operating Effort - The force required to activate handles, pulls, latches, locks, and other operable parts of door exceeds 5 lbs.	1991 ADAAG 4.27.4
Existing Condition: 7 LBF.	2004 ADAAG 309.4
	2007 CBC 1117B.6 item 4
	Other -

Corrective Action
072D - Replace Hardware with Panic Device - Replace door hardware with panic device.
Additional Comments:

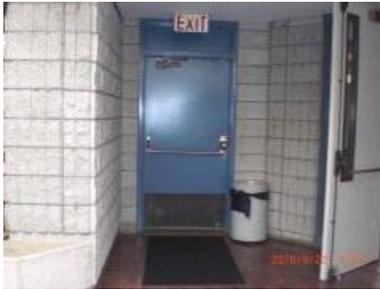
**Location:** Hallway  
**Photo #** 50

<b>Field Condition</b>	
10.08 - Kick Plate - Bottom 10" of door does not have a smooth, uninterrupted surface on the push side to allow the door to be opened by a wheelchair footrest without creating a trap or hazardous condition. (This requirement does not apply to automatic and sliding doors.)	1991 ADAAG -
Existing Condition: Door stop on kick plate.	2004 ADAAG 404.2.10
	2007 CBC 1133B.2.6
	Other -

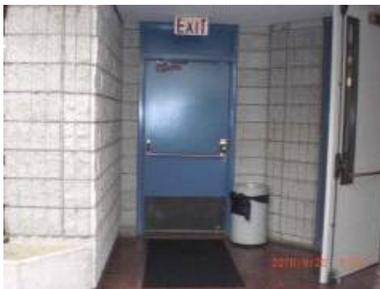
**Location:** Hallway  
**Photo #** 50

<b>Field Condition</b>	
11.07D - Floor Mat - Attachment to Floor - Floor mat used on a ground or floor surface is not securely attached.	1991 ADAAG 4.5.3
Existing Condition: Loose floor mats.	2004 ADAAG 303.2; Advisory 302.2
	2007 CBC 1124B.3
	Other -

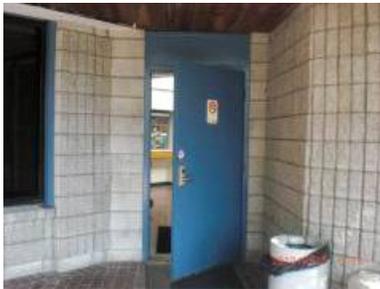
**Location:** Hallway  
**Photo #** 49

11.17A - Recommendation: Providing Room/Space ID Sign - A sign designating the permanent room or space has not been provided.

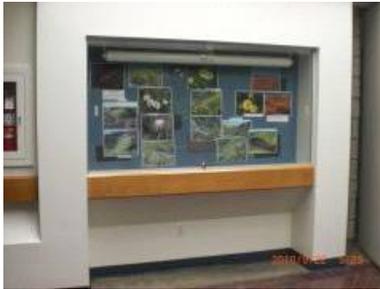
**Location:** Hallway  
**Photo #** 56

Field Condition									
14.35 - Controls - Operation - The controls are not accessible. (Accessible controls shall be operable with one hand, and without tight grasping, pinching, or twisting of the wrist, and the force to operate the controls shall be no greater than 5 lbs.)

1991 ADAAG	4.27.4	2004 ADAAG	309.4	2007 CBC	1117B.6(4)	Other	-
1991 ADAAG	4.27.4								
2004 ADAAG	309.4								
2007 CBC	1117B.6(4)								
Other	-								
Existing Condition: Non-compliant controls for display cabinets.

Corrective Action
031B - Replace Control - Replace control. Repair/refinish as required.
Additional Comments:

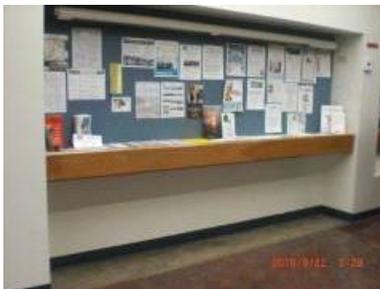
**Location:** Hallway  
**Photo #** 57

Field Condition									
14.28 - Fixed/Built-in Seating, Tables or Counters - At fixed or built-in seating, tables, or counters in public or common employee areas, less than 5% of the provided seating spaces are wheelchair accessible and have a 30" by 48" clear space which overlaps an accessible route of travel. (Wheelchair accessible seating spaces are between 28" - 34" high and with knee space measuring at least 27" high, 30" wide, and 19" deep.) (These elements include study carrels and student laboratory stations.)

1991 ADAAG	4.1.3(18); 4.32.1; 4.32.4	2004 ADAAG	226.1; Advisory 226.1; 305; 306; 902.2	2007 CBC	1122B.1	Other	-
1991 ADAAG	4.1.3(18); 4.32.1; 4.32.4								
2004 ADAAG	226.1; Advisory 226.1; 305; 306; 902.2								
2007 CBC	1122B.1								
Other	-								
Existing Condition: 36 1/2" high Counter, 7" deep.

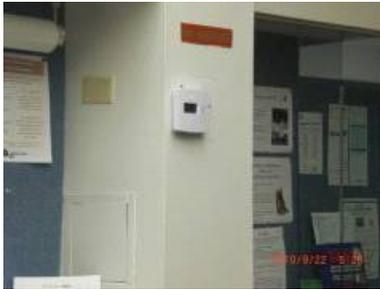
<b>Field Condition</b>	
14.32A - Reach Range - Controls - Controls, dispensers, and similar devices are not between 9" and 54" AFF when the clear floor space allows a parallel approach. OR They are not between 15" and 48" AFF when the clear floor space allows only a forward approach.	<b>1991 ADAAG</b> 4.1.3(13); 4.27.3; 4.2.5; 4.2.6 ; Fig. 5; Fig. 6 <b>2004 ADAAG</b> - <b>2007 CBC</b> 1117B.6(3); 1118.5; 1118.6; Fig. 11B-5C; Fig. 11B-5D <b>Other</b> -
Existing Condition: 65" high thermostat.

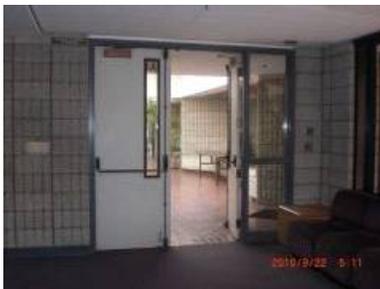
<b>Field Condition</b>	
11.15A - Kick Plate - Bottom 10" of door does not have a smooth, uninterrupted surface on the push side to allow the door to be opened by a wheelchair footrest without creating a trap or hazardous condition. (This requirement does not apply to automatic and sliding doors.)	<b>1991 ADAAG</b> - <b>2004 ADAAG</b> 404.2.10 <b>2007 CBC</b> 1133B.2.6 <b>Other</b> -
Existing Condition: Door stop and panic rod on kick plate.

<b>Corrective Action</b>
072D - Replace Hardware with Panic Device - Replace door hardware with panic device.
Additional Comments: Provide compliant panic hardware and remove door stops.

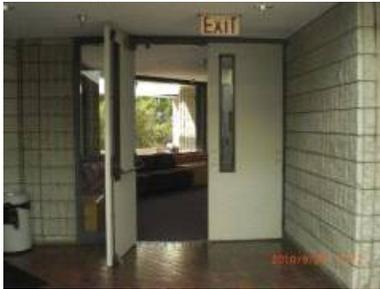
**Location:** Activity Room  
**Photo #** 62

Field Condition	
11.17A - Recommendation: Providing Room/Space ID Sign - A sign designating the permanent room or space has not been provided.	1991 ADAAG 4.1.2(7)
Existing Condition:	2004 ADAAG 216.2; 703.1; 703.2; 703.5
	2007 CBC 1117B.5.1 item 1
	Other -

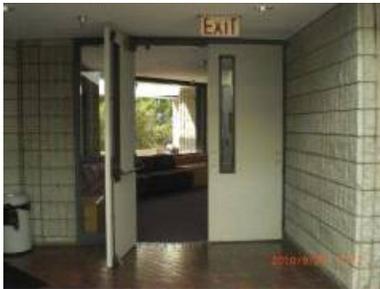
**Location:** Activity Room  
**Photo #** 62

Field Condition	
11.14 - Closers - Door closer is not adjusted so that from an open position of 70 degrees, the door will take at least 3 seconds to move to a point 3" from the latch (measured to the leading edge of the door).	1991 ADAAG 4.13.10
Existing Condition: 2.65 seconds.	2004 ADAAG 404.2.8.1
	2007 CBC 1133B.2.5.1
	Other -

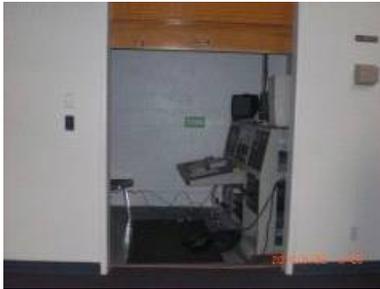
<b>Field Condition</b>									
14.23B - Floor Surface - Accessible route surfaces are not stable, firm and slip-resistant.  Existing Condition: Loose floor mat.

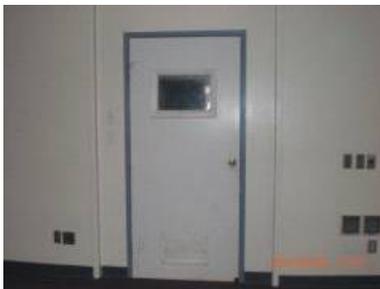
<b>Field Condition</b>									
11.11 - Single-Action Hardware - Handles, locks, and latches or other operative devices are not operable with one hand and without tight grasping, pinching, or twisting of the wrist. (U-shaped handles, levers, and push/pull type mechanisms are acceptable designs.)  Existing Condition: Twist type lock and knob.

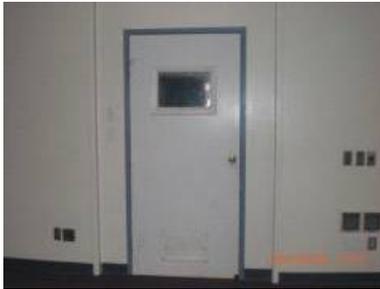
<b>Field Condition</b>	
11.15B_04AG - Vision Lights - Door, gate, or adjacent sidelight, containing one or more vision lights, does not include at least one vision light mounted with the bottom edge of the glazed panel at 43" max.. AFF. (Exception: Vision lights with the lowest part more than 66" AFF.)	1991 ADAAG -
Existing Condition: 57" high Vision light.	2004 ADAAG 404.2.11
	2007 CBC -
	Other -

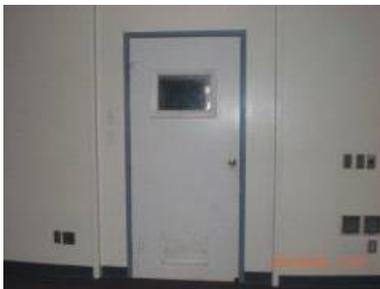
<b>Field Condition</b>	
11.15A - Kick Plate - Bottom 10" of door does not have a smooth, uninterrupted surface on the push side to allow the door to be opened by a wheelchair footrest without creating a trap or hazardous condition. (This requirement does not apply to automatic and sliding doors.)	1991 ADAAG -
Existing Condition: 7" to door grille.	2004 ADAAG 404.2.10
	2007 CBC 1133B.2.6
	Other -

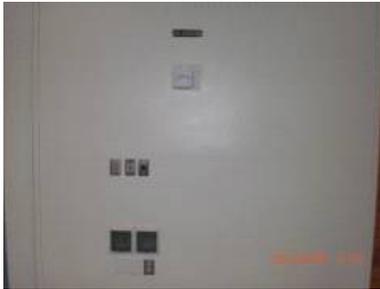
<b>Field Condition</b>	
14.35 - Controls - Operation - The controls are not accessible. (Accessible controls shall be operable with one hand, and without tight grasping, pinching, or twisting of the wrist, and the force to operate the controls shall be no greater than 5 lbs.)	1991 ADAAG 4.27.4
Existing Condition: Twist type controls.	2004 ADAAG 309.4
	2007 CBC 1117B.6(4)
	Other -

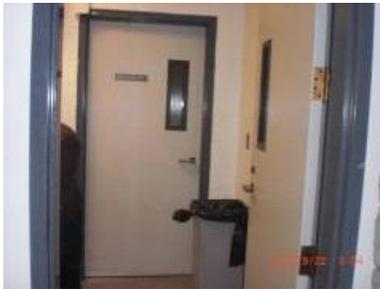
<b>Field Condition</b>	
11.13A - Door Operating Effort - The force required to operate door exceeds 5 lbs. (Fire doors may have up to 15 lbs to achieve positive latching).	1991 ADAAG 4.13.11
Existing Condition: 10 LBF.	2004 ADAAG 404.2.9
	2007 CBC 1133B.2.5
	Other -

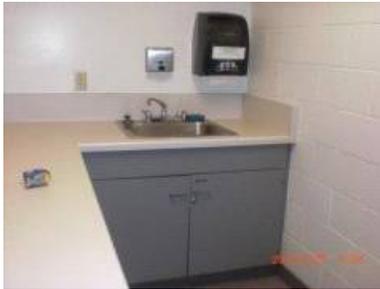
<b>Field Condition</b>	
16.84A - Paper Towel Dispenser - Operating Height - Mounting height of paper towel dispenser's highest operable part exceeds 40" AFF. (Where provided, ADA Standards require at least one paper towel dispenser to be accessible with the highest operable part placed within at least one of the reach ranges specified in 4.2.5 and 4.2.6; where provided, CBC Standards require at least one paper towel dispenser to be accessible with the highest operable part no higher than 40" AFF.)	1991 ADAAG 4.22.7; 4.27.3; 4.2.5; 4.2.6
Existing Condition: 51" high.	2004 ADAAG 308; 309
	2007 CBC 1115B.8.3
	Other -

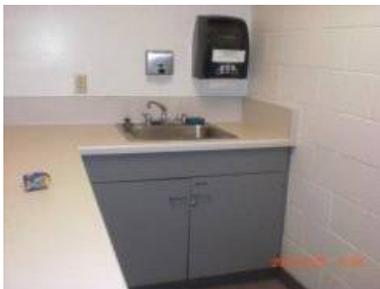
<b>Field Condition</b>	
16.84C - Soap Dispenser - Operating Height - Mounting height of soap dispenser's highest operable part exceeds 40" AFF. (Where provided, ADA Standards require at least one soap dispenser to be accessible with the highest operable part placed within at least one of the reach ranges specified in 4.2.5 and 4.2.6; where provided, CBC Standards require at least one soap dispenser to be accessible with the highest operable part no higher than 40" AFF.)	1991 ADAAG 4.22.7; 4.27.3; 4.2.5; 4.2.6
Existing Condition: 49" high.	2004 ADAAG 308; 309
	2007 CBC 1115B.8.3
	Other -

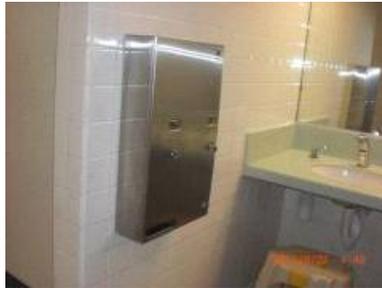
Field Condition	
16.84D - Sanitary Napkin/Feminine Hygiene Dispenser - Operating Height - Mounting height of sanitary napkin/femin.ine hygiene dispenser's highest operable part exceeds 40" AFF. (Where provided, ADA Standards require at least one sanitary napkin/femin.ine hygiene dispenser to be accessible with the highest operable part placed within at least one of the reach ranges specified in 4.2.5 and 4.2.6; where provided, CBC Standards require at least one sanitary napkin/femin.ine hygiene dispenser to be accessible with the highest operable part no higher than 40" AFF.)	<b>1991 ADAAG</b> 4.22.7; 4.27.3; 4.2.5; 4.2.6 <b>2004 ADAAG</b> 308; 309 <b>2007 CBC</b> 1115B.8.3 <b>Other</b> -
Existing Condition: 45 1/2" high.

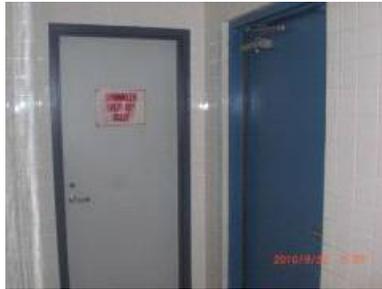
Field Condition	
11.17A - Recommendation: Providing Room/Space ID Sign - A sign designating the permanent room or space has not been provided.	1991 ADAAG 4.1.2(7)
Existing Condition:	2004 ADAAG 216.2; 703.1; 703.2; 703.5
	2007 CBC 1117B.5.1 item 1
	Other -

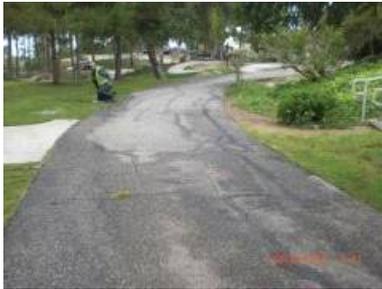
<b>Field Condition</b>	
30.07F - Outdoor Recreation Access Routes (ORAR) - Edge Protection - Where edge protection is provided, it does not have a height of 3" min..	1991 ADAAG -
Existing Condition: No edge protection provided at drainage area.	2004 ADAAG -
	2007 CBC -
	Other 1999 ADAAG-16.3.9
