*City of Rancho Palos Verdes*  
**Rancho Palos Verdes ADA Assessment**  
**Facility Report with Photos**

**Facility ID: # 08 - Ladera Linda Park & Community Center**

**Author: Vaish, B**

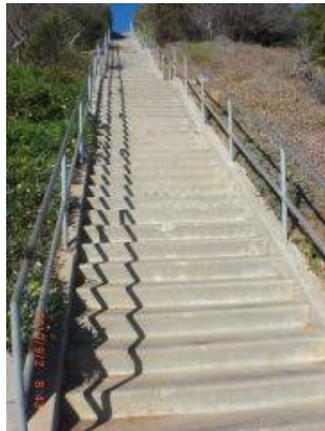
**Keynote 135**

<b>Field Condition</b>	
08.02B - Riser Height - The risers are not uniform. OR The risers are not between 4" and 7" in height.	1991 ADAAG 4.9.2
Existing Condition: 5 1/2" to 6 1/4" high.	2004 ADAAG 504.2
	2007 CBC 1009.3; 1133B.4.5.3
	Other -

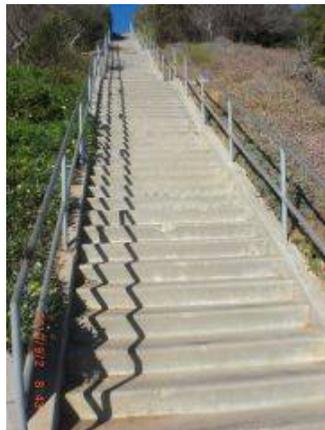
**Keynote 139**

08.05A - Exterior Stairs - Color Strip - Contrasting color strips have not been provided.

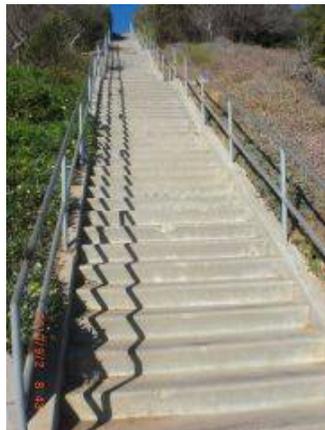
**Location:** Stairs  
**Photo #** 135

<b>Field Condition</b>	
08.09A - Handrail Extensions - Top Landing - At ends of handrails, less than 12" of handrail extends beyond the top nosing. (Top and bottom handrail extensions are important safety features for persons with balance problems and must extend in the direction of the stair run to permit the intended use.) (Per ADA/CBC Standards, in existing buildings and facilities, full extension of handrails at stairs shall not be required in alterations where such extensions would be hazardous or impossible due to plan configuration.)	<b>1991 ADAAG</b> 4.9.4(2)
Existing Condition:	<b>2004 ADAAG</b> 505.10; 505.10.2; Fig. 505.10.2
	<b>2007 CBC</b> 1133B.4.2.2
	<b>Other</b> -

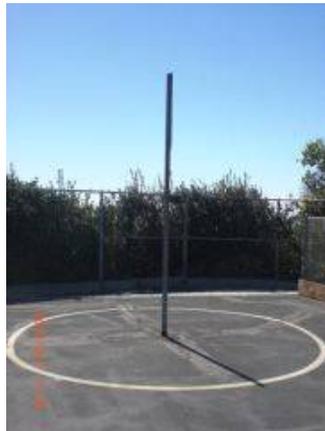
**Location:** Basketball Courts  
**Photo #** 153

<b>Field Condition</b>	
03B.09 - Cross Slope - Cross slope of the accessible route of travel exceeds 1:50. Existing Condition: 3.0% CS at tetherball court	<b>1991 ADAAG</b> 4.3.7  <b>2004 ADAAG</b> 403.3  <b>2007 CBC</b> 1133B.7.1.3  <b>Other</b> -

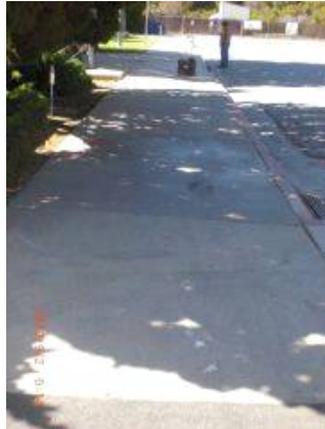
**Location:** School Grounds  
**Photo #** 172

Field Condition									
03B.09 - Cross Slope - Cross slope of the accessible route of travel exceeds 1:50. Existing Condition: 2.5% to 2.9% CS.

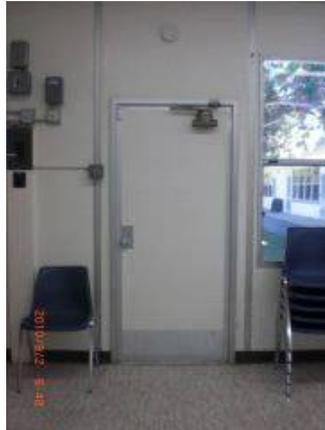
**Location:** Classroom G  
**Photo #** 212

<b>Field Condition</b>	
10.13A - Required Exit Door Sign - At grade level exterior exit door, there is no tactile and CA Braille exit sign with the word "EXIT" mounted on the wall adjacent to the latch side of the door.	<b>1991 ADAAG</b> 4.1.3(16); 4.30.1
Existing Condition:	<b>2004 ADAAG</b> 216.4; 703.2; 703.3; 703.4
	<b>2007 CBC</b> 1011.3 item 1
	<b>Other</b> -

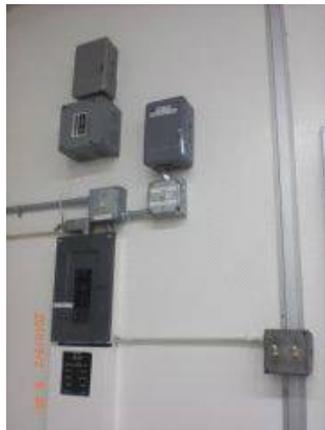
**Location:** Classroom G      **Photo #** 221

<b>Field Condition</b>	
14.32A - Reach Range - Controls - Controls, dispensers, and similar devices are not between 9" and 54" AFF when the clear floor space allows a parallel approach. OR They are not between 15" and 48" AFF when the clear floor space allows only a forward approach.	<b>1991 ADAAG</b> 4.1.3(13); 4.27.3; 4.2.5; 4.2.6 ; Fig. 5; Fig. 6 <b>2004 ADAAG</b> - <b>2007 CBC</b> 1117B.6(3); 1118.5; 1118.6; Fig. 11B-5C; Fig. 11B-5D <b>Other</b> -
Existing Condition: 76" to gas switch.

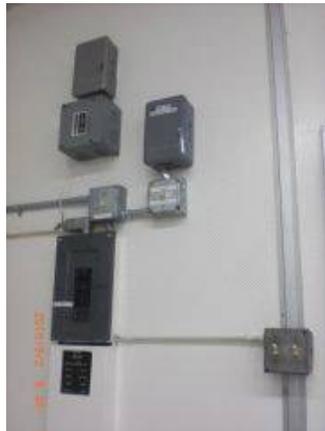
**Location:** Classroom G  
**Photo #** 221

<b>Field Condition</b>	
14.32A - Reach Range - Controls - Controls, dispensers, and similar devices are not between 9" and 54" AFF when the clear floor space allows a parallel approach. OR They are not between 15" and 48" AFF when the clear floor space allows only a forward approach.	<b>1991 ADAAG</b> 4.1.3(13); 4.27.3; 4.2.5; 4.2.6 ; Fig. 5; Fig. 6 <b>2004 ADAAG</b> - <b>2007 CBC</b> 1117B.6(3); 1118.5; 1118.6; Fig. 11B-5C; Fig. 11B-5D <b>Other</b> -
Existing Condition: 75" to playground light switch.

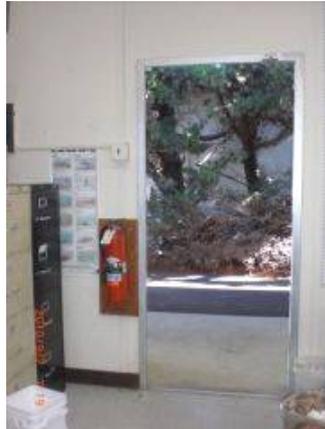
**Location:** Classroom H  
**Photo #** 242

Field Condition	
10.13A - Required Exit Door Sign - At grade level exterior exit door, there is no tactile and CA Braille exit sign with the word "EXIT" mounted on the wall adjacent to the latch side of the door.	1991 ADAAG 4.1.3(16); 4.30.1
Existing Condition:	2004 ADAAG 216.4; 703.2; 703.3; 703.4
	2007 CBC 1011.3 item 1
	Other -

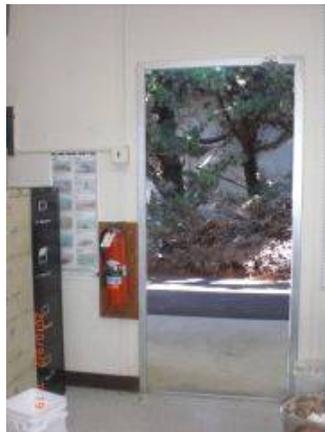
**Location:** Classroom H  
**Photo #** 242

<b>Field Condition</b>	
14.32A - Reach Range - Controls - Controls, dispensers, and similar devices are not between 9" and 54" AFF when the clear floor space allows a parallel approach. OR They are not between 15" and 48" AFF when the clear floor space allows only a forward approach.	<b>1991 ADAAG</b> 4.1.3(13); 4.27.3; 4.2.5; 4.2.6 ; Fig. 5; Fig. 6 <b>2004 ADAAG</b> - <b>2007 CBC</b> 1117B.6(3); 1118.5; 1118.6; Fig. 11B-5C; Fig. 11B-5D <b>Other</b> -
Existing Condition: 60" to light switch.

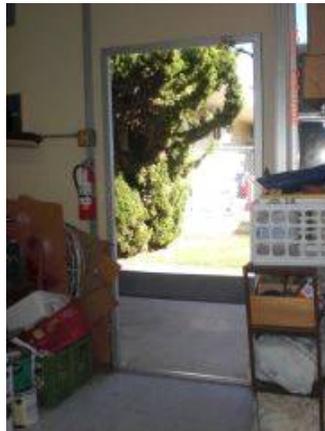
**Location:** Classroom      **Photo #** 264

Field Condition	
10.13A - Required Exit Door Sign - At grade level exterior exit door, there is no tactile and CA Braille exit sign with the word "EXIT" mounted on the wall adjacent to the latch side of the door.	1991 ADAAG 4.1.3(16); 4.30.1
Existing Condition:	2004 ADAAG 216.4; 703.2; 703.3; 703.4
	2007 CBC 1011.3 item 1
	Other -

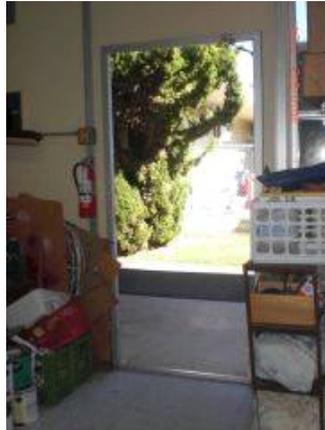
**Location:** Classroom  
**Photo #** 264

Field Condition	
10.06A - Door Maneuvering Space - Door that is not automatic or power-assisted does not have compliant maneuvering space relative to the direction of approach as shown in CBC Fig. 11B-26. (Approach // Side // Width // Depth) (Front // Pull // D + 24" * // 60") (Front // Push // D + 0" ** // 48") (Latch // Pull // D + 24" // 60") (Latch // Push // D + 24" // 44" ***) (Hinge // Pull // D + 36" // 60") (Hinge // Push // 54" **** // 44" *****) (* D + 18" at interior doors.) (** D + 12" if door has both a latch and a closer.) (***) 48" if door has closer.) (**** Measured from latch toward hinge.) (***** 48" if door has both a latch and a closer.)	<b>1991 ADAAG</b> 4.13.6; Fig. 25  <b>2004 ADAAG</b> 404.2.4.1; Tab.404.2.4.1; Fig.404.2.4.1  <b>2007 CBC</b> 1133B.2.4.2; Fig. 11B-26  <b>Other</b> -
Existing Condition: 4" due to FE.

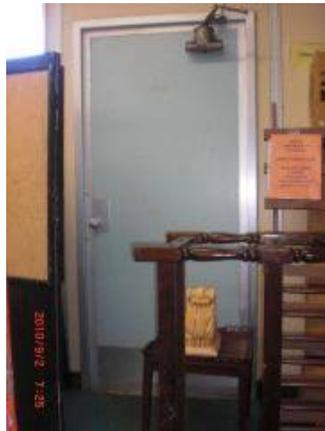
**Location:** Classroom **Photo #** 274

<b>Field Condition</b>	
10.10 - Single-Action Hardware - Handles, locks, and latches or other operative devices are not operable with one hand and without tight grasping, pinching, or twisting of the wrist. (U-shaped handles, levers, and push/pull type mechanisms are acceptable designs.)	<b>1991 ADAAG</b> 4.13.9 <b>2004 ADAAG</b> 309.4; 404.2.7; Advisory 404.2.7 <b>2007 CBC</b> 1133B.2.5.2 <b>Other</b> -
Existing Condition: Knob.

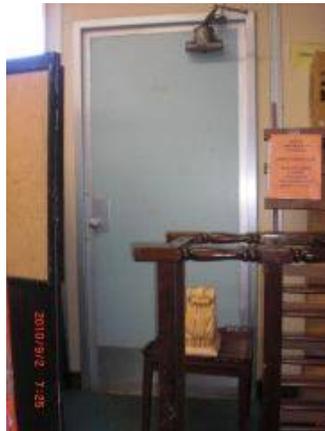
**Location:** Classroom      **Photo #** 274

Field Condition	
14.31 - Head Room - Clear head room is at less than 80" within the pedestrian circulation area, including the accessible route of travel.	1991 ADAAG 4.4.2
Existing Condition: 79" to headroom and closer.	2004 ADAAG 307.2; Fig. 307.2
	2007 CBC 1133B.8.6.2
	Other -

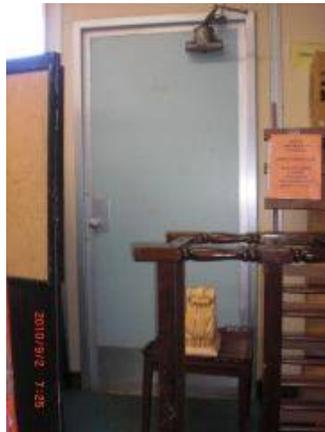
**Location:** Classroom  
**Photo #** 274

<b>Field Condition</b>	
10.06A - Door Maneuvering Space - Door that is not automatic or power-assisted does not have compliant maneuvering space relative to the direction of approach as shown in CBC Fig. 11B-26. (Approach // Side // Width // Depth) (Front // Pull // D + 24" * // 60") (Front // Push // D + 0" ** // 48") (Latch // Pull // D + 24" // 60") (Latch // Push // D + 24" // 44" ***) (Hinge // Pull // D + 36" // 60") (Hinge // Push // 54" **** // 44" *****) (* D + 18" at interior doors.) (** D + 12" if door has both a latch and a closer.) (***) 48" if door has closer.) (**** Measured from latch toward hinge.) (***** 48" if door has both a latch and a closer.)	<b>1991 ADAAG</b> 4.13.6; Fig. 25  <b>2004 ADAAG</b> 404.2.4.1; Tab.404.2.4.1; Fig.404.2.4.1  <b>2007 CBC</b> 1133B.2.4.2; Fig. 11B-26  <b>Other</b> -
Existing Condition: 1" due to furniture.

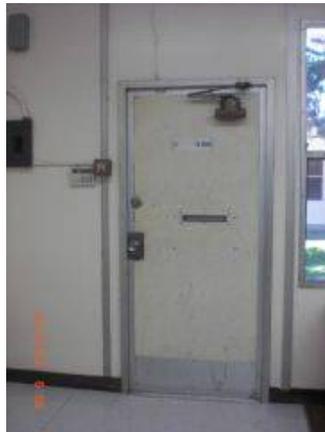
**Location:** Classroom K  
**Photo #** 292

Field Condition	
10.13A - Required Exit Door Sign - At grade level exterior exit door, there is no tactile and CA Braille exit sign with the word "EXIT" mounted on the wall adjacent to the latch side of the door.	1991 ADAAG 4.1.3(16); 4.30.1
Existing Condition:	2004 ADAAG 216.4; 703.2; 703.3; 703.4
	2007 CBC 1011.3 item 1
	Other -

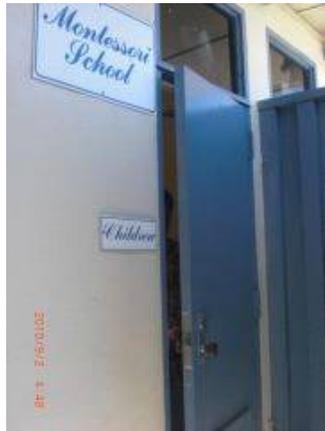
**Location:** Children's Restroom      **Photo #** 613

Field Condition	
16.11A - Door Operating Effort - The force required to operate door exceeds 5 lbs. (Fire doors may have up to 15 lbs to achieve positive latching).	1991 ADAAG 4.13.11
Existing Condition: 6 LBF.	2004 ADAAG 404.2.9
	2007 CBC 1133B.2.5
	Other -

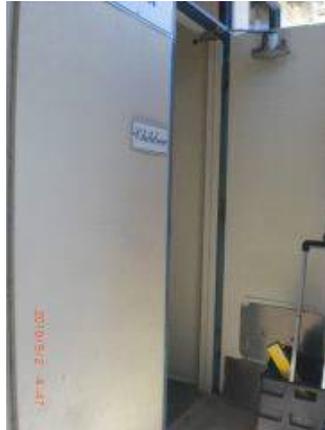
**Location:** Children's Restroom  
**Photo #** 615

Field Condition	
16.07 - Clear Door Opening - When the door is open 90 degrees, clear opening width is less than 32" measured between the face of the door and the doorstop on the latch side.	1991 ADAAG 4.13.5
Existing Condition: 23" wide.	2004 ADAAG 404.2.3
	2007 CBC 1133B.1.1.1.1; 1133B.2.2
	Other -

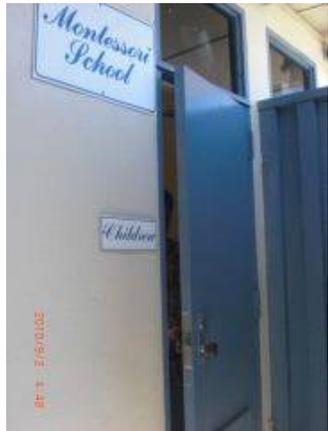
**Location:** Children's Restroom      **Photo #** 613

<b>Field Condition</b>	
16.10 - Single-Action Hardware - Handles, locks, and latches or other operative devices are not operable with one hand. OR They are not operable without tight grasping, pinching, or twisting of the wrist. (U-shaped handles, levers, and push/pull type mechanisms are acceptable designs.)	<b>1991 ADAAG</b> 4.13.9  <b>2004 ADAAG</b> 309.4; 404.2.7; Advisory 404.2.7  <b>2007 CBC</b> 1133B.2.5.2  <b>Other</b> -
Existing Condition: Knob.

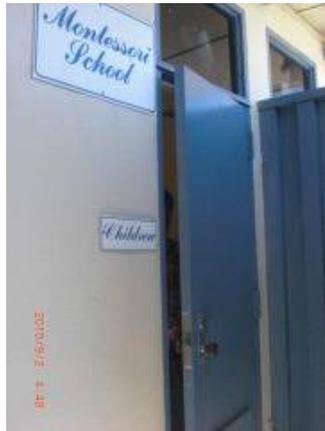
**Location:** Children's Restroom      **Photo #** 613

Field Condition	
16.12 - Other Door Requirements - Door does not comply with all applicable ADAAG and CBC accessibility requirements.	1991 ADAAG 4.13
Existing Condition: 2.3 seconds door sweep.	2004 ADAAG 404.1; Advisory 404.1
	2007 CBC 1133B.2
	Other -

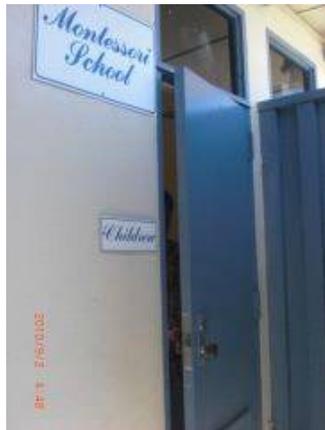
**Location:** Children's Restroom      **Photo #** 613

Field Condition	
16.13C - Unisex RR Geometric Symbol Signage - Circle/Triangle - Doorway leading to a unisex toilet room is not identified by a 12" circle, 1/4" with a 1/4" thick triangle superimposed and within the circle. OR Circle and triangle are provided, however they are accompanied by words in raised characters and Braille. (ADA and CBC Standards require a separate sign with raised characters and Braille mounted on the wall adjacent to the latch side of the door.)	1991 ADAAG -
Existing Condition:	2004 ADAAG -
	2007 CBC 1115B.6
	Other -

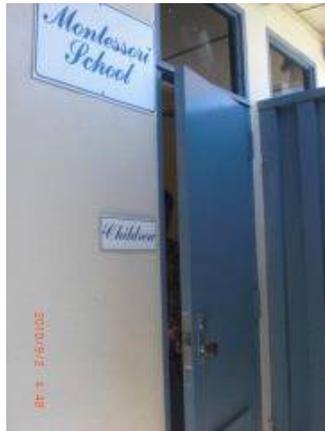
**Location:** Children's Restroom      **Photo #** 613

Field Condition									
16.15B - Room/Space Identification Signs (Visual/Tactile Signs) - Sign designating the permanent room or space does not comply with ADAAG and CBC requirements for tactile signs.

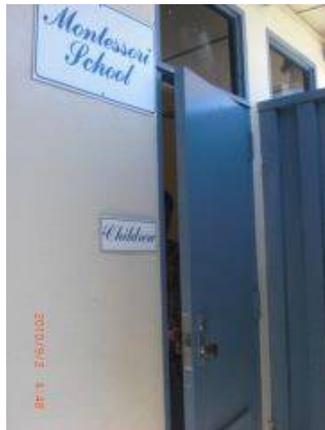
**Location:** Children's Restroom      **Photo #** 613

Field Condition									
16.18A - ISA - Accessible toilet room is not identified by an ISA.

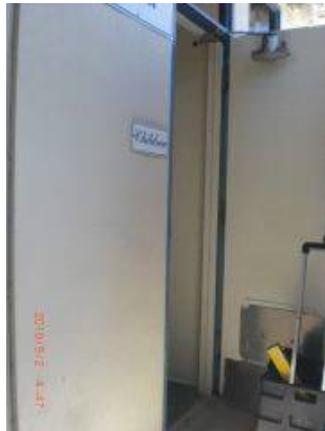
**Location:** Children's Restroom  
**Photo #** 615

<b>Field Condition</b>	
20.02 - Toilet, Bathroom, or Shower Room - Visual Alarms - Visual alarms are not provided at public or common use toilet, bathroom, or shower room.	<b>1991 ADAAG</b> 4.28.1
Existing Condition:	<b>2004 ADAAG</b> 215.1; Advisory 215.1; 702.1
	<b>2007 CBC</b> 907.9.1.1
	<b>Other</b> -

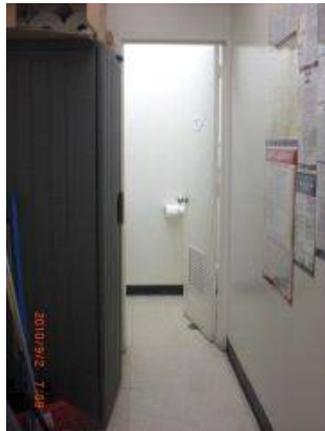
**Keynote 688**

<b>Field Condition</b>	
20.03 - General Use Areas - Visual Alarms - Visual alarms are not provided at public use area(s) of the building such as waiting areas, assembly areas, meeting rooms, corridors, stairways, hallways, and lobbies. (Visual alarms are not required in enclosed exit stairways, exterior exit stairs and exterior exit ramps.)	1991 ADAAG 4.28.1
Existing Condition:	2004 ADAAG 215.1; Advisory 215.1; 702.1
	2007 CBC 907.9.1.1
	Other -

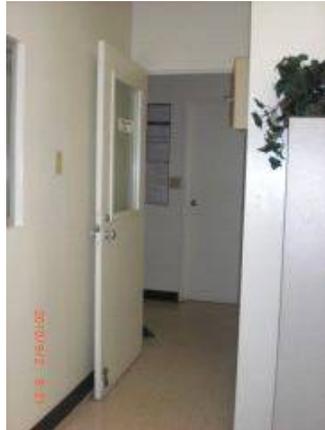
**Keynote 719**

Field Condition	
11.06A - Door Maneuvering Space - Door that is not automatic or power-assisted does not have compliant maneuvering space relative to the direction of approach as shown in CBC Fig. 11B-26. (Approach // Side // Width // Depth) (Front // Pull // D + 24" * // 60") (Front // Push // D + 0" ** // 48") (Latch // Pull // D + 24" // 60") (Latch // Push // D + 24" // 44" ***) (Hinge // Pull // D + 36" // 60") (Hinge // Push // 54" **** // 44" *****) (* D + 18" at interior doors.) (** D + 12" if door has both a latch and a closer.) (***) 48" if door has closer.) (**** Measured from latch toward hinge.) (***** 48" if door has both a latch and a closer.)	<b>1991 ADAAG</b> 4.13.6; Fig. 25  <b>2004 ADAAG</b> 404.2.4.1; Tab. 404.2.4.1; Fig. 404.2.4.1  <b>2007 CBC</b> 1133B.2.4.2 Fig. 11B-26  <b>Other</b> -
Existing Condition: 2" pull strike clearance.
