City of Rancho Palos Verdes
Rancho Palos Verdes ADA Assessment
Facility Report with Photos

Reporting: 380 of 4367 Rcd Facility ID: # 09 - Lower Point Vicente Park & Point Vicente Interpretive Center (PVIC)

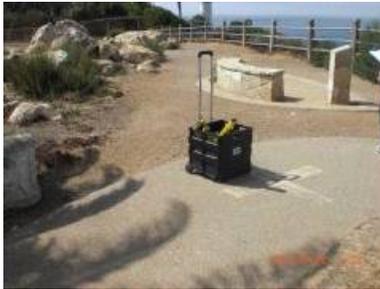
Location: Vista Point
Photo # 1

Field Condition	
03B.03 - Facilities Connected - Accessible routes of travel do not connect all accessible buildings, facilities, elements and spaces on the same site with one another.	1991 ADAAG 4.1.2(2)(a) 2004 ADAAG 206.2.2; Advisory 206.2.2 2007 CBC 1114B.1.2; 1127B.1 Other -
Existing Condition: No accessible POT connects to vista point.

Corrective Action
001A - Accessible Route - Provide new accessible route.
Additional Comments:

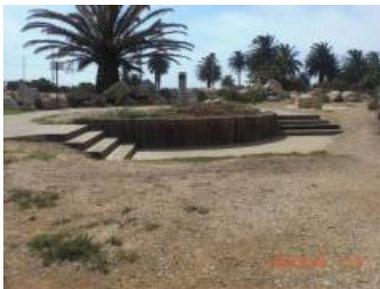
Location: Vista Point
Photo # 2

Field Condition	
30.02 - On-site Accessible Route of Travel - There is no accessible route within the property line of the site linking accessible site elements with site arrival points serving the following, if provided: public transportation stops, accessible parking, passenger loading zones, and public sidewalks.	1991 ADAAG 4.1.2(1) 2004 ADAAG 202.2.1; Advisory 206.2.1 2007 CBC 1114B.1.2; 1127B.1 Other -
Existing Condition: No access to point of view.

Corrective Action
090B - Ramp with Handrails - Remove non-compliant pavement and replace with new ramp with handrails. The ramp slope shall not exceed 8.33% along the POT and cross slope shall not exceed 2%.
Additional Comments: Provide compliant handrails at new ramp.

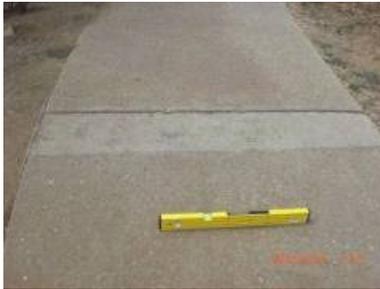
Keynote 7

Field Condition	
03B.13 - > 1/2" Changes in Level - Curb ramps, ramps, or elevators are not used for changes in level greater than 1/2 inch. (Lifts may only be used in certain limited situations.)	1991 ADAAG 4.5.2
Existing Condition: 1/2" level change.	2004 ADAAG 303.4
	2007 CBC 1124B.2
	Other -

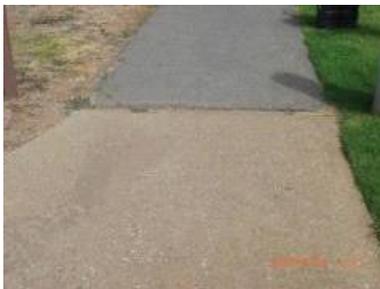
Keynote 8

Field Condition	
03B.13 - > 1/2" Changes in Level - Curb ramps, ramps, or elevators are not used for changes in level greater than 1/2 inch. (Lifts may only be used in certain limited situations.)	1991 ADAAG 4.5.2
Existing Condition: 3/4" level change from concrete to asphalt.	2004 ADAAG 303.4
	2007 CBC 1124B.2
	Other -

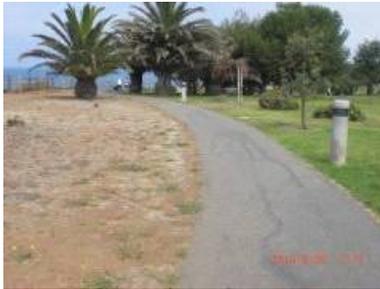
Keynote 9

Field Condition									
03B.09 - Cross Slope - Cross slope of the accessible route of travel exceeds 1:50. Existing Condition: 2.1% to 7.7% CS.

Corrective Action	
004A - Asphalt Paving - Remove non-compliant pavement and replace with new asphalt paving (area as shown on the drawings). The walkway slope shall not exceed 5% along the POT and cross slope shall not exceed 2%. Additional Comments:

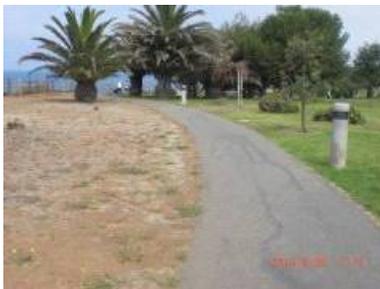
Keynote 10

Field Condition									
03B.10 - Running Slope - Slope of the accessible route of travel exceeds 1:20. Existing Condition: 6.3% to 6.5% RS.

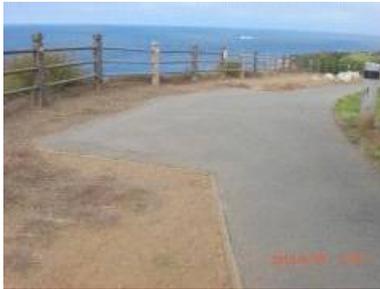
Keynote 11

Field Condition									
03B.10 - Running Slope - Slope of the accessible route of travel exceeds 1:20. Existing Condition: 8.6% RS at resting space.

Corrective Action	
004A - Asphalt Paving - Remove non-compliant pavement and replace with new asphalt paving (area as shown on the drawings). The walkway slope shall not exceed 5% along the POT and cross slope shall not exceed 2%. Additional Comments:

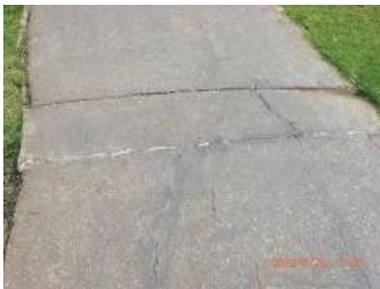
Keynote 12

Field Condition									
03B.13 - > 1/2" Changes in Level - Curb ramps, ramps, or elevators are not used for changes in level greater than 1/2 inch. (Lifts may only be used in certain limited situations.) Existing Condition: 1/2" level change.

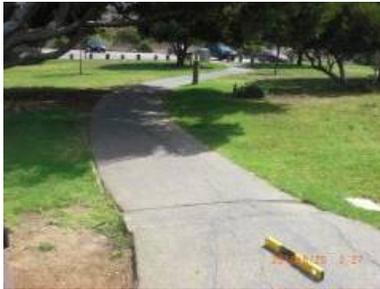
Keynote 13

Field Condition									
03B.09 - Cross Slope - Cross slope of the accessible route of travel exceeds 1:50. Existing Condition: 4.5% to 9.7% CS.

Corrective Action	
004A - Asphalt Paving - Remove non-compliant pavement and replace with new asphalt paving (area as shown on the drawings). The walkway slope shall not exceed 5% along the POT and cross slope shall not exceed 2%.	
Additional Comments:

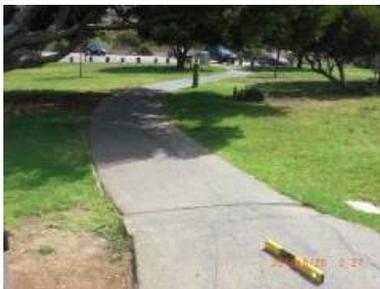
Keynote 14

Field Condition									
03B.10 - Running Slope - Slope of the accessible route of travel exceeds 1:20. Existing Condition: 5.3% to 10.5% RS.

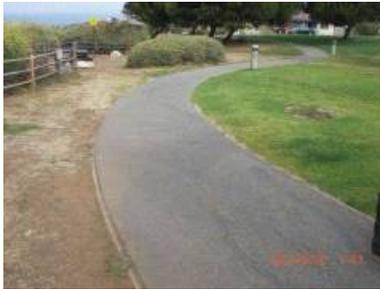
Keynote 15

Field Condition									
03B.09 - Cross Slope - Cross slope of the accessible route of travel exceeds 1:50. Existing Condition: 3% to 9.5% CS.

Corrective Action	
004A - Asphalt Paving - Remove non-compliant pavement and replace with new asphalt paving (area as shown on the drawings). The walkway slope shall not exceed 5% along the POT and cross slope shall not exceed 2%. Additional Comments:

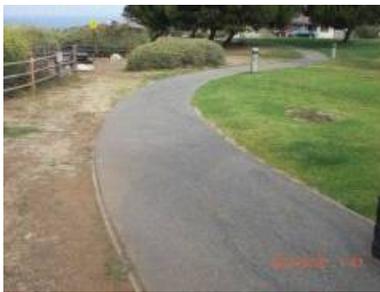
Keynote 16

Field Condition									
03B.10 - Running Slope - Slope of the accessible route of travel exceeds 1:20. Existing Condition: 5.6% to 8.7% RS.

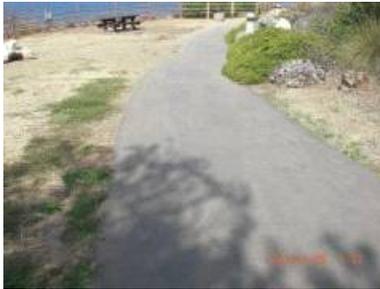
Keynote 17

Field Condition
 30.25 - Number - Accessible Picnic Tables - Where fixed picnic tables are provided in a picnic area, the required number of fixed picnic tables is not provided. (1999 ADAAG: Where two or more fixed picnic tables are provided in a picnic area, at least 50%, but never less than two, shall comply with 16.5.4 through 16.5.6. In addition, at least 40%, but never less than two, of the accessible picnic tables shall be connected to an outdoor recreation access route complying with 16.3.)
 Existing Condition: 4 picnic tables, 0 accessible.

Corrective Action
 019C - Accessible Picnic Table - Provide an accessible picnic table with integrated wheelchair seating.
 Additional Comments:

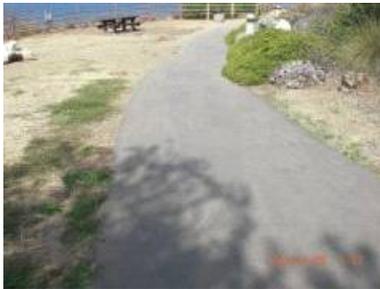
Keynote 18

Field Condition
 30.24 - Picnic Table - Accessible Route - Picnic table is not accessible. OR Picnic table is not connected to an outdoor recreation access route.
 Existing Condition:

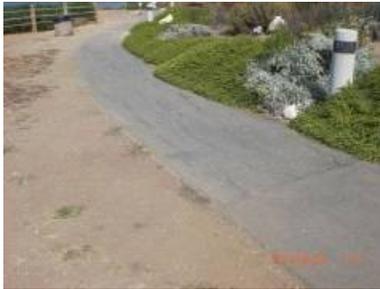
Keynote 19

Field Condition									
03B.09 - Cross Slope - Cross slope of the accessible route of travel exceeds 1:50. Existing Condition: 2.5% to 14.1% CS.

Corrective Action
004A - Asphalt Paving - Remove non-compliant pavement and replace with new asphalt paving (area as shown on the drawings). The walkway slope shall not exceed 5% along the POT and cross slope shall not exceed 2%. Additional Comments:

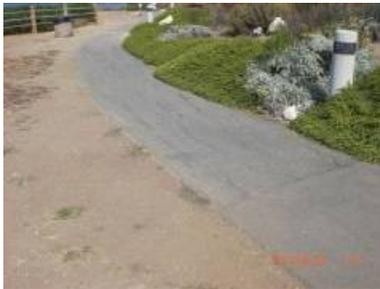
Keynote 20

Field Condition									
03B.10 - Running Slope - Slope of the accessible route of travel exceeds 1:20. Existing Condition: 5.25 to 10.7% RS.

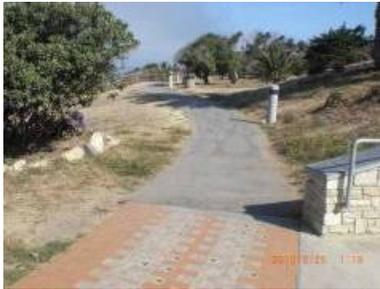
Keynote 21

Field Condition									
03B.09 - Cross Slope - Cross slope of the accessible route of travel exceeds 1:50. Existing Condition: 3.7% to 13.4% CS.

Corrective Action	
004A - Asphalt Paving - Remove non-compliant pavement and replace with new asphalt paving (area as shown on the drawings). The walkway slope shall not exceed 5% along the POT and cross slope shall not exceed 2%.	
Additional Comments:

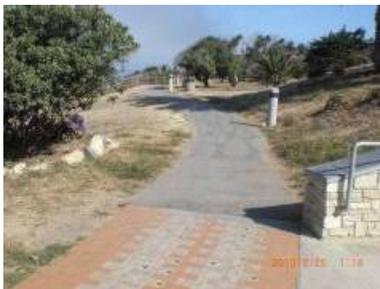
Keynote 22

Field Condition									
03B.10 - Running Slope - Slope of the accessible route of travel exceeds 1:20. Existing Condition: 5.3%.

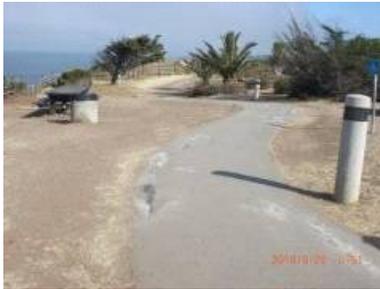
Keynote 23

Field Condition									
03B.09 - Cross Slope - Cross slope of the accessible route of travel exceeds 1:50. Existing Condition: 3.85 to 7.7% CS.

Corrective Action	
004A - Asphalt Paving - Remove non-compliant pavement and replace with new asphalt paving (area as shown on the drawings). The walkway slope shall not exceed 5% along the POT and cross slope shall not exceed 2%. Additional Comments:

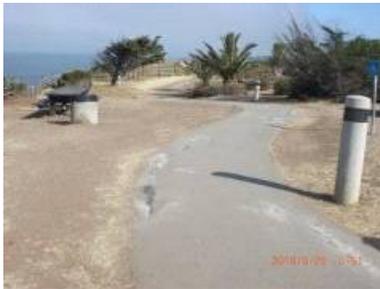
Keynote 24

Field Condition									
03B.10 - Running Slope - Slope of the accessible route of travel exceeds 1:20. Existing Condition: 5.3% to 10.9% RS.

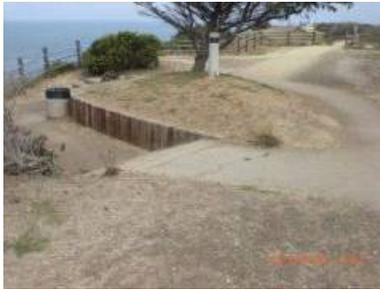
Location: Vista Point
Photo # 25

Field Condition	
30.02 - On-site Accessible Route of Travel - There is no accessible route within the property line of the site linking accessible site elements with site arrival points serving the following, if provided: public transportation stops, accessible parking, passenger loading zones, and public sidewalks.	1991 ADAAG 4.1.2(1)
Existing Condition:	2004 ADAAG 202.2.1; Advisory 206.2.1
	2007 CBC 1114B.1.2; 1127B.1
	Other -

Corrective Action
090B - Ramp with Handrails - Remove non-compliant pavement and replace with new ramp with handrails. The ramp slope shall not exceed 8.33% along the POT and cross slope shall not exceed 2%.
Additional Comments: Provide compliant handrails at new ramp.

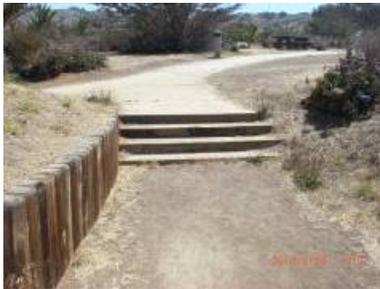
Location: Vista Point
Photo # 26

Field Condition	
08.07A - Continuous Handrails - Continuous handrails are not provided along both sides.	1991 ADAAG 4.9.4
Existing Condition: None provided.	2004 ADAAG 504.6; 505.2
	2007 CBC 1133B.4.1.1
	Other -

Corrective Action
244 - Freestanding Steel Stair Handrails - Provide new freestanding handrails. Handrails shall be of galvanized steel tubing 1 1/2" outside diameter, mounted 36" above nosing of the stair treads, and shall extend a minimum of 12" beyond the top nosing and shall extend a minimum of tread width (1' m
Additional Comments: Remove one stair and replace w/ new ramp per keynote 25.

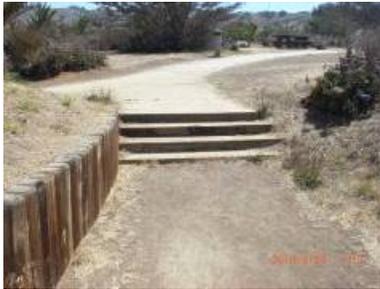
Keynote 27

Field Condition	
08.05A - Exterior Stairs - Color Strip - Contrasting color strips have not been provided.	1991 ADAAG -
Existing Condition: None provided.	2004 ADAAG -
	2007 CBC 1133B.4.4
	Other -

Corrective Action	
255D - Paint-Applied Warning Striping - All Treads and Top Landing - Paint 2" wide stripes a maximum of 1" from the tread nosing on all treads and top landing. Stripes shall extend the full width of stair. Apply epoxy paint of clearly contrasting color (70% minimum contrast) with band grit to achieve compliant slip resista	
Additional Comments: Remove one stair and replace w/ new ramp per keynote 25.

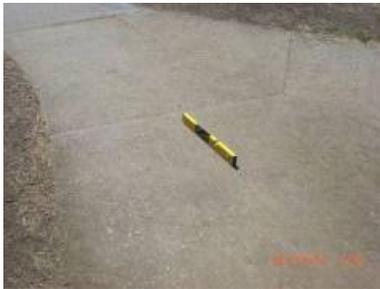
Location: Vista Point
Photo # 28

Field Condition	
08.03D - Level Landing - Landing is not level (slope is greater than 2% in some or all directions).	1991 ADAAG -
Existing Condition: 2.5% CS & 5.4% RS at bottom landing.	2004 ADAAG -
	2007 CBC 1009.5.1
	Other -

Corrective Action	
008 - Concrete Landing - Remove non-compliant pavement and replace with new concrete. The landing slope shall not exceed 2% in any direction.	
Additional Comments:

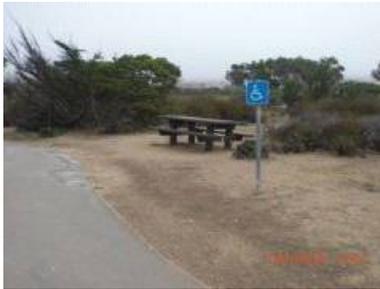
Location: Picnic Area
Photo # 31

Field Condition	
30.28 - Picnic Site - Surface Slope - The accessible picnic site is located on a surface area with slope greater than 2% in some or all directions.(1999 ADAAG: 3% slope is allowed when necessary for drainage).	1991 ADAAG 4.3.7
Existing Condition: 12.2% RS from asphalt path to picnic area, 2.1% to 4.5% around picnic table.	2004 ADAAG 403.3
	2007 CBC -
	Other 1999 ADAAG-16.5.7

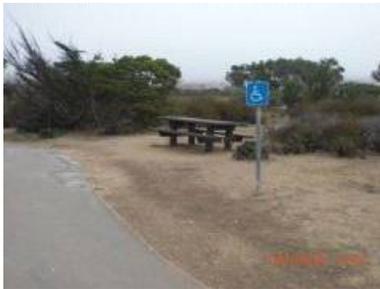
Keynote 32

Field Condition	
30.29 - Picnic Site Surface - Picnic tables and benches are not on a firm and stable surface.	1991 ADAAG -
Existing Condition: Loose surface.	2004 ADAAG -
	2007 CBC -
	Other 1999 ADAAG-16.5.6

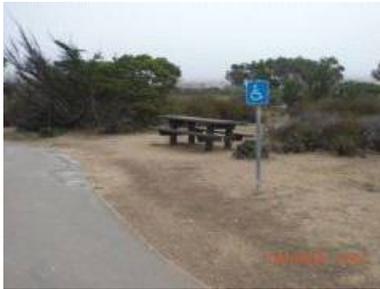
Keynote 33

Field Condition	
30.32 - 36" Aisle Width Standard - Around the picnic table, there is less than 36" clear space measured from the seat.	1991 ADAAG -
Existing Condition: 30" and 32" Aisle width at picnic table.	2004 ADAAG -
	2007 CBC -
	Other 1999 ADAAG-16.5.5

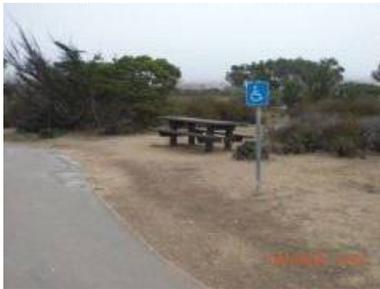
Keynote 34

Field Condition	
30.47 - Trash & Recycling Receptacles - Location - The picnic area does not provide a trash receptacle at the site or on an accessible route to the site.	1991 ADAAG -
Existing Condition:	2004 ADAAG -
	2007 CBC -
	Other 1999 ADAAG-16.8.1

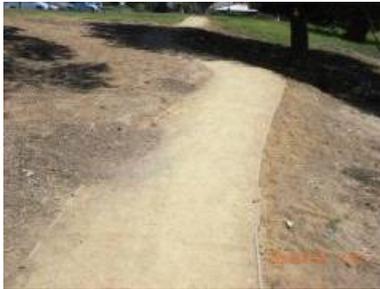
Keynote 37

Field Condition	
30.06E - Outdoor Recreation Access Route (ORAR) Segment - Cross Slope - Cross slope of the access route segment exceeds 3.33%. Exception: Cross slopes of 5% maximum are permitted to ensure proper drainage.	1991 ADAAG -
Existing Condition: 3.9% to 8.0% CS.	2004 ADAAG -
	2007 CBC -
	Other 1999 ADAAG-16.3.7.1

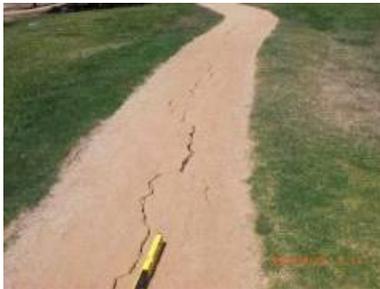
Keynote 38

Field Condition	
30.68 - Other - Parks - See Additional Comments	1991 ADAAG -
Existing Condition: Water erosion.	2004 ADAAG -
	2007 CBC -
	Other -

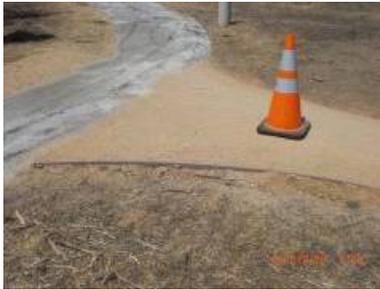
Keynote 39

Existing Condition: 8.1% RS at middle of P.O.T. and 12.3% RS at end of ORAR.

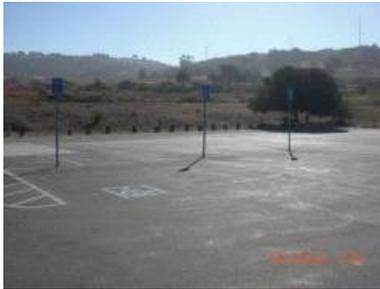
Location: Parking
Photo # 41

Field Condition	01.15C - Minimum Fine Sign - Accessible parking space has no sign stating "Minimum Fine \$250" below the ISA.	1991 ADAAG -
Existing Condition:		2004 ADAAG -
		2007 CBC 1129B.4
		Other

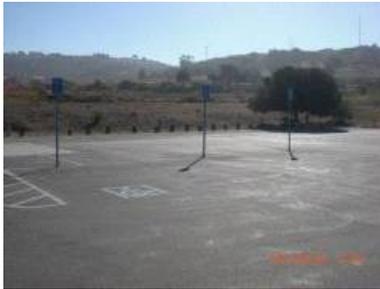
Keynote 45

Field Condition	
01.18 - Pavement Sign - A 36" square ISA is not painted on the pavement at the rear of the stall.	1991 ADAAG -
Existing Condition: 36" x 42".	2004 ADAAG 502.6
	2007 CBC 1129B.4
	Other

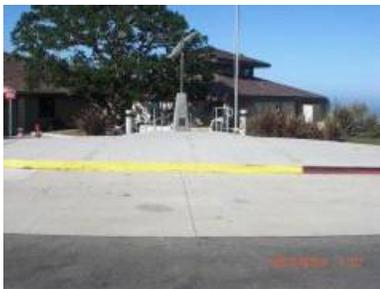
Keynote 46

Field Condition	
02.10 - Sign - There is no reflectorized sign stating "Passenger Loading Zone Only", with the ISA in white on a blue background, adjacent to and visible from the accessible passenger loading zone.	1991 ADAAG 4.1.2(7)(b)
Existing Condition:	2004 ADAAG -
	2007 CBC 1131B.2 item 1
	Other

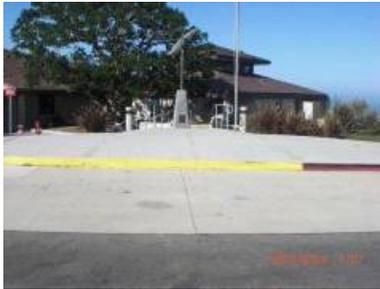
Keynote 47

Field Condition									
02.12B - Bus Stop Pad Slope Perpendicular to Roadway - Bus stop pad slope perpendicular to the roadway exceeds 2%. Existing Condition: 2.8% CS.

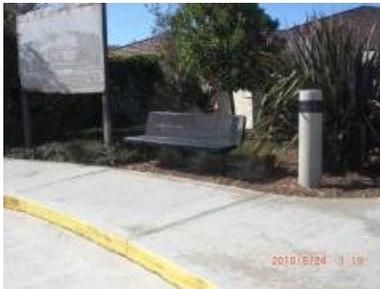
Keynote 48

Field Condition									
02.17 - Other - Passenger Loading Zones - See Additional Comments Existing Condition: Bench provided at bus drop-off, no wheelchair seating provided.

Corrective Action
008 - Concrete Landing - Remove non-compliant pavement and replace with new concrete. The landing slope shall not exceed 2% in any direction. Additional Comments: Provide concrete pad at bench area.

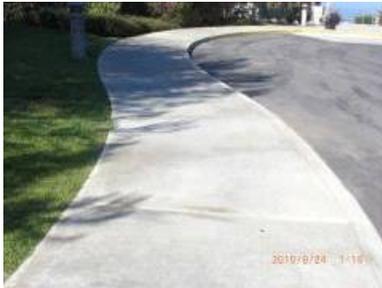
Keynote 49

Field Condition									
03B.09 - Cross Slope - Cross slope of the accessible route of travel exceeds 1:50. Existing Condition: 2.8% to 4.0% CS.

Corrective Action	
006 - Concrete Walk - Remove non-compliant pavement and replace with new concrete (area as shown on the drawings). The walkway slope shall not exceed 5% along the POT and cross slope shall not exceed 2%.	
Additional Comments:

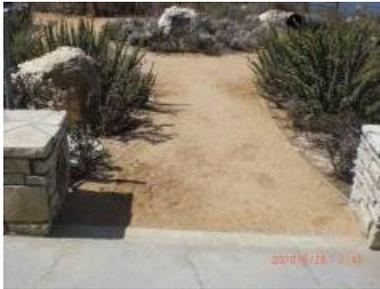
Keynote 60

Field Condition	
30.06E - Outdoor Recreation Access Route (ORAR) Segment - Cross Slope - Cross slope of the access route segment exceeds 3.33%. Exception: Cross slopes of 5% maximum are permitted to ensure proper drainage.	1991 ADAAG -
Existing Condition: 4.9% to 10.3% CS.	2004 ADAAG -
	2007 CBC -
	Other 1999 ADAAG-16.3.7.1

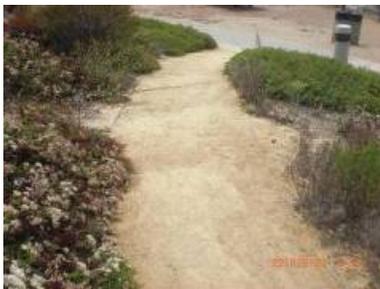
Keynote 61

Field Condition	
30.06E - Outdoor Recreation Access Route (ORAR) Segment - Cross Slope - Cross slope of the access route segment exceeds 3.33%. Exception: Cross slopes of 5% maximum are permitted to ensure proper drainage.	1991 ADAAG -
Existing Condition: 4.8% to 14.1% CS.	2004 ADAAG -
	2007 CBC -
	Other 1999 ADAAG-16.3.7.1

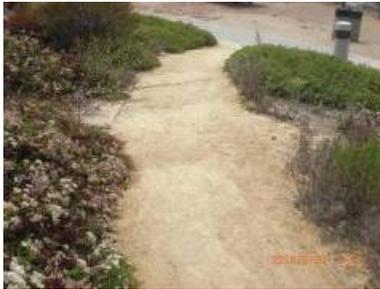
Keynote 62

Field Condition	
30.06A - Outdoor Recreation Access Route (ORAR) Segment - Running Slope - Running slope of access route segment in the direction of travel does not comply with the following: a. 5% or less for any distance. b. From 5.1% to 8.33% for 50' maximum. c. From 8.34% to 10% for 30' maximum.	1991 ADAAG -
Existing Condition: 6.5% to 14.7% RS.	2004 ADAAG -
	2007 CBC -
	Other 1999 ADAAG-16.3.7.2.1; 16.3.7.2.2; 16.3.7.2.3

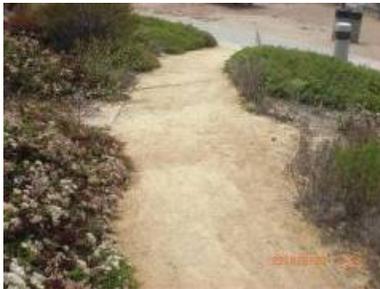
Keynote 63

Field Condition	
30.68 - Other - Parks - See Additional Comments	1991 ADAAG -
Existing Condition: Level change due to water erosion.	2004 ADAAG -
	2007 CBC -
	Other -

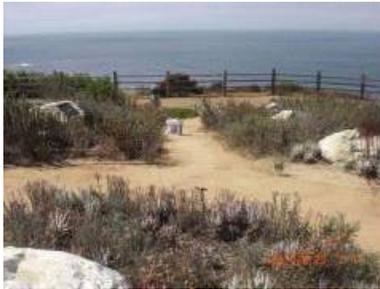
Keynote 64

Field Condition
 30.06E - Outdoor Recreation Access Route (ORAR) Segment - Cross Slope - Cross slope of the access route segment exceeds 3.33%. Exception: Cross slopes of 5% maximum are permitted to ensure proper drainage.
 Existing Condition: 5.1% to 10.0% CS.

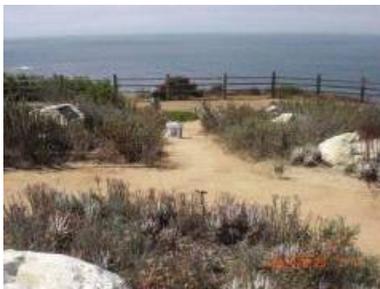
Keynote 65

Field Condition
 30.06A - Outdoor Recreation Access Route (ORAR) Segment - Running Slope - Running slope of access route segment in the direction of travel does not comply with the following: a. 5% or less for any distance. b. From 5.1% to 8.33% for 50' maximum. c. From 8.34% to 10% for 30' maximum.
 Existing Condition: 12.9% to 20.0% RS.

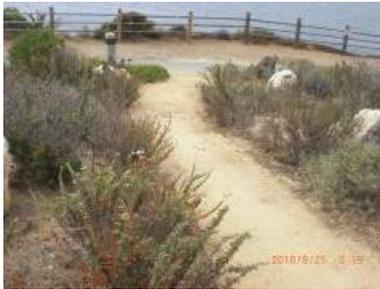
Keynote 66

Field Condition	
30.06E - Outdoor Recreation Access Route (ORAR) Segment - Cross Slope - Cross slope of the access route segment exceeds 3.33%. Exception: Cross slopes of 5% maximum are permitted to ensure proper drainage.	1991 ADAAG -
Existing Condition: 3.7% to 10.3% CS.	2004 ADAAG -
	2007 CBC -
	Other 1999 ADAAG-16.3.7.1

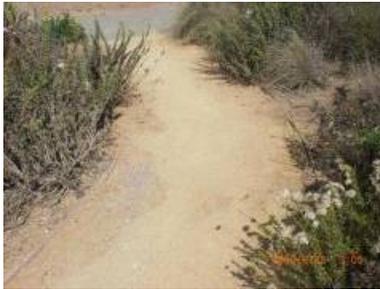
Keynote 68

Field Condition	
30.06E - Outdoor Recreation Access Route (ORAR) Segment - Cross Slope - Cross slope of the access route segment exceeds 3.33%. Exception: Cross slopes of 5% maximum are permitted to ensure proper drainage.	1991 ADAAG -
Existing Condition: 8.0% to 14.3% CS.	2004 ADAAG -
	2007 CBC -
	Other 1999 ADAAG-16.3.7.1

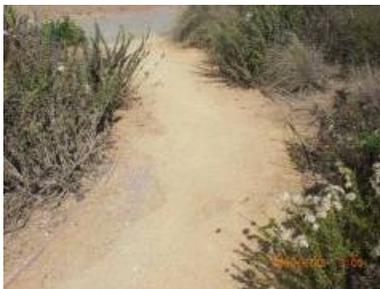
Keynote 69

Field Condition	
30.06A - Outdoor Recreation Access Route (ORAR) Segment - Running Slope - Running slope of access route segment in the direction of travel does not comply with the following: a. 5% or less for any distance. b. From 5.1% to 8.33% for 50' maximum. c. From 8.34% to 10% for 30' maximum.	1991 ADAAG -
Existing Condition: 11.8% to 23.4% RS.	2004 ADAAG -
	2007 CBC -
	Other 1999 ADAAG-16.3.7.2.1; 16.3.7.2.2; 16.3.7.2.3

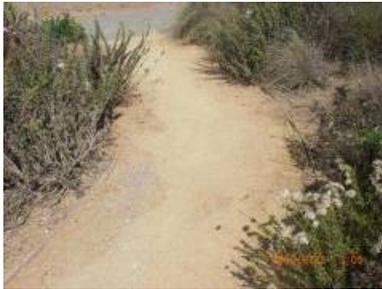
Keynote 70

Field Condition	
30.68 - Other - Parks - See Additional Comments	1991 ADAAG -
Existing Condition: Level change due to water erosion.	2004 ADAAG -
	2007 CBC -
	Other -

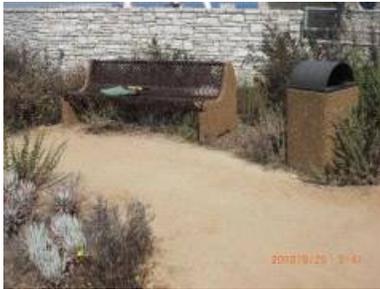
Keynote 72

Field Condition	30.16 - Fixed Bench / Wheelchair Seating Space - Shoulder Alignment - A clear space at least 30" x 48" in size has not been provided at one end of the fixed bench so that a wheelchair user may be seated shoulder-to-shoulder with an individual seated on the bench.	1991 ADAAG -
	Existing Condition:	2004 ADAAG -
		2007 CBC -
		Other 1999 ADAAG-16.12.4

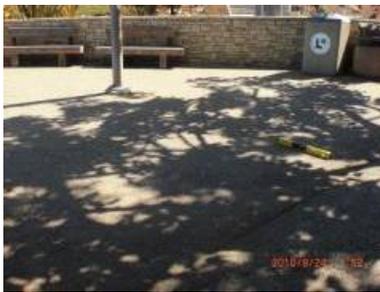
Keynote 92

Field Condition	
03B.13 - > 1/2" Changes in Level - Curb ramps, ramps, or elevators are not used for changes in level greater than 1/2 inch. (Lifts may only be used in certain limited situations.) Existing Condition:	1991 ADAAG 4.5.2 2004 ADAAG 303.4 2007 CBC 1124B.2 Other -

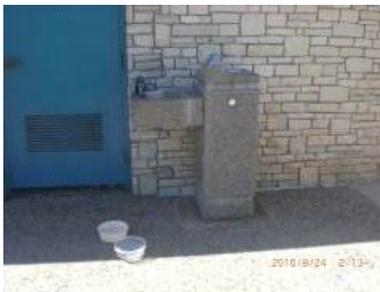
Keynote 96

Field Condition	
05.05A - Knee Space Height - Drinking fountain provides less than 27" high accessible knee clearance between the bottom of the apron and the floor.	1991 ADAAG 4.15.5(1); Figs. 27(a) and (b)
Existing Condition: 26 3/4" high.	2004 ADAAG 306.3; Fig. 306.3
	2007 CBC 1115B.4.6 item 2
	Other -

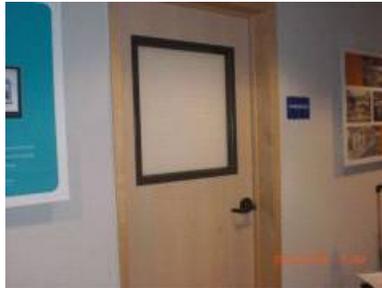
Keynote 141

Field Condition									
11.25A - Raised Characters and Braille (Visual/Tactile Signs) - The raised characters on this sign are not accompanied by California Grade 2 Braille (California Grade 2 Braille requires the dots within each cell to be domed and spaced 1/10" o.c.)

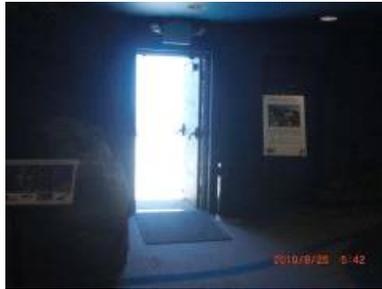
Keynote 249

Field Condition	
10.08 - Kick Plate - Bottom 10" of door does not have a smooth, uninterrupted surface on the push side to allow the door to be opened by a wheelchair footrest without creating a trap or hazardous condition. (This requirement does not apply to automatic and sliding doors.)	1991 ADAAG -
Existing Condition: Door stop.	2004 ADAAG 404.2.10
	2007 CBC 1133B.2.6
	Other -

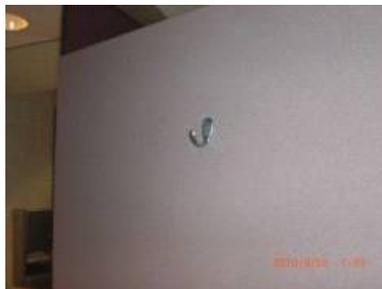
Keynote 264

Field Condition
 16.83 - Coat Hook - Height - Where a coat hook is provided In an accessible stall, height of coat hook exceeds 48" AFF.
 Existing Condition: 61" high.

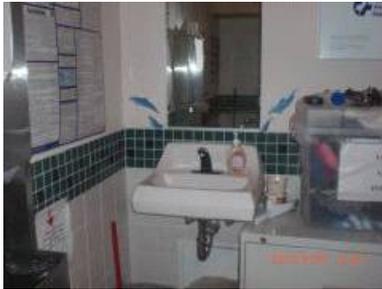
Keynote 293

Field Condition	
16.78 - Pipe Insulation at Lavatory - Drainpipes and hot water pipes are not insulated to protect against contact.	1991 ADAAG 4.19.4
Existing Condition:	2004 ADAAG 606.5
	2007 CBC 1115B.4.3(4)
	Other -

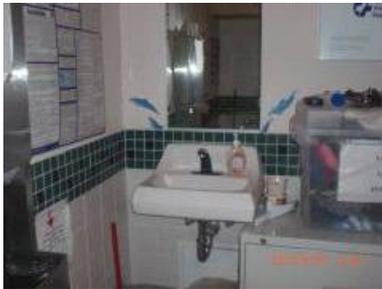
Keynote 294

Field Condition	
14.32A - Reach Range - Controls - Controls, dispensers, and similar devices are not between 9" and 54" AFF when the clear floor space allows a parallel approach. OR They are not between 15" and 48" AFF when the clear floor space allows only a forward approach.	1991 ADAAG 4.1.3(13); 4.27.3; 4.2.5; 4.2.6 ; Fig. 5; Fig. 6
Existing Condition: First Aid Kit at 66" high.	2004 ADAAG -
	2007 CBC 1117B.6(3); 1118.5; 1118.6; Fig. 11B-5C; Fig. 11B-5D
	Other -

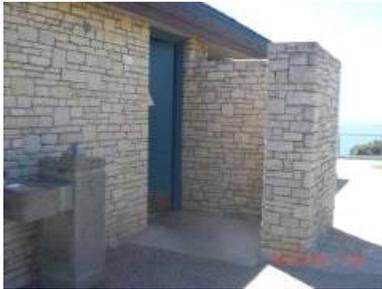
Keynote 320

Field Condition	
16.12 - Other Door Requirements - Door does not comply with all applicable ADAAG and CBC accessibility requirements.	1991 ADAAG 4.13
Existing Condition: 2.2% - 3.0% slope at door landing.	2004 ADAAG 404.1; Advisory 404.1
	2007 CBC 1133B.2
	Other -

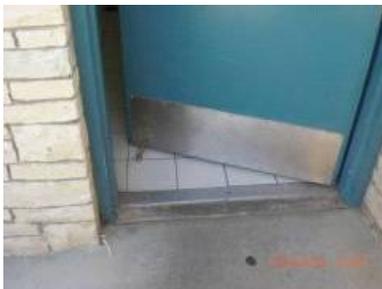
Keynote 321

Field Condition	
16.88 - Other - Toilet Facilities - See Additional Comments	1991 ADAAG -
Existing Condition: Door stop.	2004 ADAAG -
	2007 CBC -
	Other -

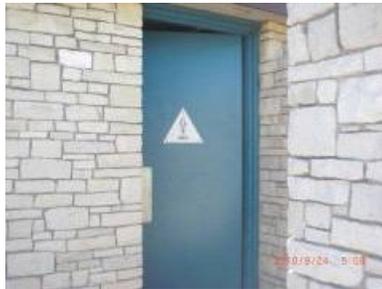
Keynote 324

Field Condition	
16.88 - Other - Toilet Facilities - See Additional Comments	1991 ADAAG -
Existing Condition: 2.03 seconds.	2004 ADAAG -
	2007 CBC -
	Other -
