City of Rancho Palos Verdes
Rancho Palos Verdes ADA Assessment
Facility Report with Photos

Reporting: 325 of 4367 Rcds

Facility ID: # 12 - Robert E. Ryan Park

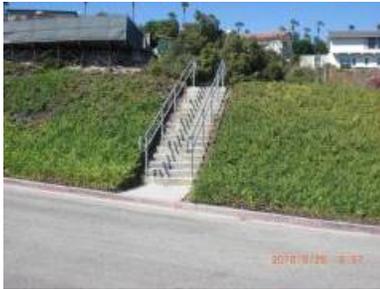
Location: Stairway
Photo # 1

Field Condition	
08.03D - Level Landing - Landing is not level (slope is greater than 2% in some or all directions).	1991 ADAAG -
Existing Condition: 4.4% CS & 2.0% RS at top landing.	2004 ADAAG -
	2007 CBC 1009.5.1
	Other -

Corrective Action
008 - Concrete Landing - Remove non-compliant pavement and replace with new concrete. The landing slope shall not exceed 2% in any direction.
Additional Comments:

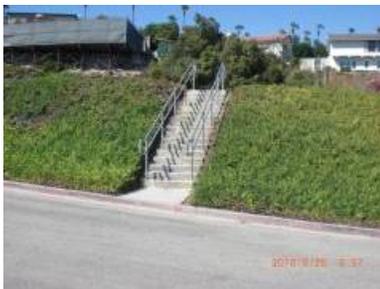
Location: Stairway
Photo # 1

Field Condition	
08.03D - Level Landing - Landing is not level (slope is greater than 2% in some or all directions).	1991 ADAAG -
Existing Condition: 4.1% CS & 6.6% RS at bottom landing.	2004 ADAAG -
	2007 CBC 1009.5.1
	Other -

Corrective Action
008 - Concrete Landing - Remove non-compliant pavement and replace with new concrete. The landing slope shall not exceed 2% in any direction.
Additional Comments:

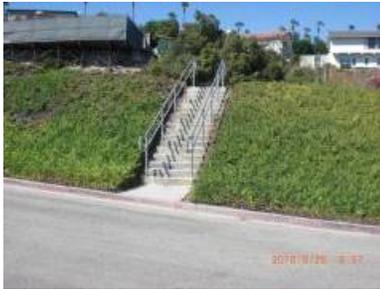
Field Condition	
08.09B - Handrail Extensions - Bottom Landing - At ends of handrails, less than 12" plus the tread width extends beyond the bottom nosing. (Top and bottom handrail extensions are important safety features for persons with balance problems and must extend in the direction of the stair run to permit the intended use.) (Per ADA/CBC Standards, in existing buildings and facilities, full extension of handrails at stairs shall not be required in alterations where such extensions would be hazardous or impossible due to plan configuration.)	1991 ADAAG 4.9.4(2) 2004 ADAAG 505.10; 505.10.3; Fig. 505.10.3 2007 CBC 1133B.4.2.2 Other -
Existing Condition: Only 12" extension at bottom.

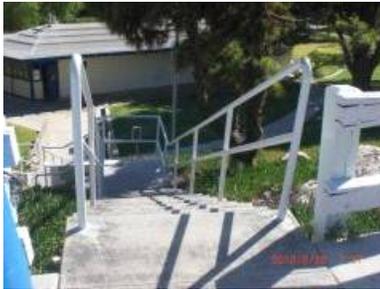
Location: Stairway
Photo # 6

08.09A - Handrail Extensions - Top Landing - At ends of handrails, less than 12" of handrail extends beyond the top nosing. (Top and bottom handrail extensions are important safety features for persons with balance problems and must extend in the direction of the stair run to permit the intended use.) (Per ADA/CBC Standards, in existing buildings and facilities, full extension of handrails at stairs shall not be required in alterations where such extensions would be hazardous or impossible due to plan configuration.)

Existing Condition: Top landing. 0" handrail extension.

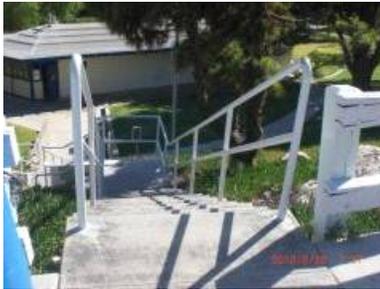
Location: Stairway
Photo # 6

Field Condition	
08.05A - Exterior Stairs - Color Strip - Contrasting color strips have not been provided.	1991 ADAAG -
Existing Condition: No stripes.	2004 ADAAG -
	2007 CBC 1133B.4.4
	Other -

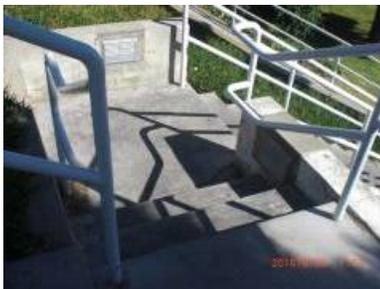
Location: Stairway
Photo # 9

Field Condition	
08.09B - Handrail Extensions - Bottom Landing - At ends of handrails, less than 12" plus the tread width extends beyond the bottom nosing. (Top and bottom handrail extensions are important safety features for persons with balance problems and must extend in the direction of the stair run to permit the intended use.) (Per ADA/CBC Standards, in existing buildings and facilities, full extension of handrails at stairs shall not be required in alterations where such extensions would be hazardous or impossible due to plan configuration.)	1991 ADAAG 4.9.4(2)
Existing Condition: 12" extension at bottom handrail.	2004 ADAAG 505.10; 505.10.3; Fig. 505.10.3
	2007 CBC 1133B.4.2.2
	Other -

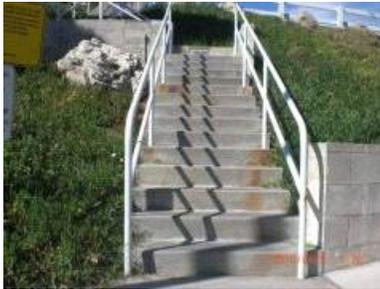
Field Condition	
08.09B - Handrail Extensions - Bottom Landing - At ends of handrails, less than 12" plus the tread width extends beyond the bottom nosing. (Top and bottom handrail extensions are important safety features for persons with balance problems and must extend in the direction of the stair run to permit the intended use.) (Per ADA/CBC Standards, in existing buildings and facilities, full extension of handrails at stairs shall not be required in alterations where such extensions would be hazardous or impossible due to plan configuration.)	1991 ADAAG 4.9.4(2) 2004 ADAAG 505.10; 505.10.3; Fig. 505.10.3 2007 CBC 1133B.4.2.2 Other -
Existing Condition: No bottom extensions provided.

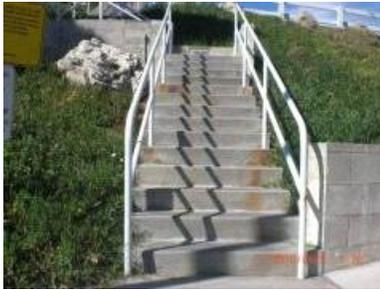
Location: Stairway
Photo # 10

Field Condition	
08.09A - Handrail Extensions - Top Landing - At ends of handrails, less than 12" of handrail extends beyond the top nosing. (Top and bottom handrail extensions are important safety features for persons with balance problems and must extend in the direction of the stair run to permit the intended use.) (Per ADA/CBC Standards, in existing buildings and facilities, full extension of handrails at stairs shall not be required in alterations where such extensions would be hazardous or impossible due to plan configuration.)	1991 ADAAG 4.9.4(2) 2004 ADAAG 505.10; 505.10.2; Fig. 505.10.2 2007 CBC 1133B.4.2.2 Other -
Existing Condition: No top handrail extensions.

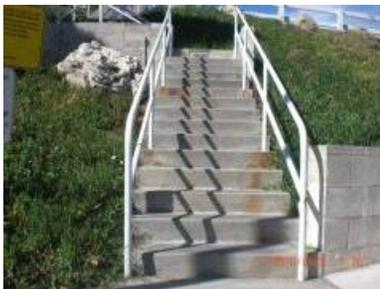
Location: Stairway
Photo # 10

Field Condition	
08.10A - Profile of Handrails - The diameter of the handrail is not between 1-1/4" and 1-1/2" in cross-sectional nominal dimension. OR The shape does not provide an equivalent gripping surface (equivalent gripping surfaces are 4" to 6-1/4" in perimeter, and 2-1/4" max. in any direction). (Note: Standard pipe sizes designated by the industry as 1-1/4" to 1-1/2" are acceptable).	1991 ADAAG 4.9.4; 4.26.2 2004 ADAAG 505.7.1; 505.7.2; Fig. 505.7.2 2007 CBC 1133B.4.2.6 Other -
Existing Condition: Handrail profile at 2".

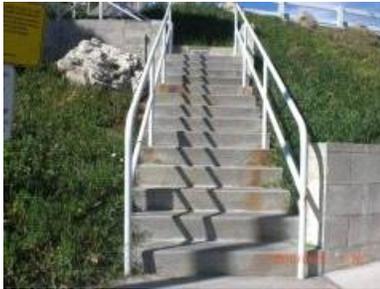
Field Condition	
08.09E - Handrails - Height above Stair Nosings - The tops of handrails are not between 34" and 38" above the stair nosings.	1991 ADAAG 4.9.4(5)
Existing Condition: Handrails at 31" H.	2004 ADAAG 505.4; Advisory 505.4; Fig. 505.4
	2007 CBC 1133B.4.2.1
	Other -

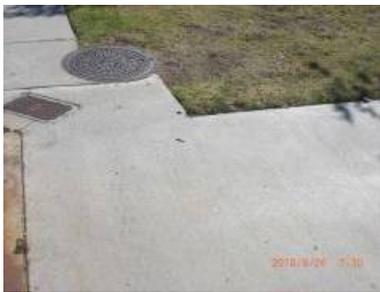
Field Condition	
03B.10 - Running Slope - Slope of the accessible route of travel exceeds 1:20.	1991 ADAAG 4.3.7
Existing Condition: 8% RS.	2004 ADAAG 403.3
	2007 CBC 1133B.7.3
	Other -

Corrective Action
006 - Concrete Walk - Remove non-compliant pavement and replace with new concrete (area as shown on the drawings). The walkway slope shall not exceed 5% along the POT and cross slope shall not exceed 2%.
Additional Comments:

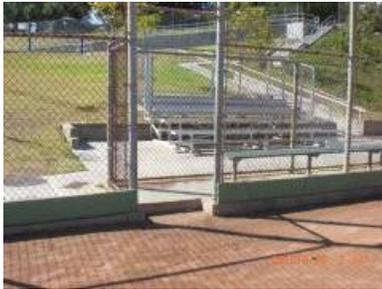
Field Condition	
03B.09 - Cross Slope - Cross slope of the accessible route of travel exceeds 1:50. Existing Condition: 2.3% CS.	<p>1991 ADAAG 4.3.7</p> <p>2004 ADAAG 403.3</p> <p>2007 CBC 1133B.7.1.3</p> <p>Other -</p>

Corrective Action	
006 - Concrete Walk - Remove non-compliant pavement and replace with new concrete (area as shown on the drawings). The walkway slope shall not exceed 5% along the POT and cross slope shall not exceed 2%.	
Additional Comments:

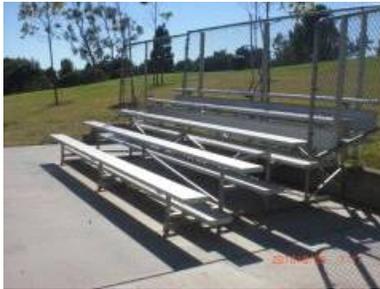
15A.33 - Accessible Assembly Seating - In assembly areas with fixed seating, the required number of accessible seating is not provided. (Seating Capacity // W // C // S // A // ALS Receiver) (4 to 26 // 1 // 1 // 2 // 1 // 2) (27 to 50 // 2 // 2 // 2 // 1 // 2) (51 to 100 // 4 // 4 // 2 // 1 // 4%) (101 to 200 // 4 // 4 // 2 // 1 // 4%) (201 to 300 // 4 // 4 // 1% // 1% // 4%) (301 to 500 // 6 // 6 // 1% // 1% // 4%) (501 + // 6 + 1 per add. 100 seats over 500 // 6 + 1 per add. 100 seats over 500 // 1% // 1% // 4%) W= Wheelchair spaces, A= Aisle (transfer) seats, C= Companion seats, S= Semi-ambulant seats

Existing Condition: 2 bleachers provided. 50 seats per bleacher. 2 wheelchair spaces, 2 companion seats, 2 semi-ambulant seats and 1 aisle transfer seat required per bleacher.

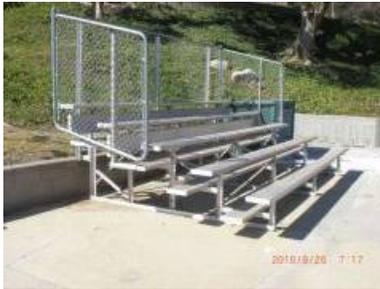
Location: Bleachers
Photo # 17

Field Condition	
08.01B - Exterior Stairs - Public or common use exterior stair does not comply with accessibility requirements. (Stairs to floors or portions of floors not customarily occupied, including non-occupiable or employee spaces accessed only by ladders, catwalks, crawl spaces, very narrow passageways, and frequented only by service personnel for repair or maintenance purposes: such spaces as elevator pits and elevator penthouses, piping and equipment catwalks and machinery rooms need not be accessible with the exception of stair striping.)	1991 ADAAG 4.1.3(4) 2004 ADAAG 210.1; Advisory 210.1; 504 2007 CBC 1114B.1.1; 1133B.4 Other -
Existing Condition:

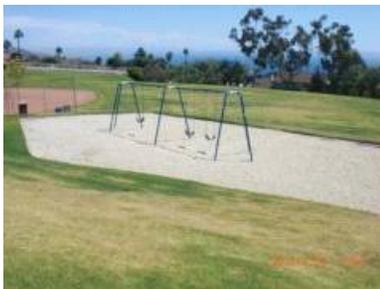
Location: Swing Set
Photo # 18

Field Condition	
31.05 - Ground Level Play Components - Accessible Route - Where ground level play components are provided, there is not at least one of each type located on an accessible route.	1991 ADAAG - 2004 ADAAG 240.2.1.1 2007 CBC - Other 2000 ADAAG-15.6.2.1
Existing Condition:

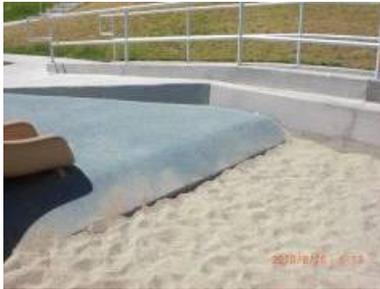
Field Condition	
31.38 - Other - Play Areas - See Additional Comments	1991 ADAAG -
Existing Condition: 2" to 9" level change.	2004 ADAAG -
	2007 CBC -
	Other -

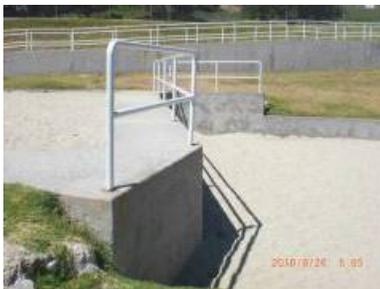
Field Condition	
03B.18 - > 30" Abrupt Change in Level - Site includes abrupt changes in level adjacent to pedestrian areas exceeding 30" vertical (exception: where a 42" high guardrail is provided to prevent persons from falling off the open edge. See 1013.1 for exceptions).	1991 ADAAG -
Existing Condition: 39" drop. Guardrails at 33 3/4" H.	2004 ADAAG -
	2007 CBC 1013.1 exceptions
	Other -

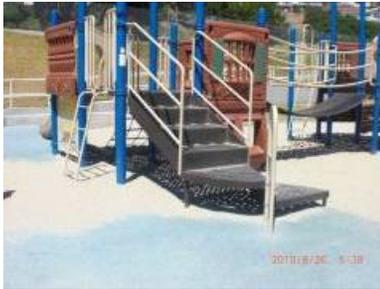
Location: Playground
Photo # 21

Field Condition	
31.30B - Play Components - Clear Floor or Ground Space Slope - The clear floor or ground space has a slope greater than 2% in some or all directions.	1991 ADAAG -
Existing Condition: 2.4% and 6.0% slope.	2004 ADAAG 1008.4.2; 305.2; 305.3
	2007 CBC -
	Other 2000 ADAAG-15.6.6.2; PRC 5410-5411

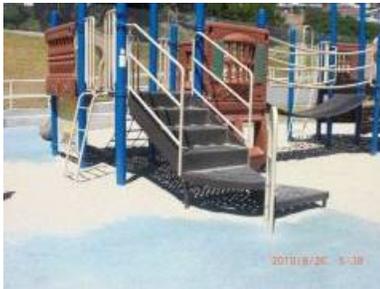
Location: Playground
Photo # 21

Field Condition	
31.34 - Play Areas - Ground Surfaces - Ground surfaces along accessible routes, clear floor or ground spaces, or turning spaces are not compliant.	1991 ADAAG -
Existing Condition: Sand creates unstable surface.	2004 ADAAG 1008.2.6
	2007 CBC -
	Other 2000 ADAAG-15.6.7; PRC 5410-5411; H&SC 115725

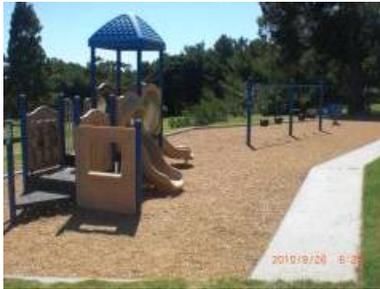
Location: Playground
Photo # 23

Field Condition	
31.34 - Play Areas - Ground Surfaces - Ground surfaces along accessible routes, clear floor or ground spaces, or turning spaces are not compliant.	1991 ADAAG -
Existing Condition: Woodchip floor.	2004 ADAAG 1008.2.6
	2007 CBC -
	Other 2000 ADAAG-15.6.7; PRC 5410-5411; H&SC 115725

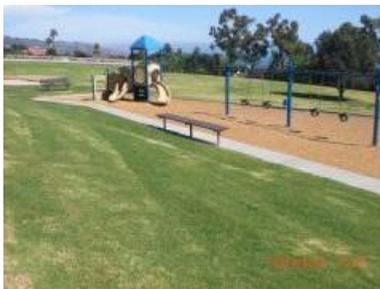
Location: Playground
Photo # 24

Field Condition	
31.05 - Ground Level Play Components - Accessible Route - Where ground level play components are provided, there is not at least one of each type located on an accessible route.	1991 ADAAG -
Existing Condition:	2004 ADAAG 240.2.1.1
	2007 CBC -
	Other 2000 ADAAG-15.6.2.1

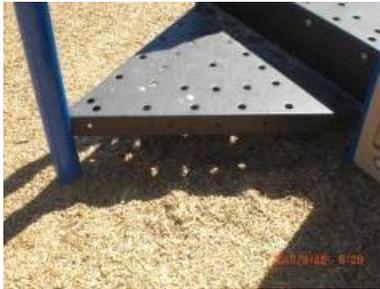
Field Condition	
31.26 - Transfer Steps - Height - Transfer step height exceeds 8".	1991 ADAAG -
Existing Condition: 10" high transfer step.	2004 ADAAG 1008.3.2.2
	2007 CBC -
	Other 2000 ADAAG-15.6.5.2.2

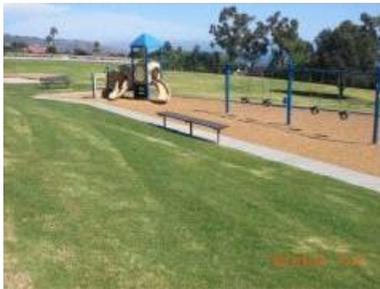
Field Condition	
03B.09 - Cross Slope - Cross slope of the accessible route of travel exceeds 1:50.	1991 ADAAG 4.3.7
Existing Condition: 2.1% to 4.1% CS.	2004 ADAAG 403.3
	2007 CBC 1133B.7.1.3
	Other -

Corrective Action
006 - Concrete Walk - Remove non-compliant pavement and replace with new concrete (area as shown on the drawings). The walkway slope shall not exceed 5% along the POT and cross slope shall not exceed 2%.
Additional Comments:

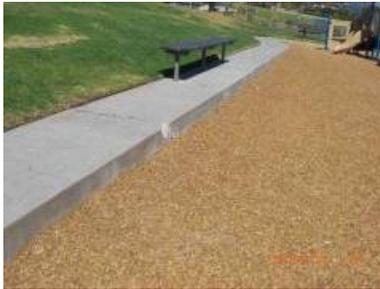
Field Condition	
03B.17 - > 4" Abrupt Change in Level - Site includes abrupt changes in level adjacent to pedestrian areas exceeding 4" vertical (exceptions: (1) between a walk or sidewalk and an adjacent street or driveway, or (2) where a 6" high warning curb or guardrail is provided to warn of a potential drop off).	1991 ADAAG -
Existing Condition: 5" drop. 90LF.	2004 ADAAG -
	2007 CBC 1133B.8.1
	Other -

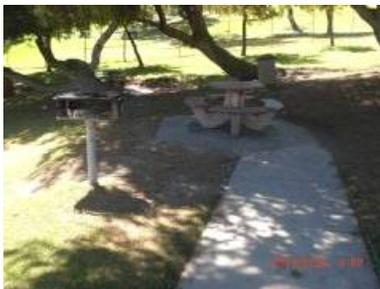
Field Condition	
30.25 - Number - Accessible Picnic Tables - Where fixed picnic tables are provided in a picnic area, the required number of fixed picnic tables is not provided. (1999 ADAAG: Where two or more fixed picnic tables are provided in a picnic area, at least 50%, but never less than two, shall comply with 16.5.4 through 16.5.6. In addition, at least 40%, but never less than two, of the accessible picnic tables shall be connected to an outdoor recreation access route complying with 16.3.)	1991 ADAAG -
Existing Condition: 10 picnic tables. Only 1 on accessible route.	2004 ADAAG -
	2007 CBC -
	Other 1999 ADAAG-16.5.1.2

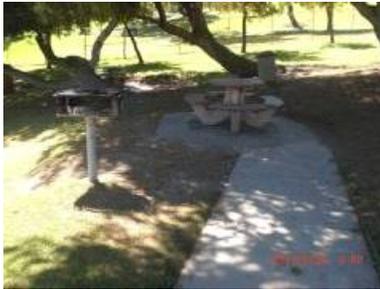
Field Condition
30.30 - Number - Picnic Table Wheelchair Seating Spaces - Picnic table does not provide at least one wheelchair seating space. OR Where the table top perimeter exceeds 24 linear feet, the number of wheelchair seating spaces provided does not comply with the following: (Table Top Perimeter // Wheelchair Spaces) (25 LF - 44 LF // 2 spaces) (45 LF - 64 LF // 3 spaces) (65 LF - 84 LF // 4 spaces) (85 LF - 104 LF // 5 spaces)

Existing Condition: No wheelchair seating provided.

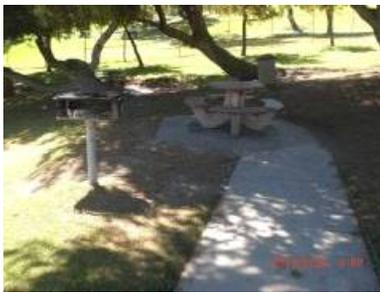
Field Condition
30.27 - Dispersal - Accessible Picnic Tables - Accessible picnic tables are not dispersed throughout the picnic area.

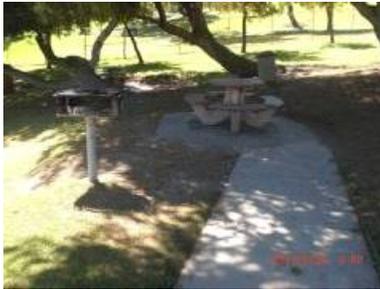
Field Condition	
30.28 - Picnic Site - Surface Slope - The accessible picnic site is located on a surface area with slope greater than 2% in some or all directions.(1999 ADAAG: 3% slope is allowed when necessary for drainage).	1991 ADAAG 4.3.7
Existing Condition: Surface slope varies between 2.5% and 3.1%.	2004 ADAAG 403.3
	2007 CBC -
	Other 1999 ADAAG-16.5.7

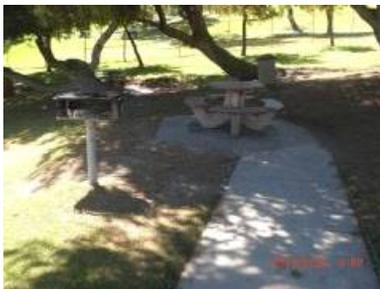
Field Condition	
30.35 - Cooking Surface or Fire Ring - Accessible Route - Cooking surface or fire ring is not accessible. OR Cooking surface or fire ring is not connected to an outdoor recreation access route.	1991 ADAAG -
Existing Condition:	2004 ADAAG -
	2007 CBC -
	Other 1999 ADAAG-16.6.1.1; 16.7.1.1

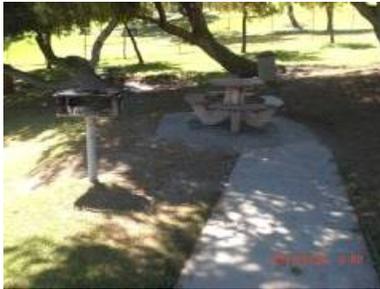
Field Condition	
30.36B - Dispersal - Accessible Cooking Surfaces, Fire Rings or Grills - Accessible cooking surfaces, fire rings or pedestal grills are not dispersed throughout the picnic area.	1991 ADAAG -
Existing Condition:	2004 ADAAG -
	2007 CBC -
	Other 1999 ADAAG-16.6.2; 16.7.2

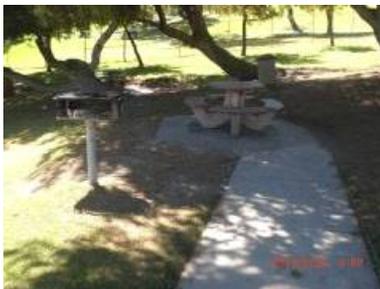
Field Condition	
30.37 - Cooking Surfaces or Fire Rings on Accessible Route - Where cooking surfaces, fire rings or pedestal grills are provided in an area, less than 40% or less than two are connected to an outdoor recreation access route.	1991 ADAAG -
Existing Condition: None on accessible route.	2004 ADAAG -
	2007 CBC -
	Other 1999 ADAAG-16.6.1.2; 16.7.1.2

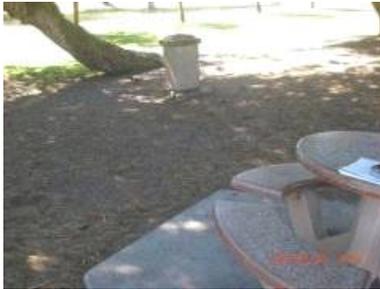
Field Condition	
30.47 - Trash & Recycling Receptacles - Location - The picnic area does not provide a trash receptacle at the site or on an accessible route to the site.	1991 ADAAG -
Existing Condition:	2004 ADAAG -
	2007 CBC -
	Other 1999 ADAAG-16.8.1

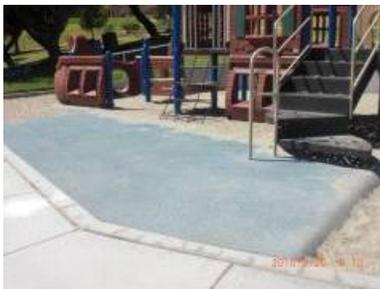
Field Condition	
31.38 - Other - Play Areas - See Additional Comments	1991 ADAAG -
Existing Condition: 4" level change.	2004 ADAAG -
	2007 CBC -
	Other -

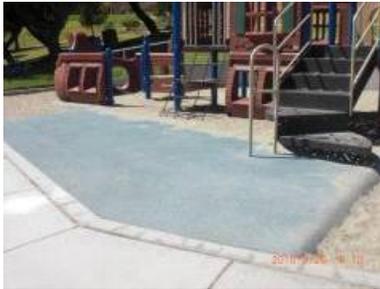
Field Condition	
31.34 - Play Areas - Ground Surfaces - Ground surfaces along accessible routes, clear floor or ground spaces, or turning spaces are not compliant.	1991 ADAAG -
Existing Condition: Sand creates unstable surface.	2004 ADAAG 1008.2.6
	2007 CBC -
	Other 2000 ADAAG-15.6.7; PRC 5410-5411; H&SC 115725

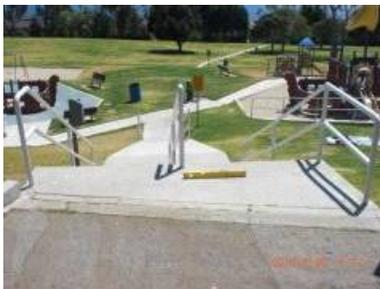
Field Condition	
03B.18 - > 30" Abrupt Change in Level - Site includes abrupt changes in level adjacent to pedestrian areas exceeding 30" vertical (exception: where a 42" high guardrail is provided to prevent persons from falling off the open edge. See 1013.1 for exceptions).	1991 ADAAG -
Existing Condition: 42 1/4" drop. Guardrail at 36" H.	2004 ADAAG -
	2007 CBC 1013.1 exceptions
	Other -

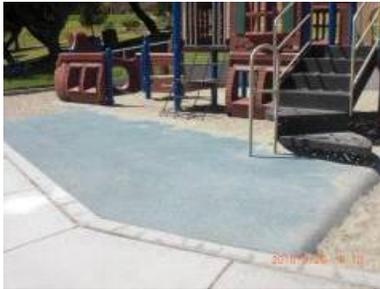
Location: Playground
Photo # 36

Field Condition	
31.30B - Play Components - Clear Floor or Ground Space Slope - The clear floor or ground space has a slope greater than 2% in some or all directions.	1991 ADAAG -
Existing Condition: Ground space slope varies between 2.6% and 10.8%.	2004 ADAAG 1008.4.2; 305.2; 305.3
	2007 CBC -
	Other 2000 ADAAG-15.6.6.2; PRC 5410-5411

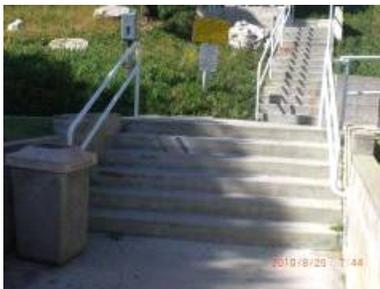
Location: Stairway
Photo # 40

Field Condition	
08.05A - Exterior Stairs - Color Strip - Contrasting color strips have not been provided.	1991 ADAAG -
Existing Condition: No stripes.	2004 ADAAG -
	2007 CBC 1133B.4.4
	Other -

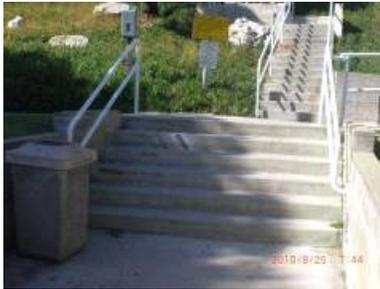
Location: Stairway
Photo # 40

08.09A - Handrail Extensions - Top Landing - At ends of handrails, less than 12" of handrail extends beyond the top nosing. (Top and bottom handrail extensions are important safety features for persons with balance problems and must extend in the direction of the stair run to permit the intended use.) (Per ADA/CBC Standards, in existing buildings and facilities, full extension of handrails at stairs shall not be required in alterations where such extensions would be hazardous or impossible due to plan configuration.)

Existing Condition: None provided.

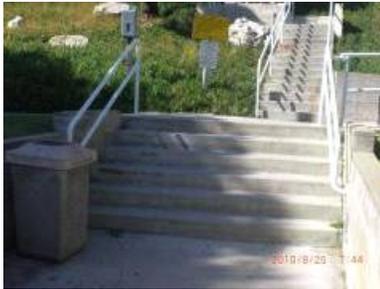
Location: Stairway
 Photo # 40

08.09B - Handrail Extensions - Bottom Landing - At ends of handrails, less than 12" plus the tread width extends beyond the bottom nosing. (Top and bottom handrail extensions are important safety features for persons with balance problems and must extend in the direction of the stair run to permit the intended use.) (Per ADA/CBC Standards, in existing buildings and facilities, full extension of handrails at stairs shall not be required in alterations where such extensions would be hazardous or impossible due to plan configuration.)

Existing Condition: None provided.

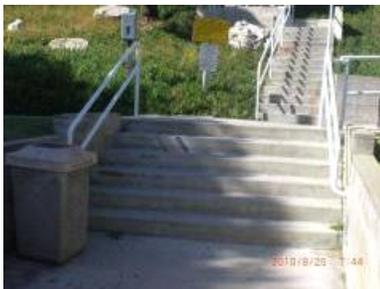
Location: Stairway
 Photo # 40

Existing Condition: 2" profile.

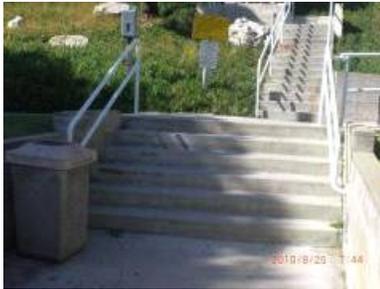
Field Condition	
08.03D - Level Landing - Landing is not level (slope is greater than 2% in some or all directions).	1991 ADAAG -
Existing Condition: 6.6%.1.1% CS & 6.6% RS at top landing	2004 ADAAG -
	2007 CBC 1009.5.1
	Other -

Corrective Action
008 - Concrete Landing - Remove non-compliant pavement and replace with new concrete. The landing slope shall not exceed 2% in any direction.
Additional Comments:

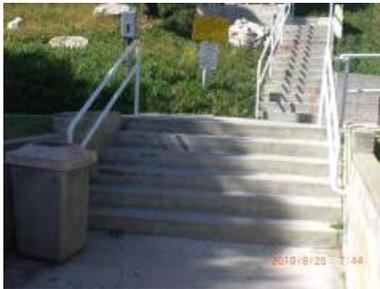
Field Condition	
08.03D - Level Landing - Landing is not level (slope is greater than 2% in some or all directions).	1991 ADAAG -
Existing Condition: 2.9% RS at bottom landing.	2004 ADAAG -
	2007 CBC 1009.5.1
	Other -

Corrective Action
008 - Concrete Landing - Remove non-compliant pavement and replace with new concrete. The landing slope shall not exceed 2% in any direction.
Additional Comments:

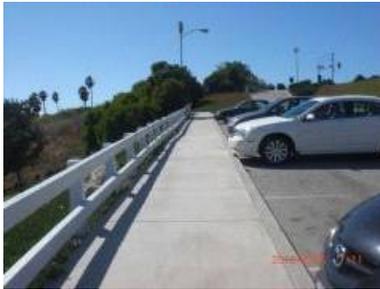
Existing Condition: No accessible stalls provided. 2 required.

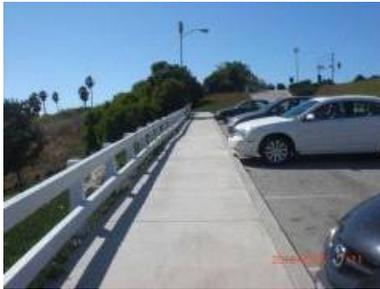
Location: Parking Lot
Photo # 47

Field Condition	
01.19B - Tow-away Sign - A California tow-away sign is not posted in a conspicuous place at each entrance to off-street parking lot, or immediately adjacent to and visible from each accessible stall.	1991 ADAAG -
Existing Condition:	2004 ADAAG -
	2007 CBC 1129B.4
	Other

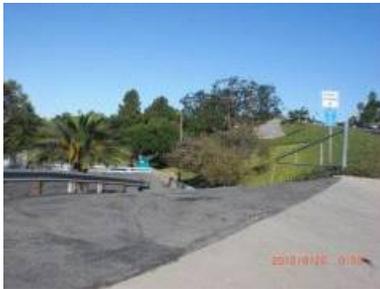
Location: Accessible Parking Lot
Photo # 48

Field Condition	
01.19B - Tow-away Sign - A California tow-away sign is not posted in a conspicuous place at each entrance to off-street parking lot, or immediately adjacent to and visible from each accessible stall.	1991 ADAAG -
Existing Condition:	2004 ADAAG -
	2007 CBC 1129B.4
	Other

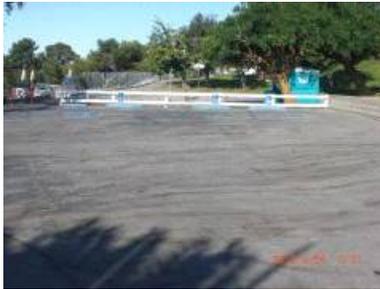
Location: Accessible Parking Lot
Photo # 49

Field Condition	
01.18 - Pavement Sign - A 36" square ISA is not painted on the pavement at the rear of the stall.	1991 ADAAG -
Existing Condition: 50" x 46"	2004 ADAAG 502.6
	2007 CBC 1129B.4
	Other

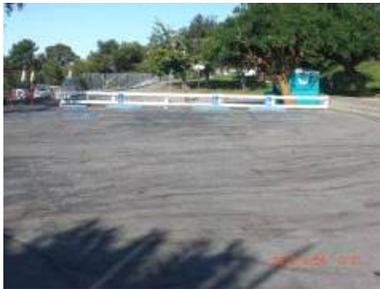
Location: Accessible Parking Lot
Photo # 49

Field Condition	
01.19A - Lettering - The words "NO PARKING" is not provided in each access aisle, painted in white, 12" high letters.	1991 ADAAG -
Existing Condition:	2004 ADAAG -
	2007 CBC 1129B.3 items 1 & 2
	Other

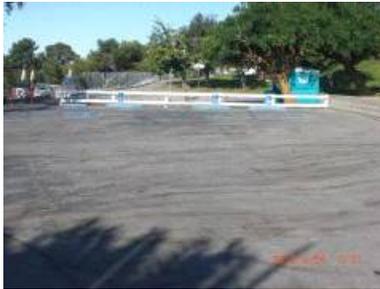
Field Condition	
01.11 - Car Access Aisle - Dimensions - Car access aisle is not at least 5' wide and 18' long. (Aisle width is measured from the center line of the stripe on one side to the center line of the stripe on the other.)	1991 ADAAG 4.1.2(5)(a)
Existing Condition:	2004 ADAAG 502.3.1
	2007 CBC 1129B.3 item 1
	Other

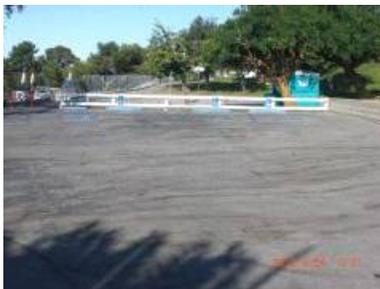
Field Condition	
01.13 - Level Surface - The accessible parking spaces and access aisles are not level (slope is greater than 2%).	1991 ADAAG 4.6.3
Existing Condition:	2004 ADAAG 502.4; advisory 502.4
	2007 CBC 1129B.3 items 3 & 4
	Other

Corrective Action
004A - Asphalt Paving - Remove non-compliant pavement and replace with new asphalt paving (area as shown on the drawings). The walkway slope shall not exceed 5% along the POT and cross slope shall not exceed 2%.
Additional Comments:

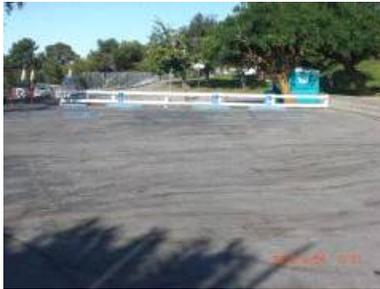
Location: Accessible Parking Lot
Photo # 49

Field Condition	
01.15C - Minimum Fine Sign - Accessible parking space has no sign stating "Minimum Fine \$250" below the ISA.	1991 ADAAG -
Existing Condition:	2004 ADAAG -
	2007 CBC 1129B.4
	Other

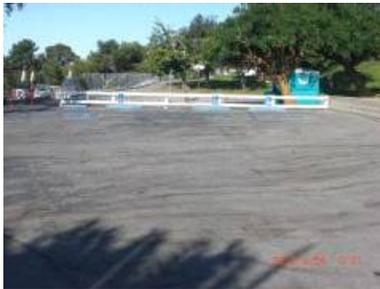
Location: Accessible Parking Lot
Photo # 49

Field Condition	
01.17 - Van Accessible Sign - Van accessible space has no sign stating "Van Accessible" below the ISA.	1991 ADAAG 4.6.4
Existing Condition:	2004 ADAAG 502.6
	2007 CBC 1129B.4
	Other

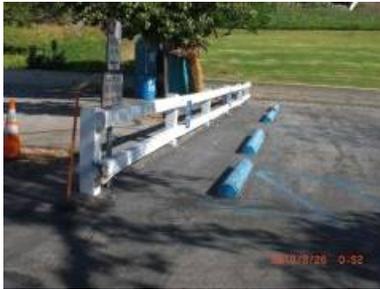
Field Condition	
03B.04 - Width - Accessible route of travel is less than 48" wide (note: 48" wide requirement does not apply to doorways or gates).	1991 ADAAG 4.3.3
Existing Condition: 38" wide walkway.	2004 ADAAG 403.5.1
	2007 CBC 1133B.7.1
	Other -

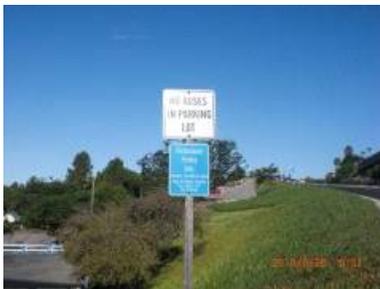
Field Condition	
01.23 - Other - Parking - See Additional Comments	1991 ADAAG -
Existing Condition: Uses the term "handicapped."	2004 ADAAG -
	2007 CBC -
	Other

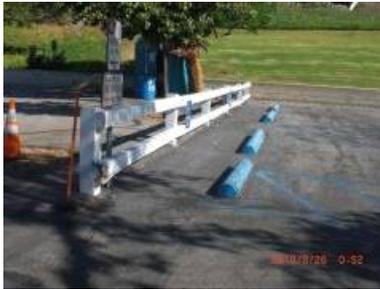
Location: Accessible Parking Lot
Photo # 57

Field Condition	
01.14 - Surface - Access aisle is not stable, firm, and slip resistant.	1991 ADAAG 4.5.1
Existing Condition: Uneven surface at walkway.	2004 ADAAG 302
	2007 CBC 1124B.1
	Other

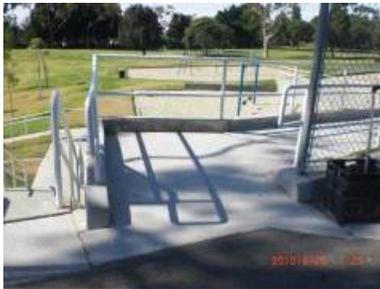
Location: Ramp
Photo # 60

Field Condition	
03B.13 - > 1/2" Changes in Level - Curb ramps, ramps, or elevators are not used for changes in level greater than 1/2 inch. (Lifts may only be used in certain limited situations.)	1991 ADAAG 4.5.2
Existing Condition: 1 1/2" high level change.	2004 ADAAG 303.4
	2007 CBC 1124B.2
	Other -

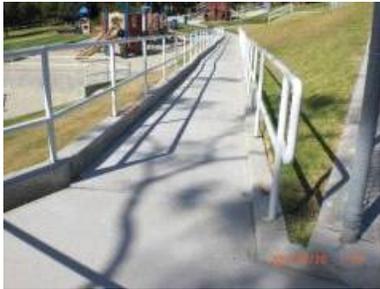
Location: Ramp
Photo # 61

Field Condition	
03B.13 - > 1/2" Changes in Level - Curb ramps, ramps, or elevators are not used for changes in level greater than 1/2 inch. (Lifts may only be used in certain limited situations.)	1991 ADAAG 4.5.2
Existing Condition: 1" high.	2004 ADAAG 303.4
	2007 CBC 1124B.2
	Other -

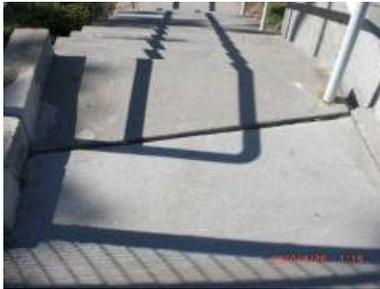
Field Condition	
03B.22 - Other - On-Site Accessible Path of Travel - See Additional Comments	1991 ADAAG -
Existing Condition: 3/4" gap.	2004 ADAAG -
	2007 CBC -
	Other -

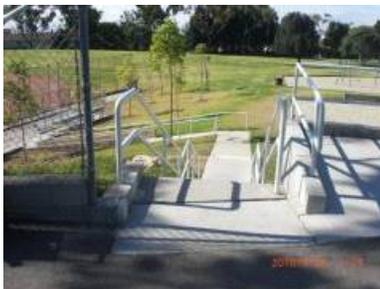
Field Condition	
08.03D - Level Landing - Landing is not level (slope is greater than 2% in some or all directions).	1991 ADAAG -
Existing Condition: 2.4% CS & 0.1% RS at top landing.	2004 ADAAG -
	2007 CBC 1009.5.1
	Other -

Corrective Action	
008 - Concrete Landing - Remove non-compliant pavement and replace with new concrete. The landing slope shall not exceed 2% in any direction.	
Additional Comments:

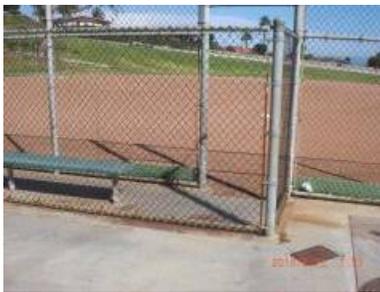
Field Condition	
30.68 - Other - Parks - See Additional Comments	1991 ADAAG -
Existing Condition: No access to dugout.	2004 ADAAG -
	2007 CBC -
	Other -

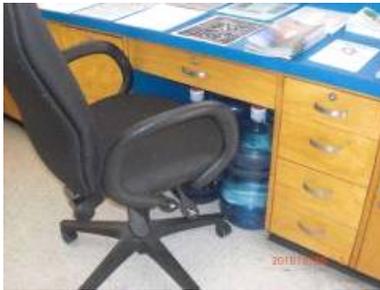
Field Condition	
14.29A - Counter - Knee Space Height - Where seating for persons in wheelchairs is provided at table or counter, knee space is less than 27" high.	1991 ADAAG 4.32.3
Existing Condition: 23 1/4" high Counter.	2004 ADAAG 306.3.1; Fig. 306.3
	2007 CBC 1122B.3; Fig. 11B-13
	Other -

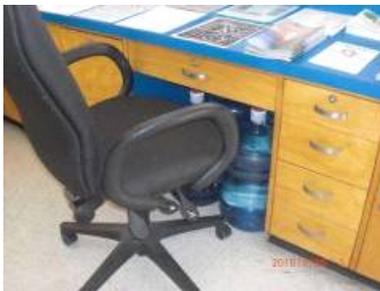
Field Condition	
14.29B - Counter - Knee Space Width - Where seating for persons in wheelchairs is provided at table or counter, knee space is less than 30" wide.	1991 ADAAG 4.32.3
Existing Condition: 24" wide Counter.	2004 ADAAG 306.3.5; Fig. 306.3
	2007 CBC 1122B.3; Fig. 11B-13
	Other -

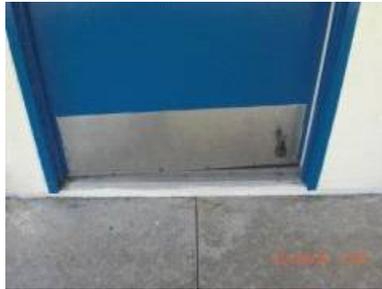
Field Condition	
16.88 - Other - Toilet Facilities - See Additional Comments	1991 ADAAG -
Existing Condition: Threshold at 2".	2004 ADAAG -
	2007 CBC -
	Other -
