City of Rancho Palos Verdes
**Rancho Palos Verdes ADA Assessment
 Facility Report with Photos**

Facility ID: # 01 - Abalone Cove Shoreline Park

Author: Vaish, B

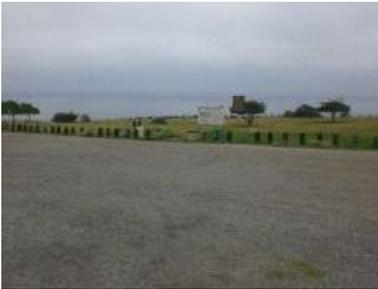
Photo #
1

01.02 - Number - Accessible Parking Spaces - Where parking spaces are provided for self-parking by employees or visitors or both, the required number of accessible parking spaces is not provided. (Note: All or some of the accessible parking spaces may be in a different location if equivalent or greater accessibility is ensured.) (Spaces required: (1 to 25 // 1) (26 to 50 // 2) (51 to 75 // 3) (76 to 100 // 4) (101 to 150 // 5) (151 to 200 // 6) (201 to 300 // 7) (301 to 400 // 8) (401 to 500 // 9) (501 to 1,000 // *) (1,000 and over // **) (*Twenty percent of total.) (**Twenty plus one for each 100, or fraction over 1,001.)

1991 ADAAG	4.1.2(5)
2004 ADAAG	208.3.1(2)
2007 CBC	1129B.1; 1129B.2; Table 11B-6
Other

Existing Condition: Non marked stalls, two ISA Signs at central entrance.

190 - Accessible Automobile Parking Stall - Re-stripe parking space with blue traffic paint. Provide a 5' wide access aisle on one side of each space. Provide concrete bumpers, located away from aisle. Place ISA at the rear of parking space. Paint-apply the words "NO PARKING" in each access aisle, in white, 12" high letters.

Additional Comments: Provide 3 accessible spaces and 1 Van, estimate based on parking lot size.

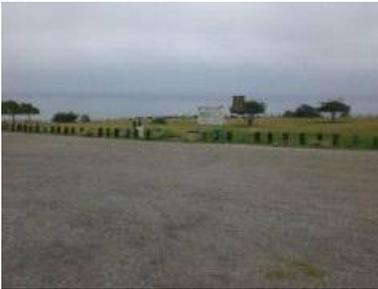
Location: Parking Lot
Photo # 1

Field Condition	
01.11 - Car Access Aisle - Dimensions - Car access aisle is not at least 5' wide and 18' long. (Aisle width is measured from the center line of the stripe on one side to the center line of the stripe on the other.)	1991 ADAAG 4.1.2(5)(a)
Existing Condition: Not demarcated, none provided.	2004 ADAAG 502.3.1
	2007 CBC 1129B.3 item 1
	Other

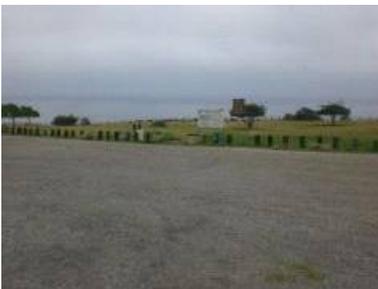
Location: Parking Lot
Photo # 1

Field Condition	
01.14 - Surface - Access aisle is not stable, firm, and slip resistant.	1991 ADAAG 4.5.1
Existing Condition: Gravel.	2004 ADAAG 302
	2007 CBC 1124B.1
	Other

Corrective Action
194 - Asphalt Paved Parking Stall and Access Aisle - Remove non-compliant pavement and replace with new asphalt paving. The parking space and access aisle slope shall not exceed 2% in any direction.
Additional Comments:

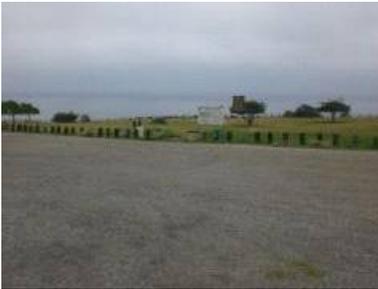
Location: Parking Lot
 Photo # 1

Field Condition	
01.15A - Access Aisle and Accessible Route - Access aisle do not connects directly to an accessible route of travel.	1991 ADAAG 4.3
Existing Condition: None provided.	2004 ADAAG 502.3
	2007 CBC 1129B.1
	Other

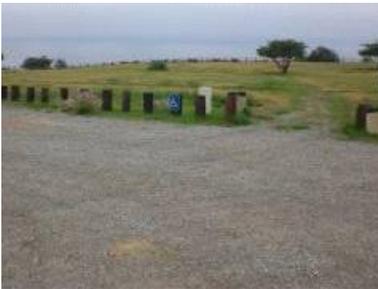
Location: Parking Lot
 Photo # 7

Field Condition	
01.15B - Parking Space Sign - Accessible parking space has no reflectorized sign visible from the stall, showing an ISA in white on a blue background.	1991 ADAAG 4.6.4
Existing Condition:	2004 ADAAG 502.6
	2007 CBC 1129B.4
	Other

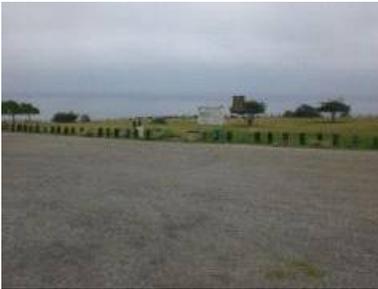
Location: Photo #
Parking Lot 1

Field Condition	
01.15C - Minimum Fine Sign - Accessible parking space has no sign stating "Minimum Fine \$250" below the ISA.	1991 ADAAG -
Existing Condition:	2004 ADAAG -
	2007 CBC 1129B.4
	Other

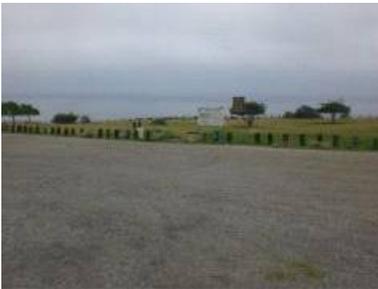
Location: Photo #
Parking Lot 1

Field Condition	
01.18 - Pavement Sign - A 36" square ISA is not painted on the pavement at the rear of the stall.	1991 ADAAG -
Existing Condition:	2004 ADAAG 502.6
	2007 CBC 1129B.4
	Other

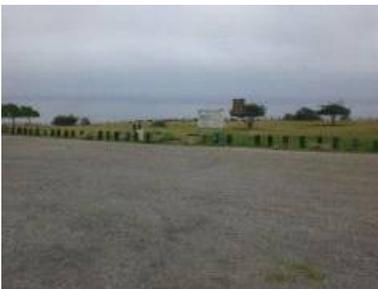
Location: Photo #
Parking Lot 1

Existing Condition: 14 1/2" high Parking Sign.

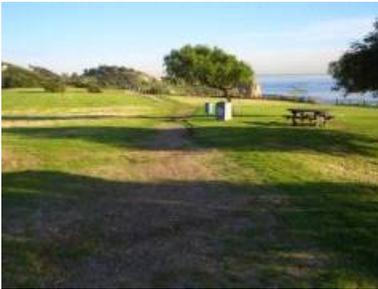
Field Condition	
30.06C - Outdoor Recreation Access Route (ORAR) Surface - The surface of the access route is not firm or stable.	1991 ADAAG -
Existing Condition: Loose gravel, and grass.	2004 ADAAG -
	2007 CBC -
	Other 1999 ADAAG-16.3.1

Classification	
DOJ Location Type:	2
Use:	PV
Severity:	A
Level of Difficulty	Low to Moderate

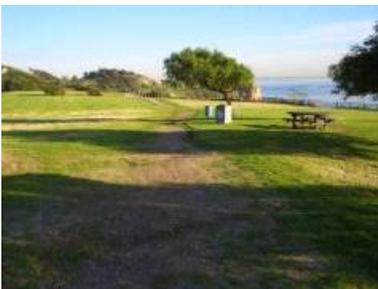
Field Condition	
30.06E - Outdoor Recreation Access Route (ORAR) Segment - Cross Slope - Cross slope of the access route segment exceeds 3.33%. Exception: Cross slopes of 5% maximum are permitted to ensure proper drainage.	1991 ADAAG -
Existing Condition: Varies 3.0% to 6.4%	2004 ADAAG -
	2007 CBC -
	Other 1999 ADAAG-16.3.7.1

Classification	
DOJ Location Type:	2
Use:	PV
Severity:	C
Level of Difficulty	Moderate to High

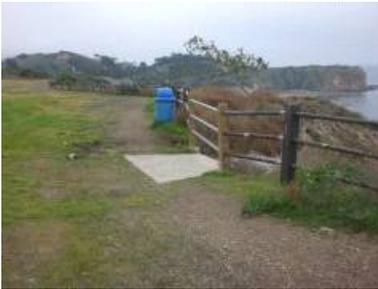
Location: Perimeter Route
Photo # 17

Existing Condition: Varies 4.1% to 31%

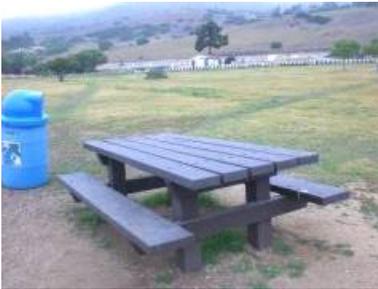
Location: Near South Route
 Photo # 19

Field Condition	
30.34C - Picnic Table - Knee Space Depth - Picnic table does not provide at least 19" depth for accessible knee clearance.	1991 ADAAG 4.32.3
Existing Condition: 14 1/2" deep.	2004 ADAAG 305; 306
	2007 CBC 1122B.3
	Other 1999 ADAAG-16.5.4

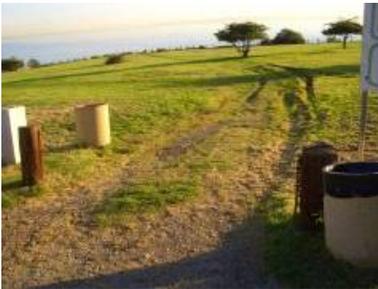
Location: Central Route
 Photo # 21

Field Condition	
30.06A - Outdoor Recreation Access Route (ORAR) Segment - Running Slope - Running slope of access route segment in the direction of travel does not comply with the following: a. 5% or less for any distance. b. From 5.1% to 8.33% for 50' maximum. c. From 8.34% to 10% for 30' maximum.	1991 ADAAG -
Existing Condition: 11.1%	2004 ADAAG -
	2007 CBC -
	Other 1999 ADAAG-16.3.7.2.1; 16.3.7.2.2; 16.3.7.2.3

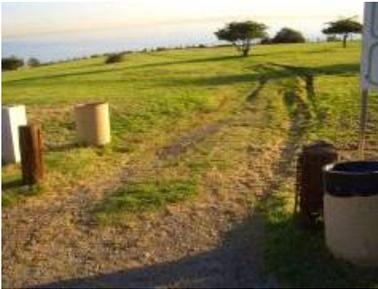
Field Condition	
30.06C - Outdoor Recreation Access Route (ORAR) Surface - The surface of the access route is not firm or stable.	1991 ADAAG -
Existing Condition: Loose dirt, erosion, & grass on trail.	2004 ADAAG -
	2007 CBC -
	Other 1999 ADAAG-16.3.1

Classification	
DOJ Location Type:	2
Use:	PV
Severity:	A
Level of Difficulty	Moderate to High

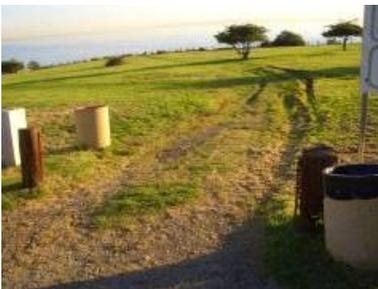
Field Condition	
30.06E - Outdoor Recreation Access Route (ORAR) Segment - Cross Slope - Cross slope of the access route segment exceeds 3.33%. Exception: Cross slopes of 5% maximum are permitted to ensure proper drainage.	1991 ADAAG -
Existing Condition: 4.8%	2004 ADAAG -
	2007 CBC -
	Other 1999 ADAAG-16.3.7.1

Classification	
DOJ Location Type:	2
Use:	PV
Severity:	C
Level of Difficulty	Moderate to High

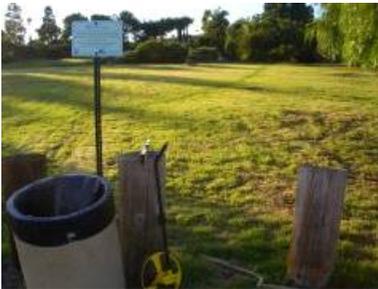
Location: West Route entrance
Photo # 24

Field Condition	
30.05 - Accessible Route - Width - Accessible route of travel is less than 48" wide (note: 48" wide requirement does not apply to doorways or gates).	1991 ADAAG 4.3.3
Existing Condition: 35" clear width.	2004 ADAAG 403.5.1
	2007 CBC 1133B.7.1
	Other -

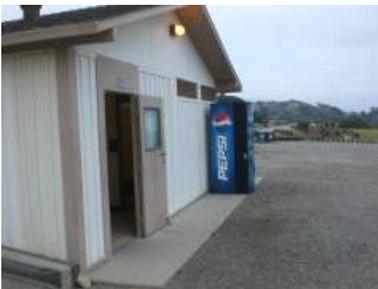
Location: Concession Entry
Photo # 25

Field Condition	
10.02 - Entrance Sign - Accessible entrance is not identified by an ISA.	1991 ADAAG 28 CFR 35.163(b)1
Existing Condition:	2004 ADAAG 216.6
	2007 CBC 1117B.5.8.1.2
	Other -

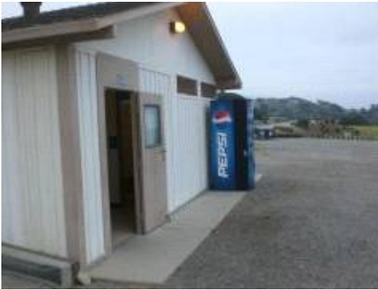
Location: Concession Entry Photo # 25

Field Condition	
10.07A - Landing - Level and Clear - Floor is not level (slope is greater than 2% in some or all directions). OR Floor is not clear within the required maneuvering space.	1991 ADAAG 4.13.6; Fig. 25
Existing Condition:	2004 ADAAG 305; 404.2.4.4
	2007 CBC 1133B.2.4
	Other -

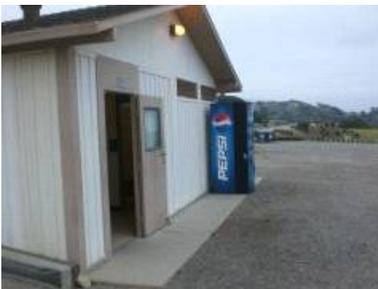
Location: Concession Entry Photo # 25

Field Condition	
10.08 - Kick Plate - Bottom 10" of door does not have a smooth, uninterrupted surface on the push side to allow the door to be opened by a wheelchair footrest without creating a trap or hazardous condition. (This requirement does not apply to automatic and sliding doors.)	1991 ADAAG -
Existing Condition:	2004 ADAAG 404.2.10
	2007 CBC 1133B.2.6
	Other -

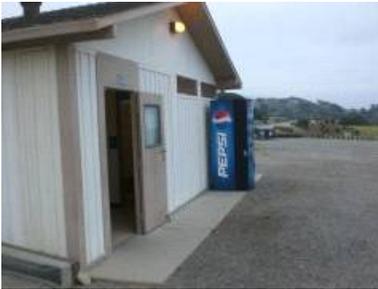
Location: Concession Entry
Photo # 25

Field Condition	
10.10 - Single-Action Hardware - Handles, locks, and latches or other operative devices are not operable with one hand and without tight grasping, pinching, or twisting of the wrist. (U-shaped handles, levers, and push/pull type mechanisms are acceptable designs.)	1991 ADAAG 4.13.9
Existing Condition:	2004 ADAAG 309.4; 404.2.7; Advisory 404.2.7
	2007 CBC 1133B.2.5.2
	Other -

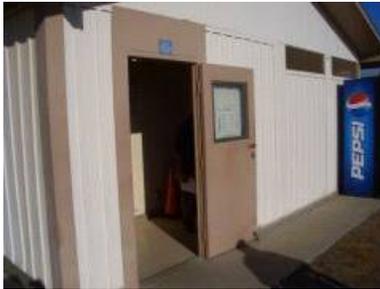
Location: Photo #
 Concession Entry 30

Field Condition	
11.17A - Recommendation: Providing Room/Space ID Sign - A sign designating the permanent room or space has not been provided.	1991 ADAAG 4.1.2(7)
Existing Condition:	2004 ADAAG 216.2; 703.1; 703.2; 703.5
	2007 CBC 1117B.5.1 item 1
	Other -

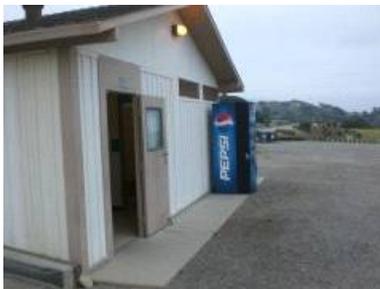
Location: Photo #
 Concession Entry 25

Field Condition	
11.15B_04AG - Vision Lights - Door, gate, or adjacent sidelight, containing one or more vision lights, does not include at least one vision light mounted with the bottom edge of the glazed panel at 43" max.. AFF. (Exception: Vision lights with the lowest part more than 66" AFF.)	1991 ADAAG -
Existing Condition:	2004 ADAAG 404.2.11
	2007 CBC -
	Other -

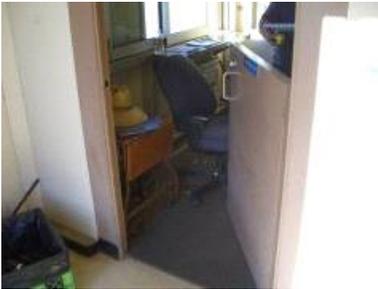
Location: Concession - Office
Photo # 33

Field Condition	
11.23A - Mounting Location (Visual/Tactile Signs) - Sign is not mounted on the wall adjacent to the latch side of the door. OR At double leaf doors, the sign is not placed on the nearest adjacent wall.	1991 ADAAG 4.30.6
Existing Condition:	2004 ADAAG 703.4.2
	2007 CBC 1117B.5.7
	Other -

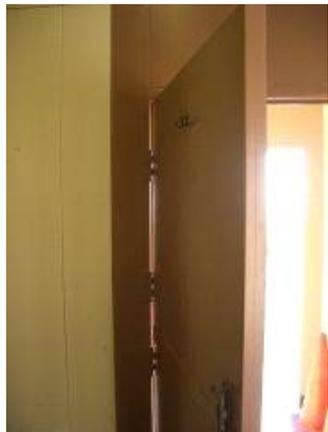
Location: Concession - Office
Photo # 35

Field Condition	
14.32A - Reach Range - Controls - Controls, dispensers, and similar devices are not between 9" and 54" AFF when the clear floor space allows a parallel approach. OR They are not between 15" and 48" AFF when the clear floor space allows only a forward approach.	1991 ADAAG 4.1.3(13); 4.27.3; 4.2.5; 4.2.6 ; Fig. 5; Fig. 6
Existing Condition: Coat hook.	2004 ADAAG -
	2007 CBC 1117B.6(3); 1118.5; 1118.6; Fig. 11B-5C; Fig. 11B-5D
	Other -

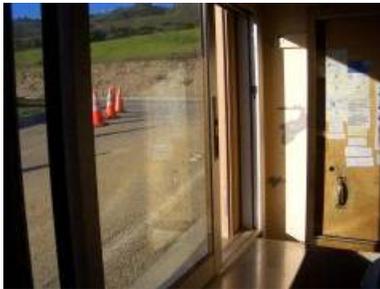
Location: Photo #
 Concession - Office 36

Field Condition	
14.50 - Other - Rooms and Spaces - See Additional Comments	1991 ADAAG -
Existing Condition: 7 LBF. sliding window at counter.	2004 ADAAG -
	2007 CBC -
	Other -

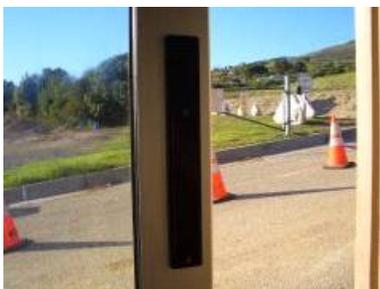
Location: Photo #
 Concession - Office 37

Field Condition	
14.32A - Reach Range - Controls - Controls, dispensers, and similar devices are not between 9" and 54" AFF when the clear floor space allows a parallel approach. OR They are not between 15" and 48" AFF when the clear floor space allows only a forward approach.	1991 ADAAG 4.1.3(13); 4.27.3; 4.2.5; 4.2.6 ; Fig. 5; Fig. 6
Existing Condition: 58" high lock.	2004 ADAAG -
	2007 CBC 1117B.6(3); 1118.5; 1118.6; Fig. 11B-5C; Fig. 11B-5D
	Other -

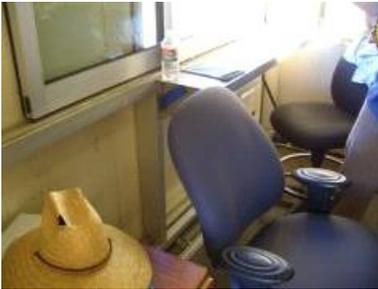
Location: Photo #
 Concession - Office 39

Field Condition	
14.29C - Counter - Knee Space Depth - Where seating for persons in wheelchairs is provided at table or counter, knee space is less than 19" deep.	1991 ADAAG 4.32.3
Existing Condition: 14 1/2"	2004 ADAAG 306.3.2; Fig. 306.3
	2007 CBC 1122B.3; Fig. 11B-13
	Other -

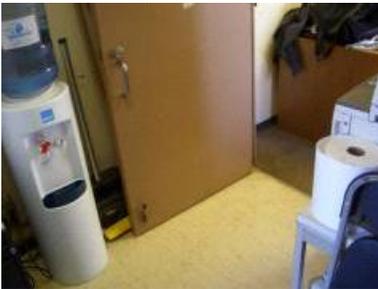
Location: Photo #
 Storage 41

Field Condition	
11.15A - Kick Plate - Bottom 10" of door does not have a smooth, uninterrupted surface on the push side to allow the door to be opened by a wheelchair footrest without creating a trap or hazardous condition. (This requirement does not apply to automatic and sliding doors.)	1991 ADAAG -
Existing Condition: Door stop.	2004 ADAAG 404.2.10
	2007 CBC 1133B.2.6
	Other -

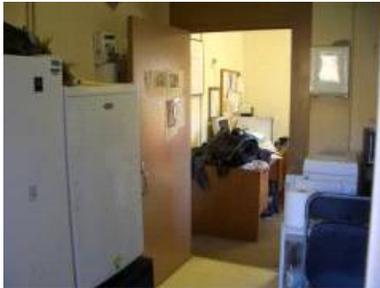
Location: Storage Photo # 42

Field Condition	
11.17A - Recommendation: Providing Room/Space ID Sign - A sign designating the permanent room or space has not been provided.	1991 ADAAG 4.1.2(7)
Existing Condition:	2004 ADAAG 216.2; 703.1; 703.2; 703.5
	2007 CBC 1117B.5.1 item 1
	Other -

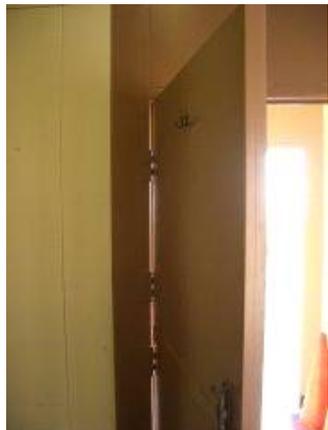
Location: Storage Photo # 43

Field Condition	
14.32A - Reach Range - Controls - Controls, dispensers, and similar devices are not between 9" and 54" AFF when the clear floor space allows a parallel approach. OR They are not between 15" and 48" AFF when the clear floor space allows only a forward approach.	1991 ADAAG 4.1.3(13); 4.27.3; 4.2.5; 4.2.6 ; Fig. 5; Fig. 6
Existing Condition: 71" high coat hook.	2004 ADAAG -
	2007 CBC 1117B.6(3); 1118.5; 1118.6; Fig. 11B-5C; Fig. 11B-5D
	Other -

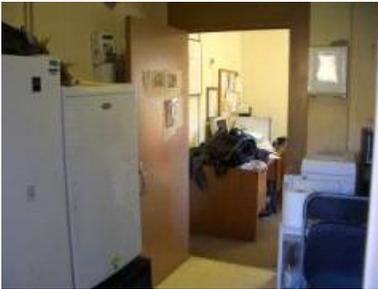
11.06A - Door Maneuvering Space - Door that is not automatic or power-assisted does not have compliant maneuvering space relative to the direction of approach as shown in CBC Fig. 11B-26. (Approach // Side // Width // Depth) (Front // Pull // D + 24" * // 60") (Front // Push // D + 0" ** // 48") (Latch // Pull // D + 24" // 60") (Latch // Push // D + 24" // 44" ***) (Hinge // Pull // D + 36" // 60") (Hinge // Push // 54" **** // 44" *****) (* D + 18" at interior doors.) (** D + 12" if door has both a latch and a closer.) (***) 48" if door has closer.) (**** Measured from latch toward hinge.) (***** 48" if door has both a latch and a closer.)

Existing Condition: Non-fixed furniture.

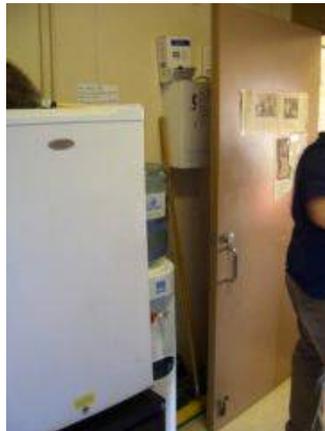
Location: Storage Photo # 45

Field Condition	
14.32A - Reach Range - Controls - Controls, dispensers, and similar devices are not between 9" and 54" AFF when the clear floor space allows a parallel approach. OR They are not between 15" and 48" AFF when the clear floor space allows only a forward approach.	1991 ADAAG 4.1.3(13); 4.27.3; 4.2.5; 4.2.6 ; Fig. 5; Fig. 6
Existing Condition: 65" high first aid kit.	2004 ADAAG -
	2007 CBC 1117B.6(3); 1118.5; 1118.6; Fig. 11B-5C; Fig. 11B-5D
	Other -

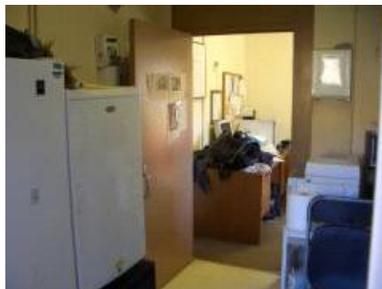
Location: Storage Photo # 42

Field Condition	
14.32A - Reach Range - Controls - Controls, dispensers, and similar devices are not between 9" and 54" AFF when the clear floor space allows a parallel approach. OR They are not between 15" and 48" AFF when the clear floor space allows only a forward approach.	1991 ADAAG 4.1.3(13); 4.27.3; 4.2.5; 4.2.6 ; Fig. 5; Fig. 6
Existing Condition: 60" high PTD.	2004 ADAAG -
	2007 CBC 1117B.6(3); 1118.5; 1118.6; Fig. 11B-5C; Fig. 11B-5D
	Other -

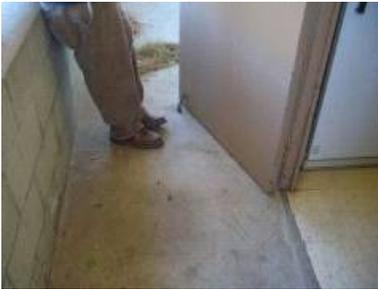
10.06A - Door Maneuvering Space - Door that is not automatic or power-assisted does not have compliant maneuvering space relative to the direction of approach as shown in CBC Fig. 11B-26. (Approach // Side // Width // Depth) (Front // Pull // D + 24" * // 60") (Front // Push // D + 0" ** // 48") (Latch // Pull // D + 24" // 60") (Latch // Push // D + 24" // 44" ***) (Hinge // Pull // D + 36" // 60") (Hinge // Push // 54" **** // 44" *****) (* D + 18" at interior doors.) (** D + 12" if door has both a latch and a closer.) (***) 48" if door has closer.) (**** Measured from latch toward hinge.) (***** 48" if door has both a latch and a closer.)

Existing Condition: 40" CLR. @ pull side landing.

008 - Concrete Landing - Remove non-compliant pavement and replace with new concrete. The landing slope shall not exceed 2% in any direction.

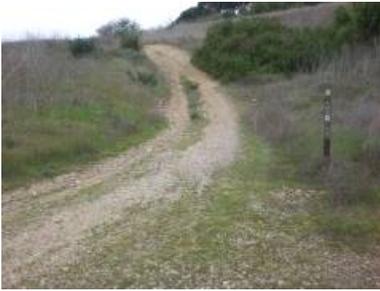
Field Condition	
30.10E - Trail Surface - The surface of the trail is not firm or stable.	1991 ADAAG -
Existing Condition: Loose rocks.	2004 ADAAG -
	2007 CBC -
	Other 1999 ADAAG-16.2.1
