City of Rancho Palos Verdes
Rancho Palos Verdes ADA Assessment
Facility Report with Photos

Facility ID: # 02B - City Hall Buildings

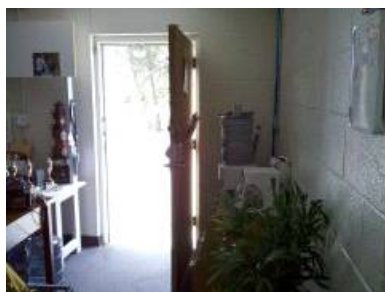
Location: Photo #
Ch. 33 - Office 2

Existing Condition: Door jamb at 77 3/4" AFF.

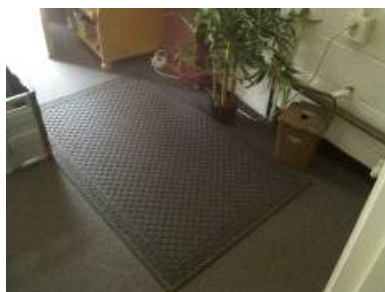
Location: Photo #
Ch. 33 - Office 11

Existing Condition: Floor mat.

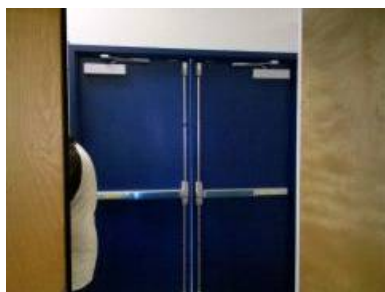
Location: Photo #
Ch. 33 - Back Door 26

Existing Condition: 10 & 16 LBF.

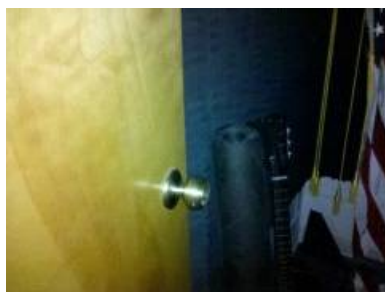
Location: Photo #
Ch. 33 - Storage 29

Existing Condition: Door knob.

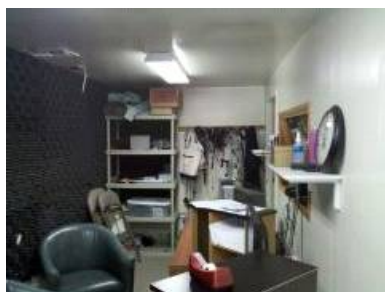
Location: Photo #
Ch. 33 - Control Room 36

Existing Condition: 2 shelves at 57" AFF.

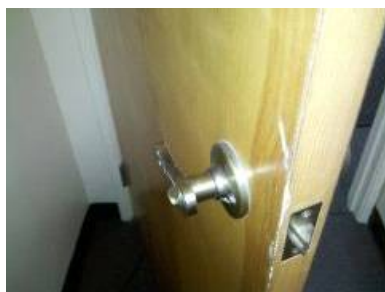
Location: Photo #
Ch. 33 - Control Room 40

Existing Condition: Door knob & twist-type locking mechanism.

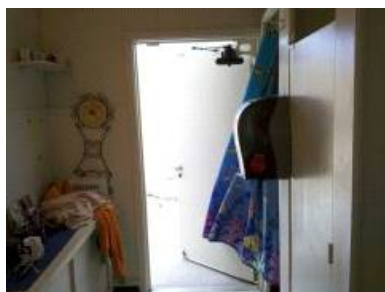
Location: Photo #
Ch. 33 - Restroom 44

Existing Condition: Door jamb at 77" AFF & Closer at 71" AFF.

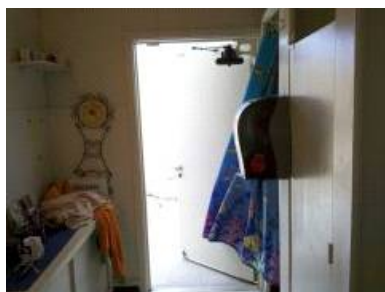
Location: Photo #
Ch. 33 - Restroom 44

Existing Condition: 45" AFF.

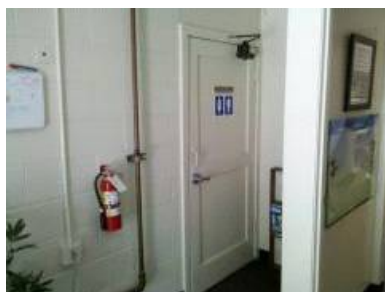
Location: Ch. 33 - Restroom
Photo # 61

Existing Condition: 11 LBF.

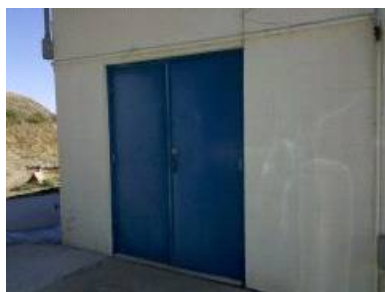
Location: Photo #
Ch. 33 - Storage 68

Existing Condition: 28" clear opening.

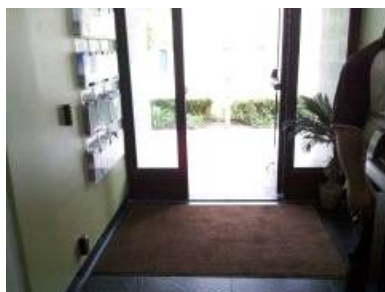
Location: Photo #
Comm. Dev. - Entrance 72

Existing Condition: Unsecured floor mat.

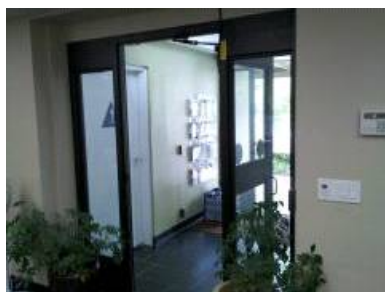
Location: Photo #
Comm. Dev. - Vestibule 75

Existing Condition: 15 LBF.

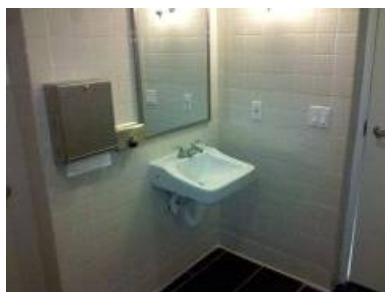
Location: Photo #
Comm. Dev. - Public Restroom 78

Existing Condition: Door swing encroaches lavatory clear floor space.

053 - Reverse Door Swing - Remove existing door and frame and replace with new frame. Reinstall existing door (reverse door swing). Provide new accessible door hardware.

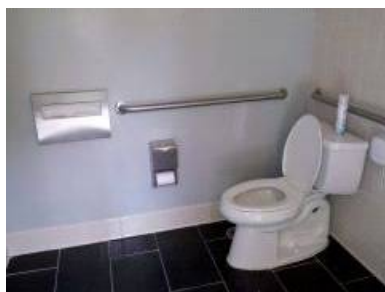
Location: Photo #
Comm. Dev. - Public Restroom 87

Existing Condition: 50 1/2".

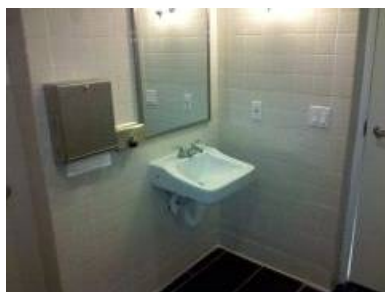
Location: Photo #
Comm. Dev. - Public Restroom 78

Existing Condition: 26 1/4" clear.

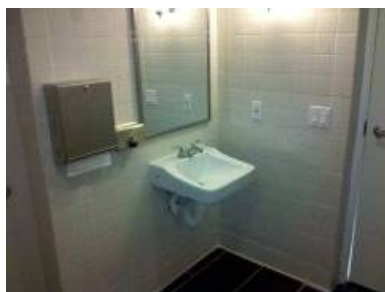
Location: Photo #
Comm. Dev. - Public Restroom 78

Existing Condition: 40 3/4" AFF.

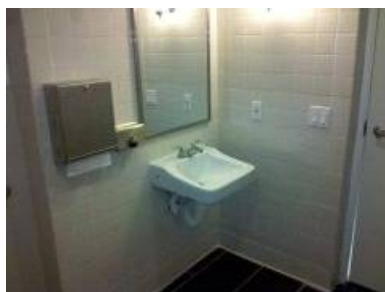
Location: Photo #
Comm. Dev. - Public Restroom 78

Existing Condition: 40 1/2" AFF.

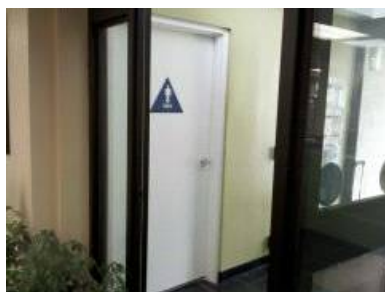
Location: Photo #
Comm. Dev. - Men's Staff Restroom 101

Existing Condition: 7 LBF.

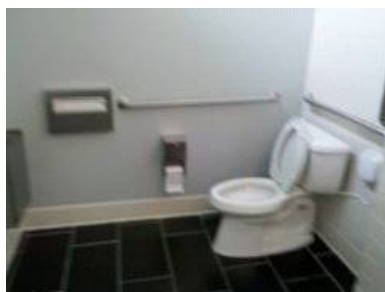
Location: Photo #
Comm. Dev. - Men's Staff Restroom 105

Existing Condition: 49" clear.

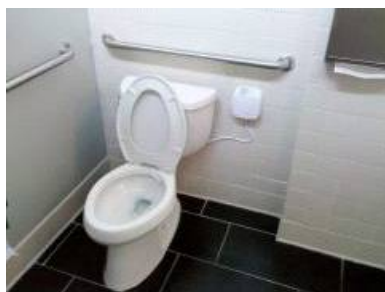
Location: Photo #
Comm. Dev. - Men's Staff Restroom 106

Existing Condition: 18 1/2" from side wall.

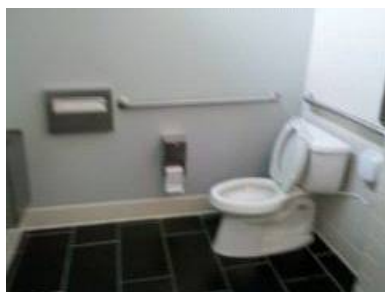
Location: Photo #
Comm. Dev. - Men's Staff Restroom 105

Existing Condition: 35 1/4" AFF.

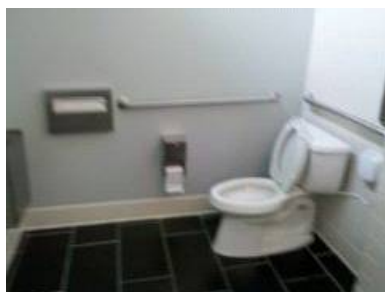
Location: Photo #
Comm. Dev. - Men's Staff Restroom 105

Existing Condition: 51 1/2".

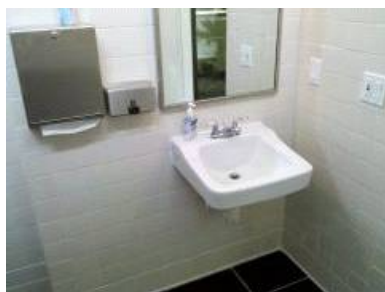
Location: Photo #
Comm. Dev. - Men's Staff Restroom 118

Existing Condition: 40 1/2" AFF.

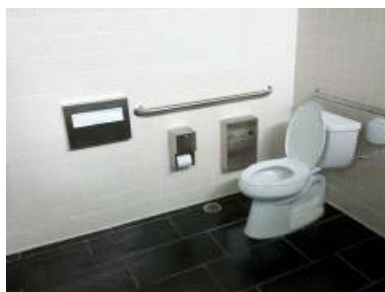
Location: Photo #
Comm. Dev. - Women's Staff Restroom 131

Existing Condition: 44" from back wall.

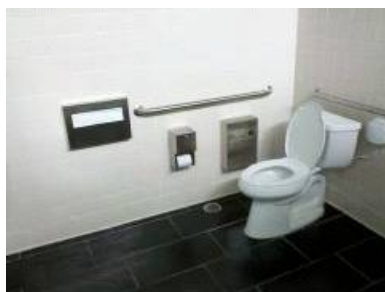
Location: Photo #
Comm. Dev. - Women's Staff Restroom 131

Existing Condition: 52 1/4".

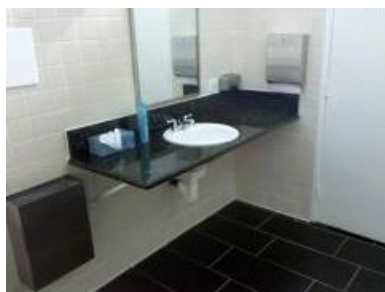
Location: Photo #
Comm. Dev. - Women's Staff Restroom 134

Existing Condition: 42" AFF.

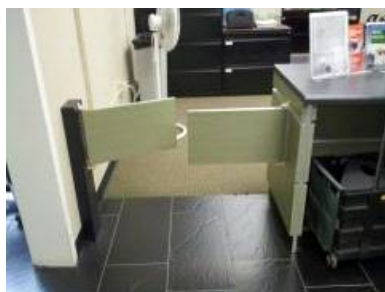
Location: Photo #
Comm. Dev. - Open Office 157

Existing Condition: Bottom of swing gate at 16 1/4" AFF.

Additional Comments: Replace swing gate.
