City of Rancho Palos Verdes
**Rancho Palos Verdes ADA Assessment
 Facility Report with Photos**

Facility ID: # Area 1 Bus Stops

Author: Vaish, B

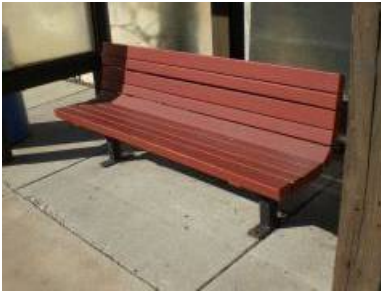
Keynote 1

Field Condition	
02.13A - Bus Stop Shelter - Clear Floor Area - Clear floor area of 30" by 48" is not completely within the shelter.	1991 ADAAG 10.2.1(2)
Existing Condition: No WC space provided within the shelter.	2004 ADAAG 810.3
	2007 CBC 1121B.2.1
	Other

Classification	
DOJ Location Type:	1
Use:	PV
Severity:	C
Level of Difficulty	Moderate

Corrective Action
027 - Site Work - Miscellaneous - See Additional Comments
Additional Comments: See Keynote 2 for corrective action.

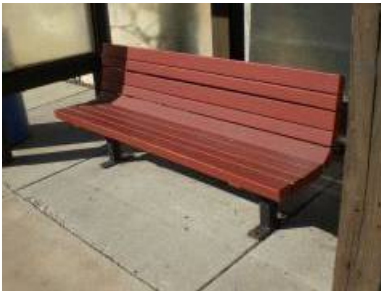
Keynote 2

Field Condition	
02.17 - Other - Passenger Loading Zones - See Additional Comments	1991 ADAAG -
Existing Condition: Bench (16" high seat, 14" deep seat, 14" high back support).	2004 ADAAG -
	2007 CBC -
	Other

Classification	
DOJ Location Type:	1
Use:	PV
Severity:	C
Level of Difficulty	Moderate

Corrective Action
027 - Site Work - Miscellaneous - See Additional Comments
Additional Comments: Provide compliant bench & relocate for clear WC seating space.

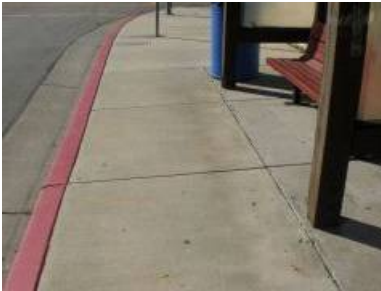
Keynote 3

02.17 - Other - Passenger Loading Zones - See Additional Comments

Existing Condition: 2.1% to 2.9% CS.

Severity: C

006 - Concrete Walk - Remove non-compliant pavement and replace with new concrete (area as shown on the drawings). The walkway slope shall not exceed 5% along the POT and cross slope shall not exceed 2%.

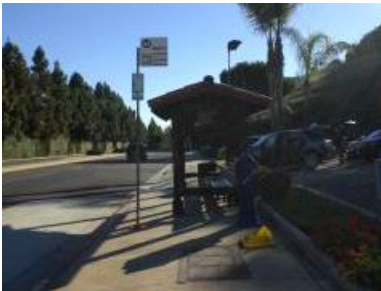
Keynote 4

02.17 - Other - Passenger Loading Zones - See Additional Comments

Existing Condition: 3.0% CS.

Severity: C

006 - Concrete Walk - Remove non-compliant pavement and replace with new concrete (area as shown on the drawings). The walkway slope shall not exceed 5% along the POT and cross slope shall not exceed 2%.

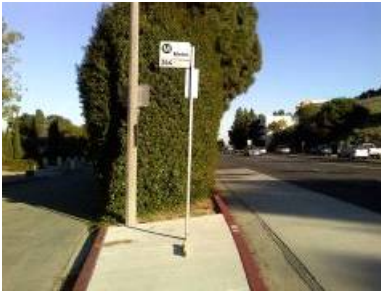
Keynote 5

Field Condition		1991 ADAAG	10.2.1
02.12B - Bus Stop Pad Slope Perpendicular to Roadway - Bus stop pad slope perpendicular to the roadway exceeds 2%.			
Existing Condition: 8% CS.		2004 ADAAG	810.2.4
		2007 CBC	1121B.2.1
		Other

Classification	
DOJ Location Type:	1
Use:	PV
Severity:	C
Level of Difficulty	High

Corrective Action	
006 - Concrete Walk - Remove non-compliant pavement and replace with new concrete (area as shown on the drawings). The walkway slope shall not exceed 5% along the POT and cross slope shall not exceed 2%.	
Additional Comments:

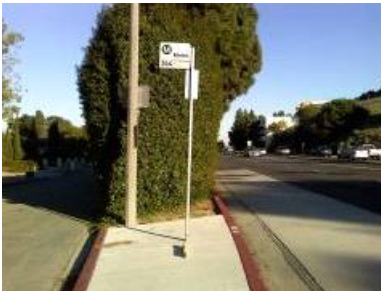
Keynote 6

Field Condition		1991 ADAAG	10.2.1
02.11A - Bus Stop Pad Size - Bus stop pad does not measure 8' long (measured from the curb or vehicle roadway edge) by 5' wide (measured parallel to the vehicle roadway).			
Existing Condition: Bus pad 6' long x 5' wide.		2004 ADAAG	810.2.2
		2007 CBC	1121B.1
		Other

Classification	
DOJ Location Type:	1
Use:	PV
Severity:	C
Level of Difficulty	High

Corrective Action	
006 - Concrete Walk - Remove non-compliant pavement and replace with new concrete (area as shown on the drawings). The walkway slope shall not exceed 5% along the POT and cross slope shall not exceed 2%.	
Additional Comments:

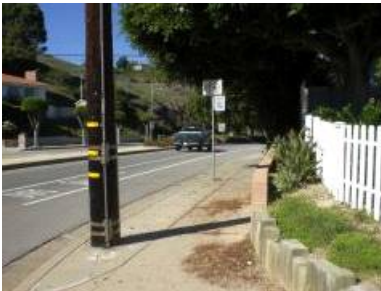
Keynote 7

Field Condition	
02.11A - Bus Stop Pad Size - Bus stop pad does not measure 8' long (measured from the curb or vehicle roadway edge) by 5' wide (measured parallel to the vehicle roadway).	1991 ADAAG 10.2.1
	2004 ADAAG 810.2.2
	2007 CBC 1121B.1
	Other
Existing Condition: Bus pad 7'-1" long by 5' wide.

Classification	
DOJ Location Type:	1
Use:	PV
Severity:	C
Level of Difficulty	High

Corrective Action
006 - Concrete Walk - Remove non-compliant pavement and replace with new concrete (area as shown on the drawings). The walkway slope shall not exceed 5% along the POT and cross slope shall not exceed 2%.
Additional Comments:

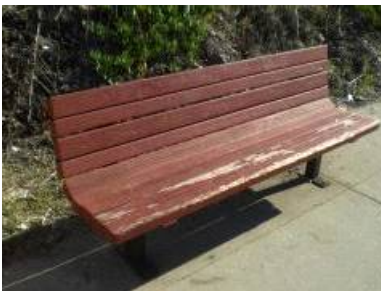
Keynote 8

Field Condition	
02.17 - Other - Passenger Loading Zones - See Additional Comments	1991 ADAAG -
	2004 ADAAG -
	2007 CBC -
	Other
Existing Condition: Bench (16" high seat, 14" deep seat, 14 1/2" high back support).

Classification	
DOJ Location Type:	1
Use:	PV
Severity:	E
Level of Difficulty	Moderate

Corrective Action
027 - Site Work - Miscellaneous - See Additional Comments
Additional Comments: Provide compliant bench.

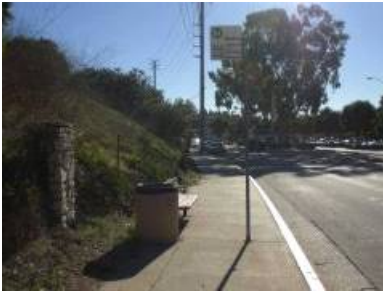
Keynote 9

Field Condition	
02.17 - Other - Passenger Loading Zones - See Additional Comments	1991 ADAAG -
Existing Condition: 3.1% to 4.3% CS.	2004 ADAAG -
	2007 CBC -
	Other

Classification	
DOJ Location Type:	1
Use:	PV
Severity:	C
Level of Difficulty	High

Corrective Action
006 - Concrete Walk - Remove non-compliant pavement and replace with new concrete (area as shown on the drawings). The walkway slope shall not exceed 5% along the POT and cross slope shall not exceed 2%.
Additional Comments:

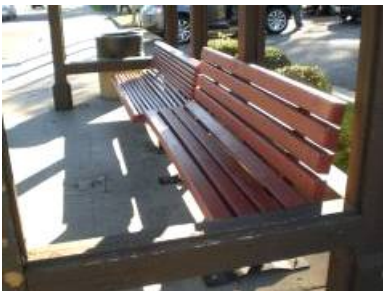
Keynote 10

Field Condition	
02.13A - Bus Stop Shelter - Clear Floor Area - Clear floor area of 30" by 48" is not completely within the shelter.	1991 ADAAG 10.2.1(2)
Existing Condition: No WC space provided within the shelter.	2004 ADAAG 810.3
	2007 CBC 1121B.2.1
	Other

Classification	
DOJ Location Type:	1
Use:	PV
Severity:	C
Level of Difficulty	Moderate

Corrective Action
027 - Site Work - Miscellaneous - See Additional Comments
Additional Comments: See Keynote 11 for corrective action.

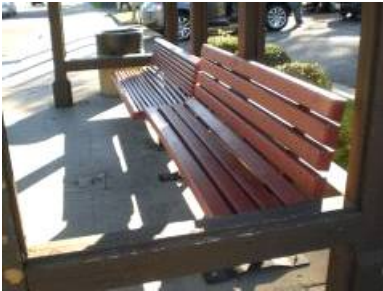
Keynote 11

Field Condition	
02.17 - Other - Passenger Loading Zones - See Additional Comments	1991 ADAAG -
Existing Condition: 2 benches provided, 0 accessible (17" high back support, 14" deep seat).	2004 ADAAG -
	2007 CBC -
	Other

Classification	
DOJ Location Type:	1
Use:	PV
Severity:	C
Level of Difficulty	Moderate

Corrective Action
027 - Site Work - Miscellaneous - See Additional Comments
Additional Comments: Remove one bench to allow for 30"x48" wheelchair seating space and provide one new compliant bench.
