City of Rancho Palos Verdes
 Rancho Palos Verdes ADA Assessment
 Facility Report with Photos

Facility ID: # Area 7 Bus Stops

Author: Vaish, B

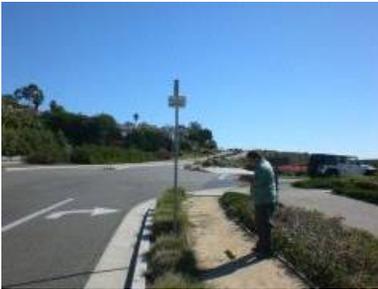
Keynote 1

Field Condition	
02.11B - Bus Stop Pad and Accessible Route - Bus stop pad is not connected to an accessible route.	1991 ADAAG 10.2.1
Existing Condition: No accessible route to bus stop (planters).	2004 ADAAG 810.2.3
	2007 CBC 1121B.1
	Other

Classification	
DOJ Location Type:	1
Use:	PV
Severity:	C
Level of Difficulty	Moderate to High

Corrective Action	
015A - Decomposed Granite Pathway - New decomposed granite pathway. The walkway slope shall not exceed 5% along the POT and cross slope shall not exceed 2%.	
Additional Comments:

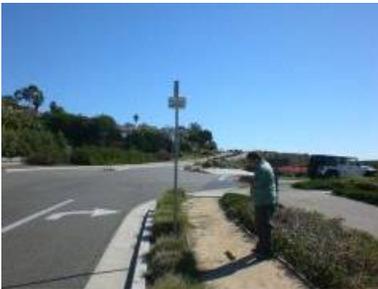
Keynote 2

Field Condition	
02.11A - Bus Stop Pad Size - Bus stop pad does not measure 8' long (measured from the curb or vehicle roadway edge) by 5' wide (measured parallel to the vehicle roadway).	1991 ADAAG 10.2.1
Existing Condition: Bus pad 3'-6" long by 5' wide.	2004 ADAAG 810.2.2
	2007 CBC 1121B.1
	Other

Classification	
DOJ Location Type:	1
Use:	PV
Severity:	C
Level of Difficulty	Moderate

Corrective Action	
027 - Site Work - Miscellaneous - See Additional Comments	
Additional Comments: See Keynote 1 for corrective action.

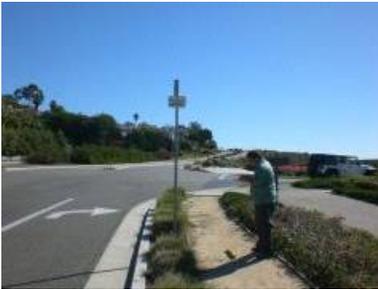
Keynote 3

Field Condition		1991 ADAAG	10.2.1
02.12A - Bus Stop Pad Slope Parallel to Roadway - Bus stop pad is not at the same slope as the roadway in the direction parallel to the roadway.			
Existing Condition: 3.9% RS at bus pad , 3.8% RS at the road.		2004 ADAAG	810.2.4
		2007 CBC	1121B.2.1
		Other

Classification	
DOJ Location Type:	1
Use:	PV
Severity:	C
Level of Difficulty	Moderate

Corrective Action
027 - Site Work - Miscellaneous - See Additional Comments
Additional Comments: See Keynote 1 for corrective action.

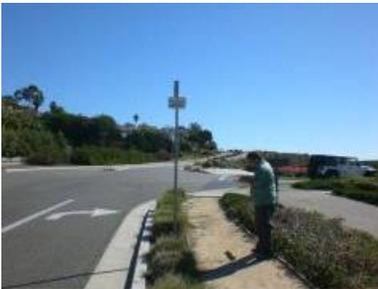
Keynote 4

Field Condition		1991 ADAAG	10.2.1
02.12B - Bus Stop Pad Slope Perpendicular to Roadway - Bus stop pad slope perpendicular to the roadway exceeds 2%.			
Existing Condition: 4.1% CS.		2004 ADAAG	810.2.4
		2007 CBC	1121B.2.1
		Other

Classification	
DOJ Location Type:	1
Use:	PV
Severity:	C
Level of Difficulty	Moderate

Corrective Action
027 - Site Work - Miscellaneous - See Additional Comments
Additional Comments: See Keynote 1 for corrective action.

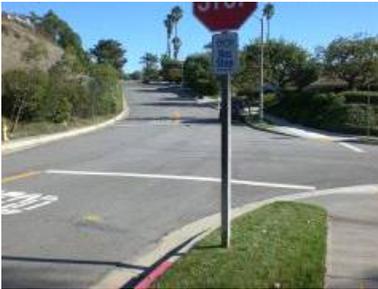
Keynote 5

Field Condition	
02.11B - Bus Stop Pad and Accessible Route - Bus stop pad is not connected to an accessible route.	1991 ADAAG 10.2.1
Existing Condition: No accessible route to bus stop (grass).	2004 ADAAG 810.2.3
	2007 CBC 1121B.1
	Other

Classification	
DOJ Location Type:	1
Use:	PV
Severity:	C
Level of Difficulty	Moderate

Corrective Action
027 - Site Work - Miscellaneous - See Additional Comments
Additional Comments: See Keynote 6 for corrective action.

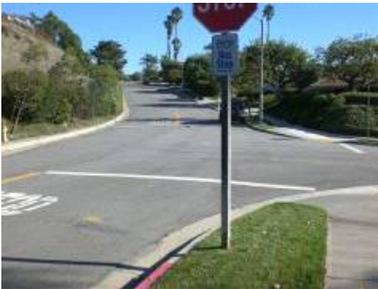
Keynote 6

Field Condition	
02.11A - Bus Stop Pad Size - Bus stop pad does not measure 8' long (measured from the curb or vehicle roadway edge) by 5' wide (measured parallel to the vehicle roadway).	1991 ADAAG 10.2.1
Existing Condition: Bus pad 3'-11" long by 5' wide.	2004 ADAAG 810.2.2
	2007 CBC 1121B.1
	Other

Classification	
DOJ Location Type:	1
Use:	PV
Severity:	C
Level of Difficulty	High

Corrective Action
006 - Concrete Walk - Remove non-compliant pavement and replace with new concrete (area as shown on the drawings). The walkway slope shall not exceed 5% along the POT and cross slope shall not exceed 2%.
Additional Comments:

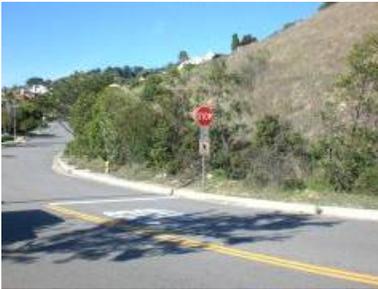
Keynote 7

Field Condition	
02.11A - Bus Stop Pad Size - Bus stop pad does not measure 8' long (measured from the curb or vehicle roadway edge) by 5' wide (measured parallel to the vehicle roadway).	1991 ADAAG 10.2.1
	2004 ADAAG 810.2.2
	2007 CBC 1121B.1
Existing Condition: None provided.	Other

Classification	
DOJ Location Type:	1
Use:	PV
Severity:	C
Level of Difficulty	High

Corrective Action	
006 - Concrete Walk - Remove non-compliant pavement and replace with new concrete (area as shown on the drawings). The walkway slope shall not exceed 5% along the POT and cross slope shall not exceed 2%.	
Additional Comments:

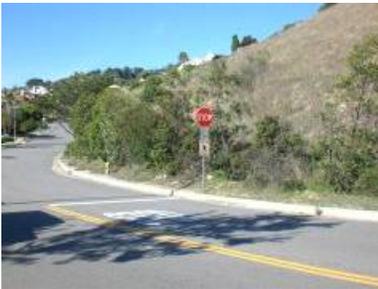
Keynote 8

Field Condition	
02.11B - Bus Stop Pad and Accessible Route - Bus stop pad is not connected to an accessible route.	1991 ADAAG 10.2.1
	2004 ADAAG 810.2.3
	2007 CBC 1121B.1
Existing Condition: No accessible route to bus stop.	Other

Classification	
DOJ Location Type:	1
Use:	PV
Severity:	C
Level of Difficulty	High

Corrective Action	
027 - Site Work - Miscellaneous - See Additional Comments	
Additional Comments: Provide compliant curb ramp.

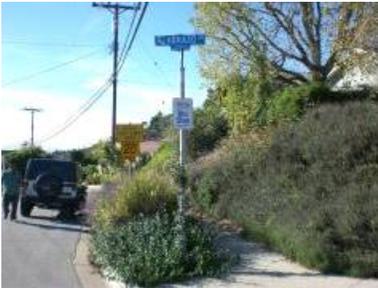
Keynote 9

Field Condition	
02.11B - Bus Stop Pad and Accessible Route - Bus stop pad is not connected to an accessible route.	1991 ADAAG 10.2.1
Existing Condition: No accessible route to bus stop (shrubs).	2004 ADAAG 810.2.3
	2007 CBC 1121B.1
	Other

Classification	
DOJ Location Type:	1
Use:	PV
Severity:	C
Level of Difficulty	Moderate

Corrective Action
027 - Site Work - Miscellaneous - See Additional Comments
Additional Comments: See Keynote 11 for corrective action.

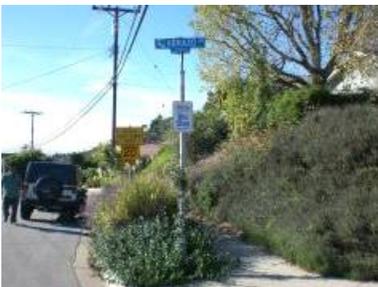
Keynote 10

Field Condition	
02.11A - Bus Stop Pad Size - Bus stop pad does not measure 8' long (measured from the curb or vehicle roadway edge) by 5' wide (measured parallel to the vehicle roadway).	1991 ADAAG 10.2.1
Existing Condition: Bus pad 4' long by 5' wide.	2004 ADAAG 810.2.2
	2007 CBC 1121B.1
	Other

Classification	
DOJ Location Type:	1
Use:	PV
Severity:	C
Level of Difficulty	High

Corrective Action
027 - Site Work - Miscellaneous - See Additional Comments
Additional Comments: See Keynote 11 for corrective action.

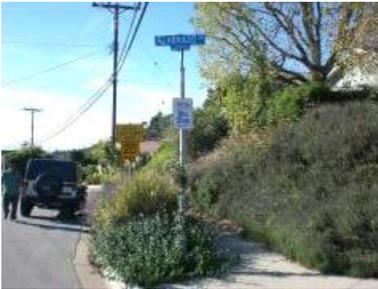
Keynote 11

Field Condition	
02.12A - Bus Stop Pad Slope Parallel to Roadway - Bus stop pad is not at the same slope as the roadway in the direction parallel to the roadway.	1991 ADAAG 10.2.1
Existing Condition: 4.6% RS at bus pad , 5.2% RS at the road.	2004 ADAAG 810.2.4
	2007 CBC 1121B.2.1
	Other

Classification	
DOJ Location Type:	1
Use:	PV
Severity:	C
Level of Difficulty	High

Corrective Action
006 - Concrete Walk - Remove non-compliant pavement and replace with new concrete (area as shown on the drawings). The walkway slope shall not exceed 5% along the POT and cross slope shall not exceed 2%.
Additional Comments:

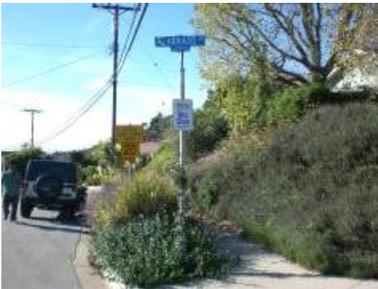
Keynote 12

Field Condition	
02.12B - Bus Stop Pad Slope Perpendicular to Roadway - Bus stop pad slope perpendicular to the roadway exceeds 2%.	1991 ADAAG 10.2.1
Existing Condition: 2.1% CS.	2004 ADAAG 810.2.4
	2007 CBC 1121B.2.1
	Other

Classification	
DOJ Location Type:	1
Use:	PV
Severity:	C
Level of Difficulty	Moderate

Corrective Action
027 - Site Work - Miscellaneous - See Additional Comments
Additional Comments: See Keynote 11 for corrective action.

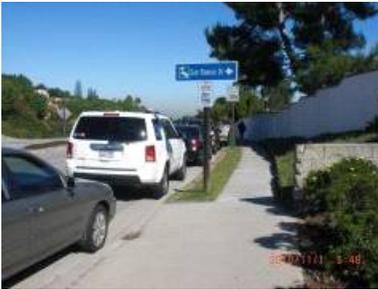
Keynote 13

Field Condition	
02.11A - Bus Stop Pad Size - Bus stop pad does not measure 8' long (measured from the curb or vehicle roadway edge) by 5' wide (measured parallel to the vehicle roadway).	1991 ADAAG 10.2.1
	2004 ADAAG 810.2.2
Existing Condition: 3'-10" long by 5' wide Bus pad	2007 CBC 1121B.1
	Other

Classification	
DOJ Location Type:	1
Use:	PV
Severity:	C
Level of Difficulty	Moderate

Corrective Action
027 - Site Work - Miscellaneous - See Additional Comments
Additional Comments: See Keynote 15 for corrective action.

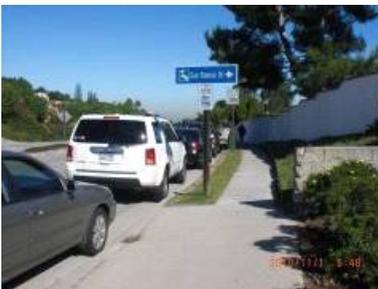
Keynote 14

Field Condition	
02.11B - Bus Stop Pad and Accessible Route - Bus stop pad is not connected to an accessible route.	1991 ADAAG 10.2.1
	2004 ADAAG 810.2.3
Existing Condition: No accessible route to bus stop (grass).	2007 CBC 1121B.1
	Other

Classification	
DOJ Location Type:	1
Use:	PV
Severity:	C
Level of Difficulty	Moderate

Corrective Action
027 - Site Work - Miscellaneous - See Additional Comments
Additional Comments: See Keynote 15 for corrective action.

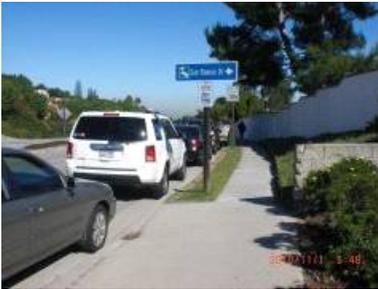
Keynote 15

Field Condition	
02.12B - Bus Stop Pad Slope Perpendicular to Roadway - Bus stop pad slope perpendicular to the roadway exceeds 2%.	1991 ADAAG 10.2.1
Existing Condition: 7.5% CS.	2004 ADAAG 810.2.4
	2007 CBC 1121B.2.1
	Other

Classification	
DOJ Location Type:	1
Use:	PV
Severity:	C
Level of Difficulty	High

Corrective Action	
006 - Concrete Walk - Remove non-compliant pavement and replace with new concrete (area as shown on the drawings). The walkway slope shall not exceed 5% along the POT and cross slope shall not exceed 2%.	
Additional Comments:

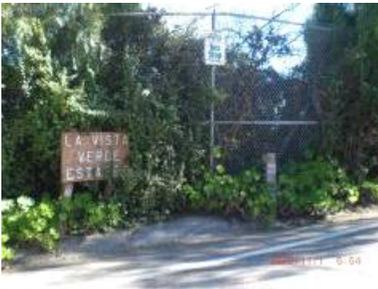
Keynote 16

Field Condition	
02.11A - Bus Stop Pad Size - Bus stop pad does not measure 8' long (measured from the curb or vehicle roadway edge) by 5' wide (measured parallel to the vehicle roadway).	1991 ADAAG 10.2.1
Existing Condition: None provided.	2004 ADAAG 810.2.2
	2007 CBC 1121B.1
	Other

Classification	
DOJ Location Type:	1
Use:	PV
Severity:	C
Level of Difficulty	High

Corrective Action	
006 - Concrete Walk - Remove non-compliant pavement and replace with new concrete (area as shown on the drawings). The walkway slope shall not exceed 5% along the POT and cross slope shall not exceed 2%.	
Additional Comments:

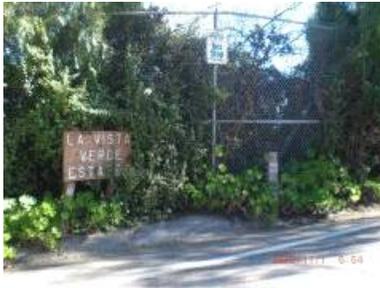
Keynote 17

Field Condition	
02.11B - Bus Stop Pad and Accessible Route - Bus stop pad is not connected to an accessible route.	1991 ADAAG 10.2.1
Existing Condition: No accessible route to bus stop.	2004 ADAAG 810.2.3
	2007 CBC 1121B.1
	Other

Classification	
DOJ Location Type:	1
Use:	PV
Severity:	C
Level of Difficulty	Moderate to High

Corrective Action
001A - Accessible Route - Provide new accessible route.
Additional Comments:

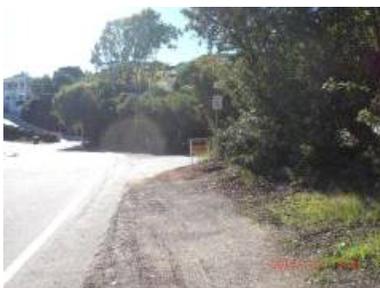
Keynote 18

Field Condition	
02.11A - Bus Stop Pad Size - Bus stop pad does not measure 8' long (measured from the curb or vehicle roadway edge) by 5' wide (measured parallel to the vehicle roadway).	1991 ADAAG 10.2.1
Existing Condition: None provided.	2004 ADAAG 810.2.2
	2007 CBC 1121B.1
	Other

Classification	
DOJ Location Type:	1
Use:	PV
Severity:	C
Level of Difficulty	High

Corrective Action
006 - Concrete Walk - Remove non-compliant pavement and replace with new concrete (area as shown on the drawings). The walkway slope shall not exceed 5% along the POT and cross slope shall not exceed 2%.
Additional Comments:

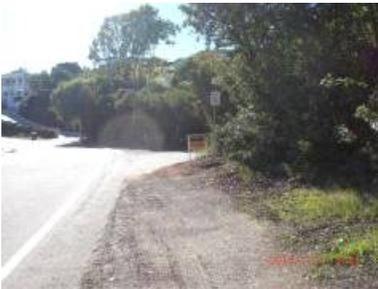
Keynote 19

Field Condition		
02.11B - Bus Stop Pad and Accessible Route - Bus stop pad is not connected to an accessible route.	1991 ADAAG	10.2.1
Existing Condition: No accessible route to bus stop.	2004 ADAAG	810.2.3
	2007 CBC	1121B.1
	Other

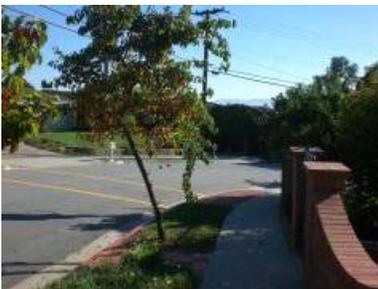
Keynote 20

Field Condition		
02.11A - Bus Stop Pad Size - Bus stop pad does not measure 8' long (measured from the curb or vehicle roadway edge) by 5' wide (measured parallel to the vehicle roadway).	1991 ADAAG	10.2.1
Existing Condition: Not provided.	2004 ADAAG	810.2.2
	2007 CBC	1121B.1
	Other

Corrective Action
008 - Concrete Landing - Remove non-compliant pavement and replace with new concrete. The landing slope shall not exceed 2% in any direction.
Additional Comments:

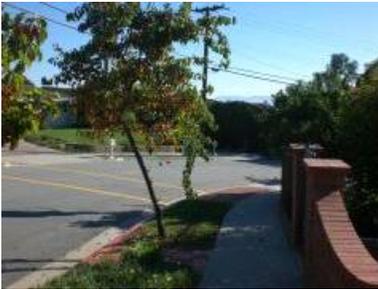
Keynote 21

Field Condition	
02.11B - Bus Stop Pad and Accessible Route - Bus stop pad is not connected to an accessible route.	1991 ADAAG 10.2.1
Existing Condition:	2004 ADAAG 810.2.3
	2007 CBC 1121B.1
	Other

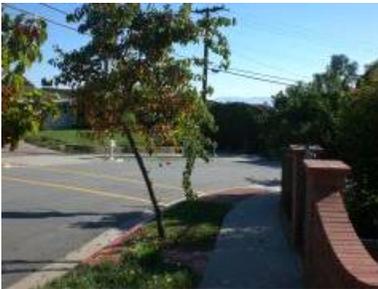
Keynote 22

Field Condition	
02.12A - Bus Stop Pad Slope Parallel to Roadway - Bus stop pad is not at the same slope as the roadway in the direction parallel to the roadway.	1991 ADAAG 10.2.1
Existing Condition: 12% slope parallel to road.	2004 ADAAG 810.2.4
	2007 CBC 1121B.2.1
	Other

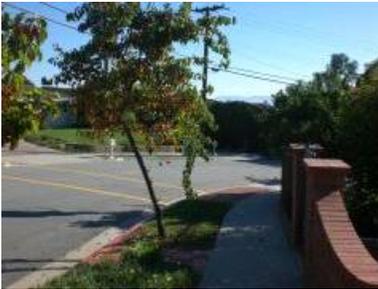
Keynote 23

Field Condition		1991 ADAAG	10.2.1
02.12B - Bus Stop Pad Slope Perpendicular to Roadway - Bus stop pad slope perpendicular to the roadway exceeds 2%.			
Existing Condition: 3.7% slope perpendicular to road.		2004 ADAAG	810.2.4
		2007 CBC	1121B.2.1
		Other

Classification	
DOJ Location Type:	1
Use:	PV
Severity:	C
Level of Difficulty	Moderate

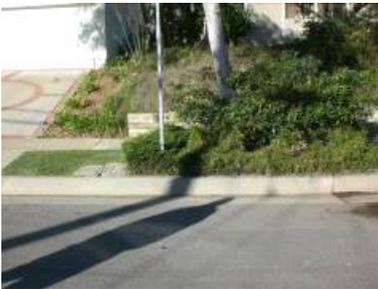
Keynote 24

Field Condition		1991 ADAAG	10.2.1
02.11A - Bus Stop Pad Size - Bus stop pad does not measure 8' long (measured from the curb or vehicle roadway edge) by 5' wide (measured parallel to the vehicle roadway).			
Existing Condition: Not Provided.		2004 ADAAG	810.2.2
		2007 CBC	1121B.1
		Other

Classification	
DOJ Location Type:	1
Use:	PV
Severity:	C
Level of Difficulty	High

Corrective Action	
008 - Concrete Landing - Remove non-compliant pavement and replace with new concrete. The landing slope shall not exceed 2% in any direction.	
Additional Comments:

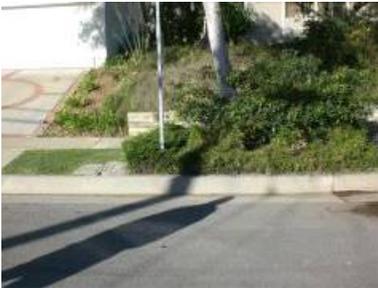
Keynote 25

Field Condition	
02.11B - Bus Stop Pad and Accessible Route - Bus stop pad is not connected to an accessible route.	1991 ADAAG 10.2.1
Existing Condition:	2004 ADAAG 810.2.3
	2007 CBC 1121B.1
	Other

Classification	
DOJ Location Type:	1
Use:	PV
Severity:	C
Level of Difficulty	Moderate

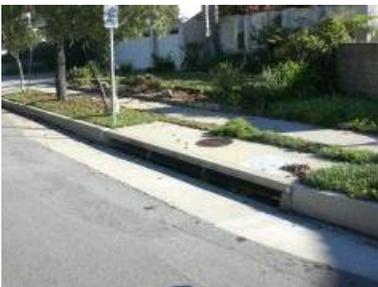
Keynote 26

Field Condition	
02.11A - Bus Stop Pad Size - Bus stop pad does not measure 8' long (measured from the curb or vehicle roadway edge) by 5' wide (measured parallel to the vehicle roadway).	1991 ADAAG 10.2.1
Existing Condition: Not provided.	2004 ADAAG 810.2.2
	2007 CBC 1121B.1
	Other

Classification	
DOJ Location Type:	1
Use:	PV
Severity:	C
Level of Difficulty	High

Corrective Action	
008 - Concrete Landing - Remove non-compliant pavement and replace with new concrete. The landing slope shall not exceed 2% in any direction.	
Additional Comments:

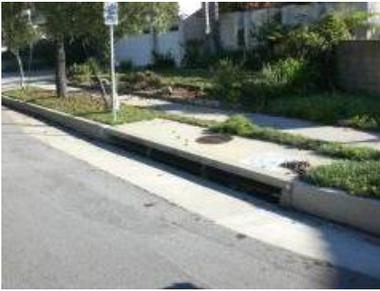
Keynote 27

Field Condition	
02.11B - Bus Stop Pad and Accessible Route - Bus stop pad is not connected to an accessible route.	1991 ADAAG 10.2.1
Existing Condition:	2004 ADAAG 810.2.3
	2007 CBC 1121B.1
	Other

Classification	
DOJ Location Type:	1
Use:	PV
Severity:	C
Level of Difficulty	Moderate

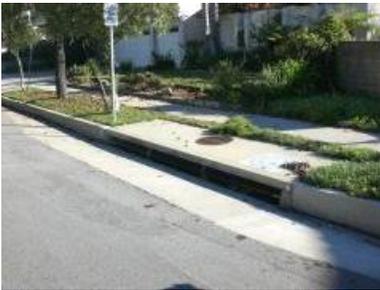
Keynote 28

Field Condition	
02.12A - Bus Stop Pad Slope Parallel to Roadway - Bus stop pad is not at the same slope as the roadway in the direction parallel to the roadway.	1991 ADAAG 10.2.1
Existing Condition: 1.2% slope parallel to road.	2004 ADAAG 810.2.4
	2007 CBC 1121B.2.1
	Other

Classification	
DOJ Location Type:	1
Use:	PV
Severity:	C
Level of Difficulty	Moderate

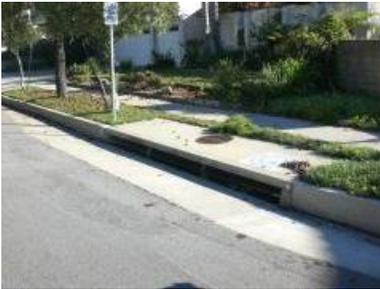
Keynote 29

Field Condition	
02.12B - Bus Stop Pad Slope Perpendicular to Roadway - Bus stop pad slope perpendicular to the roadway exceeds 2%.	1991 ADAAG 10.2.1
Existing Condition: 3.5% slope perpendicular to road.	2004 ADAAG 810.2.4
	2007 CBC 1121B.2.1
	Other

Classification	
DOJ Location Type:	1
Use:	PV
Severity:	C
Level of Difficulty	Moderate
