City of Rancho Palos Verdes
 Rancho Palos Verdes ADA Assessment
 Facility Report with Photos

Facility ID: # Area 8 Bus Stops

Author: Vaish, B

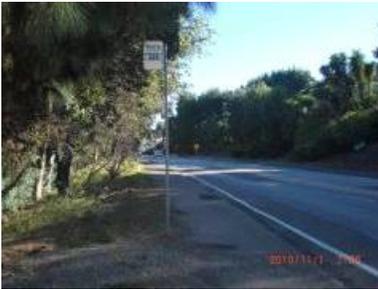
Keynote 1

Field Condition	
02.11A - Bus Stop Pad Size - Bus stop pad does not measure 8' long (measured from the curb or vehicle roadway edge) by 5' wide (measured parallel to the vehicle roadway).	1991 ADAAG 10.2.1
	2004 ADAAG 810.2.2
	2007 CBC 1121B.1
Existing Condition: None provided.	Other

Classification	
DOJ Location Type:	1
Use:	PV
Severity:	C
Level of Difficulty	High

Corrective Action	
006 - Concrete Walk - Remove non-compliant pavement and replace with new concrete (area as shown on the drawings). The walkway slope shall not exceed 5% along the POT and cross slope shall not exceed 2%.	
Additional Comments:

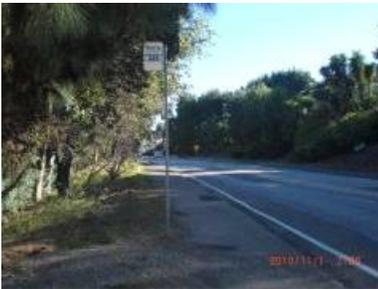
Keynote 2

Field Condition	
02.11B - Bus Stop Pad and Accessible Route - Bus stop pad is not connected to an accessible route.	1991 ADAAG 10.2.1
	2004 ADAAG 810.2.3
	2007 CBC 1121B.1
Existing Condition: No accessible route to bus stop.	Other

Classification	
DOJ Location Type:	1
Use:	PV
Severity:	C
Level of Difficulty	Moderate to High

Corrective Action	
001A - Accessible Route - Provide new accessible route.	
Additional Comments:

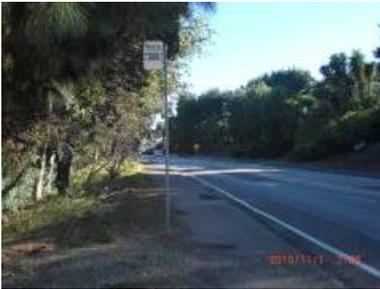
Keynote 3

02.16 - Hazardous Vehicular Area - Where a walk crosses or adjoins the vehicular way and the walking surface is not separated by curbs, railings, or other elements between the pedestrian areas and vehicular areas, the boundary between the areas is not defined by a continuous detectable warning at least 36" wide complying with CBC 1121B.3.1 item 8(a). (i.e., the warning surface shall contrast visually with adjoining surfaces, either light on dark or dark on light, and shall differ from adjoining walking surfaces in resiliency or sound on cane contact. Color: yellow conforming to Federal Color No. 33538, Table IV/ Standard No. 595B. Where the color value contrast between the yellow warning and the main walking surface is less than 70 percent, a 1" wide black strip shall separate the yellow warning from the main walking surface.)

Existing Condition: No boundary between shoulder and road.

1991 ADAAG	4.29.5
2004 ADAAG	-
2007 CBC	1133B.8.5
Other

DOJ Location Type:	1
Use:	PV
Severity:	C
Level of Difficulty	Moderate

027 - Site Work - Miscellaneous - See Additional Comments
 Additional Comments: See Keynote 2 for corrective action.

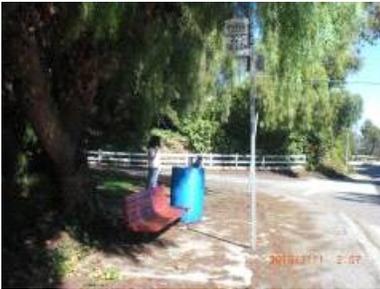
Keynote 4

Field Condition	
02.17 - Other - Passenger Loading Zones - See Additional Comments	1991 ADAAG -
Existing Condition: Bench (12" high seat, 14" deep seat, 14" high back support).	2004 ADAAG -
	2007 CBC -
	Other

Classification	
DOJ Location Type:	1
Use:	PV
Severity:	E
Level of Difficulty	Moderate

Corrective Action
027 - Site Work - Miscellaneous - See Additional Comments
Additional Comments: Provide compliant bench with clear WC seating space.

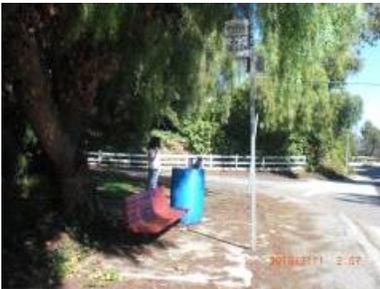
Keynote 5

Field Condition	
02.11A - Bus Stop Pad Size - Bus stop pad does not measure 8' long (measured from the curb or vehicle roadway edge) by 5' wide (measured parallel to the vehicle roadway).	1991 ADAAG 10.2.1
Existing Condition: Bus pad 8' long by 3'-2" wide.	2004 ADAAG 810.2.2
	2007 CBC 1121B.1
	Other

Classification	
DOJ Location Type:	1
Use:	PV
Severity:	C
Level of Difficulty	High

Corrective Action
006 - Concrete Walk - Remove non-compliant pavement and replace with new concrete (area as shown on the drawings). The walkway slope shall not exceed 5% along the POT and cross slope shall not exceed 2%.
Additional Comments:

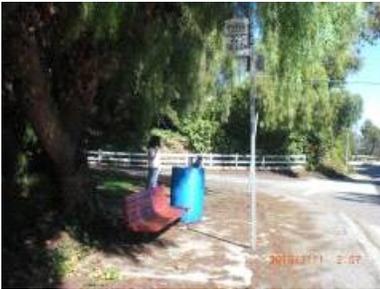
Keynote 6

Field Condition	
02.11B - Bus Stop Pad and Accessible Route - Bus stop pad is not connected to an accessible route.	1991 ADAAG 10.2.1
Existing Condition: No accessible route to bus stop.	2004 ADAAG 810.2.3
	2007 CBC 1121B.1
	Other

Classification	
DOJ Location Type:	1
Use:	PV
Severity:	C
Level of Difficulty	Moderate to High

Corrective Action
001A - Accessible Route - Provide new accessible route.
Additional Comments:

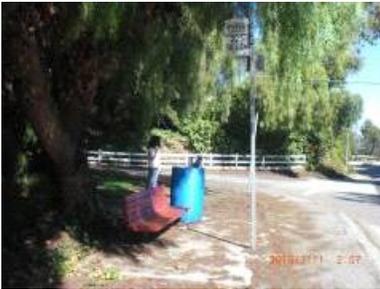
Keynote 7

02.16 - Hazardous Vehicular Area - Where a walk crosses or adjoins the vehicular way and the walking surface is not separated by curbs, railings, or other elements between the pedestrian areas and vehicular areas, the boundary between the areas is not defined by a continuous detectable warning at least 36" wide complying with CBC 1121B.3.1 item 8(a). (i.e., the warning surface shall contrast visually with adjoining surfaces, either light on dark or dark on light, and shall differ from adjoining walking surfaces in resiliency or sound on cane contact. Color: yellow conforming to Federal Color No. 33538, Table IV/ Standard No. 595B. Where the color value contrast between the yellow warning and the main walking surface is less than 70 percent, a 1" wide black strip shall separate the yellow warning from the main walking surface.)

1991 ADAAG	4.29.5
2004 ADAAG	-
2007 CBC	1133B.8.5
Other

Existing Condition: No boundary from bus stop to road.

DOJ Location Type:	1
Use:	PV
Severity:	C
Level of Difficulty	Moderate

027 - Site Work - Miscellaneous - See Additional Comments
 Additional Comments: See Keynote 6 for corrective action.

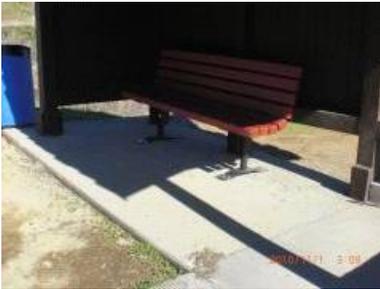
Keynote 8

Field Condition	
02.17 - Other - Passenger Loading Zones - See Additional Comments	1991 ADAAG -
Existing Condition: Bench (15" deep seat, 5" shoulder alignment).	2004 ADAAG -
	2007 CBC -
	Other

Classification	
DOJ Location Type:	1
Use:	PV
Severity:	E
Level of Difficulty	Moderate

Corrective Action	
027 - Site Work - Miscellaneous - See Additional Comments	
Additional Comments: Provide compliant bench and relocate to allow 12" shoulder alignment.

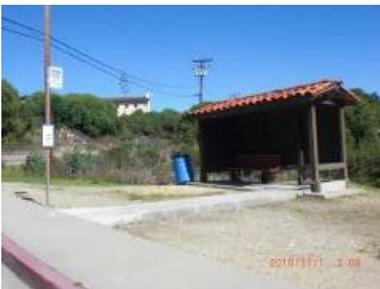
Keynote 9

Field Condition	
02.11A - Bus Stop Pad Size - Bus stop pad does not measure 8' long (measured from the curb or vehicle roadway edge) by 5' wide (measured parallel to the vehicle roadway).	1991 ADAAG 10.2.1
Existing Condition: Bus pad 8' long by 4' wide.	2004 ADAAG 810.2.2
	2007 CBC 1121B.1
	Other

Classification	
DOJ Location Type:	1
Use:	PV
Severity:	C
Level of Difficulty	High

Corrective Action	
006 - Concrete Walk - Remove non-compliant pavement and replace with new concrete (area as shown on the drawings). The walkway slope shall not exceed 5% along the POT and cross slope shall not exceed 2%.	
Additional Comments:

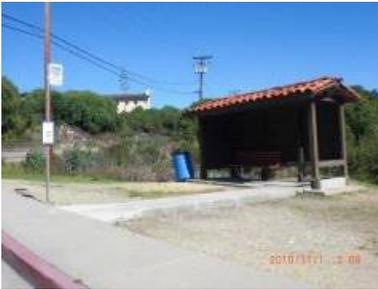
Keynote 10

Field Condition	
02.17 - Other - Passenger Loading Zones - See Additional Comments	1991 ADAAG -
Existing Condition: 7" drop.	2004 ADAAG -
	2007 CBC -
	Other

Classification	
DOJ Location Type:	1
Use:	PV
Severity:	C
Level of Difficulty	High

Corrective Action	
012 - Concrete Curb - Saw-cut concrete curb and remove. Grind all edges smooth so adjacent floor surfaces align flush.	
Additional Comments:

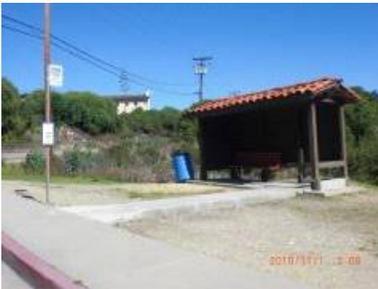
Keynote 11

Field Condition	
02.12B - Bus Stop Pad Slope Perpendicular to Roadway - Bus stop pad slope perpendicular to the roadway exceeds 2%.	1991 ADAAG 10.2.1
Existing Condition: 2.3% CS.	2004 ADAAG 810.2.4
	2007 CBC 1121B.2.1
	Other

Classification	
DOJ Location Type:	1
Use:	PV
Severity:	C
Level of Difficulty	High

Corrective Action	
006 - Concrete Walk - Remove non-compliant pavement and replace with new concrete (area as shown on the drawings). The walkway slope shall not exceed 5% along the POT and cross slope shall not exceed 2%.	
Additional Comments:

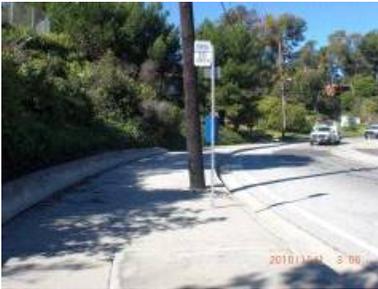
Keynote 12

Field Condition	
02.12A - Bus Stop Pad Slope Parallel to Roadway - Bus stop pad is not at the same slope as the roadway in the direction parallel to the roadway.	1991 ADAAG 10.2.1
Existing Condition: 4.9% RS at bus pad , 3.8% RS at the road.	2004 ADAAG 810.2.4
	2007 CBC 1121B.2.1
	Other

Classification	
DOJ Location Type:	1
Use:	PV
Severity:	C
Level of Difficulty	High

Corrective Action
006 - Concrete Walk - Remove non-compliant pavement and replace with new concrete (area as shown on the drawings). The walkway slope shall not exceed 5% along the POT and cross slope shall not exceed 2%.
Additional Comments:

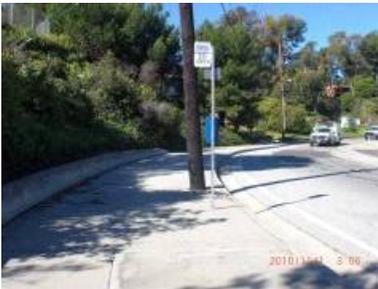
Keynote 13

Field Condition	
02.12B - Bus Stop Pad Slope Perpendicular to Roadway - Bus stop pad slope perpendicular to the roadway exceeds 2%.	1991 ADAAG 10.2.1
Existing Condition: 2.3% CS.	2004 ADAAG 810.2.4
	2007 CBC 1121B.2.1
	Other

Classification	
DOJ Location Type:	1
Use:	PV
Severity:	C
Level of Difficulty	Moderate

Corrective Action
027 - Site Work - Miscellaneous - See Additional Comments
Additional Comments: See Keynote 12 for corrective action.

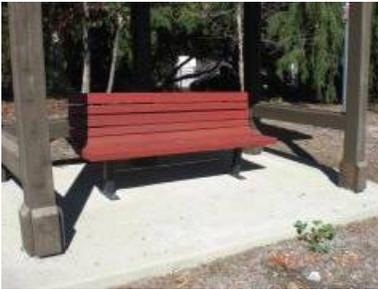
Keynote 14

Field Condition	
02.17 - Other - Passenger Loading Zones - See Additional Comments	1991 ADAAG -
Existing Condition: Bench (16" high seat, 15 1/2" deep seat, 15 1/2" high back support).	2004 ADAAG -
	2007 CBC -
	Other

Classification	
DOJ Location Type:	1
Use:	PV
Severity:	E
Level of Difficulty	Moderate

Corrective Action
027 - Site Work - Miscellaneous - See Additional Comments
Additional Comments: Provide compliant bench with clear WC seating space.

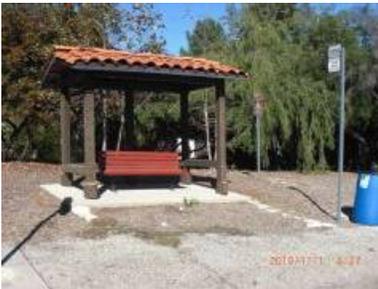
Keynote 15

Field Condition	
02.11A - Bus Stop Pad Size - Bus stop pad does not measure 8' long (measured from the curb or vehicle roadway edge) by 5' wide (measured parallel to the vehicle roadway).	1991 ADAAG 10.2.1
Existing Condition: None provided.	2004 ADAAG 810.2.2
	2007 CBC 1121B.1
	Other

Classification	
DOJ Location Type:	1
Use:	PV
Severity:	C
Level of Difficulty	High

Corrective Action
006 - Concrete Walk - Remove non-compliant pavement and replace with new concrete (area as shown on the drawings). The walkway slope shall not exceed 5% along the POT and cross slope shall not exceed 2%.
Additional Comments:

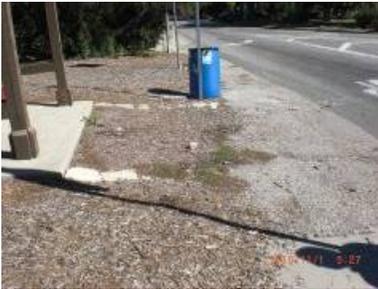
Keynote 16

Field Condition		1991 ADAAG	10.2.1
02.11B - Bus Stop Pad and Accessible Route - Bus stop pad is not connected to an accessible route.			
Existing Condition: No accessible route to bus stop.		2004 ADAAG	810.2.3
		2007 CBC	1121B.1
		Other

Classification	
DOJ Location Type:	1
Use:	PV
Severity:	C
Level of Difficulty	Moderate to High

Corrective Action	
001A - Accessible Route - Provide new accessible route.	
Additional Comments:

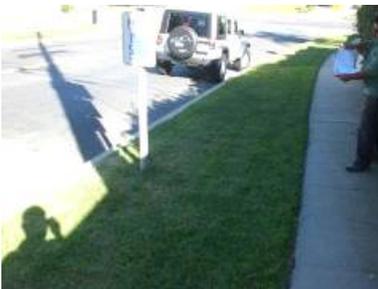
Keynote 17

Field Condition		1991 ADAAG	10.2.1
02.11A - Bus Stop Pad Size - Bus stop pad does not measure 8' long (measured from the curb or vehicle roadway edge) by 5' wide (measured parallel to the vehicle roadway).			
Existing Condition: Bus pad 4' long by 5' wide.		2004 ADAAG	810.2.2
		2007 CBC	1121B.1
		Other

Classification	
DOJ Location Type:	1
Use:	PV
Severity:	C
Level of Difficulty	High

Corrective Action	
006 - Concrete Walk - Remove non-compliant pavement and replace with new concrete (area as shown on the drawings). The walkway slope shall not exceed 5% along the POT and cross slope shall not exceed 2%.	
Additional Comments:

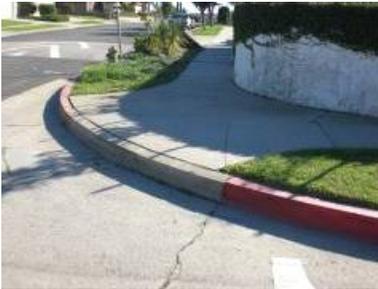
Keynote 18

Field Condition	
02.11B - Bus Stop Pad and Accessible Route - Bus stop pad is not connected to an accessible route.	1991 ADAAG 10.2.1
Existing Condition: No accessible route to bus stop.	2004 ADAAG 810.2.3
	2007 CBC 1121B.1
	Other

Classification	
DOJ Location Type:	1
Use:	PV
Severity:	C
Level of Difficulty	Moderate

Corrective Action	
027 - Site Work - Miscellaneous - See Additional Comments	
Additional Comments: Provide compliant curb ramp.

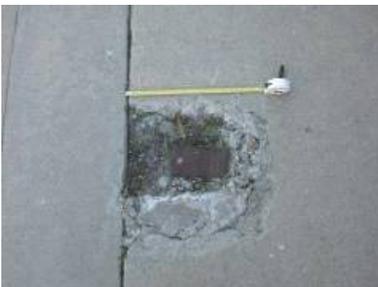
Keynote 19

Field Condition	
02.17 - Other - Passenger Loading Zones - See Additional Comments	1991 ADAAG -
Existing Condition: Uneven surface at bus stop.	2004 ADAAG -
	2007 CBC -
	Other

Classification	
DOJ Location Type:	1
Use:	PV
Severity:	C
Level of Difficulty	High

Corrective Action	
006 - Concrete Walk - Remove non-compliant pavement and replace with new concrete (area as shown on the drawings). The walkway slope shall not exceed 5% along the POT and cross slope shall not exceed 2%.	
Additional Comments:

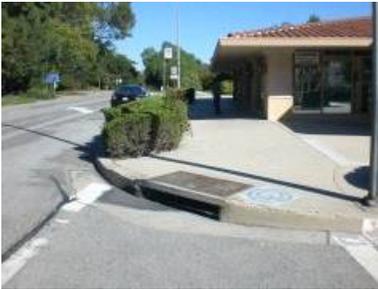
Keynote 20

Field Condition	
02.11B - Bus Stop Pad and Accessible Route - Bus stop pad is not connected to an accessible route.	1991 ADAAG 10.2.1
Existing Condition: No accessible route to bus stop.	2004 ADAAG 810.2.3
	2007 CBC 1121B.1
	Other

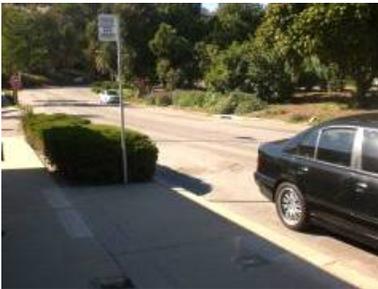
Keynote 21

Field Condition	
02.17 - Other - Passenger Loading Zones - See Additional Comments	1991 ADAAG -
Existing Condition: Car obstructs access to bus stop.	2004 ADAAG -
	2007 CBC -
	Other

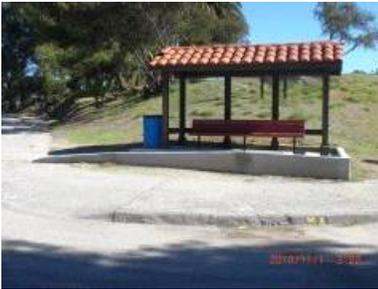
Keynote 22

Existing Condition: Bench (14" deep seat, 16" high back support).

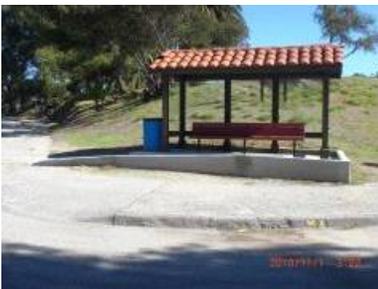
Keynote 23

Existing Condition: No WC space provided within the shelter.

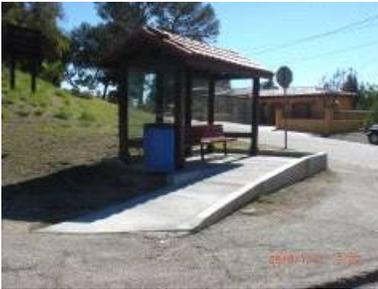
Keynote 24

Field Condition	
02.17 - Other - Passenger Loading Zones - See Additional Comments	1991 ADAAG -
Existing Condition: 5 1/2" drop	2004 ADAAG -
	2007 CBC -
	Other

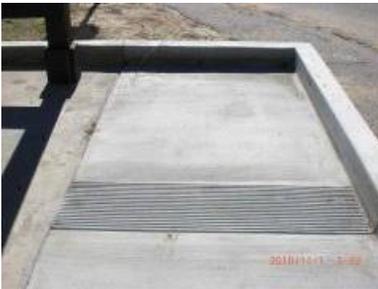
Keynote 25

Field Condition	
07.07A - Level Landings - Landings at the top or bottom of each ramp or each ramp run is not level (slope is greater than 2% in some or all directions).	1991 ADAAG 4.8.4
Existing Condition: 3.6% slope at top ramp landing.	2004 ADAAG 405.7; 405.7.1
	2007 CBC 1133B.5.4.1
	Other -

Corrective Action
008 - Concrete Landing - Remove non-compliant pavement and replace with new concrete. The landing slope shall not exceed 2% in any direction.
Additional Comments:

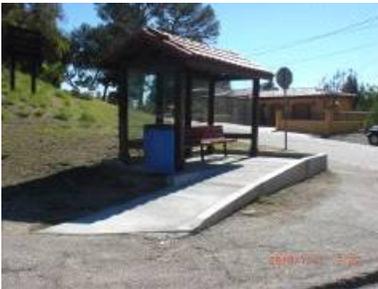
Keynote 26

Field Condition	
02.17 - Other - Passenger Loading Zones - See Additional Comments	1991 ADAAG -
Existing Condition: Uneven surface.	2004 ADAAG -
	2007 CBC -
	Other

Classification	
DOJ Location Type:	1
Use:	PV
Severity:	C
Level of Difficulty	Moderate to High

Corrective Action
004A - Asphalt Paving - Remove non-compliant pavement and replace with new asphalt paving (area as shown on the drawings). The walkway slope shall not exceed 5% along the POT and cross slope shall not exceed 2%.
Additional Comments:

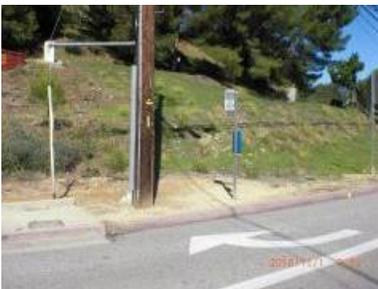
Keynote 27

Field Condition	
02.11A - Bus Stop Pad Size - Bus stop pad does not measure 8' long (measured from the curb or vehicle roadway edge) by 5' wide (measured parallel to the vehicle roadway).	1991 ADAAG 10.2.1
Existing Condition: None provided.	2004 ADAAG 810.2.2
	2007 CBC 1121B.1
	Other

Classification	
DOJ Location Type:	1
Use:	PV
Severity:	C
Level of Difficulty	High

Corrective Action
006 - Concrete Walk - Remove non-compliant pavement and replace with new concrete (area as shown on the drawings). The walkway slope shall not exceed 5% along the POT and cross slope shall not exceed 2%.
Additional Comments:

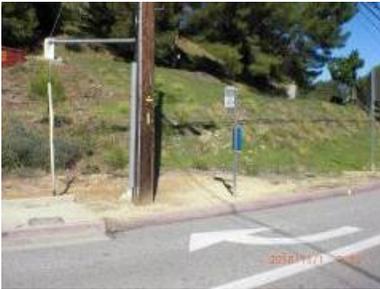
Keynote 28

Field Condition	
02.11B - Bus Stop Pad and Accessible Route - Bus stop pad is not connected to an accessible route.	1991 ADAAG 10.2.1
Existing Condition: No accessible route to bus stop.	2004 ADAAG 810.2.3
	2007 CBC 1121B.1
	Other

Classification	
DOJ Location Type:	1
Use:	PV
Severity:	C
Level of Difficulty	Moderate to High
