City of Rancho Palos Verdes
Rancho Palos Verdes ADA Assessment
Facility Report with Photos

Facility ID: # Area 9 Bus Stops

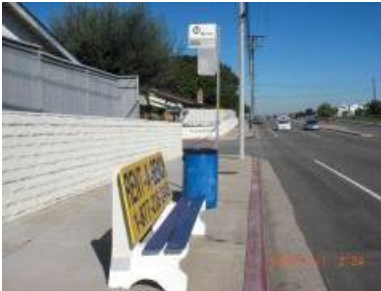
Keynote 1

Field Condition	
02.17 - Other - Passenger Loading Zones - See Additional Comments	1991 ADAAG -
Existing Condition: Bench (15 1/2" deep seat).	2004 ADAAG -
	2007 CBC -
	Other

Corrective Action
027 - Site Work - Miscellaneous - See Additional Comments
Additional Comments: Provide compliant bench.

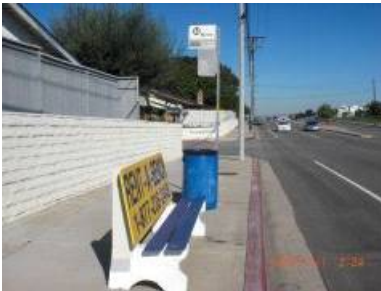
Keynote 2

Field Condition	
02.12B - Bus Stop Pad Slope Perpendicular to Roadway - Bus stop pad slope perpendicular to the roadway exceeds 2%.	1991 ADAAG 10.2.1
Existing Condition: 4.3% to 4.7% CS.	2004 ADAAG 810.2.4
	2007 CBC 1121B.2.1
	Other

Corrective Action
006 - Concrete Walk - Remove non-compliant pavement and replace with new concrete (area as shown on the drawings). The walkway slope shall not exceed 5% along the POT and cross slope shall not exceed 2%.
Additional Comments:

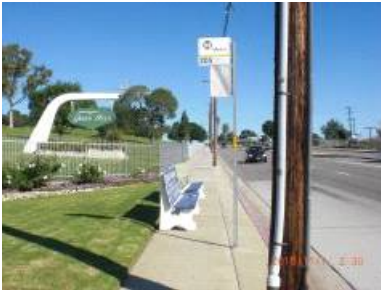
Keynote 3

Field Condition	
02.17 - Other - Passenger Loading Zones - See Additional Comments	1991 ADAAG -
Existing Condition: Bench (16" deep seat).	2004 ADAAG -
	2007 CBC -
	Other

Corrective Action
027 - Site Work - Miscellaneous - See Additional Comments
Additional Comments: Provide compliant bench.

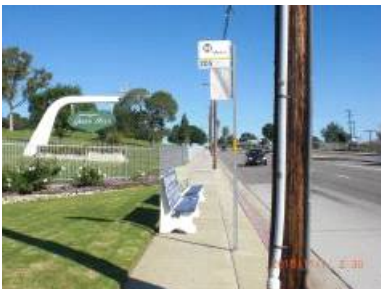
Keynote 4

Field Condition	
02.12A - Bus Stop Pad Slope Parallel to Roadway - Bus stop pad is not at the same slope as the roadway in the direction parallel to the roadway.	1991 ADAAG 10.2.1
Existing Condition: 4.4% to 5.2% RS at bus pad, 4.8% to 5.3% RS at the road.	2004 ADAAG 810.2.4
	2007 CBC 1121B.2.1
	Other

Corrective Action
027 - Site Work - Miscellaneous - See Additional Comments
Additional Comments: See Keynote 5 for corrective action.

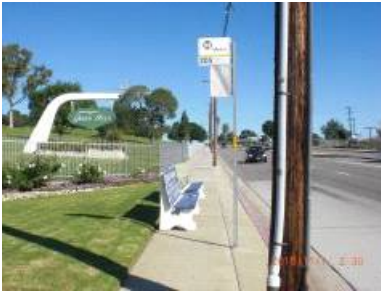
Keynote 5

Field Condition	
02.12B - Bus Stop Pad Slope Perpendicular to Roadway - Bus stop pad slope perpendicular to the roadway exceeds 2%.	1991 ADAAG 10.2.1
Existing Condition: 10.6% to 12.4% CS.	2004 ADAAG 810.2.4
	2007 CBC 1121B.2.1
	Other

Corrective Action
006 - Concrete Walk - Remove non-compliant pavement and replace with new concrete (area as shown on the drawings). The walkway slope shall not exceed 5% along the POT and cross slope shall not exceed 2%.
Additional Comments:

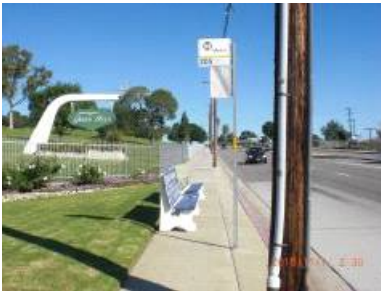
Keynote 6

Field Condition	
02.11A - Bus Stop Pad Size - Bus stop pad does not measure 8' long (measured from the curb or vehicle roadway edge) by 5' wide (measured parallel to the vehicle roadway).	1991 ADAAG 10.2.1
Existing Condition: Bus pad 6' long by 5' wide.	2004 ADAAG 810.2.2
	2007 CBC 1121B.1
	Other

Corrective Action
027 - Site Work - Miscellaneous - See Additional Comments
Additional Comments: See Keynote 5 for corrective action.

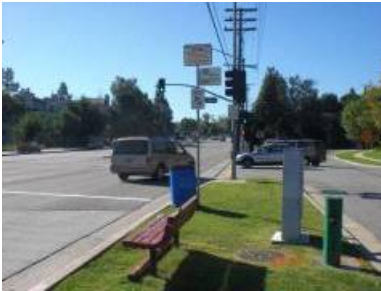
Keynote 7

Field Condition	
02.17 - Other - Passenger Loading Zones - See Additional Comments	1991 ADAAG -
Existing Condition: Bench (16" high seat, 14" deep seat, 12" high back support).	2004 ADAAG -
	2007 CBC -
	Other

Corrective Action
027 - Site Work - Miscellaneous - See Additional Comments
Additional Comments: Provide compliant bench.

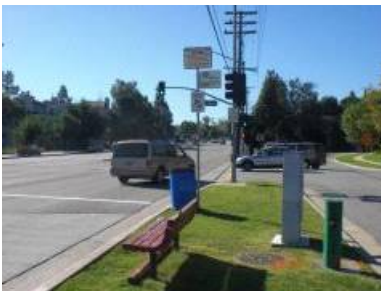
Keynote 8

Field Condition	
02.11B - Bus Stop Pad and Accessible Route - Bus stop pad is not connected to an accessible route.	1991 ADAAG 10.2.1
Existing Condition: No accessible route to bus stop.	2004 ADAAG 810.2.3
	2007 CBC 1121B.1
	Other

Corrective Action
001A - Accessible Route - Provide new accessible route.
Additional Comments:

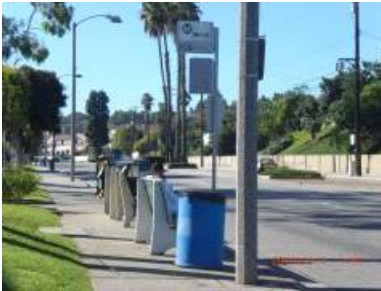
Keynote 9

Field Condition	
02.17 - Other - Passenger Loading Zones - See Additional Comments	1991 ADAAG -
Existing Condition: Bench (17" deep seat) 3 benches, 0 accessible.	2004 ADAAG -
	2007 CBC -
	Other

Corrective Action
027 - Site Work - Miscellaneous - See Additional Comments
Additional Comments: Provide compliant bench.

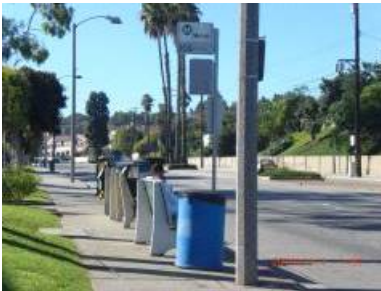
Keynote 10

Field Condition	
02.11A - Bus Stop Pad Size - Bus stop pad does not measure 8' long (measured from the curb or vehicle roadway edge) by 5' wide (measured parallel to the vehicle roadway).	1991 ADAAG 10.2.1
Existing Condition: Bus pad 7' long by 5' wide.	2004 ADAAG 810.2.2
	2007 CBC 1121B.1
	Other

Corrective Action
027 - Site Work - Miscellaneous - See Additional Comments
Additional Comments: See Keynote 11 for corrective action.

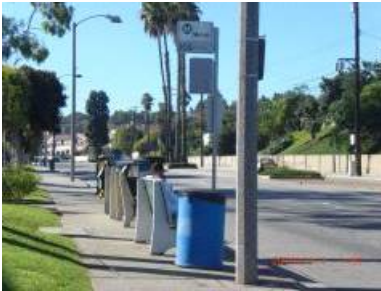
Keynote 11

Field Condition	
02.12B - Bus Stop Pad Slope Perpendicular to Roadway - Bus stop pad slope perpendicular to the roadway exceeds 2%.	1991 ADAAG 10.2.1
Existing Condition: 2.4% to 3.8% CS.	2004 ADAAG 810.2.4
	2007 CBC 1121B.2.1
	Other

Corrective Action	
006 - Concrete Walk - Remove non-compliant pavement and replace with new concrete (area as shown on the drawings). The walkway slope shall not exceed 5% along the POT and cross slope shall not exceed 2%.	
Additional Comments:

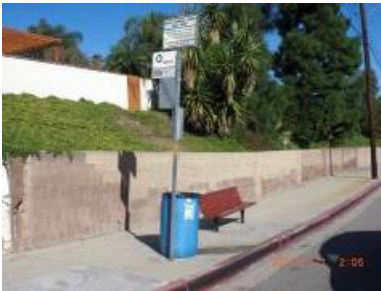
Keynote 12

Field Condition	
02.17 - Other - Passenger Loading Zones - See Additional Comments	1991 ADAAG -
Existing Condition: Bench (16" high seat, 14" deep seat, 14" high back support).	2004 ADAAG -
	2007 CBC -
	Other

Corrective Action	
027 - Site Work - Miscellaneous - See Additional Comments	
Additional Comments: Provide compliant bench.

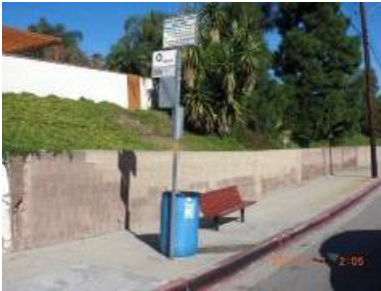
Keynote 13

Field Condition	
02.12A - Bus Stop Pad Slope Parallel to Roadway - Bus stop pad is not at the same slope as the roadway in the direction parallel to the roadway.	1991 ADAAG 10.2.1
Existing Condition: 3.1% to 4.3% RS at bus pad.	2004 ADAAG 810.2.4
	2007 CBC 1121B.2.1
	Other

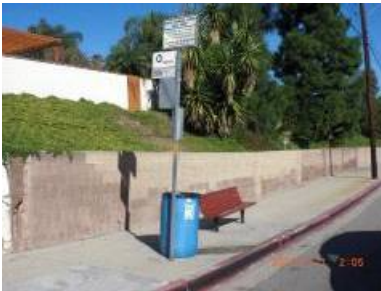
Keynote 14

Field Condition	
02.12B - Bus Stop Pad Slope Perpendicular to Roadway - Bus stop pad slope perpendicular to the roadway exceeds 2%.	1991 ADAAG 10.2.1
Existing Condition: 2.3% to 3.6% CS.	2004 ADAAG 810.2.4
	2007 CBC 1121B.2.1
	Other

Corrective Action
006 - Concrete Walk - Remove non-compliant pavement and replace with new concrete (area as shown on the drawings). The walkway slope shall not exceed 5% along the POT and cross slope shall not exceed 2%.
Additional Comments:

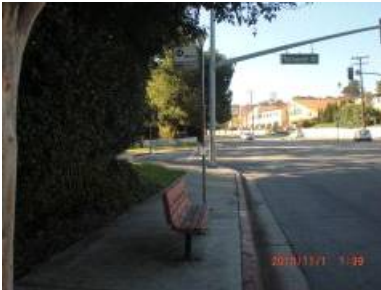
Keynote 15

Field Condition	
02.17 - Other - Passenger Loading Zones - See Additional Comments	1991 ADAAG -
Existing Condition: Bench (16" high seat, 11" deep seat, 14" high back support).	2004 ADAAG -
	2007 CBC -
	Other

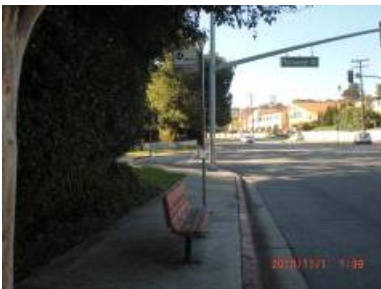
Keynote 16

Field Condition	
02.12B - Bus Stop Pad Slope Perpendicular to Roadway - Bus stop pad slope perpendicular to the roadway exceeds 2%.	1991 ADAAG 10.2.1
Existing Condition: 2.6% CS.	2004 ADAAG 810.2.4
	2007 CBC 1121B.2.1
	Other

Corrective Action
006 - Concrete Walk - Remove non-compliant pavement and replace with new concrete (area as shown on the drawings). The walkway slope shall not exceed 5% along the POT and cross slope shall not exceed 2%.
Additional Comments:

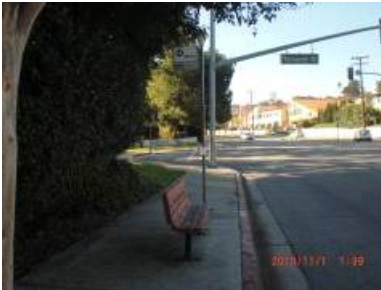
Keynote 17

Field Condition	
02.11A - Bus Stop Pad Size - Bus stop pad does not measure 8' long (measured from the curb or vehicle roadway edge) by 5' wide (measured parallel to the vehicle roadway).	1991 ADAAG 10.2.1
	2004 ADAAG 810.2.2
Existing Condition: Bus pad 7'-8" long by 5' wide.	2007 CBC 1121B.1
	Other

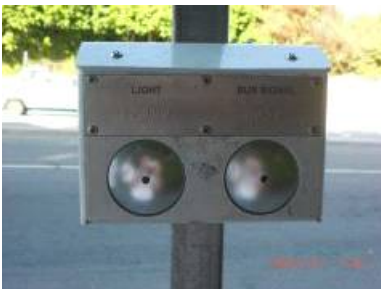
Keynote 18

Field Condition	
02.17 - Other - Passenger Loading Zones - See Additional Comments	1991 ADAAG -
Existing Condition: Bus signal button has non-compliant Braille.	2004 ADAAG -
	2007 CBC -
	Other

Corrective Action
039 - Operable Parts - Miscellaneous - See Additional Comments
Additional Comments: Replace with compliant Braille.

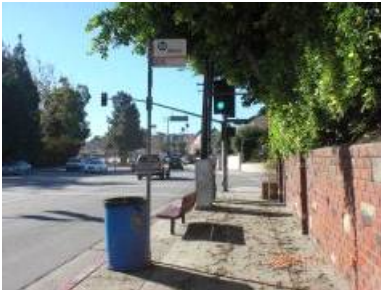
Keynote 19

Field Condition	
02.17 - Other - Passenger Loading Zones - See Additional Comments	1991 ADAAG -
Existing Condition: Bench (12" - 15" high seat, 14" deep seat, 16" high back support).	2004 ADAAG -
	2007 CBC -
	Other

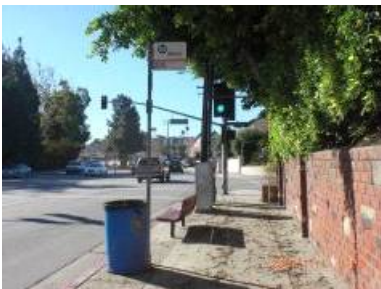
Keynote 20

Field Condition	
02.12A - Bus Stop Pad Slope Parallel to Roadway - Bus stop pad is not at the same slope as the roadway in the direction parallel to the roadway.	1991 ADAAG 10.2.1
Existing Condition: 3.0% to 6.6% at bus pad, 4.4% to 4.5% RS at the road.	2004 ADAAG 810.2.4
	2007 CBC 1121B.2.1
	Other

Corrective Action
006 - Concrete Walk - Remove non-compliant pavement and replace with new concrete (area as shown on the drawings). The walkway slope shall not exceed 5% along the POT and cross slope shall not exceed 2%.
Additional Comments:

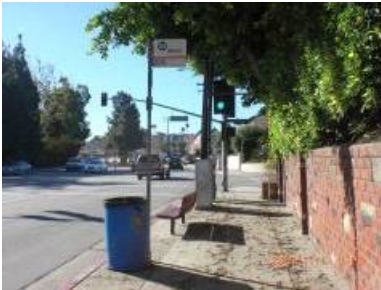
Keynote 21

Field Condition	
02.12B - Bus Stop Pad Slope Perpendicular to Roadway - Bus stop pad slope perpendicular to the roadway exceeds 2%.	1991 ADAAG 10.2.1
Existing Condition: 2.2% to 3.3% CS.	2004 ADAAG 810.2.4
	2007 CBC 1121B.2.1
	Other

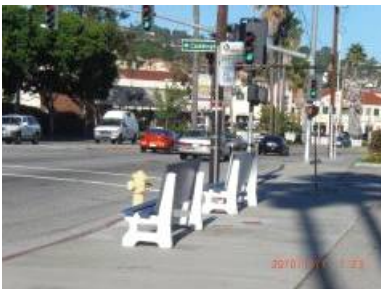
Keynote 22

Field Condition	
02.17 - Other - Passenger Loading Zones - See Additional Comments	1991 ADAAG -
Existing Condition: Bench (16 1/4" high seat).	2004 ADAAG -
	2007 CBC -
	Other

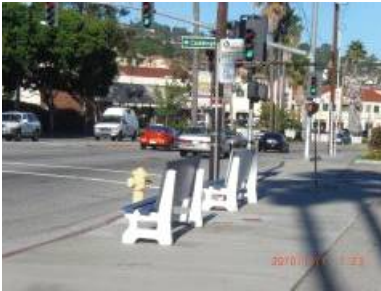
Keynote 23

Field Condition	
02.12A - Bus Stop Pad Slope Parallel to Roadway - Bus stop pad is not at the same slope as the roadway in the direction parallel to the roadway.	1991 ADAAG 10.2.1
Existing Condition: 3.0% RS at bus pad, 2.0% to 2.5% RS at the road.	2004 ADAAG 810.2.4
	2007 CBC 1121B.2.1
	Other

Corrective Action	
006 - Concrete Walk - Remove non-compliant pavement and replace with new concrete (area as shown on the drawings). The walkway slope shall not exceed 5% along the POT and cross slope shall not exceed 2%.	
Additional Comments:

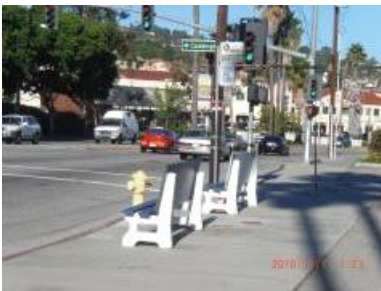
Keynote 24

Field Condition	
02.12B - Bus Stop Pad Slope Perpendicular to Roadway - Bus stop pad slope perpendicular to the roadway exceeds 2%.	1991 ADAAG 10.2.1
Existing Condition: 2.5% to 3.3% CS.	2004 ADAAG 810.2.4
	2007 CBC 1121B.2.1
	Other

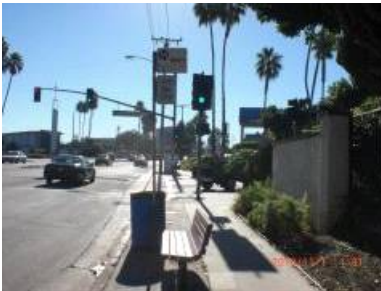
Keynote 25

Field Condition	
02.17 - Other - Passenger Loading Zones - See Additional Comments	1991 ADAAG -
Existing Condition: Bench (16 1/2" high seat, 14" deep seat, 14" high back support).	2004 ADAAG -
	2007 CBC -
	Other

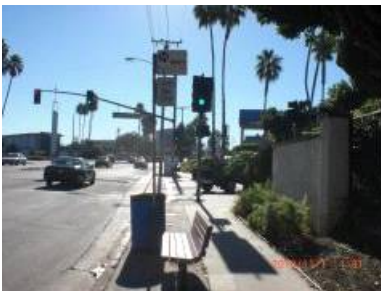
Keynote 26

Field Condition	
02.12A - Bus Stop Pad Slope Parallel to Roadway - Bus stop pad is not at the same slope as the roadway in the direction parallel to the roadway.	1991 ADAAG 10.2.1
Existing Condition: 3.05 to 3.5% RS at bus pad, 2.3% to 2.5% RS at the road.	2004 ADAAG 810.2.4
	2007 CBC 1121B.2.1
	Other

Corrective Action
006 - Concrete Walk - Remove non-compliant pavement and replace with new concrete (area as shown on the drawings). The walkway slope shall not exceed 5% along the POT and cross slope shall not exceed 2%.
Additional Comments:

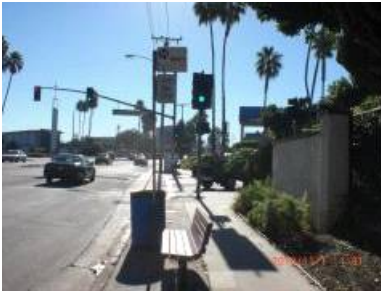
Keynote 27

Field Condition	
02.12B - Bus Stop Pad Slope Perpendicular to Roadway - Bus stop pad slope perpendicular to the roadway exceeds 2%.	1991 ADAAG 10.2.1
Existing Condition: 3.5% CS.	2004 ADAAG 810.2.4
	2007 CBC 1121B.2.1
	Other

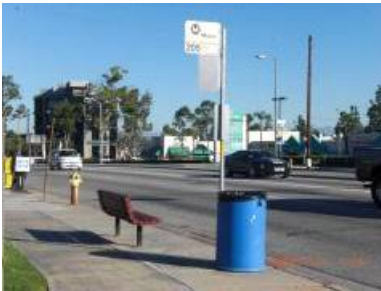
Keynote 28

Field Condition	
02.17 - Other - Passenger Loading Zones - See Additional Comments	1991 ADAAG -
Existing Condition: Bench (16" high seat, 14 1/2" deep seat, 14" high back support).	2004 ADAAG -
	2007 CBC -
	Other

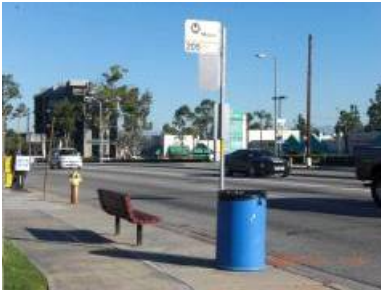
Keynote 29

Field Condition	
02.12A - Bus Stop Pad Slope Parallel to Roadway - Bus stop pad is not at the same slope as the roadway in the direction parallel to the roadway.	1991 ADAAG 10.2.1
Existing Condition: 2.9% to 3.0% RS at bus pad, 0.8% to 0.9% RS at the road.	2004 ADAAG 810.2.4
	2007 CBC 1121B.2.1
	Other

Corrective Action
006 - Concrete Walk - Remove non-compliant pavement and replace with new concrete (area as shown on the drawings). The walkway slope shall not exceed 5% along the POT and cross slope shall not exceed 2%.
Additional Comments:

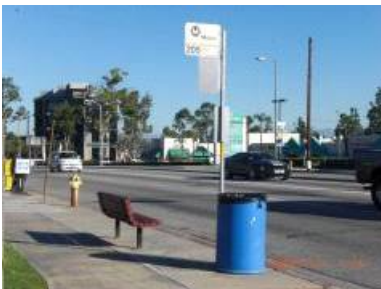
Keynote 30

Field Condition	
02.12B - Bus Stop Pad Slope Perpendicular to Roadway - Bus stop pad slope perpendicular to the roadway exceeds 2%.	1991 ADAAG 10.2.1
Existing Condition: 3.2% CS.	2004 ADAAG 810.2.4
	2007 CBC 1121B.2.1
	Other

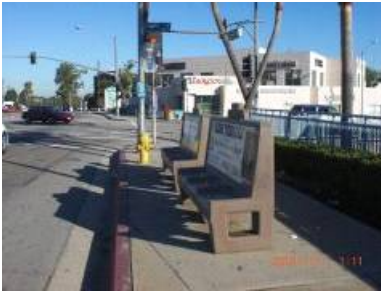
Keynote 31

Field Condition	
02.17 - Other - Passenger Loading Zones - See Additional Comments	1991 ADAAG -
Existing Condition: Bench (14 1/2" deep seat).	2004 ADAAG -
	2007 CBC -
	Other

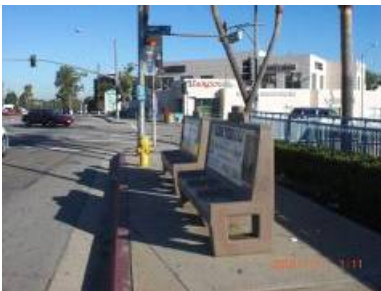
Keynote 32

Field Condition	
02.12A - Bus Stop Pad Slope Parallel to Roadway - Bus stop pad is not at the same slope as the roadway in the direction parallel to the roadway.	1991 ADAAG 10.2.1
Existing Condition: 1.4% to 2.3% RS at bus pad , 0.8% to 1.0% RS at the road.	2004 ADAAG 810.2.4
	2007 CBC 1121B.2.1
	Other

Corrective Action
006 - Concrete Walk - Remove non-compliant pavement and replace with new concrete (area as shown on the drawings). The walkway slope shall not exceed 5% along the POT and cross slope shall not exceed 2%.
Additional Comments:

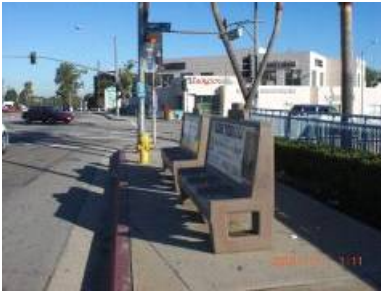
Keynote 33

Field Condition	
02.12B - Bus Stop Pad Slope Perpendicular to Roadway - Bus stop pad slope perpendicular to the roadway exceeds 2%.	1991 ADAAG 10.2.1
Existing Condition: 2.2% to 2.4% CS.	2004 ADAAG 810.2.4
	2007 CBC 1121B.2.1
	Other

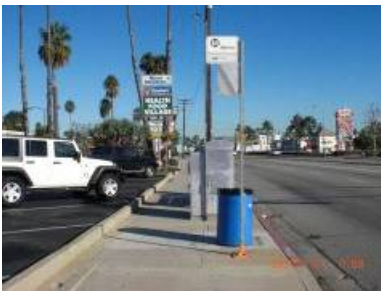
Keynote 34

Field Condition	
02.17 - Other - Passenger Loading Zones - See Additional Comments	1991 ADAAG -
Existing Condition: Bench (16" high seat, 14" deep seat, 15" high back support).	2004 ADAAG -
	2007 CBC -
	Other

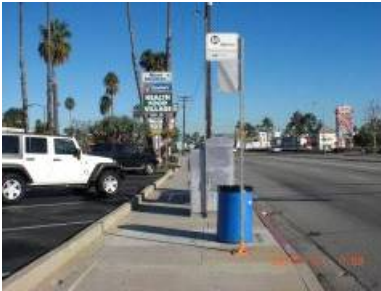
Keynote 35

Field Condition	
02.12B - Bus Stop Pad Slope Perpendicular to Roadway - Bus stop pad slope perpendicular to the roadway exceeds 2%.	1991 ADAAG 10.2.1
Existing Condition: 3.9% CS.	2004 ADAAG 810.2.4
	2007 CBC 1121B.2.1
	Other

Corrective Action
006 - Concrete Walk - Remove non-compliant pavement and replace with new concrete (area as shown on the drawings). The walkway slope shall not exceed 5% along the POT and cross slope shall not exceed 2%.
Additional Comments:

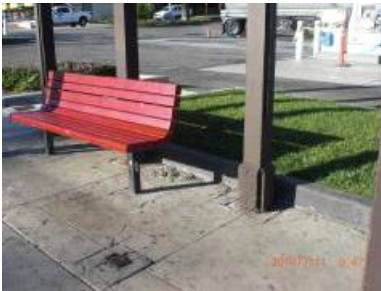
Keynote 36

Field Condition	
02.17 - Other - Passenger Loading Zones - See Additional Comments	1991 ADAAG -
Existing Condition: Bench (14" deep seat, 15 1/2" high back support, 9" shoulder alignment).	2004 ADAAG -
	2007 CBC -
	Other

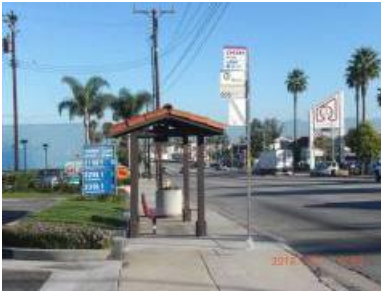
Keynote 37

Field Condition	
02.12A - Bus Stop Pad Slope Parallel to Roadway - Bus stop pad is not at the same slope as the roadway in the direction parallel to the roadway.	1991 ADAAG 10.2.1
Existing Condition: 3.7% to 5.7% RS at bus pad, 3.8% to 4.5% RS at the road.	2004 ADAAG 810.2.4
	2007 CBC 1121B.2.1
	Other

Corrective Action
006 - Concrete Walk - Remove non-compliant pavement and replace with new concrete (area as shown on the drawings). The walkway slope shall not exceed 5% along the POT and cross slope shall not exceed 2%.
Additional Comments:

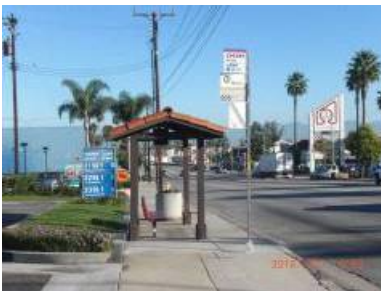
Keynote 38

Field Condition	
02.12B - Bus Stop Pad Slope Perpendicular to Roadway - Bus stop pad slope perpendicular to the roadway exceeds 2%.	1991 ADAAG 10.2.1
Existing Condition: 2.8% to 4.0% CS.	2004 ADAAG 810.2.4
	2007 CBC 1121B.2.1
	Other

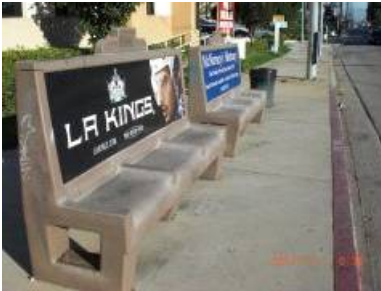
Keynote 39

Field Condition	
02.17 - Other - Passenger Loading Zones - See Additional Comments	1991 ADAAG -
Existing Condition: Bench (14 1/2" deep seat).	2004 ADAAG -
	2007 CBC -
	Other

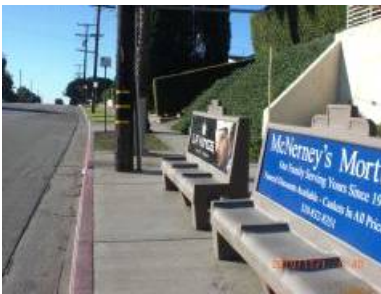
Keynote 40

Field Condition	
02.12A - Bus Stop Pad Slope Parallel to Roadway - Bus stop pad is not at the same slope as the roadway in the direction parallel to the roadway.	1991 ADAAG 10.2.1
Existing Condition: 4.1% to 4.7% RS at bus pad, 3.5% to 3.7% RS at the road.	2004 ADAAG 810.2.4
	2007 CBC 1121B.2.1
	Other

Corrective Action
006 - Concrete Walk - Remove non-compliant pavement and replace with new concrete (area as shown on the drawings). The walkway slope shall not exceed 5% along the POT and cross slope shall not exceed 2%.
Additional Comments:

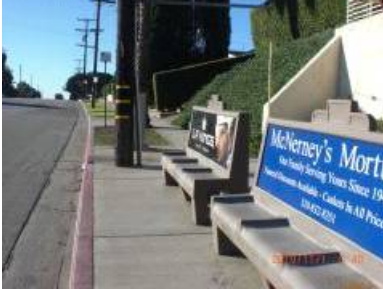
Keynote 41

Field Condition	
02.12B - Bus Stop Pad Slope Perpendicular to Roadway - Bus stop pad slope perpendicular to the roadway exceeds 2%.	1991 ADAAG 10.2.1
Existing Condition: 2.7% to 3.8% CS.	2004 ADAAG 810.2.4
	2007 CBC 1121B.2.1
	Other
