# **CIVIC CENTER FACILITIES ASSESSMENT**

**The City of Rancho Palos Verdes**

November 2010

**GONZALEZ GOODALE ARCHITECTS**

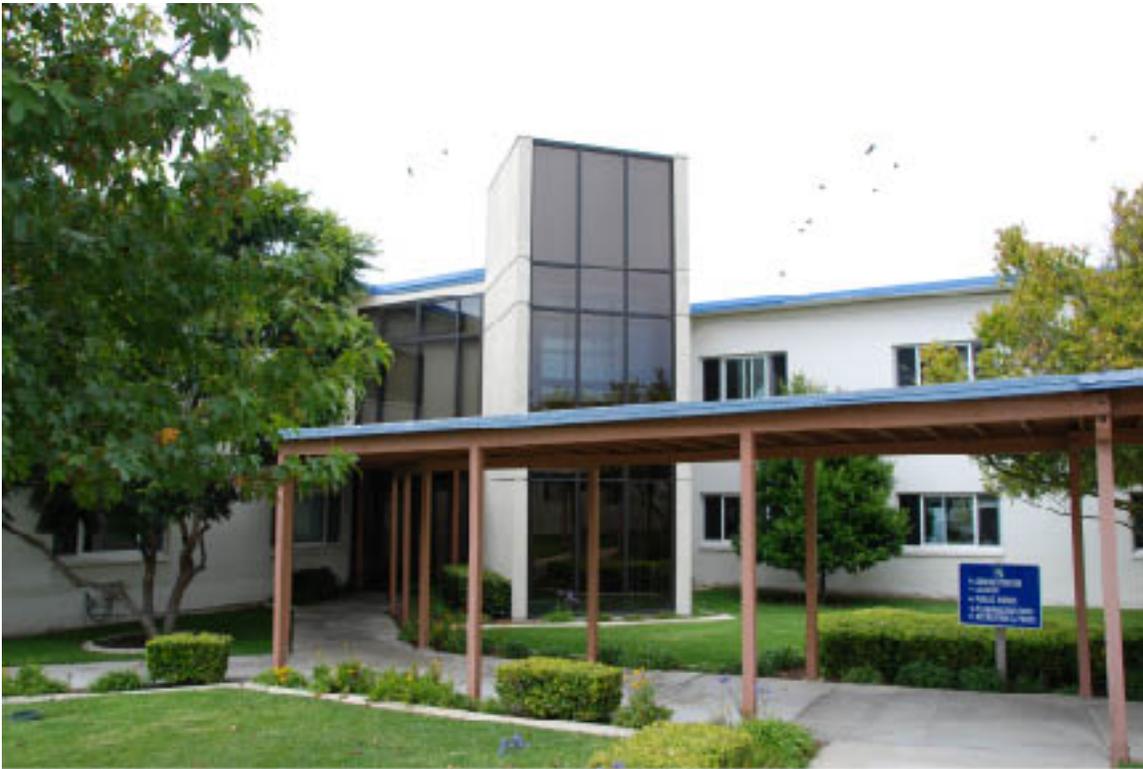
1.

Administration Building Entry

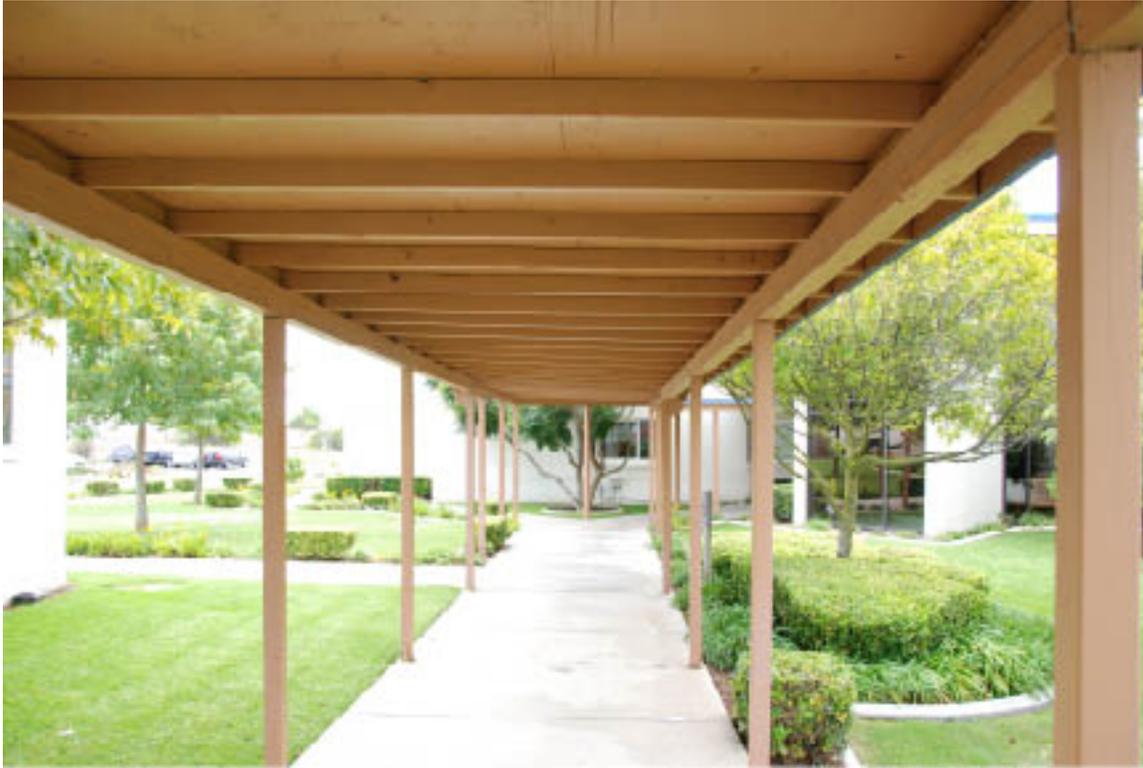
2.

Covered Walk

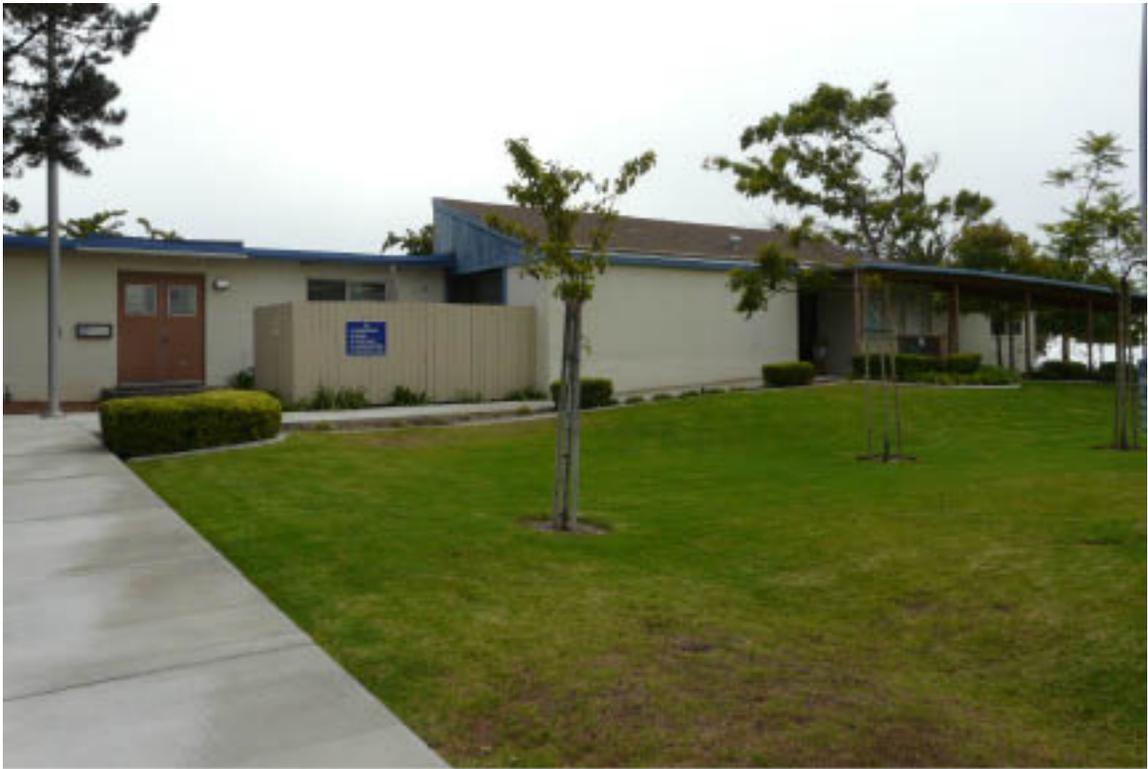
3.

Community Development Building

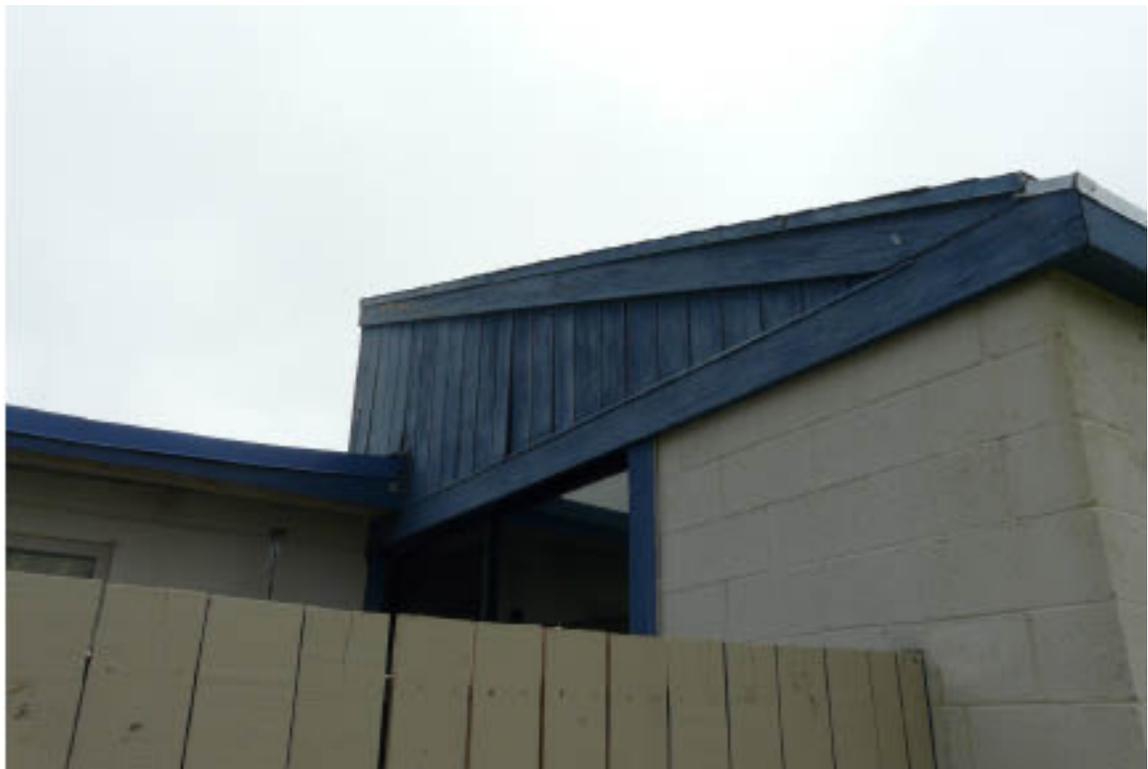
4.

The general condition of the Architectural finishes is sound, but worn. Roof covering has been recently replaced and is still covered by warranty. Exterior CMU walls are sound, paint is worn particularly near ground level.

Worn Siding

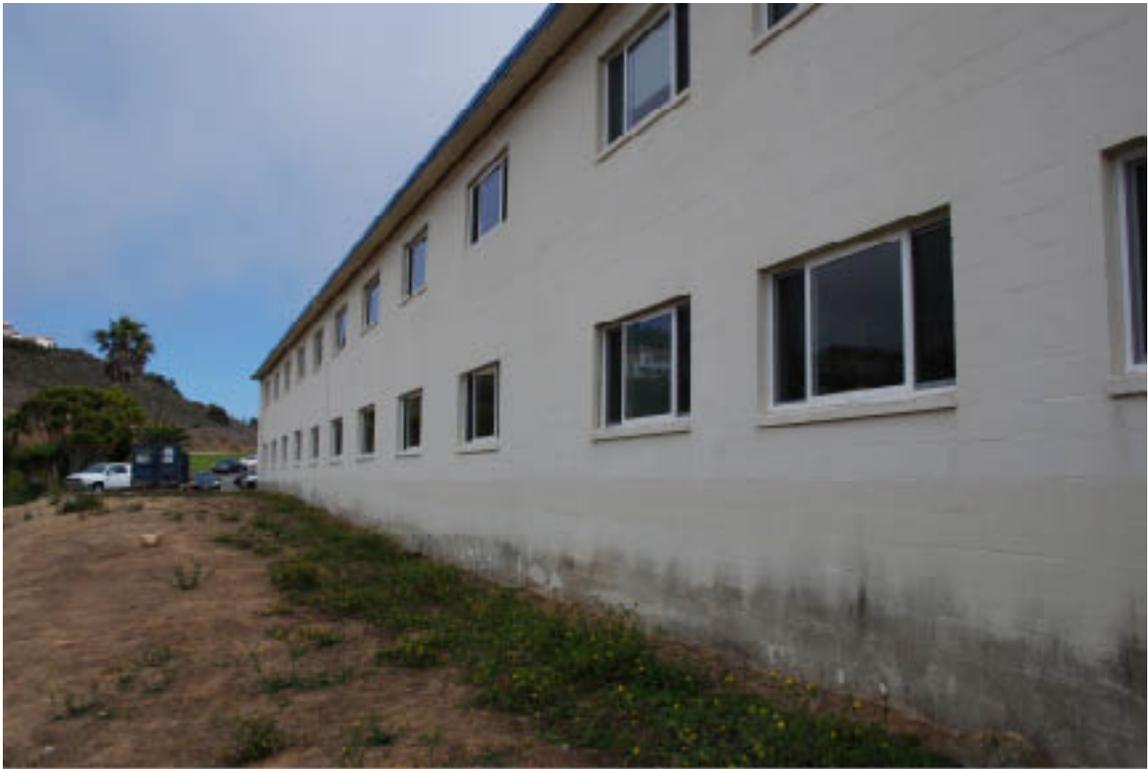
5.

North Side

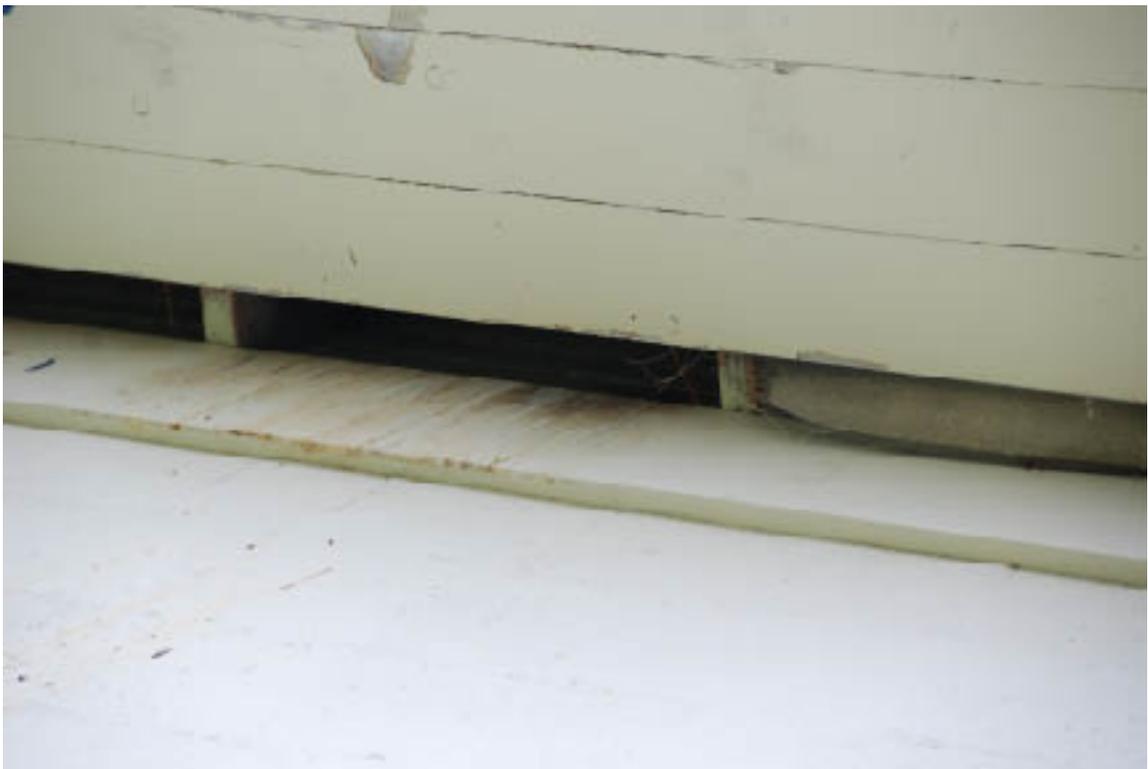
6.

Deteriorated Bird Screen

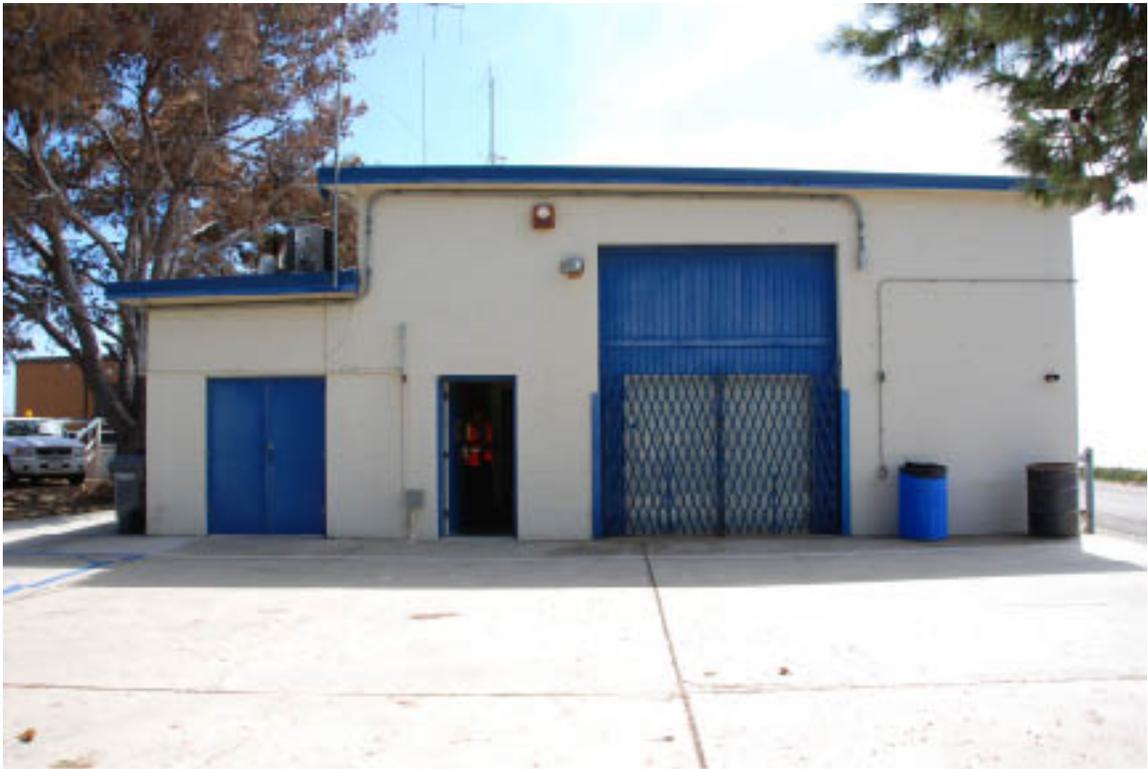
8.

Cable TV Building

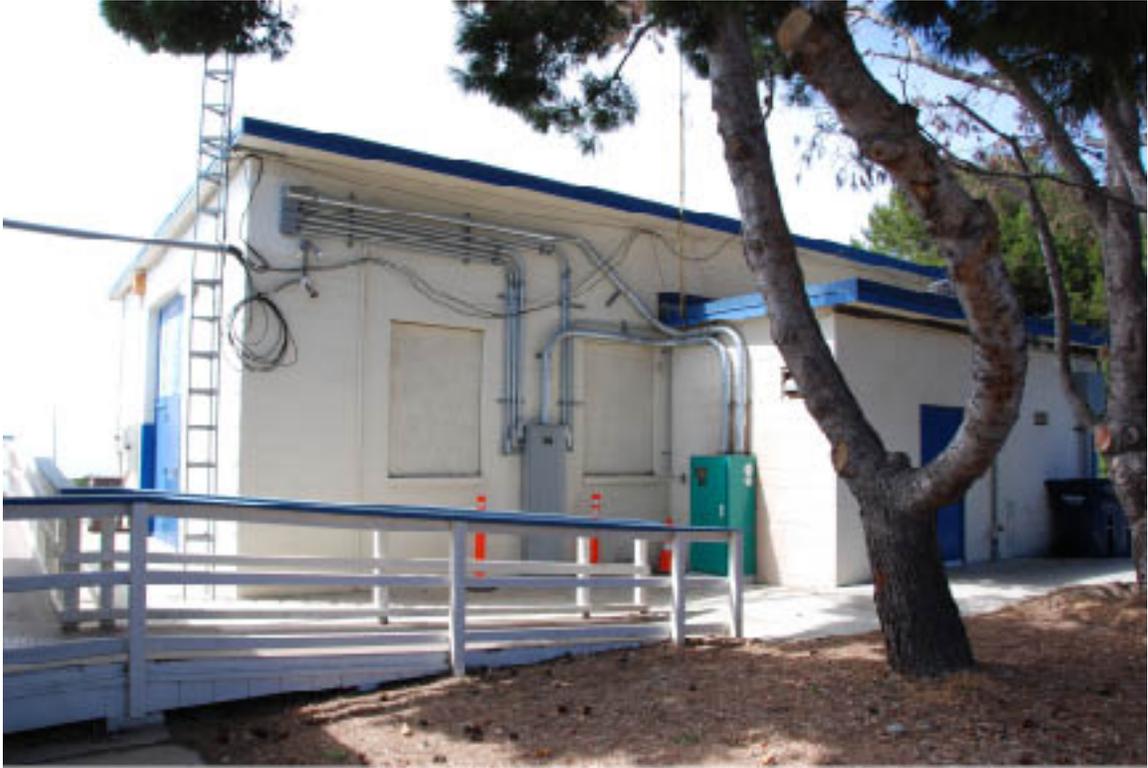
New Emergency Panels

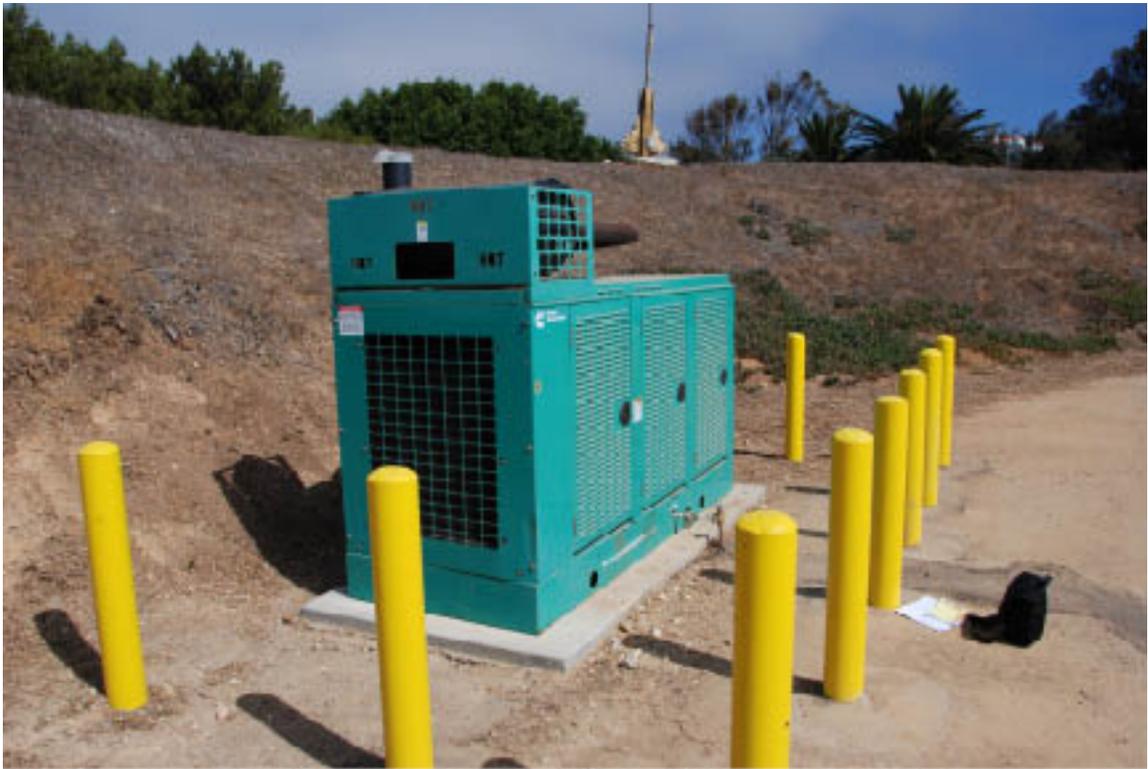
9.

New Generator

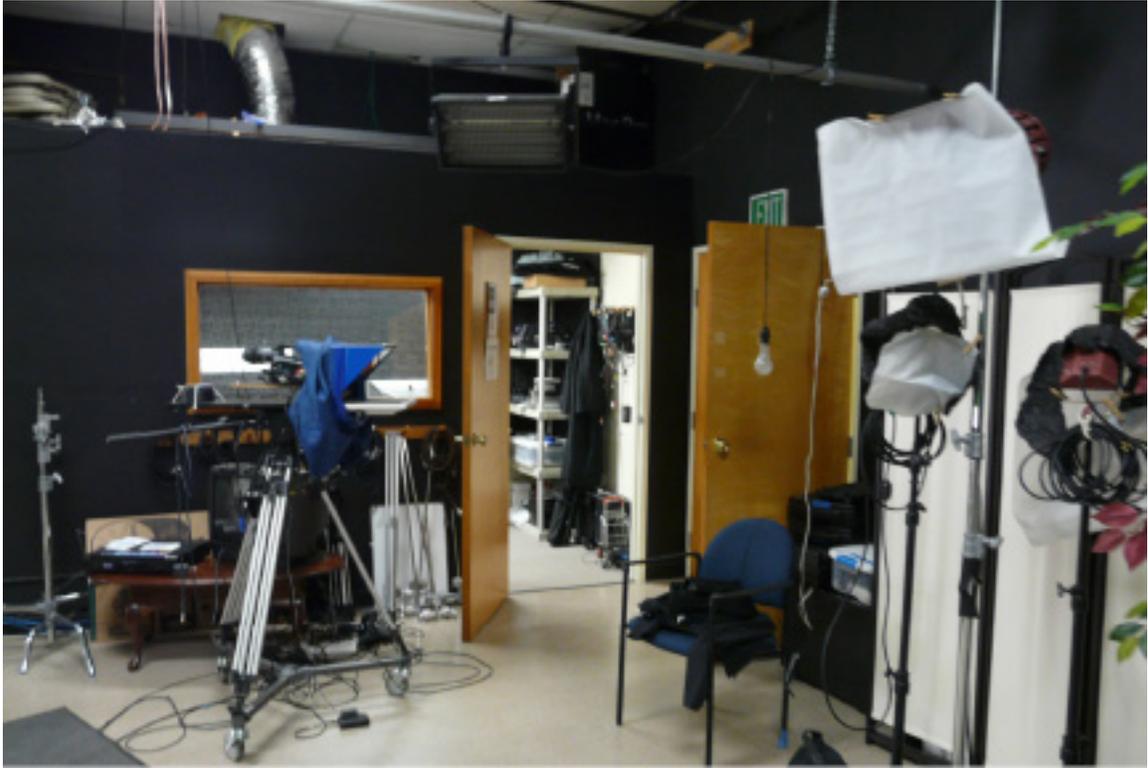
10.

Cable TV Studio

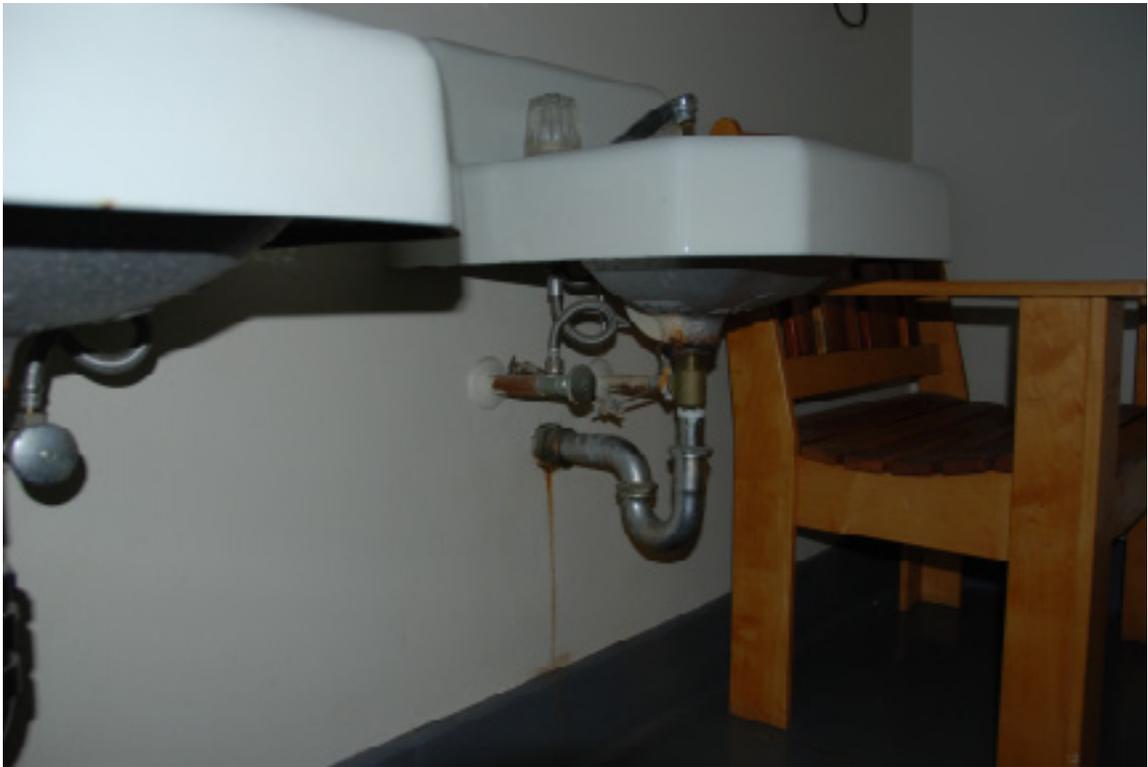
11.

Domestic water supply piping is a mixture of galvanized pipe and copper pipe. (Galvanized is original condition, copper is recently replaced/repaired sections.)

Leaking Plumbing

1. Replace all domestic and waste piping
2. Bring natural gas to the site, serving high efficiency condensing water heater.

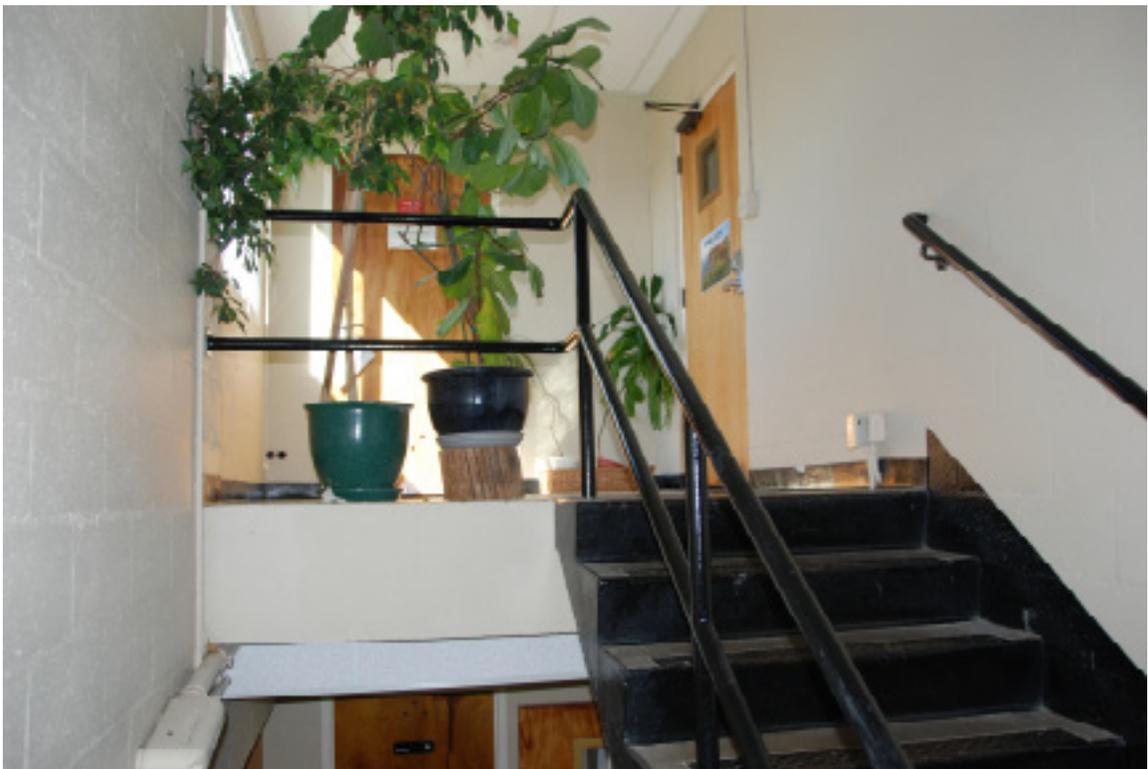
12.

**Exiting System:** The existing exiting system is nearly compliant with current code requirements. Doors to stair shafts are not properly maintained in fire-safe condition. Some corridors empty through non-rated spaces. Southwest stair (photo 12) is not separated from the corridor.

Non-Compliant Railing

1. Replace stair handrails
2. Add automatic fire sprinkler system and fire alarm system. This will correct the existing non-compliant exit issues and the non-compliant stair shaft and corridor ratings.
3. Replace/expand toilet facilities for both fixture count requirements and accessibility.
4. Add appropriate insulation to walls and roof to meet Title 24 requirements

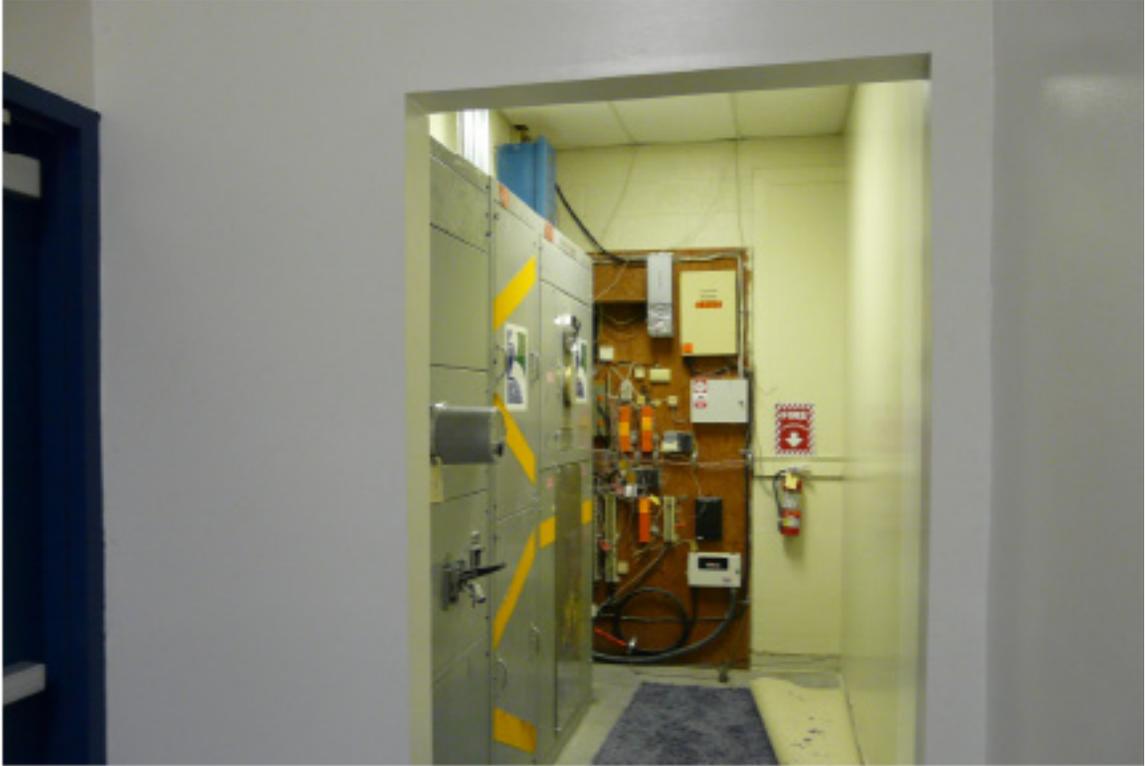
13.

New Main Distribution Panel

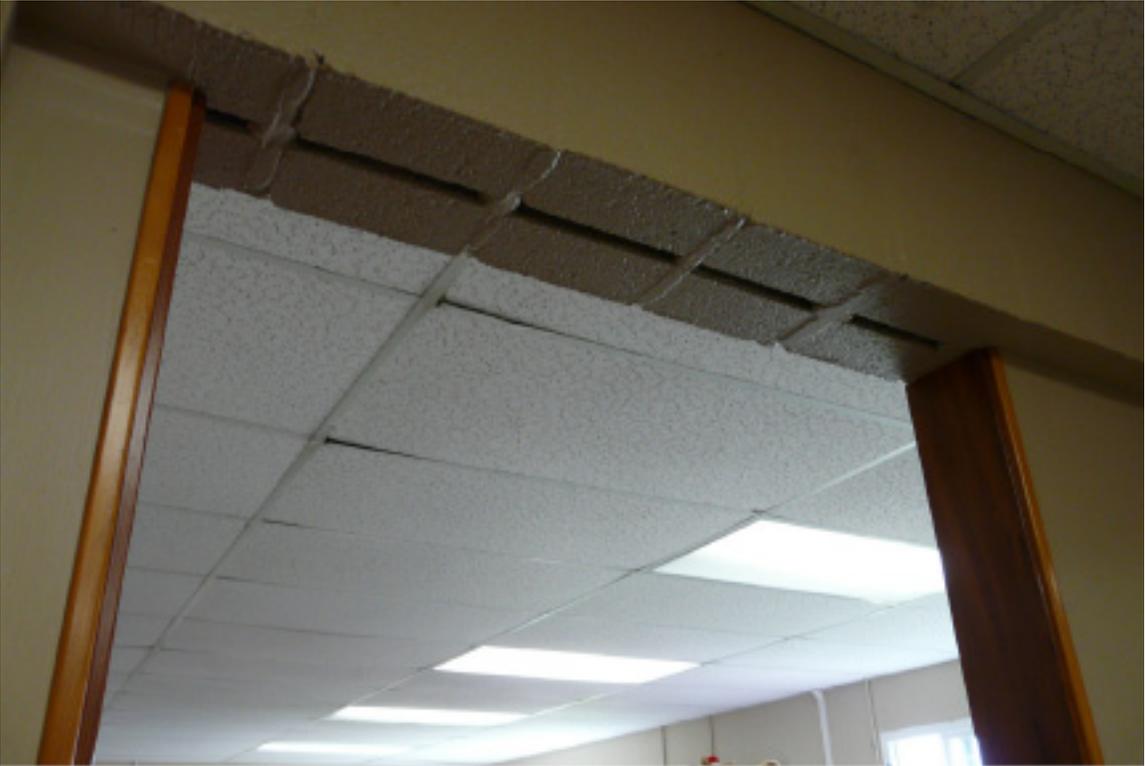
14.

This building was not studied by the Thermography report. We believe it is reasonable, given the apparent similar age and other visible construction similarities, to assume the same every third cells grouting conditions present in the other two buildings.

Un-grouted Bond Beam

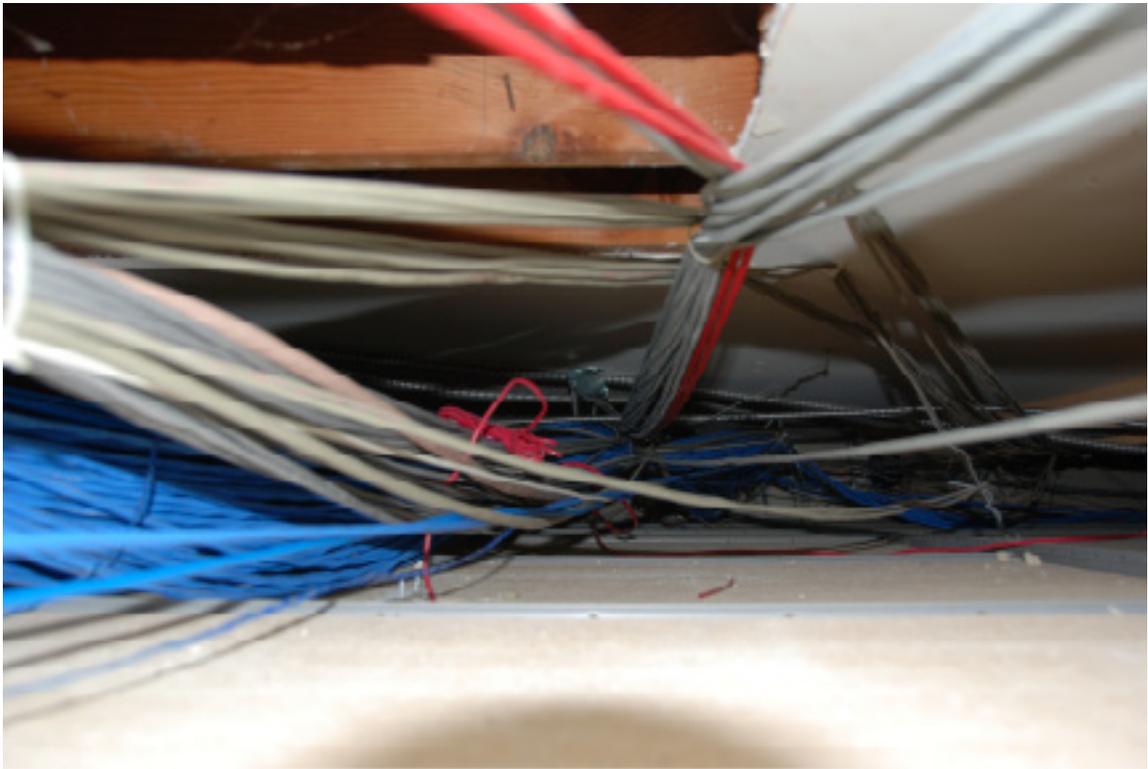
15.

Data and technology systems are less than optimal. The cabling is “roped” thru the attic space in a non-organized fashion. Computer workstation hardware is suffering premature failure due to lack of air conditioning.

Data/Communications Cables

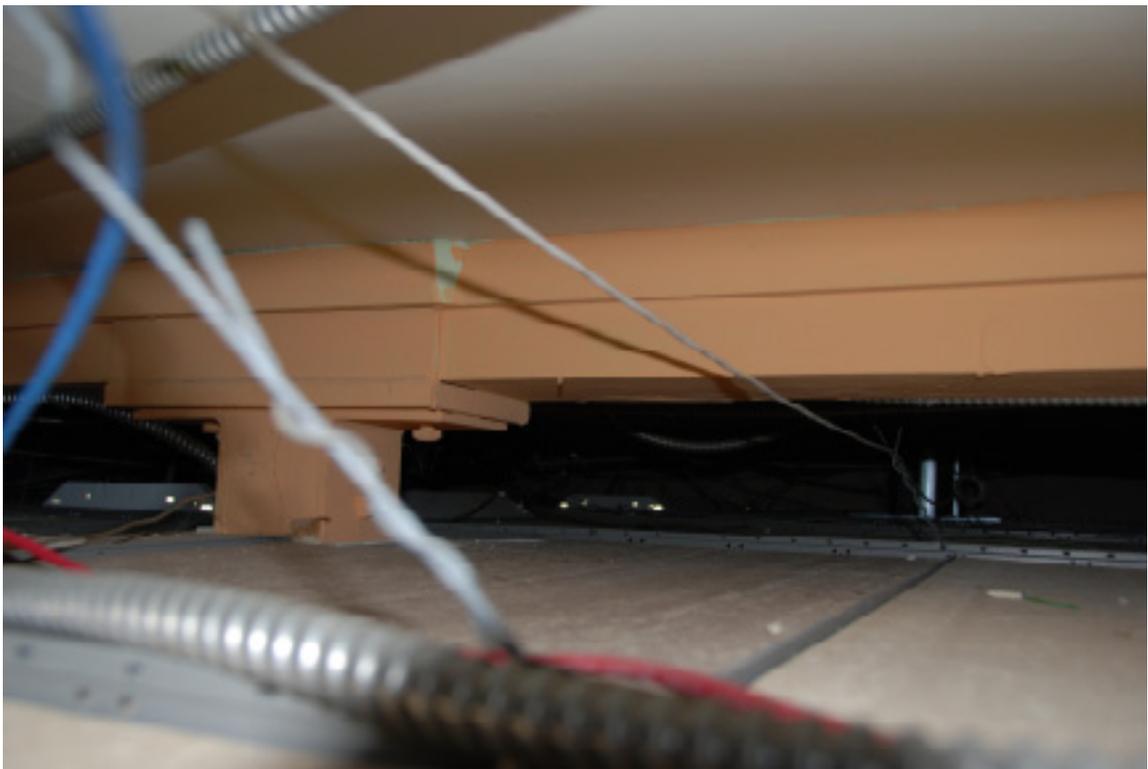
16.

Space Above Ceiling
