Certified Thermography Report
for

Planning Department Building
30940 Hawthorne Blvd.

Ladera Linda Community Center
Recreation Room Building J & K
32201 Forrestal Drive

Thermography Report

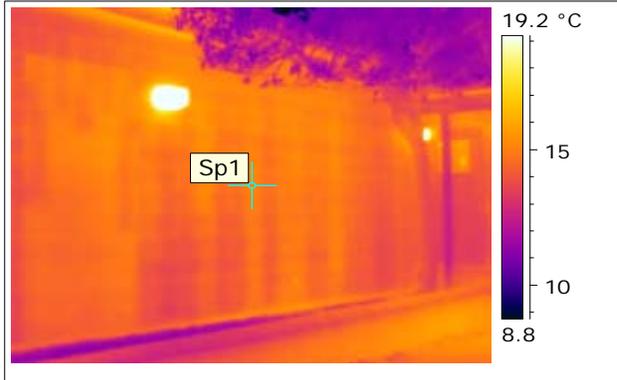
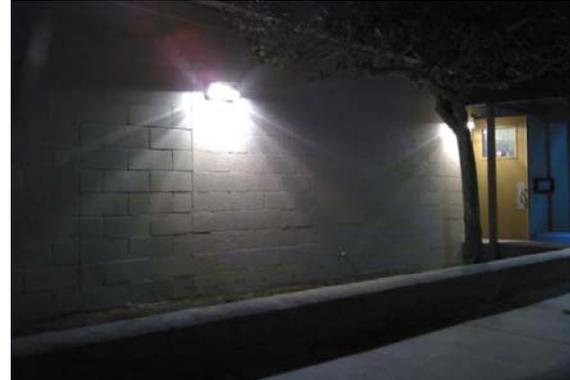
Picture 1. Captured at: (Planning Department
Date & Time: 3/12/2010 7:13:32 PM

Comment: Thermal differential inadequate for IR imaging.

Recommendation: Re-image later

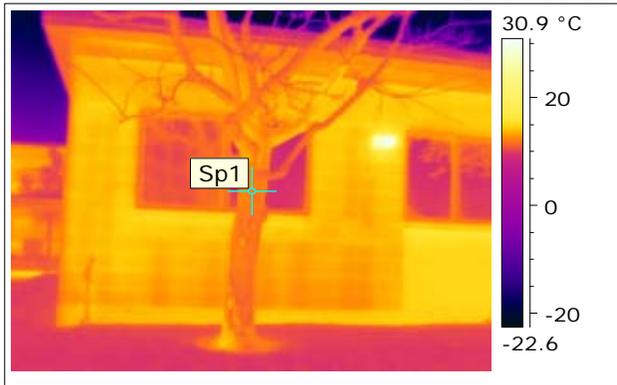
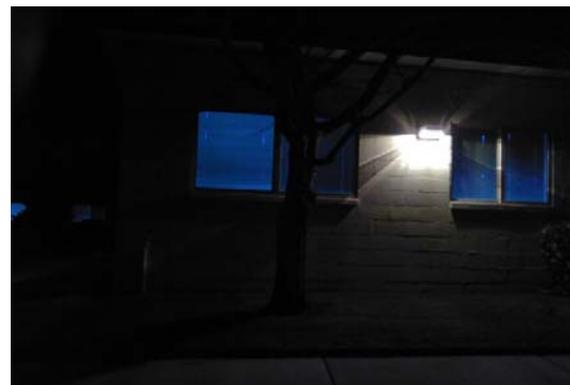
Picture 2. Captured at: (South Elevation SW Quadrant)
Date & Time: 3/13/2010 7:03:45 PM

Comment: Note solid bright section below window on right. Graphic and block joint alignment indicate door opening existed when originally constructed.

Recommendation: None

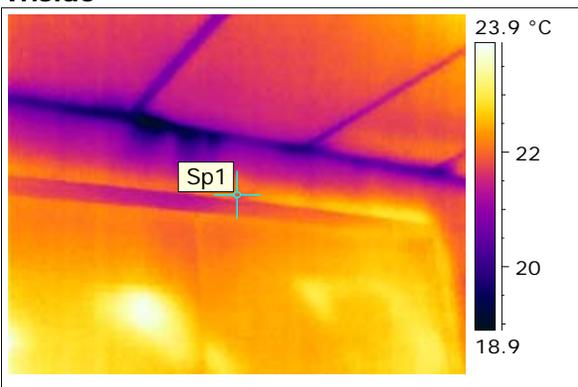
Picture 3. Captured at: (South Elevation SE Quadrant)

Comment: Bright spot under window could be a combination of metal flashing and energy loss. Difficult to know without further investigation and testing

Recommendation: Make small penetration to establish substrate material or presence of metal flashing.

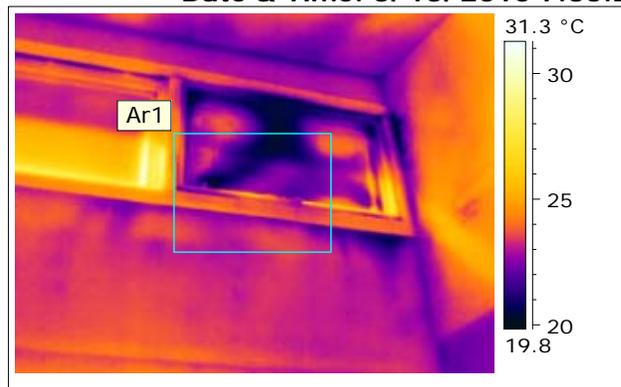
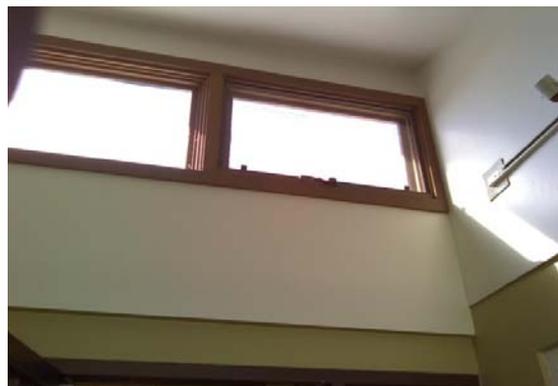
Picture 4. Captured at: (Bathroom window above roof line)

Comment: Significant air-infiltration in and around bathroom window above roof line

Recommendation: Caulk and seal from interior and exterior window may need to be removed, replaced or reinstalled. Further investigation required

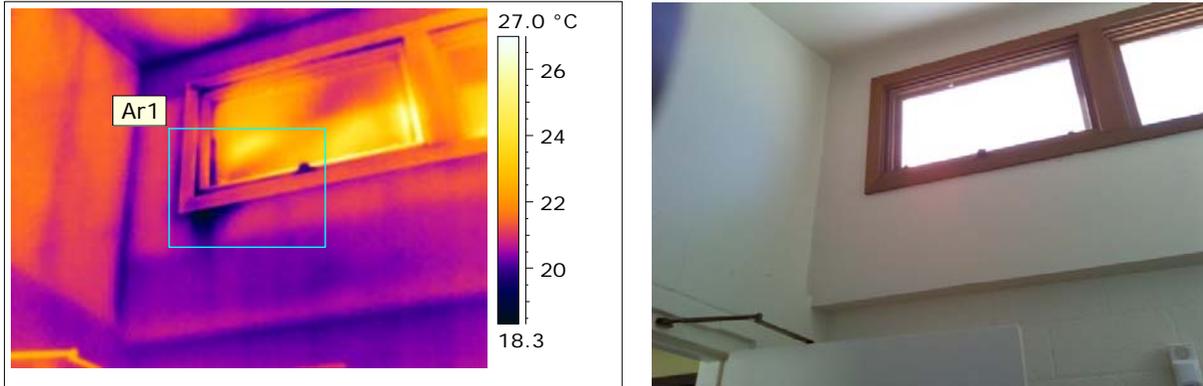
Picture 5. Captured at: (Bathroom window above roof line)

Comment: Lid-line and window air-infiltration

Recommendation: Caulk and seal from interior and exterior, Note: window may need to be replaced and/or removed and re-installed further investigation required

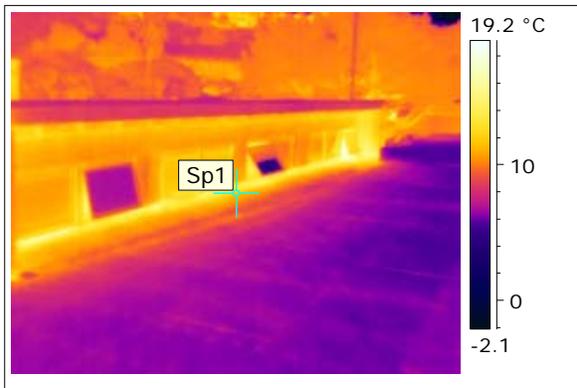
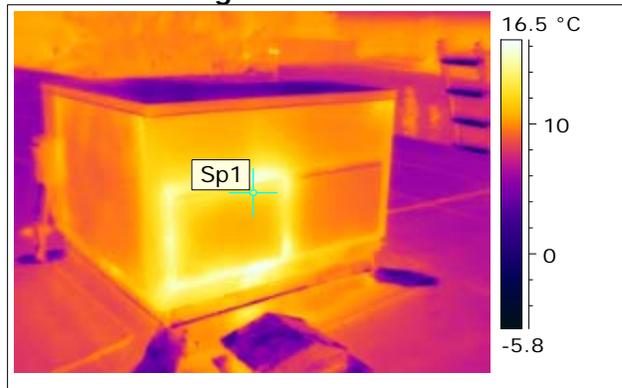
Picture 6. Captured at: (Planning Roof 3/13 7:45:21 PM)

Comment: Hot spot below windows is more than likely flashing. However the hot spots around the windows are points of interest regarding energy loss.

Recommendation: See interior images above for reasonable confirmation.

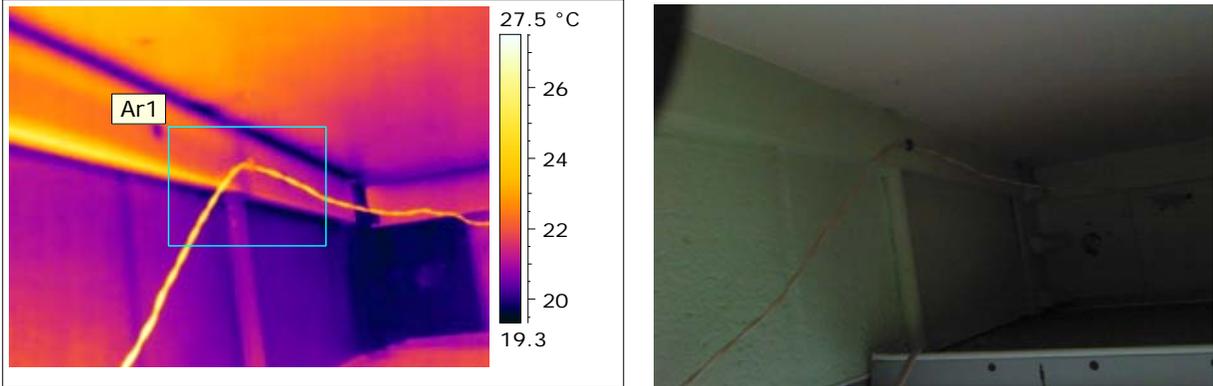
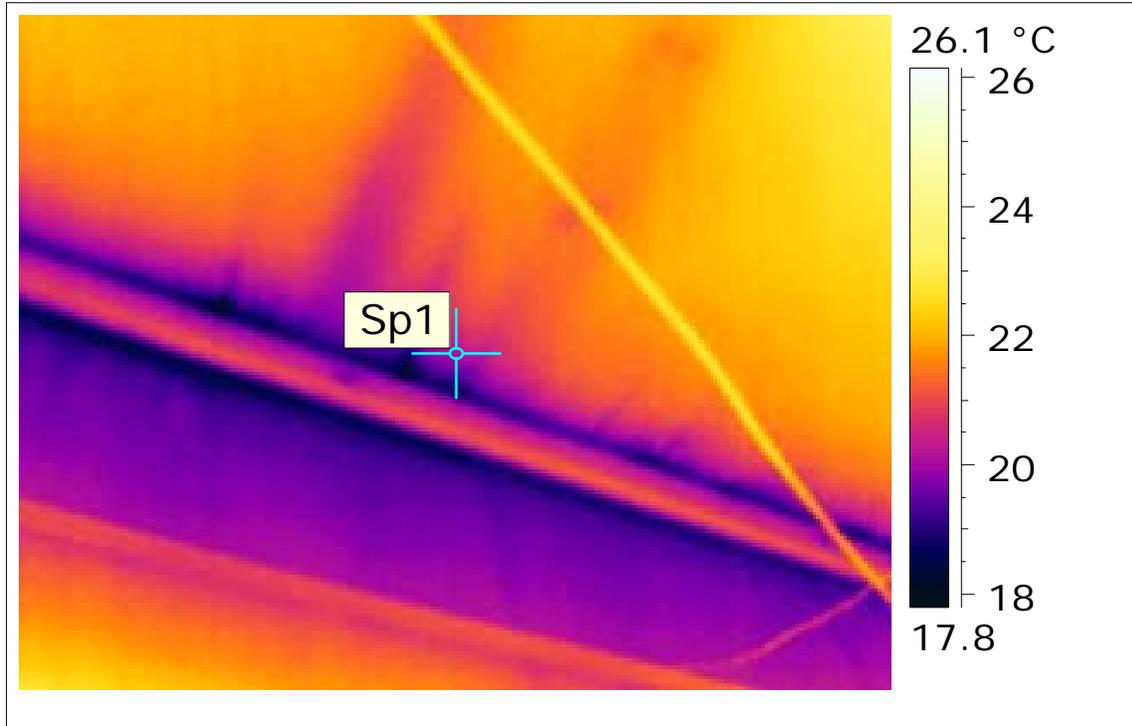
Picture 7. Captured at: (Inside Ceiling SW Corner office)

Comment: Black line above and below wood baton indicates colder air-infiltration. Note: This infiltration is present without the use of blower door.

Recommendation: See same image below using blower door. Cable indicates potential phantom electrical issue.

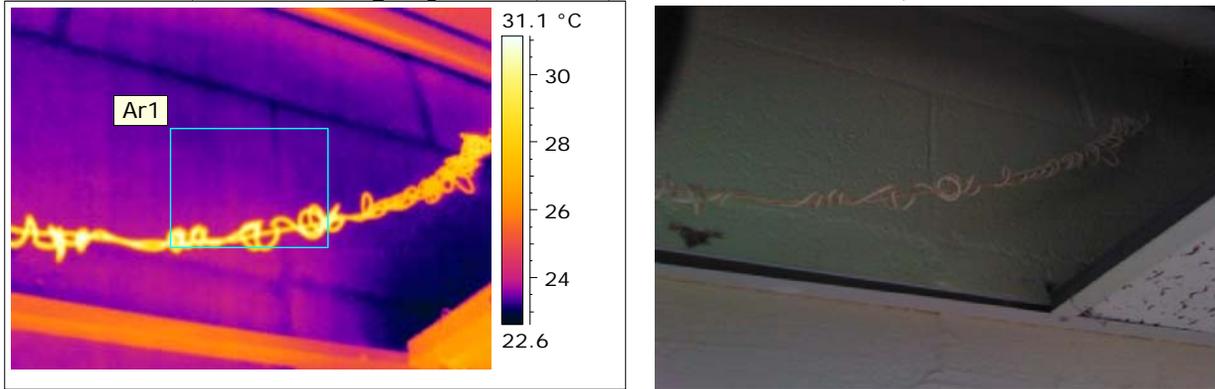
Picture 8. (Inside Ceiling adjacent (west) to SW Corner office)

Comment: Black line above and below wood baton indicates colder air-infiltration. Note: This infiltration is present without the use of blower door.

Recommendation: See same image below using blower door. Cable indicates potential phantom electrical issue.

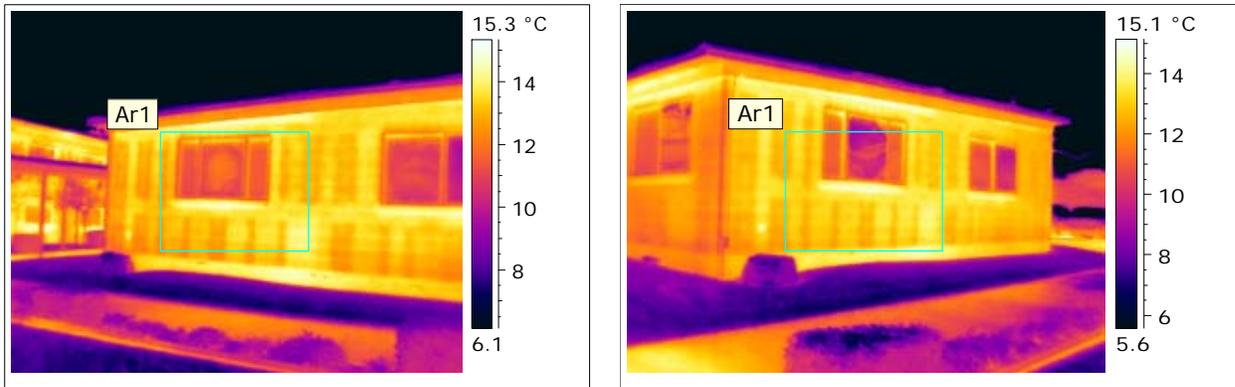
Picture 9. Captured at: (West Elevation)

Comment: Thermal signature almost achieved

Recommendation: Further investigation and testing recommended

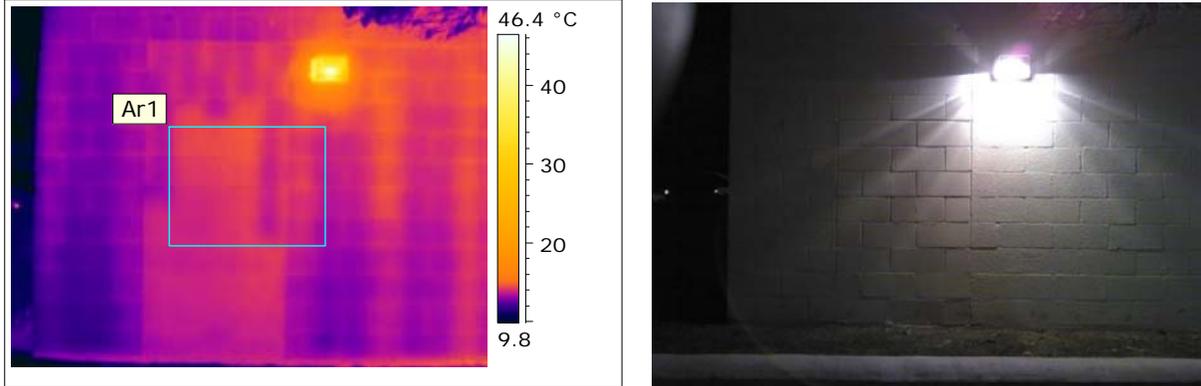
Picture 10. Captured at: (East Elevation)

Comment: Wall still acclimating to addressable thermal signature

Recommendation: See image below

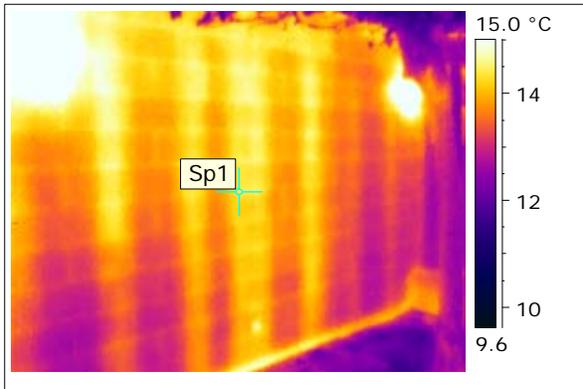
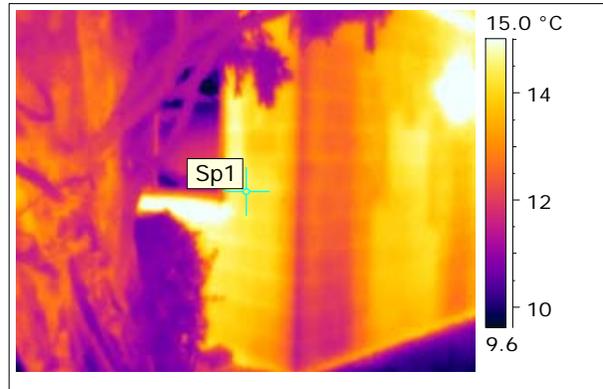
Picture 11. Captured at: (East and SE Corner Elevation)
South Elevation

Comment: Note picture on left with double grouted cells in center. Picture on right indicates prior doorway during original construction.

Recommendation: Further investigation and testing recommended

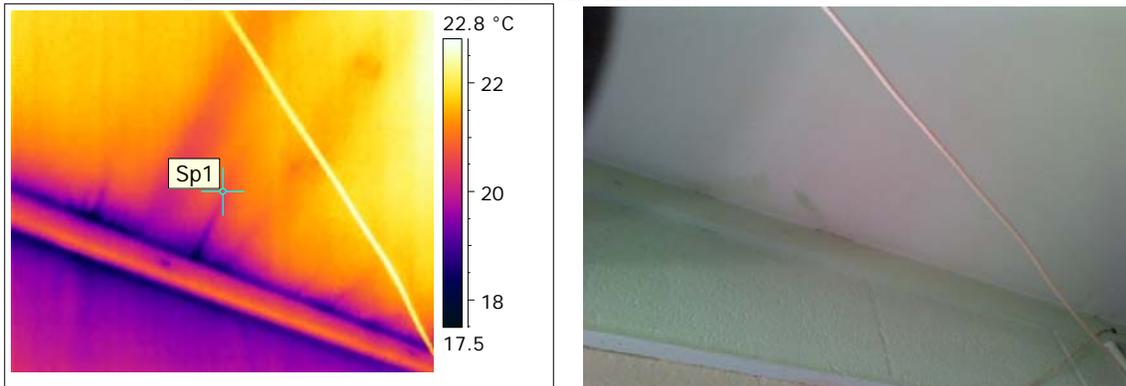
Picture 12. Captured at: (SW Office)

Comment: Lid line air-infiltration using blower door

Recommendation: Perimeter tile removed. Baton exposed along with underside of finished roof joints. Caulk and seal wood baton all sides. Further investigation required

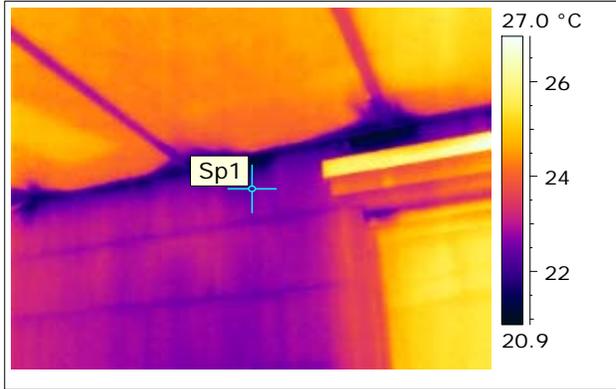
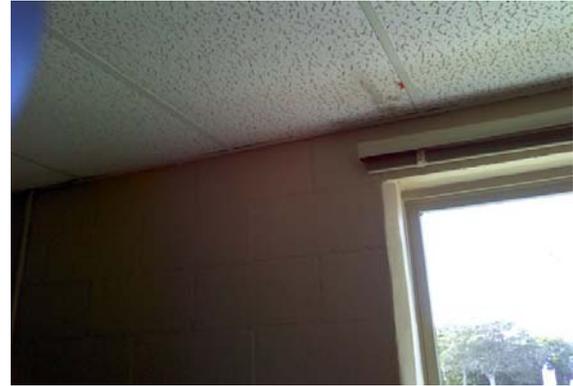
Picture 13. Captured at: (Office adjacent to SW Office)

Comment: View of lid line air leaks with tile in place

Recommendation: Remove perimeter tile caulk and seal wood baton all sides. Further investigation required

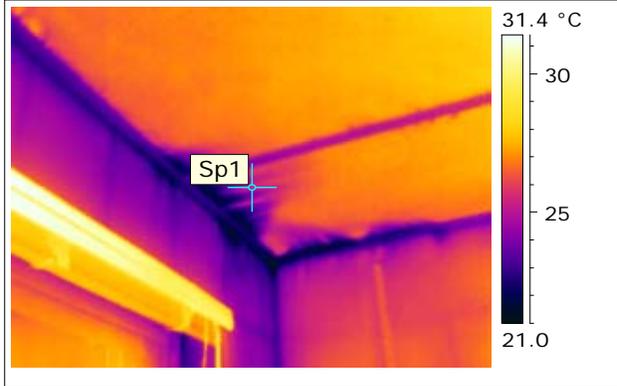
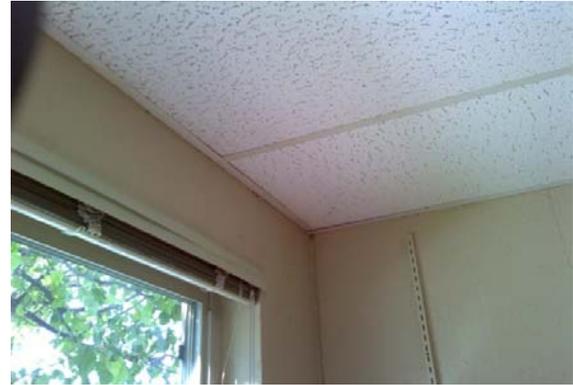
Picture 15. Captured at: (South Elevation Office)

Comment: Lid line air-infiltration

Recommendation: Remove perimeter tile caulk and seal wood baton all sides. Further investigation required.

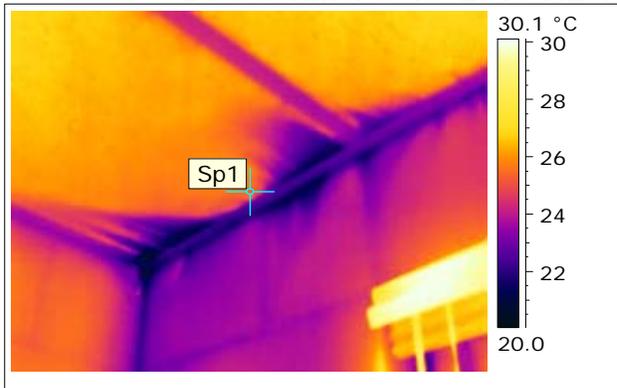
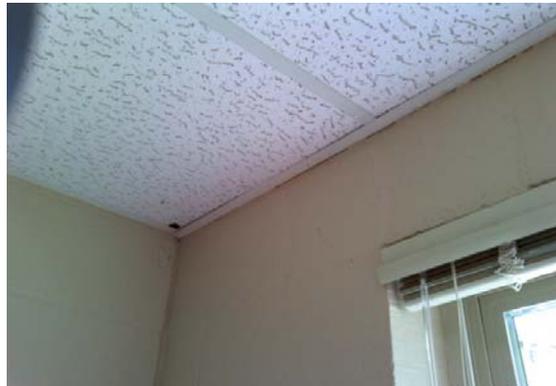
Picture 16. Captured at: (South Elevation Office)

Comment: Lid line air-infiltration

Recommendation: Remove perimeter tile caulk and seal wood baton all sides. Further investigation required

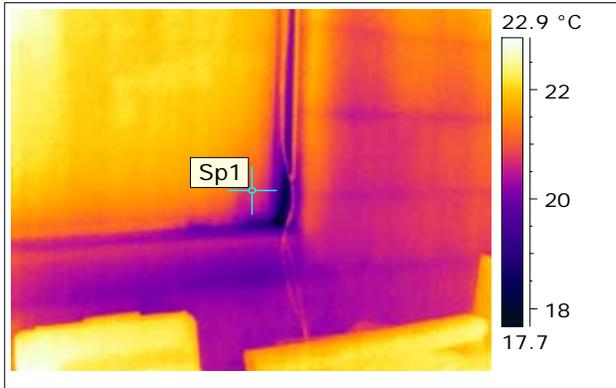
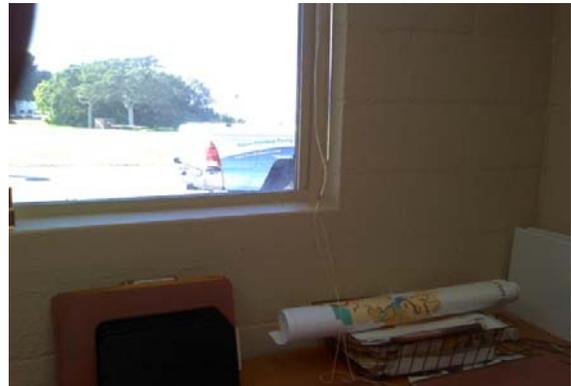
Picture 17. Captured at: (South Elevation Office)

Comment: Lower right corner air-infiltration

Recommendation: Caulk and seal as needed from interior and exterior Further investigation needed.

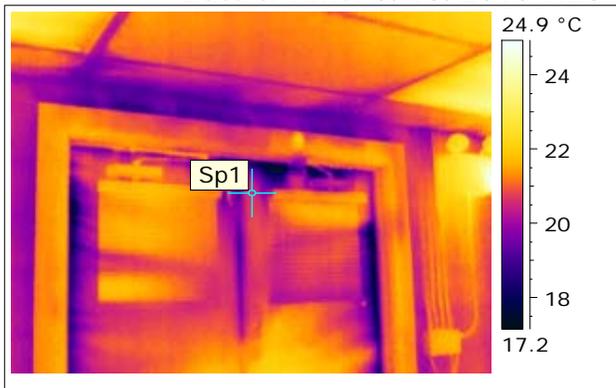
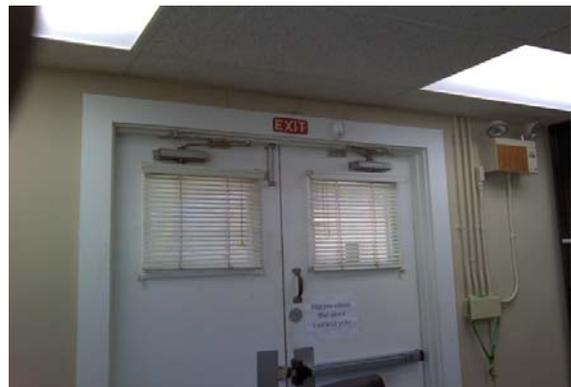
Picture 18. Captured at: (Exit doors Conference room)

Comment: Ceiling tile and door air-infiltration

Recommendation: Caulk and seal as needed. Removal of door moldings may be required. Further investigation needed.

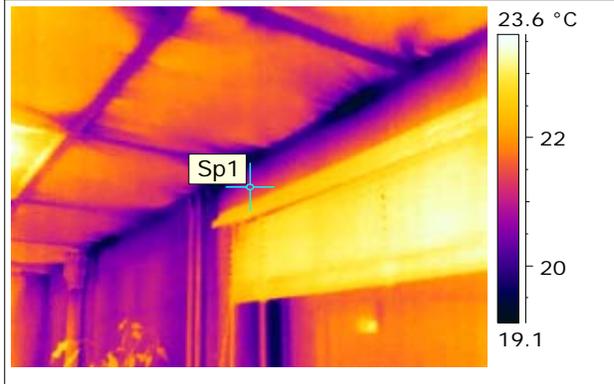
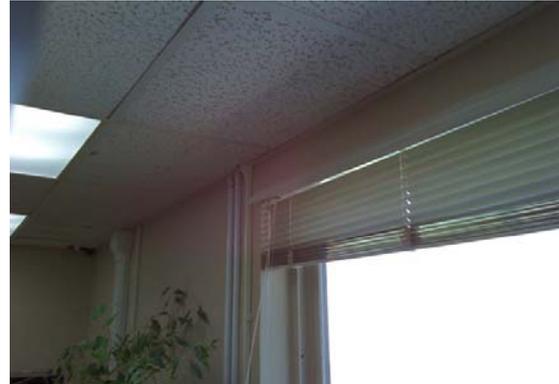
Picture 19. Captured at: (South Elevation Office)

Comment: Severe lid line and ceiling tile air-infiltration

Recommendation: Caulk and seal as needed. Removal of ceiling tile will be required for further investigation of infiltration source.

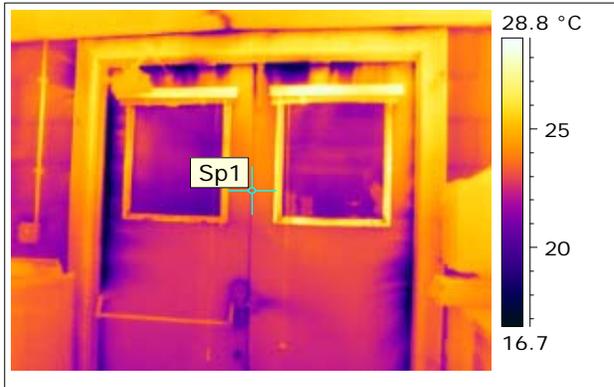
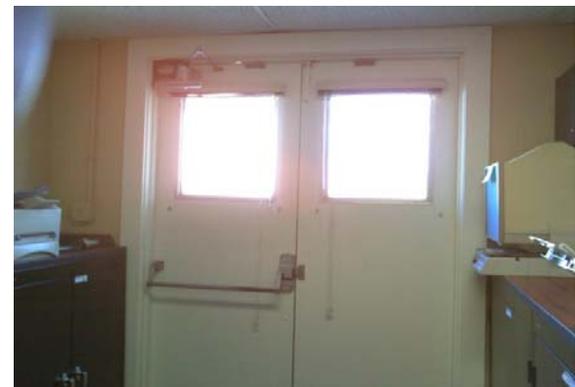
Picture 20. Captured at: (Exit Door 2)

Comment: Air-infiltration around door, jamb and ceiling tile

Recommendation: Caulk and seal as needed. Removal of door moldings may be required. Further investigation needed.

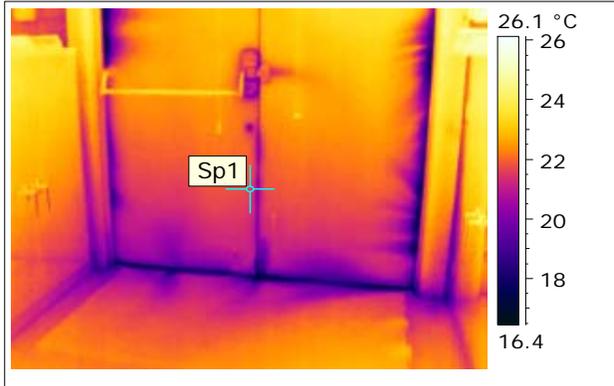
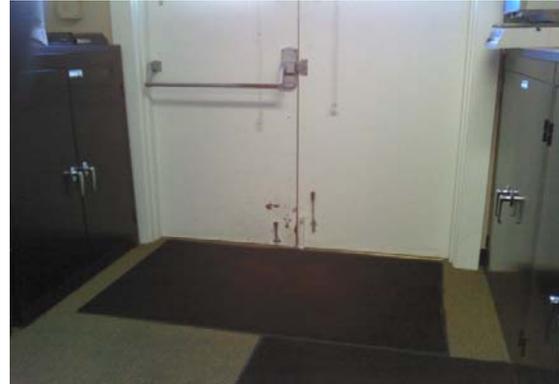
Picture 21. Captured at: (Exit Door 2)

Comment: Air-infiltration door and jamb

Recommendation: Caulk and seal as needed. Removal of door moldings may be required. Further investigation needed

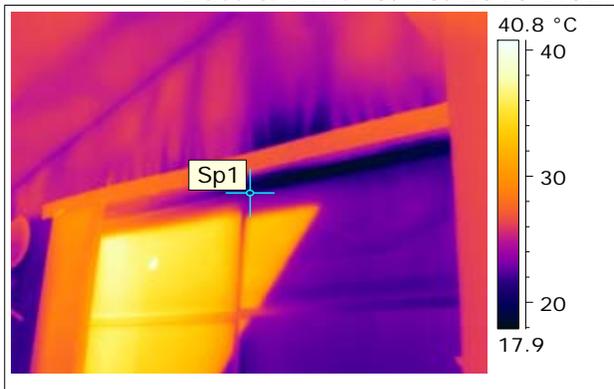
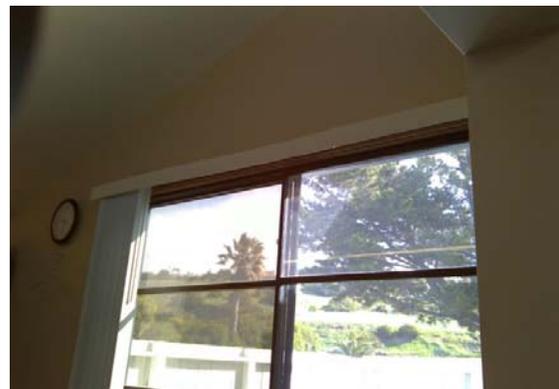
Picture 22. Captured at: (North Elevation)

Comment: Air-infiltration from window frame at courtyard location

Recommendation: Caulk and seal as needed from interior and exterior. Remove, replace and or reinstall properly as needed

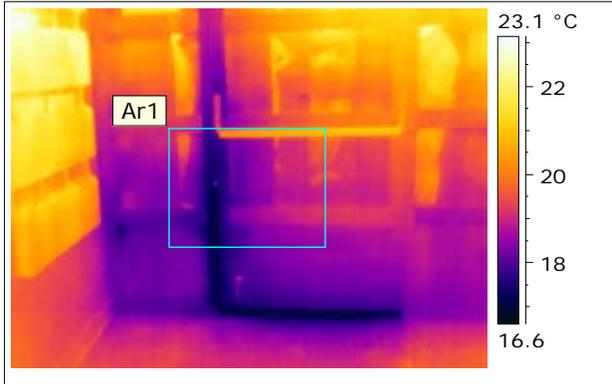
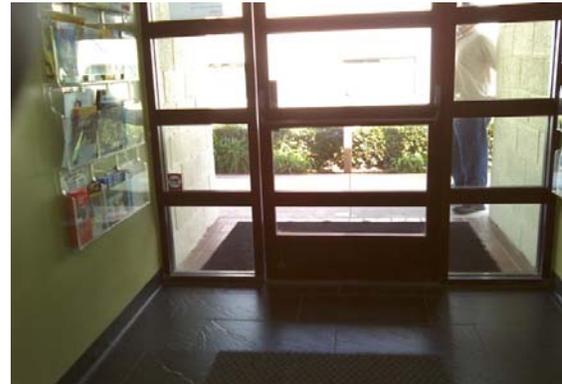
Picture 23. Captured at: (Entry)

Comment: Lower entrance door air-infiltration

Recommendation: Add weather stripping where applicable

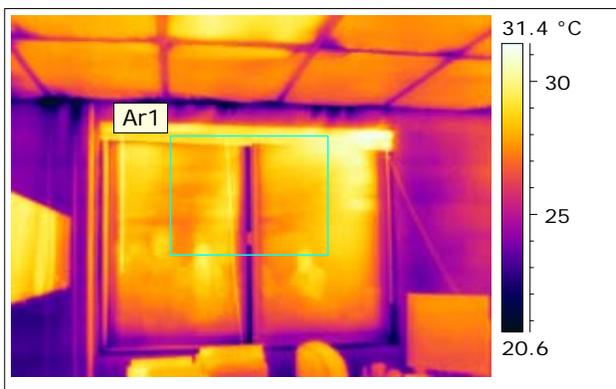
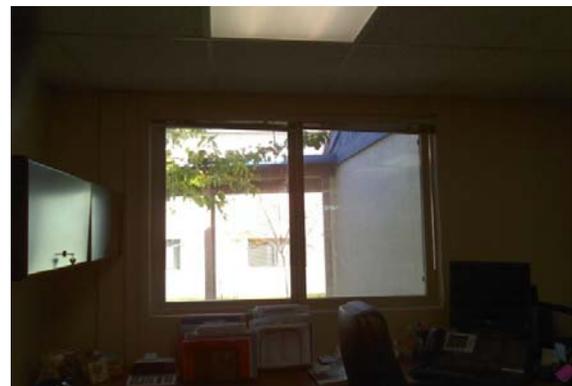
Picture 24. Captured at: (North West office adjacent to NW corner office)

Comment: Dark spots along ceiling tile line, center and bottom corners of window indicate air-infiltration. Note additional air-infiltration at corners of ceiling tile.

Recommendation: Air-infiltration at the center of the room and light warrants further investigation and testing. Removal of field tile required to be able to properly examine infiltration

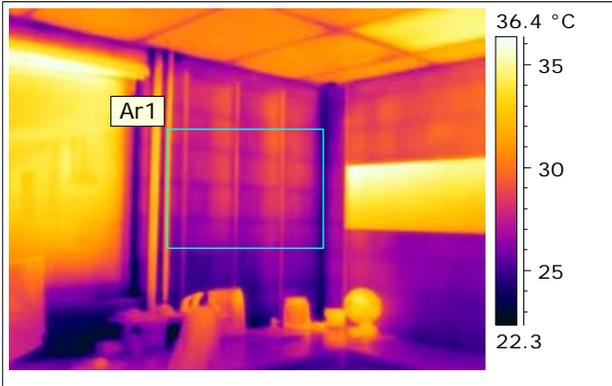
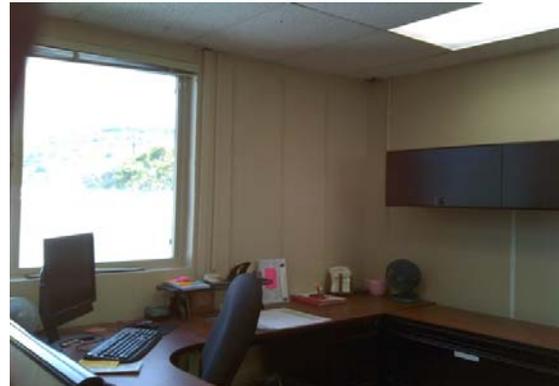
South Elevation Office

Comment: Dark spots around pipes, corners of walls, around window and along ceiling tile line indicate air-infiltration

Recommendation: Walls need to be fixed and insulated properly to meet energy standards

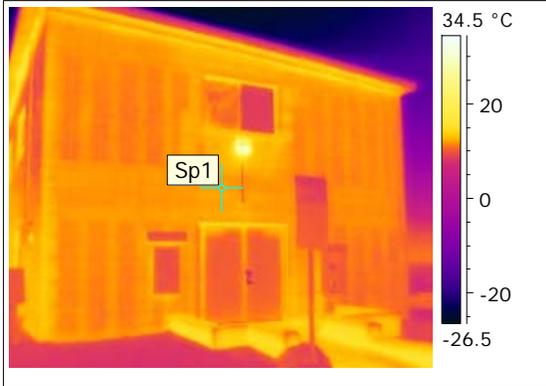
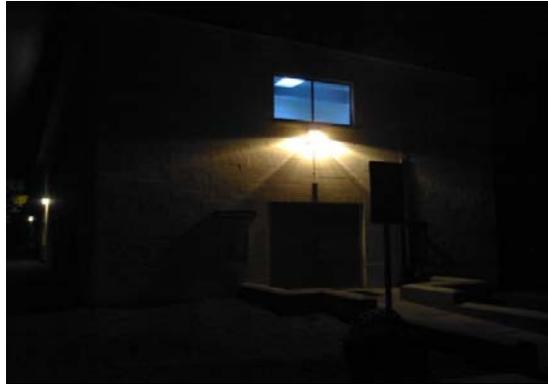
Comment: Thermal signature still acclimating across East Elevation surface. Note potential energy loss around window and door.

Recommendation: None

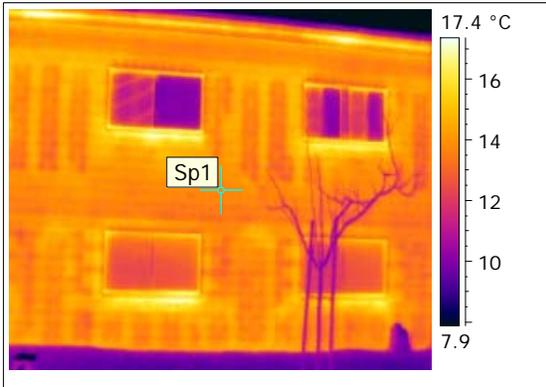
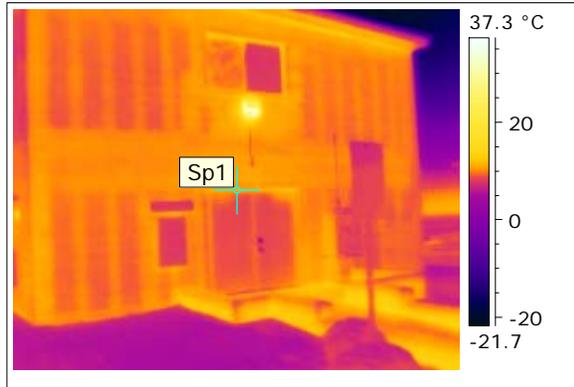
Comment: Thermal signature still settling across South Elevation surface, window frames appear to be emitting energy at tops and sides. Thermal signature of East elevation ideal for imaging.

Recommendation: Aluminum windows should be replaced with energy efficient windows and installed properly. Engineer should review and evaluate structure for integrity based on current codes.

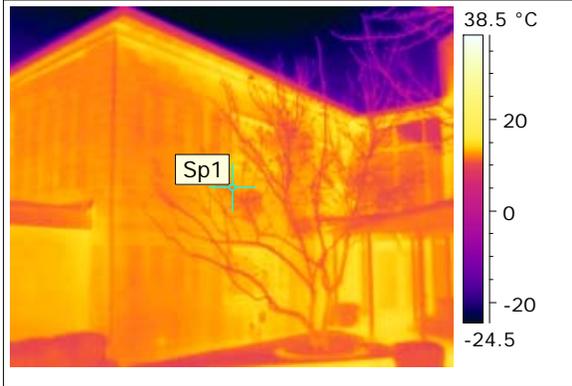
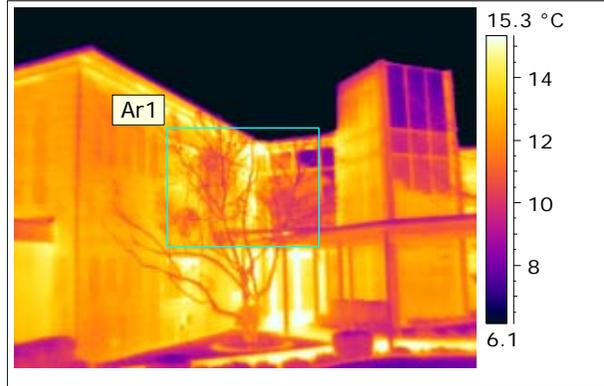
City Hall Entrance

Comment: Glass entrance indicates possible source of energy loss

Recommendation: Check glass panels for proper sealing and/or replace with properly sealed double pane insulated glass panels. Further investigation recommended.

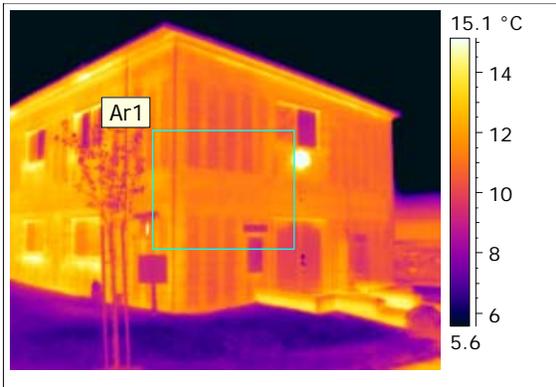
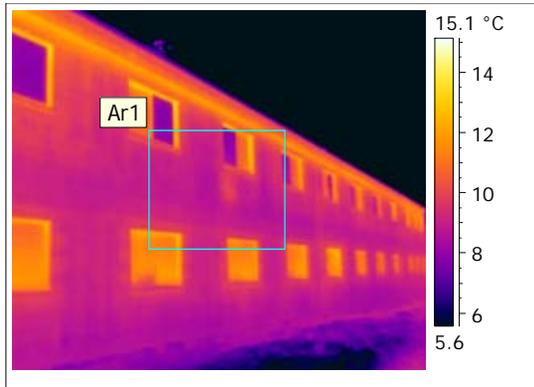
Comment: Dark spaces are empty cells, light color indicates grouted cells 2' O.C. Picture on right light color around windows indicates heat emitting through window frames

Recommendation: Engineer should review and evaluate structural concerns, replace aluminum frame windows. Proper Sealing when Installed Required.

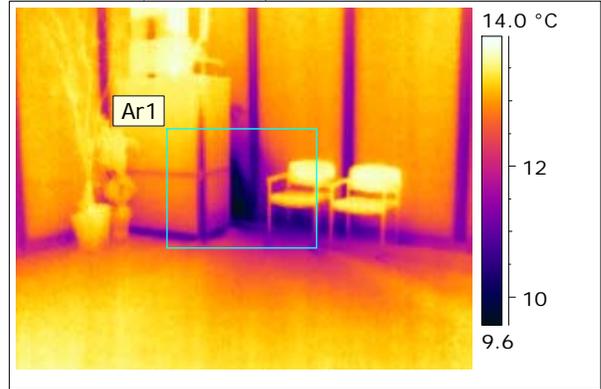
Air-leak (14"x14") behind furnace

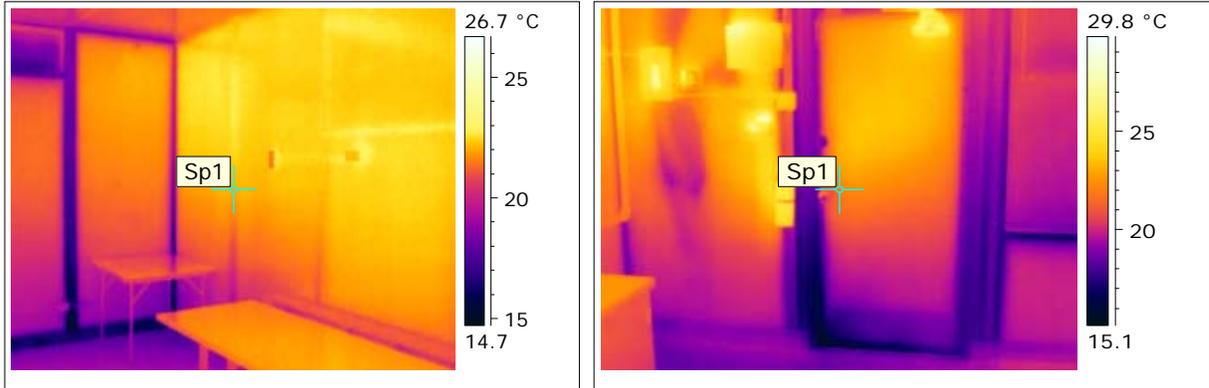
Picture 25. Captured at: (Center Room)

Comment: Dark wall mullions absorbing cooler air from outside and window and door air-infiltration

Recommendation: Further testing of materials required to determine best practice remediation for mullions, windows and door requiring weather stripping

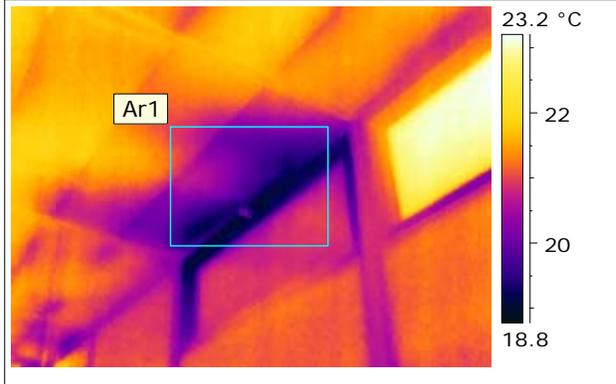
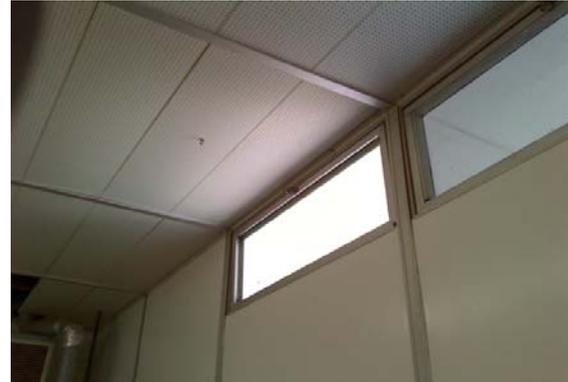
Picture 27. Captured at: (Game Room)

Comment: Severe window air-infiltration

Recommendation: Caulk and seal properly, may need replacement

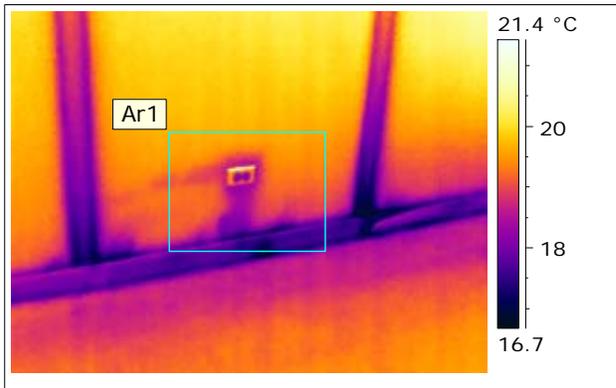
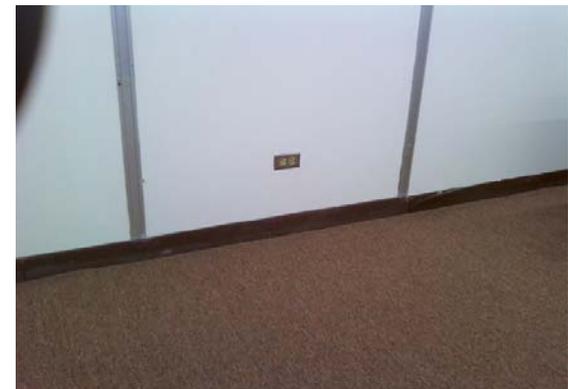
Picture 28. Captured at: (Where)

Comment: Outlet air-infiltration, Panel and sill joint air-infiltration

Recommendation: Caulk and seal behind outlet plate, Panel joints and sill molding may need to be removed to seal properly. May require additional costs once unforeseen conditions are exposed.

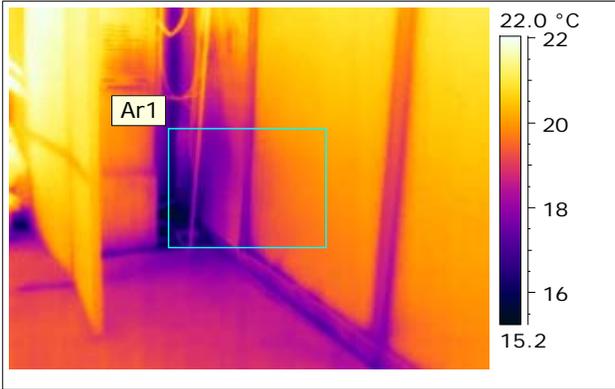
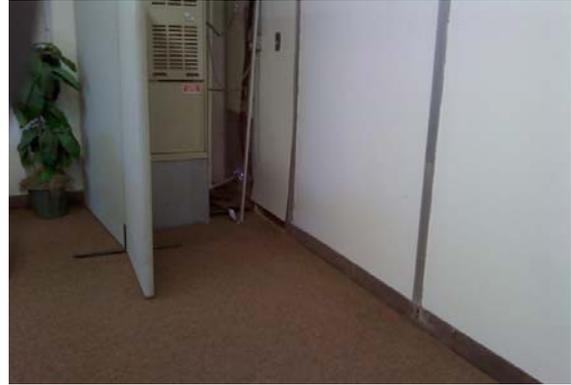
Picture 29. (Center Room)

Comment: Typical 14" x 14" hole behind furnace in wall all rooms

Recommendation: Patch as needed and re-plumb as needed
