City of Rancho Palos Verdes
Rancho Palos Verdes ADA Assessment
Facility Report with Photos

Facility ID: # 05 - Eastview Park

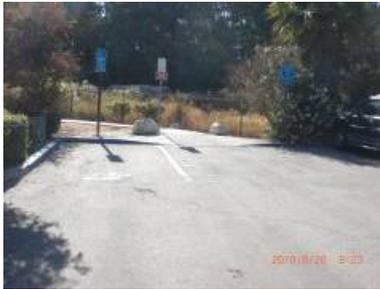
Keynote 1

Field Condition	
01.09 - Stall Dimensions - Accessible parking spaces, including van spaces, are not at least 9' wide and 18' long with a demarcated access aisle. (Two spaces may share a common aisle; parking space width is measured from the center line of the stripe on one side to the center line of the stripe on the other.)	1991 ADAAG 4.6.3
Existing Condition: 8'-10" by 18'	2004 ADAAG 502.2
	2007 CBC 1129B.3 items 1 & 2
	Other

Corrective Action	
193B - Re-stripe for Compliant Dimensions - Re-stripe to provide parking spaces with compliant dimensions.	
Additional Comments:

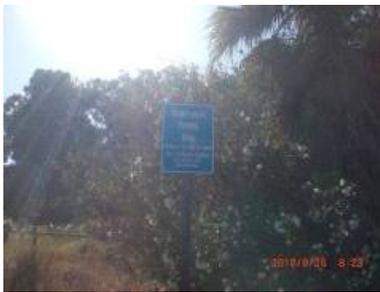
Keynote 2

Field Condition	
01.15B - Parking Space Sign - Accessible parking space has no reflectorized sign visible from the stall, showing an ISA in white on a blue background.	1991 ADAAG 4.6.4
Existing Condition:	2004 ADAAG 502.6
	2007 CBC 1129B.4
	Other

Corrective Action	
396 - Accessible Parking Sign - Provide accessible parking sign, pole-mounted to a height of 80" above finish grade measured to bottom of sign.	
Additional Comments:

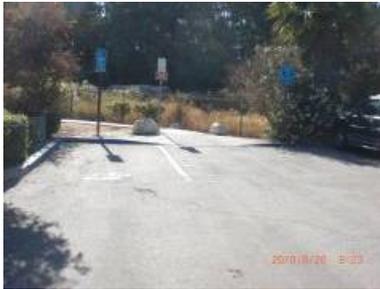
Keynote 3

Field Condition	
01.15C - Minimum Fine Sign - Accessible parking space has no sign stating "Minimum Fine \$250" below the ISA.	1991 ADAAG -
Existing Condition:	2004 ADAAG -
	2007 CBC 1129B.4
	Other

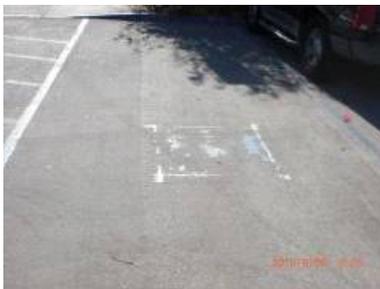
Keynote 4

Field Condition	
01.18 - Pavement Sign - A 36" square ISA is not painted on the pavement at the rear of the stall.	1991 ADAAG -
Existing Condition:	2004 ADAAG 502.6
	2007 CBC 1129B.4
	Other

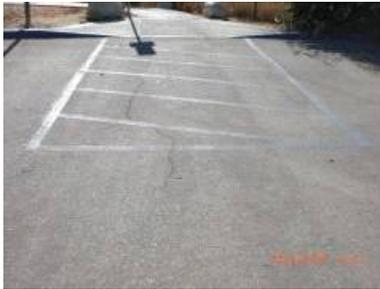
Keynote 5

Field Condition	01.19A - Lettering - The words "NO PARKING" is not provided in each access aisle, painted in white, 12" high letters.	1991 ADAAG -
Existing Condition:		2004 ADAAG -
		2007 CBC 1129B.3 items 1 & 2
		Other

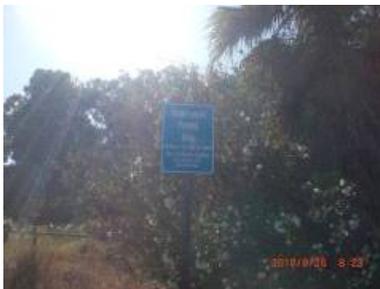
Keynote 6

Field Condition	01.19B - Tow-away Sign - A California tow-away sign is not posted in a conspicuous place at each entrance to off-street parking lot, or immediately adjacent to and visible from each accessible stall.	1991 ADAAG -
Existing Condition: Non-compliant tow-away sign, the term "Handicapped" is used.		2004 ADAAG -
		2007 CBC 1129B.4
		Other

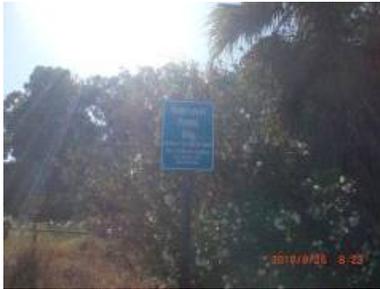
Keynote 7

Field Condition	
01.19C - Tow-away Sign - Contact Information - California tow-away sign does not include contact information.	1991 ADAAG -
Existing Condition:	2004 ADAAG -
	2007 CBC 1129B.4
	Other

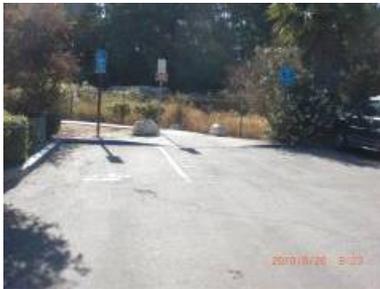
Keynote 8

Field Condition	
01.13 - Level Surface - The accessible parking spaces and access aisles are not level (slope is greater than 2%).	1991 ADAAG 4.6.3
Existing Condition: 2.6% to 4.2% RS.	2004 ADAAG 502.4; advisory 502.4
	2007 CBC 1129B.3 items 3 & 4
	Other

Corrective Action
194 - Asphalt Paved Parking Stall and Access Aisle - Remove non-compliant pavement and replace with new asphalt paving. The parking space and access aisle slope shall not exceed 2% in any direction.
Additional Comments:

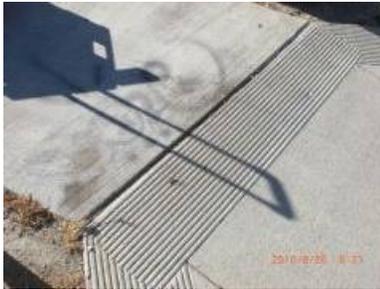
Keynote 9

Field Condition	
03B.22 - Other - On-Site Accessible Path of Travel - See Additional Comments	1991 ADAAG -
Existing Condition: 1" gap.	2004 ADAAG -
	2007 CBC -
	Other -

Corrective Action	
005B - Concrete Crack Repair - Clean-out existing concrete crack and inject with epoxy grout. Cracks over 1/4" in width will require a foam backer rod and sealant.	
Additional Comments:

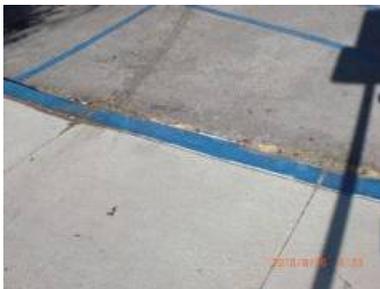
Keynote 10

Field Condition	
04.03 - Transition - The transition from the curb ramp to the road or gutter is not flush or free of abrupt changes.	1991 ADAAG 4.7.2
Existing Condition: 1" lip.	2004 ADAAG 406.2; Fig. 406.2
	2007 CBC 1127B.5 item 3
	Other 2005 PROWAG-R301.5.1

Corrective Action	
120D - Replace Curb Ramp - Remove existing curb ramp, provide new.	
Additional Comments:

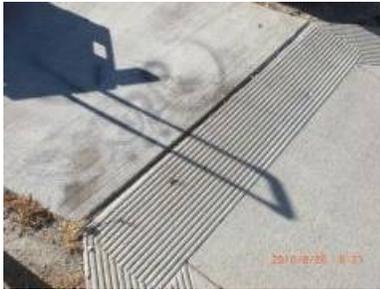
Keynote 11

Field Condition	
04.09B - Grooved Border - Location - A 12" wide grooved border has not been provided on the level surface of the walkway.	1991 ADAAG -
Existing Condition: On sloped surface.	2004 ADAAG -
	2007 CBC 1127B.5 item 6
	Other -

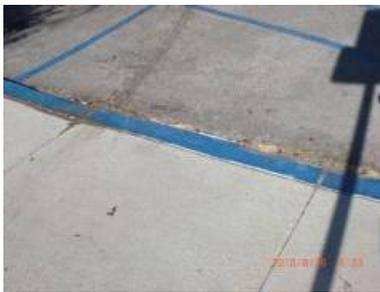
Keynote 12

Field Condition	
04.10 - Detectable Warning Requirement - Regardless of slope, the curb ramp does not have a detectable warning.	1991 ADAAG 4.7.7; 4.29.2
Existing Condition: None provided.	2004 ADAAG 705.1; Fig. 705.1
	2007 CBC 1127B.5 item 7
	Other 2005 PROWAG-R303.3.2

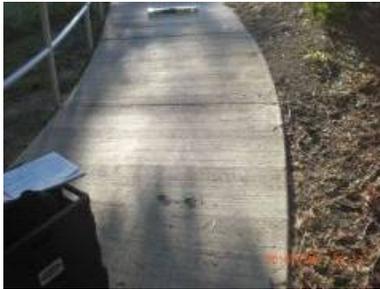
Keynote 13

Field Condition									
03B.09 - Cross Slope - Cross slope of the accessible route of travel exceeds 1:50. Existing Condition: 2.1% to 4.0% CS.

Corrective Action	
006 - Concrete Walk - Remove non-compliant pavement and replace with new concrete (area as shown on the drawings). The walkway slope shall not exceed 5% along the POT and cross slope shall not exceed 2%.	
Additional Comments:

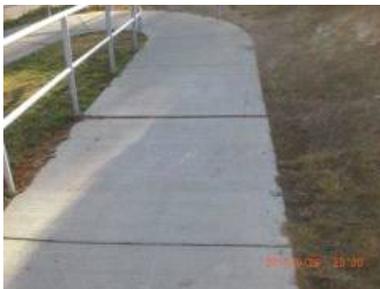
Keynote 14

Field Condition									
03B.10 - Running Slope - Slope of the accessible route of travel exceeds 1:20. Existing Condition: 5.2% RS.

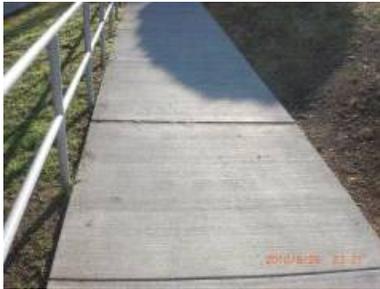
Keynote 15

Field Condition									
03B.10 - Running Slope - Slope of the accessible route of travel exceeds 1:20. Existing Condition: 5.7% RS.

Corrective Action
006 - Concrete Walk - Remove non-compliant pavement and replace with new concrete (area as shown on the drawings). The walkway slope shall not exceed 5% along the POT and cross slope shall not exceed 2%. Additional Comments: Provide concrete path with less than 5% RS.

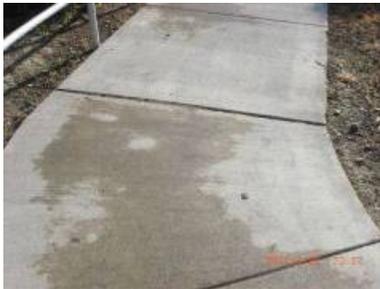
Keynote 16

Field Condition									
03B.10 - Running Slope - Slope of the accessible route of travel exceeds 1:20. Existing Condition: 5.4% to 5.8% RS.

Corrective Action
006 - Concrete Walk - Remove non-compliant pavement and replace with new concrete (area as shown on the drawings). The walkway slope shall not exceed 5% along the POT and cross slope shall not exceed 2%. Additional Comments: Provide concrete path with less than 5% RS.

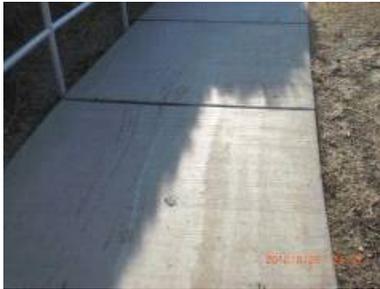
Keynote 17

Field Condition	
03B.10 - Running Slope - Slope of the accessible route of travel exceeds 1:20. Existing Condition: 5.1% to 5.6% RS.	1991 ADAAG 4.3.7 2004 ADAAG 403.3 2007 CBC 1133B.7.3 Other -

Corrective Action	
006 - Concrete Walk - Remove non-compliant pavement and replace with new concrete (area as shown on the drawings). The walkway slope shall not exceed 5% along the POT and cross slope shall not exceed 2%.	
Additional Comments: Provide concrete path with less than 5% RS.

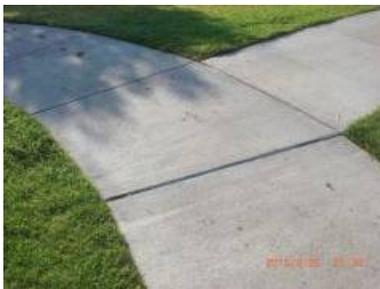
Keynote 18

Field Condition	
03B.10 - Running Slope - Slope of the accessible route of travel exceeds 1:20. Existing Condition: 5.6% RS.	1991 ADAAG 4.3.7 2004 ADAAG 403.3 2007 CBC 1133B.7.3 Other -

Corrective Action	
006 - Concrete Walk - Remove non-compliant pavement and replace with new concrete (area as shown on the drawings). The walkway slope shall not exceed 5% along the POT and cross slope shall not exceed 2%.	
Additional Comments: Provide concrete path with less than 5% RS.

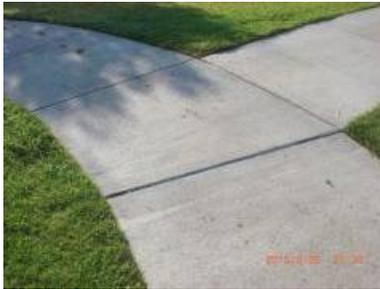
Keynote 19

Field Condition									
03B.09 - Cross Slope - Cross slope of the accessible route of travel exceeds 1:50. Existing Condition: 3.7% CS.

Corrective Action
008 - Concrete Landing - Remove non-compliant pavement and replace with new concrete. The landing slope shall not exceed 2% in any direction. Additional Comments: Provide concrete landing with a cross slope and RS of 2% or less.

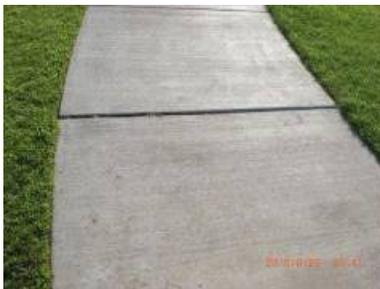
Keynote 20

Field Condition									
03B.10 - Running Slope - Slope of the accessible route of travel exceeds 1:20. Existing Condition: 5.5% RS.

Corrective Action
006 - Concrete Walk - Remove non-compliant pavement and replace with new concrete (area as shown on the drawings). The walkway slope shall not exceed 5% along the POT and cross slope shall not exceed 2%. Additional Comments: Provide concrete path with less than 5% RS.

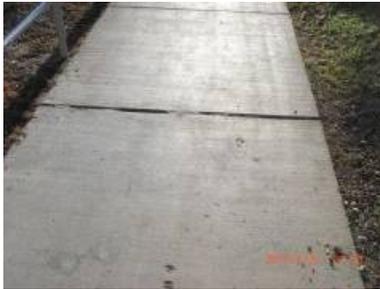
Keynote 21

Field Condition	
03B.22 - Other - On-Site Accessible Path of Travel - See Additional Comments	1991 ADAAG -
Existing Condition: 21 1" gaps throughout concrete path.	2004 ADAAG -
	2007 CBC -
	Other -

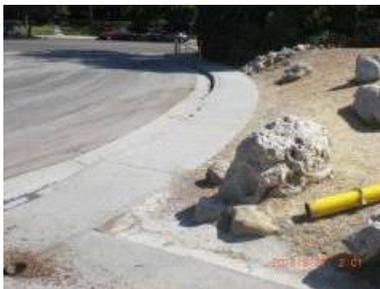
Keynote 22

Field Condition	
03B.09 - Cross Slope - Cross slope of the accessible route of travel exceeds 1:50.	1991 ADAAG 4.3.7
Existing Condition: 2.3% to 9.6% CS.	2004 ADAAG 403.3
	2007 CBC 1133B.7.1.3
	Other -

Corrective Action	
006 - Concrete Walk - Remove non-compliant pavement and replace with new concrete (area as shown on the drawings). The walkway slope shall not exceed 5% along the POT and cross slope shall not exceed 2%.	
Additional Comments:

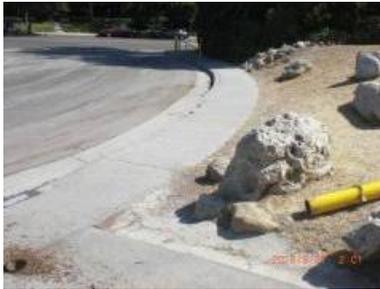
Keynote 23

Field Condition									
03B.10 - Running Slope - Slope of the accessible route of travel exceeds 1:20. Existing Condition: 5.2% to 7.8% RS.

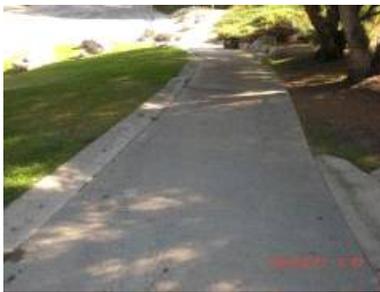
Keynote 24

Field Condition									
03B.09 - Cross Slope - Cross slope of the accessible route of travel exceeds 1:50. Existing Condition: 2.7% to 5.9% CS.

Corrective Action
006 - Concrete Walk - Remove non-compliant pavement and replace with new concrete (area as shown on the drawings). The walkway slope shall not exceed 5% along the POT and cross slope shall not exceed 2%. Additional Comments:

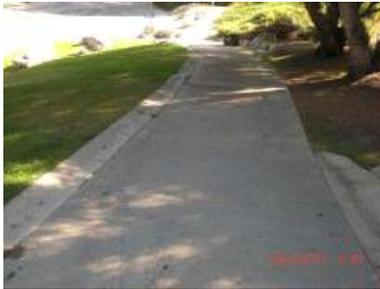
Keynote 25

Field Condition									
03B.10 - Running Slope - Slope of the accessible route of travel exceeds 1:20. Existing Condition: 6.3% to 19.6% RS.

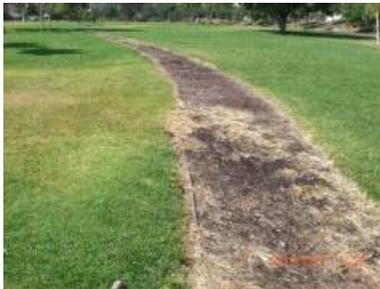
Keynote 26

Field Condition									
30.06E - Outdoor Recreation Access Route (ORAR) Segment - Cross Slope - Cross slope of the access route segment exceeds 3.33%. Exception: Cross slopes of 5% maximum are permitted to ensure proper drainage. Existing Condition: 5.1% to 6.9% CS.

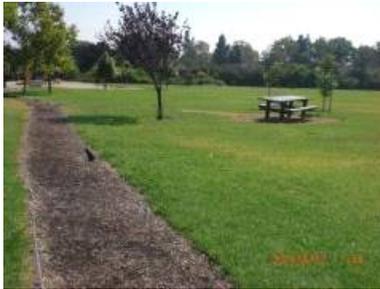
Keynote 27

Field Condition	
30.06A - Outdoor Recreation Access Route (ORAR) Segment - Running Slope - Running slope of access route segment in the direction of travel does not comply with the following: a. 5% or less for any distance. b. From 5.1% to 8.33% for 50' maximum. c. From 8.34% to 10% for 30' maximum.	1991 ADAAG - 2004 ADAAG - 2007 CBC - Other 1999 ADAAG-16.3.7.2.1; 16.3.7.2.2; 16.3.7.2.3
Existing Condition: 5.4% to 8.6% RS.

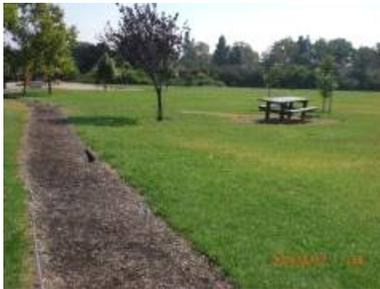
Keynote 28

Field Condition	
30.06E - Outdoor Recreation Access Route (ORAR) Segment - Cross Slope - Cross slope of the access route segment exceeds 3.33%. Exception: Cross slopes of 5% maximum are permitted to ensure proper drainage.	1991 ADAAG - 2004 ADAAG - 2007 CBC - Other 1999 ADAAG-16.3.7.1
Existing Condition: 3.6% CS.

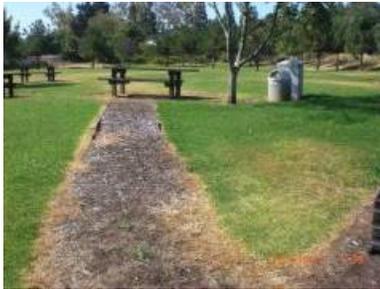
Keynote 29

Field Condition	
30.06E - Outdoor Recreation Access Route (ORAR) Segment - Cross Slope - Cross slope of the access route segment exceeds 3.33%. Exception: Cross slopes of 5% maximum are permitted to ensure proper drainage.	1991 ADAAG -
Existing Condition: 3.4% CS. & 4.1% at two locations.	2004 ADAAG -
	2007 CBC -
	Other 1999 ADAAG-16.3.7.1

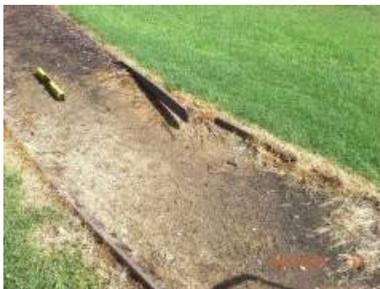
Keynote 30

Field Condition	
30.68 - Other - Parks - See Additional Comments	1991 ADAAG -
Existing Condition: Trip hazards at 7 locations.	2004 ADAAG -
	2007 CBC -
	Other -

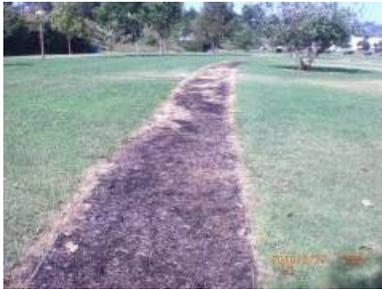
Keynote 31

Field Condition	
30.06E - Outdoor Recreation Access Route (ORAR) Segment - Cross Slope - Cross slope of the access route segment exceeds 3.33%. Exception: Cross slopes of 5% maximum are permitted to ensure proper drainage.	1991 ADAAG -
Existing Condition: 3.9% CS.	2004 ADAAG -
	2007 CBC -
	Other 1999 ADAAG-16.3.7.1

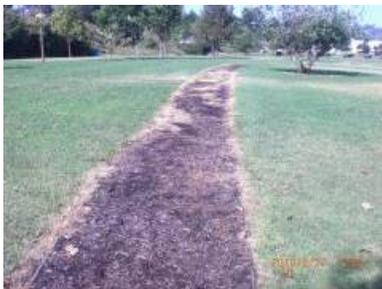
Keynote 32

Field Condition	
30.06A - Outdoor Recreation Access Route (ORAR) Segment - Running Slope - Running slope of access route segment in the direction of travel does not comply with the following: a. 5% or less for any distance. b. From 5.1% to 8.33% for 50' maximum. c. From 8.34% to 10% for 30' maximum.	1991 ADAAG -
Existing Condition: 5.1% to 9.7% RS.	2004 ADAAG -
	2007 CBC -
	Other 1999 ADAAG-16.3.7.2.1; 16.3.7.2.2; 16.3.7.2.3

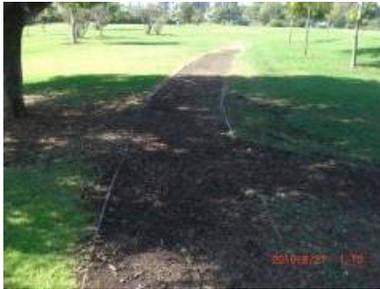
Keynote 33

Field Condition	
30.06C - Outdoor Recreation Access Route (ORAR) Surface - The surface of the access route is not firm or stable.	1991 ADAAG -
Existing Condition: Mulch surface at trail.	2004 ADAAG -
	2007 CBC -
	Other 1999 ADAAG-16.3.1

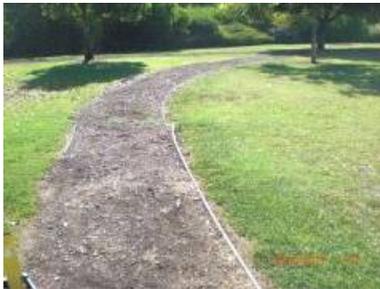
Keynote 34

Field Condition	
30.06E - Outdoor Recreation Access Route (ORAR) Segment - Cross Slope - Cross slope of the access route segment exceeds 3.33%. Exception: Cross slopes of 5% maximum are permitted to ensure proper drainage.	1991 ADAAG -
Existing Condition: 4.1% CS.	2004 ADAAG -
	2007 CBC -
	Other 1999 ADAAG-16.3.7.1

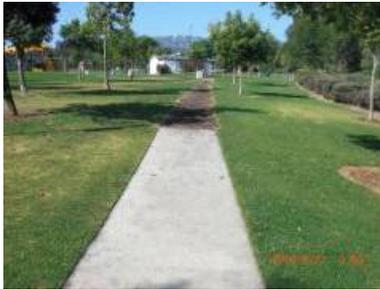
Keynote 35

Field Condition	
30.06E - Outdoor Recreation Access Route (ORAR) Segment - Cross Slope - Cross slope of the access route segment exceeds 3.33%. Exception: Cross slopes of 5% maximum are permitted to ensure proper drainage.	1991 ADAAG -
Existing Condition: 4.2% to 4.3% CS.	2004 ADAAG -
	2007 CBC -
	Other 1999 ADAAG-16.3.7.1

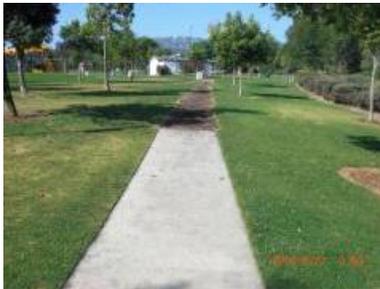
Keynote 36

Field Condition	
30.06A - Outdoor Recreation Access Route (ORAR) Segment - Running Slope - Running slope of access route segment in the direction of travel does not comply with the following: a. 5% or less for any distance. b. From 5.1% to 8.33% for 50' maximum. c. From 8.34% to 10% for 30' maximum.	1991 ADAAG -
Existing Condition: 5.3% to 11.9% RS.	2004 ADAAG -
	2007 CBC -
	Other 1999 ADAAG-16.3.7.2.1; 16.3.7.2.2; 16.3.7.2.3

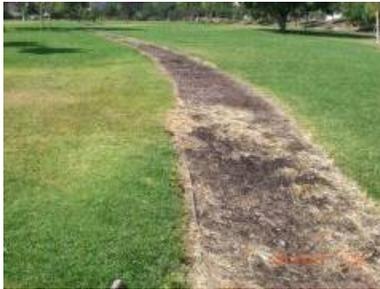
Keynote 37

Field Condition		1991 ADAAG -	
30.06B - Outdoor Recreation Access Route (ORAR) Resting Space - Resting space does not comply with 1999 ADAAG Section 16.3.8 (Resting intervals shall be 60" min. in length, shall have a width at least as wide as the access route and have a slope of 3.33% or less in any direction. The installation of resting spaces is required as follows: Percent slope, maximum length, Rest interval: 0% to 5.0%, No restriction, No restriction; 5.1% to 8.33%, 50', Every 50'; 8.34% to 10%, 30', Every 30'.)		2004 ADAAG -	
Existing Condition:		2007 CBC -	
		Other 1999 ADAAG-16.3.8

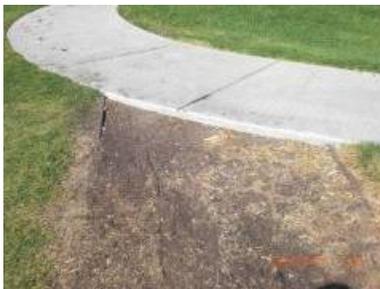
Keynote 38

Field Condition		1991 ADAAG -	
30.68 - Other - Parks - See Additional Comments		2004 ADAAG -	
Existing Condition: 2" change in level at walkway/trail merger.		2007 CBC -	
		Other -

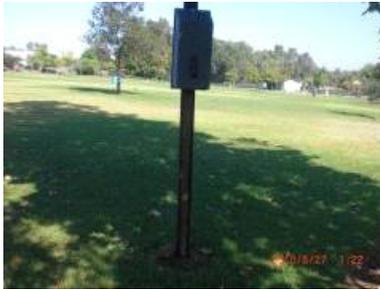
Keynote 39

Field Condition	
30.68 - Other - Parks - See Additional Comments	1991 ADAAG -
Existing Condition: Accessible path of travel to dog waste bags not provided, at three locations.	2004 ADAAG -
	2007 CBC -
	Other -

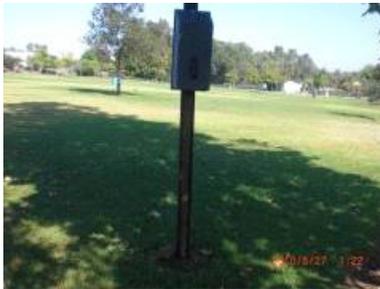
Keynote 40

Field Condition	
30.68 - Other - Parks - See Additional Comments	1991 ADAAG -
Existing Condition: 61" to dog waste bags at two locations.	2004 ADAAG -
	2007 CBC -
	Other -

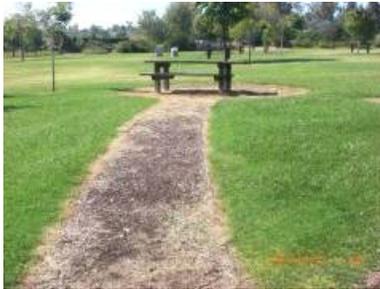
Keynote 41

Field Condition	
30.33 - Tabletop Height - Distance from the tabletop to the ground is not between 28" and 34".	1991 ADAAG 4.32.4
Existing Condition: 36" high.	2004 ADAAG 902.3
	2007 CBC 1122B.4
	Other -

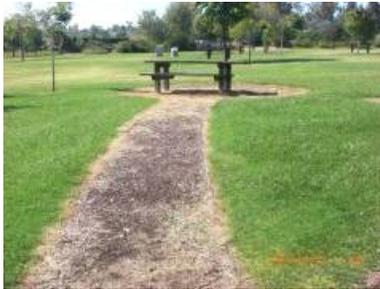
Keynote 43

Field Condition	
30.28 - Picnic Site - Surface Slope - The accessible picnic site is located on a surface area with slope greater than 2% in some or all directions.(1999 ADAAG: 3% slope is allowed when necessary for drainage).	1991 ADAAG 4.3.7
Existing Condition: 6.8% slope, uneven landing.	2004 ADAAG 403.3
	2007 CBC -
	Other 1999 ADAAG-16.5.7

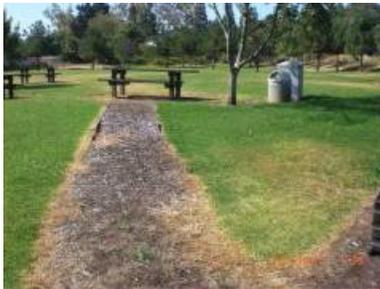
Keynote 44

Field Condition	
30.33 - Tabletop Height - Distance from the tabletop to the ground is not between 28" and 34".	1991 ADAAG 4.32.4
Existing Condition: 36" high.	2004 ADAAG 902.3
	2007 CBC 1122B.4
	Other -

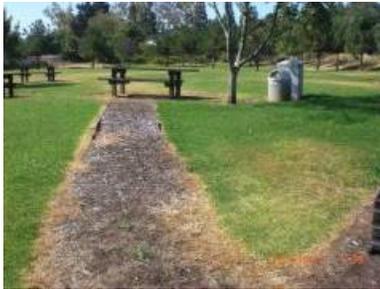
Keynote 45

Field Condition	
30.32 - 36" Aisle Width Standard - Around the picnic table, there is less than 36" clear space measured from the seat.	1991 ADAAG -
Existing Condition:	2004 ADAAG -
	2007 CBC -
	Other 1999 ADAAG-16.5.5

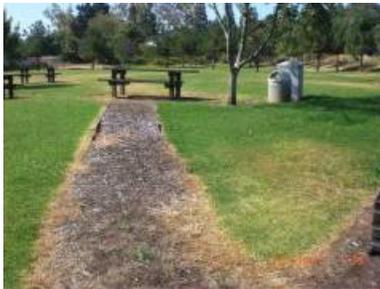
Keynote 46

Field Condition	
30.28 - Picnic Site - Surface Slope - The accessible picnic site is located on a surface area with slope greater than 2% in some or all directions.(1999 ADAAG: 3% slope is allowed when necessary for drainage).	1991 ADAAG 4.3.7
Existing Condition: 7.0% slope.	2004 ADAAG 403.3
	2007 CBC -
	Other 1999 ADAAG-16.5.7

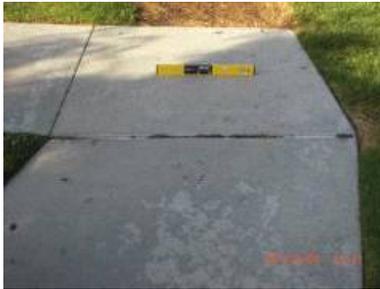
Keynote 49

Field Condition									
03B.09 - Cross Slope - Cross slope of the accessible route of travel exceeds 1:50. Existing Condition: 2.5% to 2.8% CS.

Corrective Action	
006 - Concrete Walk - Remove non-compliant pavement and replace with new concrete (area as shown on the drawings). The walkway slope shall not exceed 5% along the POT and cross slope shall not exceed 2%. Additional Comments: At turning point, cross slope shall not exceed 2% in any direction.

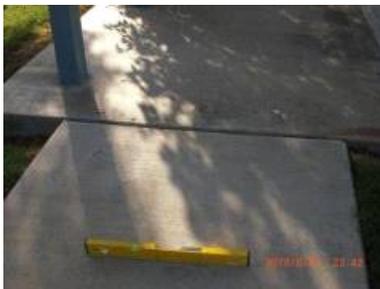
Keynote 50

Field Condition									
03B.22 - Other - On-Site Accessible Path of Travel - See Additional Comments Existing Condition: 1" gap.

Corrective Action	
005B - Concrete Crack Repair - Clean-out existing concrete crack and inject with epoxy grout. Cracks over 1/4" in width will require a foam backer rod and sealant. Additional Comments: Fill gap with epoxy grout, backer rod and sealant.

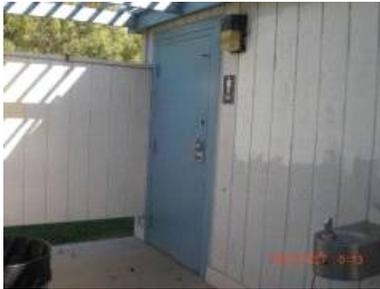
Keynote 51

Field Condition	
16.11A - Door Operating Effort - The force required to operate door exceeds 5 lbs. (Fire doors may have up to 15 lbs to achieve positive latching).	1991 ADAAG 4.13.11
Existing Condition: 11 LBF., (fire rated door).	2004 ADAAG 404.2.9
	2007 CBC 1133B.2.5
	Other -

Corrective Action
072B - Replace Closer - Replace door closer.
Additional Comments:

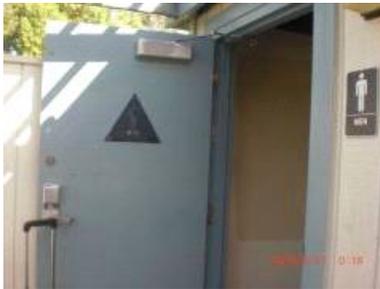
Keynote 52

Field Condition	
16.13A - Men's RR Geometric Symbol Signage - Triangle - Doorway leading to a men's toilet room is not identified by an equilateral triangle 1/4" thick with edges 12" long. OR Equilateral triangle is provided, however it is accompanied by words in raised characters and Braille. (ADA and CBC Standards require a separate sign with raised characters and Braille mounted on the wall adjacent to the latch side of the door.)	1991 ADAAG -
Existing Condition: Geometric sign on wrong side of door. Geometric sign has Braille.	2004 ADAAG -
	2007 CBC 1115B.6
	Other -

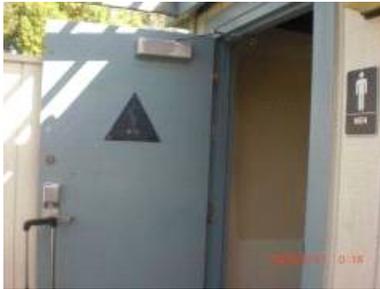
Keynote 53

Field Condition									
16.19B - Mounting Height (Visual/Tactile Signs) - Sign is not mounted at 60" o.c. AFF to the centerline of the sign. (If the sign contains pictorial symbols (pictograms) or other non-tactile information, mounting height is measured to the centerline of the tactile characters / Braille portion of the sign.)

1991 ADAAG	4.30.6	2004 ADAAG	703.4.1	2007 CBC	1117B.5.7	Other	-
1991 ADAAG	4.30.6								
2004 ADAAG	703.4.1								
2007 CBC	1117B.5.7								
Other	-								
Existing Condition: 61" high Wall Sign.

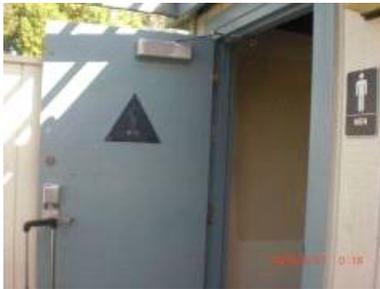
Keynote 54

Field Condition									
16.18A - ISA - Accessible toilet room is not identified by an ISA.

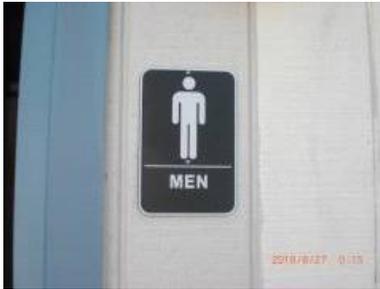
Keynote 55

Field Condition	
16.21A - Raised Characters and Braille (Visual/Tactile Signs) - The raised characters on this sign are not accompanied by California Grade 2 Braille (i.e., the dots within each cell are domed and spaced 1/10" o.c.)	1991 ADAAG 4.30.4
Existing Condition: Braille spacing too narrow.	2004 ADAAG 703.2; 703.3
	2007 CBC 1117B.5.5 item 1, 1117B.5.6
	Other -

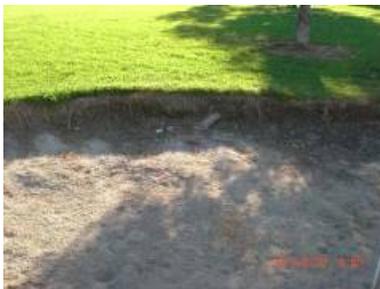
Keynote 56

Field Condition	
03B.17 - > 4" Abrupt Change in Level - Site includes abrupt changes in level adjacent to pedestrian areas exceeding 4" vertical (exceptions: (1) between a walk or sidewalk and an adjacent street or driveway, or (2) where a 6" high warning curb or guardrail is provided to warn of a potential drop off).	1991 ADAAG -
Existing Condition: 4" - 12" drop from grass area to playground area.	2004 ADAAG -
	2007 CBC 1133B.8.1
	Other -

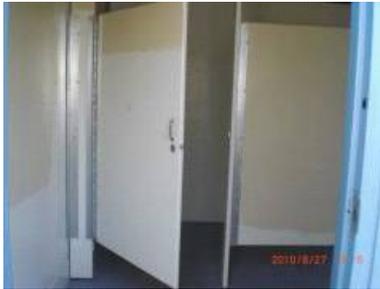
Keynote 57

Field Condition	
16.26A - Cross Slope - Cross slope of the accessible route of travel exceeds 1:50. Existing Condition: 3.5% slope at drain.	1991 ADAAG 4.3.7 2004 ADAAG 403.3 2007 CBC 1133B.7.1.3 Other -

Corrective Action	
006 - Concrete Walk - Remove non-compliant pavement and replace with new concrete (area as shown on the drawings). The walkway slope shall not exceed 5% along the POT and cross slope shall not exceed 2%.	
Additional Comments:

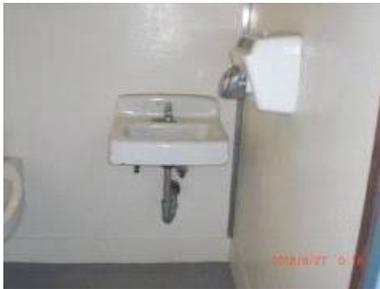
Keynote 58

Field Condition	
16.84B - Electric Hand Dryer - Operating Height - Mounting height of electric hand dryer's highest operable part exceeds 40" AFF. (Where provided, ADA Standards require at least one electric hand dryer to be accessible with the highest operable part placed within at least one of the reach ranges specified in 4.2.5 and 4.2.6; where provided, CBC Standards require at least one electric hand dryer to be accessible with the highest operable part no higher than 40" AFF.) Existing Condition: 44" AFF.	1991 ADAAG 4.22.7; 4.27.3; 4.2.5; 4.2.6 2004 ADAAG 308; 309 2007 CBC 1115B.8.3 Other -

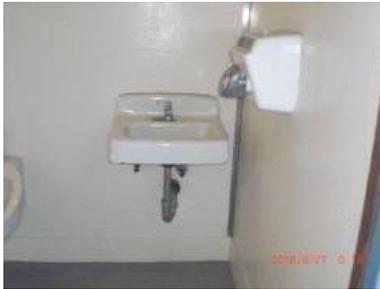
Keynote 59

Field Condition	
14.30A - Wall-Mounted Protruding Objects - Wall-mounted object(s) with leading edges between 27 and 80" from the floor project more than 4" into the pathway. (Wall mounted objects with leading edges at or below 27" may project any amount as long as the required clear width of an accessible route is not reduced.)	1991 ADAAG 4.4.1 2004 ADAAG 307.2; Fig. 307.2 2007 CBC 1133B.8.6.1 Other -
Existing Condition: Hand dryer protrudes 6 1/2" at 41" AFF.

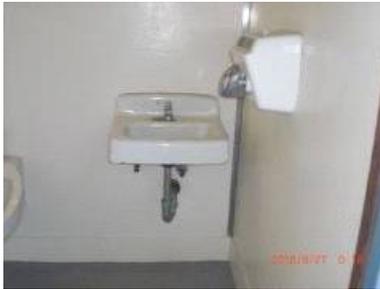
Keynote 61

Field Condition	
16.79 - Smooth Surfaces at Lavatory - The area below the lavatory is not free of sharp or abrasive surfaces.	1991 ADAAG 4.19.4
Existing Condition:	2004 ADAAG 606.5
	2007 CBC 1115B.4.3(4)
	Other -

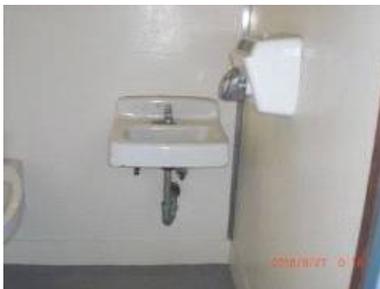
Keynote 62

Field Condition	
16.73 - Lavatory Knee Clearance - Lavatory does not provide accessible knee clearance (i.e. at least 27" clearance from the floor to the underside of the lavatory, extending 8" min.. measured from the front edge underneath the lavatory back towards the wall).	1991 ADAAG 4.19.2; Fig. 31
Existing Condition: 26" high.	2004 ADAAG 306.3; Fig. 306.3
	2007 CBC 1115B.4.3(2); Fig 11B-1D
	Other -

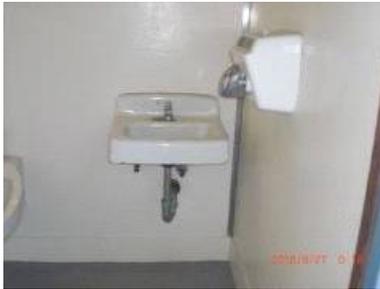
Keystone 63

Existing Condition: 14 1/2" from side wall.

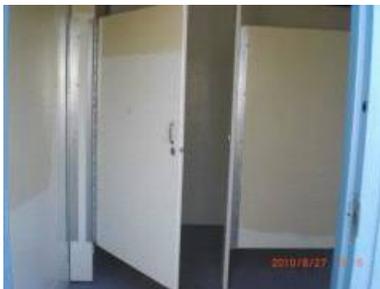
Keystone 64

Existing Condition: 57 1/2" wide.

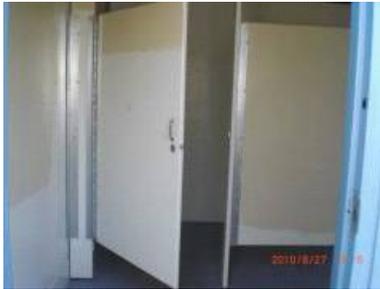
Keynote 67

Field Condition	
16.33 - Self-Closing Stall Door - The stall door is not self-closing.	1991 ADAAG 4.13.10
Existing Condition:	2004 ADAAG 604.8.1.2
	2007 CBC 1115B.3.1(4.4)
	Other -

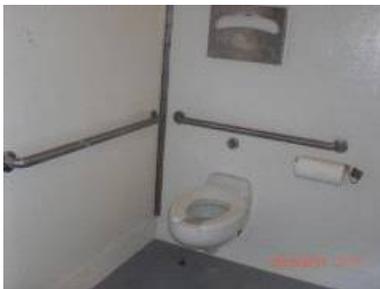
Keynote 68

Field Condition	
16.47A - WC Location from Sidewall - The centerline of the WC is not 18" absolute from a wall or partition.	1991 ADAAG 4.22.4
Existing Condition: 18 1/2" from side wall.	2004 ADAAG -
	2007 CBC 1115B.4.1(1)
	Other -

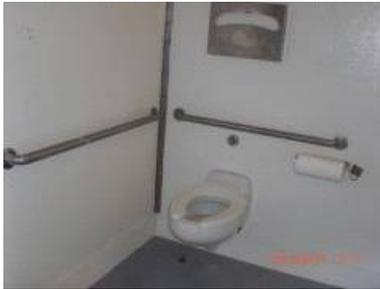
Keynote 71

Field Condition	
16.53 - SC Dispenser Height - Mounting height of seat cover dispenser's highest operable part exceeds 40" AFF.	1991 ADAAG 4.22.7; 4.27.3; 4.2.5; 4.2.6
Existing Condition: 55" AFF behind water closet.	2004 ADAAG -
	2007 CBC 1115B.8.3
	Other -

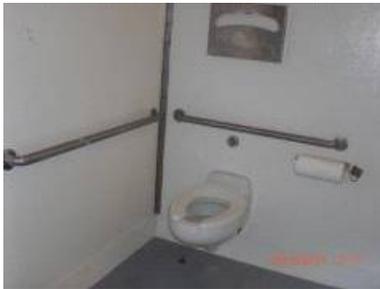
Keynote 72

Field Condition	
16.85A - Clear Floor Space at Dispensers - There is no clear floor space at least 30" x 48" in front of the dispenser to allow either a forward or a parallel approach to the dispenser. (Where provided, at least one dispenser of each type shall be accessible.)	1991 ADAAG 4.27.2; 4.2.4
Existing Condition: SCD behind WC.	2004 ADAAG 305.3
	2007 CBC 1117B.6(2); 1118B.4
	Other -
