## 1.0 Introduction

### 2.2 ~~System Evaluation~~Condition Assessment and Capacity Analysis Findings

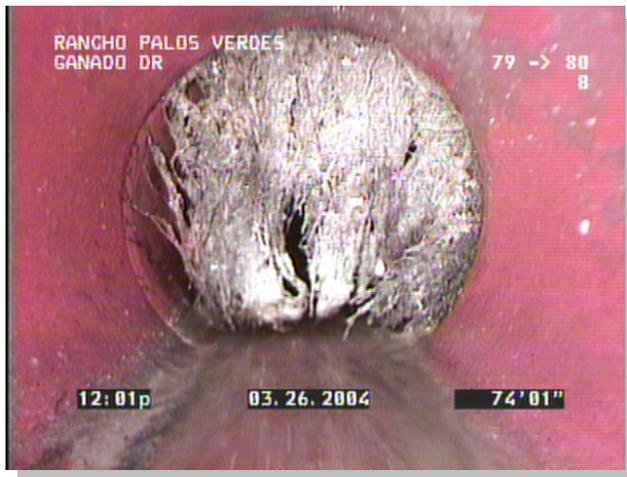
Photos of the 2006 study by the county were unavailable and the following photos show the conditions observed in the 2004 CCTV study. It is important to realize that these types of defects are typical and occur in approximately 20% of the observed system. This means that most of the system (80%) is in fair or better condition

Figure 2-1 Typical TV Observation of **Normal of Roots at Ungasketed Joint (2004)**

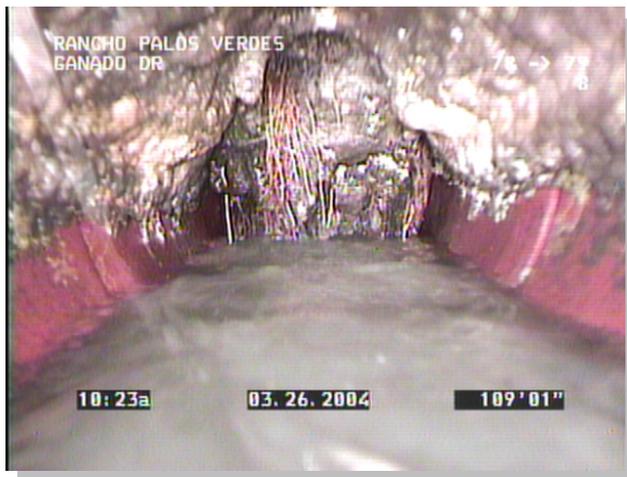
Figure 2-2 Fats, Oils and Grease (2004)

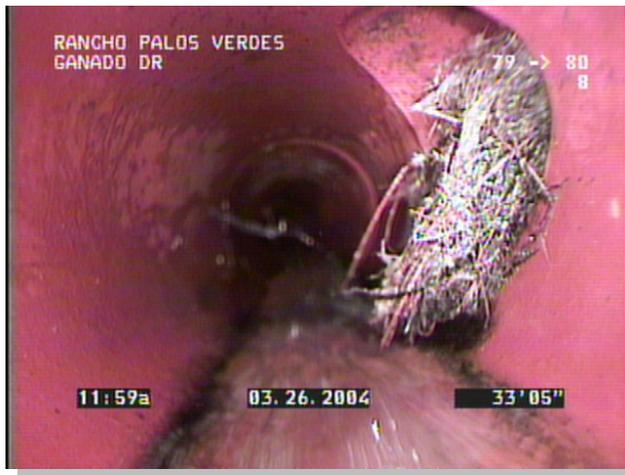
**Figure 2-3 Roots from Service Connection (2004)**

The previous photos are shown as a representative example of undesirable pipeline conditions. Note that these types of defects are found in 20% of the system inspected. The City should attain all inspection records including the photographs for inclusion in the City's GIS. This will enhance the overall management function and provide documentation of changing conditions in the system. For instance, the property owner of the lateral connection shown in Figure 2-3 should be contacted and advised of the extensive root intrusion in the lateral. Staff recognizes that this practice is not without risk as cleaning the private lateral may result in pushing roots into the city system and creating a downstream blockage.

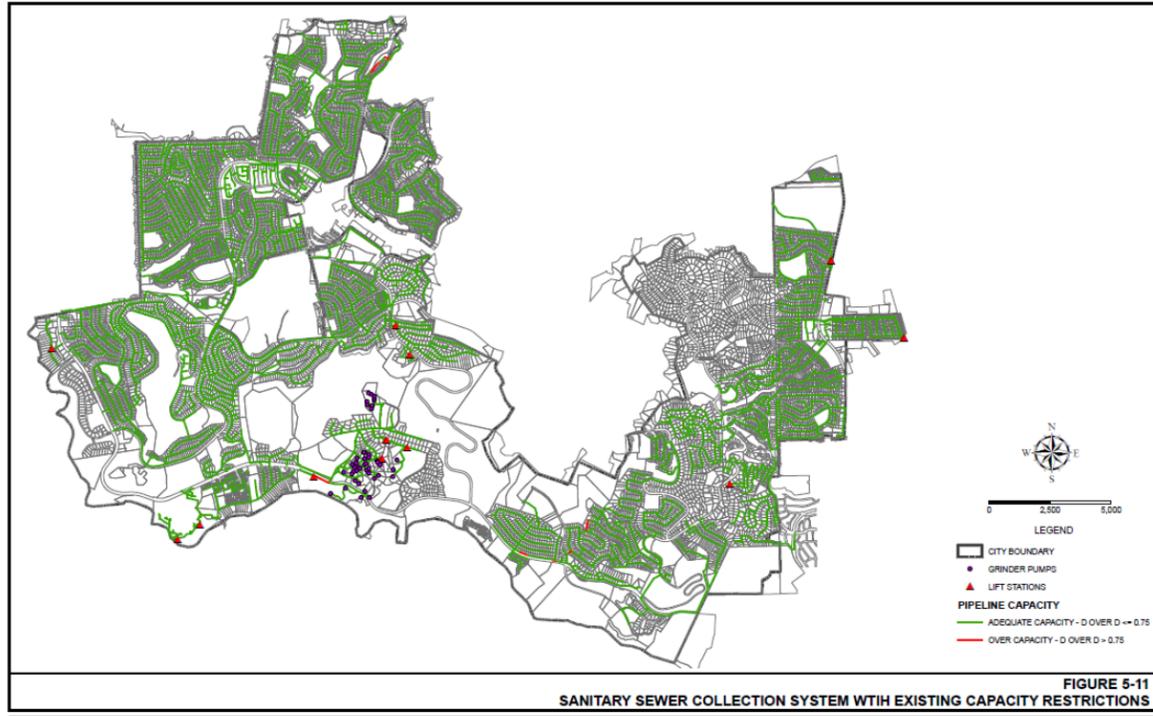
Figure 5-8 Existing Capacity Restrictions

Flow Load	Deficient Segments	% Deficient
Average Dry Weather	14	0.37%
2.5 x ADW	71	1.9%

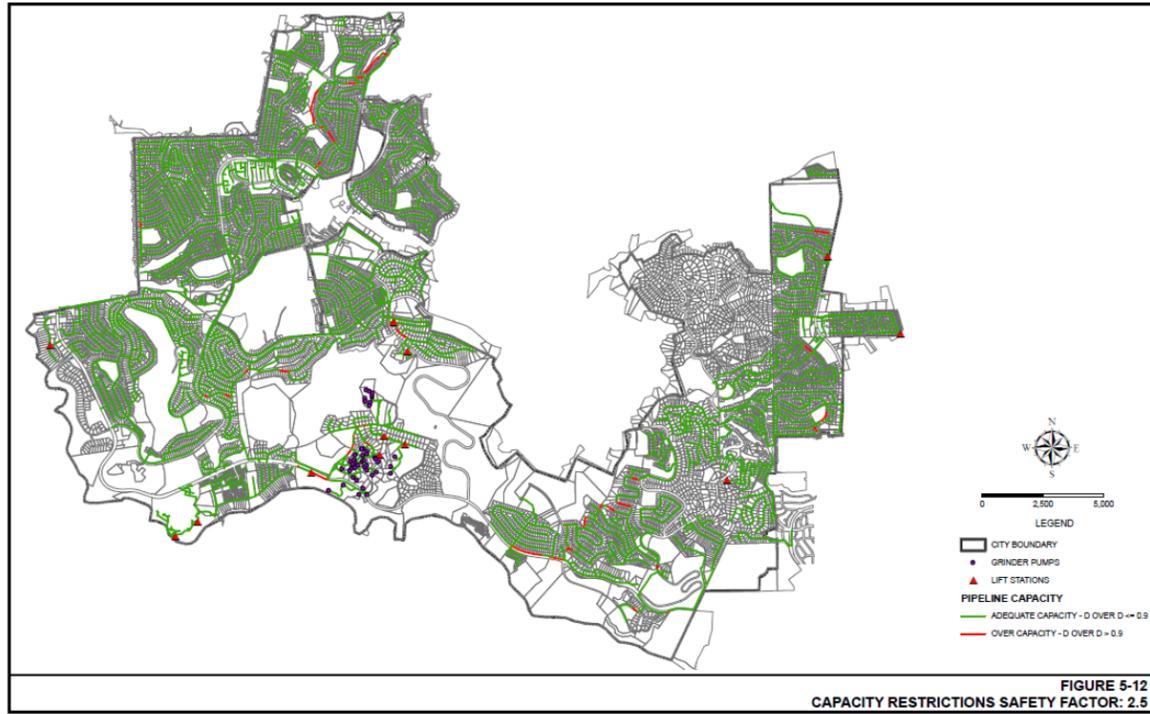
Figure 5-9 Capacity Restrictions Safety Factor = 2.5

area. Approximately 880 linear feet of pipeline is over capacity for the existing flow conditions, and 1,708 linear feet are over capacity for the 2.5 safety factor flow condition.

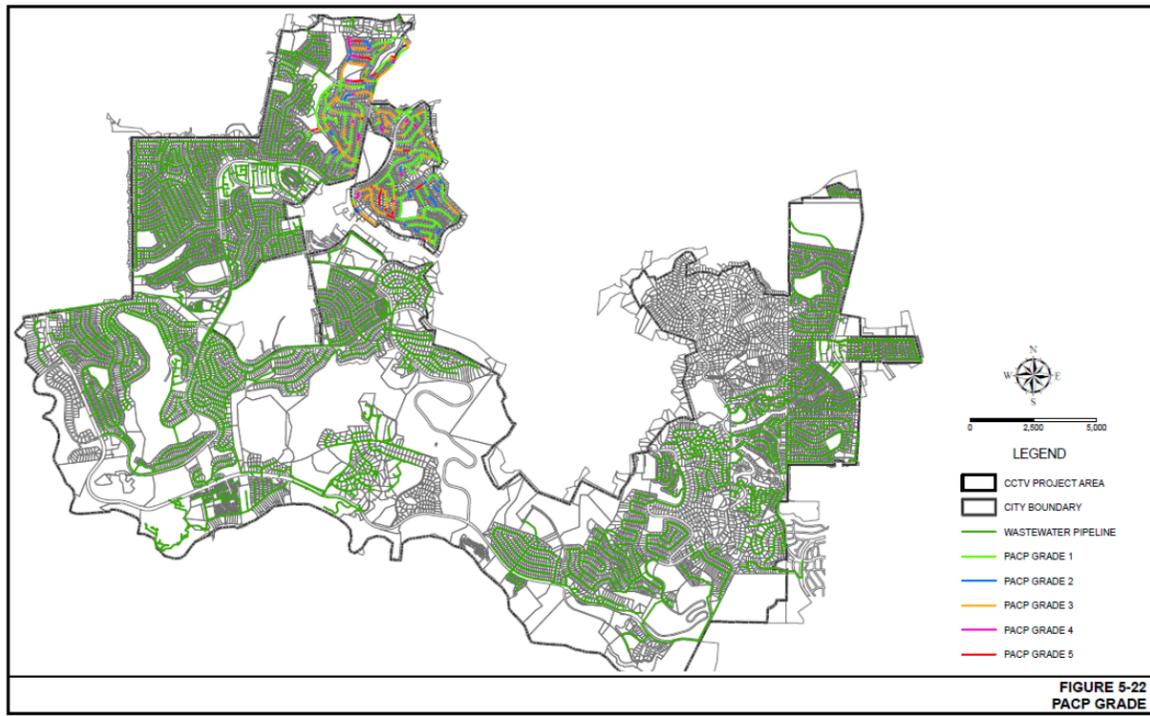
Figure 5-13 PACP Grade

Of the 388 pipe segments that were CCTV inspected, 42 were given a Structural Quick Rating of 4 or 5, meaning they were either in poor structural condition or had structural defects that required immediate attention.

Of the approximately 388 pipeline segments that were CCTV inspected, 79 were given a Pipeline Assessment and Certification Program (PACP) Maintenance Quick Rating of 4 or 5, indicating blockages, either due to roots, fats, or grease. This represents approximately 20.4% of the pipelines observed.
