DECEMBER 18, 2017
PROJECT # P1E 2017-11-011

SUBJECT SITE
LADERA LINDA PARK
32201 FORRESTAL DRIVE,
RANCHO PALOS VERDES, CA 90275
APNS: 7564001905, 7564001906, 7564001908, 7564001910,
7564001911, 7564001912, AND 7564001913
LAT: 33.737981, LONG: -118.34854

PHASE 1 ENVIRONMENTAL SITE ASSESSMENT REPORT

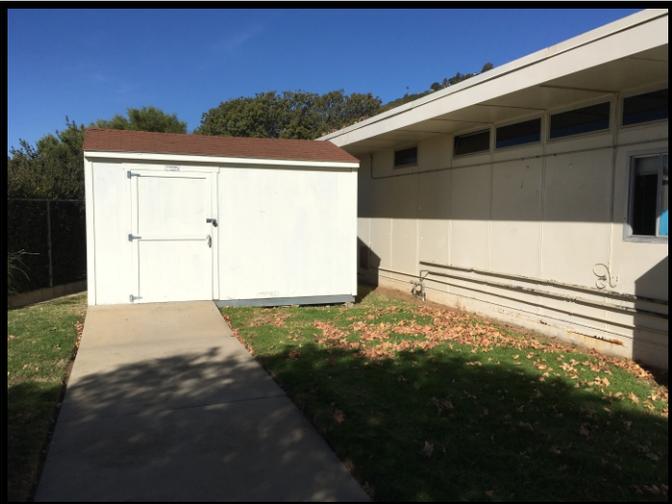
Photo #5: View of shed on southwest side of community buildings.

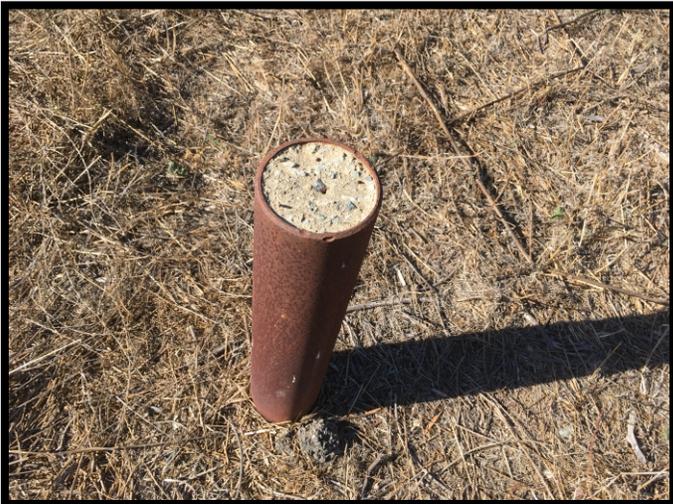
Photo #8: View of cement filled concrete pipe in lower pad area.

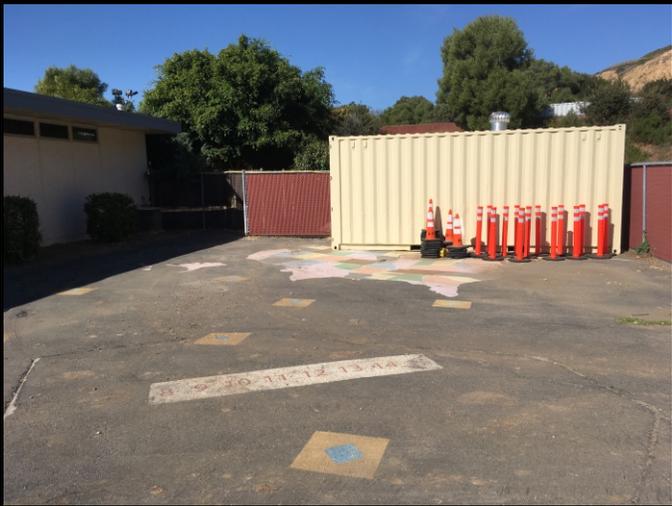
Photo #9: View of storage container in asphalt storage area.

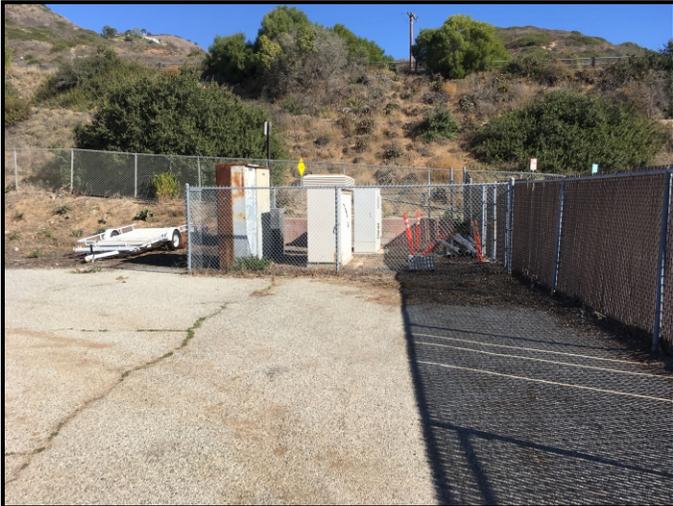
Photo #10: View of transformers on east side of property.

PCB manufacturing in the United States was discontinued in 1978. Pad-Mounted transformers were found in the vicinity of the subject building, appearing in good condition without any sign of leakage.

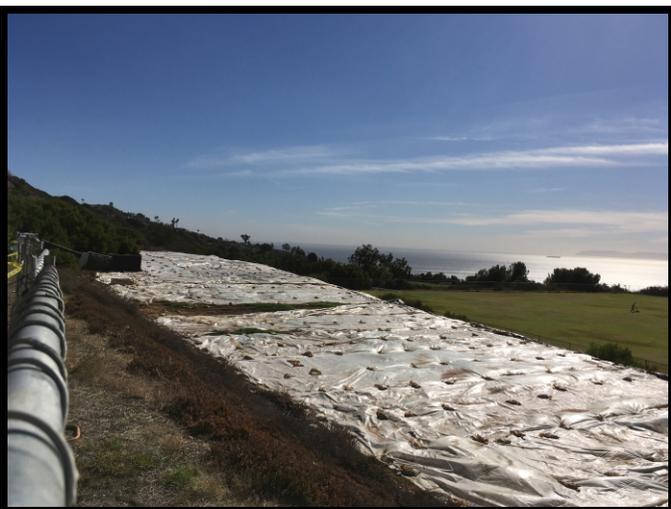
Photo #17: View of soccer fields to the north looking southeast towards the subject site.

Photo #17: Notes: This is a the property to the north which is owned by the local school district, and not included in the subject property. plastic covered stockpiles soils is an area of concern for asbestos containing materials (ACMs).

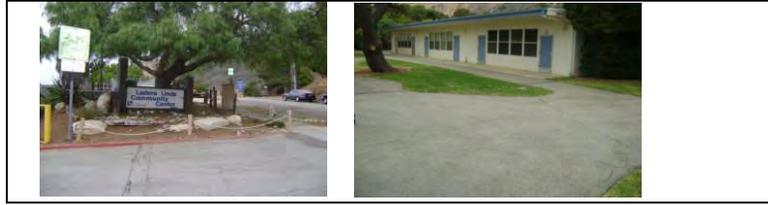
Facility No.: B8
Facility Name: Community Building
Location: Ladera Linda Community Center

Condition:

1	Background Info	Prefabricated, assembled on-site, interlocking metallic panel constructed school classroom type units.
	Year Built	1960's
	Last Renovation/Improvement	
2	Any Recent Work	
3	Any Scheduled Future Work	<p>The city is considering the rehabilitation of the of community center (CIP Plan for FY17/18)</p> <p>LADERA LINDA PARK & COMMUNITY CENTER BUILDINGS REPLACEMENT The initial stage of this project, <u>for which a budget is appropriated</u>, is to create a master plan which will lay the groundwork for the site's long-term redevelopment and phased implementation. This stage involves a study of community needs through public outreach along with contemplating the City's needs for public service facilities. This work will be followed by programming, quantifying the needs, planning and preparing a feasibility report to create a master plan which can be phased for design and construction.</p> <p>The cost calculation for Ladera Linda Buildings Replacement project is based on an estimated need for 12,000 square-feet of buildings to replace the existing 18,000 square-feet. The anticipated square footage can cover park restrooms, a staff building, multipurpose room, activity rooms, discovery room and a Park Ranger/Deputy Sheriff drop-in office. Other improvements include park grounds landscaping & irrigation, picnic tables, benches and an emergency generator. The project can be divided in three phases. The first phase will include Hazmat abatement, removal of all buildings, installation of all utility infrastructures, the construction of 6,000 SF of new building, park grounds, landscaping & improvements. The second and third phase will include 3,000 SF of new buildings each.</p> <p>For Phase 1: \$1.4 M is estimated for the park improvements and Infrastructure (20% of the \$7.2M), and \$2.6M for buildings. Phase 2 (\$3.2M) buildings only. Total for buildings is \$5.8. Not considered in investment needs.</p>

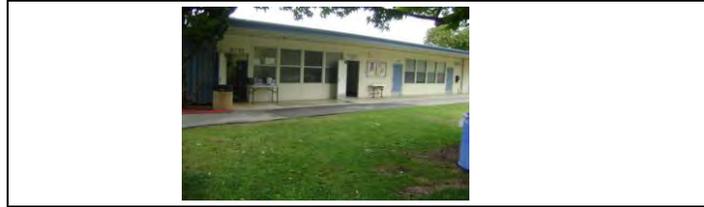
Facility No.: B9
Facility Name: Discovery Room
Location: Ladera Linda Community Center

Condition:

1	Background Info	Prefabricated, assembled on-site, interlocking metallic panel constructed school classroom type units.
	Year Built	1960's
	Last Renovation/Improvement	
2	Any Recent Work	
3	Any Scheduled Future Work	Same plan for all buildings. Details on B-8 sheet.
4	Identified Problems / Issues	Old buildings. Maintenance no longer effective. No ventilation, heating/cooling

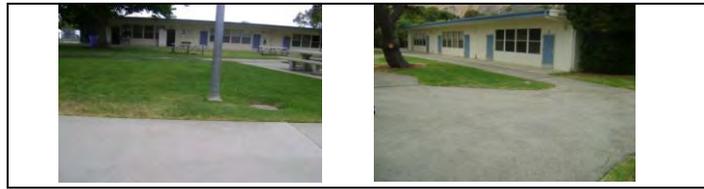
Facility No.: **B10**
 Facility Name: **Multi Purpose Room**
 Location: **Ladera Linda Community Center**

Condition:

1	Background Info	Prefabricated, assembled on-site, interlocking metallic panel constructed school classroom type units.
	Year Built	1960's
	Last Renovation/Improvement	
2	Any Recent Work	
3	Any Scheduled Future Work	
4	Identified Problems / Issues	Old buildings. Maintenance no longer effective. No ventilation, heating/cooling

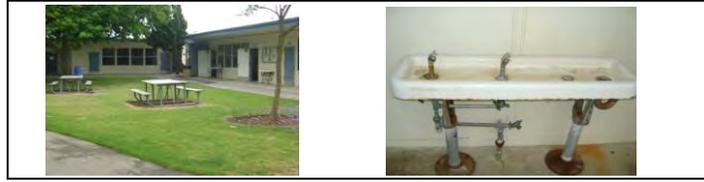
Facility No.: B11
Facility Name: Classroom
Location: Ladera Linda Community Center

Condition:

1	Background Info	Prefabricated, assembled on-site, interlocking metallic panel constructed school classroom type units.
	Year Built	1960's
	Last Renovation/Improvement	
2	Any Recent Work	
3	Any Scheduled Future Work	
4	Identified Problems / Issues	Old buildings. Maintenance no longer effective. No ventilation, heating/cooling
