City of Rancho Palos Verdes  
Rancho Palos Verdes ADA Assessment  
Facility Report with Photos

Facility ID: # Area 2 Bus Stops

Author: Vaish, B

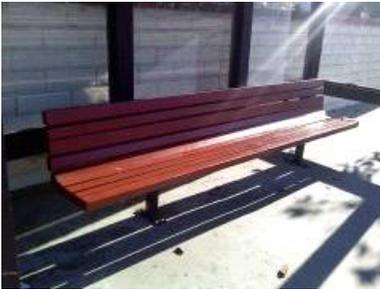
Location: Hawthorne Blvd./ Ridgeway Dr.(NB) Photo # 1

Field Condition	
02.17 - Other - Passenger Loading Zones - See Additional Comments	1991 ADAAG -
Existing Condition: Bench (16" high seat, 14" deep seat, 15" high back support).	2004 ADAAG -
	2007 CBC -
	Other

Corrective Action
027 - Site Work - Miscellaneous - See Additional Comments
Additional Comments: Provide compliant bench & relocate for clear WC seating space.

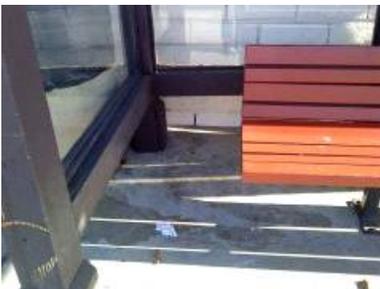
Location: Hawthorne Blvd./ Ridgeway Dr.(NB) Photo # 2

Field Condition	
02.13A - Bus Stop Shelter - Clear Floor Area - Clear floor area of 30" by 48" is not completely within the shelter.	1991 ADAAG 10.2.1(2)
Existing Condition: No WC space provided within the shelter.	2004 ADAAG 810.3
	2007 CBC 1121B.2.1
	Other

Corrective Action
027 - Site Work - Miscellaneous - See Additional Comments
Additional Comments: See Keynote 1 for corrective action.

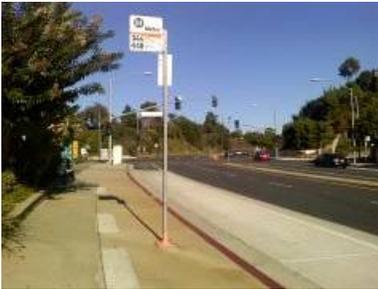
Location: Hawthorne Blvd./ Granvia Altamira (SB)  
Photo # 3

Field Condition	
02.12A - Bus Stop Pad Slope Parallel to Roadway - Bus stop pad is not at the same slope as the roadway in the direction parallel to the roadway.	1991 ADAAG 10.2.1
Existing Condition: 5.3% RS at bus pad , 3.2% RS at the road.	2004 ADAAG 810.2.4
	2007 CBC 1121B.2.1
	Other

Corrective Action
006 - Concrete Walk - Remove non-compliant pavement and replace with new concrete (area as shown on the drawings). The walkway slope shall not exceed 5% along the POT and cross slope shall not exceed 2%.
Additional Comments:

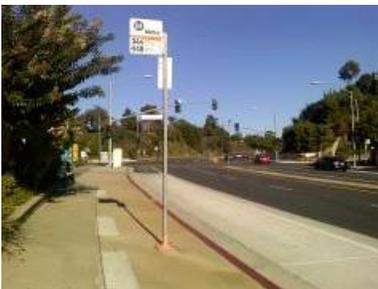
Location: Hawthorne Blvd./ Granvia Altamira (SB)  
Photo # 3

Field Condition	
02.12B - Bus Stop Pad Slope Perpendicular to Roadway - Bus stop pad slope perpendicular to the roadway exceeds 2%.	1991 ADAAG 10.2.1
Existing Condition: 3.3% CS.	2004 ADAAG 810.2.4
	2007 CBC 1121B.2.1
	Other

Corrective Action
027 - Site Work - Miscellaneous - See Additional Comments
Additional Comments: See Keynote 3 for corrective action.

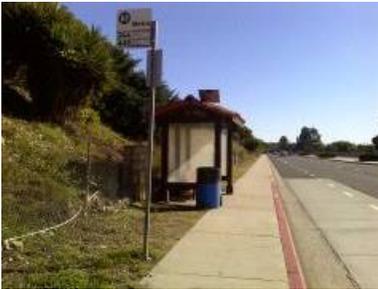
Field Condition	
02.11A - Bus Stop Pad Size - Bus stop pad does not measure 8' long (measured from the curb or vehicle roadway edge) by 5' wide (measured parallel to the vehicle roadway).	1991 ADAAG 10.2.1
	2004 ADAAG 810.2.2
	2007 CBC 1121B.1
Existing Condition: Bus pad 5' long x 5' wide.	Other

Corrective Action
006 - Concrete Walk - Remove non-compliant pavement and replace with new concrete (area as shown on the drawings). The walkway slope shall not exceed 5% along the POT and cross slope shall not exceed 2%.
Additional Comments:

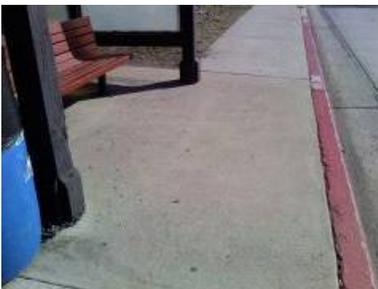
Location: Hawthorne Blvd./ Seamount Dr. (NB) Photo # 6

Field Condition	
02.17 - Other - Passenger Loading Zones - See Additional Comments	1991 ADAAG -
	2004 ADAAG -
	2007 CBC -
Existing Condition: 4.0% to 4.5% CS.	Other

Corrective Action
006 - Concrete Walk - Remove non-compliant pavement and replace with new concrete (area as shown on the drawings). The walkway slope shall not exceed 5% along the POT and cross slope shall not exceed 2%.
Additional Comments:

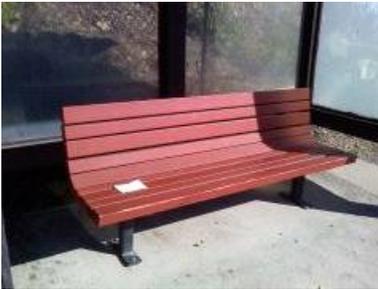
Location: Hawthorne Blvd./ Seamount Dr. (NB) Photo # 7

Field Condition	
02.13A - Bus Stop Shelter - Clear Floor Area - Clear floor area of 30" by 48" is not completely within the shelter.	1991 ADAAG 10.2.1(2)
Existing Condition: No WC space provided within the shelter.	2004 ADAAG 810.3
	2007 CBC 1121B.2.1
	Other

Corrective Action
027 - Site Work - Miscellaneous - See Additional Comments
Additional Comments: See Keynote 8 for corrective action.

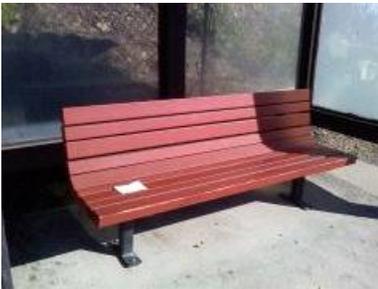
Location: Hawthorne Blvd./ Seamount Dr. (NB) Photo # 7

Field Condition	
02.17 - Other - Passenger Loading Zones - See Additional Comments	1991 ADAAG -
Existing Condition: Bench (16" high seat, 14" deep seat, 15" high back rest).	2004 ADAAG -
	2007 CBC -
	Other

Corrective Action
027 - Site Work - Miscellaneous - See Additional Comments
Additional Comments: Provide new compliant bench and relocate to allow for 30"x48" wheelchair seating space.

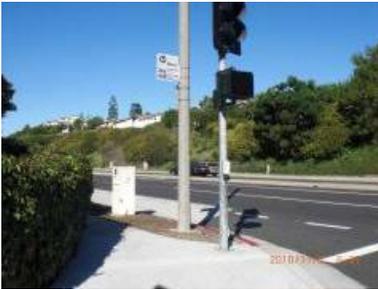
Location: Hawthorne Blvd./ Eddinghill Dr. (SB) Photo # 9

Field Condition	
02.11A - Bus Stop Pad Size - Bus stop pad does not measure 8' long (measured from the curb or vehicle roadway edge) by 5' wide (measured parallel to the vehicle roadway).	1991 ADAAG 10.2.1
	2004 ADAAG 810.2.2
	2007 CBC 1121B.1
	Other

Existing Condition: Bus pad 4' long x 5' wide.

Corrective Action
027 - Site Work - Miscellaneous - See Additional Comments
Additional Comments: See Keynote 10 for corrective action.

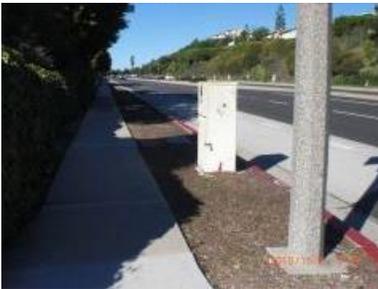
Location: Hawthorne Blvd./ Eddinghill Dr. (SB) Photo # 10

Field Condition	
02.12B - Bus Stop Pad Slope Perpendicular to Roadway - Bus stop pad slope perpendicular to the roadway exceeds 2%.	1991 ADAAG 10.2.1
	2004 ADAAG 810.2.4
	2007 CBC 1121B.2.1
	Other

Existing Condition: 3.0% CS.

Corrective Action
006 - Concrete Walk - Remove non-compliant pavement and replace with new concrete (area as shown on the drawings). The walkway slope shall not exceed 5% along the POT and cross slope shall not exceed 2%.
Additional Comments:

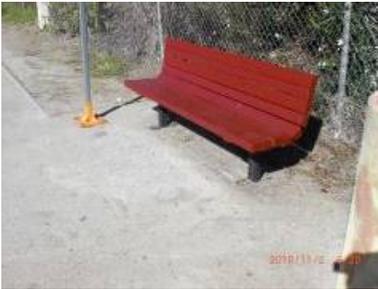
Location: Photo #  
 Hawthorne Blvd./ Verde Ridge Rd. 11  
 (NB)

Field Condition	
02.17 - Other - Passenger Loading Zones - See Additional Comments	1991 ADAAG -
Existing Condition: Bench (16" high seat, 14" deep seat, 14" high back support).	2004 ADAAG -
	2007 CBC -
	Other

Corrective Action
027 - Site Work - Miscellaneous - See Additional Comments
Additional Comments: Provide compliant bench.

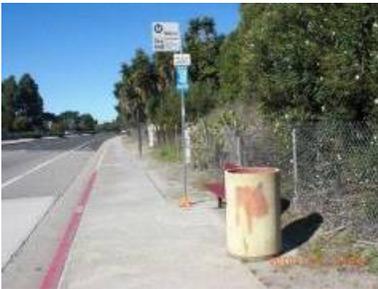
Location: Photo #  
 Hawthorne Blvd./ Verde Ridge Rd. 12  
 (NB)

Field Condition	
02.17 - Other - Passenger Loading Zones - See Additional Comments	1991 ADAAG -
Existing Condition: 2.5% to 2.8% CS.	2004 ADAAG -
	2007 CBC -
	Other

Corrective Action
006 - Concrete Walk - Remove non-compliant pavement and replace with new concrete (area as shown on the drawings). The walkway slope shall not exceed 5% along the POT and cross slope shall not exceed 2%.
Additional Comments:

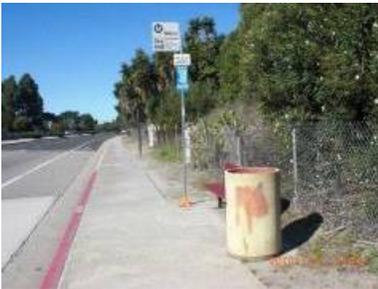
Location: Hawthorne Blvd./ Verde Ridge Rd. (NB)  
Photo # 12

Field Condition	
02.11A - Bus Stop Pad Size - Bus stop pad does not measure 8' long (measured from the curb or vehicle roadway edge) by 5' wide (measured parallel to the vehicle roadway).	1991 ADAAG 10.2.1
	2004 ADAAG 810.2.2
	2007 CBC 1121B.1
Existing Condition: Bus pad 6' long x 5' wide.	Other

Corrective Action	
006 - Concrete Walk - Remove non-compliant pavement and replace with new concrete (area as shown on the drawings). The walkway slope shall not exceed 5% along the POT and cross slope shall not exceed 2%.	
Additional Comments:

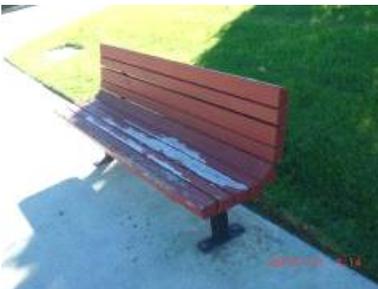
Location: Hawthorne Blvd./ Hesse Park (SB)  
Photo # 14

Field Condition	
02.17 - Other - Passenger Loading Zones - See Additional Comments	1991 ADAAG -
Existing Condition: Bench (16" high seat, 14" deep seat, 14 1/2" high back support).	2004 ADAAG -
	2007 CBC -
	Other

Corrective Action	
027 - Site Work - Miscellaneous - See Additional Comments	
Additional Comments: Provide compliant bench.

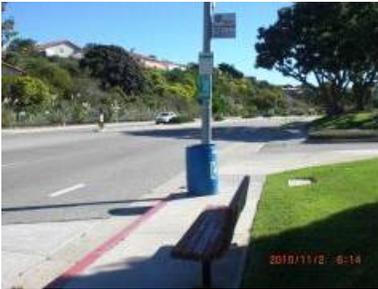
Location: Hawthorne Blvd./ Hesse Park (SB) Photo # 15

Field Condition	
02.11A - Bus Stop Pad Size - Bus stop pad does not measure 8' long (measured from the curb or vehicle roadway edge) by 5' wide (measured parallel to the vehicle roadway).	1991 ADAAG 10.2.1
	2004 ADAAG 810.2.2
	2007 CBC 1121B.1
	Other
Existing Condition: Bus pad 5' long x 5' wide.

Corrective Action
006 - Concrete Walk - Remove non-compliant pavement and replace with new concrete (area as shown on the drawings). The walkway slope shall not exceed 5% along the POT and cross slope shall not exceed 2%.
Additional Comments:

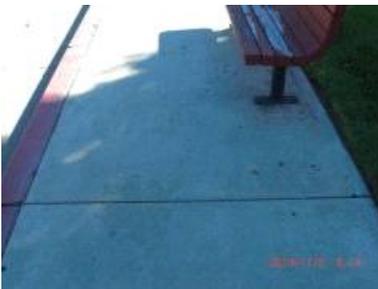
Location: Hawthorne Blvd./ Hesse Park (SB) Photo # 16

Field Condition	
02.17 - Other - Passenger Loading Zones - See Additional Comments	1991 ADAAG -
	2004 ADAAG -
	2007 CBC -
	Other
Existing Condition: 2.6% to 3.6% CS.

Corrective Action
006 - Concrete Walk - Remove non-compliant pavement and replace with new concrete (area as shown on the drawings). The walkway slope shall not exceed 5% along the POT and cross slope shall not exceed 2%.
Additional Comments:

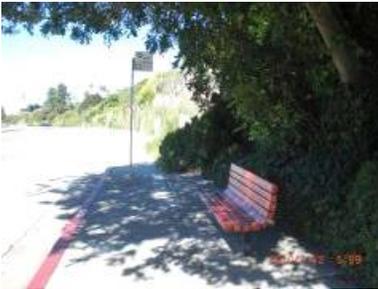
Location: Photo #  
Hawthorne Blvd./ Indian Valley Rd. 17  
(NB)

Field Condition	
02.12B - Bus Stop Pad Slope Perpendicular to Roadway - Bus stop pad slope perpendicular to the roadway exceeds 2%.	1991 ADAAG 10.2.1
Existing Condition: 4.3% CS.	2004 ADAAG 810.2.4
	2007 CBC 1121B.2.1
	Other

Corrective Action	
006 - Concrete Walk - Remove non-compliant pavement and replace with new concrete (area as shown on the drawings). The walkway slope shall not exceed 5% along the POT and cross slope shall not exceed 2%.	
Additional Comments:

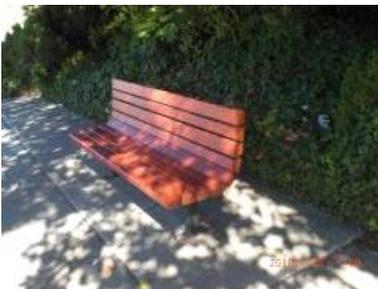
Location: Photo #  
Hawthorne Blvd./ Indian Valley Rd. 18  
(NB)

Field Condition	
02.17 - Other - Passenger Loading Zones - See Additional Comments	1991 ADAAG -
Existing Condition: Bench (16" high seat, 14" deep seat, 15" high back support).	2004 ADAAG -
	2007 CBC -
	Other

Corrective Action	
027 - Site Work - Miscellaneous - See Additional Comments	
Additional Comments: Provide compliant bench.

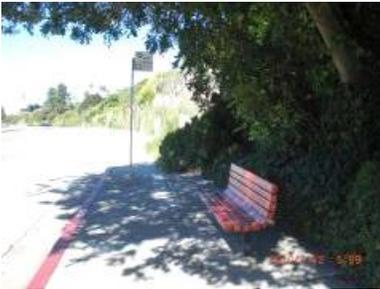
Location: Hawthorne Blvd./ Indian Valley Rd. (NB)  
 Photo # 17

02.17 - Other - Passenger Loading Zones - See Additional Comments

Existing Condition: 3.0% to 4.3% CS.

Additional Comments: See Keynote 17 for corrective action.

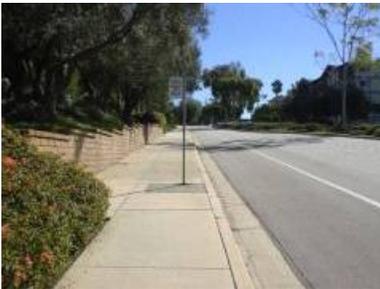
Location: Highridge Rd./ Hilltop Circle (NB)  
 Photo # 20

Existing Condition: 76" headroom clearance to bus sign.

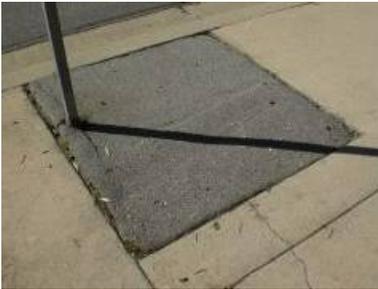
Location: Photo #  
 Highridge Rd./ Hilltop Circle (NB) 21

Field Condition	
02.17 - Other - Passenger Loading Zones - See Additional Comments	1991 ADAAG -
Existing Condition: 1 1/2" level change and gap at asphalt/ concrete transition.	2004 ADAAG -
	2007 CBC -
	Other

Corrective Action	
004A - Asphalt Paving - Remove non-compliant pavement and replace with new asphalt paving (area as shown on the drawings). The walkway slope shall not exceed 5% along the POT and cross slope shall not exceed 2%.	
Additional Comments:

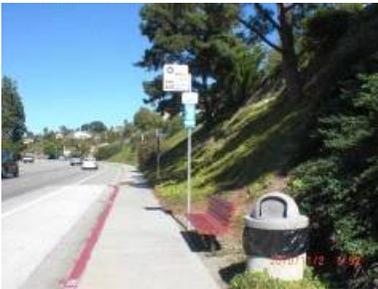
Field Condition	
02.17 - Other - Passenger Loading Zones - See Additional Comments	1991 ADAAG -
Existing Condition: Bench (16" high seat, 14" deep seat, 15" high back support, no 12" shoulder alignment).	2004 ADAAG -
	2007 CBC -
	Other

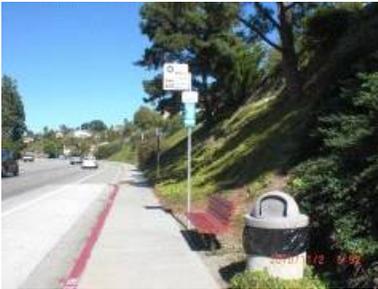
Location: Hawthorne Blvd./ Country Ln. (NB) Photo # 22

Field Condition	
02.11A - Bus Stop Pad Size - Bus stop pad does not measure 8' long (measured from the curb or vehicle roadway edge) by 5' wide (measured parallel to the vehicle roadway).	1991 ADAAG 10.2.1
	2004 ADAAG 810.2.2
	2007 CBC 1121B.1
	Other
Existing Condition: Bus pad 5' long by 5' wide.

Corrective Action
006 - Concrete Walk - Remove non-compliant pavement and replace with new concrete (area as shown on the drawings). The walkway slope shall not exceed 5% along the POT and cross slope shall not exceed 2%.
Additional Comments:

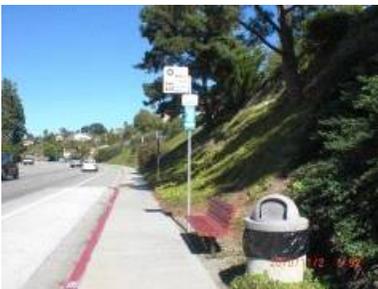
Location: Hawthorne Blvd./ Country Ln. (NB) Photo # 22

Field Condition	
02.12B - Bus Stop Pad Slope Perpendicular to Roadway - Bus stop pad slope perpendicular to the roadway exceeds 2%.	1991 ADAAG 10.2.1
	2004 ADAAG 810.2.4
	2007 CBC 1121B.2.1
	Other
Existing Condition: 2.2% CS.

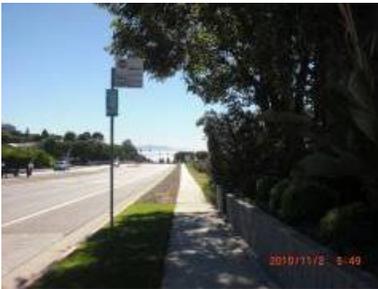
Location: Hawthorne Blvd./ Ocean Crest Dr. (SB) Photo # 25

Field Condition	
02.11A - Bus Stop Pad Size - Bus stop pad does not measure 8' long (measured from the curb or vehicle roadway edge) by 5' wide (measured parallel to the vehicle roadway).	1991 ADAAG 10.2.1
	2004 ADAAG 810.2.2
	2007 CBC 1121B.1
Existing Condition: Bus pad 4' long by 5' wide.	Other

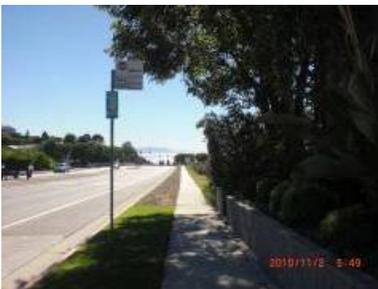
Field Condition	
02.12B - Bus Stop Pad Slope Perpendicular to Roadway - Bus stop pad slope perpendicular to the roadway exceeds 2%.	1991 ADAAG 10.2.1
	2004 ADAAG 810.2.4
	2007 CBC 1121B.2.1
Existing Condition: 2.4% CS.	Other

Corrective Action
006 - Concrete Walk - Remove non-compliant pavement and replace with new concrete (area as shown on the drawings). The walkway slope shall not exceed 5% along the POT and cross slope shall not exceed 2%.
Additional Comments:

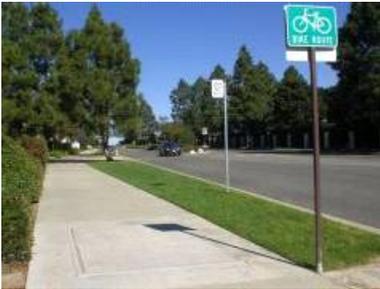
Location: Highridge Rd./ Armaga Spring Rd. (SB) Photo # 27

Field Condition	
02.11A - Bus Stop Pad Size - Bus stop pad does not measure 8' long (measured from the curb or vehicle roadway edge) by 5' wide (measured parallel to the vehicle roadway).	1991 ADAAG 10.2.1
	2004 ADAAG 810.2.2
Existing Condition: None provided (grass).	2007 CBC 1121B.1
	Other

Corrective Action
006 - Concrete Walk - Remove non-compliant pavement and replace with new concrete (area as shown on the drawings). The walkway slope shall not exceed 5% along the POT and cross slope shall not exceed 2%.
Additional Comments:
