**Survey Report**  
of the  
**Portuguese Bend Landslide 2019-2020 Monitoring Surveys**  
Date: December 8, 2019, Revised May 18, 2020  
for the  
**City of Rancho Palos Verdes**  
prepared by  
**McGee Surveying Consulting**

**Initial Survey - November 1, 2019 Full Monitoring Survey No. 25**  
**Second Survey - February 24, 2020 Partial Monitoring Survey No. 26**  
**Third Survey - April 30, 2020 Partial Monitoring Survey No. 27**

**Survey Report**  
of the  
**Portuguese Bend Land Movement Monitoring Survey**  
**Initial 2019-2020 Monitoring No. 25 November 1, 2019**  
for the  
**City of Rancho Palos Verdes**  
Prepared May 18, 2020  
by  
**McGee Surveying Consulting**

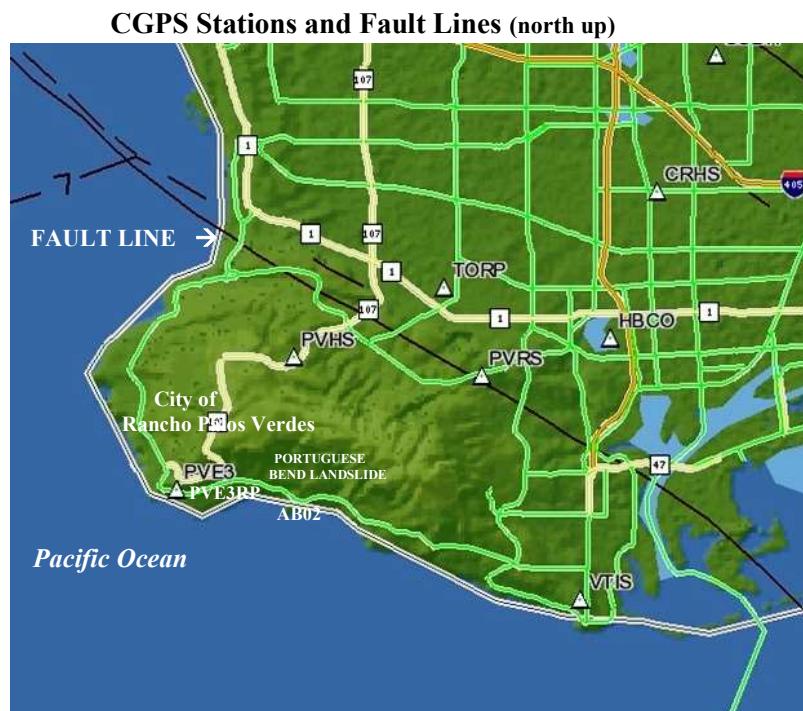
**Reference Network:** Between 2007 and 2018 the surveys were referenced by the CGPS (continuously operating GPS) Stations PVE3, PVHS, PVRS and VTIS detailed in previous Survey Reports. The CGPS in California are comparable to the national CORS (Continuously Operated Reference Stations) Network. As of May 2019, AB02 (on Portuguese Point) and PVE3RP (near City Hall) replaced the CGPS Stations as the primary monuments for the realization of the Reference Frame (see plot here).

**Datum Stability:** The City of Rancho Palos Verdes sits on the Pacific Plate which in this vicinity is moving west-northwesterly relative to the North American Plate about 4.4 centimeters (0.14 feet) per year. The area southwesterly of the Fault Line shown on the above map includes the City which includes the landslide area. This region is moving at a constant rate as exhibited below by the similar north, east and up velocities for the CGPS Stations surrounding the Portuguese Bend Landslide obtained from SOPAC. This indicates the CGPS stations used between 2007 and 2018 to realize the datum and reference frame were stable (see above plot).

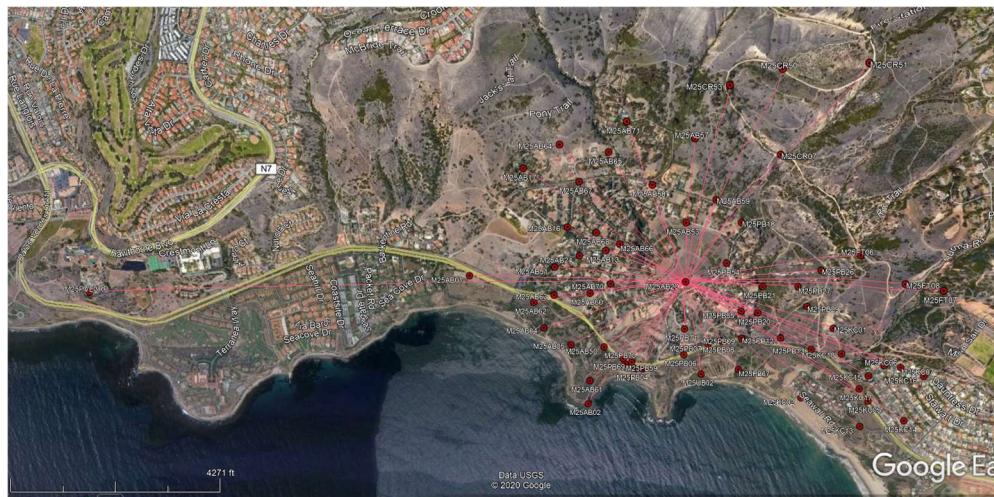
### **October-November 2019 (M25) Monitoring Network Overview (north up)**

AB61 was the primary base station and focal point of the network connecting the monitoring points and CGPS Stations since 2007. AB61 was replaced by AB20 in 2017. AB20 was replaced by AB73 in April 2020. As stated above, up until 2019 the monitoring plan utilized the CGPS Stations to recover and verify the stability of the reference frame with PVE3 (located south of RPV City Hall) being the primary control for these surveys. Over the years there have been occasional issues with obtaining data for the CGPS stations which inhibits the confirmation of the reference frame stability. After 11 years of monitoring the network, the relative positions of PVE3, AB61 and AB02 are unchanged. In 2015 a reference point (PK Nail) was set 11' southerly of PVE3 on its concrete base referred to as PVE3RP. Beginning with the October-November 2019 survey the 2018 position of AB02 (at the southeast edge of Portuguese Point) is fixed and the stability of the reference frame is confirmed by measurements to PVE3RP and AB61 and to a lesser extent to CR50 and KC16.

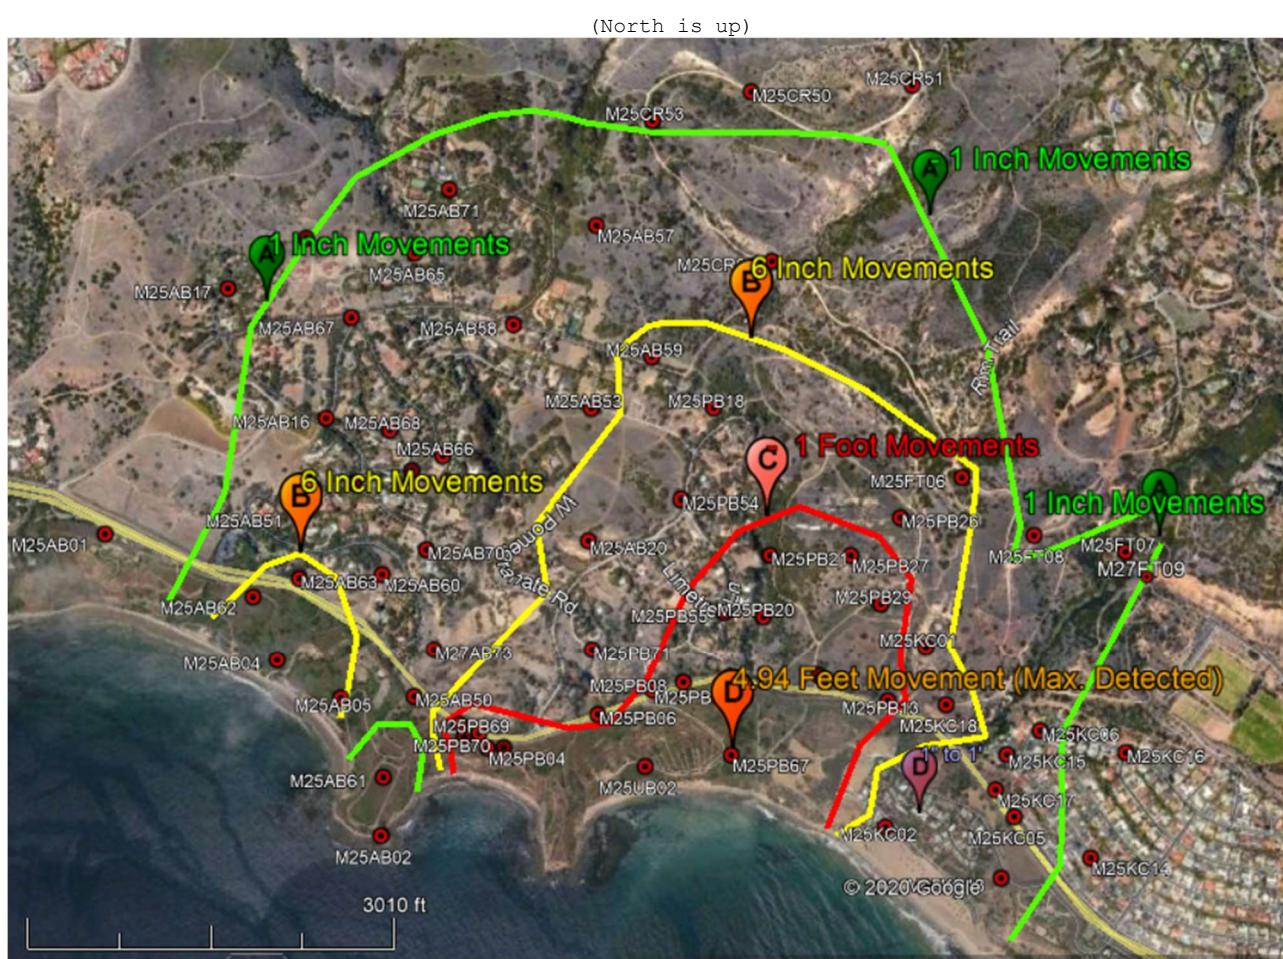
General Depiction of Horizontal Movements – Oct. 10, 2018 to Nov. 1, 2019  
(Generalized depiction of movements not to be used for planning or development purposes)

- A (Green) = Approximate 1-inch Contour Movement Line
- B (Yellow) = Approximate 6-inch Contour Movement Line
- C (Red) = Approximate 1 Foot Contour Movement Line
- D = Maximum Measured Movement of 4.9 Feet

Note: Movements approximately vary 1 inch to 6 inches between A & B, 6 inches to 1 foot between B & C, and 1 foot to 4.9 feet between C & D.

(AB##)	0.04 to 0.74
(CR##)	0.03 to 0.32
(FT##)	0.03 to 0.60
(KC##)	0.03 to 0.61
(PB##)	0.61 to 2.10 and 4.93 at PB67
(UB02)	1.90
