**Survey Report**  
of the  
**Portuguese Bend Landslide 2018-2019 Monitoring Surveys**  
Dated: June 11, 2019, Revised July 9, 2019  
for the  
**City of Rancho Palos Verdes**  
prepared by  
**McGee Surveying Consulting**

**Initial Survey - October 10, 2018 Full Monitoring Survey - No. 22**

**Survey Report**  
of the  
**Portuguese Bend Landslide Monitoring Survey**  
**October 10, 2018 Initial Monitoring No. 22**  
for the  
**City of Rancho Palos Verdes**  
Prepared June 11, 2019, Revised July 9, 2019  
by  
**McGee Surveying Consulting**

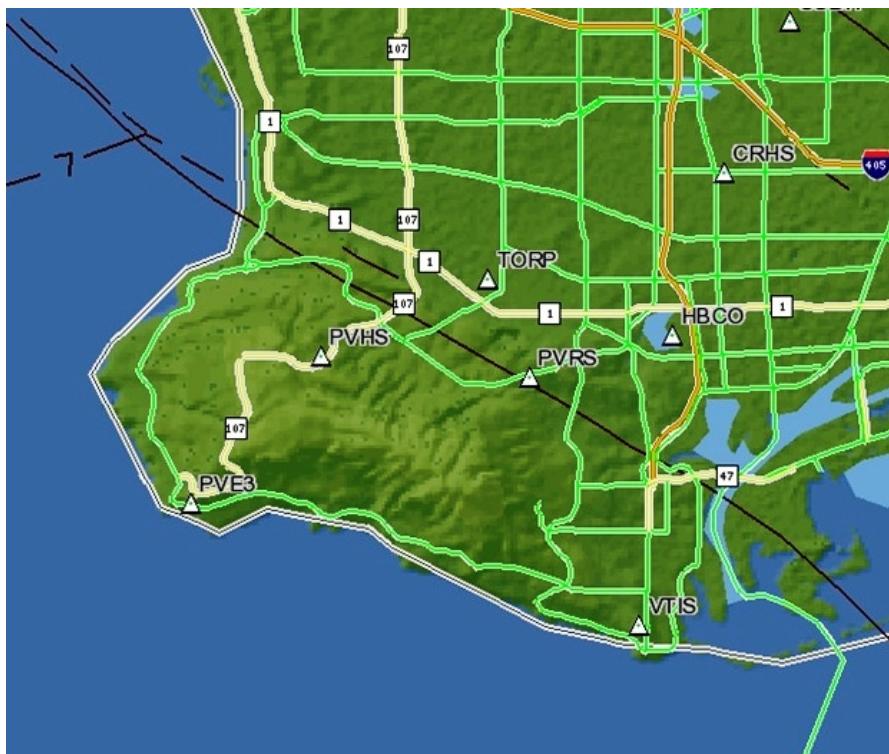
CGPS Stations (north up)

**Reference Network:** This survey is referenced to the CGPS Stations PVE3, PVHS, PVRS & VTIS shown and listed below. For more information see NGS Data Sheets for the PID's listed below and the CSRC website.

\* Falls in the proximity of a Fault Line as shown above but appears unaffected to date

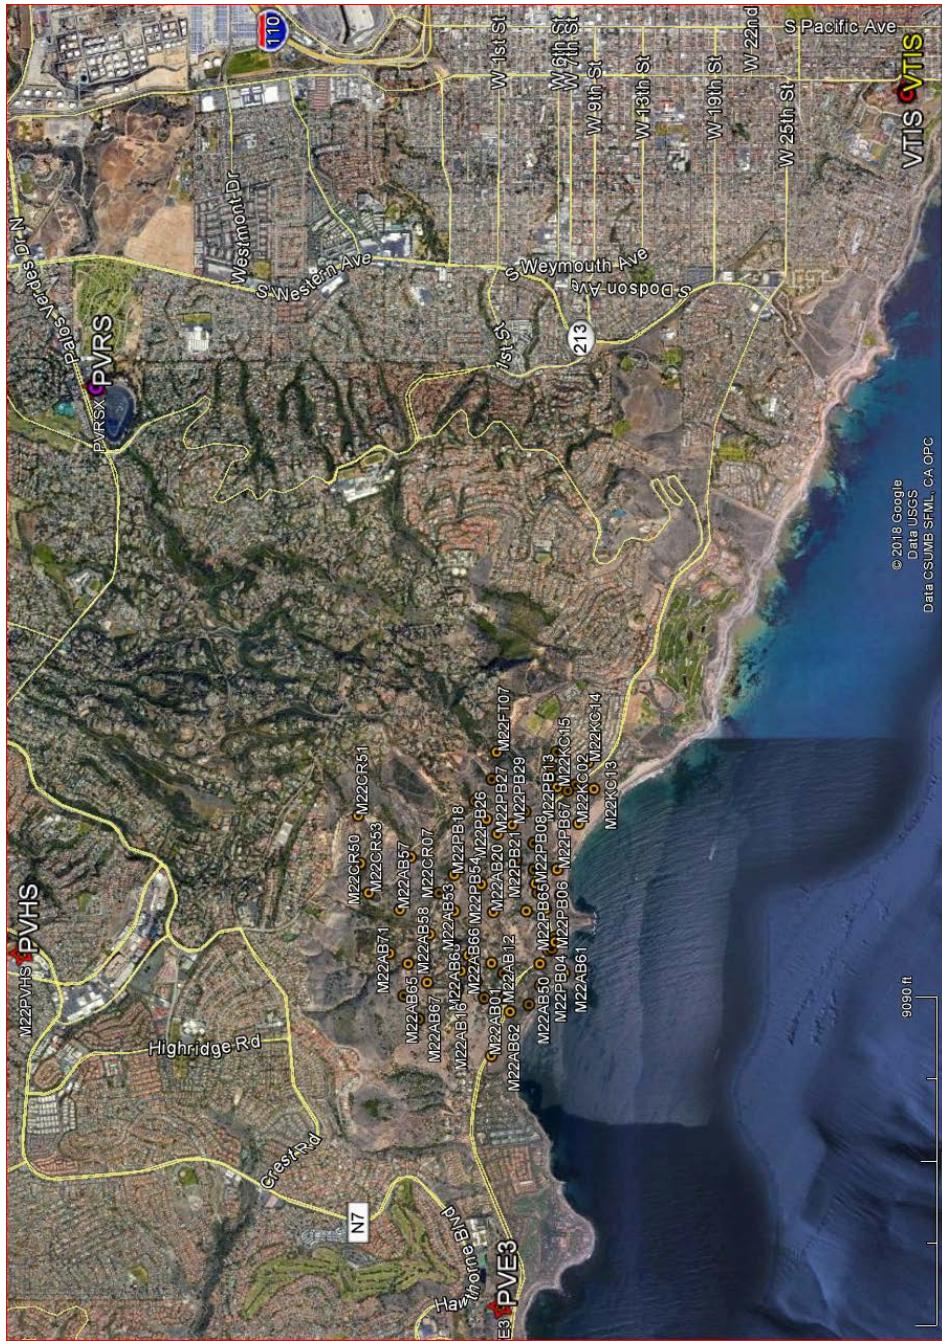
**CGPS Stations & Monitoring Network (north left)**

AB61 is the primary Base Station situated on Portuguese Point a relatively stable location and the focal point of the network connecting the monitoring points and CGPS Stations. Sixty-five points and four CGPS Stations were connected with 140 measured vectors. See the following Aerial Network Maps.

The monitoring plan utilizes the CGPS Stations to verify the stability of the reference frame. PVE3 is the primary CGPS Station used to control this survey. PVE3 is located south of RPV City Hall and 1.8 miles west-northwest of Base Station AB61. CGPS Stations PVE3, PVRS and VTIS are used to validate the stability of the network. Note: Some Stations are occasionally off-line during a monitoring campaign as stated in the reports.

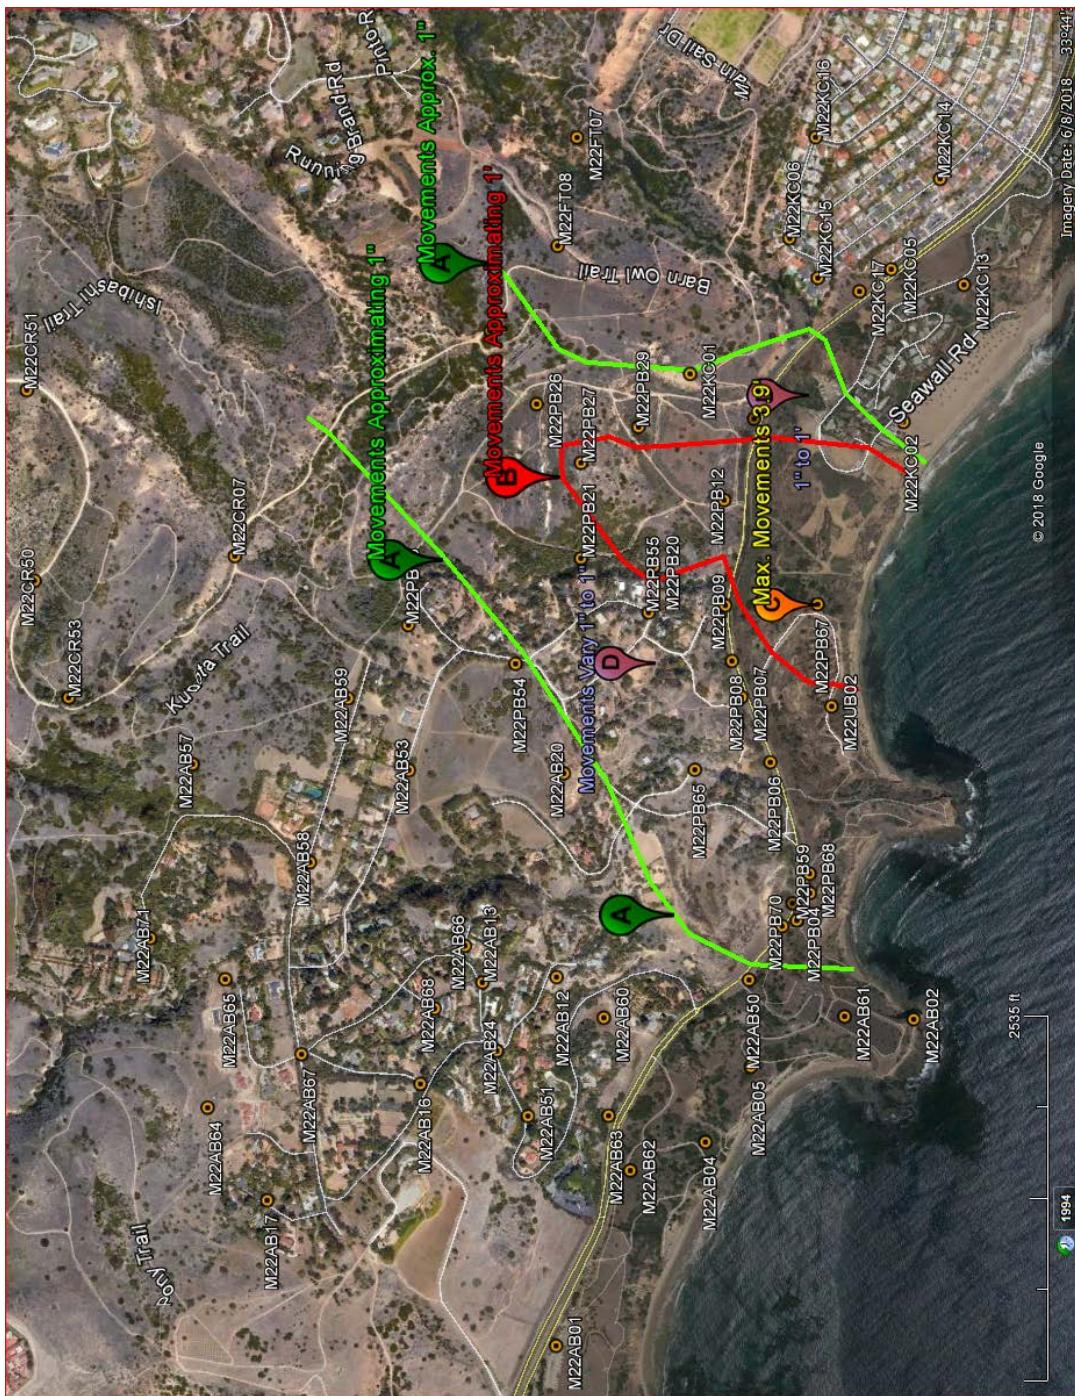
## Aerial Photo of Monitoring Points with Movements (north is left)

## General Depiction of Horizontal Movements - October 4, 2017 to Oct. 10, 2018 (Generalized depiction of movements and not to be used for planning or development purposes)

## **A = Approximate 1-inch Contour Movement Line**

## **B = Approximate 12-inch (1 foot) Contour Movement Line**

**C = Maximum Measured Movement of 3.9 feet**

**D = Movements Vary 1 inch to 1 foot between Contours Lines A & B, 1 inch or less outside of A**

See the Appendix for a graphic of the horizontal movements depicted by 1” and 1’ contours.
