Consideration and possible action to receive and file the 2016 Annual Report submitted by the Palos Verdes Peninsula Land Conservancy (PVPLC) regarding its management activities for the Palos Verdes Nature Preserve

PALOS VERDES NATURE PRESERVE ANNUAL REPORT

Alta Vicente Ecological Reserve in the Portuguese Bend Nature Preserve

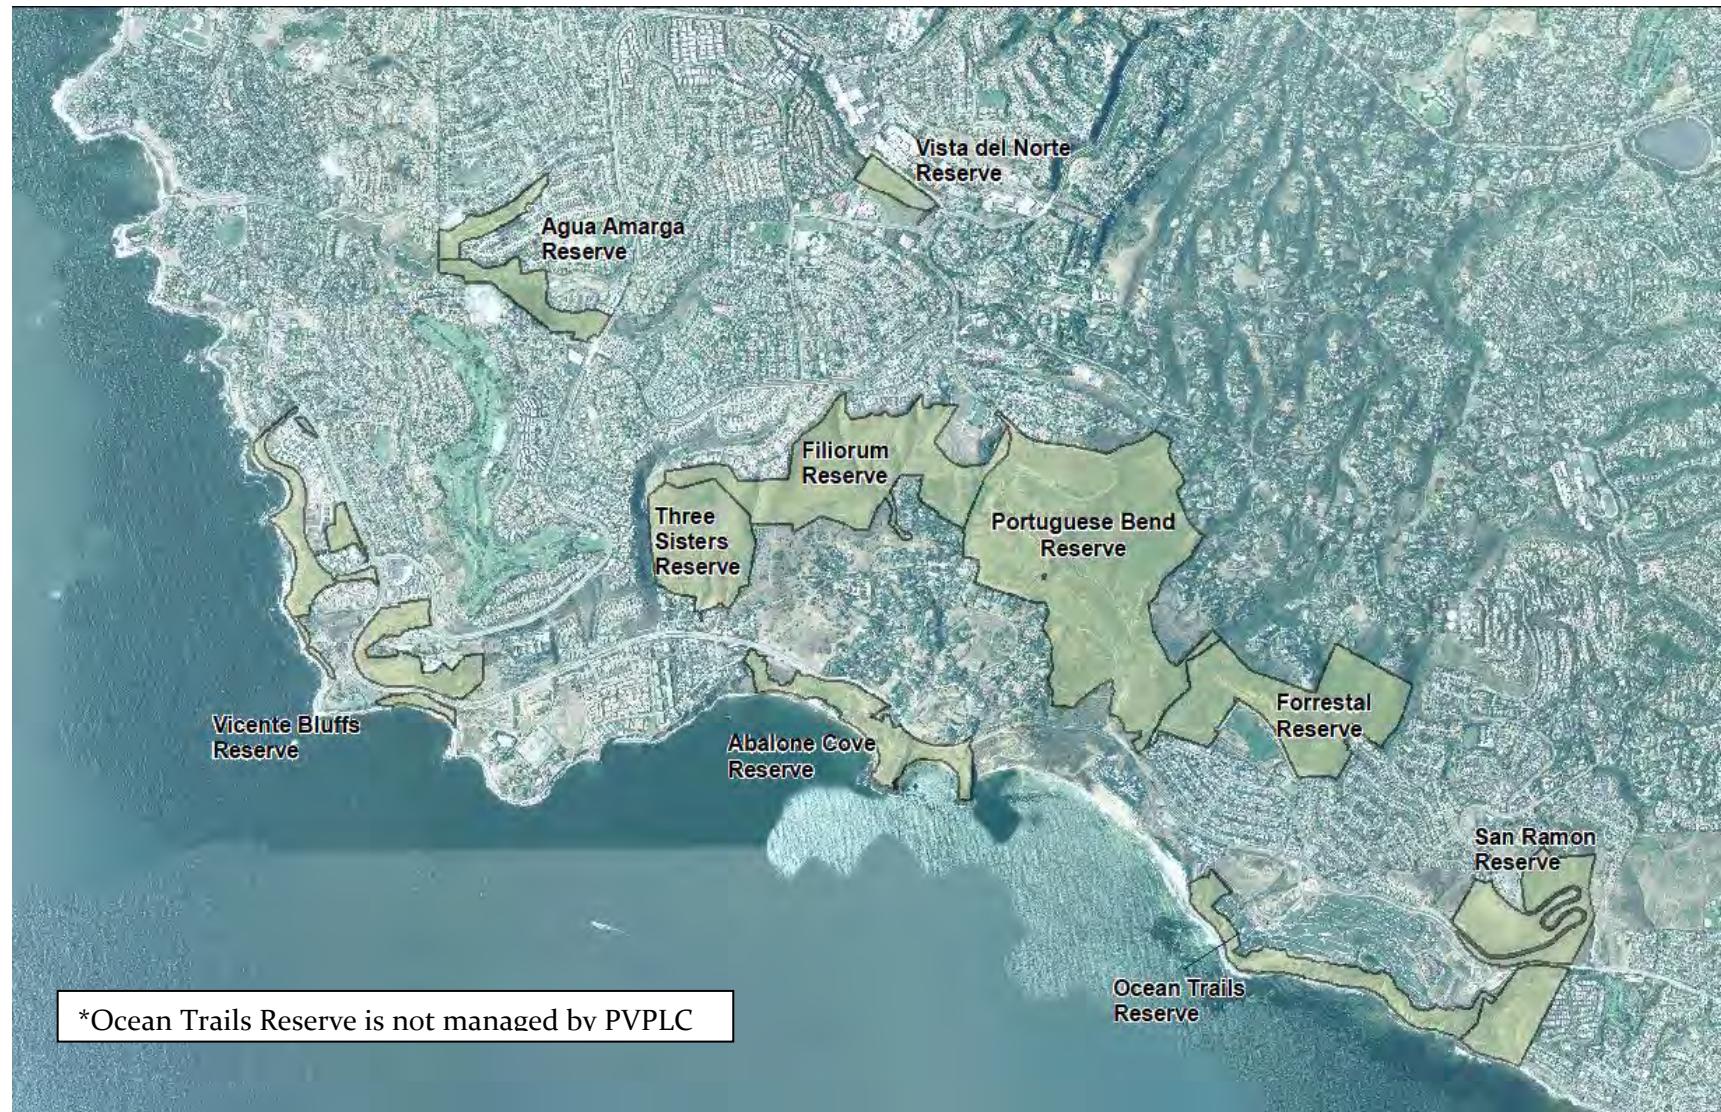
Figure 1. Map of the Palos Verdes Nature Preserve with associated Reserves locations.

Table I
Reserve Names of the Palos Verdes Nature Preserve. See Figure I for locations.

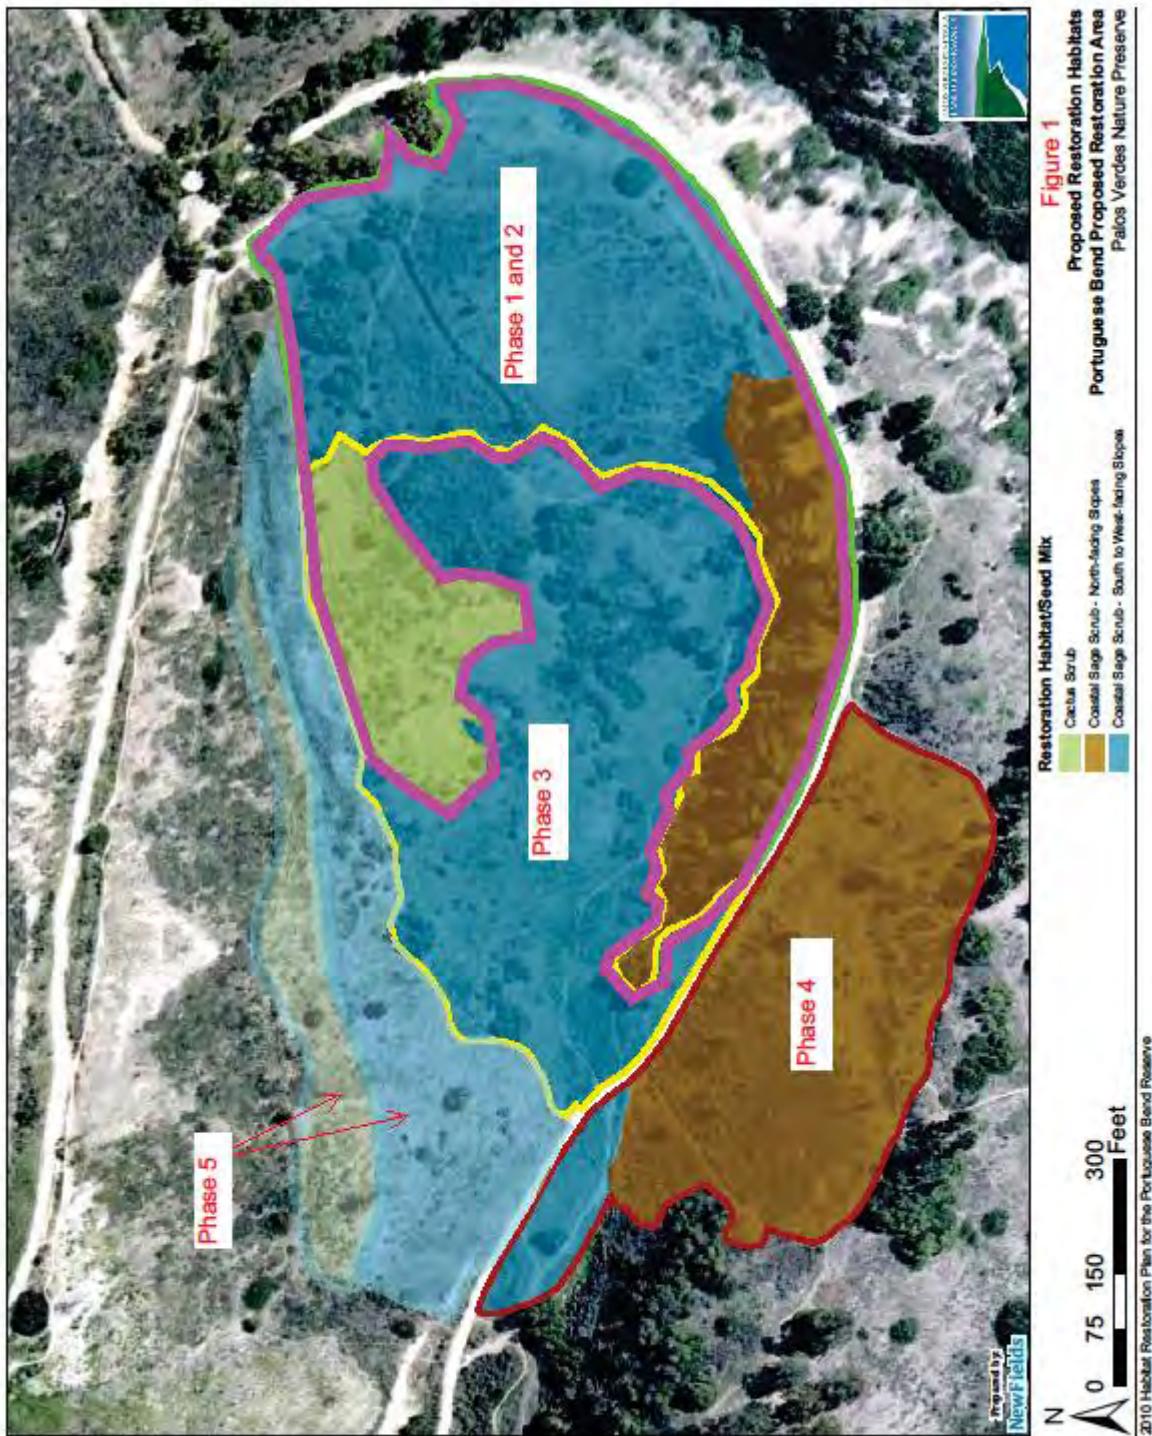
Figure 2. Map of restoration areas at Portuguese Bend Reserve.

The restoration plan for Portuguese Bend is to complete 25 acres in five phases (Table 2, Figure 2). Site preparation at Portuguese Bend began in February 2010. Field staff weeded (hand/herbicide) the burn area in 2010. In February, 2011, goats were deployed to clear vegetation. Due to the high density of weeds, an additional year of weeding was implemented, and plants were installed on ten acres in fall 2012 (Phase 1 and Phase 2).

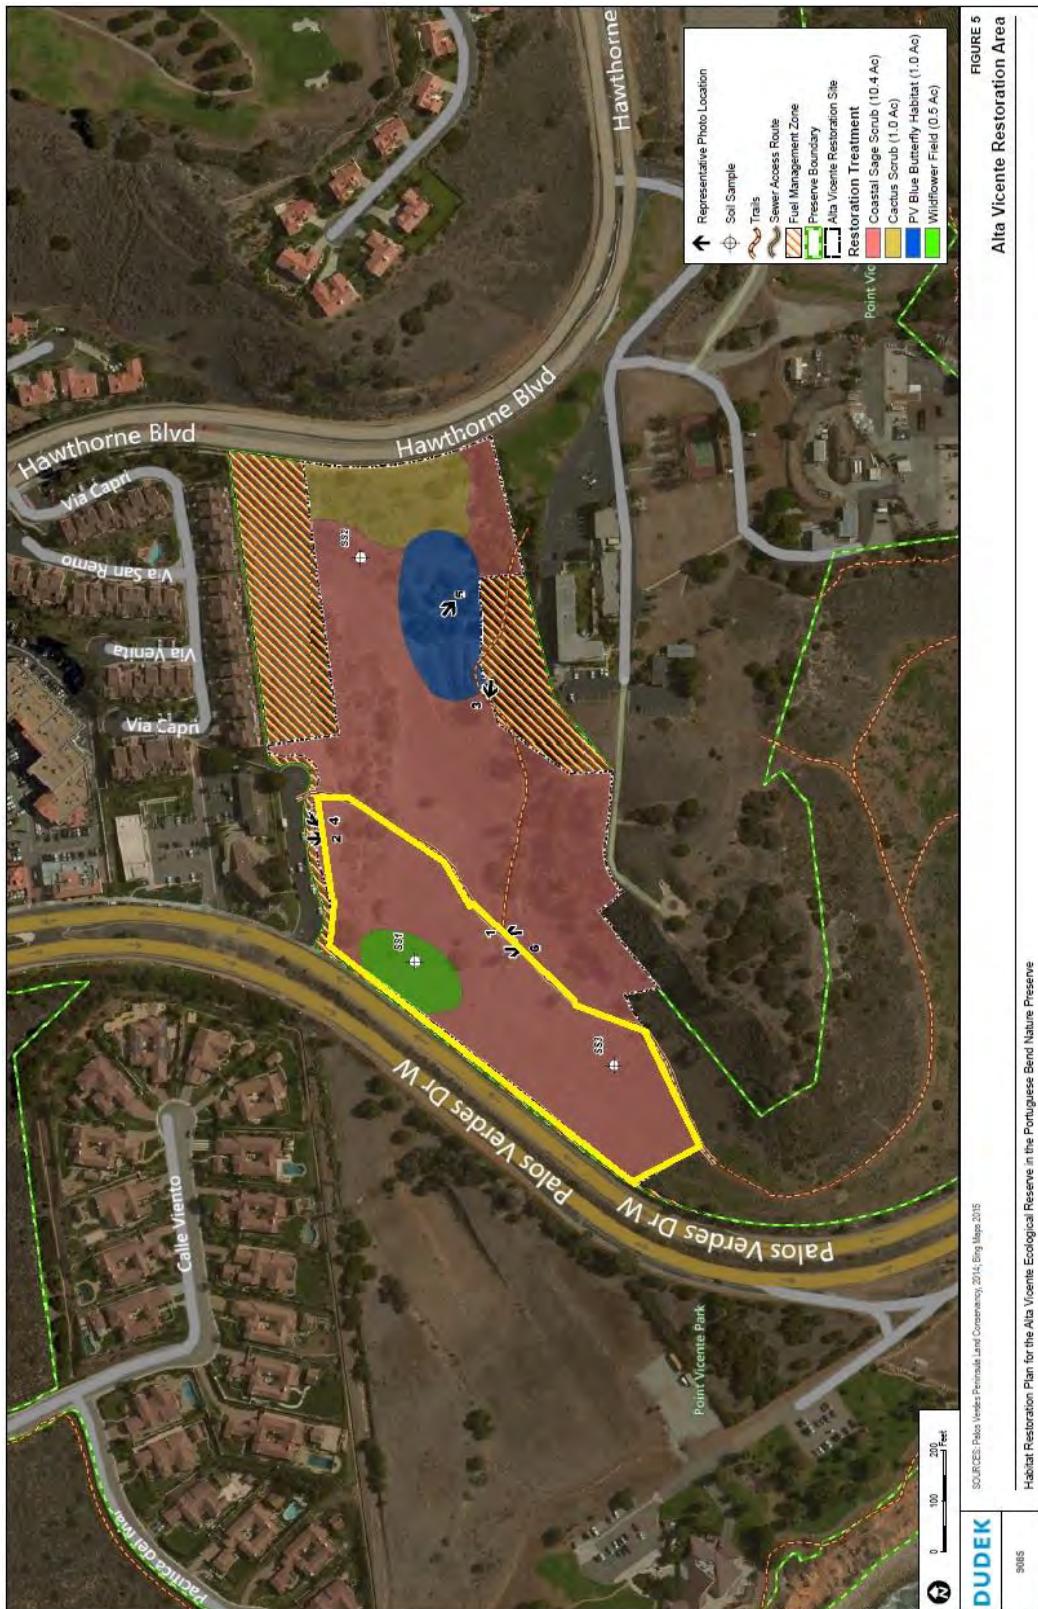
Figure 3. Map of 2016 restoration area at Alta Vicente Reserve (Phase 3 in yellow).

The habitat restoration conducted at the Alta Vicente Reserve consists of four phases, with one phase initiated each year. The first five acres of restoration (Phase 1) began with site preparation during the fall of 2007 and 2008 to minimize weeds after planting (as per the timeline in the Alta Vicente Restoration Plan, Table 2). Phase 1 plants were installed and hydroseeded during the winter of 2009/2010. Site preparation for Phase 2 began in fall 2008. In December 2010, staff removed *Acacia cyclops* and completed planting and seeding in the Phase 2 area. Staff weeded and maintained Phase 1 and 2. Additional container plants were installed from 2012 to 2014 to fill in areas with low native plant cover.

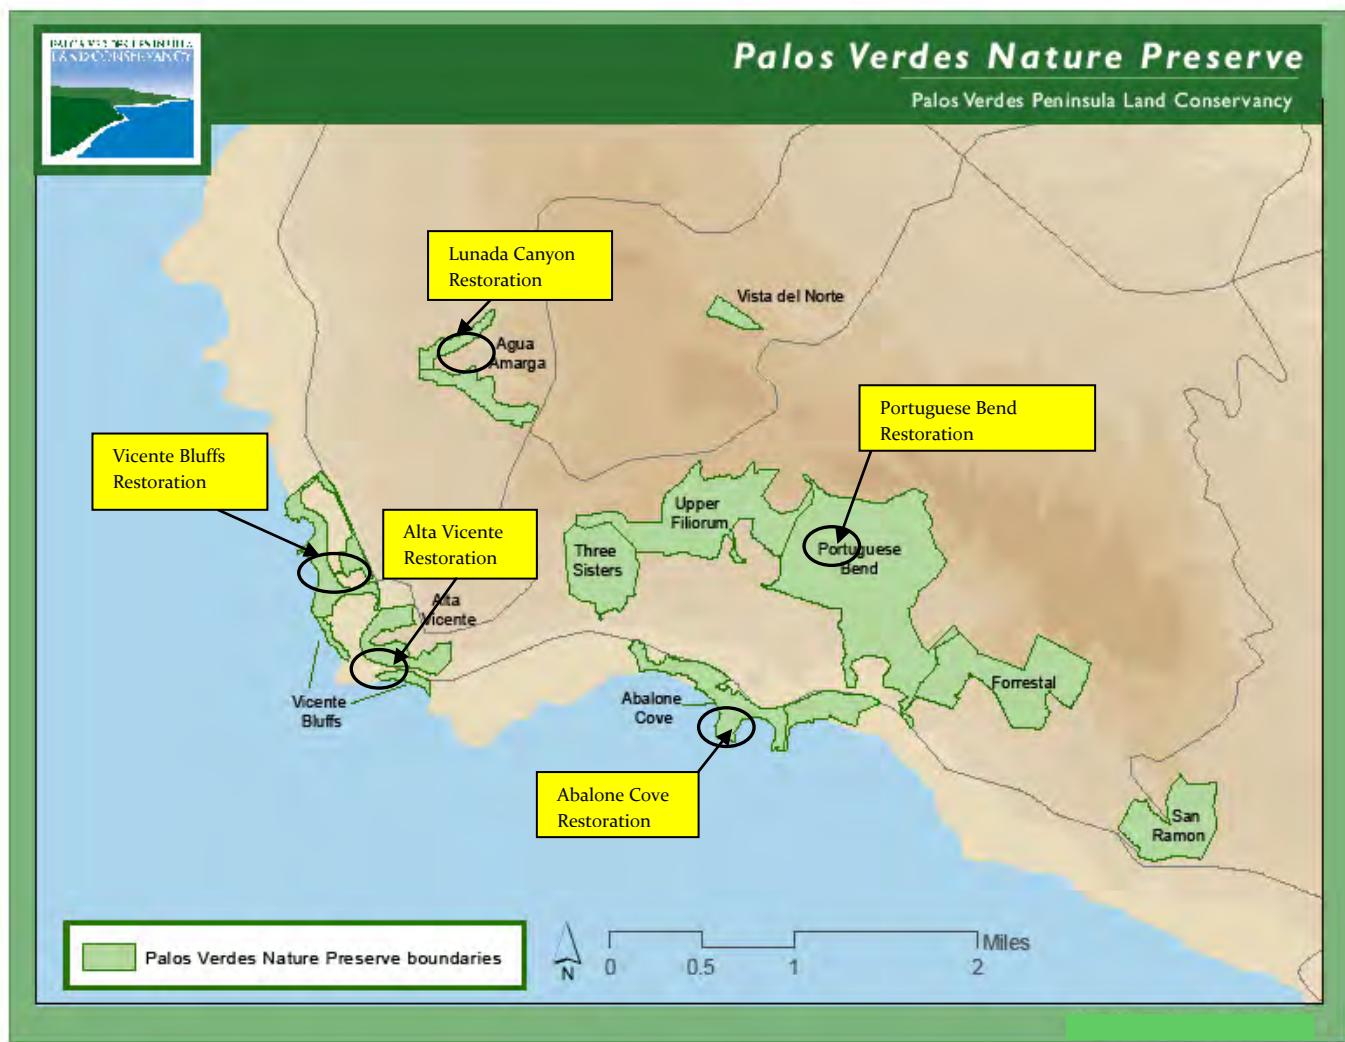
Figure 4. Site map for active 2016 restoration projects in the Palos Verdes Nature Preserve.

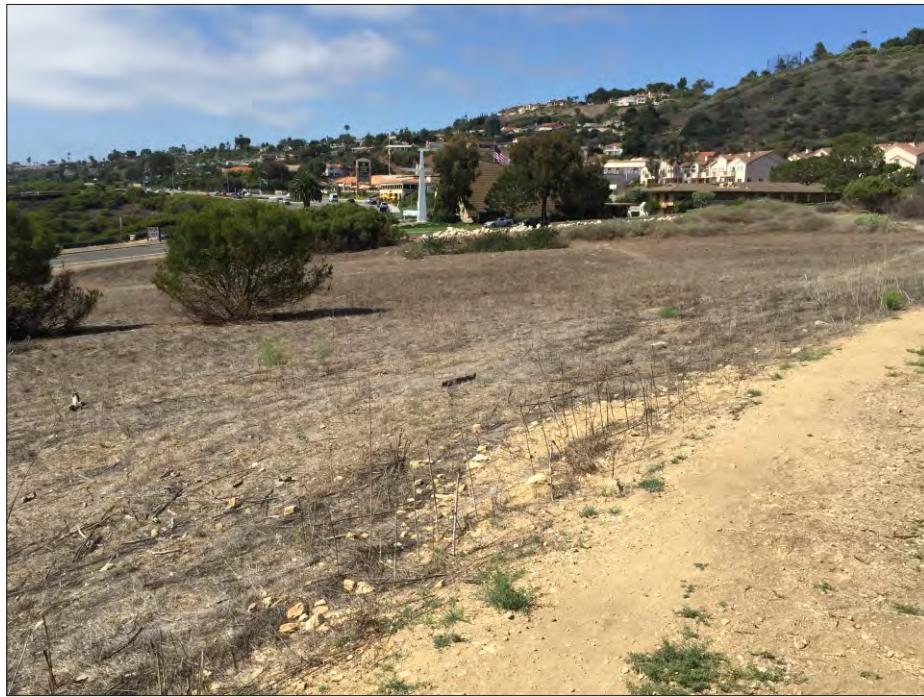
Photo 1: Representative view of lower restoration area (facing north)

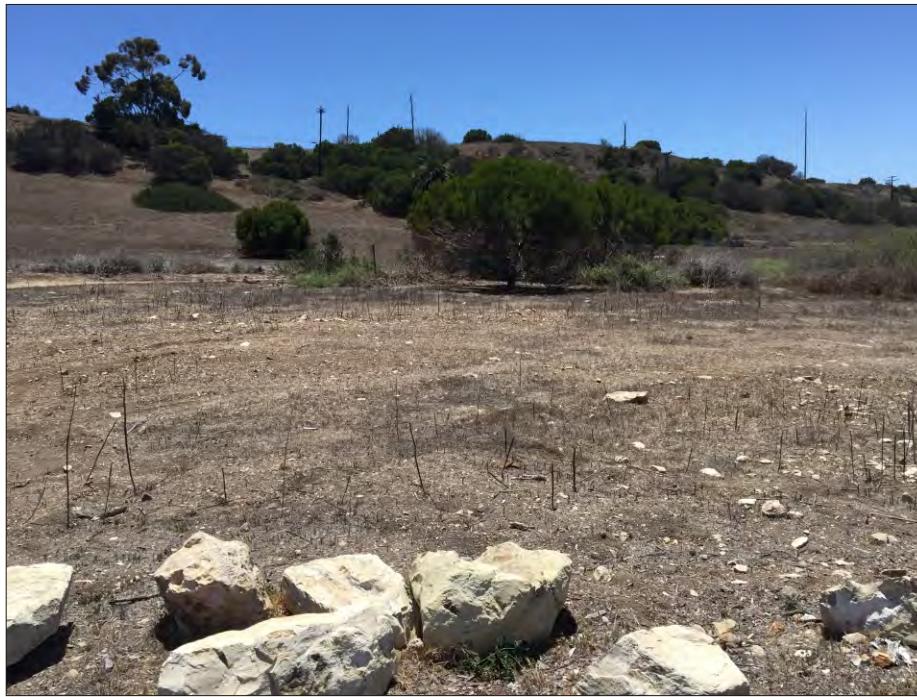
Photo 2: Non-native plants in the lower restoration area (black mustard, brome grasses, coastal wattle)

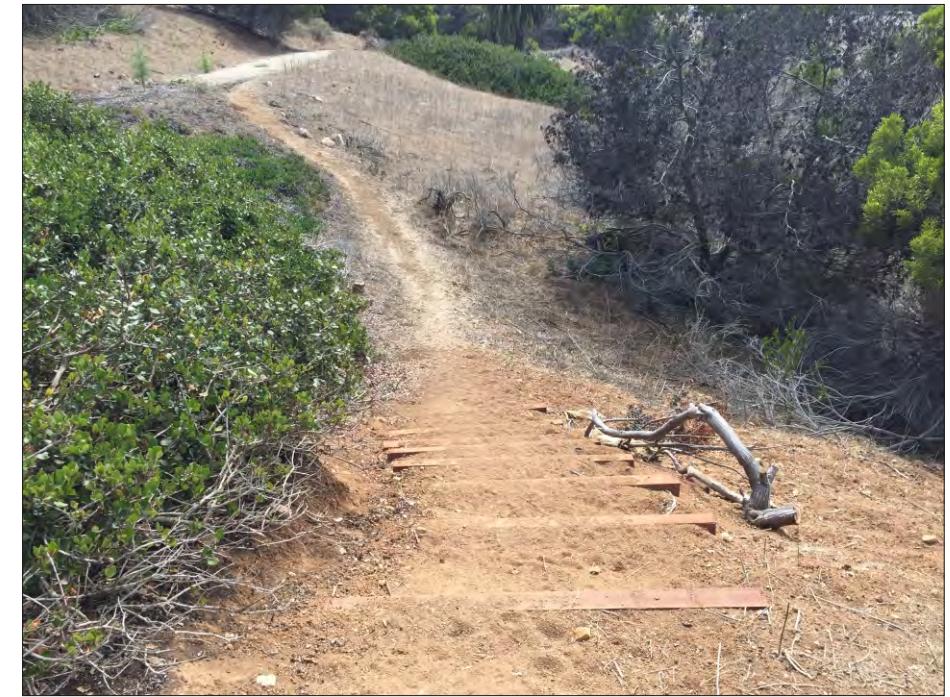
Photo 3: Trail on the southern side of the restoration area

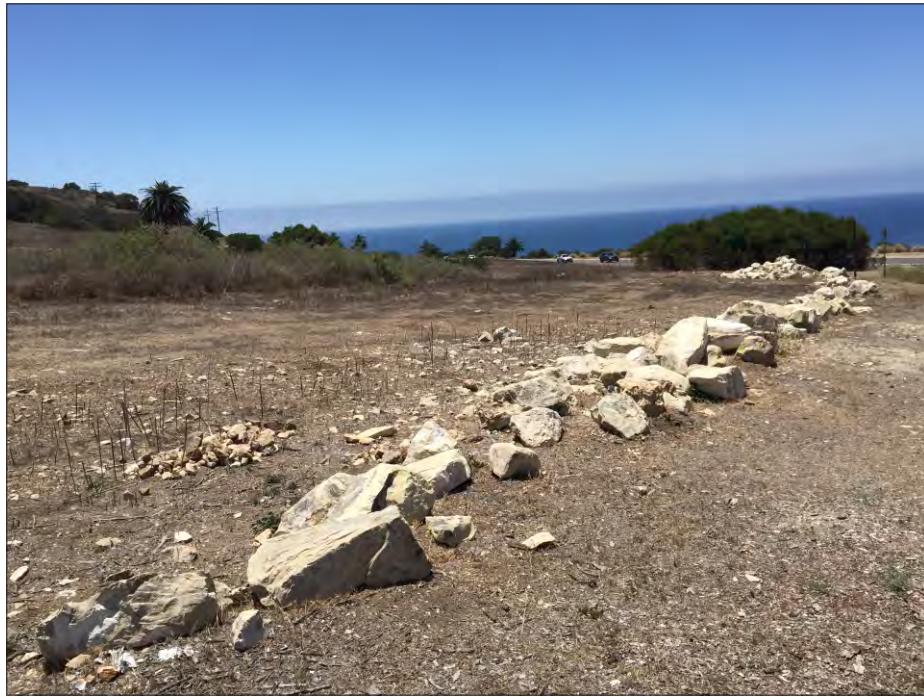
Photo 4: Northern border of the restoration area (facing south-west)

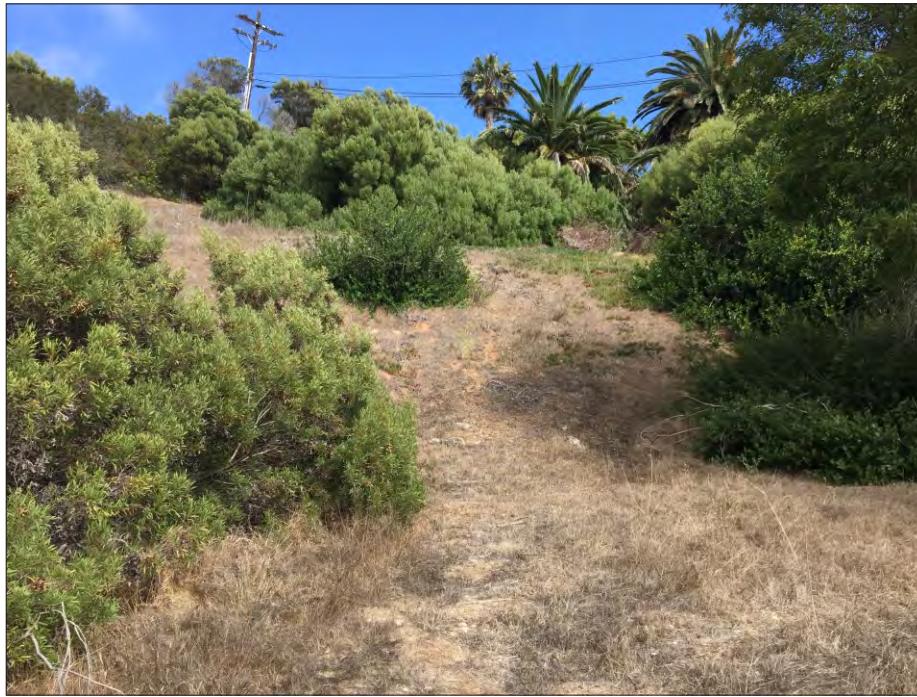
Photo 5: Invasive perennial weeds in the eastern section of the restoration area (Coastal wattle, Phoenix palm)

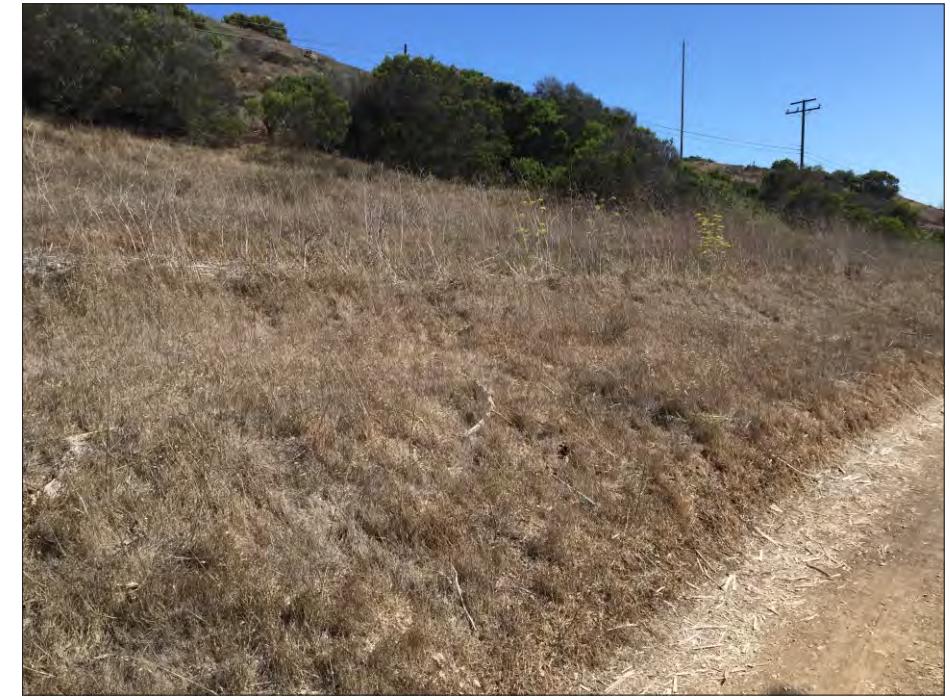
Photo 6: Invasive annual weeds in the restoration site (Fennel, black mustard, wild oat)

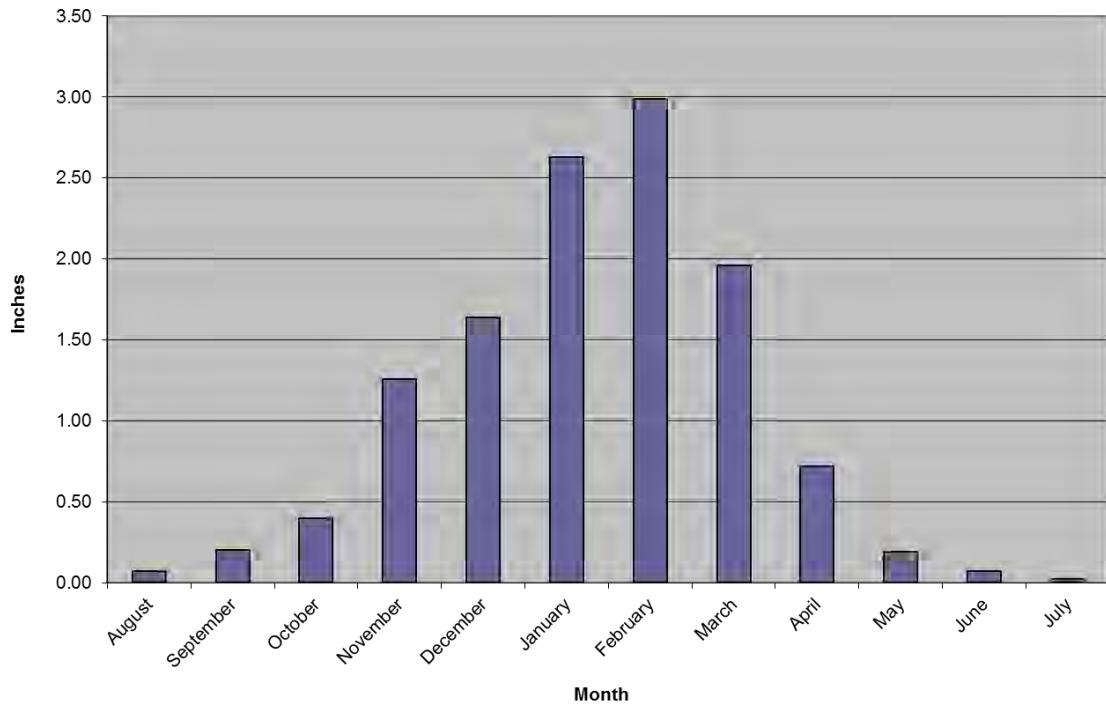
Chart 1
Average Monthly Precipitation for the Portuguese Bend Nature Preserve

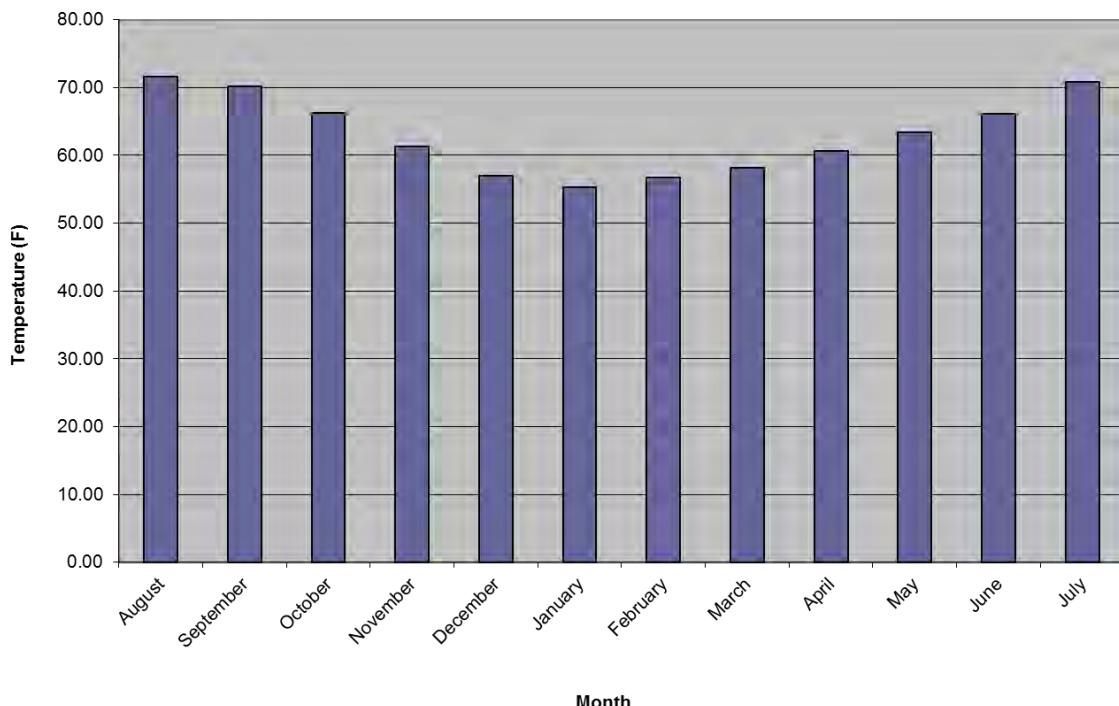
Chart 2
Average Monthly Temperatures for the Portuguese Bend Nature Preserve

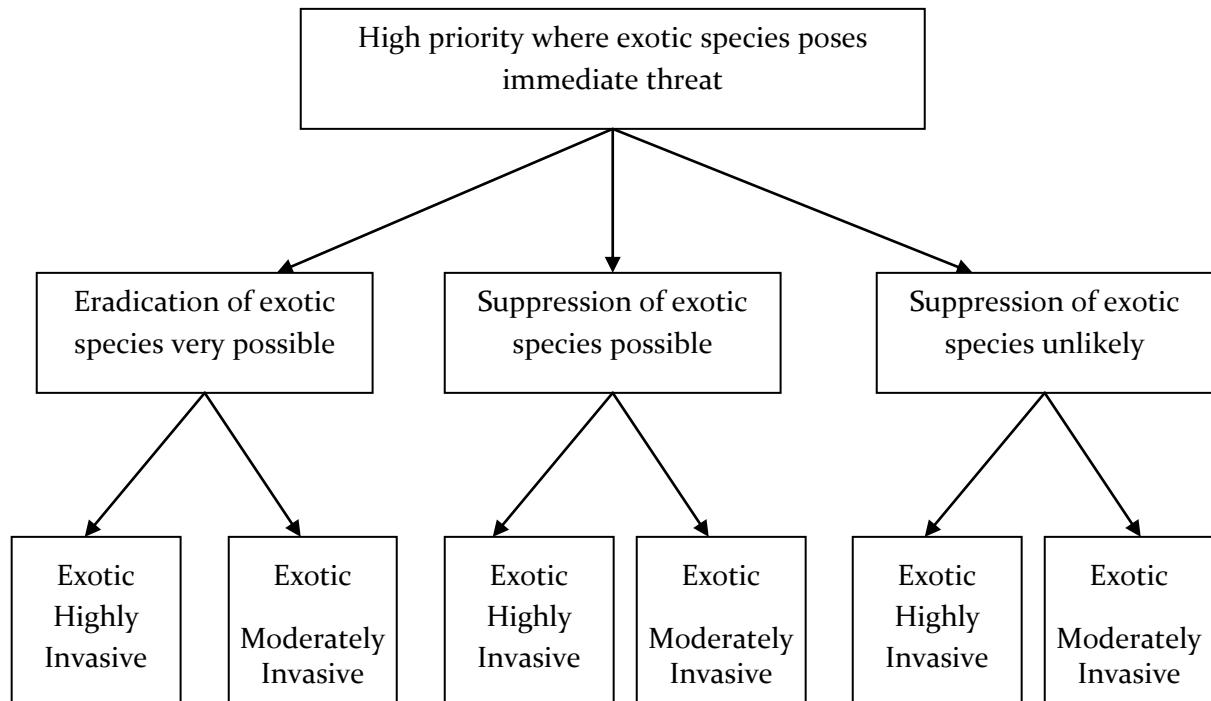
APPENDIX D2: FLOWCHART FOR HIGH PRIORITY THREAT TO NATIVE VEGETATION

Priority Ranking For Control of Exotic Species

1-3= Low priority 4-7= Medium priority 8-10= High priority

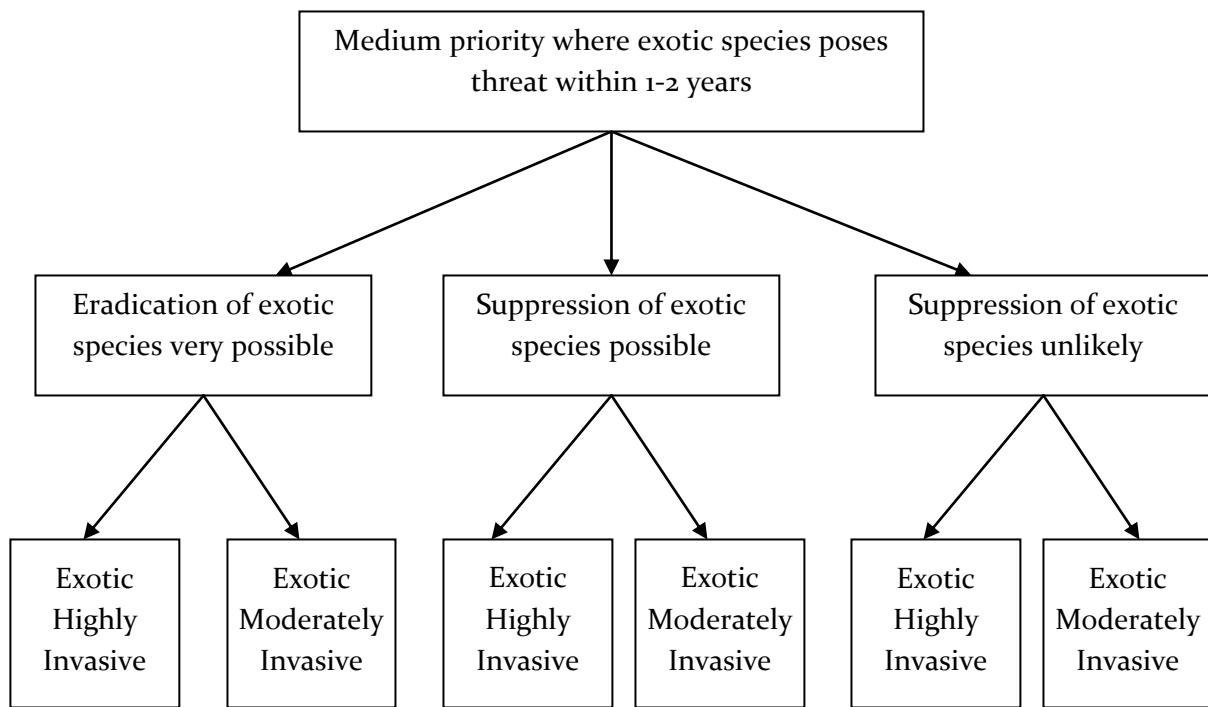
APPENDIX D3: FLOWCHART FOR MEDIUM PRIORITY DEGREE OF THREAT TO NATIVE VEGETATION

Priority Ranking For Control of Exotic Species

1-3= Low priority 4-7= Medium priority 8-10= High priority

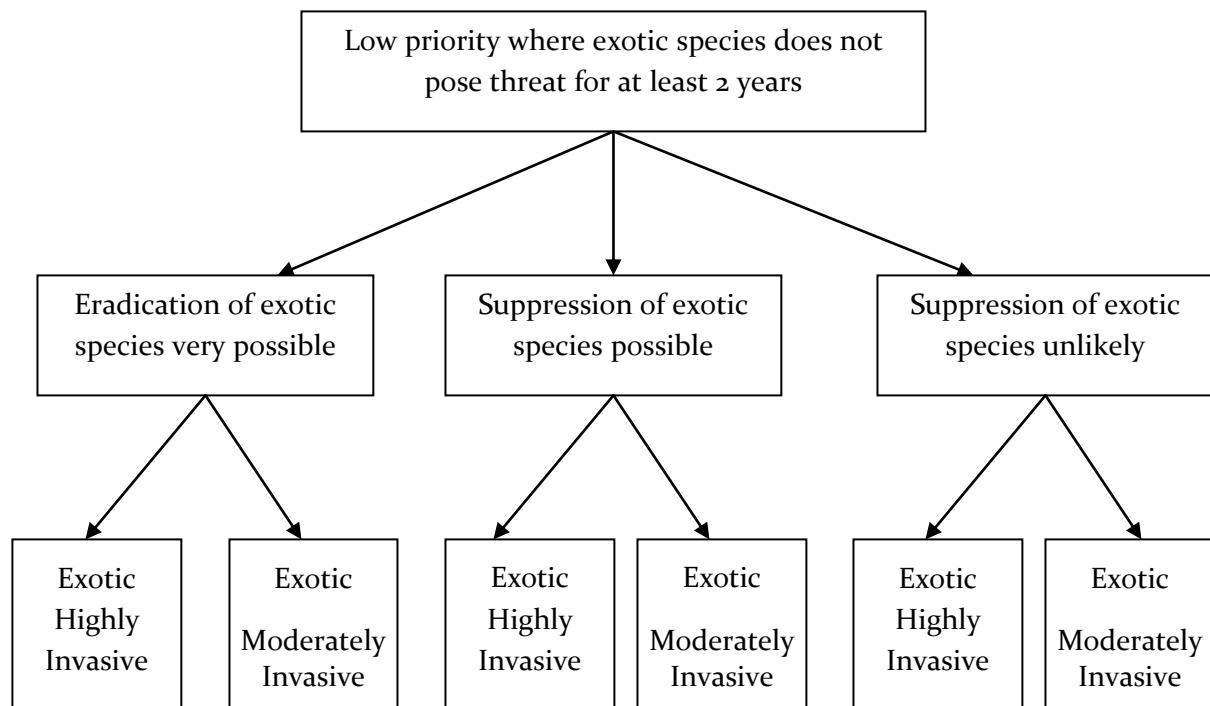
APPENDIX D4: FLOWCHART FOR LOW PRIORITY DEGREE OF THREAT TO NATIVE VEGETATION

Priority Ranking For Control of Exotic Species

1-3= Low priority 4-7= Medium priority 8-10= High priority

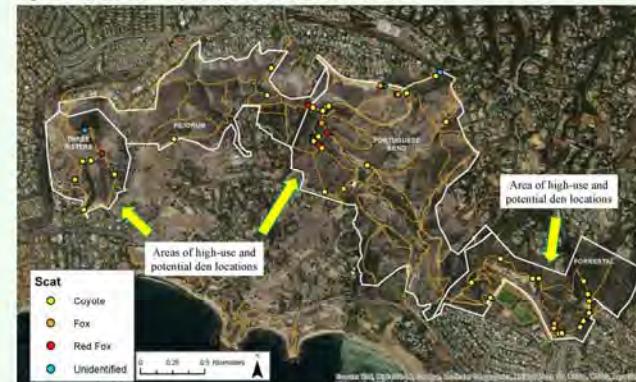
Figure 4. Locations of wild canid scats detected across the PVNP.

- 1) Field surveys identified the presence of all 3 wild canid species known to exist within the Palos Verdes Nature Preserve.
- 2) The majority of scat and track observations were coyote.
- 3) Three areas of intensive use by wild canids were found within Three Sisters, Portuguese Bend, and Forrestal reserves.
- 4) Areas of low-use or near exclusion may exist between observed high-use areas.

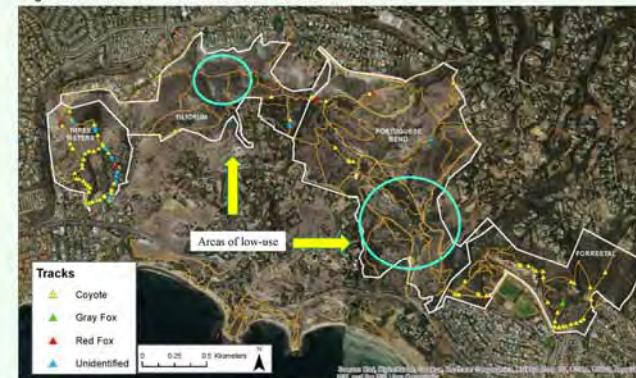
Figure 5. Location of wild canid tracks detected across the PVNP.

- 1) Coyotes were observed to be the most abundant wild canid within the Palos Verdes Nature Preserve.
- 2) Habitat areas of the PVNP support varying intensities of wild canid activity. This may potentially describe differing levels of inhabitance factors known to affect canid occupancy such as habitat quality, prey abundance, and disturbance pressure.
- 3) High-use areas may generally depict den locations.
