Palos Verdes
Nature Preserve

Annual Report

**Palos Verdes Peninsula
Land Conservancy**

The Rancho Palos Verdes
Natural Community
Conservation Plan and
Habitat Conservation Plan

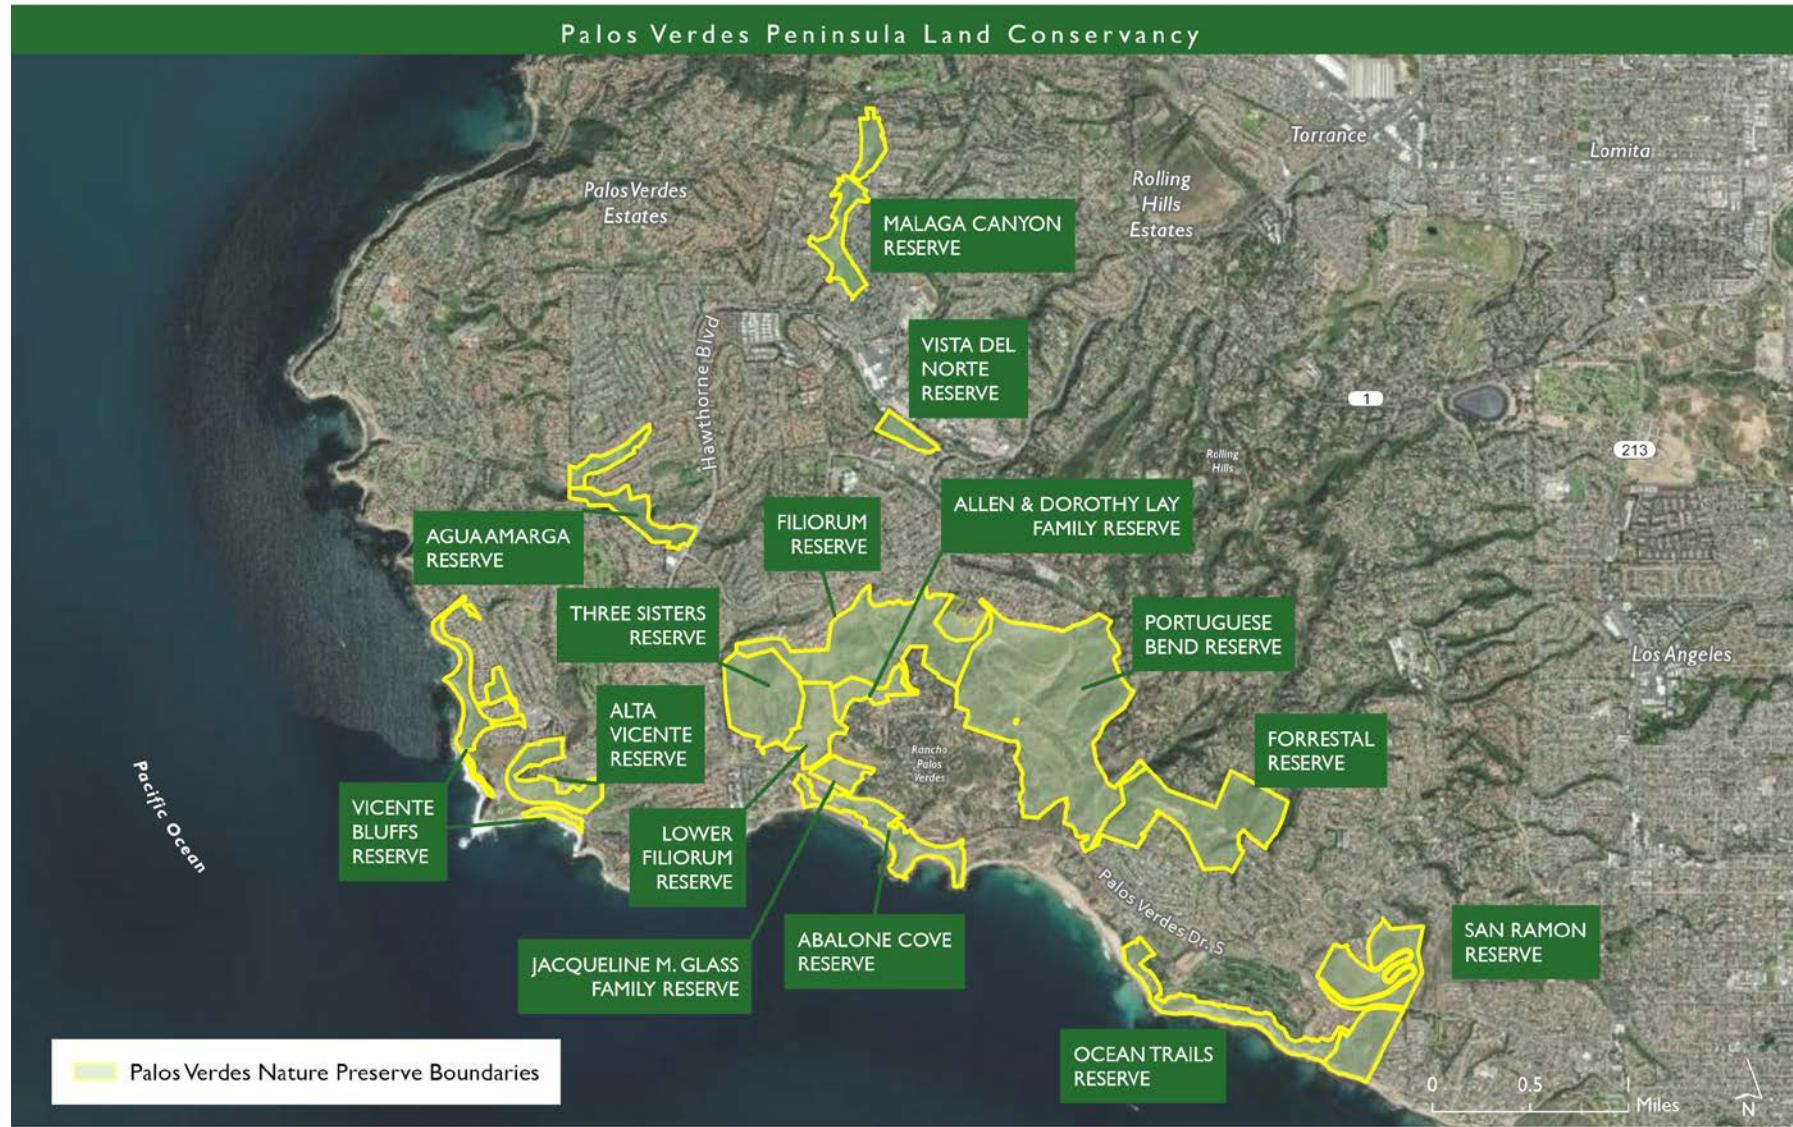
Figure 1. Map of the Palos Verdes Nature Preserve with associated Reserves locations

The Preserve is located on the southern side of the Palos Verdes Peninsula in the City of Rancho Palos Verdes, California (Figure 1). The approximately 1,500-acre Preserve has been divided into 15 subareas referred to as Reserves (Table 1).

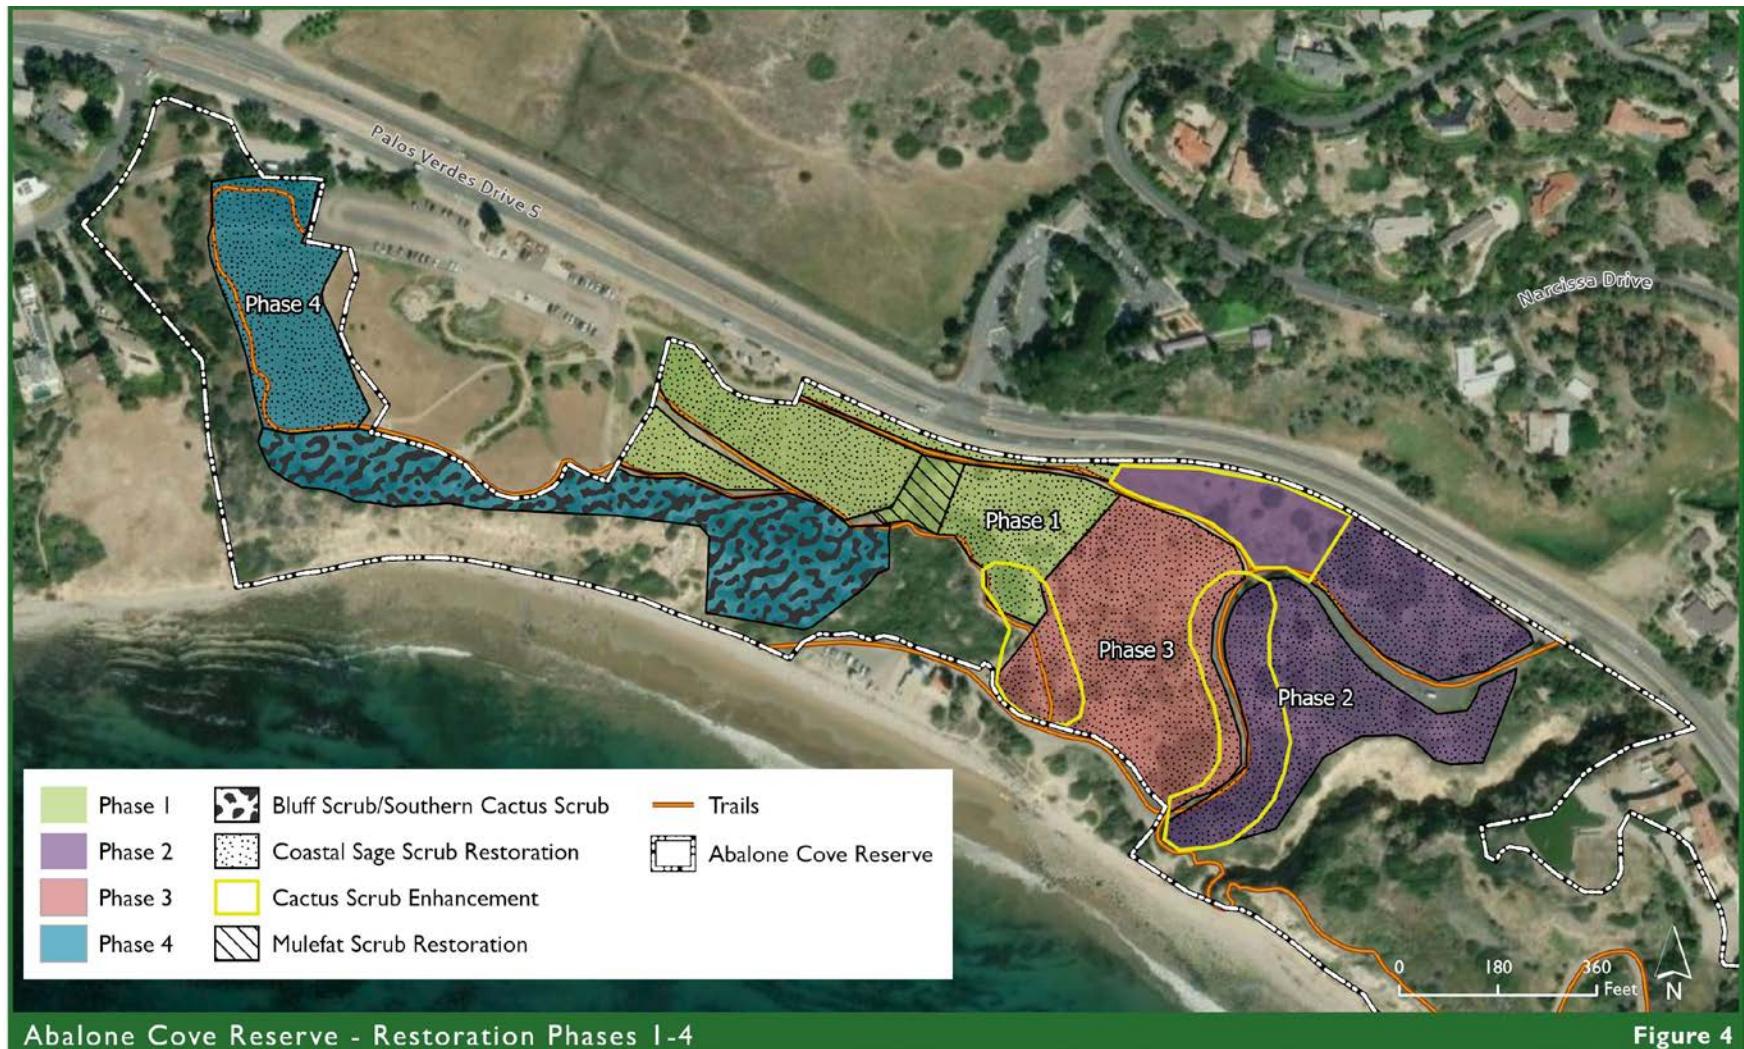
Figure 4. Map of Phase 1 – 4 Restoration Areas at Abalone Cove Reserve

The habitat restoration project at Abalone Cove Reserve will restore 20.3 total acres of mixed coastal scrub, and mixed Southern Coastal Bluff Scrub/Southern Cactus Scrub (Table 4, Figure 4). The project began in 2019, by introducing goats to graze the Phase 1 area to reduce the cover of invasive plants and prepare the site for the habitat planting effort started in 2020. At the end of 2019 and through the end of 2020, PVPLC crews removed non-native woody shrubs such as acacia and peppertree. Planting in Phase 1 began in winter of 2019 following irrigation installation. Phase 2 planting began in fall of 2020 following site preparation and irrigation installation for that phase. Phase 3 site preparation began in spring 2021 and irrigation installation was finished at the end of 2021 with planting implemented in early 2022. Phase 4 was grazed of non-natives in spring of 2022 and irrigation installation is set to be completed in early 2023 followed by planting and maintenance. The full restoration plan can be found in Appendix A.

Task	Date
PHASE 1	Site clearing	Fall 2019
	Installation of supplemental watering system	Spring 2020
	Invasive weed species control and grow-kill cycles	Fall 2019 – Summer 2020
	Planting container stock	Spring 2020
	Seed application	Fall 2020
	Monitoring and maintenance	To begin upon successful installation of plants
PHASE 2	Site clearing	Spring 2020
	Installation of supplemental watering system	Summer 2020
	Invasive weed species control and grow-kill cycles	Spring 2020 – Fall 2020
	Planting container stock	Fall 2020
	Seed application	Fall 2020
	Monitoring and maintenance	To begin upon successful installation of plants
PHASE 3	Site clearing	Spring 2021
	Installation of supplemental watering system	Summer 2021
	Invasive weed species control and grow-kill cycles	Spring 2021 – Fall 2021
	Planting container stock	Fall 2021
	Seed application	Fall 2021
	Monitoring and maintenance	To begin upon successful installation of plants

PHASE 4	Site clearing(manual and goats)	Spring 2022
	Installation of supplemental watering system	Fall-Winter 2022/23
	Invasive weed species control and grow-kill cycles	Spring 2022- Winter 2022/23
	Planting container stock	Winter 2022/23
	Seed application	Winter 2022/23
	Monitoring and maintenance	To begin upon successful installation of plants

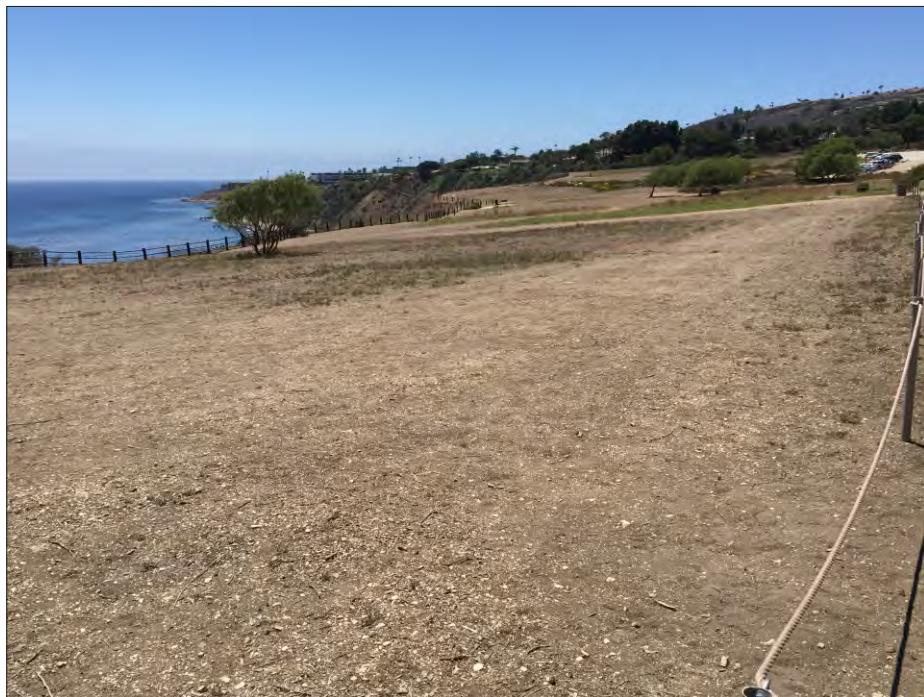
Photo 1: Representative view of western restoration area (facing west)

The habitat restoration areas are currently dominated by non-native species. The existing habitat in the restoration areas contains many non-native annual herbs, including black mustard, Russian thistle, and bromes (Figure 4, Photos 1 and 2). Non-native perennials, such as fennel, spiny holdback, Peruvian pepper, and Brazilian pepper also exist within the restoration areas.

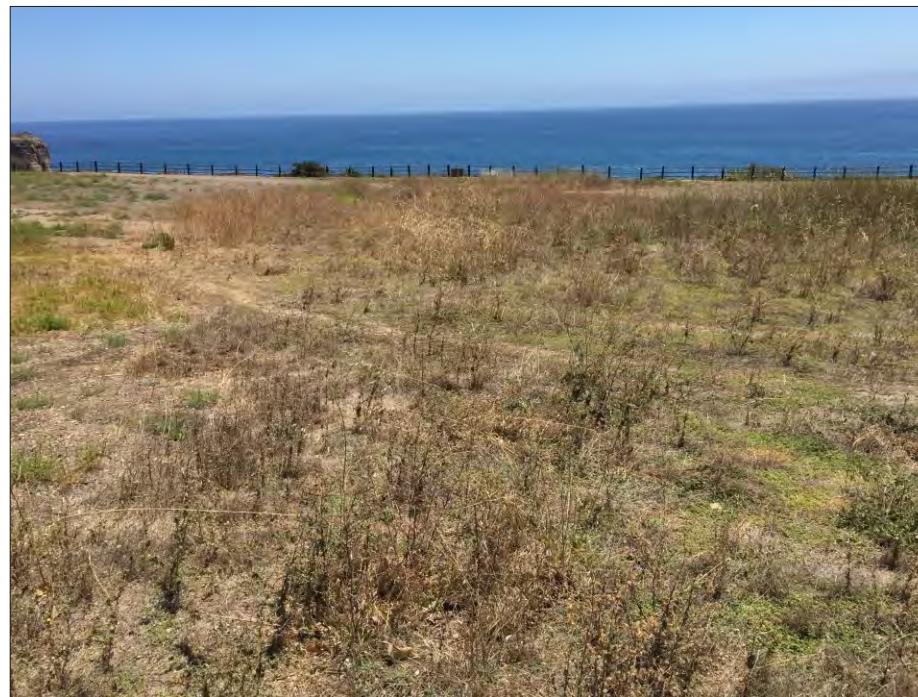
Photo 2: Non-native plants in the western restoration area (black mustard, brome grasses, Russian thistle)

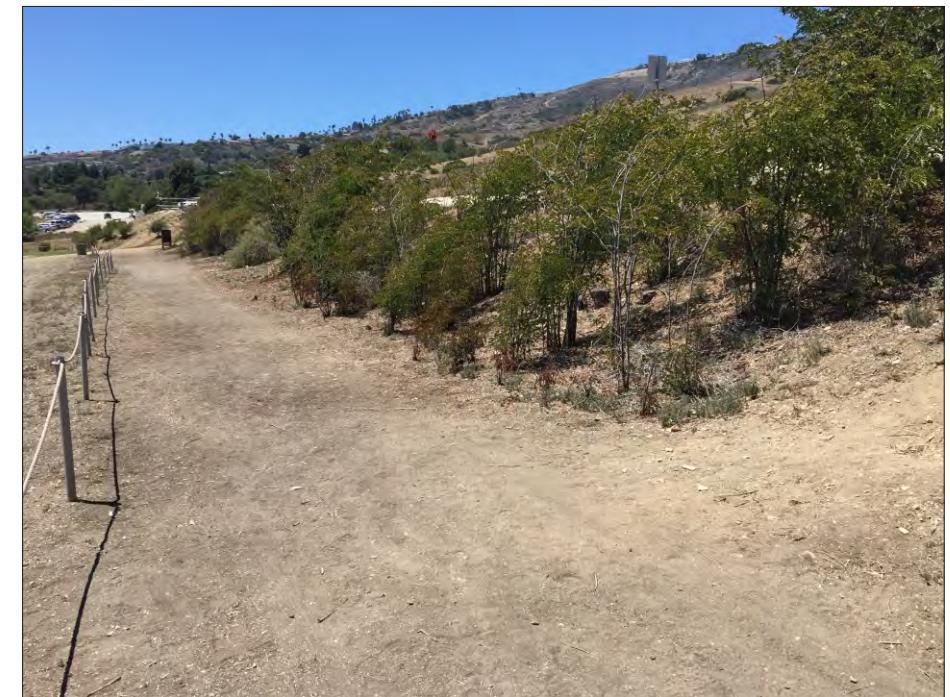
Photo 3: Trail lined by invasive spiny holdback (*Ceasalpinia spinosa*)

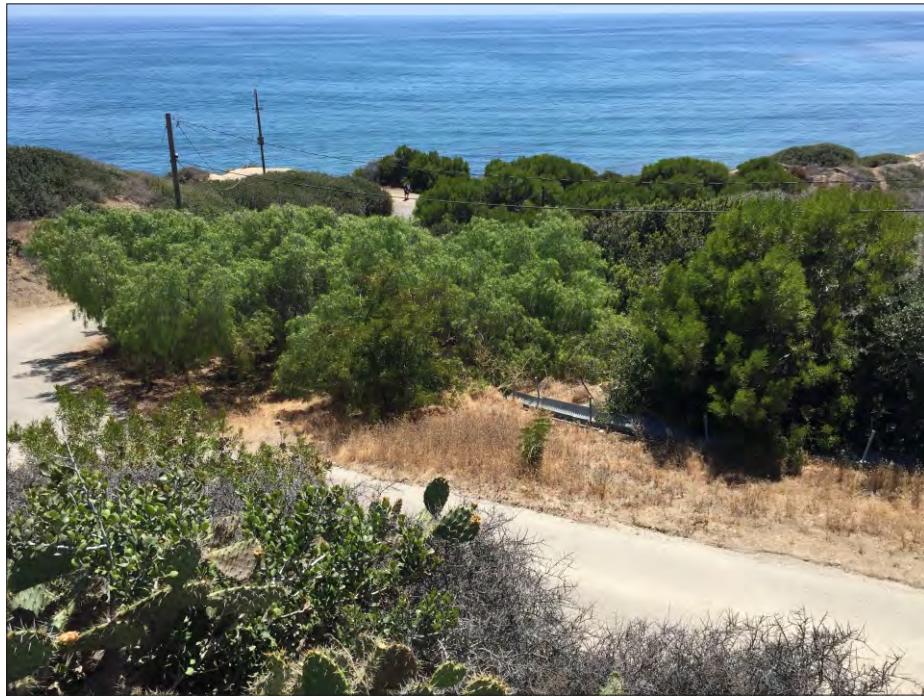
Photo 4: Invasive perennial weeds in the habitat enhancement zone (Coastal wattle, Brazilian pepper)

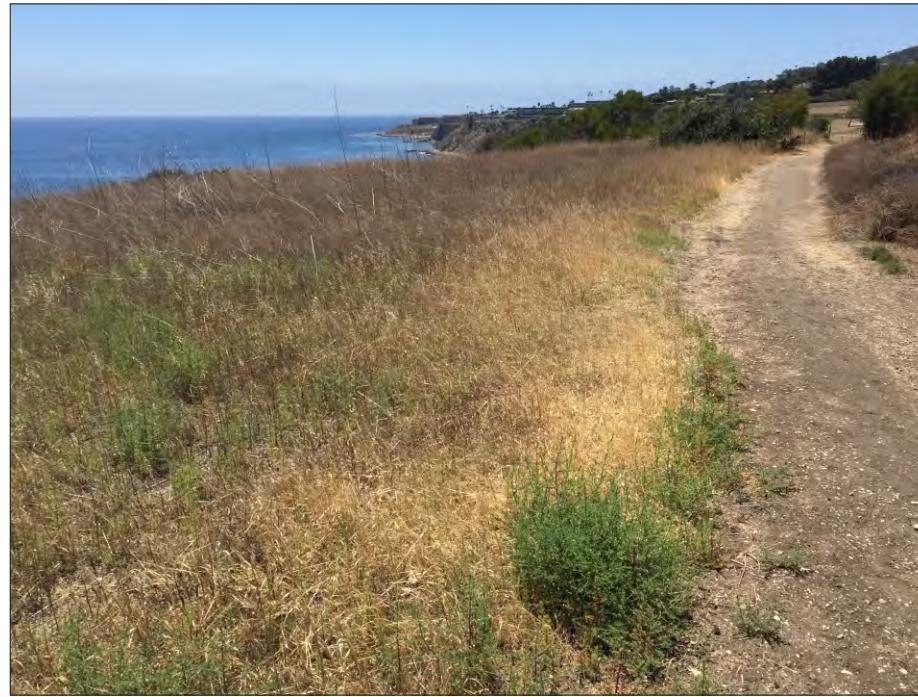
Photo 5: Representative view of the eastern restoration area (facing west)

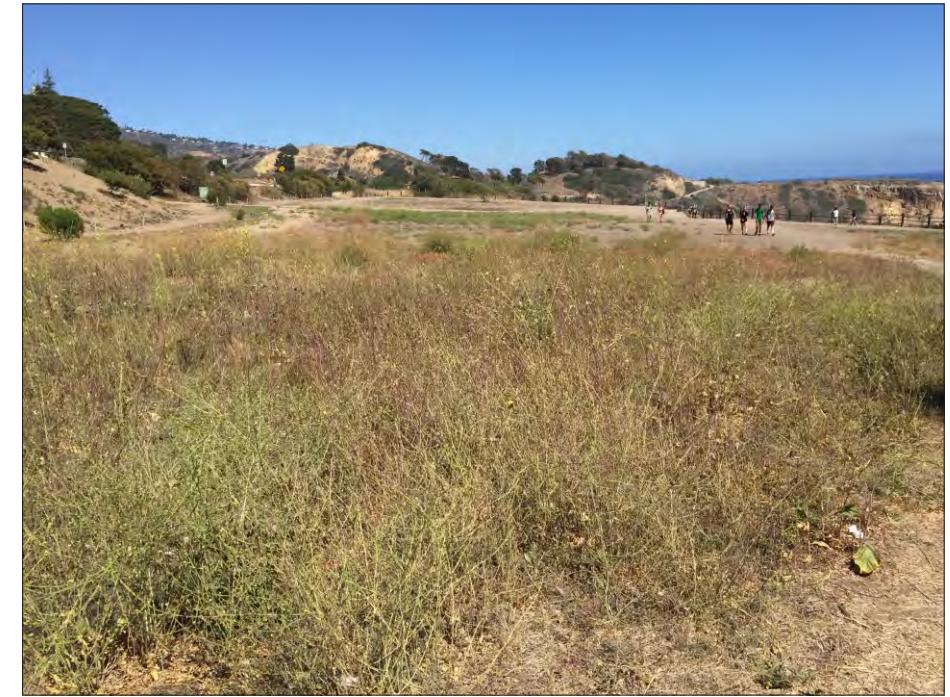
Photo 6: Invasive annual weeds in the restoration site (black mustard, wild oat)

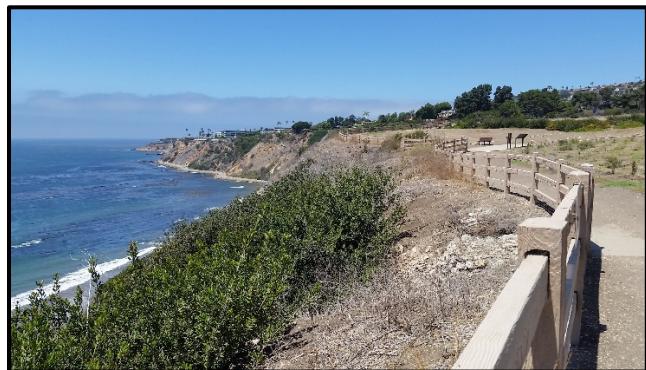
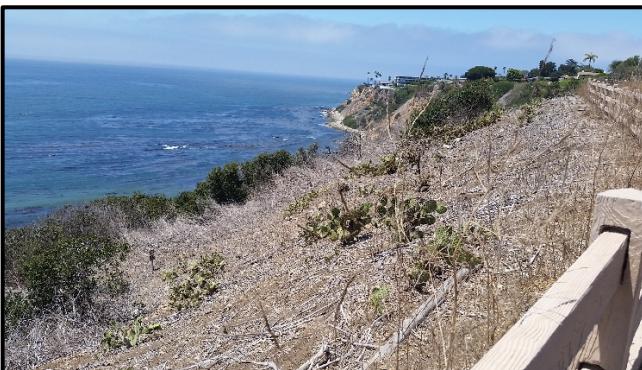
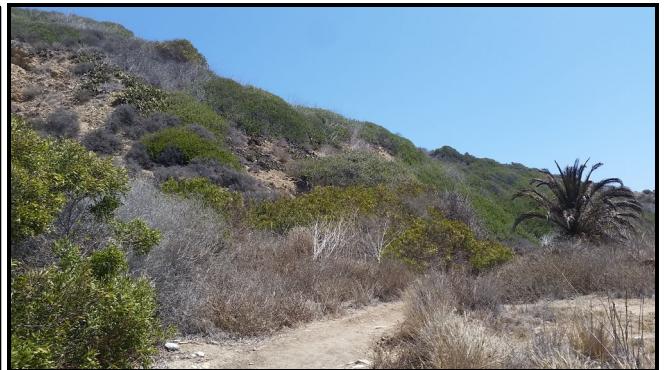
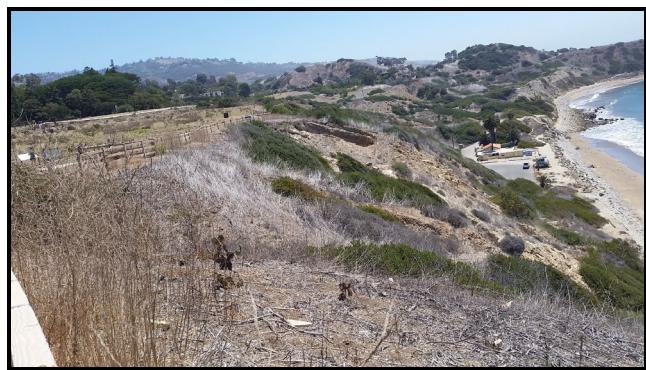
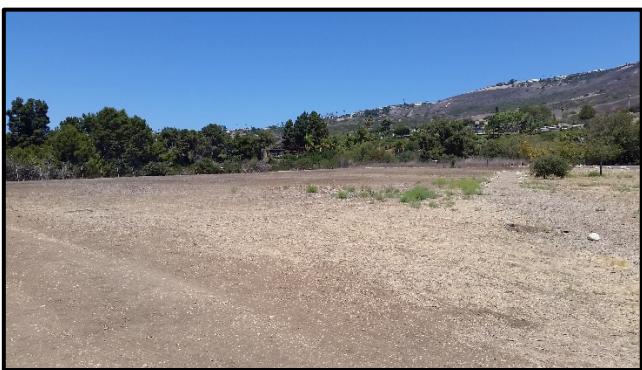
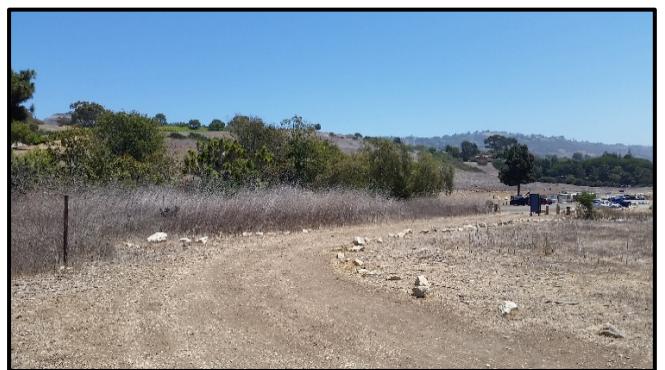
Figure 1

Current plant communities in the project vicinity according to vegetation mapping in 2010 consists of Southern Coastal Bluff Scrub, Grassland and CSS undifferentiated. The Southern Coastal Bluff Scrub, Grassland and CSS Undifferentiated have native and non-native plant components. As part of this restoration plan, non-native species will be removed and naturally occurring native plants will be left in place. Current site conditions can be seen in Figure 1.

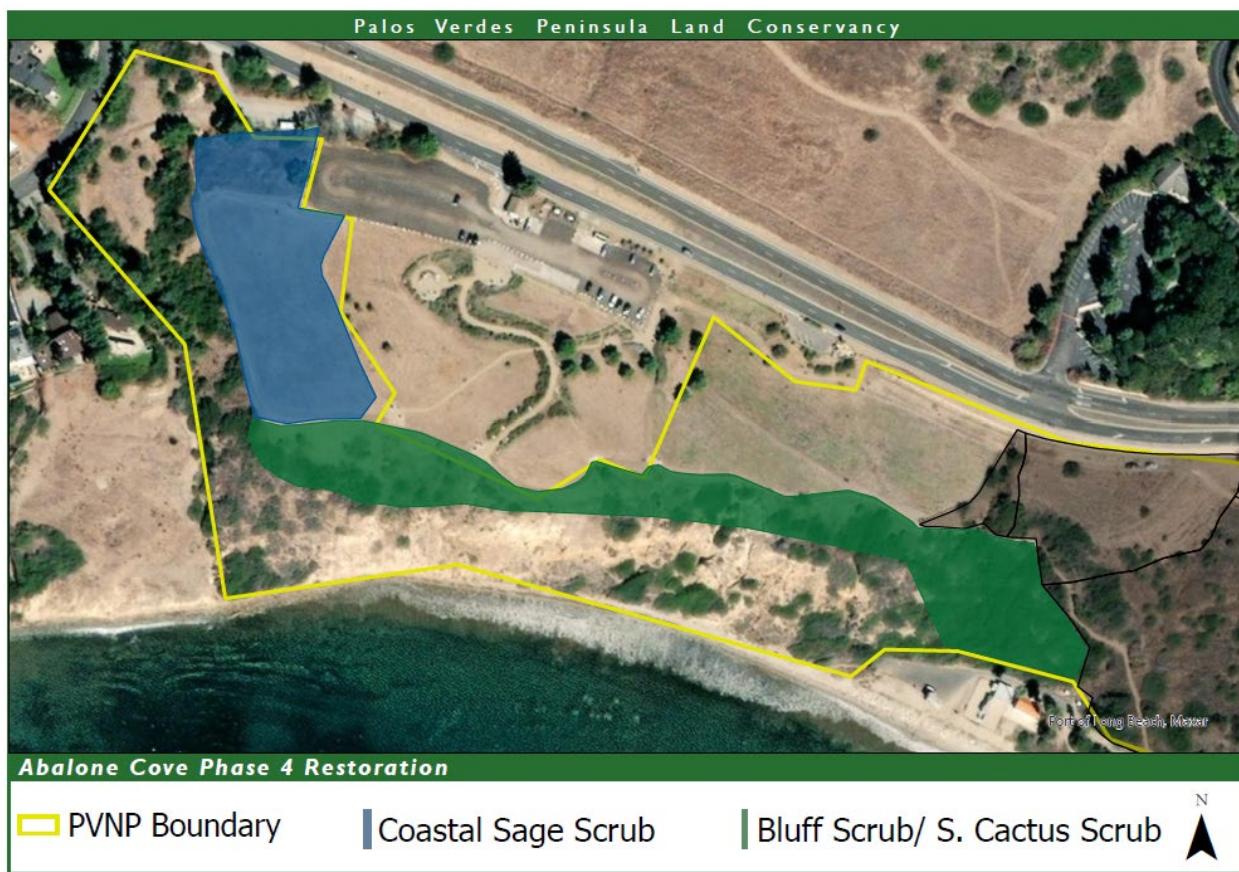
Figure 2

The two habitats to be established are Coastal Sage Scrub and Southern Coastal Bluff Scrub/Southern Cactus Scrub Mix (Figure 2 and Tables 1 and 2)

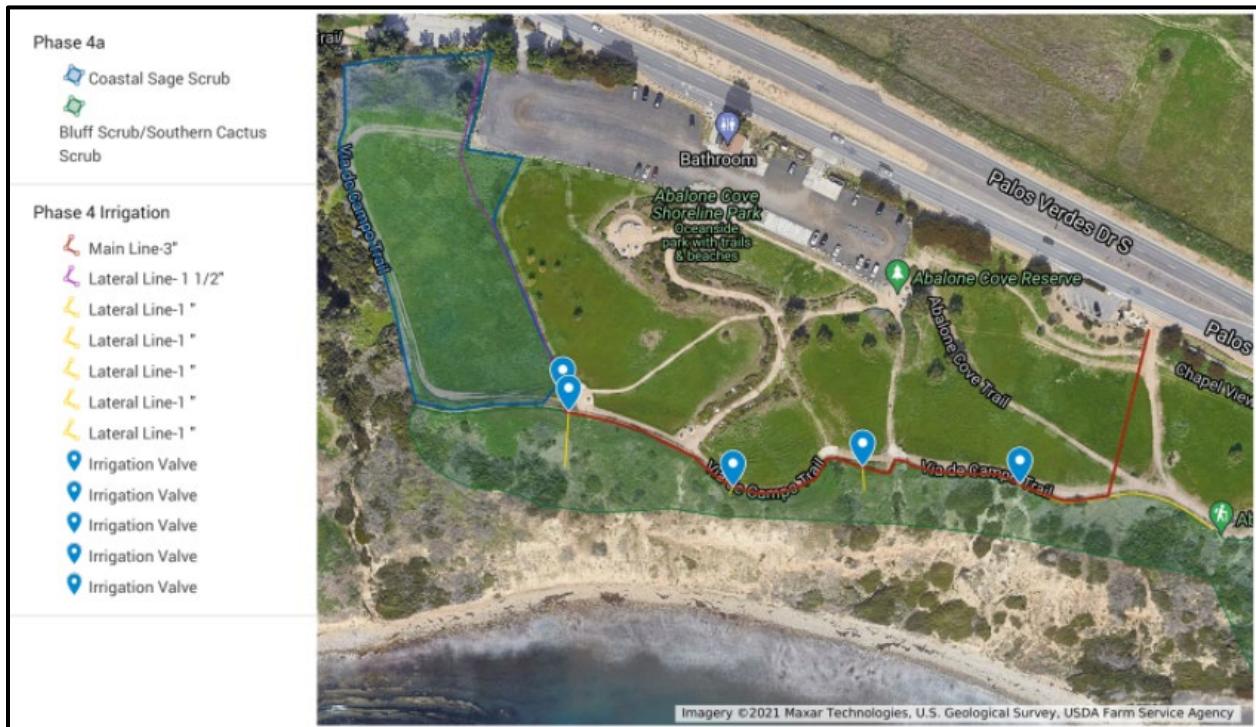
Figure 3

A temporary irrigation system will be installed to provide supplemental watering when natural precipitation rates are inadequate for plant establishment. The temporary, above ground watering system will have a point of connection at the current restoration site and its watering system. The irrigation will be placed above ground for easy removal when plants have been determined to be established and the project is deemed complete. Pipes will be buried at all trail crossings at the appropriate depth as directed by the project manager. The conceptual routed for the main line is shown in Figure 3.

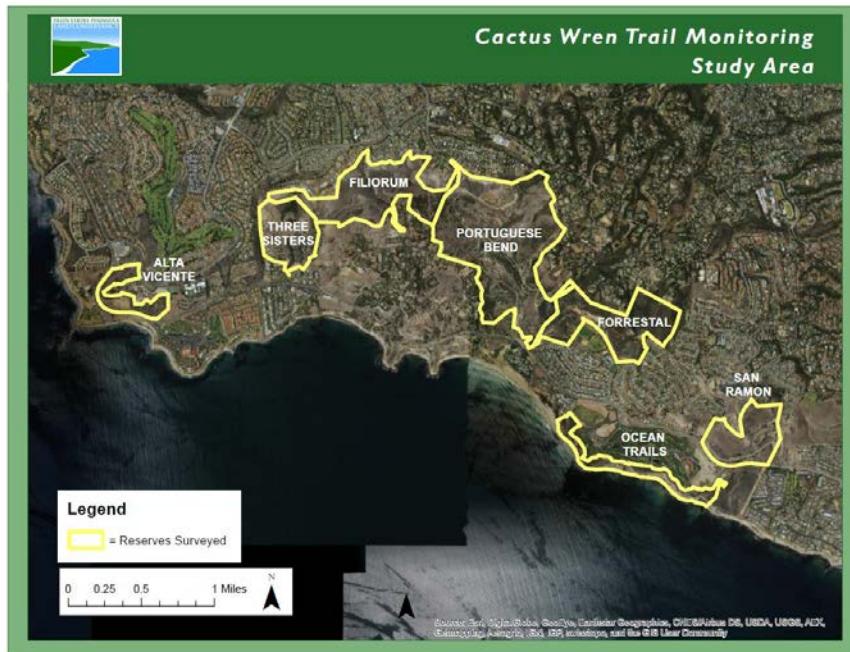
Figure 1. Study area within the Palos Verdes Peninsula Nature Preserve.

The study area was within eight reserves (Abalone Cove, Alta Vicente, Filiorum, Forrestal, Ocean Trails, Portuguese Bend, San Ramon, and Three Sisters) of the Palos Verdes Nature Preserve located in the city of Rancho Palos Verdes, CA. The reserves surveyed were those which had been documented to support CACW activity or extensive patches of prickly pear (*Opuntia littoralis* and *O. oricola*) and coastal cholla (*Cylindropuntia prolifera*) (Cooper Ecological Monitoring 2013).

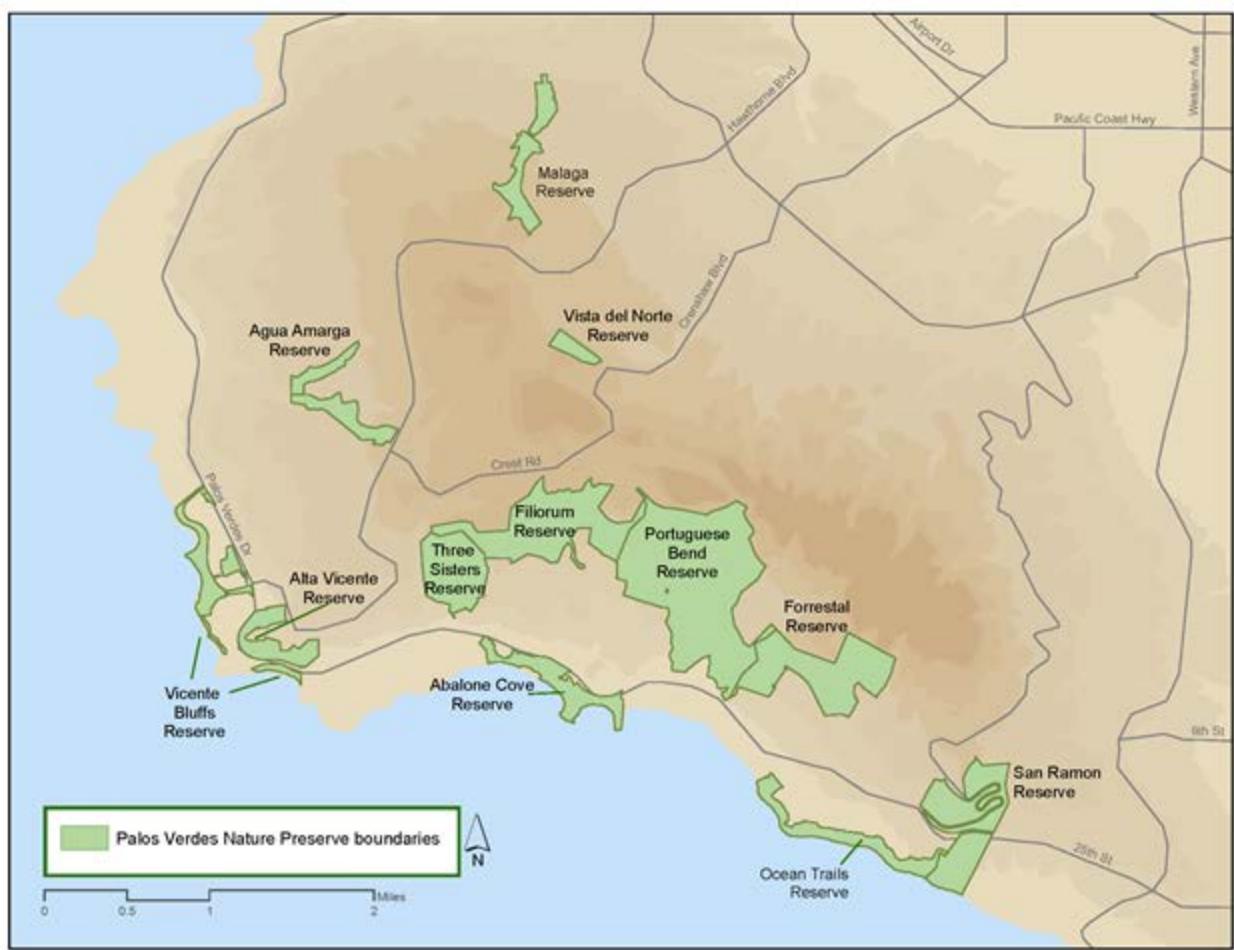
Figure 1. Wildlife Tracking Study Area Map

The study area was within 12 reserves (Abalone Cove, Agua Amarga, Alta Vicente, Filiorum, Forrestal, Malaga Canyon, Ocean Trails, Portuguese Bend, San Ramon, Three Sisters, Vicente Bluffs, and Vista Del Norte) of the Palos Verdes Nature Preserve (PVNP) located in the cities of Rancho Palos Verdes and bordering Rolling Hills, CA. Three reserves outside of the PVNP were also surveyed.

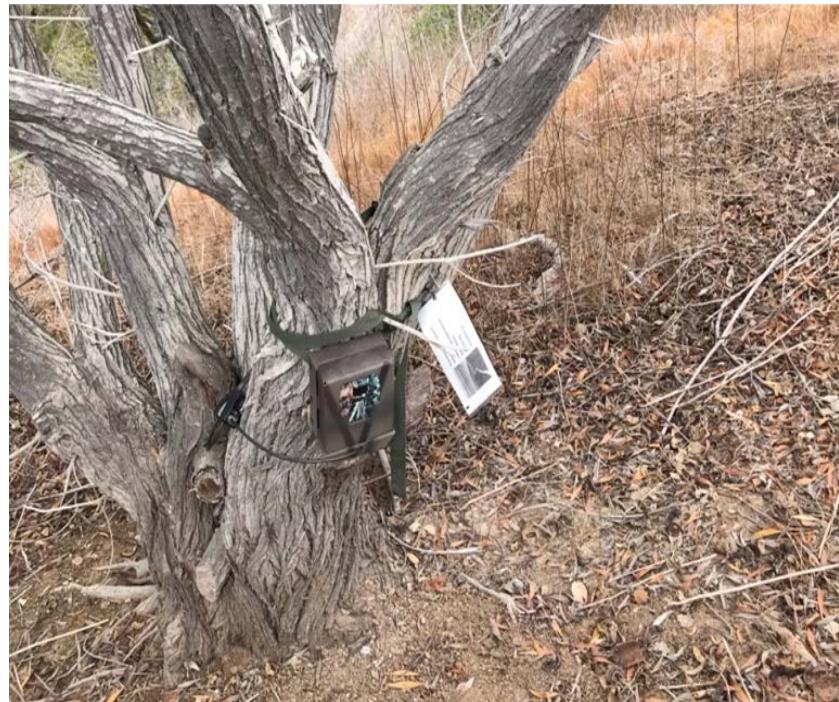
Figure 2: Wildlife camera secured to tree

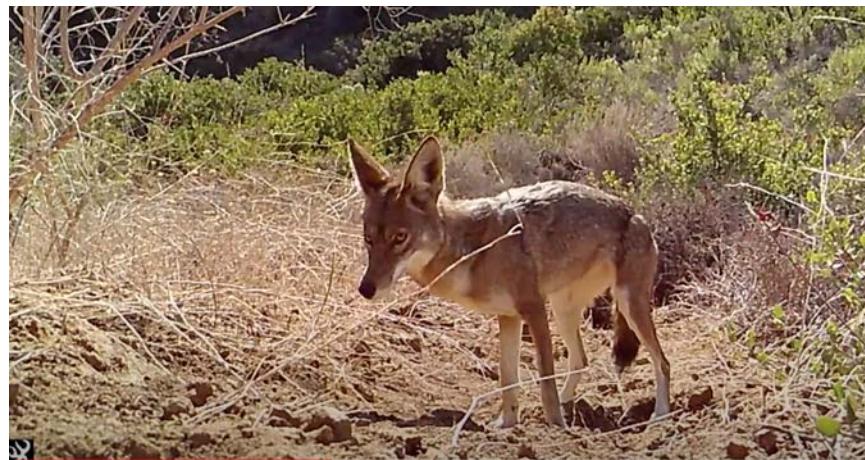
Figure 3: Coyote still from wildlife camera

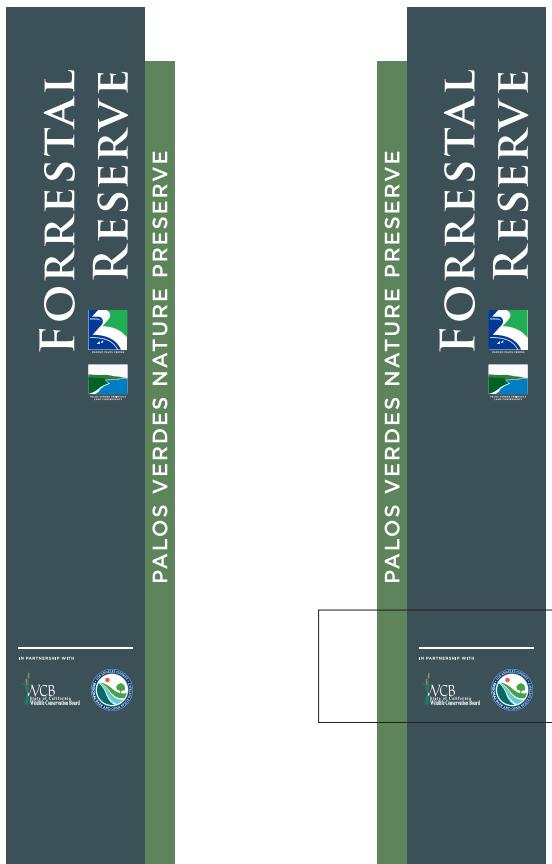
QTY=1

1 FORRESTAL FRONT & BACK
SCALE: 3/4" = 1'-0"

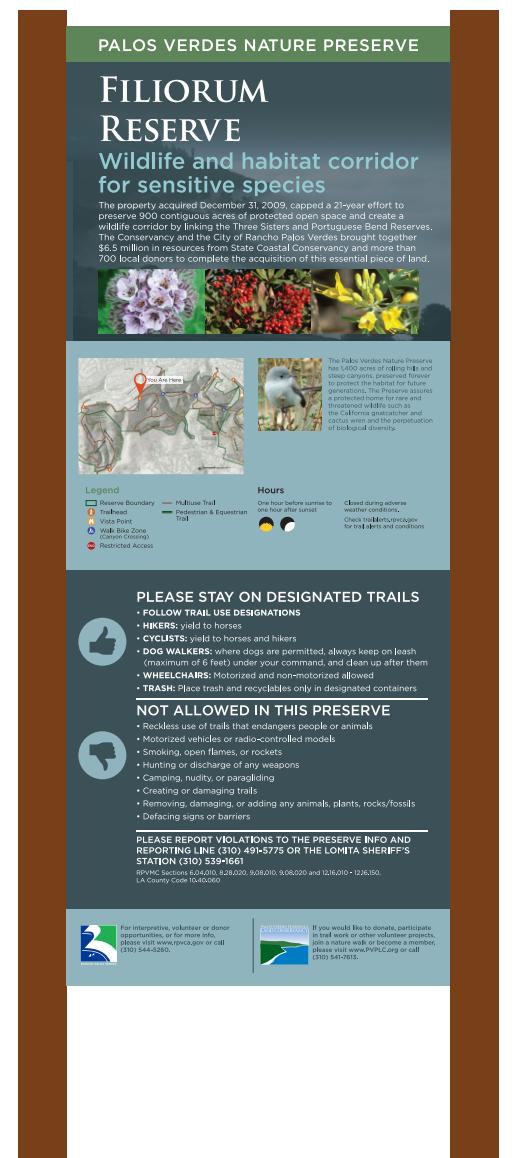
QTY=4

2 FILIORUM
SCALE: 1" = 1'-0"

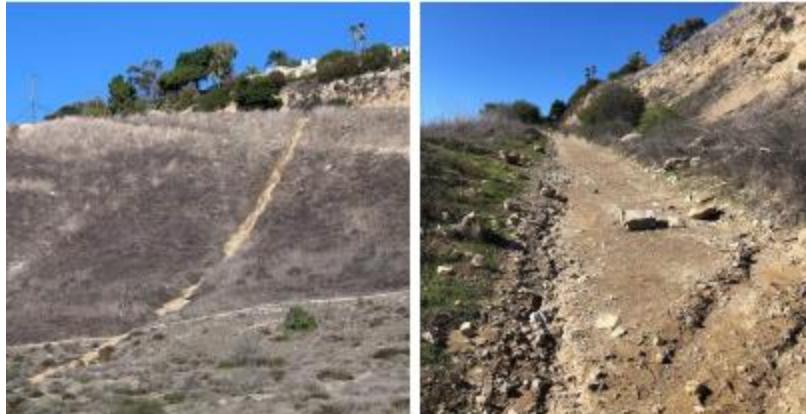
On January 2, Staff inspected trails to ensure trails had sufficiently dried, and hazards were identified and removed, to reopen to the public. Among several items, Staff removed several medium boulders that had fallen from the adjacent slope to ensure safe vehicle access for emergency and maintenance vehicles. The grade dips installed last Winter (January 2021) continued to divert most of the water off the trail resulting in minimal damage to trails.

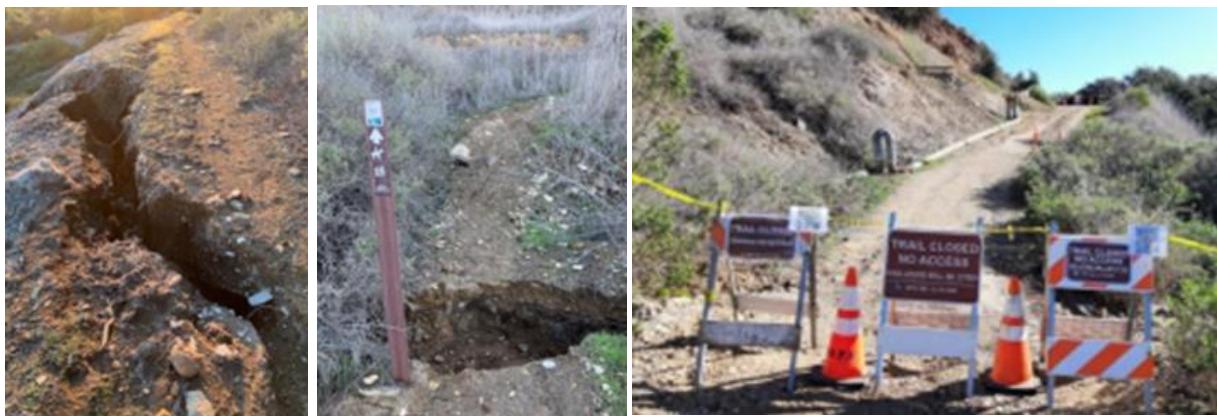
Several trails remained closed due to damage caused by the storm. The City is coordinating with the Geologist, as well as with Palos Verdes Peninsula Land Conservancy for inspections and repairs. The following trails in this Reserve were closed effective January 3: Fire Station Trail, Sandbox Trail, and a section of Burma Road Trail between Landslide Scarp Trail and Rim Trail. Garden Trail remained closed due to an emergence of erosion on the trail bed.

On January 6, Sandbox Trail was reopened after repairs were made by OSM staff. Additional maintenance procedures will be needed to inspect and assess water flow during rainstorms and to minimize impacts to the trail.

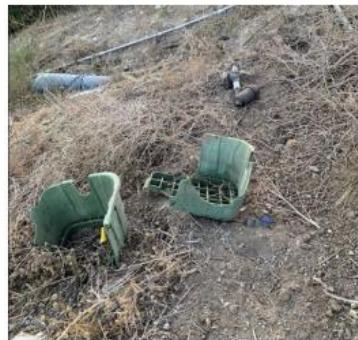
A vehicle crashed into the Abalone Cove restoration area on May 14. There was some damage to habitat and irrigation.

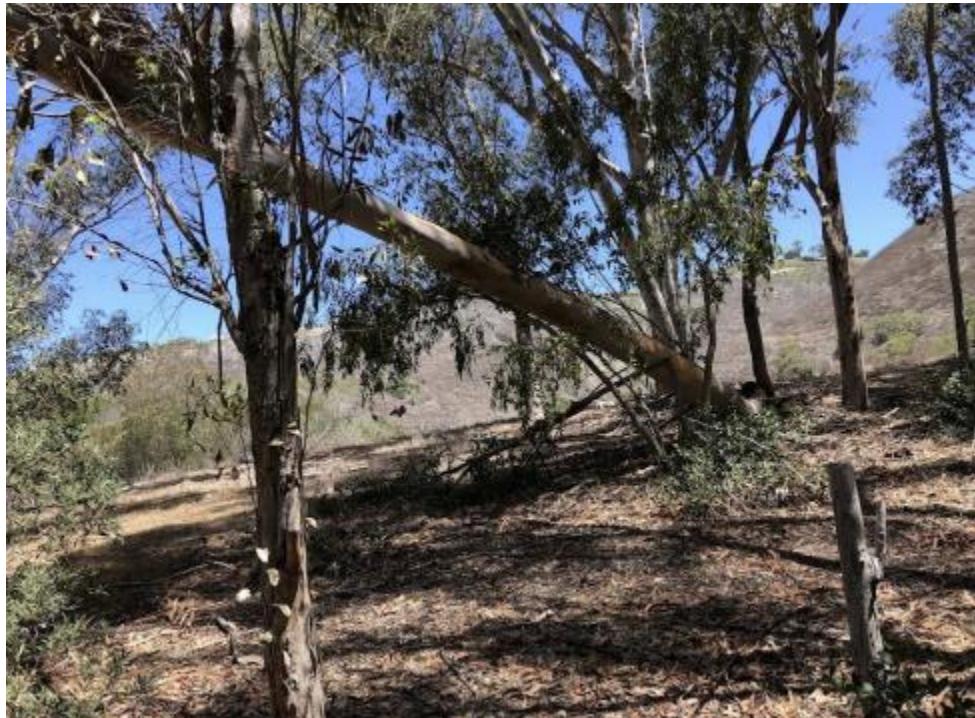
On June 21, the Eucalyptus Trail was temporarily closed due to a downed tree. The City is working with the Arborist and Public Works Department to assess the situation and reopen the trail.

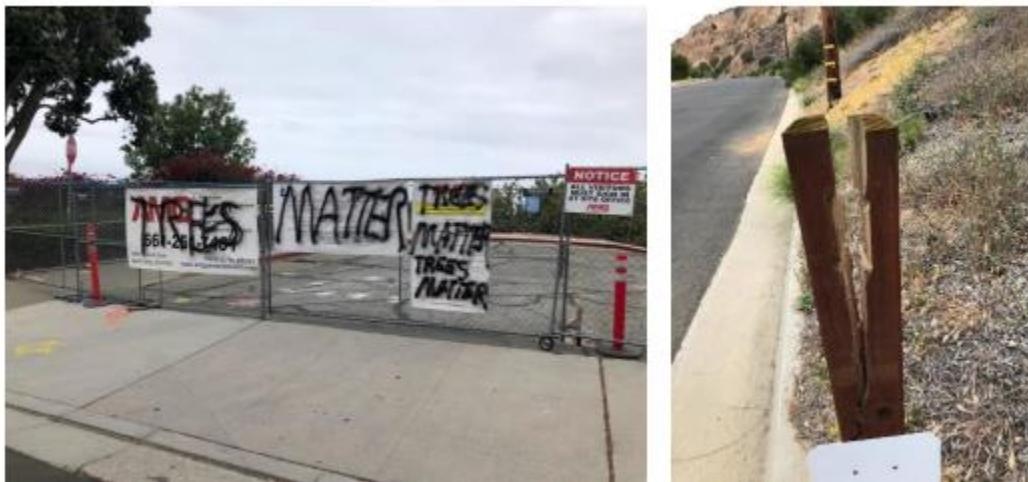
On May 2, OSM Staff observed vandalism on the construction banners at Ladera Linda Community Park and damage to a wooden post on Forrestal Drive. The incident was reported to Los Angeles County Sheriff's Department, and both the banner and post were replaced/repaired.

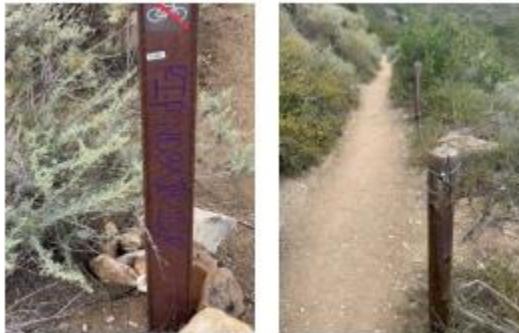
On May 8, several carbonite signs and wooden posts were defaced with graffiti along the trail system. The public is encouraged to report graffiti for removal via the MYRPV App.

Purple text on carsonite and wooden post found on the trails in Forrestal Reserve.

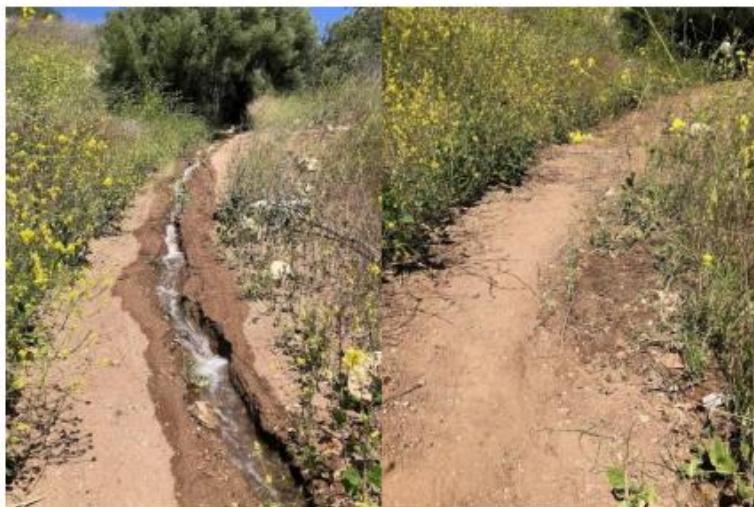
Water flowing onto Vanderlip Trail resulting in rutting on the trailbed prior to it depositing on the adjacent habitat. The picture on the right was taken after trail work was completed to reshape the grade dip and fill in ruts.

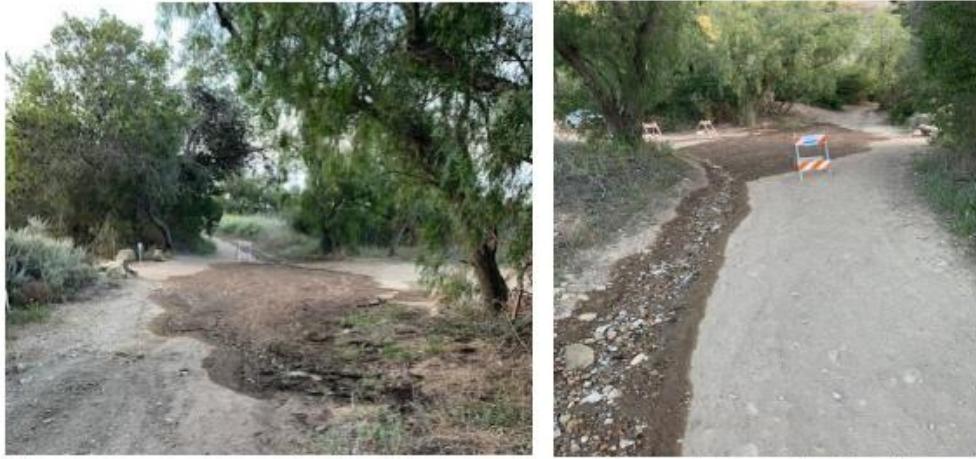
Water flowing down Burma Road Trail and three a-frames placed to notify the public of muddy conditions.

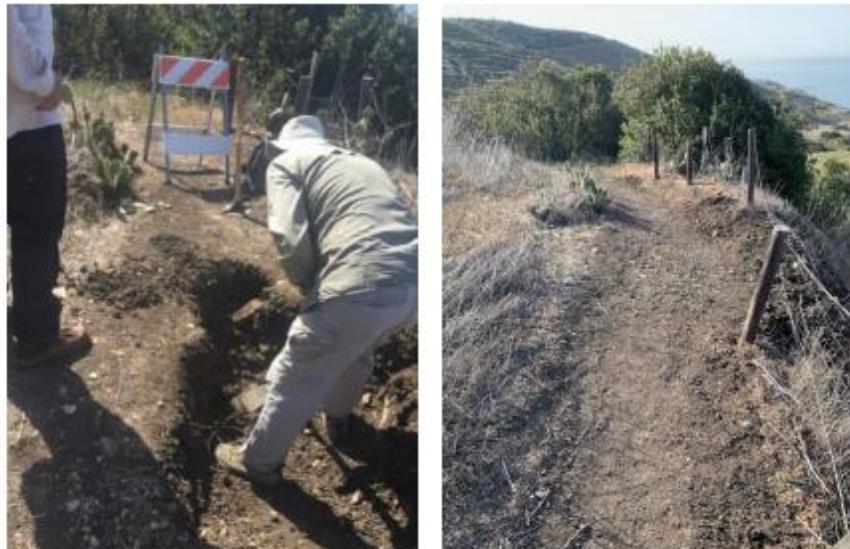
Volunteers are seen above on the left using fill dirt and compacting the trail. Picture on the right depicts the condition of the trail after work was completed.

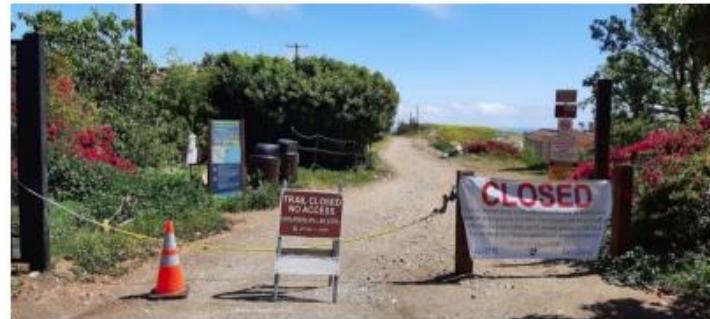
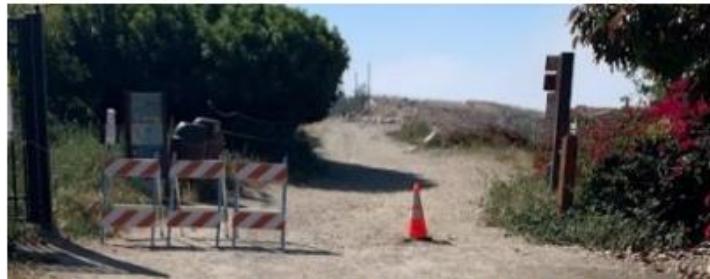
On May 6, the temporary wooden post and cable installed at the Burma Road trailhead was damaged by a vehicle collision. A police report was submitted, and the debris was retrieved by OSM Staff. A-frames have been placed in the interim. With the assistance of the Public Works Department, the temporary cable at Burma Road Trail was secured after the installation of a wooden post during the week of June 22.

Pictures above were taken at Burma Road trailhead on March 28 during a rain closure (top) and on May 6 after a vehicle damaged the middle post that secured the temporary cable.

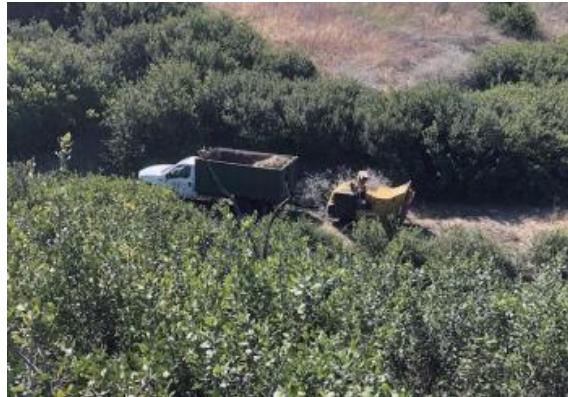
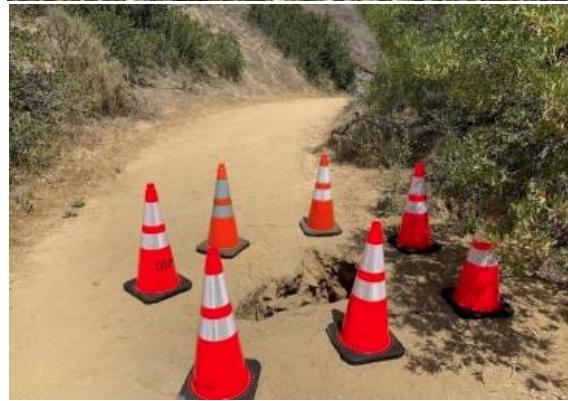
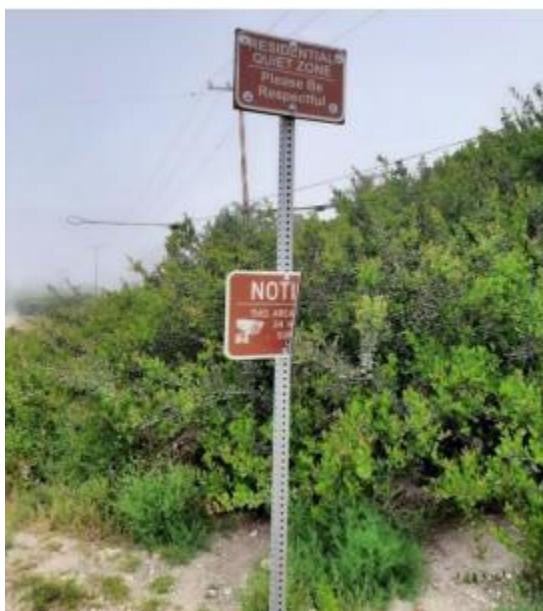
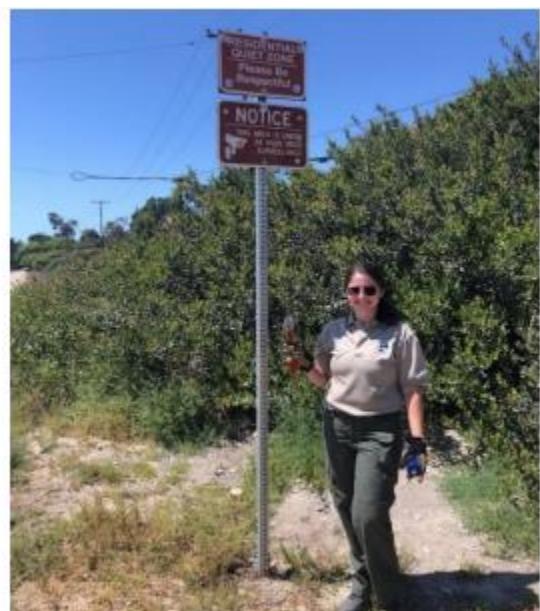
On May 26, Rangers and PVPLC staff observed a new rut that had emerged on Burma Road Trail past Toyon Trail junction. Several cones were placed to advise the public to use caution. The City will coordinate with contractors to assess and fill in the rut. On June 9, Staff observed that the camera notice sign placed at Burma Road Trail had been vandalized. The sign was repaired, reinforced, and placed higher on its metal post to deter vandalism.
