Palos Verdes
Nature Preserve

Annual Report

**Palos Verdes Peninsula
Land Conservancy**

The Rancho Palos Verdes
Natural Community
Conservation Plan and
Habitat Conservation Plan

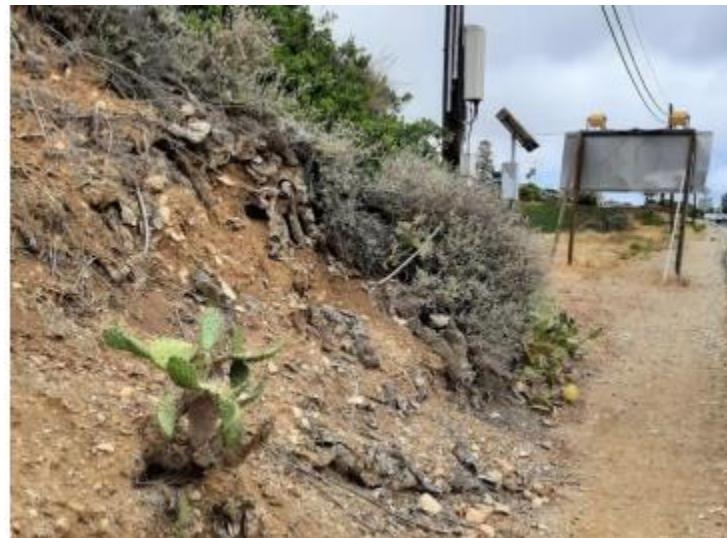
On June 13, Rangers received a report of a small fire adjacent to the Portuguese Bend Reserve boundary. The small fire burned cacti located by Palos Verdes Drive South in the Gateway area before being extinguished. The incident is under investigation.

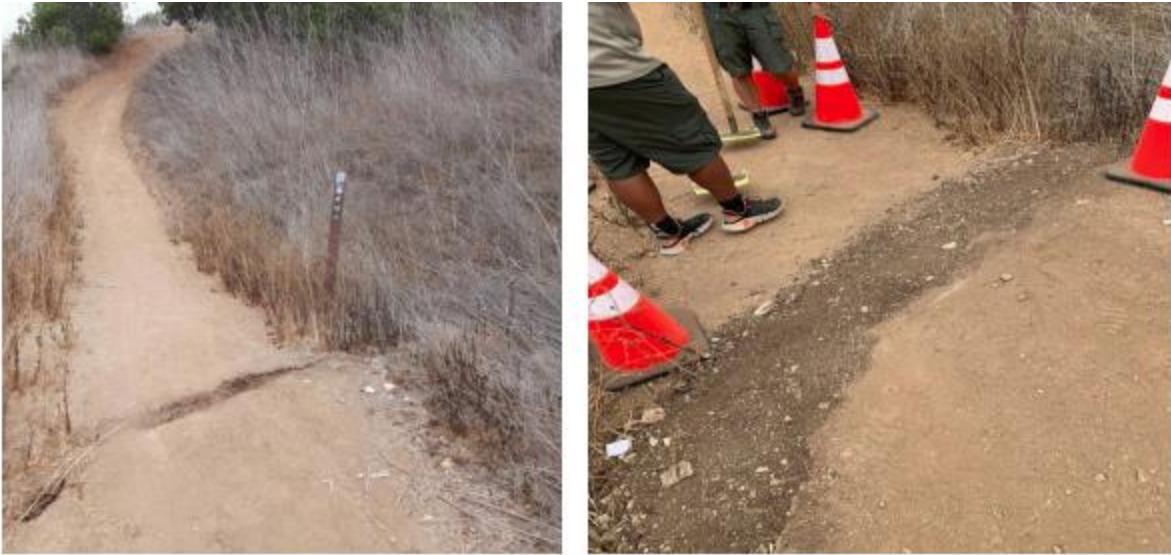
On June 16, Staff conducted repairs on a section of the Klondike Canyon Trail. No trail closures were required while the work was completed.

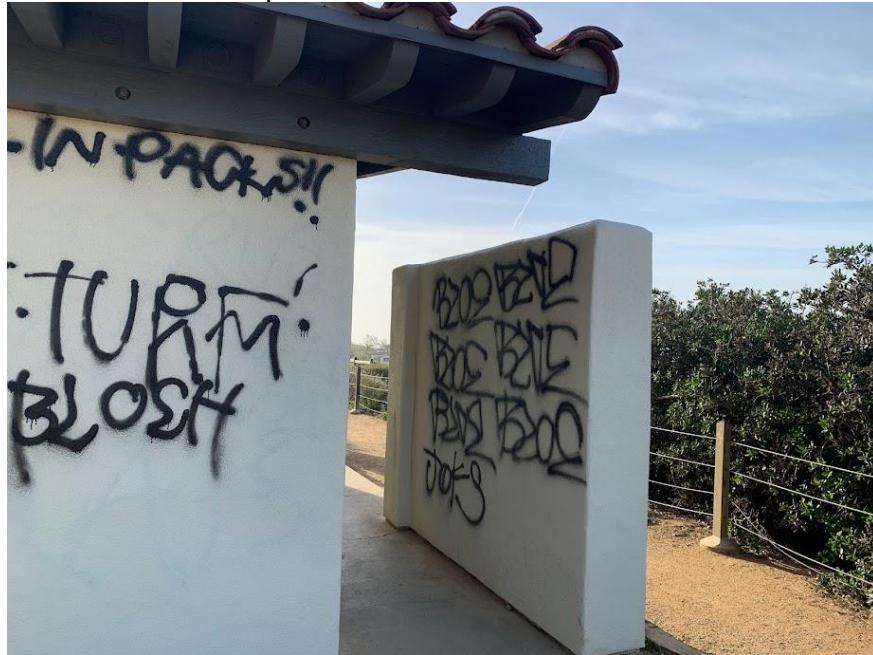
On Saturday, April 9, Rangers reported several instances of graffiti on the restroom facility, trash can, and walkway areas at Pelican Cove parking area. The restroom, A GPC report was submitted and pictures were taken to document the vandalism.

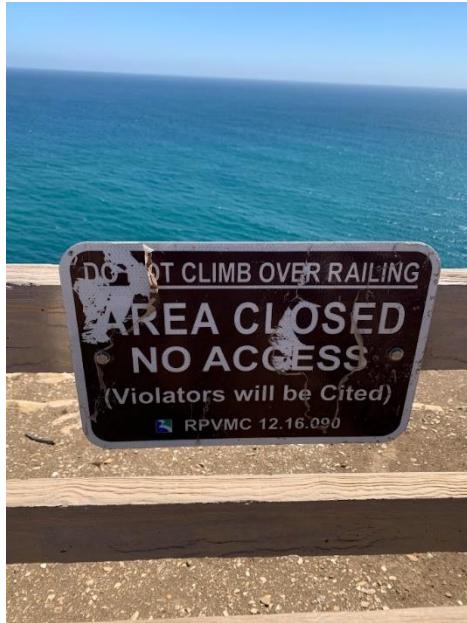
On August 16, Staff replaced an “Area Closed” sign that had been vandalized on Inspiration Point Trail. The protective coating had been scratched off resulting in peeling of the text underneath. The sign was replaced to ensure the text remained legible to advise the public to stay on designated trails.

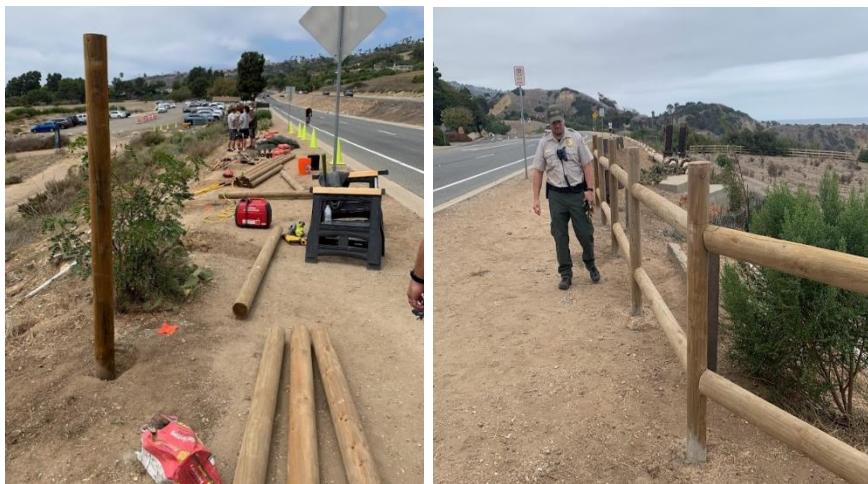
On August 20 and 21, Scout Aaron Chee, from Troop 378, worked with the City of Rancho Palos Verdes Recreation and Parks Department to complete his Eagle Scout Project. The project included the extension of the wooden fence near the 30-minute turnout at Abalone Cove Park / Reserve. Vertical posts were installed along 100 feet of the existing fence line. The benefit of extending this fence line is that it will help keep the public from trampling vegetation in a closed area.

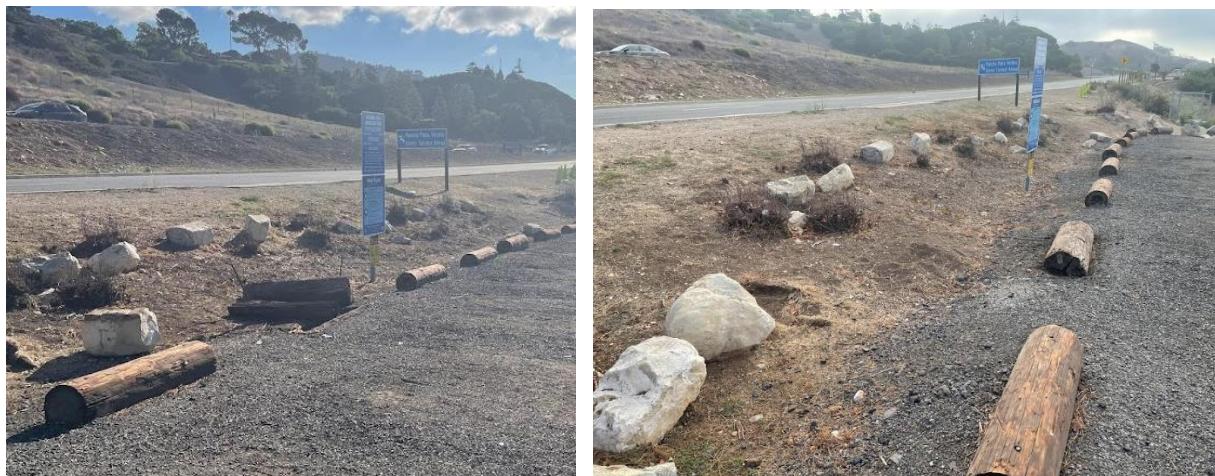
Throughout the week of September 19-26, Staff inspected and repaired ruts caused by an outside contractor's vehicle driving in muddy conditions caused by light rains on Portuguese Point Loop trail.

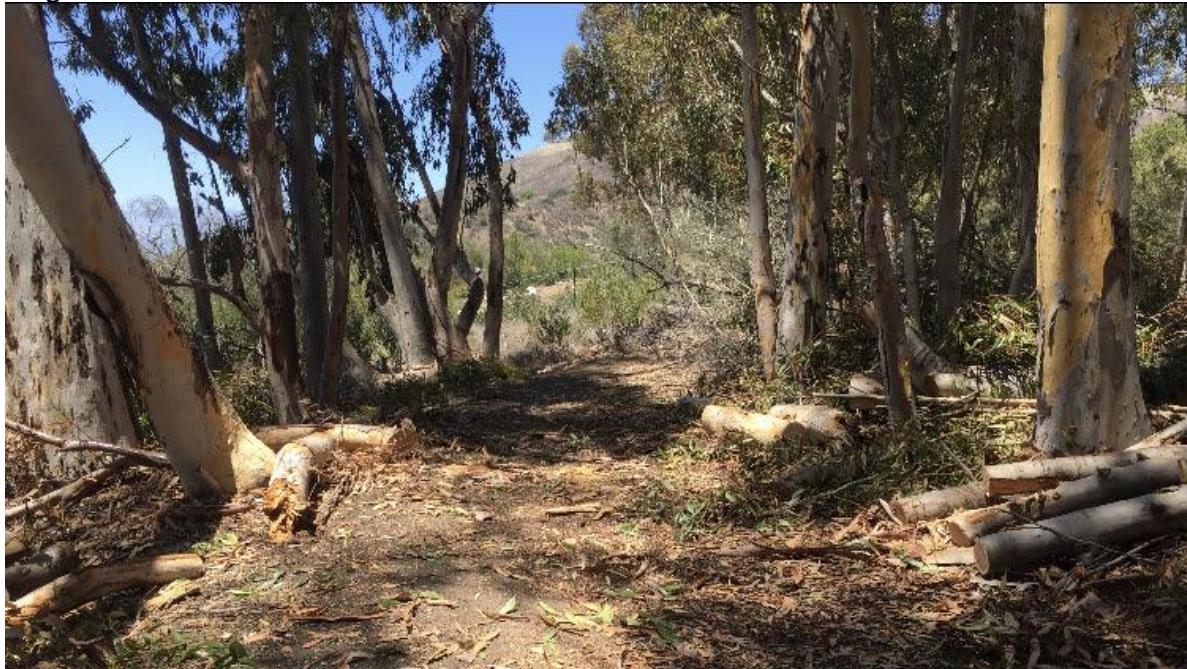
West Coast Arborists were on site on August 2 to cut the Eucalyptus tree that had uprooted, prompting a temporary closure of the trail. The trail has reopened as of August 2.

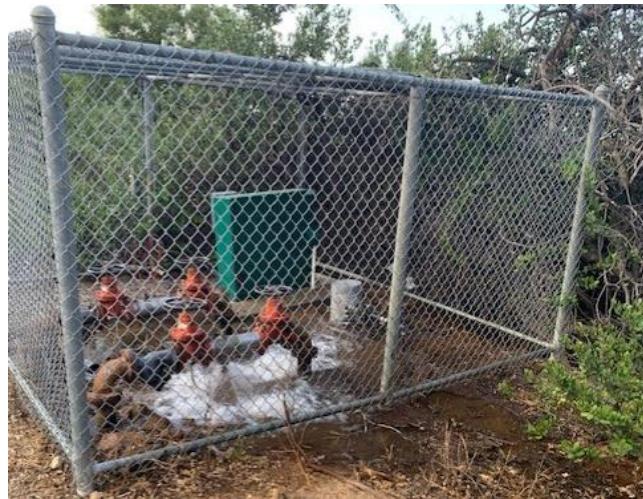
On July 30, a hiker reported running water on Forrestal Drive. Staff notified Cal Water to shut off the water, and the property owner was notified to make repairs that are needed.

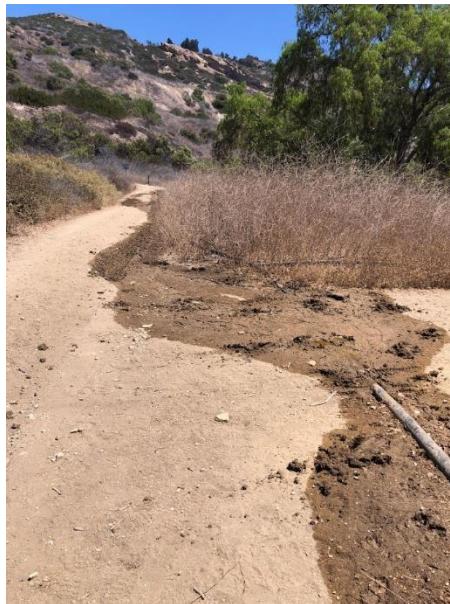
On August 28, Rangers identified and reported a water leak originating from public property, adjacent to lower section of Portuguese Bend Reserve. Public Works Department was notified and assisted with contacting the respective party for repairs.

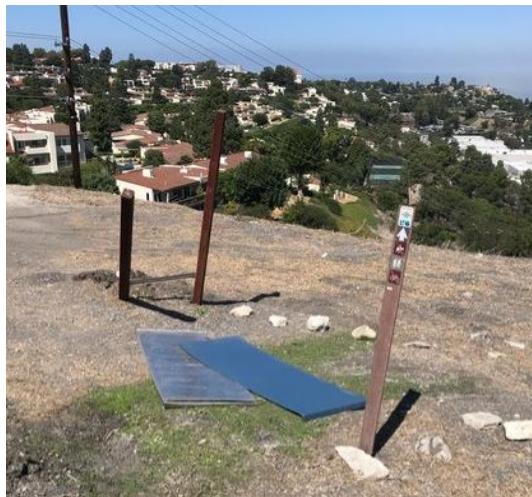
2020 damage to sign

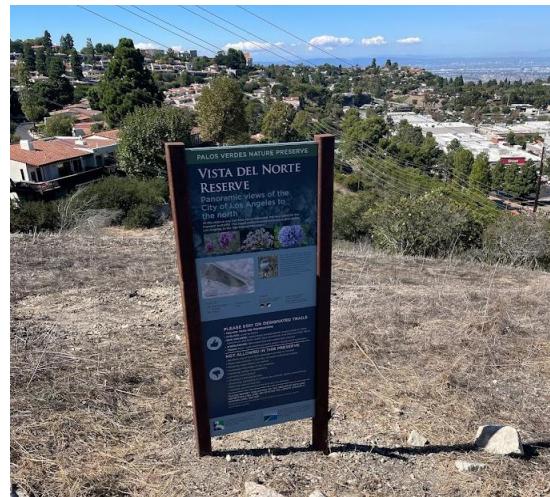
New Vista Del Norte Reserve sign

On September 19, contractors completed the installation of the Vista del Norte regulatory sign as part of Phase IV of the Preserve signage plan. The sign had been previously damaged by a vehicle in September 2020.

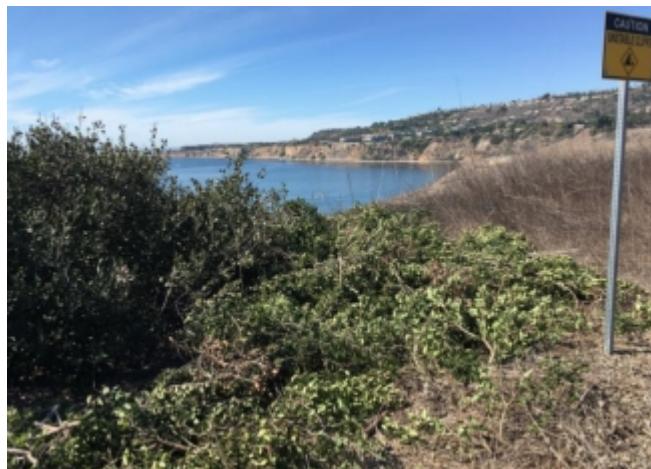
On October 19, Staff completed a multi-day project to cover up a spur trail that ran along the coastal blufftop fencing by the Portuguese Point Loop Trail. Spur trails are unauthorized, as use causes compaction and damages the habitat and native seedbank.

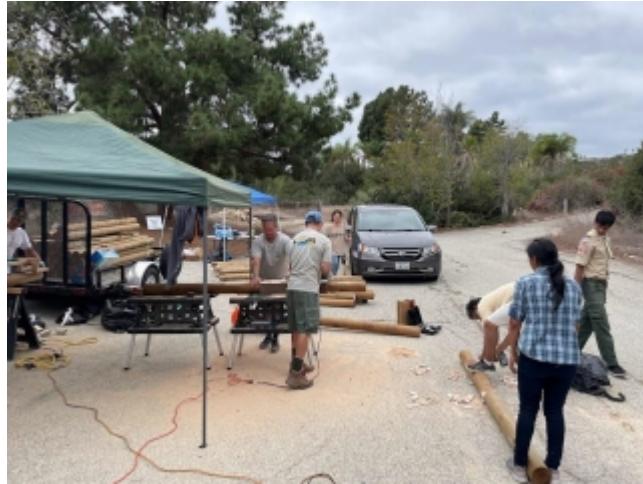
On October 22, Scout Shubham Waldiya, from Troop 378, worked with OSM to complete his Eagle Scout Project. The project included the installation of a wooden

fence adjacent to Chapel View Trail and the perimeter of the parking lot. The project included a total of 387 man-hours from 37 volunteers!

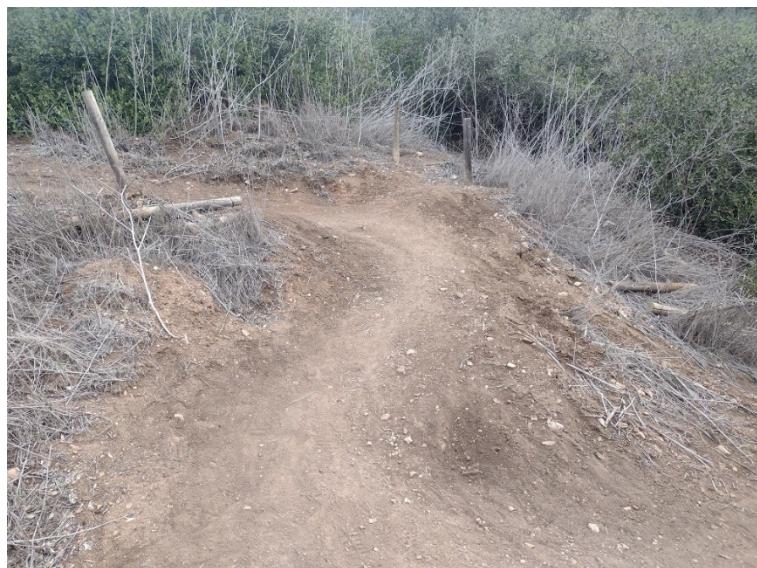
In December, Rangers were notified of damage to Flying Mane switchbacks, including new spur trails, and posts and cables on both sides of the trail dug out and tossed aside. Rangers will continue to monitor this area, and are coordinating with PVPLC on repairs.

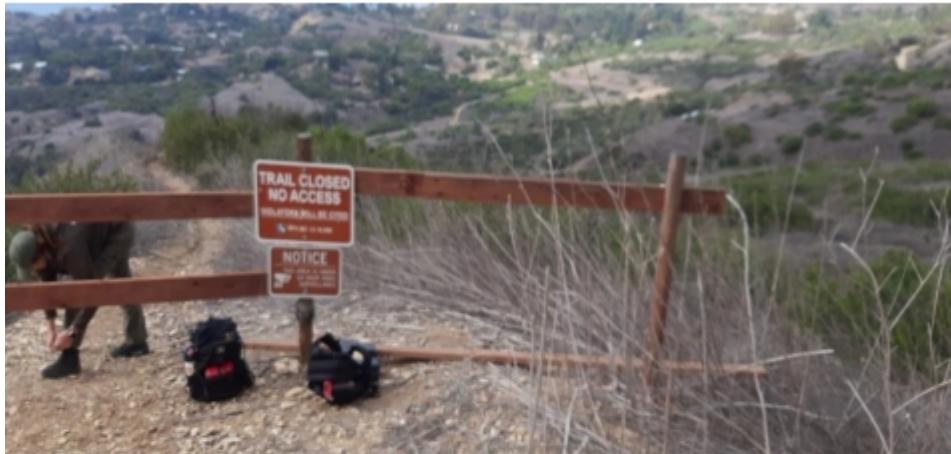
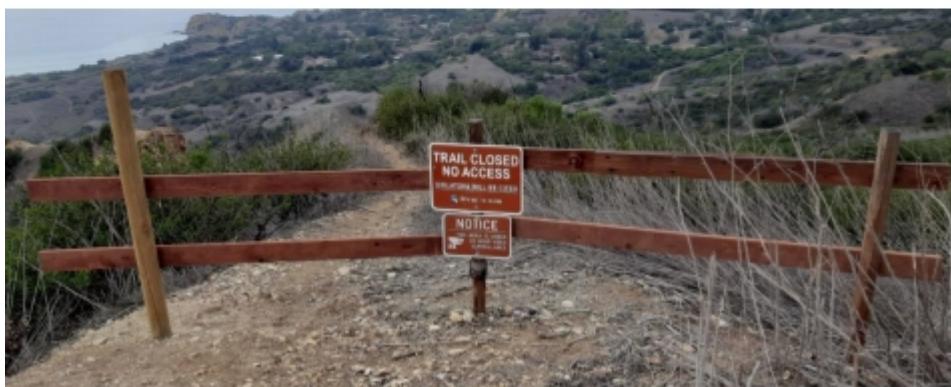
On November 28, Staff added a secondary post on the initial fence placed on the section of Rim Trail that has been temporarily closed. The bottom post had been vandalized and removed.

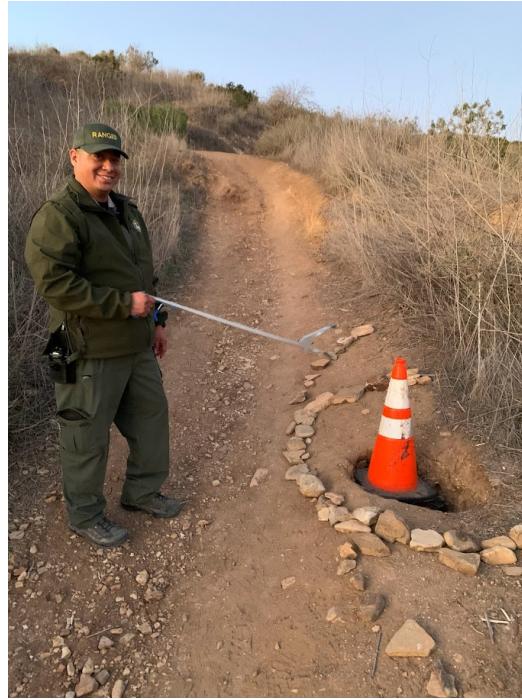
On December 23, Rangers received a report and repaired several fissures that have emerged on Klondike Canyon Trail. The trail continues to be monitored to ensure fissures are reported, and monitored with the City's Geologist.

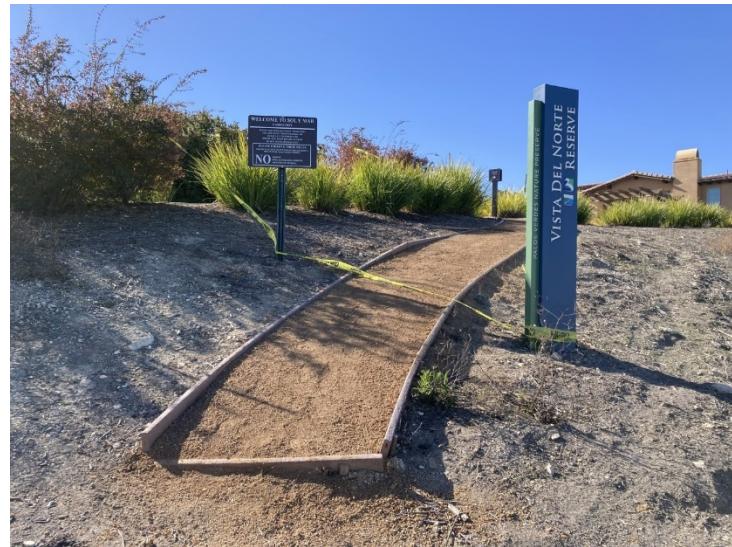
In November, the Sol y Mar HOA conducted repairs to the DG pathway that connects the public trails to the top of Vista del Norte Trail and Indian Peak Trail. Caution tape had been temporarily placed to advise the public not to use the pathway until the work was completed.
