RANCHO PALOS VERDES

GEOLOGIC MAP

ROBERT STONE & ASSOCIATES, INC.

JOB NUMBER 2037-10

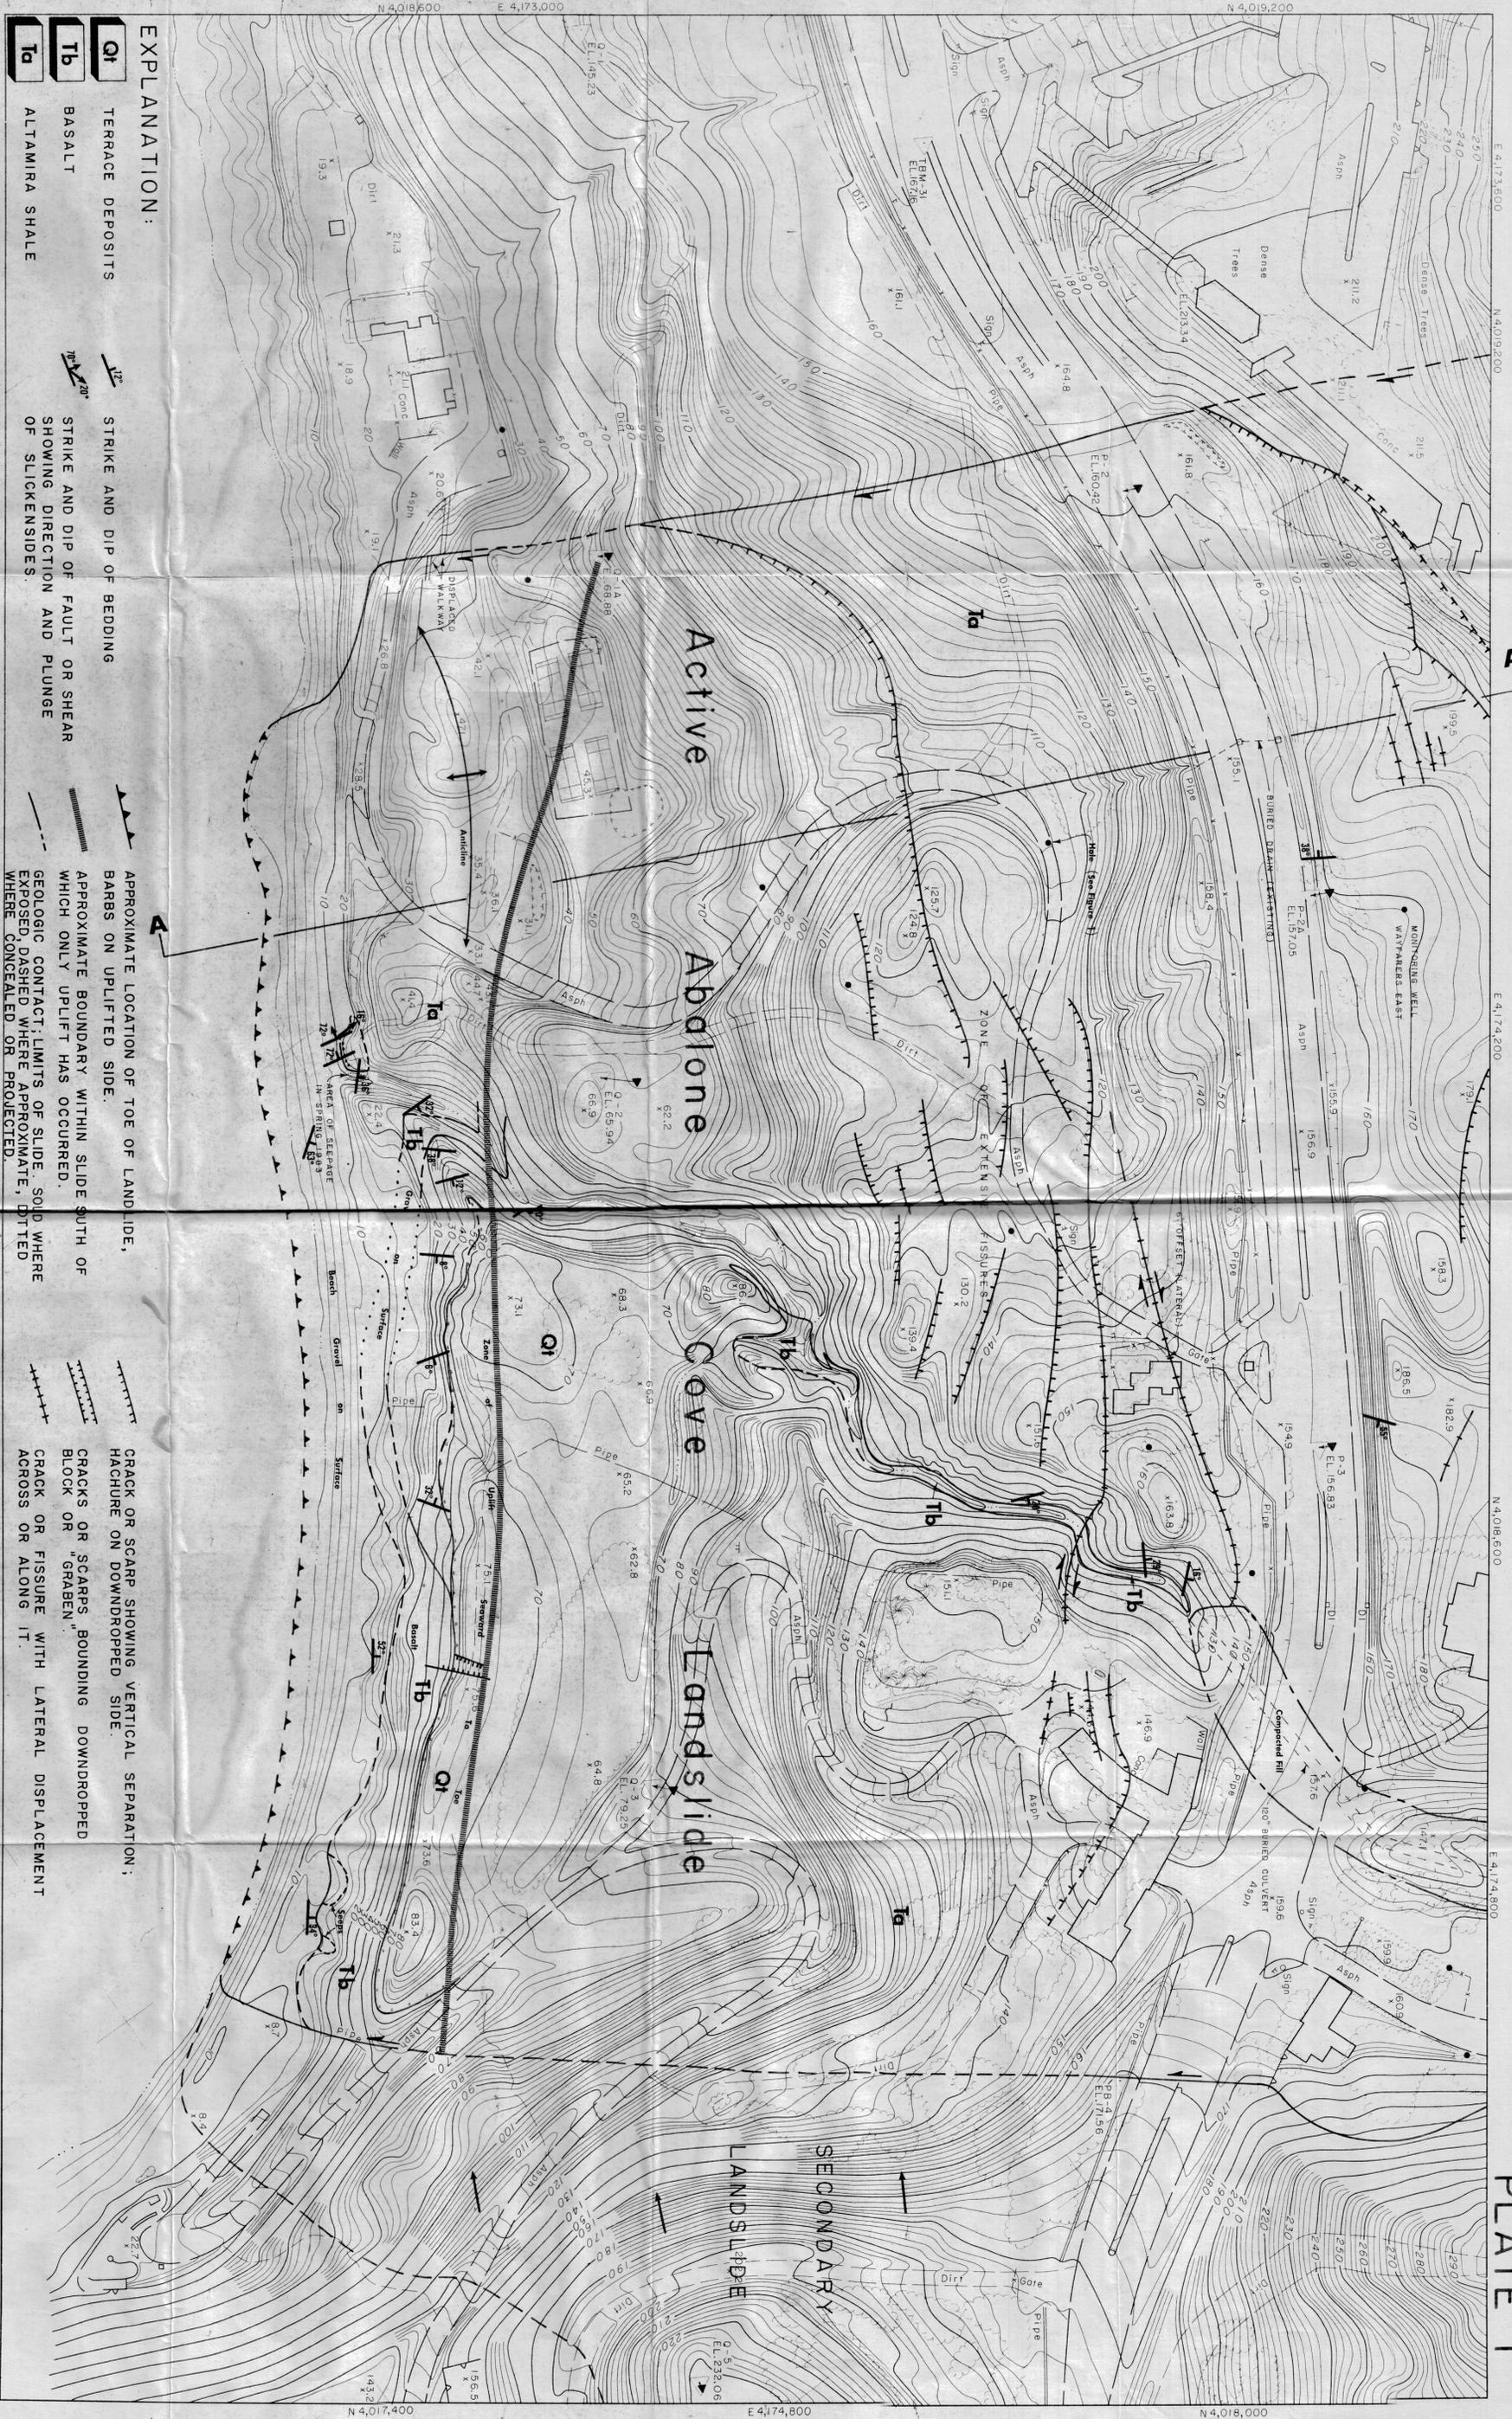
Sheet No. 1

SYMBOL INDICATING SURVEY DISPLACEMENT VECTOR SHOWING SLIDING, PREDOMINATELY SINCE 1977. FEW STATIONS EXHIBIT MINOR PREVIOUS MOVEMENT. SMALL SHADED TRIANGLE IS ORIGINAL LOCATION OF STATION OPEN TRIANGLE IS LOCATION AS OF NOVEMBER, 1982.
