COTTON, SHIRES AND ASSOCIATES, INC.
CONSULTING ENGINEERS AND GEOLOGISTS

PERCENT CHANGE IN DISPLACEMENT RATE MAP (7/1/24 TO 8/1/24)
Abalone Cove, Portuguese Bend, Klondike Canyon
RANCHO PALOS VERDES, CALIFORNIA

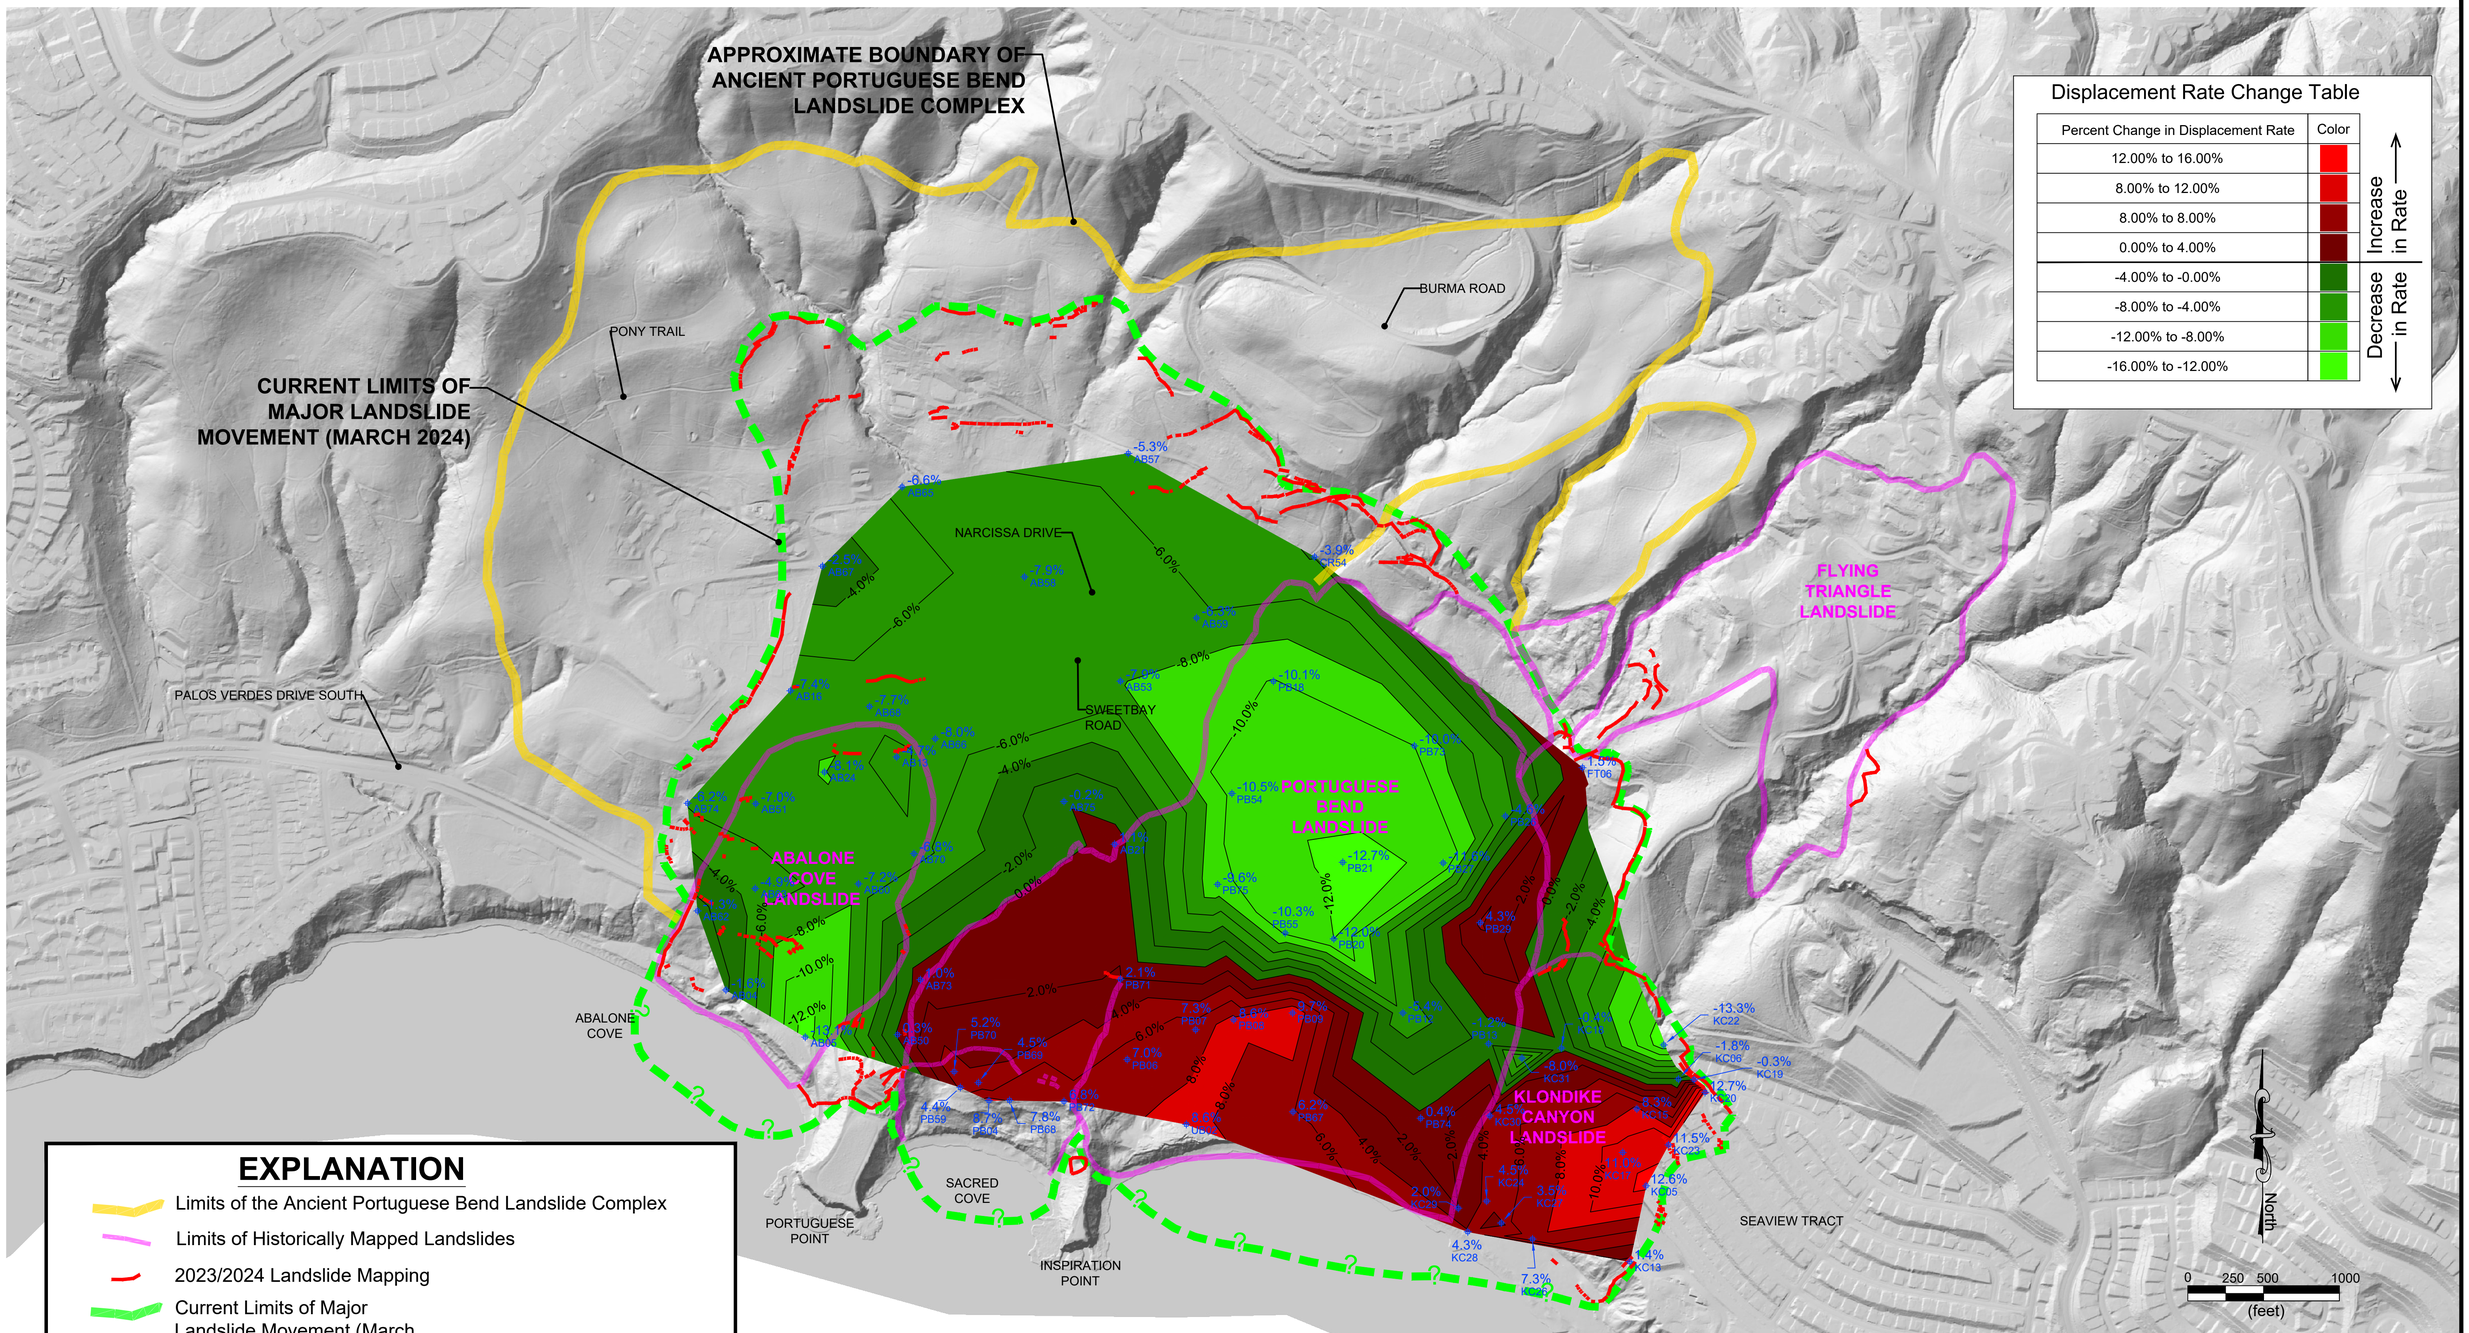
NOTES:
1) July 1, 2024 GPS monitoring data was unavailable for monuments AB78, CR55, CR57, KC34, KC35, KC36 and KC37.

2) August 1, 2024 GPS monitoring data was unavailable for monuments AB71 and CR07.
