City of Rancho Palos Verdes
 Rancho Palos Verdes ADA Assessment
 Facility Report with Photos

Facility ID: # 05 - Eastview Park

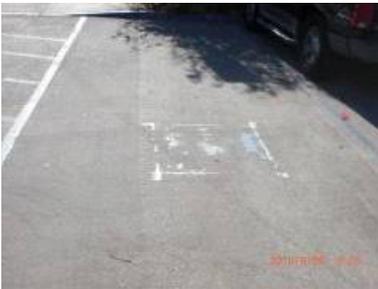
Location: Parking Photo # 4

| Field Condition | |
|---|---|
| Existing Condition: | 2004 ADAAG 502.6 |

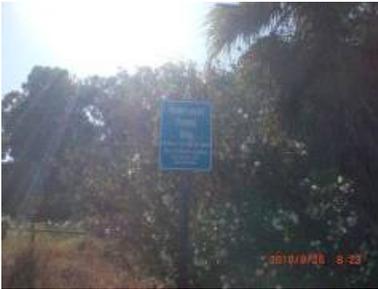
Location: Photo #
 Parking 2

| Field Condition | |
|---|---|
| Existing Condition: | 2004 ADAAG - |

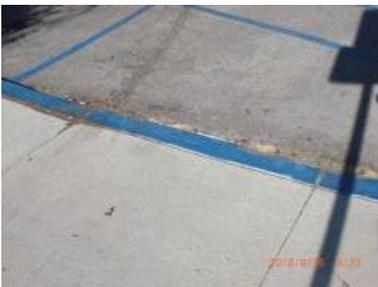
Location: Photo #
Parking 9

| Field Condition | |
|---|---|
| 04.10 - Detectable Warning Requirement - Regardless of slope, the curb ramp does not have a detectable warning. | 1991 ADAAG 4.7.7; 4.29.2 |
| Existing Condition: None provided. | 2004 ADAAG 705.1; Fig. 705.1 |

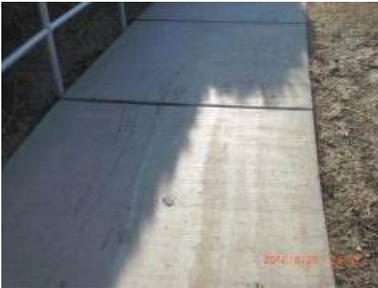
Location: Concrete Path
Photo # 17

| Field Condition | |
|--|---|
| 03B.10 - Running Slope - Slope of the accessible route of travel exceeds 1:20. Existing Condition: 5.1% to 5.6% RS. | 1991 ADAAG 4.3.7 2004 ADAAG 403.3 2007 CBC 1133B.7.3 Other - |

| Corrective Action |
|---|
| 006 - Concrete Walk - Remove non-compliant pavement and replace with new concrete (area as shown on the drawings). The walkway slope shall not exceed 5% along the POT and cross slope shall not exceed 2%. Additional Comments: Provide concrete path with less than 5% RS. |

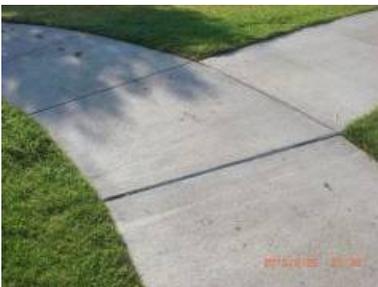
Location: Concrete Path
Photo # 18

| Field Condition | |
|--|---|
| 03B.10 - Running Slope - Slope of the accessible route of travel exceeds 1:20. Existing Condition: 5.6% RS. | 1991 ADAAG 4.3.7 2004 ADAAG 403.3 2007 CBC 1133B.7.3 Other - |

| Corrective Action |
|---|
| 006 - Concrete Walk - Remove non-compliant pavement and replace with new concrete (area as shown on the drawings). The walkway slope shall not exceed 5% along the POT and cross slope shall not exceed 2%. Additional Comments: Provide concrete path with less than 5% RS. |

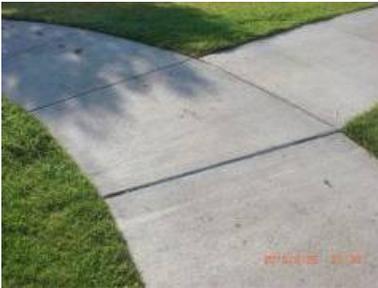
| Field Condition | |
|--|---|
| 03B.09 - Cross Slope - Cross slope of the accessible route of travel exceeds 1:50. Existing Condition: 3.7% CS. | 1991 ADAAG 4.3.7 2004 ADAAG 403.3 2007 CBC 1133B.7.1.3 Other - |

| Corrective Action | |
|---|--|
| 008 - Concrete Landing - Remove non-compliant pavement and replace with new concrete. The landing slope shall not exceed 2% in any direction. Additional Comments: Provide concrete landing with a cross slope and RS of 2% or less. | |

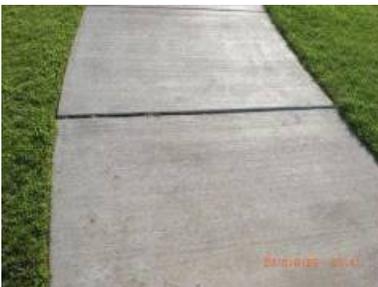
Location: Concrete Path
Photo # 18

| Field Condition | |
|--|---|
| 03B.10 - Running Slope - Slope of the accessible route of travel exceeds 1:20. Existing Condition: 5.5% RS. | 1991 ADAAG 4.3.7 2004 ADAAG 403.3 2007 CBC 1133B.7.3 Other - |

| Corrective Action | |
|---|--|
| 006 - Concrete Walk - Remove non-compliant pavement and replace with new concrete (area as shown on the drawings). The walkway slope shall not exceed 5% along the POT and cross slope shall not exceed 2%. Additional Comments: Provide concrete path with less than 5% RS. | |

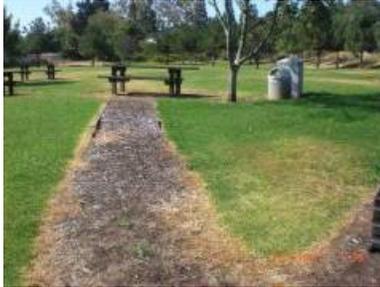
| Field Condition | |
|--|---|
| 30.32 - 36" Aisle Width Standard - Around the picnic table, there is less than 36" clear space measured from the seat. | 1991 ADAAG - |

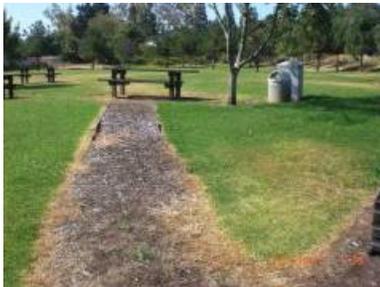
Location: Photo #
 Trail 29

| Field Condition | |
|---|---|
| 30.28 - Picnic Site - Surface Slope - The accessible picnic site is located on a surface area with slope greater than 2% in some or all directions.(1999 ADAAG: 3% slope is allowed when necessary for drainage). | 1991 ADAAG 4.3.7 |

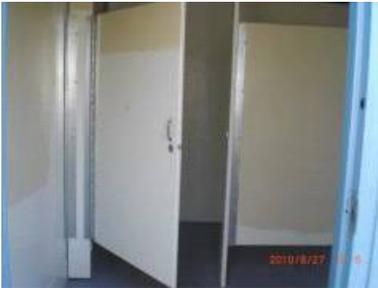
| Field Condition | |
|--|---|
| 16.26A - Cross Slope - Cross slope of the accessible route of travel exceeds 1:50. Existing Condition: 3.5% slope at drain. | 1991 ADAAG 4.3.7 2004 ADAAG 403.3 2007 CBC 1133B.7.1.3 Other - |

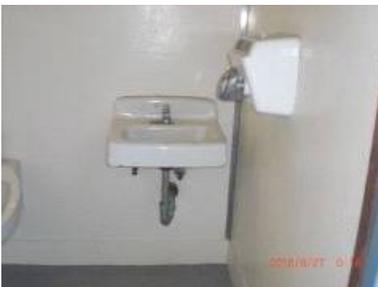
Location: Men's Restroom
Photo # 57

| Field Condition | |
|--|---|
| 16.84B - Electric Hand Dryer - Operating Height - Mounting height of electric hand dryer's highest operable part exceeds 40" AFF. (Where provided, ADA Standards require at least one electric hand dryer to be accessible with the highest operable part placed within at least one of the reach ranges specified in 4.2.5 and 4.2.6; where provided, CBC Standards require at least one electric hand dryer to be accessible with the highest operable part no higher than 40" AFF.) Existing Condition: 44" AFF. | 1991 ADAAG 4.22.7; 4.27.3; 4.2.5; 4.2.6 2004 ADAAG 308; 309 2007 CBC 1115B.8.3 Other - |

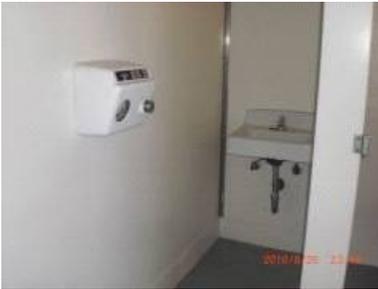
16.84B - Electric Hand Dryer - Operating Height - Mounting height of electric hand dryer's highest operable part exceeds 40" AFF. (Where provided, ADA Standards require at least one electric hand dryer to be accessible with the highest operable part placed within at least one of the reach ranges specified in 4.2.5 and 4.2.6; where provided, CBC Standards require at least one electric hand dryer to be accessible with the highest operable part no higher than 40" AFF.)

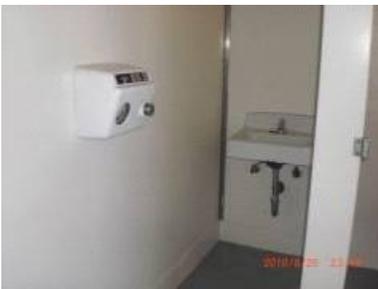
Location: Photo #
Women's Restroom 91

14.30A - Wall-Mounted Protruding Objects - Wall-mounted object(s) with leading edges between 27 and 80" from the floor project more than 4" into the pathway. (Wall mounted objects with leading edges at or below 27" may project any amount as long as the required clear width of an accessible route is not reduced.)

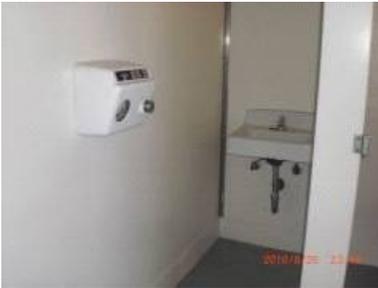
| Field Condition | |
|---|---|
| 16.73 - Lavatory Knee Clearance - Lavatory does not provide accessible knee clearance (i.e. at least 27" clearance from the floor to the underside of the lavatory, extending 8" min.. measured from the front edge underneath the lavatory back towards the wall). | 1991 ADAAG 4.19.2; Fig. 31 |

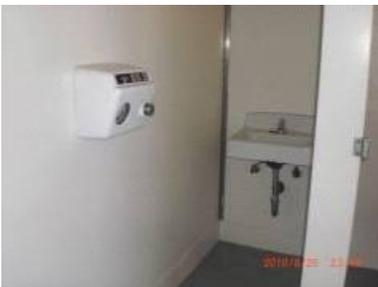
Location: Photo #
Women's Restroom 91

| Field Condition | |
|--|---|
| 16.76 - Lavatory - Clearance near Sidewall - The centerline of the lavatory is not 18" min.. from the nearest sidewall or partition. | 1991 ADAAG - |

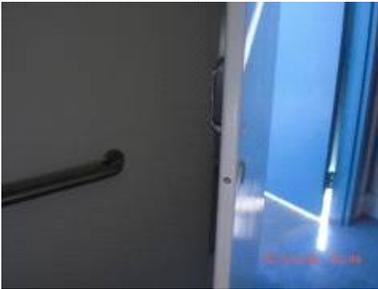
| Field Condition | |
|--|---|
| 16.32A - U-Pulls at Stall Door - The stall door does not have U-pulls on both sides. | 1991 ADAAG 4.13.9; 4.17.5 |

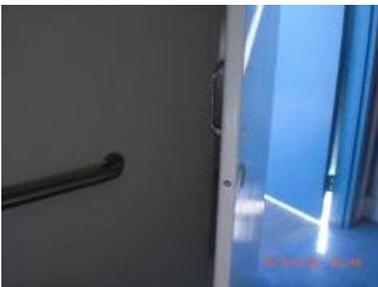
Location: Photo #
Women's Restroom 99

| Field Condition | |
|--|---|
| 16.32B - Single-Action Stall Door Hardware - The stall door's locking mechanism is not operable with one hand. OR It is not operable without tight grasping, pinching, or twisting of the wrist. | 1991 ADAAG 4.13.9; 4.17.5 |

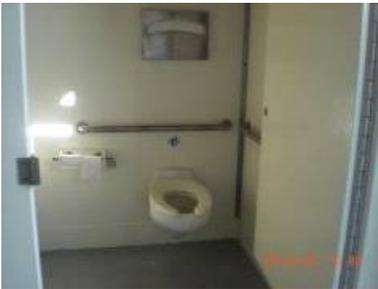
Location: Women's Restroom Photo # 99

| Field Condition | |
|---|---|
| 16.47A - WC Location from Sidewall - The centerline of the WC is not 18" absolute from a wall or partition. | 1991 ADAAG 4.22.4 |

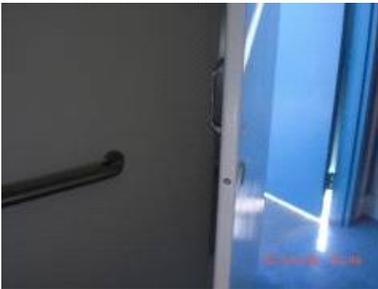
16.40 - Stall Door Location - End-Opening Stall - In an end-opening stall, the stall door is in front of the WC and not in front of the side transfer space. (ADA/CBC Standards require the door to be located in front of the side transfer space and diagonal to the WC, with a maximum stile width of 4".)

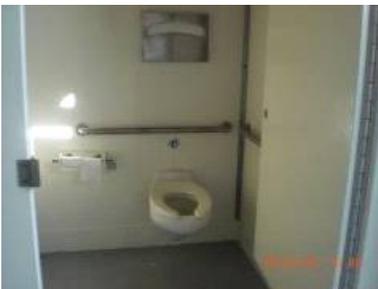
Location: Photo #
Women's Restroom 99

16.49B - WC Flush Controls - Location - Flush controls are not located on the wide side of the WC where the clear floor space is provided.

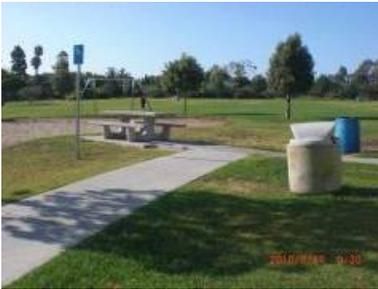
Location: Picnic Table Photo # 113

| Field Condition | |
|--|---|
| 30.32 - 36" Aisle Width Standard - Around the picnic table, there is less than 36" clear space measured from the seat. | 1991 ADAAG - |
| Existing Condition: 13" aisle around picnic table. | 2004 ADAAG - |

| Corrective Action |
|---|
| 006 - Concrete Walk - Remove non-compliant pavement and replace with new concrete (area as shown on the drawings). The walkway slope shall not exceed 5% along the POT and cross slope shall not exceed 2%. |

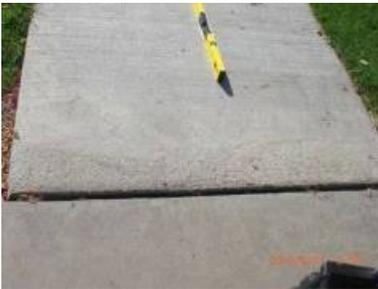
Keynote 114

| Field Condition | |
|--|---|
| 03B.22 - Other - On-Site Accessible Path of Travel - See Additional Comments | 1991 ADAAG - |
| Existing Condition: 1" gap at 5 locations. | 2004 ADAAG - |

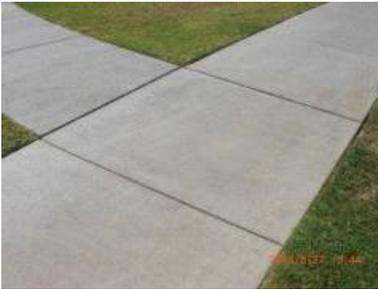
Location: Picnic Table
Photo # 115

| Field Condition | |
|--|---|
| 03B.09 - Cross Slope - Cross slope of the accessible route of travel exceeds 1:50. Existing Condition: 2.6% CS. | 1991 ADAAG 4.3.7 2004 ADAAG 403.3 2007 CBC 1133B.7.1.3 Other - |

| Corrective Action |
|---|
| 006 - Concrete Walk - Remove non-compliant pavement and replace with new concrete (area as shown on the drawings). The walkway slope shall not exceed 5% along the POT and cross slope shall not exceed 2%. Additional Comments: |

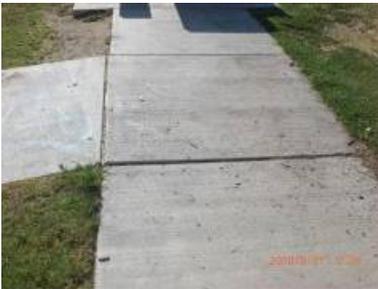
Location: Picnic Table
Photo # 116

| Field Condition | |
|--|---|
| 03B.10 - Running Slope - Slope of the accessible route of travel exceeds 1:20. Existing Condition: 5.2% to 6.5% RS. | 1991 ADAAG 4.3.7 2004 ADAAG 403.3 2007 CBC 1133B.7.3 Other - |

| Corrective Action |
|---|
| 006 - Concrete Walk - Remove non-compliant pavement and replace with new concrete (area as shown on the drawings). The walkway slope shall not exceed 5% along the POT and cross slope shall not exceed 2%. Additional Comments: Modify concrete path to provide RS no greater than 5%. At turning point, CS shall not exceed 2% in any direction. |

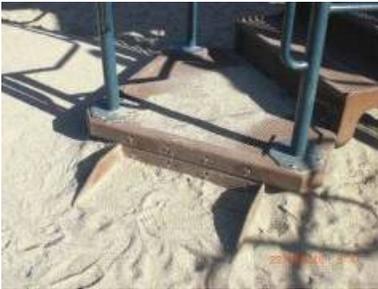
Location: Playground Area Photo # 117

| Field Condition | |
|---|---|
| 31.21 - Transfer Platforms - Height - Platforms surfaces are not 11" min. and 24" maximum from the clear ground or floor space. | 1991 ADAAG - |
| Existing Condition: 4" high. | 2004 ADAAG 1008.3.1.2 |

| Corrective Action |
|---|
| 516 - Replace Playground Equipment - Remove non-compliant playground equipment and replace with new accessible equipment. |

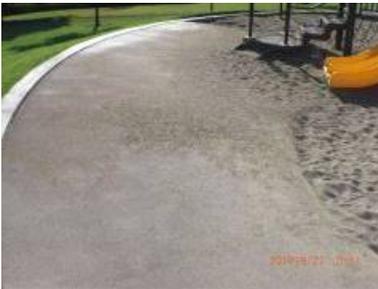
Keynote 118

| Field Condition | |
|---|--|
| 31.30B - Play Components - Clear Floor or Ground Space Slope - The clear floor or ground space has a slope greater than 2% in some or all directions. | 1991 ADAAG - |
| Existing Condition: 2.3% to 4.3% slope. | 2004 ADAAG 1008.4.2; 305.2; 305.3 |

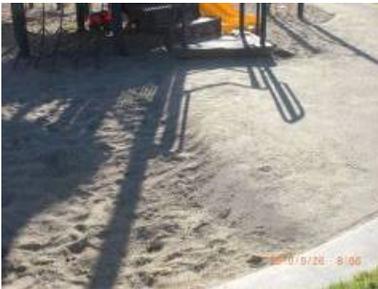
Location: Photo #
Playground Area 120

| Field Condition | |
|---|---|
| Existing Condition: 3" - 7" drop along playground area. | 2004 ADAAG - |
