*City of Rancho Palos Verdes*  
**Rancho Palos Verdes ADA Assessment**  
**Facility Report with Photos**

**Facility ID: # Area 2 Pedestrian Signals**

**Author: Vaish, B**

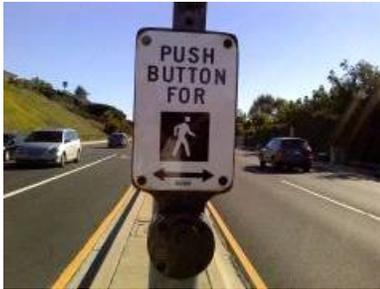
**Keynote 47**

**Field Condition**

04.24B - Vibrotactile Signal Device - A crosswalk with pedestrian signal indication does not have a vibrotactile signal device integrated into the signal device to indicate the WALK interval.

Existing Condition:
