PLANNING, BUILDING &
CODE ENFORCEMENT PN 97082-1485

August 1, 2006

Subject: Summary of Site Observations and Cursory Review of Site Conditions, Abalone Cove Landslide Area, Rancho Palos Verdes, California

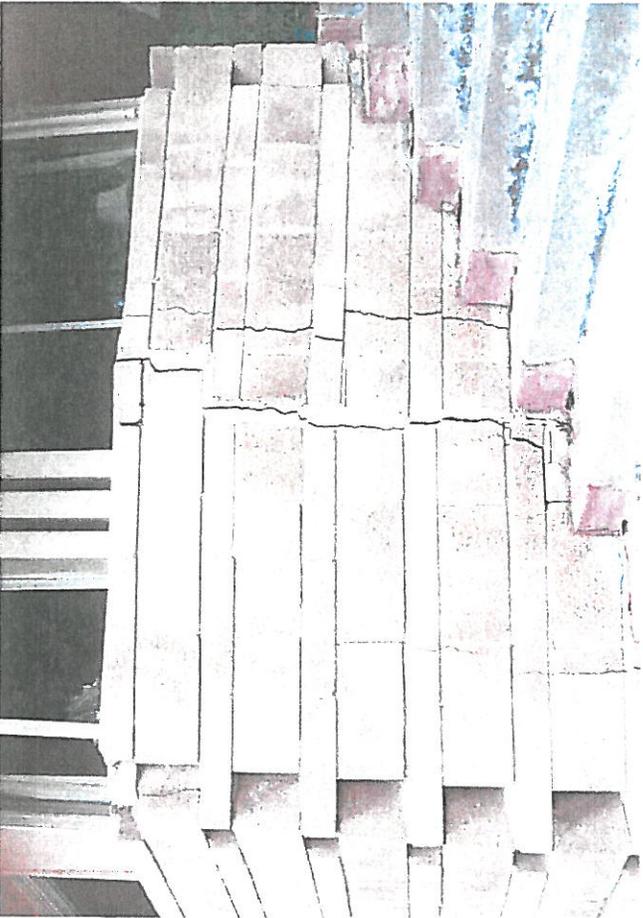
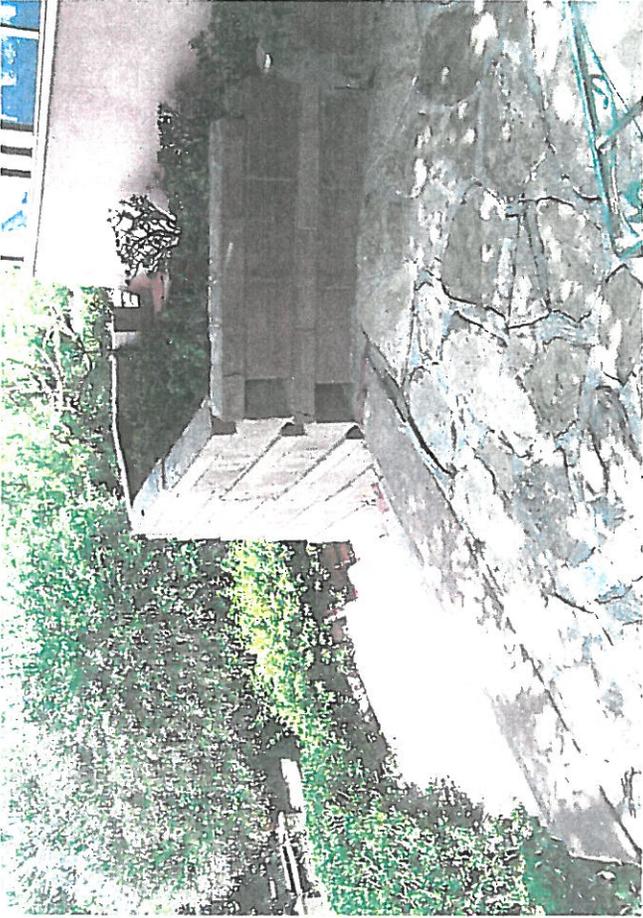
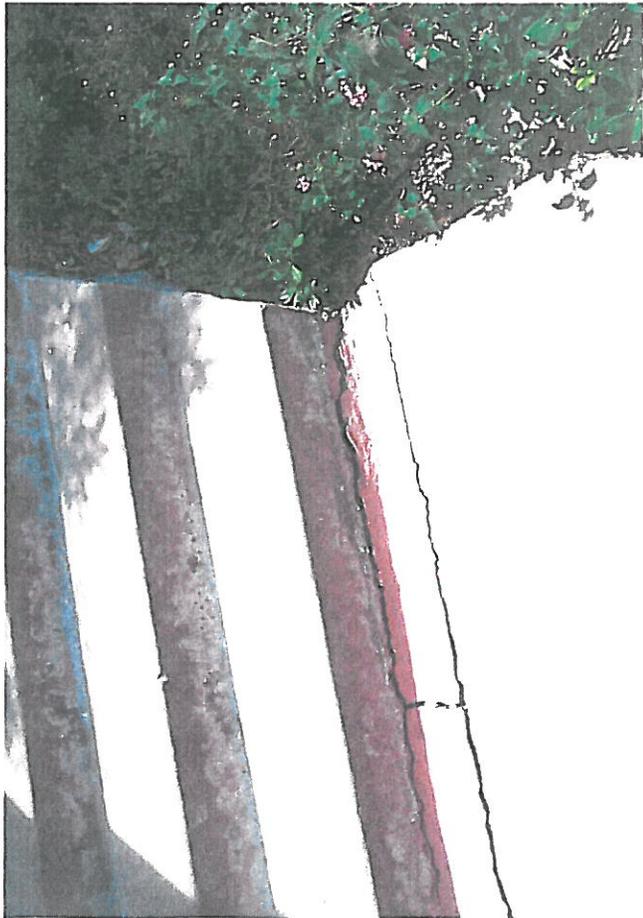
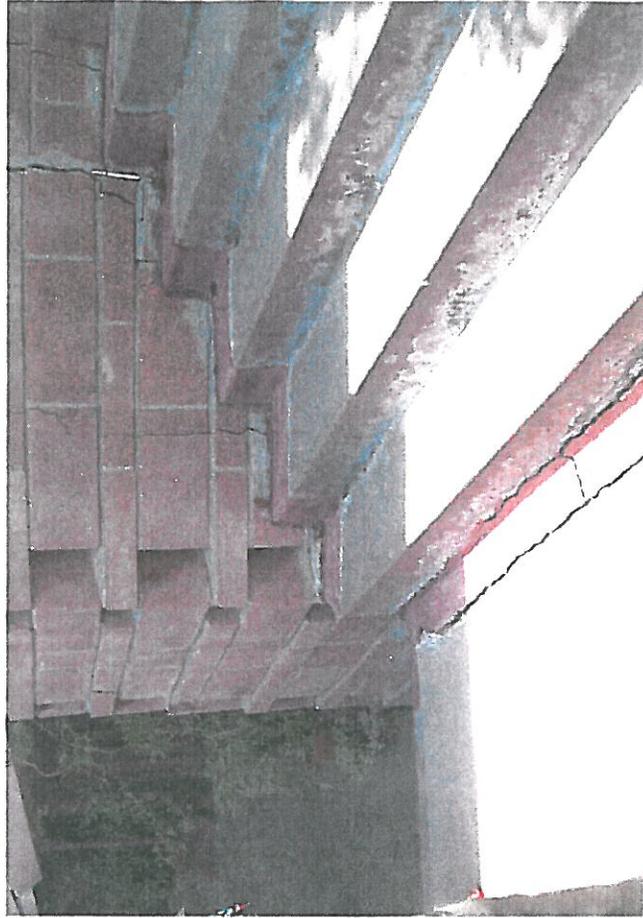
Observations at the Jester residence (28 Narcissa Drive) were confined to the exterior of the residence. Distress in the form of a somewhat continuous crack within the length of the driveway was observed. This crack showed both horizontal and vertical separations on the order of 1/2 to 1 inch (see photos 1 through 4 and ZKCI Figure 4). Additional separations and cracks were observed within the entry stairs and within flatwork and walls of the residence (see photos 5 through 12 and ZKCI photos Figure 5 and 6).
