5.0 Existing Collection System Evaluation

5.3 CCTV Inspection

5.4 County CCTV Inspection (2005-2006/2007)

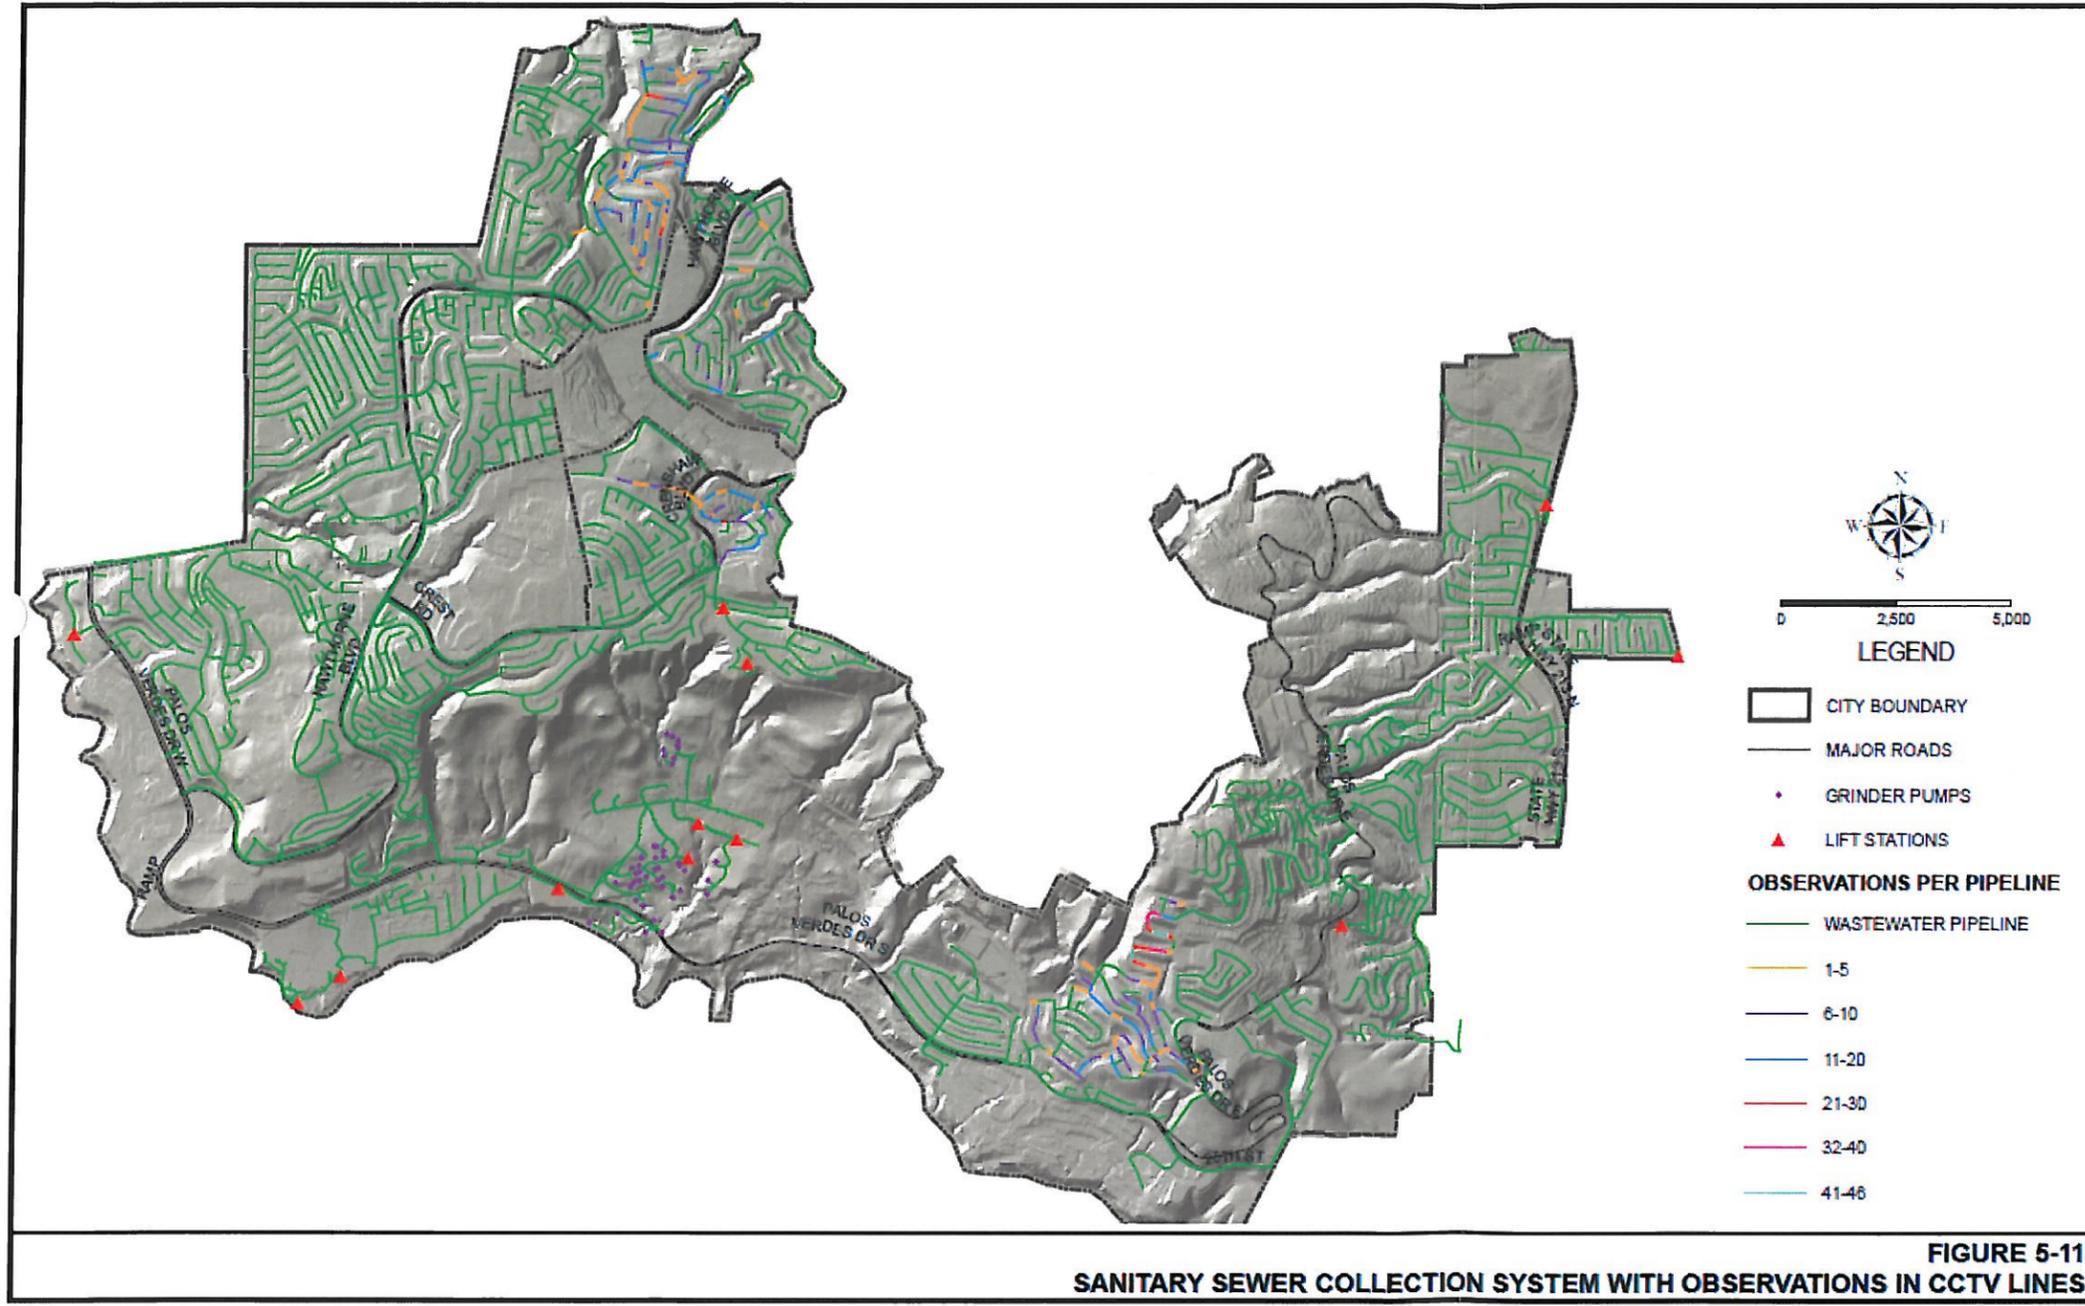
Figure 5-11 Frequency of CCTV Observations

Of the 388 pipe segments that were CCTV inspected, 42 were given a Structural Quick Rating of 4 or 5, meaning they were either in poor structural condition or had structural defects that required immediate attention.

Of the approximately 388 pipeline segments that were CCTV inspected, 79 were given a Pipeline Assessment and Certification Program (PACP) Maintenance Quick Rating of 4 or 5, indicating blockages, either due to roots, fats, or grease. This represents approximately 20.4% of the pipelines observed.
