August 1, 2006

PN 97082-1485

Subject: Summary of Site Observations and Cursory Review of Site Conditions, Abalone Cove Landslide Area, Rancho Palos Verdes, California

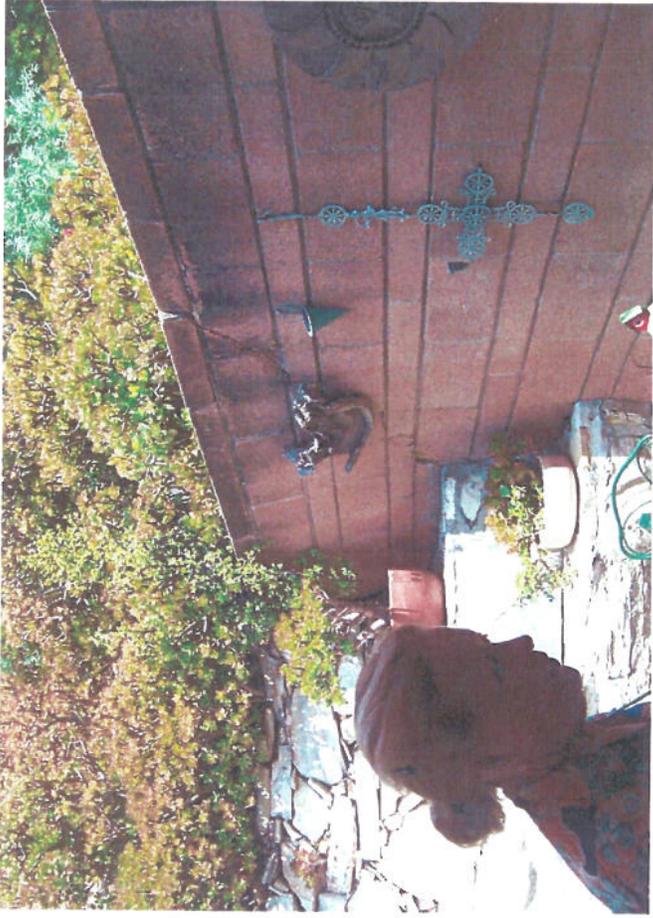
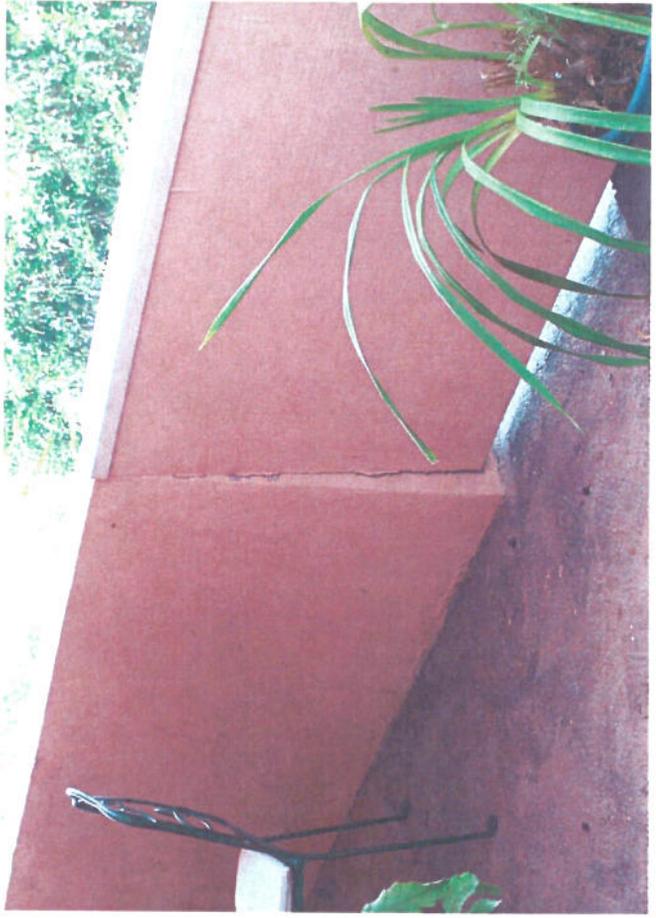
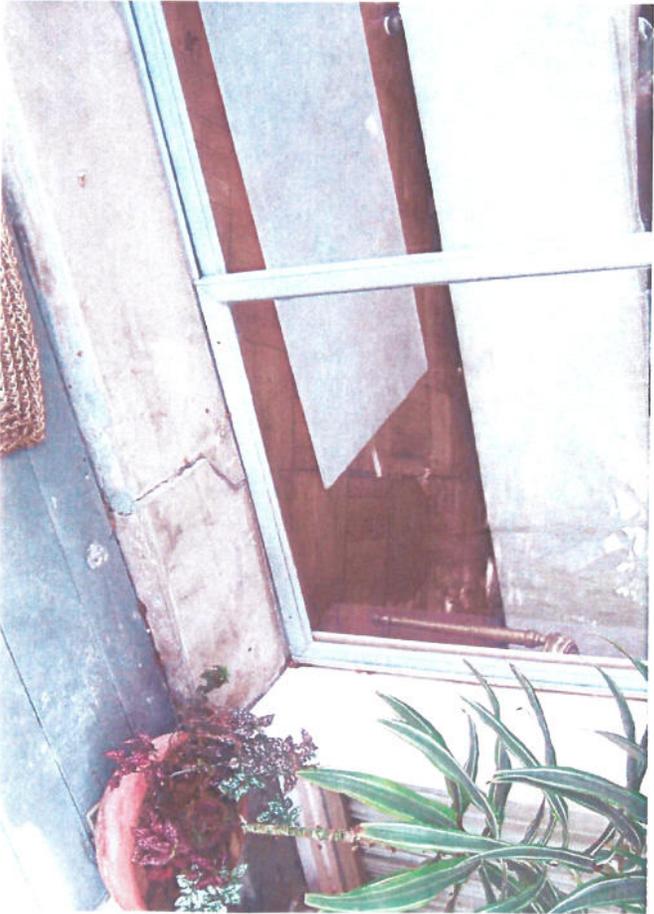
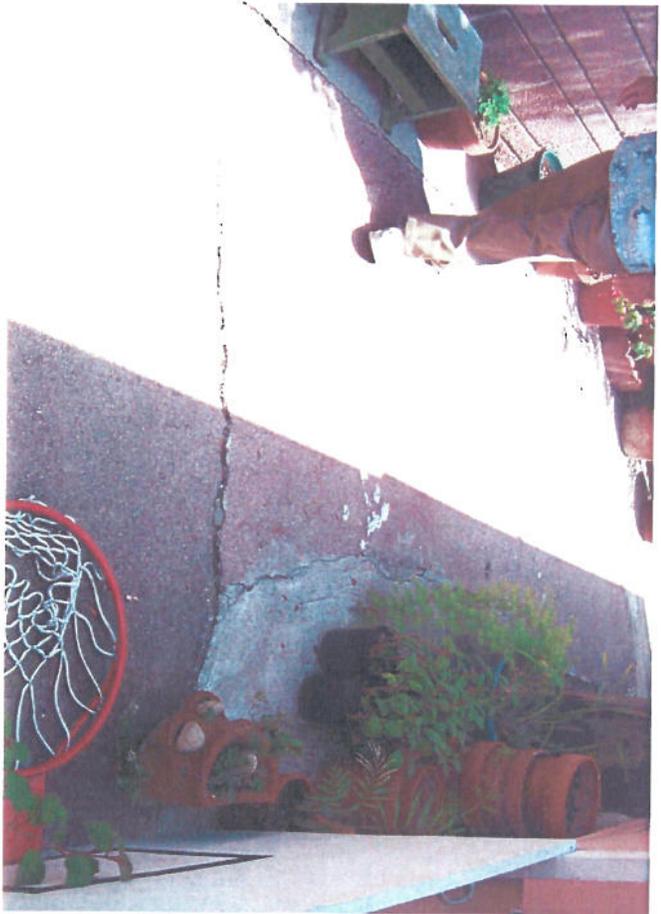
Observations at the Jester residence (28 Narcissa Drive) were confined to the exterior of the residence. Distress in the form of a somewhat continuous crack within the length of the driveway was observed. This crack showed both horizontal and vertical separations on the order of ½ to 1 inch (see photos 1 through 4 and ZKCI Figure 4). Additional separations and cracks were observed within the entry stairs and within flatwork and walls of the residence (see photos 5 through 12 and ZKCI photos Figure 5 and 6).

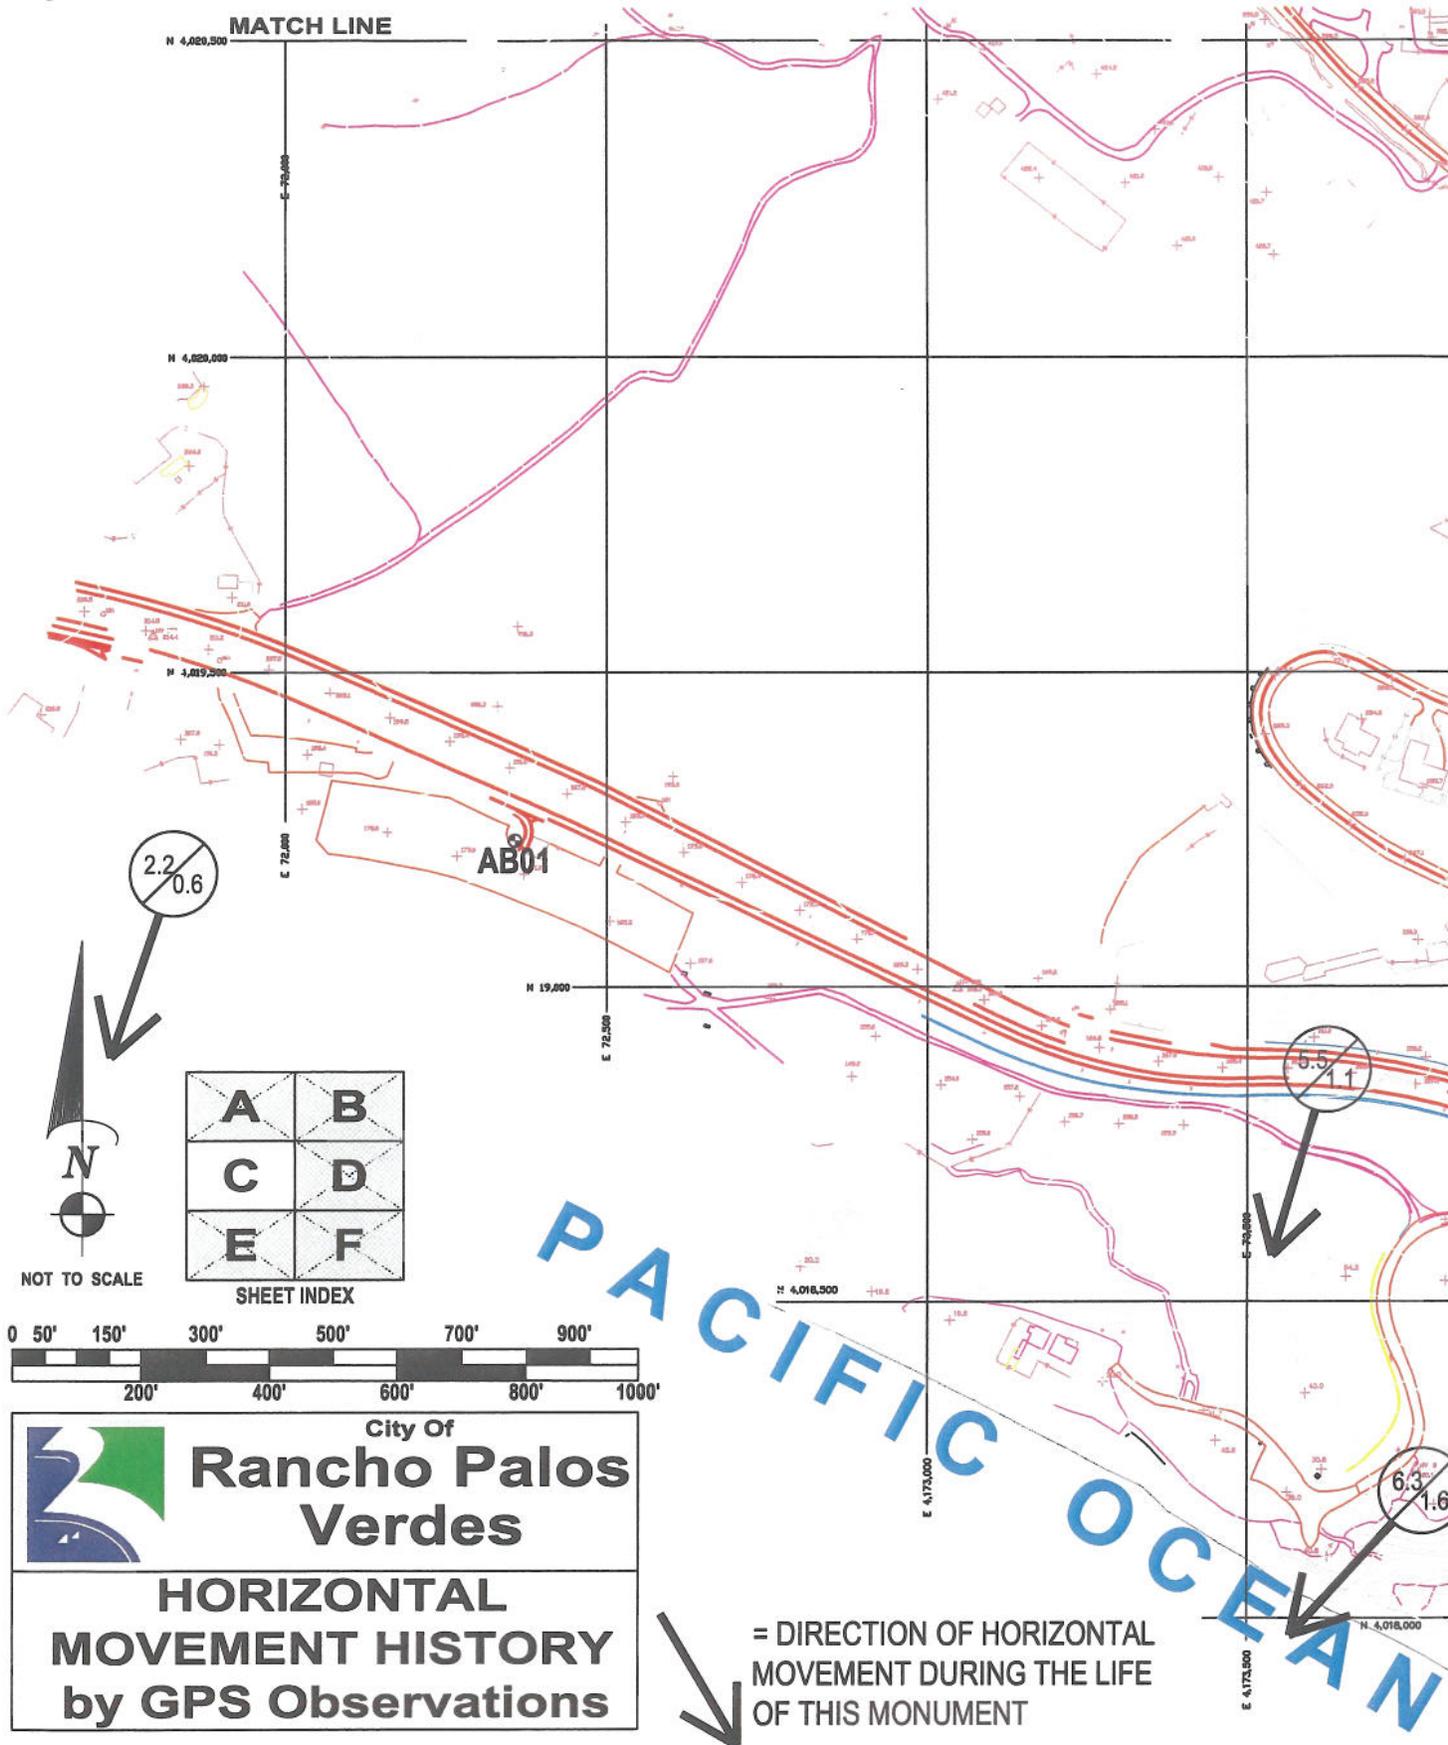
The horizontal movement recorded by GPS survey observations during 2005 within the area in question by Charles Abbott Associates, Inc. is consistent with the movement observed during our recent site visit. It is recommended that GPS survey observations be continued at a frequency of four quarterly readings per year. In addition, it is recommended that site observations of the general distress also be completed on a quarterly basis. It should be stressed to all involved that if a change in the current distress regime occurs, the city should be notified so that additional steps can be taken if warranted.
