City of Rancho Palos Verdes
 Rancho Palos Verdes ADA Assessment
 Facility Report with Photos

Facility ID: # 02A - City Hall Grounds

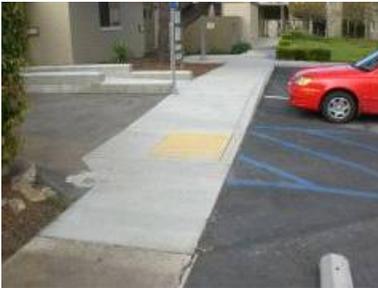
Location: NW. PV Net Bldg. Photo # 42

Field Condition	
03B.09 - Cross Slope - Cross slope of the accessible route of travel exceeds 1:50. Existing Condition: 3.3%	1991 ADAAG 4.3.7 2004 ADAAG 403.3 2007 CBC 1133B.7.1.3 Other -

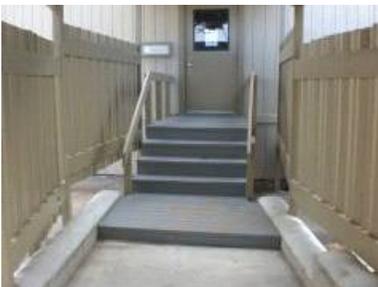
Location: W. PV Net Bldg. Photo # 43

Field Condition	
03B.13 - > 1/2" Changes in Level - Curb ramps, ramps, or elevators are not used for changes in level greater than 1/2 inch. (Lifts may only be used in certain limited situations.) Existing Condition: 5 1/4" to 8" Steps.	1991 ADAAG 4.5.2 2004 ADAAG 303.4 2007 CBC 1124B.2 Other -

Corrective Action
257A - Replace Stairs - Replace stairs to comply with rise/run requirements. Additional Comments: Relocate container & provide accessible POT from exit door to front entrance door by means of deck with guardrails.

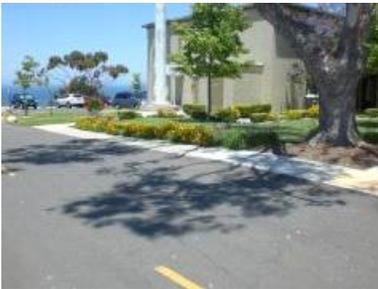
Keynote 63

Field Condition	
03B.09 - Cross Slope - Cross slope of the accessible route of travel exceeds 1:50.	1991 ADAAG 4.3.7
Existing Condition: 1.9%, 2.6%, & 2.7%	2004 ADAAG 403.3
	2007 CBC 1133B.7.1.3
	Other -

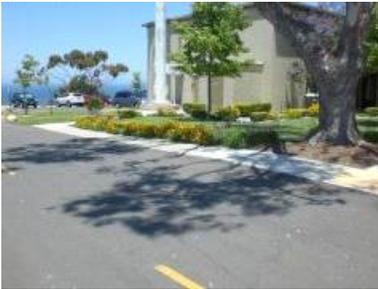
Keynote 65

03B.21 - Hazardous Vehicular Areas - Detectable Warnings - Where a walk crosses or adjoins the vehicular way and the walking surface is not separated by curbs, railings, or other elements between the pedestrian areas and vehicular areas, the boundary between the areas is not defined by a continuous detectable warning at least 36" wide complying with CBC 1121B.3.1 item 8(a). (i.e., the warning surface shall contrast visually with adjoining surfaces, either light on dark or dark on light, and shall differ from adjoining walking surfaces in resiliency or sound on cane contact. Color: yellow conforming to Federal Color No. 33538, Table IV/ Standard No. 595B. Where the color value contrast between the yellow warning and the main walking surface is less than 70 percent, a 1" wide black strip shall separate the yellow warning from the main walking surface.)

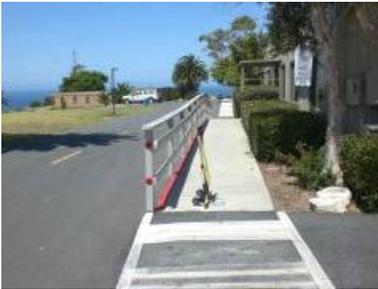
Keynote 67

03B.21 - Hazardous Vehicular Areas - Detectable Warnings - Where a walk crosses or adjoins the vehicular way and the walking surface is not separated by curbs, railings, or other elements between the pedestrian areas and vehicular areas, the boundary between the areas is not defined by a continuous detectable warning at least 36" wide complying with CBC 1121B.3.1 item 8(a). (i.e., the warning surface shall contrast visually with adjoining surfaces, either light on dark or dark on light, and shall differ from adjoining walking surfaces in resiliency or sound on cane contact. Color: yellow conforming to Federal Color No. 33538, Table IV/ Standard No. 595B. Where the color value contrast between the yellow warning and the main walking surface is less than 70 percent, a 1" wide black strip shall separate the yellow warning from the main walking surface.)

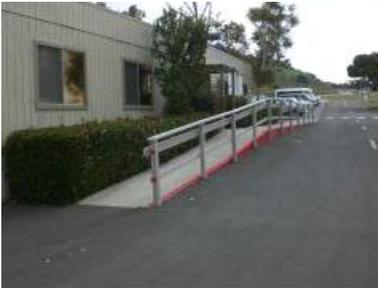
Location: S. of PV Net Bldg. Photo # 69

Field Condition	
03B.10 - Running Slope - Slope of the accessible route of travel exceeds 1:20. Existing Condition: 13.2%	1991 ADAAG 4.3.7 2004 ADAAG 403.3 2007 CBC 1133B.7.3 Other -

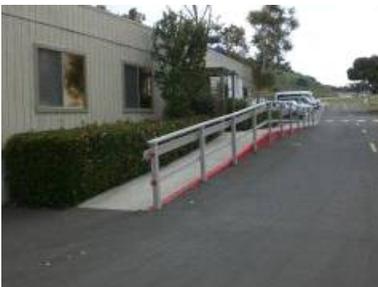
Location: S. of PV Net Bldg. Photo # 69

Field Condition	
03B.11 - Ramps - This portion of an accessible route with a slope greater than 5% does not comply with the requirements for compliant ramps. Existing Condition: No handrails or wheel guide provided.	1991 ADAAG 4.8.1 2004 ADAAG 405 2007 CBC 1133B.5 Other -

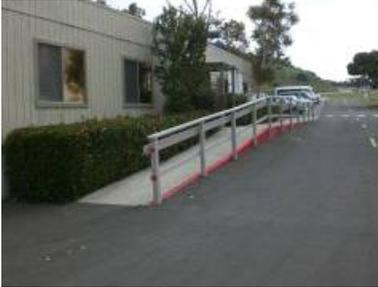
Keynote 71

03B.21 - Hazardous Vehicular Areas - Detectable Warnings - Where a walk crosses or adjoins the vehicular way and the walking surface is not separated by curbs, railings, or other elements between the pedestrian areas and vehicular areas, the boundary between the areas is not defined by a continuous detectable warning at least 36" wide complying with CBC 1121B.3.1 item 8(a). (i.e., the warning surface shall contrast visually with adjoining surfaces, either light on dark or dark on light, and shall differ from adjoining walking surfaces in resiliency or sound on cane contact. Color: yellow conforming to Federal Color No. 33538, Table IV/ Standard No. 595B. Where the color value contrast between the yellow warning and the main walking surface is less than 70 percent, a 1" wide black strip shall separate the yellow warning from the main walking surface.)

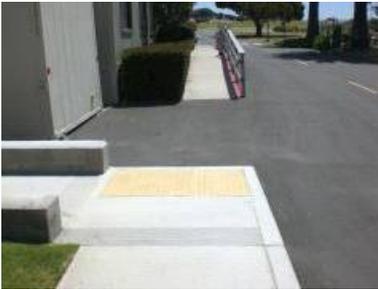
Location: SW. of PV Net Bldg. Photo # 72

Field Condition	
03B.09 - Cross Slope - Cross slope of the accessible route of travel exceeds 1:50. Existing Condition: 3.1%	1991 ADAAG 4.3.7 2004 ADAAG 403.3 2007 CBC 1133B.7.1.3 Other -

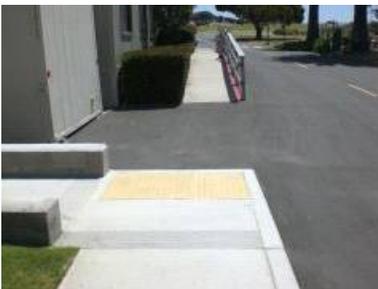
Location: SW. of PV Net Bldg. Photo # 72

Field Condition	
03B.10 - Running Slope - Slope of the accessible route of travel exceeds 1:20. Existing Condition: 5.8%	1991 ADAAG 4.3.7 2004 ADAAG 403.3 2007 CBC 1133B.7.3 Other -

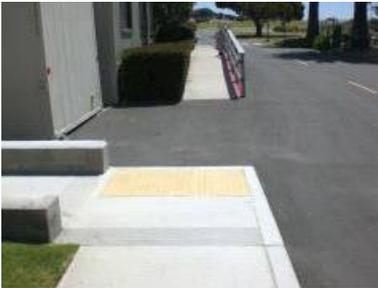
Location: SW. of PV Net Bldg. Photo # 72

Field Condition	
03B.12 - > 1/4" Changes in Level - Where walkway levels change abruptly, the vertical difference between them exceeds 1/4 inch. Or changes in level between 1/4 inch and 1/2 inch are beveled with a slope greater than 1:2.	1991 ADAAG 4.5.2
Existing Condition:	2004 ADAAG 303.2; 303.3
	2007 CBC 1124B.2
	Other -

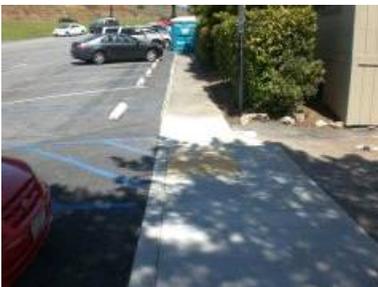
Location: N. of PV Net Bldg. Photo # 75

Field Condition	
03B.09 - Cross Slope - Cross slope of the accessible route of travel exceeds 1:50.	1991 ADAAG 4.3.7
Existing Condition: 2.8 CS	2004 ADAAG 403.3
	2007 CBC 1133B.7.1.3
	Other -

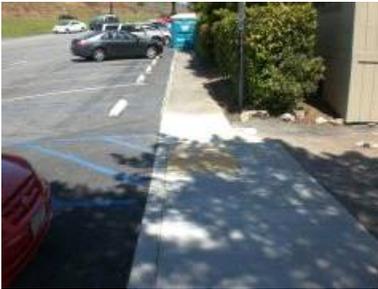
Keynote 76

03B.21 - Hazardous Vehicular Areas - Detectable Warnings - Where a walk crosses or adjoins the vehicular way and the walking surface is not separated by curbs, railings, or other elements between the pedestrian areas and vehicular areas, the boundary between the areas is not defined by a continuous detectable warning at least 36" wide complying with CBC 1121B.3.1 item 8(a). (i.e., the warning surface shall contrast visually with adjoining surfaces, either light on dark or dark on light, and shall differ from adjoining walking surfaces in resiliency or sound on cane contact. Color: yellow conforming to Federal Color No. 33538, Table IV/ Standard No. 595B. Where the color value contrast between the yellow warning and the main walking surface is less than 70 percent, a 1" wide black strip shall separate the yellow warning from the main walking surface.)

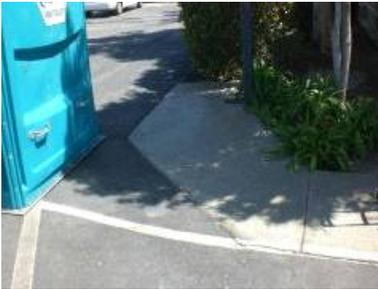
Location: NE. of PV Net Bldg. Photo # 77

Field Condition	
03B.09 - Cross Slope - Cross slope of the accessible route of travel exceeds 1:50. Existing Condition: 8.2%	1991 ADAAG 4.3.7 2004 ADAAG 403.3 2007 CBC 1133B.7.1.3 Other -

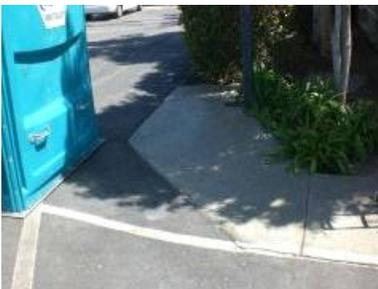
Location: NE. of PV Net Bldg. Photo # 77

Field Condition	
03B.10 - Running Slope - Slope of the accessible route of travel exceeds 1:20. Existing Condition: 10.8%	1991 ADAAG 4.3.7 2004 ADAAG 403.3 2007 CBC 1133B.7.3 Other -

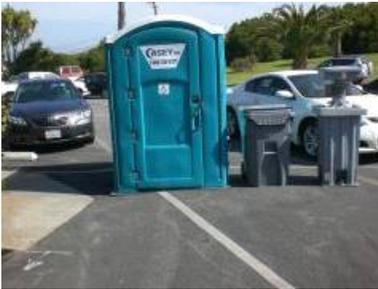
Location: Portable Restroom NE. of PV Net Bldg. Photo # 79

Field Condition	
16.01 - Toilet Rooms - Toilet room does not comply with all applicable ADAAG and CBC accessibility requirements.	1991 ADAAG 4.1.2(6); 4.1.3(11); 4.22.1
Existing Condition:	2004 ADAAG 213.2; Advisory 213.2
	2007 CBC 1115B.1
	Other -

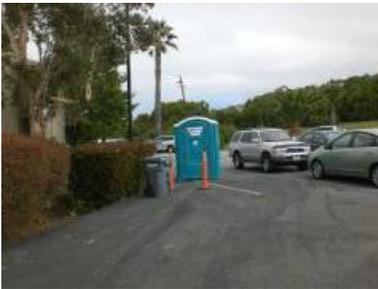
Location: Portable Restroom NE. of PV Net Bldg. Photo # 80

Field Condition	
16.04 - Accessible Path of Travel - Toilet room is not located on an accessible route of travel.	1991 ADAAG 4.22.1
Existing Condition: None provided, 4.6% CS.	2004 ADAAG 206.2.4; Advisory 206.2.4
	2007 CBC 1115B.1
	Other -

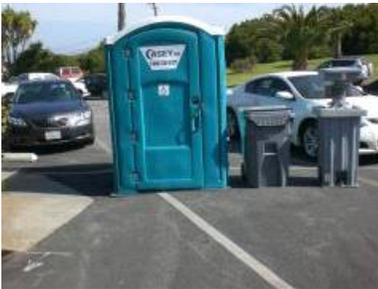
Location: Portable Restroom NE. of PV Net Bldg. Photo # 79

Field Condition	
16.13C - Unisex RR Geometric Symbol Signage - Circle/Triangle - Doorway leading to a unisex toilet room is not identified by a 12" circle, 1/4" with a 1/4" thick triangle superimposed and within the circle. OR Circle and triangle are provided, however they are accompanied by words in raised characters and Braille. (ADA and CBC Standards require a separate sign with raised characters and Braille mounted on the wall adjacent to the latch side of the door.)	1991 ADAAG -
Existing Condition: None provided	2004 ADAAG -
	2007 CBC 1115B.6
	Other -

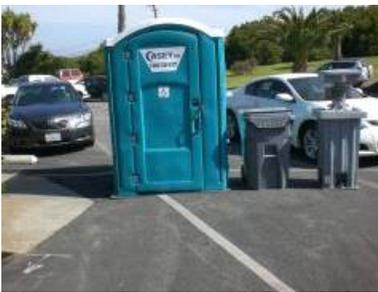
Location: Portable Restroom NE. of PV Net Bldg.
 Photo # 79

Field Condition	
16.26A - Cross Slope - Cross slope of the accessible route of travel exceeds 1:50.	1991 ADAAG 4.3.7
Existing Condition: 4.6%	2004 ADAAG 403.3
	2007 CBC 1133B.7.1.3
	Other -

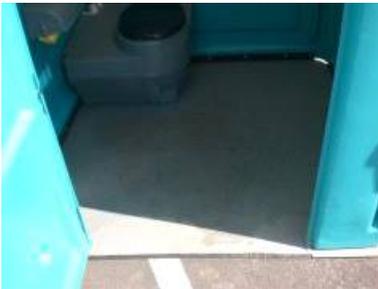
Keynote 85

Field Condition	
16.27A - 60" Wide Circle or T-Shaped Maneuvering Space - The toilet room does not include an unobstructed turning space (a 60" diameter, 27" high circle or T-shaped space). (Note: The clear floor space of fixtures and controls, the accessible path of travel, and the turning space may overlap.)	1991 ADAAG 4.22.3; Fig 3
Existing Condition:	2004 ADAAG 304.3.2; Fig.304.3.2; 603.2.1
	2007 CBC 1115B.3.1(1); 1115B.3.2(1)
	Other -

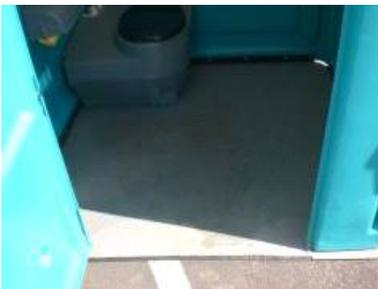
Keynote 86

Field Condition	
16.43 - WC not in Stalls - Front Transfer Space - Where the WC is not in a stall, the clear floor space in front of the WC is less than 60" wide by 48" deep.	1991 ADAAG -
Existing Condition:	2004 ADAAG -
	2007 CBC 1115B.4.1(2)
	Other -

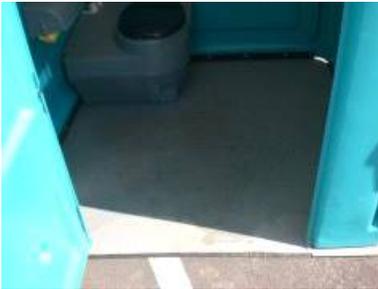
Location: Portable Restroom NE. of PV Net Bldg. Photo # 85

Field Condition	
16.47A - WC Location from Sidewall - The centerline of the WC is not 18" absolute from a wall or partition.	1991 ADAAG 4.22.4
Existing Condition:	2004 ADAAG -
	2007 CBC 1115B.4.1(1)
	Other -

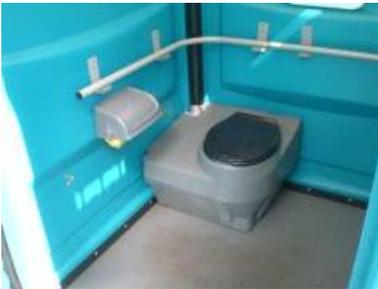
Location: Portable Restroom NE. of PV Net Bldg. Photo # 88

Field Condition	
16.50 - TP Dispenser - Location - Pre-2007 CBC Facility - Location of the toilet paper dispenser does not comply with the Standard in effect at the time of construction. (The 2001 CBC required toilet tissue dispensers located on the wall within 12" of the front edge of the toilet seat, measured to the centerline of the dispenser; mounted below the grab bar; and centered at a min. height of 19" AFF.)	1991 ADAAG 4.16.6; Fig. 29(b)
Existing Condition: 13"	2004 ADAAG 604.7; Advisory 604.7; Fig. 604.7
	2007 CBC -
	Other -

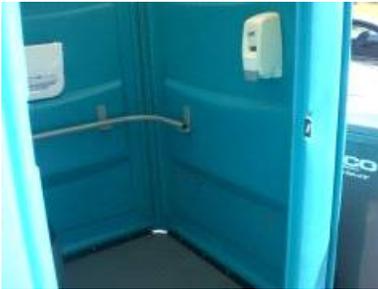
Location: Portable Restroom NE. of PV Net Bldg.
Photo # 89

Field Condition	
16.53 - SC Dispenser Height - Mounting height of seat cover dispenser's highest operable part exceeds 40" AFF.	1991 ADAAG 4.22.7; 4.27.3; 4.2.5; 4.2.6
Existing Condition: 45" high	2004 ADAAG -
	2007 CBC 1115B.8.3
	Other -

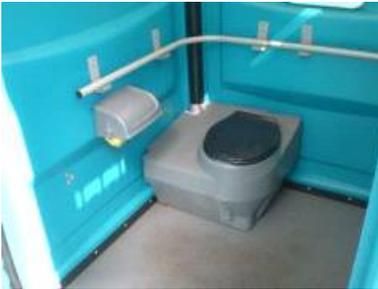
Location: Portable Restroom NE. of PV Net Bldg. Photo # 88

Field Condition	
16.55A - Side Grab Bar Height - Side grab bar is not centered at 33" AFF. (ADA Standards require side grab bars to be centered from 33" to 36" AFF; CBC Standards require side grab bars to be centered at 33" AFF.)	1991 ADAAG 4.17.6; Figs. 29 & 30
Existing Condition: 34 1/2" high	2004 ADAAG 604.5; Advisory 604.5; 604.5.2; Fig. 604.5.2; 609.4
	2007 CBC 1115B.4.1(3.1); Fig. 11B-1A
	Other -

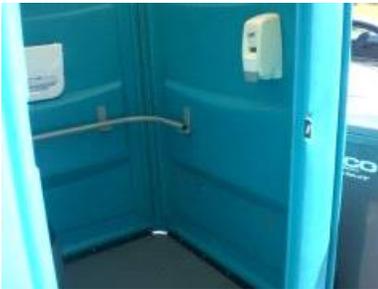
Keynote 93

16.84C - Soap Dispenser - Operating Height - Mounting height of soap dispenser's highest operable part exceeds 40" AFF. (Where provided, ADA Standards require at least one soap dispenser to be accessible with the highest operable part placed within at least one of the reach ranges specified in 4.2.5 and 4.2.6; where provided, CBC Standards require at least one soap dispenser to be accessible with the highest operable part no higher than 40" AFF.)

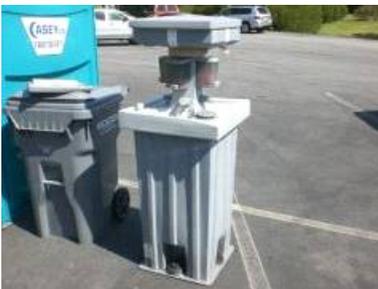
Keynote 94

16.70 - Lavatories - Lavatory does not comply with ADAAG and CBC requirements. (ADA Standards require at least one lavatory to be accessible. CBC Standards prior to August 1, 2009 required all lavatories to be accessible. Effective August 1, 2009, amended CBC Standards require at least 5% of lavatories, but not less than one lavatory, to be accessible.)

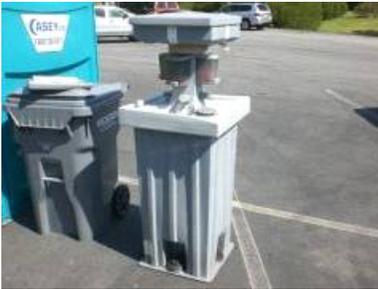
Keynote 95

Field Condition	
16.71 - Lavatory - Rim Height - Height of lavatory rim or counter surface exceeds 34" AFF.	1991 ADAAG 4.19.2; Fig. 31
Existing Condition: 39 1/2" high	2004 ADAAG 606.3
	2007 CBC 1115B.4.3(2); Fig 11B-1D
	Other -

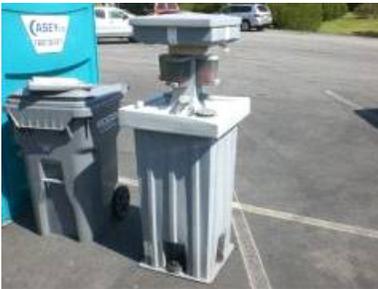
Keynote 96

Field Condition	
16.73 - Lavatory Knee Clearance - Lavatory does not provide accessible knee clearance (i.e. at least 27" clearance from the floor to the underside of the lavatory, extending 8" min.. measured from the front edge underneath the lavatory back towards the wall).	1991 ADAAG 4.19.2; Fig. 31
Existing Condition:	2004 ADAAG 306.3; Fig. 306.3
	2007 CBC 1115B.4.3(2); Fig 11B-1D
	Other -

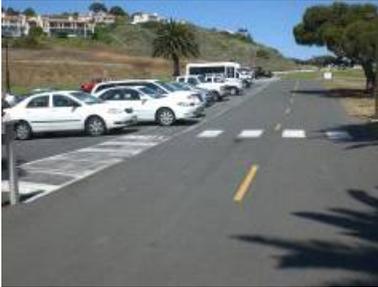
Keynote 99

03B.21 - Hazardous Vehicular Areas - Detectable Warnings - Where a walk crosses or adjoins the vehicular way and the walking surface is not separated by curbs, railings, or other elements between the pedestrian areas and vehicular areas, the boundary between the areas is not defined by a continuous detectable warning at least 36" wide complying with CBC 1121B.3.1 item 8(a). (i.e., the warning surface shall contrast visually with adjoining surfaces, either light on dark or dark on light, and shall differ from adjoining walking surfaces in resiliency or sound on cane contact. Color: yellow conforming to Federal Color No. 33538, Table IV/ Standard No. 595B. Where the color value contrast between the yellow warning and the main walking surface is less than 70 percent, a 1" wide black strip shall separate the yellow warning from the main walking surface.)

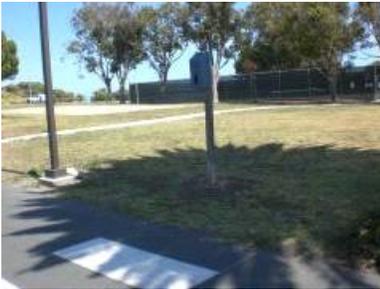
Location: N. of Tennis Court
Photo # 100

Field Condition	
03B.22 - Other - On-Site Accessible Path of Travel - See Additional Comments	1991 ADAAG -
Existing Condition: 60" high Doggy Bags.	2004 ADAAG -
	2007 CBC -
	Other -

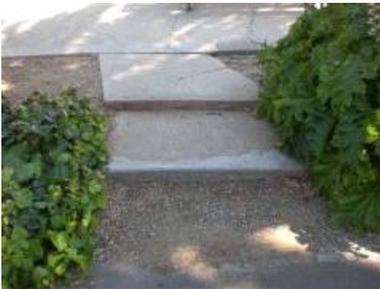
Keynote 101

Field Condition	
08.02B - Riser Height - The risers are not uniform. OR The risers are not between 4" and 7" in height.	1991 ADAAG 4.9.2
Existing Condition: 3" & 3 1/2" high	2004 ADAAG 504.2
	2007 CBC 1009.3; 1133B.4.5.3
	Other -

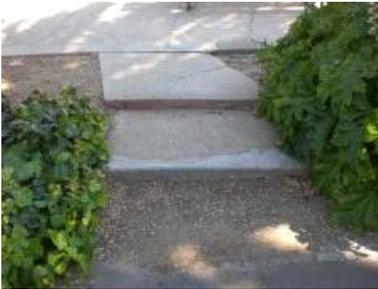
Keynote 102

Field Condition	
08.03A - Tread Depth - The treads are not uniform. OR The treads are less than 11" deep measured from riser to riser.	1991 ADAAG 4.9.2
Existing Condition: 29"	2004 ADAAG 504.2
	2007 CBC 1009.3; 1133B.4.5.3
	Other -

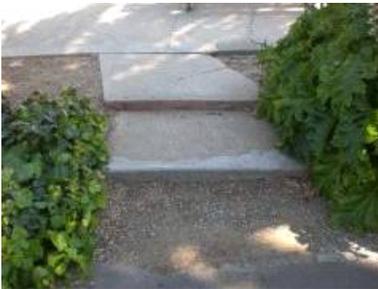
Keynote 103

Field Condition	
03B.13 - > 1/2" Changes in Level - Curb ramps, ramps, or elevators are not used for changes in level greater than 1/2 inch. (Lifts may only be used in certain limited situations.)	1991 ADAAG 4.5.2
Existing Condition: 3/4" high	2004 ADAAG 303.4
	2007 CBC 1124B.2
	Other -

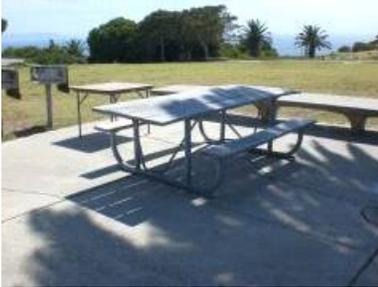
Keynote 104

Field Condition	
30.30 - Number - Picnic Table Wheelchair Seating Spaces - Picnic table does not provide at least one wheelchair seating space. OR Where the table top perimeter exceeds 24 linear feet, the number of wheelchair seating spaces provided does not comply with the following: (Table Top Perimeter // Wheelchair Spaces) (25 LF - 44 LF // 2 spaces) (45 LF - 64 LF // 3 spaces) (65 LF - 84 LF // 4 spaces) (85 LF - 104 LF // 5 spaces)	1991 ADAAG - 2004 ADAAG - 2007 CBC - Other 1999 ADAAG-16.5.3
Existing Condition:

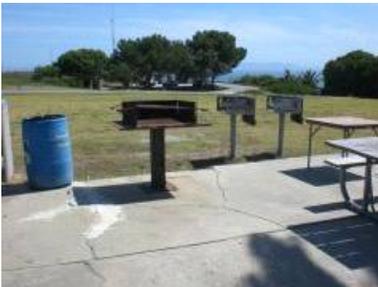
Keynote 105

Field Condition	
03B.08 - Free Standing Protruding Objects - Free standing object(s) mounted on posts with leading edges between 27" and 80" high (such as a sign or telephone) projects more than 12" into the perpendicular route of travel. (Protruding object(s) shall not reduce required clear width of an accessible route.)	1991 ADAAG 4.4.1 2004 ADAAG 307.3 2007 CBC 1133B.8.6.1 Other -
Existing Condition: BBQ protrudes > than 4" at 32" high.

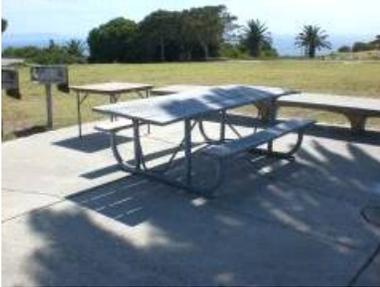
Keynote 106

Field Condition	
30.34C - Picnic Table - Knee Space Depth - Picnic table does not provide at least 19" depth for accessible knee clearance.	1991 ADAAG 4.32.3
Existing Condition: 17" deep	2004 ADAAG 305; 306
	2007 CBC 1122B.3
	Other 1999 ADAAG-16.5.4

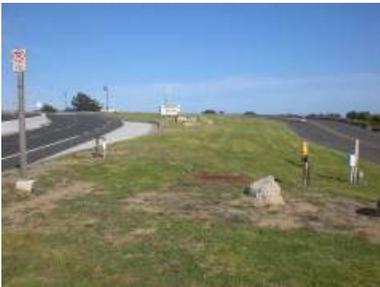
Keynote 107

Field Condition	
03B.01 - On-site Accessible Route of Travel - There is no accessible route within the property line of the site linking an accessible building entrance with site arrival points serving the following, if provided: public transportation stops, accessible parking, passenger loading zones, and public sidewalks.	1991 ADAAG 4.1.2(1)
Existing Condition: 20.9% CS & 6.2% RS at grass area.	2004 ADAAG 202.2.1; Advisory 206.2.1
	2007 CBC 1114B.1.2; 1127B.1
	Other -

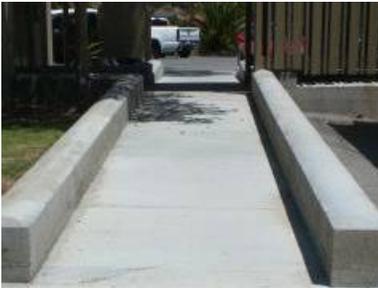
Keynote 108

Field Condition									
03B.09 - Cross Slope - Cross slope of the accessible route of travel exceeds 1:50. Existing Condition: 3.0%

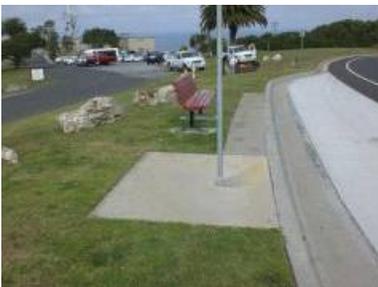
Keynote 109

Field Condition									
02.11A - Bus Stop Pad Size - Bus stop pad does not measure 8' long (measured from the curb or vehicle roadway edge) by 5' wide (measured parallel to the vehicle roadway). Existing Condition: 2'-0" x 24'-9"

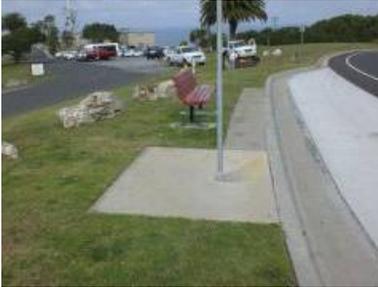
Keynote 110

Field Condition	
02.11B - Bus Stop Pad and Accessible Route - Bus stop pad is not connected to an accessible route.	1991 ADAAG 10.2.1
Existing Condition: No compliant POT to On Site POT.	2004 ADAAG 810.2.3
	2007 CBC 1121B.1
	Other

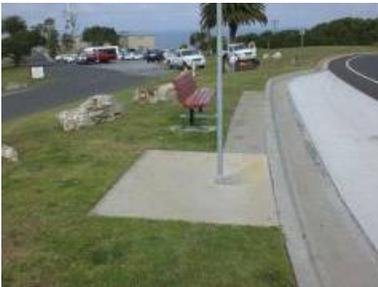
Keynote 111

Field Condition	
02.12A - Bus Stop Pad Slope Parallel to Roadway - Bus stop pad is not at the same slope as the roadway in the direction parallel to the roadway.	1991 ADAAG 10.2.1
Existing Condition: 4.5% sidewalk & 5.1% road.	2004 ADAAG 810.2.4
	2007 CBC 1121B.2.1
	Other

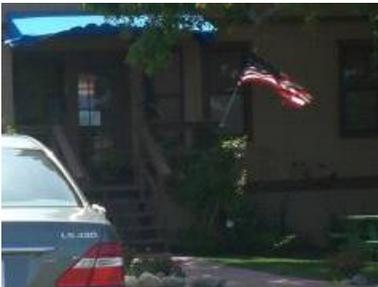
Keynote 113

Field Condition	
08.02A - Open Risers - The risers are not closed.	1991 ADAAG 4.9.2
Existing Condition:	2004 ADAAG 504.3
	2007 CBC 1133B.4.5.3
	Other -

Corrective Action
254 - Wood Retrofit Risers - Provide wood risers to close open risers. Paint or stain risers to match treads.
Additional Comments:

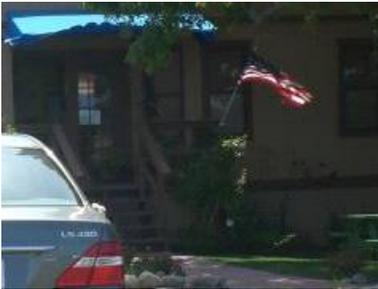
Keynote 114

Field Condition	
08.05A - Exterior Stairs - Color Strip - Contrasting color strips have not been provided.	1991 ADAAG -
Existing Condition:	2004 ADAAG -
	2007 CBC 1133B.4.4
	Other -

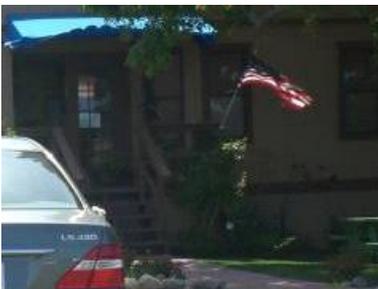
Keynote 115

Field Condition	
08.07A - Continuous Handrails - Continuous handrails are not provided along both sides.	1991 ADAAG 4.9.4
Existing Condition:	2004 ADAAG 504.6; 505.2
	2007 CBC 1133B.4.1.1
	Other -

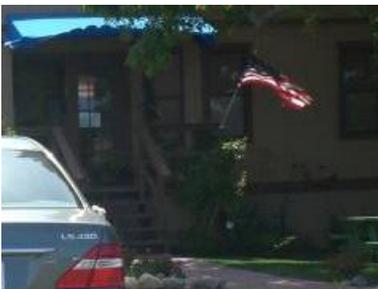
Keynote 118

Field Condition	
08.10B - Clearance - The clear space between handrails and walls is not 1-1/2" absolute. (ADA/CBC Standards apply an absolute dimension of 1-1/2", which provides knuckle clearance while generally disallowing entrapment of the forearm or elbow.)	1991 ADAAG 4.9.5(3) 2004 ADAAG 505.5 2007 CBC 1133B.4.2.5 Other -
Existing Condition: 2 1/8"

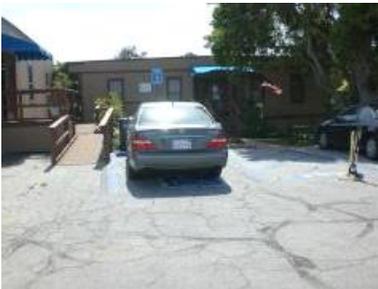
Keynote 120

Field Condition	
01.10A - Van Access Aisle - Dimensions - Where the parking space is designated as "van accessible," the adjacent access aisle is not at least 8' wide by 18' long. (Aisle width is measured from the center line of the stripe on one side to the center line of the stripe on the other.) Existing Condition: 7'-8" wide.	1991 ADAAG 4.1.2(5)(b) 2004 ADAAG - 2007 CBC 1129B.3 item 2 Other

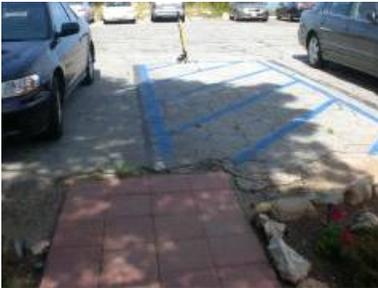
Keynote 121

Field Condition	
01.13 - Level Surface - The accessible parking spaces and access aisles are not level (slope is greater than 2%).	1991 ADAAG 4.6.3
Existing Condition: 2.7% & 3.3%	2004 ADAAG 502.4; advisory 502.4
	2007 CBC 1129B.3 items 3 & 4
	Other

Corrective Action	
194 - Asphalt Paved Parking Stall and Access Aisle - Remove non-compliant pavement and replace with new asphalt paving. The parking space and access aisle slope shall not exceed 2% in any direction.	
Additional Comments:

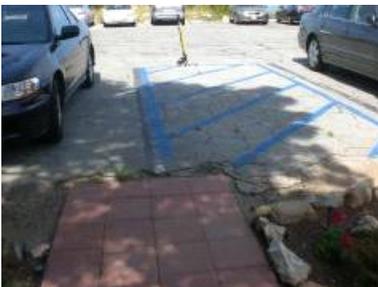
Keynote 122

Field Condition	
01.14 - Surface - Access aisle is not stable, firm, and slip resistant.	1991 ADAAG 4.5.1
Existing Condition: Cracks & deterioration.	2004 ADAAG 302
	2007 CBC 1124B.1
	Other

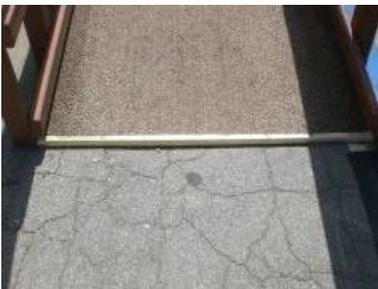
Keynote 126

Existing Condition: 1 1/2" high.

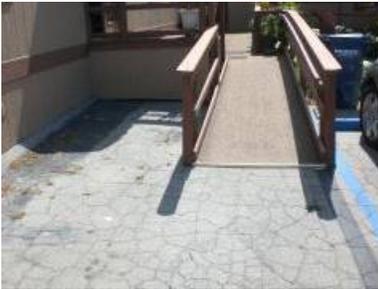
Keynote 127

Field Condition	
07.02 - Running Slope - Slope of the ramp exceeds 8.33% (or the least possible compliant slope).	1991 ADAAG 4.8.2
Existing Condition: 6.9% & 8.7% from parking to switchback landing	2004 ADAAG 405.2; Advisory 405.2
	2007 CBC 1133B.5.3
	Other -

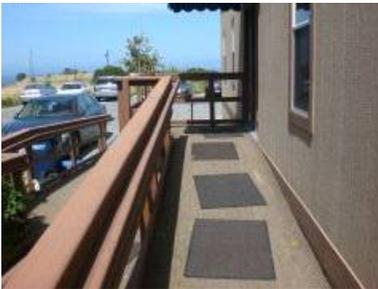
Keynote 128

Field Condition	
07.05 - Surface - The ramp surface is not stable, firm and slip-resistant.	1991 ADAAG 4.8.6; 4.5
Existing Condition: 8 floor mats	2004 ADAAG 302.1; Advisory 302.1
	2007 CBC 1124B.1
	Other -

Corrective Action
104 - Ramps - Miscellaneous - See Additional Comments
Additional Comments: Remove floor loose floor mats.

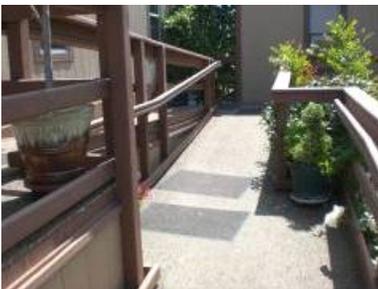
Keynote 130

Field Condition	
07.11A - Intermediate Landing - Change of Direction - Where there is an intermediate landing, and the ramp changes direction (>30-degree), the landing is less than 72" x 60".	1991 ADAAG 4.8.4(3)
Existing Condition: 74" x 70"	2004 ADAAG 405.7.4
	2007 CBC 1133B.5.4.6
	Other -

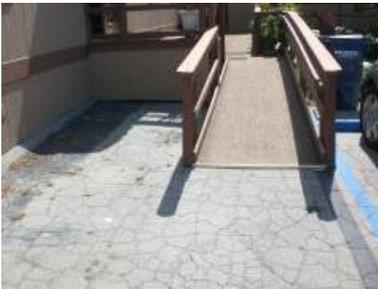
Keynote 132

Field Condition	
07.17 - Inside Handrail - On dogleg or switchback ramps, the inside handrail is not continuous.	1991 ADAAG 4.8.5(1)
Existing Condition:	2004 ADAAG 505.3
	2007 CBC 1133B.5.5.1
	Other -

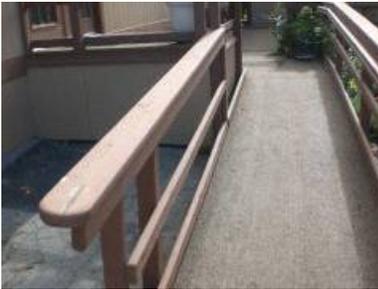
Keynote 133

Field Condition	
07.20 - Height - The top of the handrail is not between 34" and 38" above the ramp surface.	1991 ADAAG 4.8.5 (5)
Existing Condition: 33" high	2004 ADAAG 505.4; Advisory 505.4; Fig. 505.4
	2007 CBC 1133B.5.5.1
	Other -

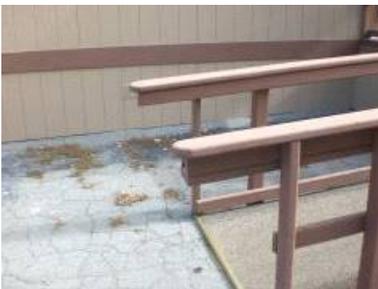
Keynote 134

Field Condition	
07.21B - Extensions - Parallel with Floor or Ground Surface - At ends of handrails, the handrail extensions is not parallel to the floor or ground surface.	1991 ADAAG 4.8.5 (2)
Existing Condition:	2004 ADAAG 505.10; 505.10.1; Fig. 505.10.1
	2007 CBC 1133B.5.5.1
	Other -

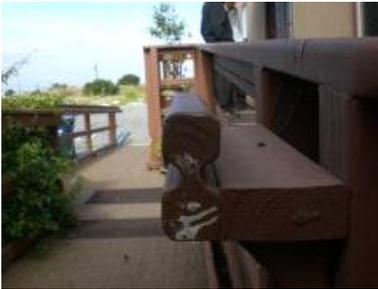
Keynote 135

Field Condition	
07.24 - Clearance - The clear space between handrails and walls is not 1-1/2" absolute. (ADA/CBC Standards apply an absolute dimension of 1-1/2", which provides knuckle clearance while generally disallowing entrapment of the forearm or elbow.)	1991 ADAAG 4.8.5; 4.26.2; Fig. 39
Existing Condition: 2 1/8"	2004 ADAAG 505.5; Fig. 505.5
	2007 CBC 1133B.5.5.1
	Other -

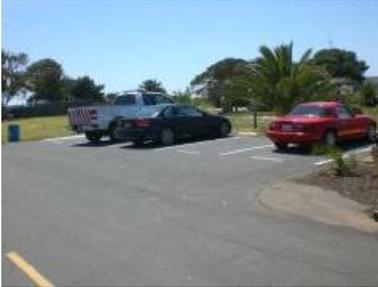
Keynote 136

Field Condition	
01.02 - Number - Accessible Parking Spaces - Where parking spaces are provided for self-parking by employees or visitors or both, the required number of accessible parking spaces is not provided. (Note: All or some of the accessible parking spaces may be in a different location if equivalent or greater accessibility is ensured.) (Spaces required: (1 to 25 // 1) (26 to 50 // 2) (51 to 75 // 3) (76 to 100 // 4) (101 to 150 // 5) (151 to 200 // 6) (201 to 300 // 7) (301 to 400 // 8) (401 to 500 // 9) (501 to 1,000 // *) (1,000 and over // **)) (**Twenty plus one for each 100, or fraction over 1,001.)	1991 ADAAG 4.1.2(5) 2004 ADAAG 208.3.1(2) 2007 CBC 1129B.1; 1129B.2; Table 11B-6 Other
Existing Condition: No accessible parking at reserved area.

Corrective Action
194 - Asphalt Paved Parking Stall and Access Aisle - Remove non-compliant pavement and replace with new asphalt paving. The parking space and access aisle slope shall not exceed 2% in any direction.
Additional Comments: Provide one Van accessible space with required signs.

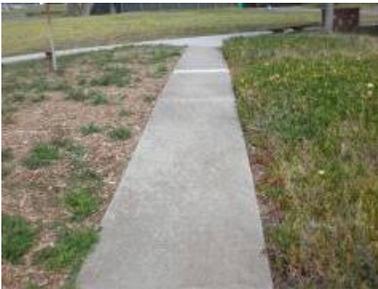
Keynote 137

Field Condition	
03B.04 - Width - Accessible route of travel is less than 48" wide (note: 48" wide requirement does not apply to doorways or gates).	1991 ADAAG 4.3.3
Existing Condition: 40" wide	2004 ADAAG 403.5.1
	2007 CBC 1133B.7.1
	Other -

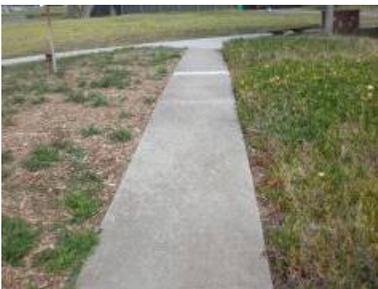
Keynote 138

Field Condition	
03B.09 - Cross Slope - Cross slope of the accessible route of travel exceeds 1:50.	1991 ADAAG 4.3.7
Existing Condition: 2.2%, 3.9%	2004 ADAAG 403.3
	2007 CBC 1133B.7.1.3
	Other -

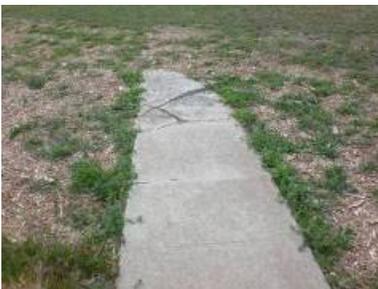
Keynote 140

Field Condition	
03B.15 - Surface - Accessible route surfaces are not stable, firm and slip-resistant. Existing Condition: Cracks	1991 ADAAG 4.5.1 2004 ADAAG 302.1; Advisory 302.1 2007 CBC 1124B.1 Other -

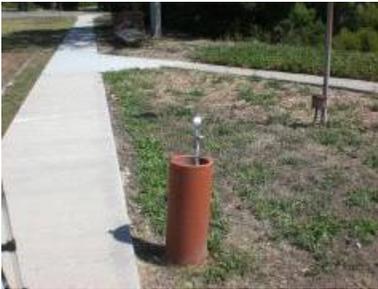
Keynote 141

Field Condition	
05.16 - Other - Drinking Fountains - See Additional Comments	1991 ADAAG -
Existing Condition: Non compliant DF & no WC approach.	2004 ADAAG -
	2007 CBC -
	Other -

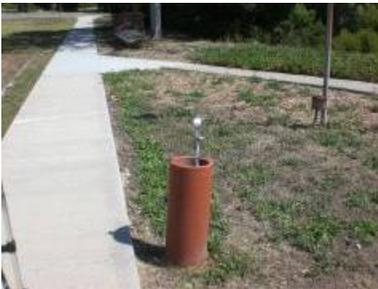
Location: Photo #
Walkway from Comm. Dev. Bldg. to Ch 33 Bldg. 141

Field Condition	
03B.09 - Cross Slope - Cross slope of the accessible route of travel exceeds 1:50.	1991 ADAAG 4.3.7
Existing Condition: 3.1% at landing.	2004 ADAAG 403.3
	2007 CBC 1133B.7.1.3
	Other -

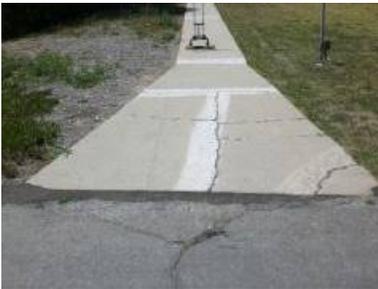
Location: Walkway from Comm. Dev. Bldg. to Ch 33 Bldg.
 Photo # 141

Field Condition	
03B.15 - Surface - Accessible route surfaces are not stable, firm and slip-resistant. Existing Condition: Cracks	1991 ADAAG 4.5.1 2004 ADAAG 302.1; Advisory 302.1 2007 CBC 1124B.1 Other -

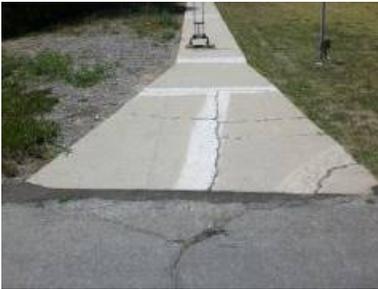
Keynote 145

03B.21 - Hazardous Vehicular Areas - Detectable Warnings - Where a walk crosses or adjoins the vehicular way and the walking surface is not separated by curbs, railings, or other elements between the pedestrian areas and vehicular areas, the boundary between the areas is not defined by a continuous detectable warning at least 36" wide complying with CBC 1121B.3.1 item 8(a). (i.e., the warning surface shall contrast visually with adjoining surfaces, either light on dark or dark on light, and shall differ from adjoining walking surfaces in resiliency or sound on cane contact. Color: yellow conforming to Federal Color No. 33538, Table IV/ Standard No. 595B. Where the color value contrast between the yellow warning and the main walking surface is less than 70 percent, a 1" wide black strip shall separate the yellow warning from the main walking surface.)

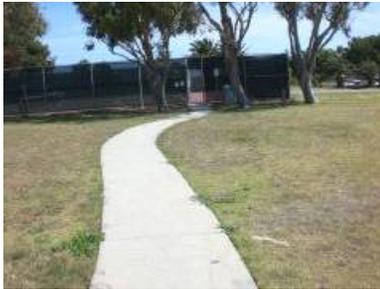
Location: Tennis Walkway
Photo # 148

Field Condition	
03B.09 - Cross Slope - Cross slope of the accessible route of travel exceeds 1:50. Existing Condition: 3.3%, 3.9%, & 4.7%	1991 ADAAG 4.3.7 2004 ADAAG 403.3 2007 CBC 1133B.7.1.3 Other -

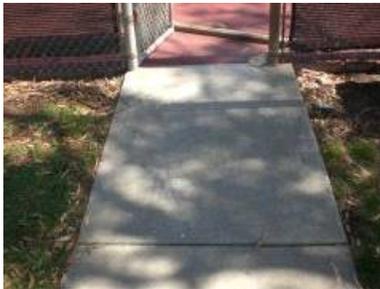
Location: Tennis Entrance
Photo # 149

Field Condition	
03B.12 - > 1/4" Changes in Level - Where walkway levels change abruptly, the vertical difference between them exceeds 1/4 inch. Or changes in level between 1/4 inch and 1/2 inch are beveled with a slope greater than 1:2. Existing Condition: 1/4" high	1991 ADAAG 4.5.2 2004 ADAAG 303.2; 303.3 2007 CBC 1124B.2 Other -

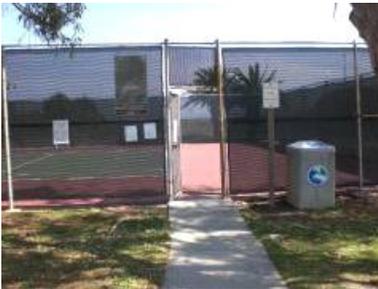
Location: Tennis Entrance
Photo # 150

Field Condition	
10.02 - Entrance Sign - Accessible entrance is not identified by an ISA.	1991 ADAAG 28 CFR 35.163(b)1
Existing Condition:	2004 ADAAG 216.6
	2007 CBC 1117B.5.8.1.2
	Other -

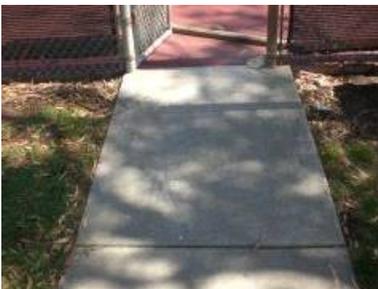
Location: Tennis Entrance
Photo # 149

Field Condition	
10.07A - Landing - Level and Clear - Floor is not level (slope is greater than 2% in some or all directions). OR Floor is not clear within the required maneuvering space.	1991 ADAAG 4.13.6; Fig. 25
Existing Condition: 8.2% & no strike clearance.	2004 ADAAG 305; 404.2.4.4
	2007 CBC 1133B.2.4
	Other -

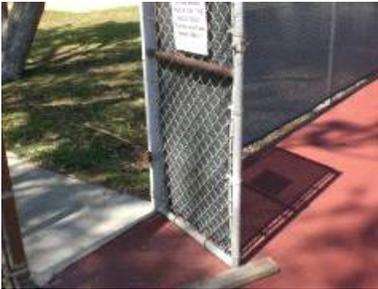
Location: Tennis Entrance
Photo # 152

Field Condition	
10.08 - Kick Plate - Bottom 10" of door does not have a smooth, uninterrupted surface on the push side to allow the door to be opened by a wheelchair footrest without creating a trap or hazardous condition. (This requirement does not apply to automatic and sliding doors.)	1991 ADAAG -
Existing Condition:	2004 ADAAG 404.2.10
	2007 CBC 1133B.2.6
	Other -

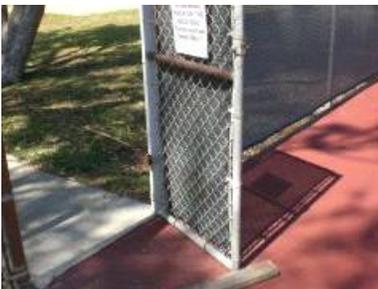
Location: Tennis Entrance
Photo # 152

Field Condition	
10.11A - Door Operating Effort - The force required to operate door exceeds 5 lbs. (Fire doors may have up to 15 lbs to achieve positive latching).	1991 ADAAG 4.13.11
Existing Condition: Door scrapes.	2004 ADAAG 404.2.9
	2007 CBC 1133B.2.5
	Other -

Corrective Action
058 - Realign Door Mounting - Realign existing door so door does not scrape against the jamb. Remove and replace existing door hinges.
Additional Comments:

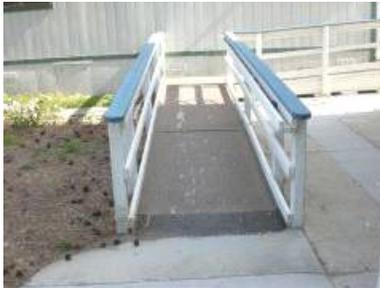
Photo #
154

Existing Condition: 45" clr.

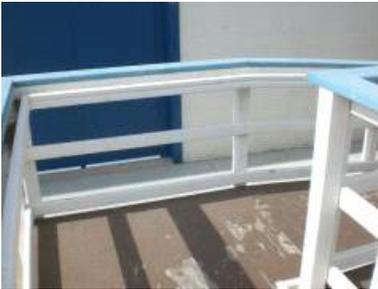
Location: Ramp at Ch 33 Bldg. Photo # 156

Field Condition	
07.11A - Intermediate Landing - Change of Direction - Where there is an intermediate landing, and the ramp changes direction (>30-degree), the landing is less than 72" x 60".	1991 ADAAG 4.8.4(3)
Existing Condition: 73" long 45" wide.	2004 ADAAG 405.7.4
	2007 CBC 1133B.5.4.6
	Other -

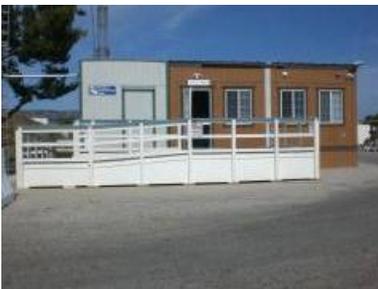
Location: Ramp at Ch 33 Bldg. Photo # 157

Field Condition	
07.14B - Guards - Where drop exceeds 30", a min.. 42" high guard has not been provided as a vertical barrier along the open edges of ramp or landing to prevent persons from falling off the open edge.	1991 ADAAG 4.8.7
Existing Condition: 32 3/4" high guards.	2004 ADAAG 405.9; 405.9.2
	2007 CBC 1013; 1133B.5.7
	Other -

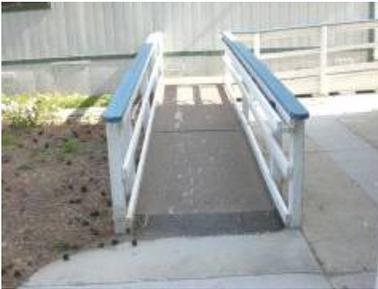
Location: Ramp at Ch 33 Bldg. Photo # 154

Field Condition	
07.21A - Extensions - Required Length - At ends of handrails, less than 12" of handrail extends beyond the top and bottom of the ramp segment. (Top and bottom handrail extensions are important safety features for persons with mobility impairments and must extend in the direction of the ramp run to permit the intended use.) (Per CBC 1133B.5.5.1.1, in existing buildings or facilities, where the extension of the handrail in the direction of the ramp run would create a hazard, the extension on the handrail may be turned 90 degrees to the run of the ramp.)	1991 ADAAG 4.8.5 (2) 2004 ADAAG 505.10; 505.10.1; Fig. 505.10.1 2007 CBC 1133B.5.5.1; 1133B.5.5.1.1 Other -
Existing Condition: One provided.

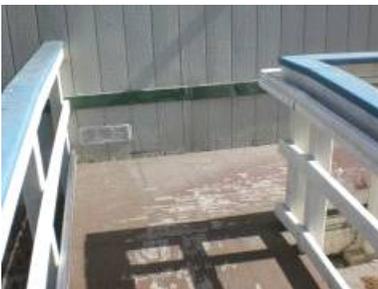
Location: Ramp at Ch 33 Bldg. Photo # 159

Field Condition	
07.24 - Clearance - The clear space between handrails and walls is not 1-1/2" absolute. (ADA/CBC Standards apply an absolute dimension of 1-1/2", which provides knuckle clearance while generally disallowing entrapment of the forearm or elbow.)	1991 ADAAG 4.8.5; 4.26.2; Fig. 39 2004 ADAAG 505.5; Fig. 505.5 2007 CBC 1133B.5.5.1 Other -
Existing Condition: 2 1/8" clr.

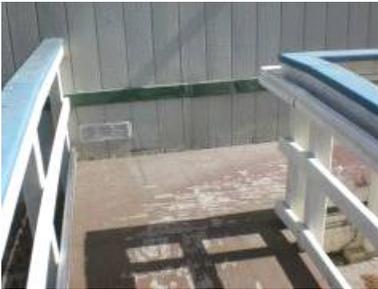
Location: Ramp at Ch 33 Bldg. Photo # 159

Field Condition	
07.16 - Handrails - Slope of the ramp exceeds 5%, and handrails are not provided on each side. (Per CBC 1133B.5.5.1, at exterior door landings, handrails are not required on ramps less than 6" high or 72" long. Handrails are not required on curb ramps or adjacent to fixed seating in assembly areas.)	1991 ADAAG 4.8.5
Existing Condition:	2004 ADAAG 405.8; 505.2
	2007 CBC 1133B.5.5.1
	Other -

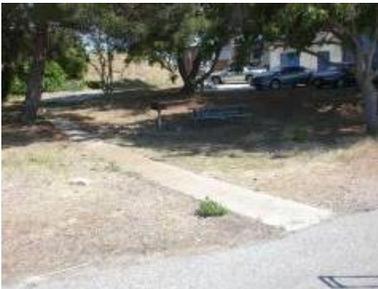
Location: N. of Ch 33 Bldg. Picnic Area Photo # 161

Field Condition	
03B.05A - Passing Spaces - Where the accessible route of travel is less than 60" wide, passing spaces at least 60" by 60" or intersecting walks, allowing passing at reasonable intervals not exceeding 200', are not provided.	1991 ADAAG 4.3.4
Existing Condition: 30" wide walkway	2004 ADAAG 403.5.3
	2007 CBC 1133B.7.1
	Other -

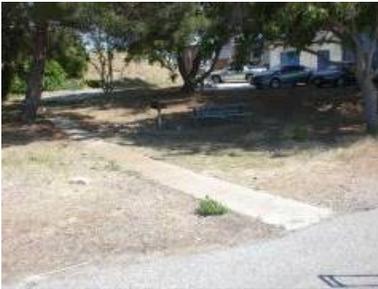
Location: N. of Ch 33 Bldg. Picnic Area
 Photo # 161

Field Condition	
03B.10 - Running Slope - Slope of the accessible route of travel exceeds 1:20. Existing Condition: 7.6%	1991 ADAAG 4.3.7 2004 ADAAG 403.3 2007 CBC 1133B.7.3 Other -

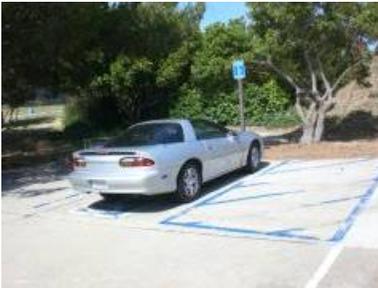
Photo #
166

Existing Condition: 7'-7" wide

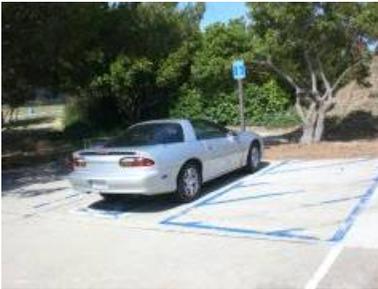
Location: Parking at Ch 33 Bldg.
 Photo # 166

Field Condition	
01.18 - Pavement Sign - A 36" square ISA is not painted on the pavement at the rear of the stall.	1991 ADAAG -
Existing Condition: 48" x 48"	2004 ADAAG 502.6
	2007 CBC 1129B.4
	Other

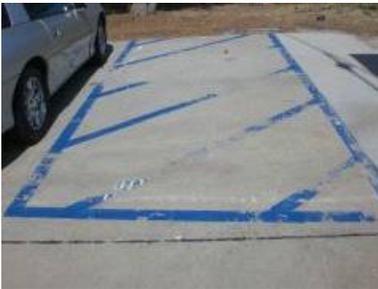
Location: Parking at Ch 33 Bldg.
 Photo # 169

Field Condition	
01.19A - Lettering - The words "NO PARKING" is not provided in each access aisle, painted in white, 12" high letters.	1991 ADAAG -
Existing Condition:	2004 ADAAG -
	2007 CBC 1129B.3 items 1 & 2
	Other

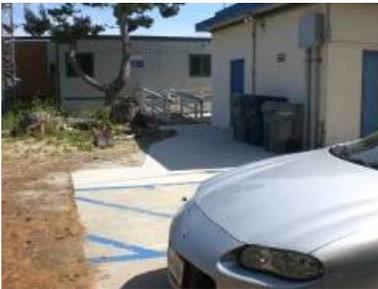
Location: N. Walkway at Ch 33 Bldg.
Photo # 172

Existing Condition: 6.1%

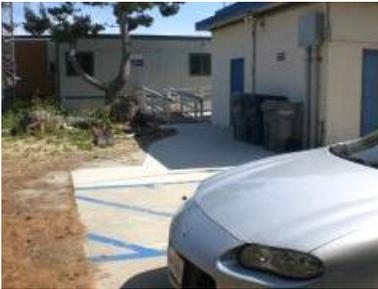
Location: N. Walkway at Ch 33 Bldg.
Photo # 172

Field Condition	
03B.09 - Cross Slope - Cross slope of the accessible route of travel exceeds 1:50. Existing Condition: 2.7% & 11.4 from accessible bldg. entrances.	1991 ADAAG 4.3.7 2004 ADAAG 403.3 2007 CBC 1133B.7.1.3 Other -

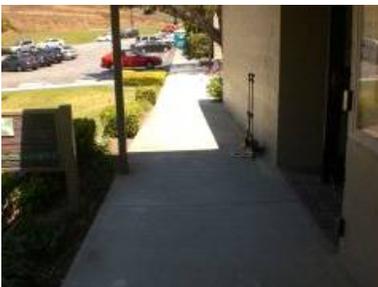
Location: N. of Comm. Dev. Bldg.
Photo # 173

Field Condition	
03B.10 - Running Slope - Slope of the accessible route of travel exceeds 1:20. Existing Condition: 5.9%, 5.2%, 5.9%	1991 ADAAG 4.3.7 2004 ADAAG 403.3 2007 CBC 1133B.7.3 Other -
